Management of Audio Tactile Edge Line Markings

Project No. 952

This R&D project No.952 "Management of Audio Tactile Edge Line Markings" considered whether the audio and vibration characteristics of the audio tactile edge line markings (ATELM) were compromised after various maintenance treatments.

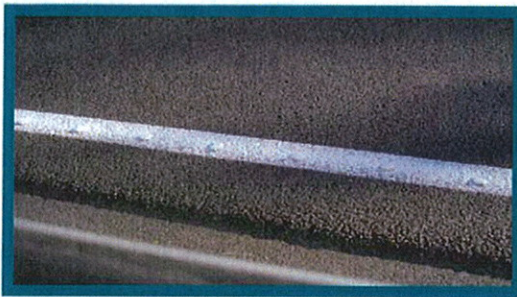
Fig 1
Audio Tactile Edge Line Marking not meeting Specification

Generally ATELM has been installed in accordance with the specified requirements, ie 200mm spacing, bar length 150mm, 50mm wide and 8mm high. However during the course of the desk top study a small number of sites were found that deviated from the standard. Figs 1 & 2 provide some examples. It is not known whether this installation was the accepted ATELM or whether this is poor placement of the ATELM. These sites did provide poor audio and vibration responses.

It is recommended that should these issues arise they are addressed if specified correctly in the Contract during the defects liability period, ensuring that the effectiveness of the ATELM installation is as expected by VicRoads and the travelling public.

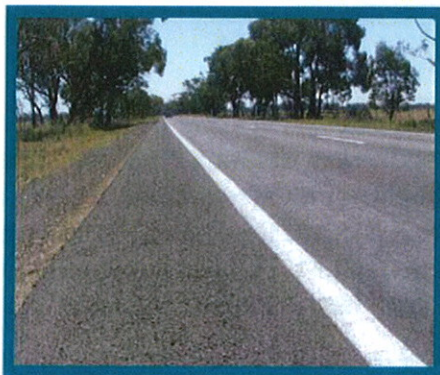
Sites where a 7mm seal was placed over the existing ATELM during a reseal program, audio and vibration responses were assessed as reasonable.(e.g. Sites 4E, 4F and 4J). See Fig 3 & 4 for examples.

Sites with a 7mm seal over the ATELM

- 7mm seals, over the ATELM will provide a reasonable audio and vibration response;
- 10mm seals, will provide a medium response and thus this treatment is considered marginal and reinstatement of the ATELM is recommended;
- 14mm seals, poor response, treatment considered not desirable, reinstatement of the audio tactiles or a review of the treatment selected; and
- Geotextile seals, (similar to 14mm seals), over the ATELM will provide poor audio and vibration responses and removal and reinstatement of the audio tactile edge line marking is considered appropriate.

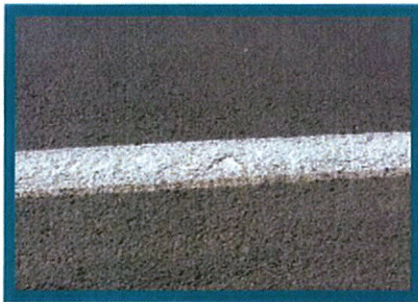
The sites that had a geotextile reinforced seal (e.g. Geotextile 14/7mm seal), the fabric tended to bridge the ATELM bars, see Fig 5& 6. There was some breaking of the seal and geotextile “bridging” the underlying tactile bars.

Geotextile and 14/7mm seal

It is recommended that when this treatment is being proposed that the ATELM be removed and replaced. This “bridging” effect did reduce the observed audio and vibration response, into the poor category.

(f) When using geotextile based treatments it appears good practice that the ATELM be removed prior to and replaced after sealing. This will ensure that bridging does not become an issue and subsequent loss of audio and vibration responses.

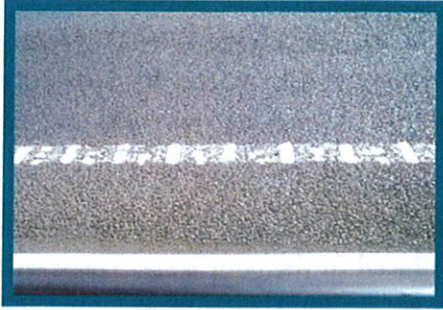
Some ATELM reinstatement works are of dubious quality and some observations of maintenance works are shown in Figs 7 and 8.

Fig 7
Intermediate reinstatement

It is recommended that care should be taken when reinstating A TELM so that bars are reinstated rather than additional intermediate bars being generated, see Fig 7. Care should also be taken when reinstating or relocating A TELM to avoid mixed or confusing information to the road users, see Fig 8.

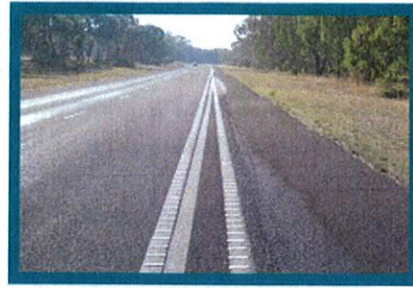
Fig 8
A TELM not removed or relocated
