road safety hardware series

Pipe Handrails and Fences TM-2011

May 2013

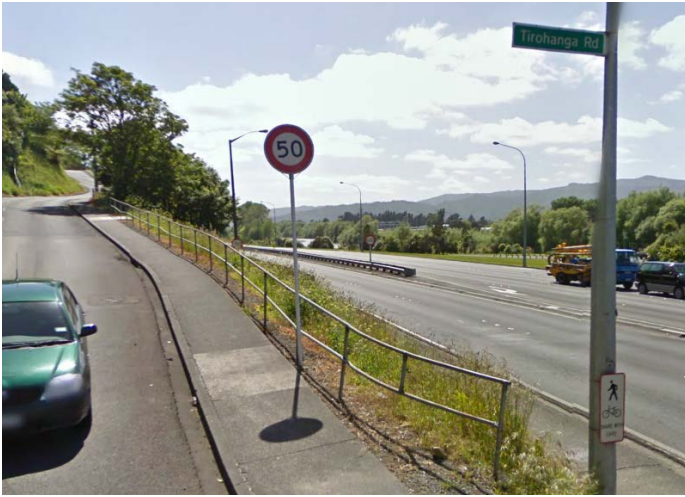
Figures 1 to 4 below show the site of a serious injury crash involving an un-welded tubular pedestrian handrail. The top rail passed completely through the vehicle, seriously injuring a passenger. The site is on a local road adjoining a State highway and has now been upgraded using a complaint road safety barrier system.

Figure 1: Typical pedestrian handrail

Notwithstanding any other code compliance issues required by the road controlling authority (whether NZ Transport Agency or local authority), in all installations, the horizontal and vertical elements must be secured together by full strength welds around the entire circumference of all joints.

All welds must be complete penetration welds which conform to the requirements of AS/NZS 1554.1:2011, and damaged galvanizing repaired as recommended by AS/NZS 4680:2006 to prevent corrosion by the application of a zinc-rich primer.

A tack weld has insufficient strength to hold the elements together in a vehicle impact and therefore must not be used.

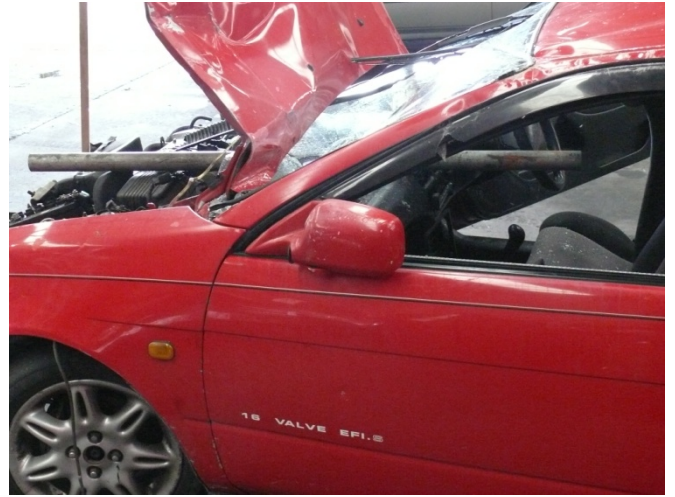
Figure 2: Entry point through front firewall

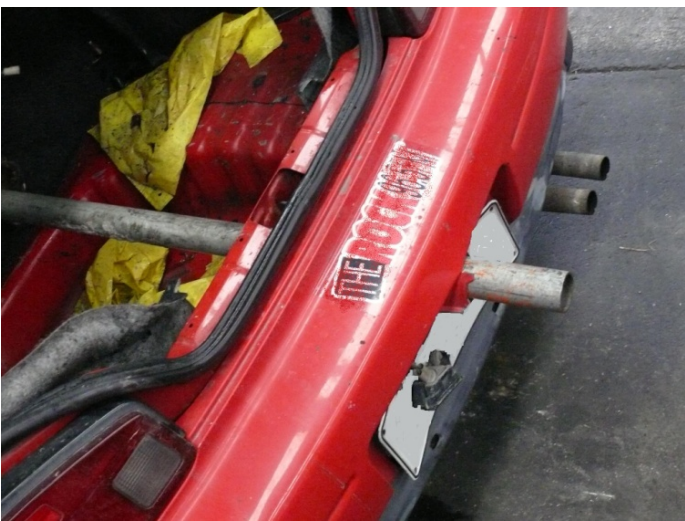
Figure 3: Exit point through rear bumper

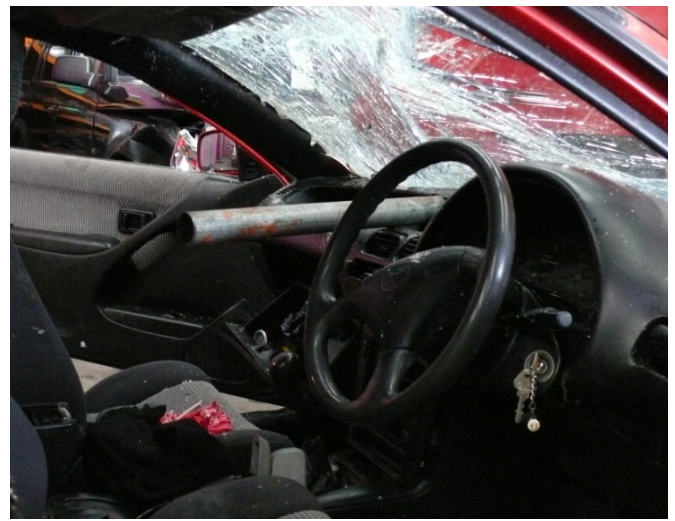
Figure 4: Front passenger area penetration
