**RISK ASSESSMENT
TECHNIQUES FOR OPTIMISING
SLOPE-FAILURE PREVENTIVE
MAINTENANCE PROGRAMMES**

Transfund New Zealand Research Report No. 134

RIDDOLLS & GROCOTT LTD
Christchurch, New Zealand

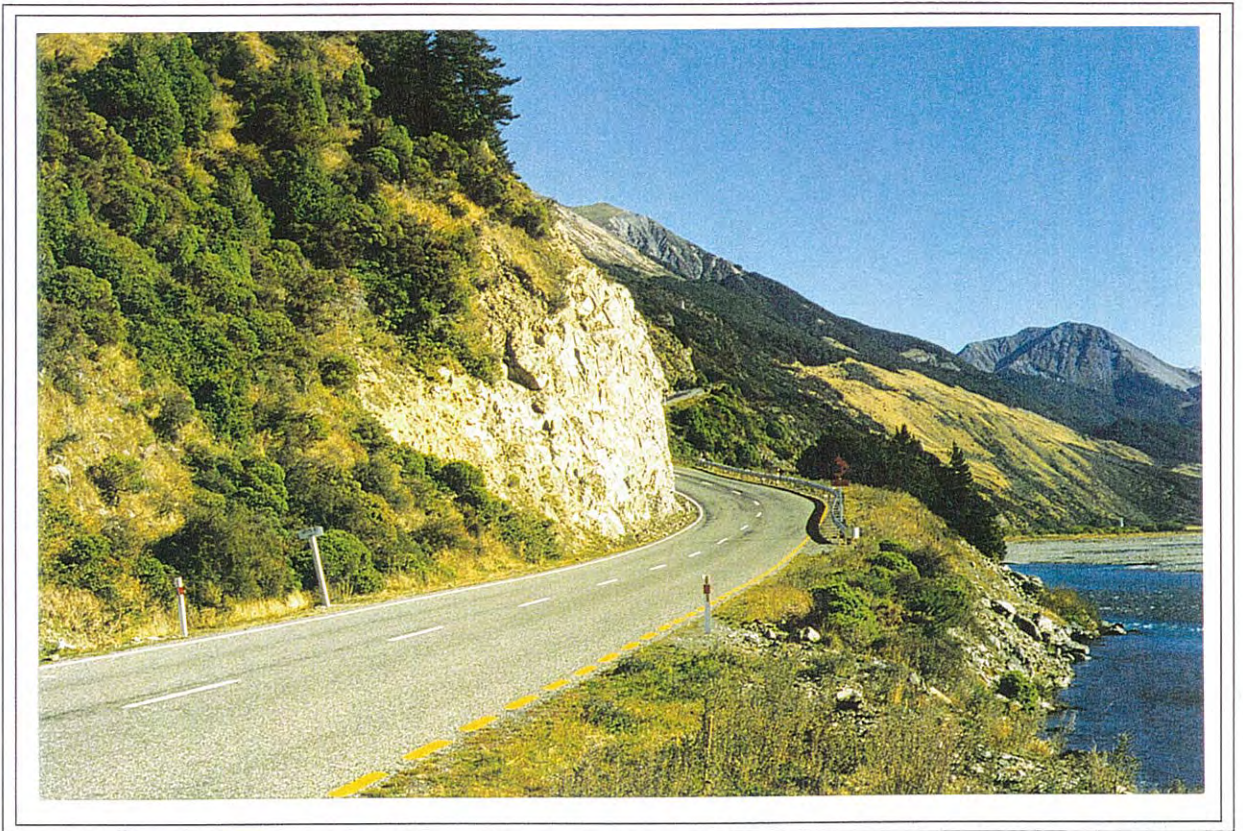
Figure 3.3 Site 2, view looking west towards Bealey, on the way to Arthur's Pass.

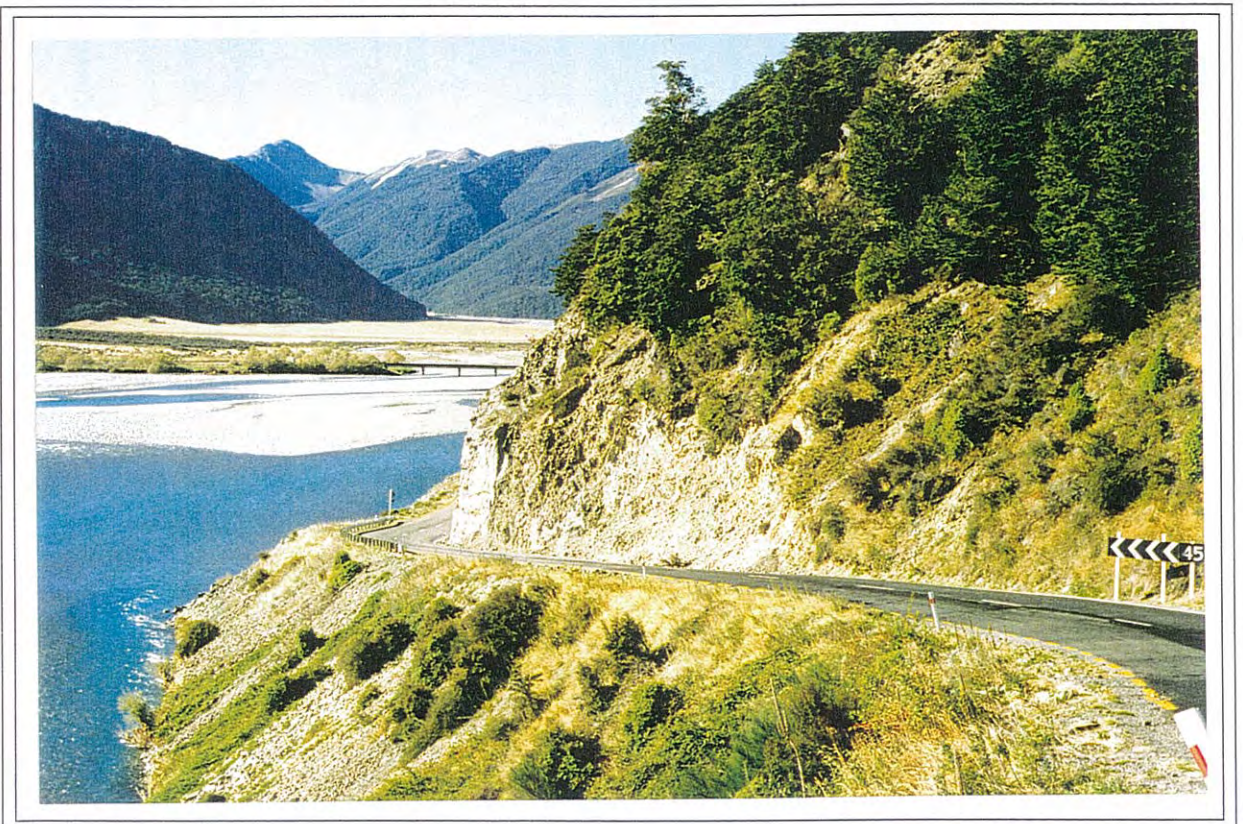
Figure 3.4 Site 2, view looking east towards Mt White bridge, on the way to Christchurch.

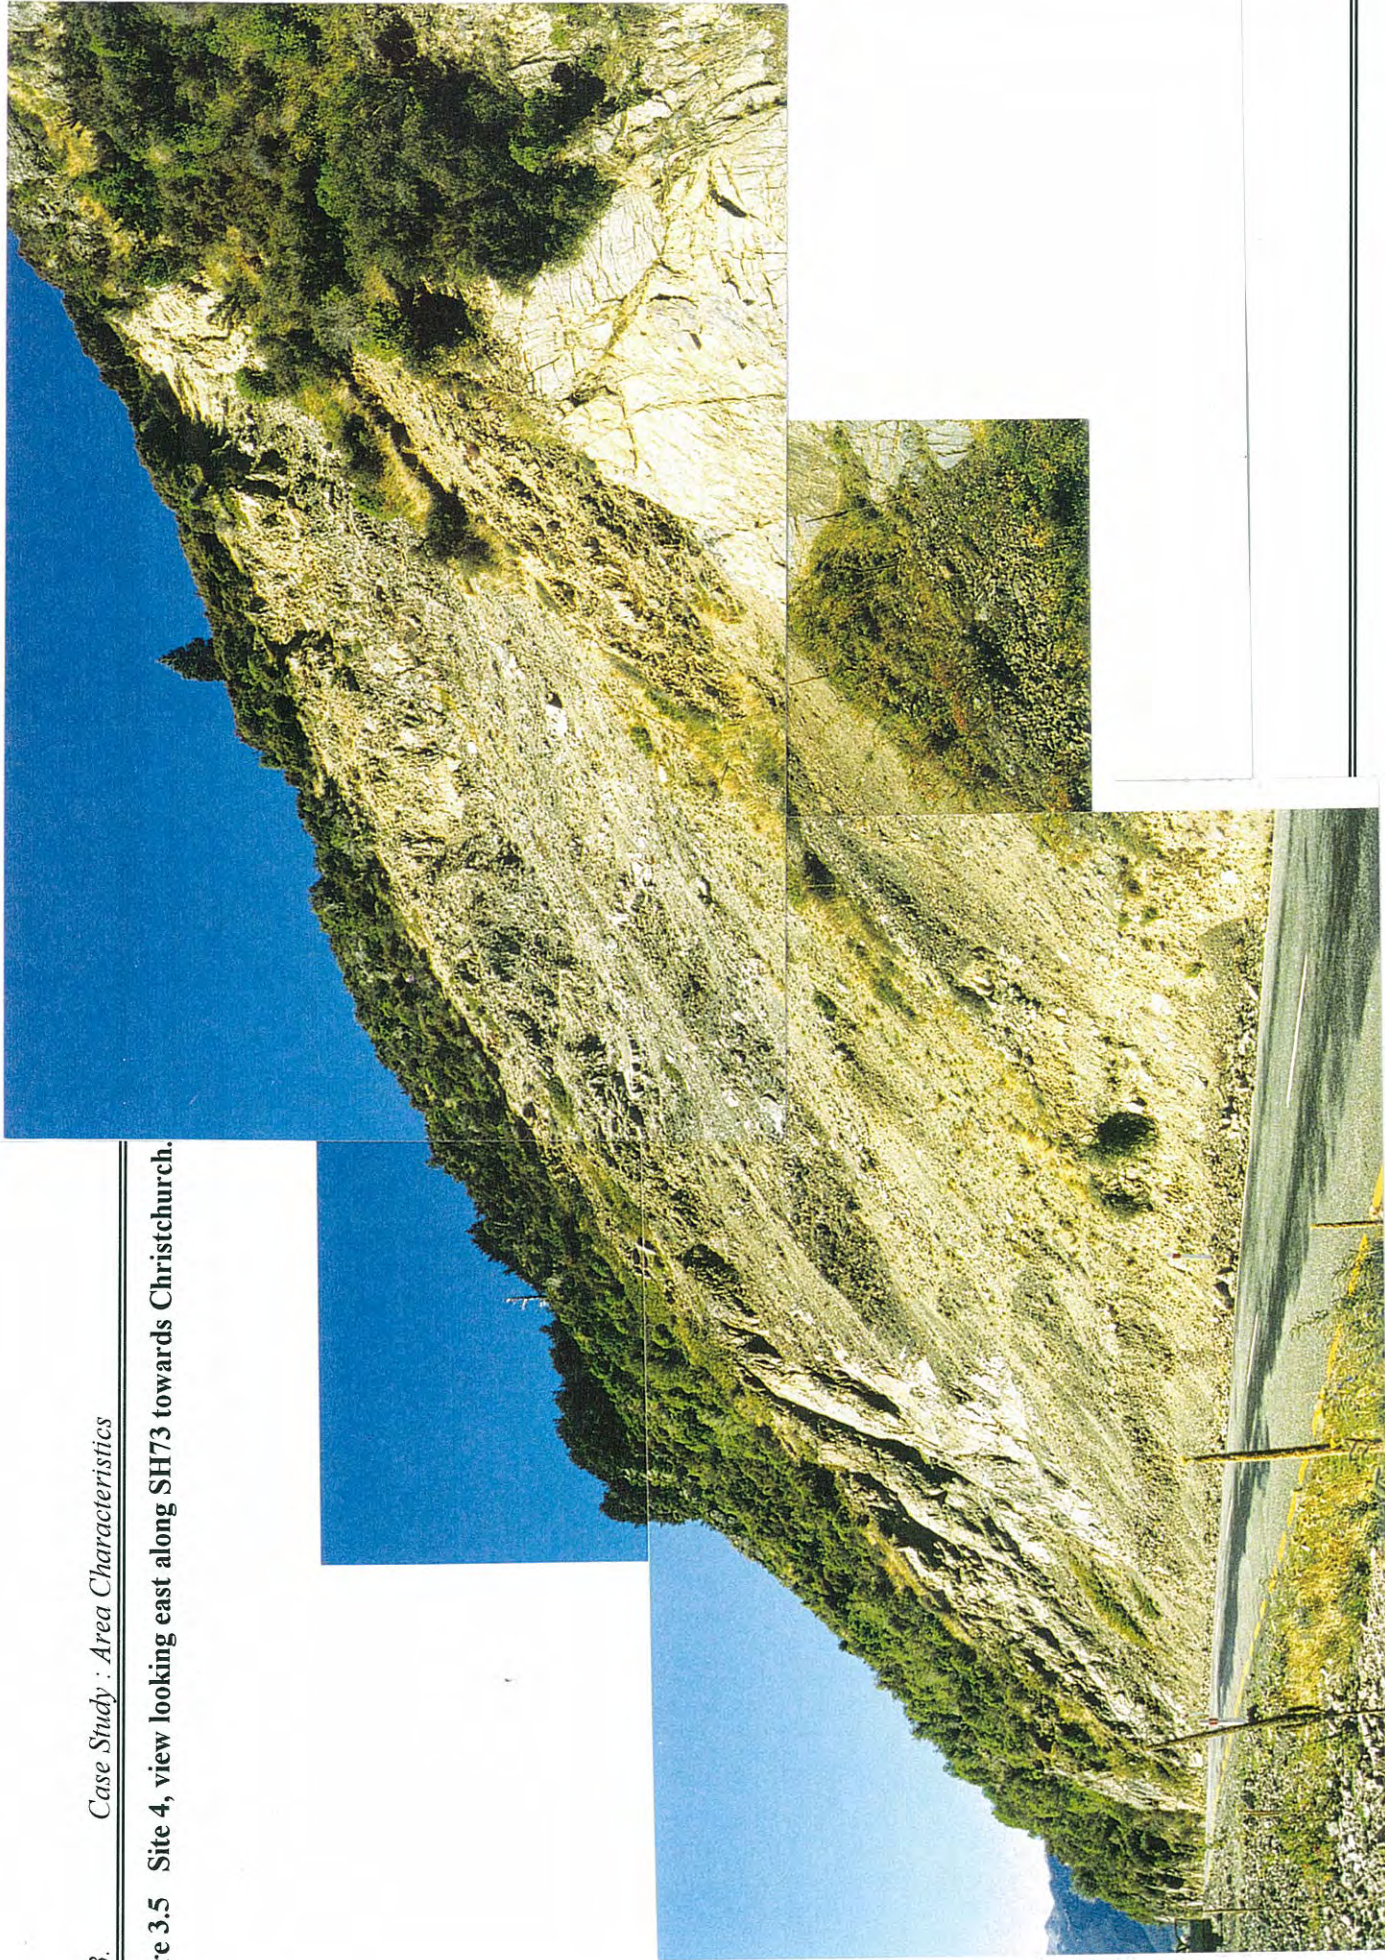
Figure 3.5 Site 4, view looking east along SH73 towards Christchurch.

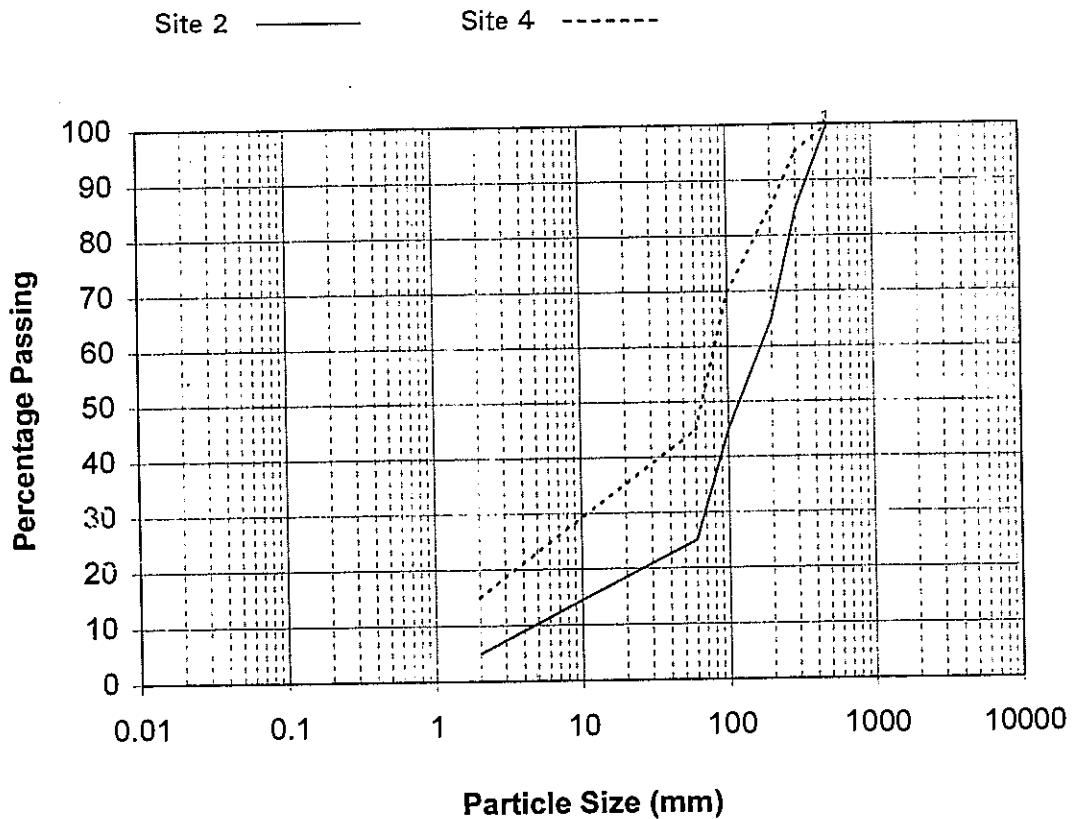
Figure 3.8 Particle size distribution of rockfall detritus.

The principal distinguishing engineering geological characteristic of the two sites is the greater degree of fracturing and hence closer spacing of rock mass defects at site 4. This characteristic is reflected in differences in the grading envelope for rockfall detritus derived from each of the sites. Figure 3.8 is based on a visual-manual assessment of the particle size distribution of rockfall detritus from sites 2 and 4, indicating the general coarsening of rockfall blocks at site 2 compared to site 4.

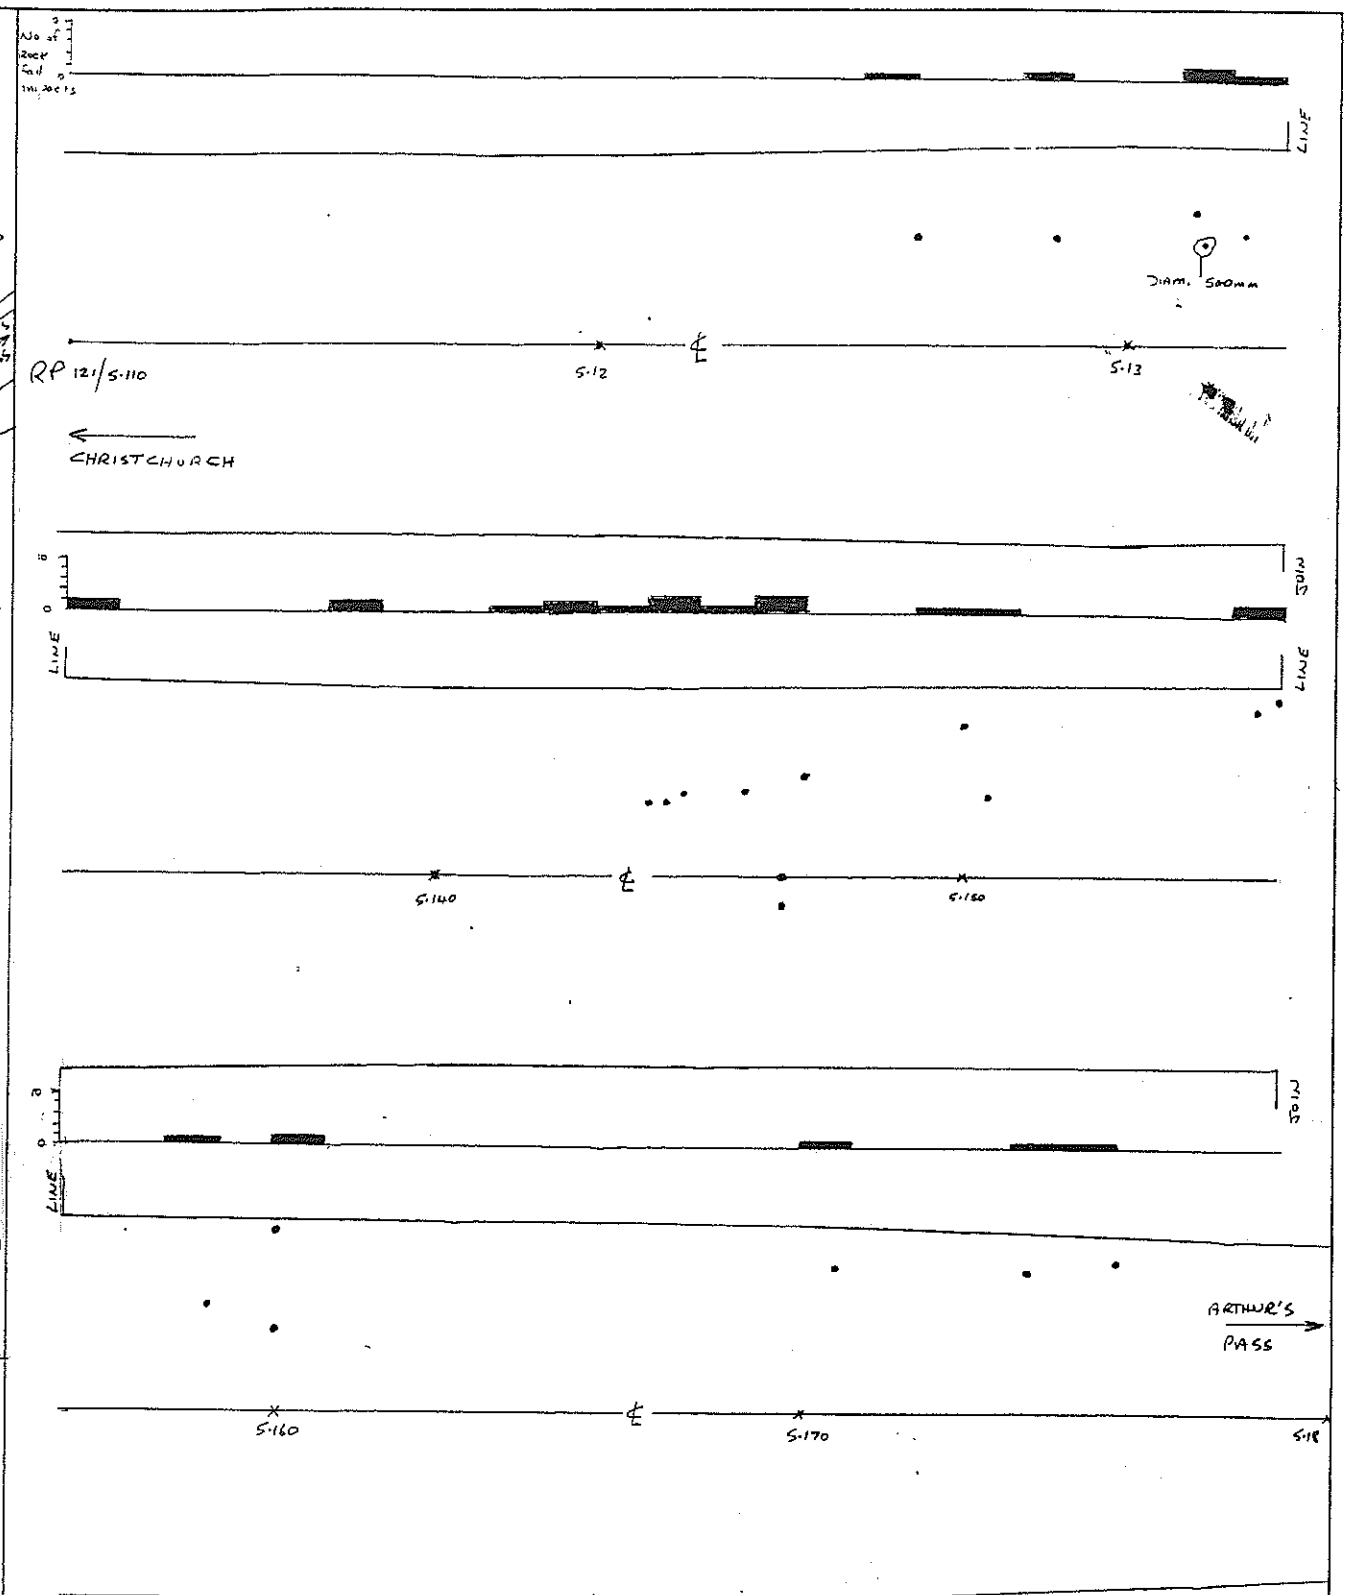
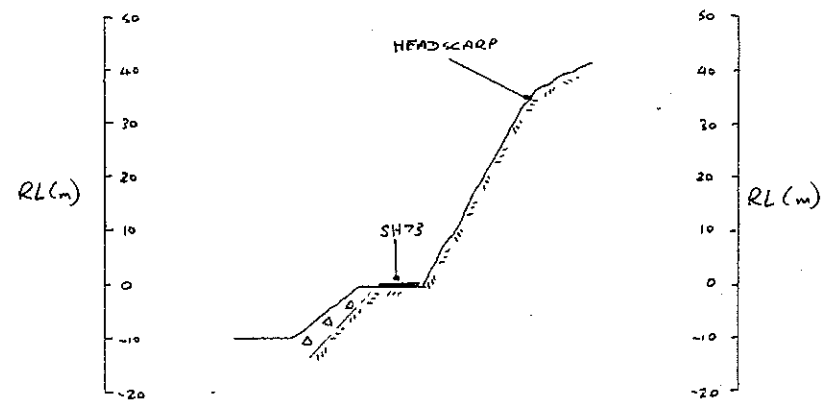
ENGINEERING GEOLOGICAL PLAN

1. Date of mapping 8/4/98
2. No. of impact marks = 22
3. Date of last pavement seal 1994
4. • Impact mark on road seal

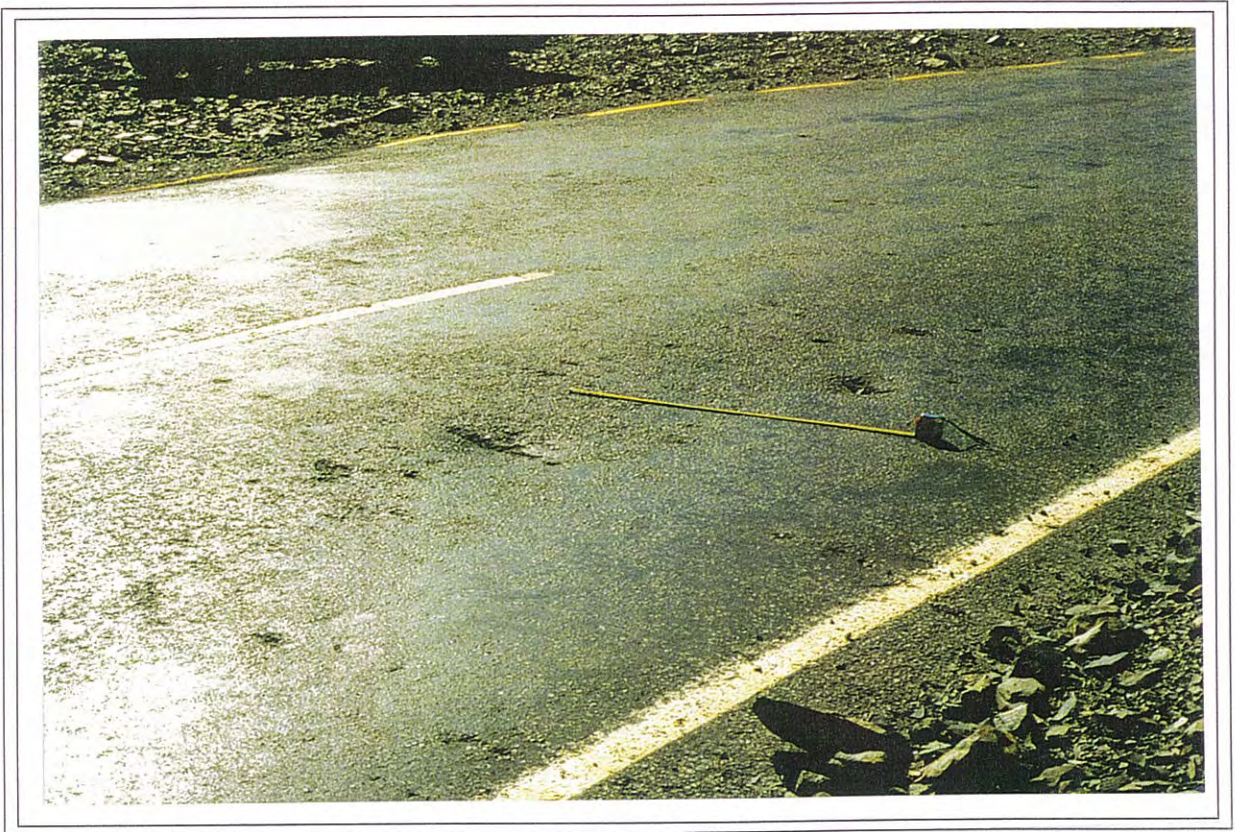
Figure 3.10 Rockfall impact marks at Site 4.
Inside lane closest to cut batter is in foreground.

At both sites 2 and 4, the number of impact marks are significantly less than the frequency of rockfall events determined through interviews of road maintenance personnel (Tables 3.5 and 3.6). A number of reasons account for this, including that blocks are not all of sufficient size to generate impact marks, and not all blocks will hit the road surface on full impact. This latter reason is considered to be the principal factor, as rockfall modelling shows that most rocks roll or bounce across the highway without impacting the pavement surface on the full (Appendix 4).

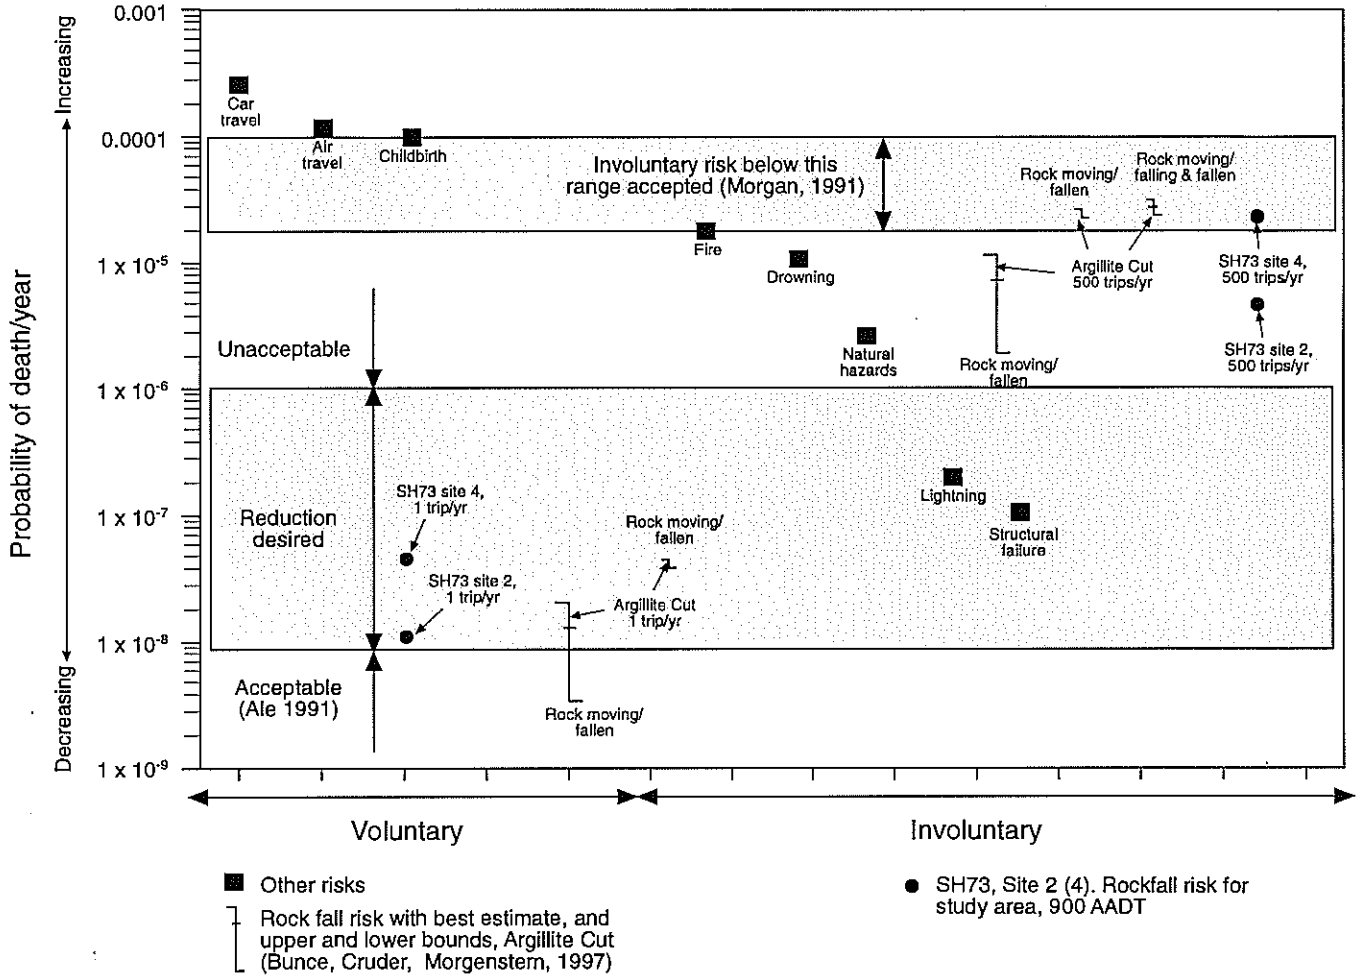
Figure 4.1 Probability of death of an individual at Sites 2 and 4, compared with involuntary and voluntary social activities (from Bunce et al. 1997).

Figure 4.1 is a summary of the risks accepted by society for a range of different activities. For comparison purposes, the risk of a fatal accident at sites 2 and 4 for an individual road user, $P(DI)$, has been calculated for the present case of 900 AADT, based on the methodology detailed in Section 3.4.3 and the results are shown on Figure 4.1. Figure 4.1 is subdivided into voluntary and involuntary risk; the former is considered to reflect a single trip per year (say for example a holiday maker travelling to the West Coast), while involuntary risk has been based on say 500 trips per year ($P(DI_{500})$) which would be the case for a freight truck operator returning daily between Christchurch and the Coast.

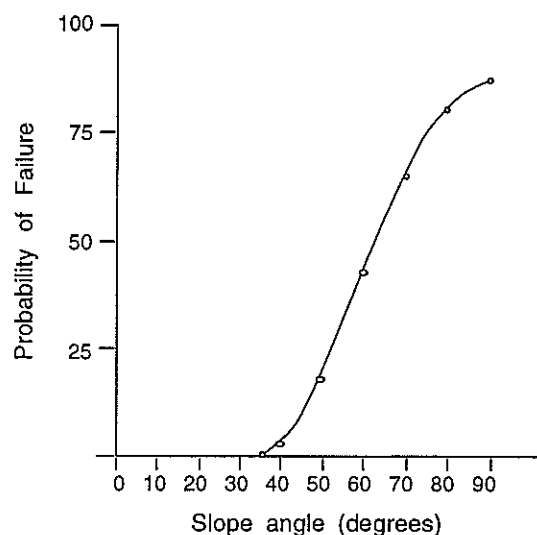
Figure 5.1 Curve of probability of failure versus slope (from McMahon 1971).

Numerical techniques are now sufficiently well advanced that, for any given slope (either rock or soil), the probability of failure can be computed for different angles of batter as illustrated in Figure 5.1 (McMahon 1971).

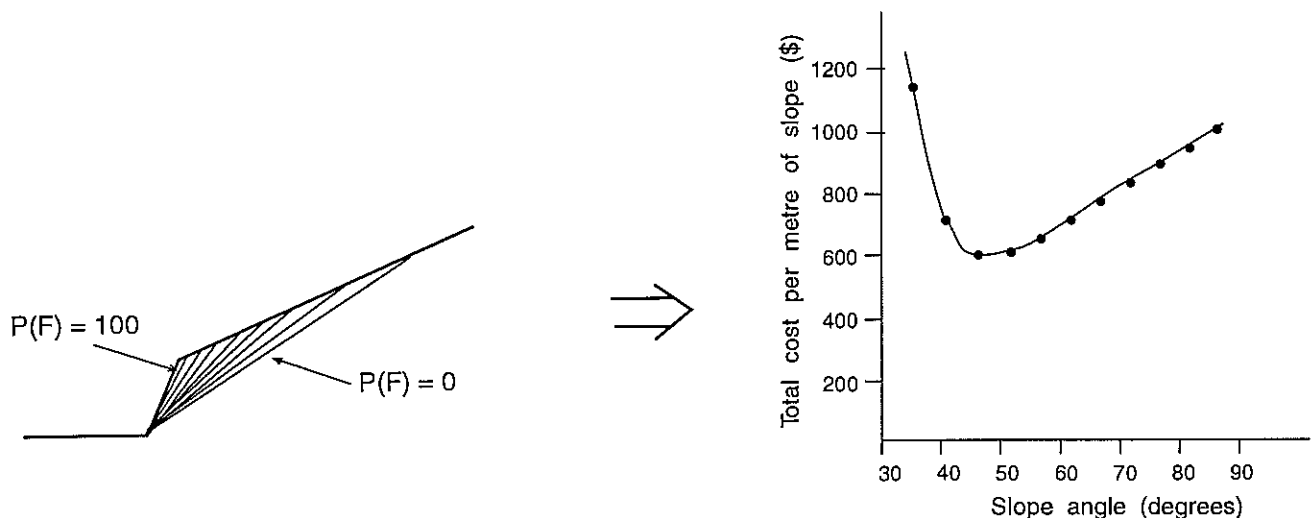
Figure 5.2 Relationship between failure volume V_f (in terms of slope angle) and failure probability $P(F)$.

As well as the probability of failure, which is itself uncertain, the other variables such as the volume of batter failure and the costs of failure are also uncertain, and best treated in terms of probability distributions using Monte Carlo simulations. Based on equation (4) above, the unit cost of failure can be determined as an incremental procedure by consideration of the product $V_f \cdot P(F)$ for a range of slope angles, as illustrated in Figure 5.2.

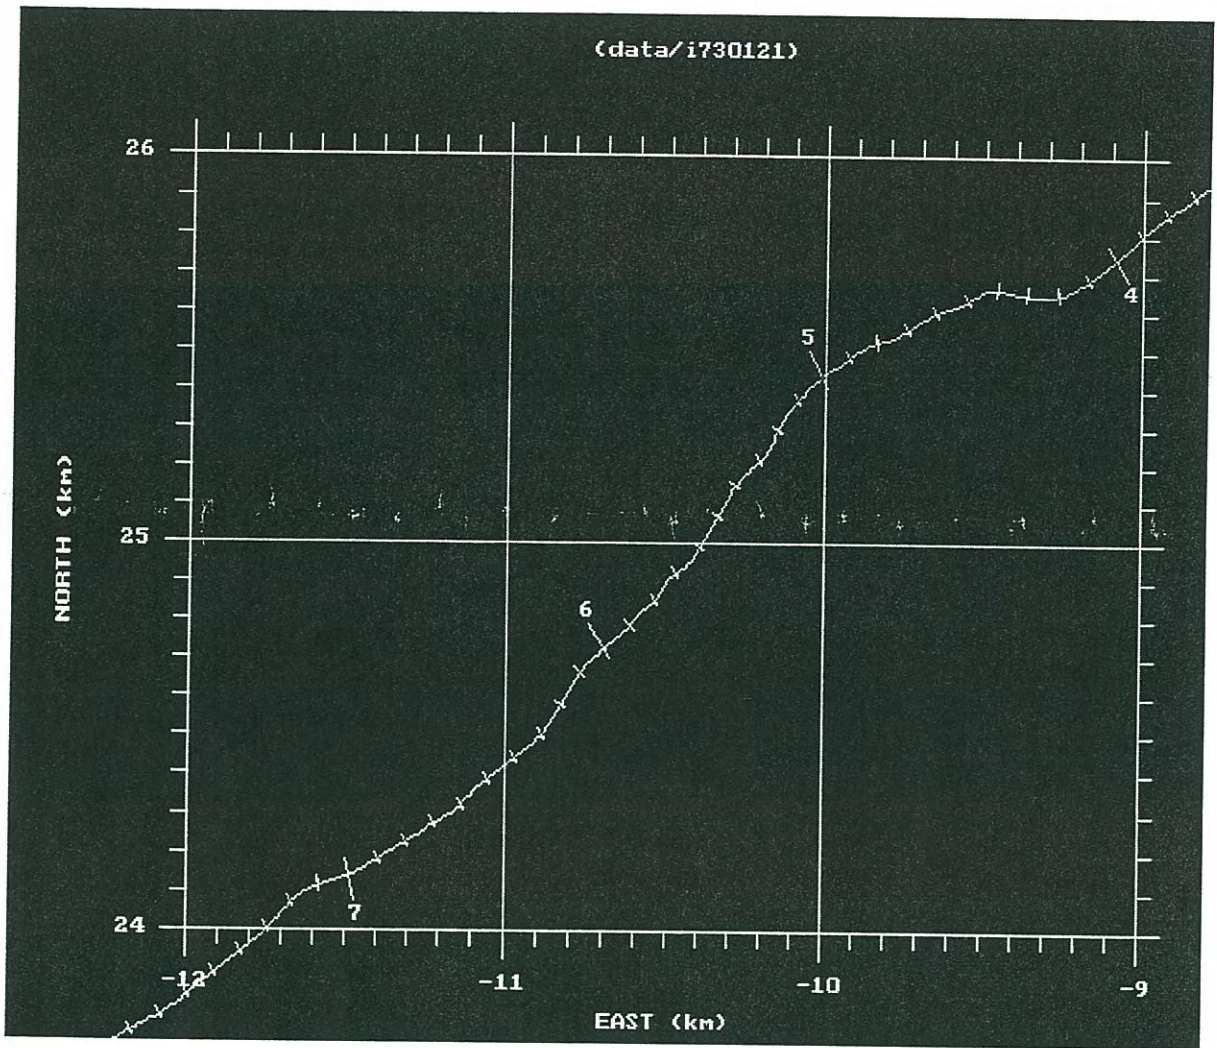
Plan showing SH73 RP121/4-7

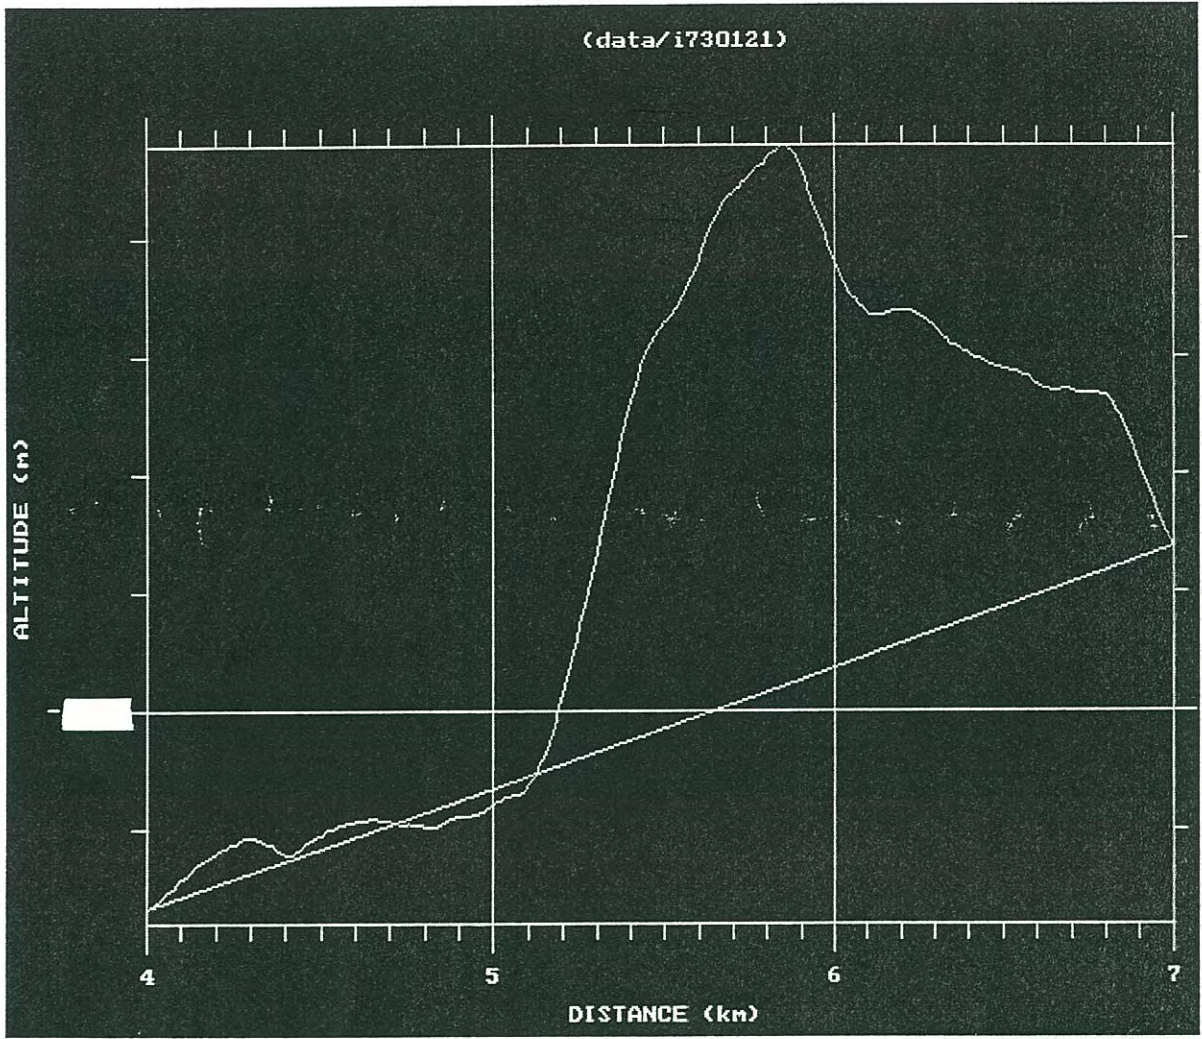
Vertical section SH73 RP121/4-7

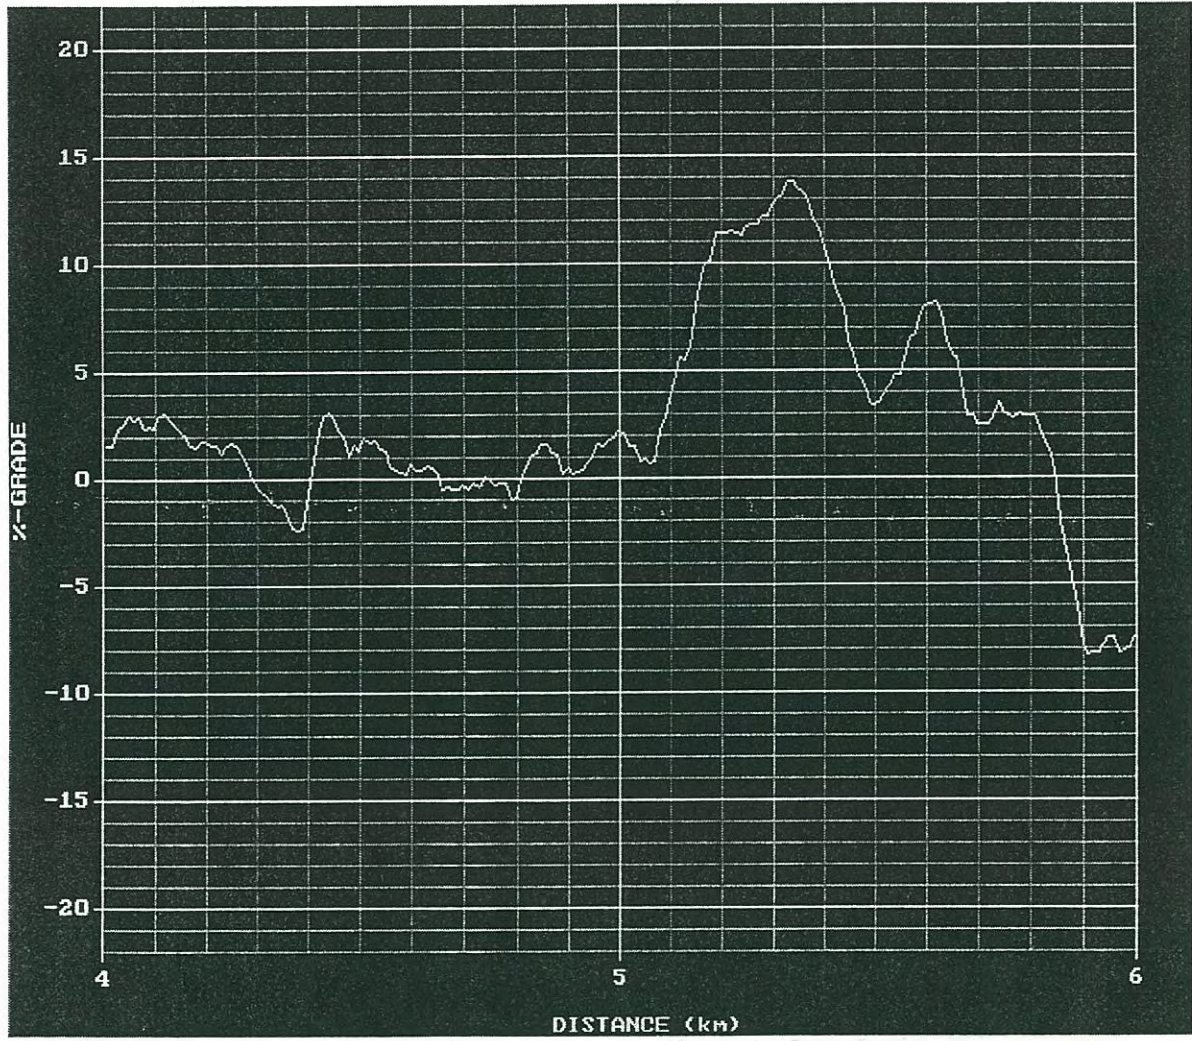
Gradient SH73 RP121/4-6

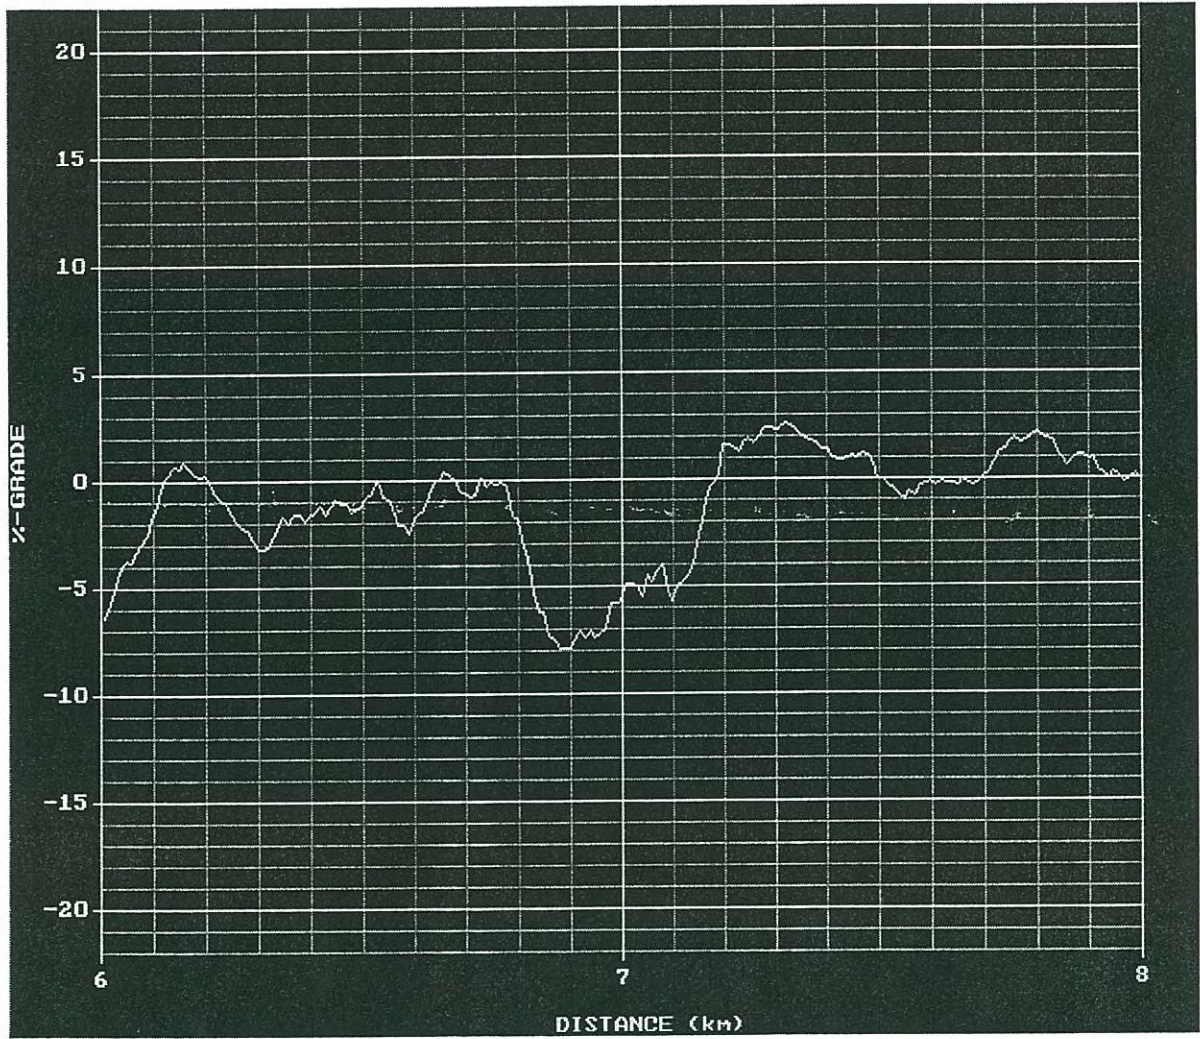
Gradient SH73 RP121/6-8

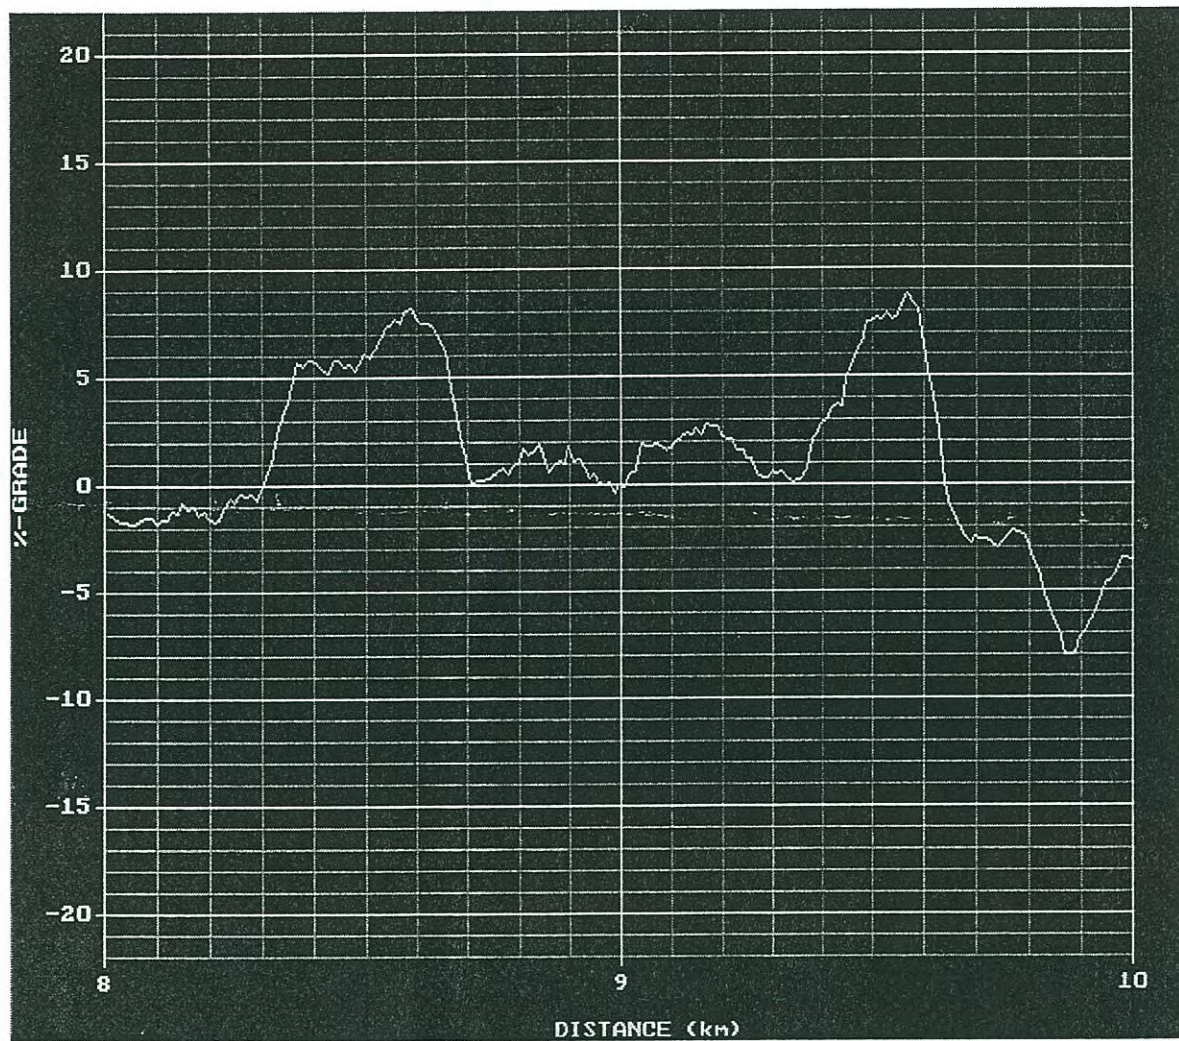
Gradient in decreasing RP lane, i.e. RP136/8-10 km back

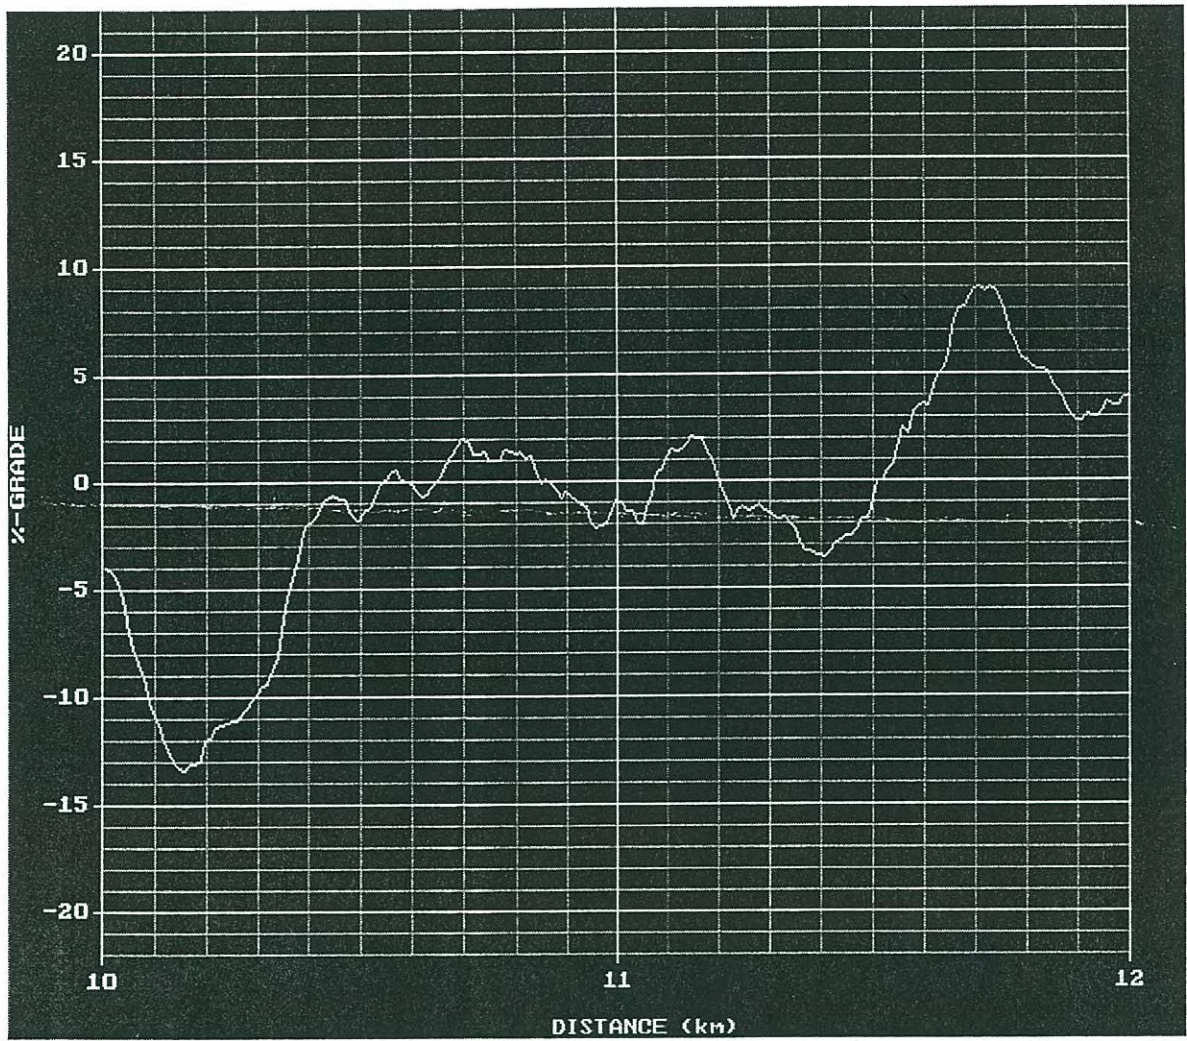
Gradient in decreasing RP lane, i.e. RP136/10-12 km back
