Applications for asphalt millings on New Zealand roads

R.J. Peploe
Bartley Consultants Ltd, Auckland

Bartley Consultants Ltd. 2006. Applications for asphalt millings on New Zealand roads. *Land Transport New Zealand Research Report 298*. 96 pp.

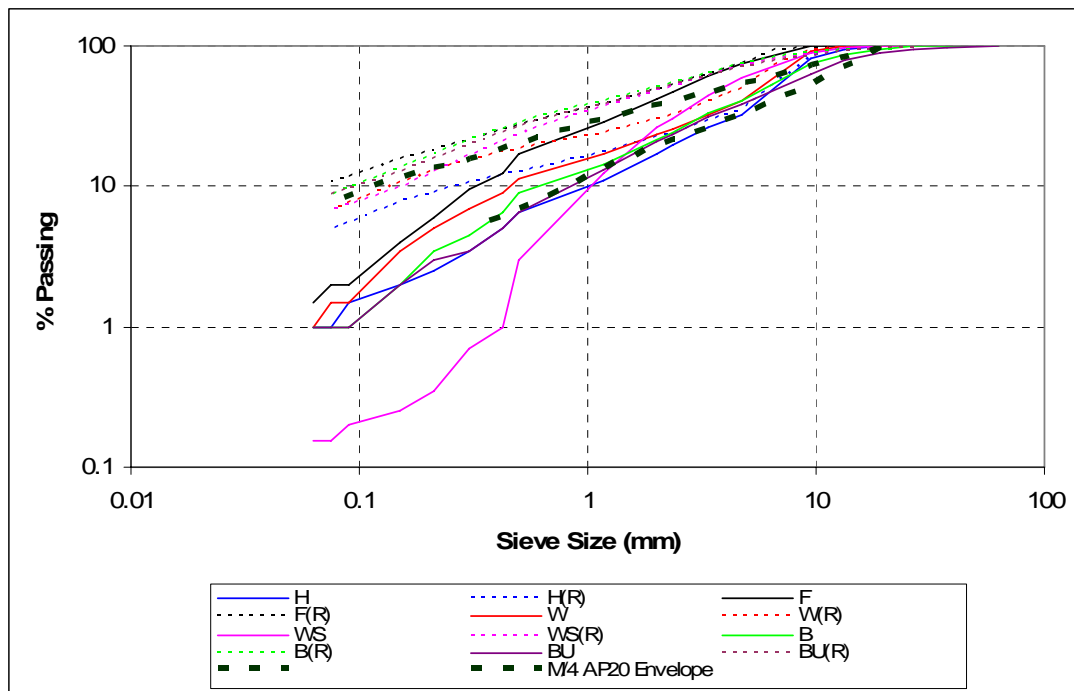
Figure 3.1 Test results for particle size distribution compared to TNZ M/4 AP20 standard.

Samples: Solid lines = as-received samples
 Dotted lines = residual samples (R) post-binder extraction
 Heavy dashed lines = the M/4 AP20 envelope

As a general observation, the as-received samples plotted outside, or close to, the fine side of the TNZ M/4 AP20 envelope for the fraction over about 10 mm. However, the converse was observed for the fraction below approximately 10 mm, with the exception of the Fulton Hogan sample. The generally low proportion of particles in the fine fraction suggests that the material would be reasonably free-draining, although it may suffer from a lack of stability if fine particles are insufficient to 'lock-up' the interstices between the larger particles. This may also make the material somewhat 'lively' and consequently difficult to place and compact.

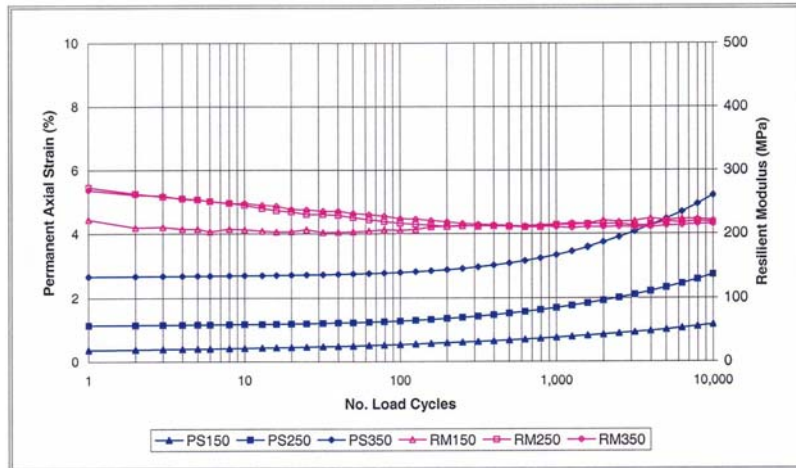
Figure 3.2 RLT test results for the Works millings sample.

Note: permanent deformation (%) and resilient modulus (MPa) are the left and right axes respectively.

The test results show that, for each source of millings, the specimens achieved a relatively constant resilient modulus (right axes on Figures 3.2–3.4) after approximately 200 to 1,000 load cycles irrespective of the level of deviator stress.

The test results indicate that the millings produce an approximately linear resilient modulus response after approximately 1,000 load cycles and for the test conditions adopted in this study.

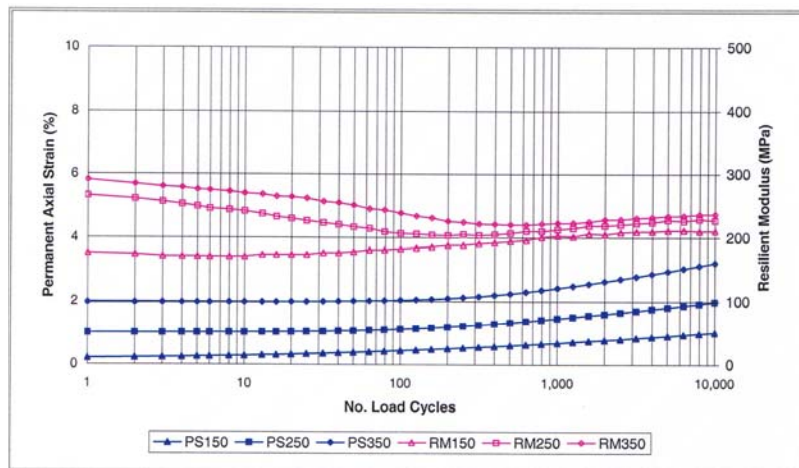
Figure 3.3 RLT test results for the Fulton Hogan millings sample.

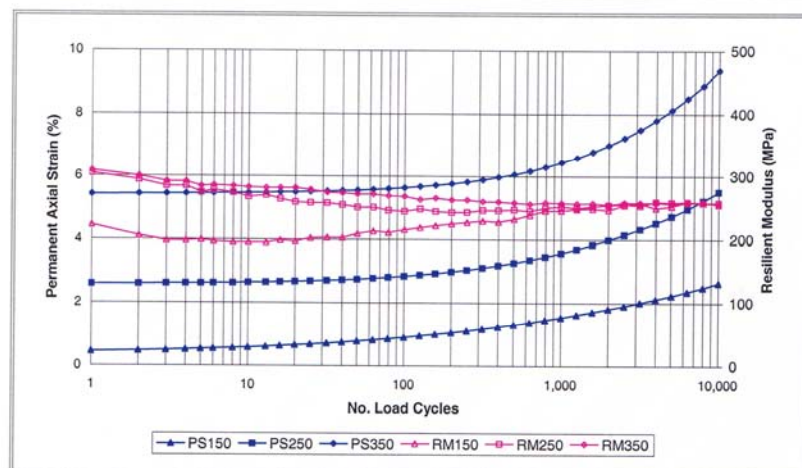
Figure 3.4 RLT test results for the Blacktop (unprocessed) millings sample.

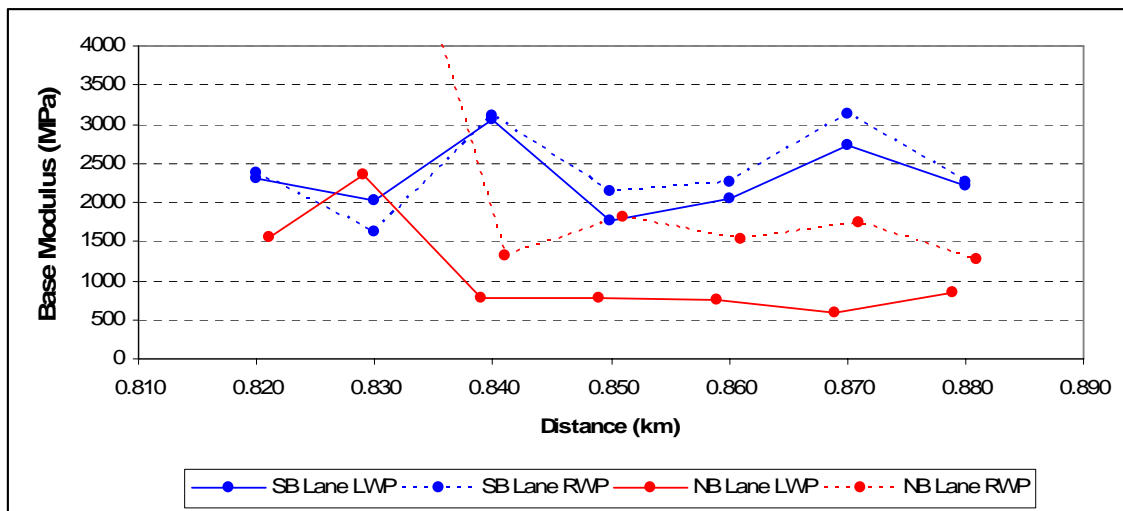
Figure 4.2 Elastic modulus values inferred by FWD for base layers of the lanes containing the millings.

FWD tests were carried out on the temporary repair in November 2004, in both wheel paths of the lanes that contained millings in the base layer. A plot of the inferred base layer modulus values versus distance is presented in Figure 4.2.

The results shown in Figure 4.2 suggest that the modulus of the millings layer ranged from approximately 700 MPa to more than 3,000 MPa. The higher values of modulus are typical of the results that could be expected for asphalt materials, whereas the moduli below about 1,000–1,500 MPa are typical of modified basecourse modulus values.

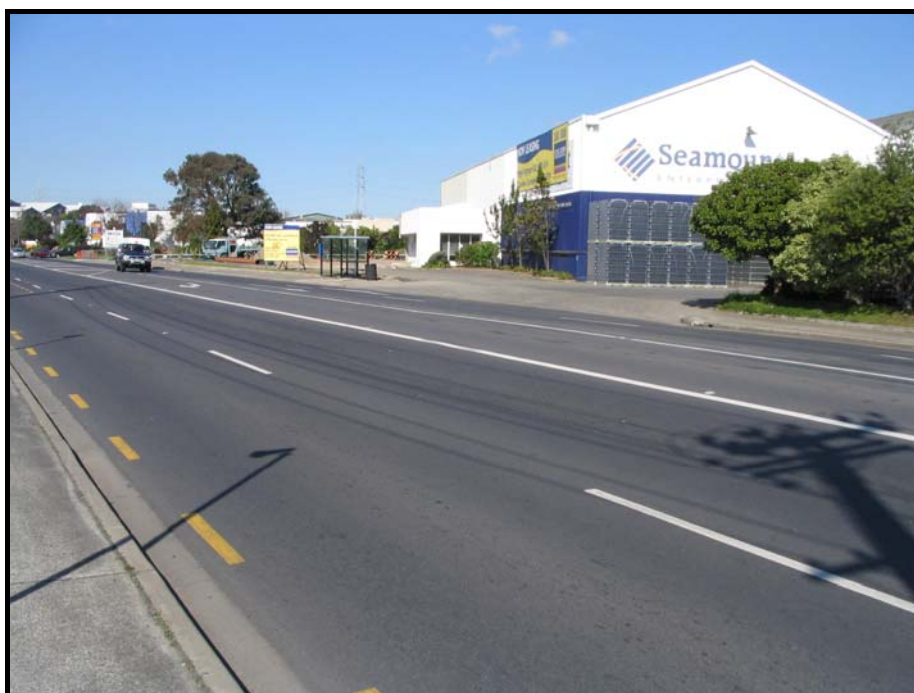
Figure 4.3 View of the Carbine Road rehabilitation site.
The second and third lanes from the camera have base layers with asphalt millings.

The Carbine Road pavement was inspected in August 2005. The inspection showed that the area containing millings was performing reasonably well considering the demanding nature of the site. The asphalt surface showed some cracking and permanent deformation, but the distress was relatively minor. Personal communications with the designers of the Carbine Road rehabilitation confirmed that the millings have performed very well, at least as a temporary repair measure. The traffic loading that has been applied since the repair was carried out is estimated to be up to 0.5×10^6 ESA.

A photograph of the pavement is presented in Figure 4.3. Note that the area containing millings comprises the second and third lanes from the camera.

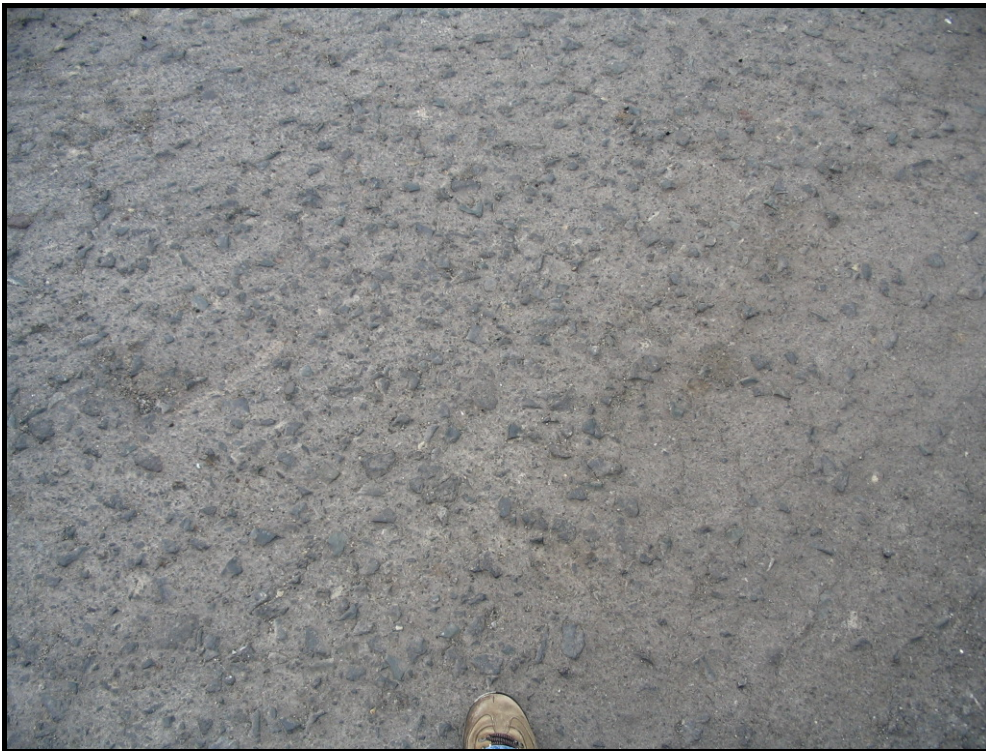
Figure 4.5 Bound surface of trial section on Aotea Road.

The surface of the trial section appeared to be bound and very hard, to the point where a car key would not penetrate the surface (see Figure 4.5). The surface showed large stone particles mixed in with the millings, most likely caused by contamination of the original material with basecourse. There was also evidence of flushing in isolated areas.

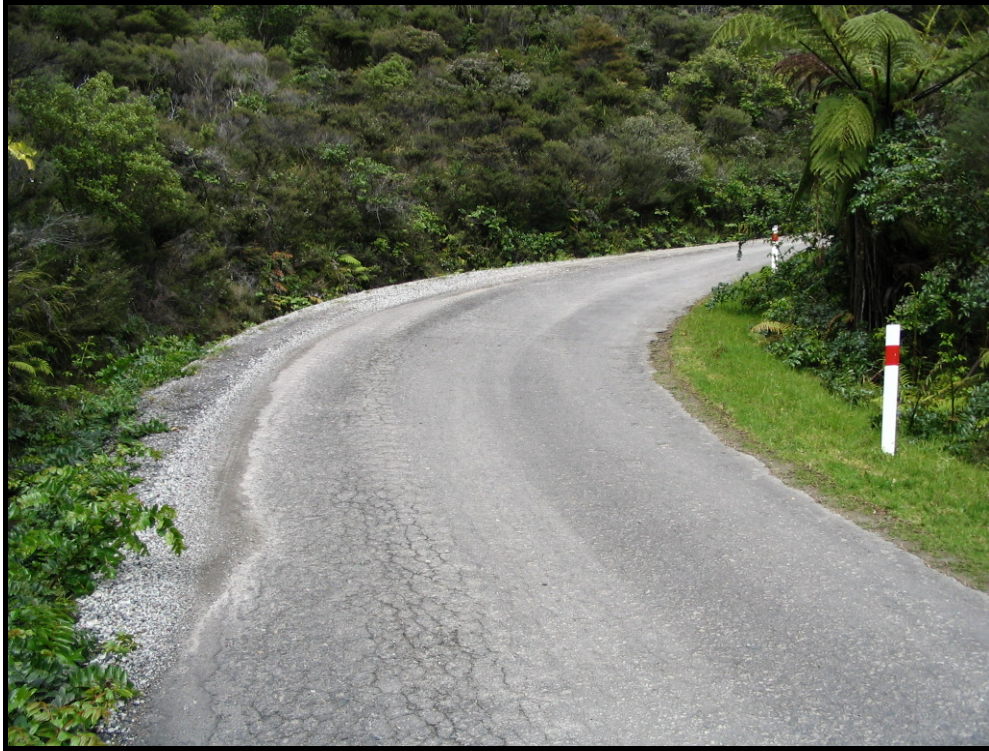
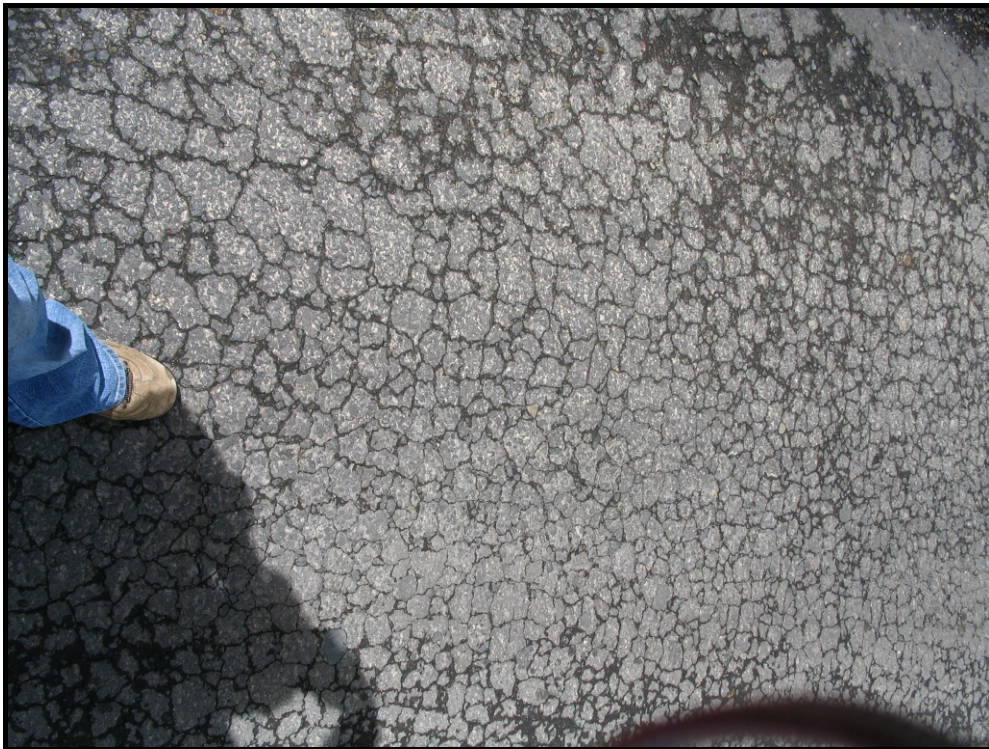
Figure 4.6 Crocodile-cracked surface.

Figure 4.7 Detailed view of crocodile-cracked surface.

Significant areas of crocodile cracking that were not confined to the wheel paths were obvious (see Figures 4.6 and 4.7). This suggests that the material has suffered fatigue failure, and therefore it may have behaved like a low-grade asphalt. Because the cracking was widespread across the carriageway suggests that the traffic wanders significantly, which is quite likely given the carriageway dimensions, or the cracking may include an

environmental mechanism. The depth of cracking appeared to be somewhat variable with evidence of delamination of the upper materials, leaving the lower materials in an unbound state. The lower materials would therefore be highly susceptible to shearing.

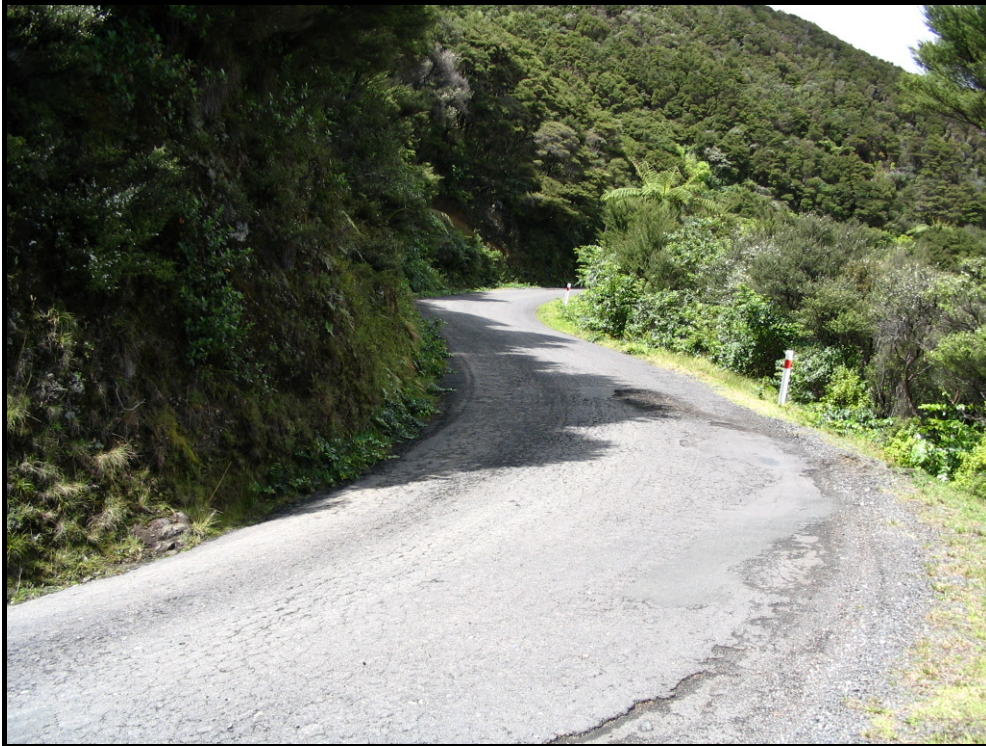
Figure 4.8 Example of edge break.

The widespread cracking, with subsequent water ingress, would certainly contribute to the pavement distress such as the significant areas of edge break, deformation (with heaving) and potholing (see Figures 4.6 to 4.9). Edge break may have been exacerbated by the improved stormwater run-off performance of the road surface. It may also have been aggravated by tracking off the edge of the pavement, given the minimal carriageway width.

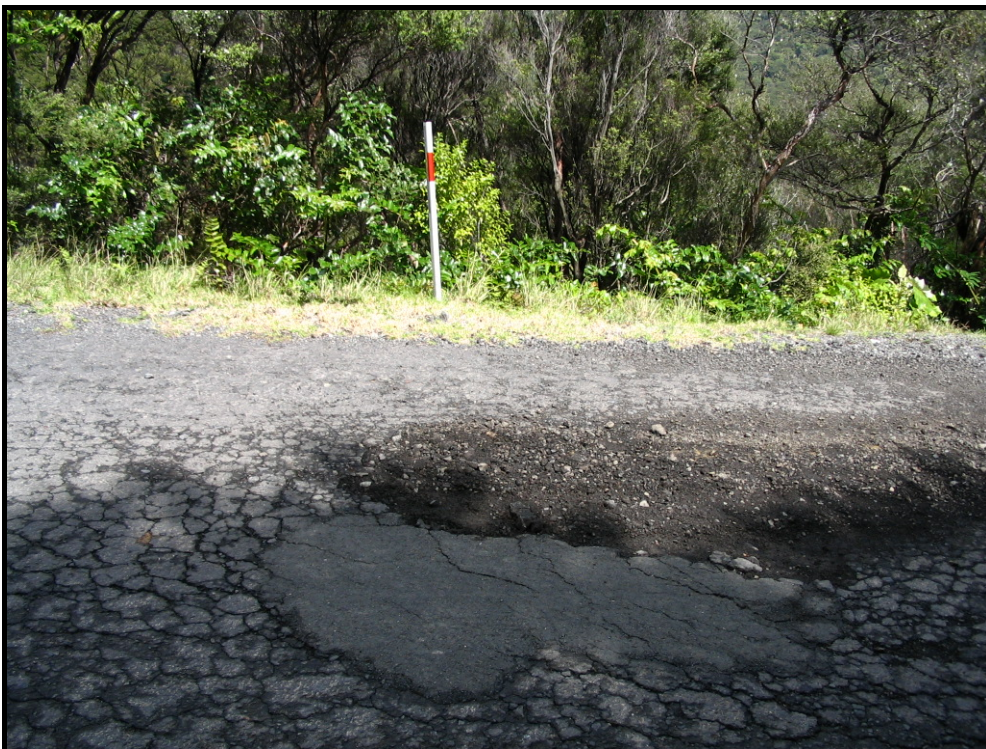
Figure 4.9 Potholing in the surface of the trial section.
