Fatigue design criteria for low noise surfaces on New Zealand roads

Land Transport New Zealand
Research Report 307

D. Alabaster and A. Fussell
Transit New Zealand, Christchurch

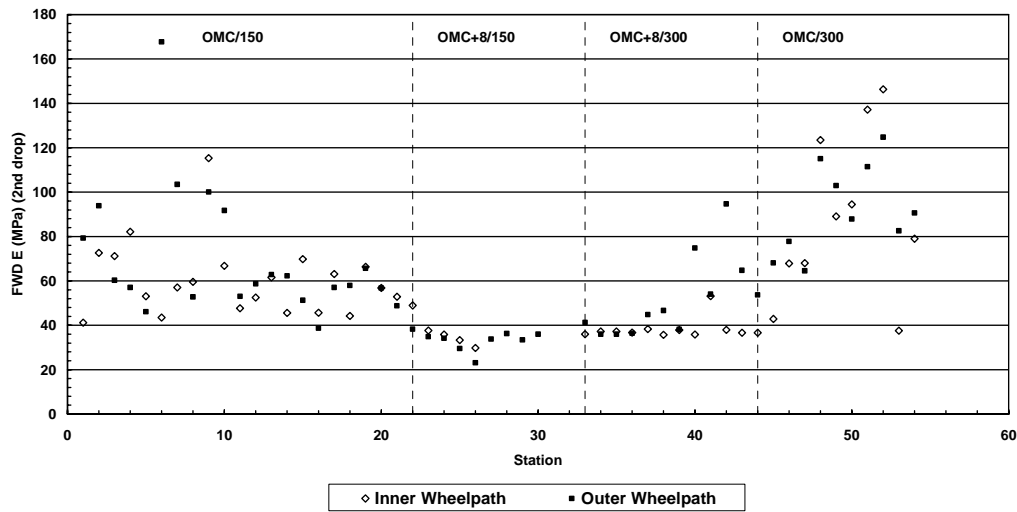
The final subgrade surface was also tested with an FWD. Tests were undertaken at each station and in both wheel paths where possible. The test set-up used a 300-mm diameter loading plate and a nominal plate pressure of 400 kPa. The results were variable with calculated elastic moduli values ranging from 38 to 168 MPa for the dry material, and from 23 to 95 MPa for the wet material (Figure 2.3). For both materials, only a limited number of high values were obtained and, if these are excluded from the analysis, the average moduli values for the dry (Tod @ OMC) and wet (Tod @ OMC+10%) materials are 71 MPa and 39 MPa respectively.

One reason for the high variability in the moduli values may be related to the uneven surface condition. The loading plate may not have been in full contact with the surface resulting in an uneven load distribution and/or rocking or bounce of the plate. The FWD results from the wet material are consistent, probably because the material had a smoother surface. Another reason for the inconsistency in the dry material could be the presence of shrinkage cracks in the dry material.

Figure 2.3 FWD modulus values obtained for subgrades under inner and outer wheel paths at each Station.

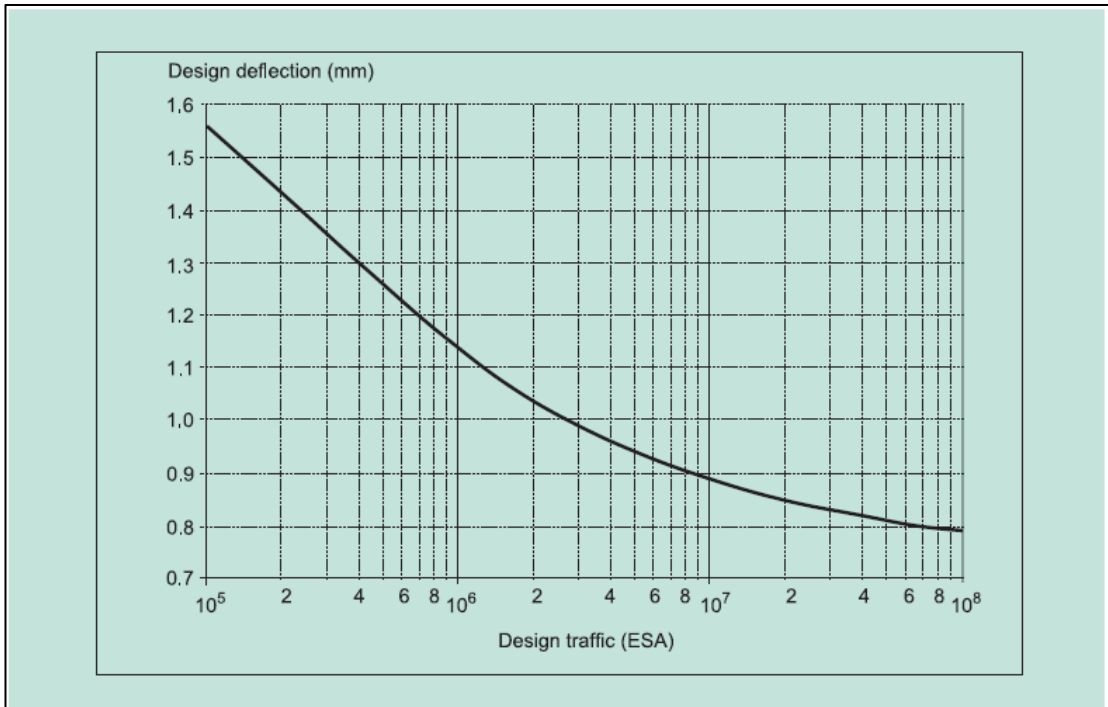
Deformation and fatigue lives have been estimated from Figures 2.4 and 2.5 that are in the Austroads Pavement Rehabilitation Guide (2004a). The Weighted Mean Average Annual Pavement Temperature (WMAPT) used was the average surface temperature (which had been recorded every 10 minutes) during loading, and it was 16.5 °C.

Figure 2.4 Design deflections to be used to limit permanent deformation (Figure 6.5 in Austroads 2004a).

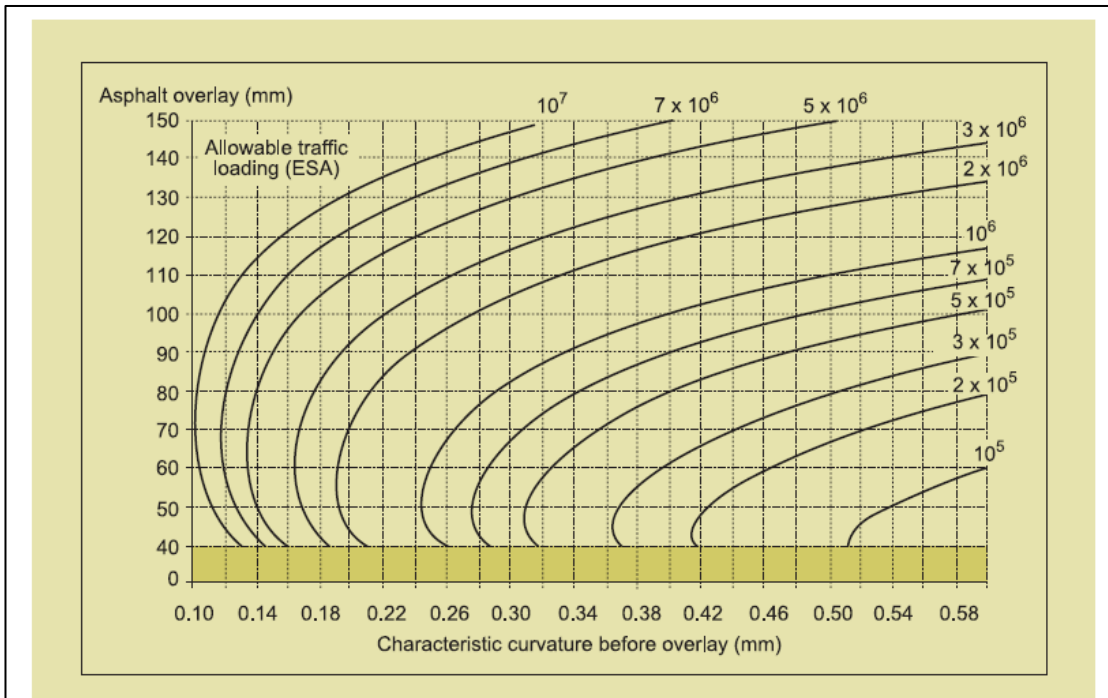
Figure 2.5 Asphalt overlay fatigue lives (calculated from overlay thicknesses and Characteristic curvatures (CC) before overlay) at WMAPT of 15-20°C (Figure A6.2.1 in Austroads 2004a).

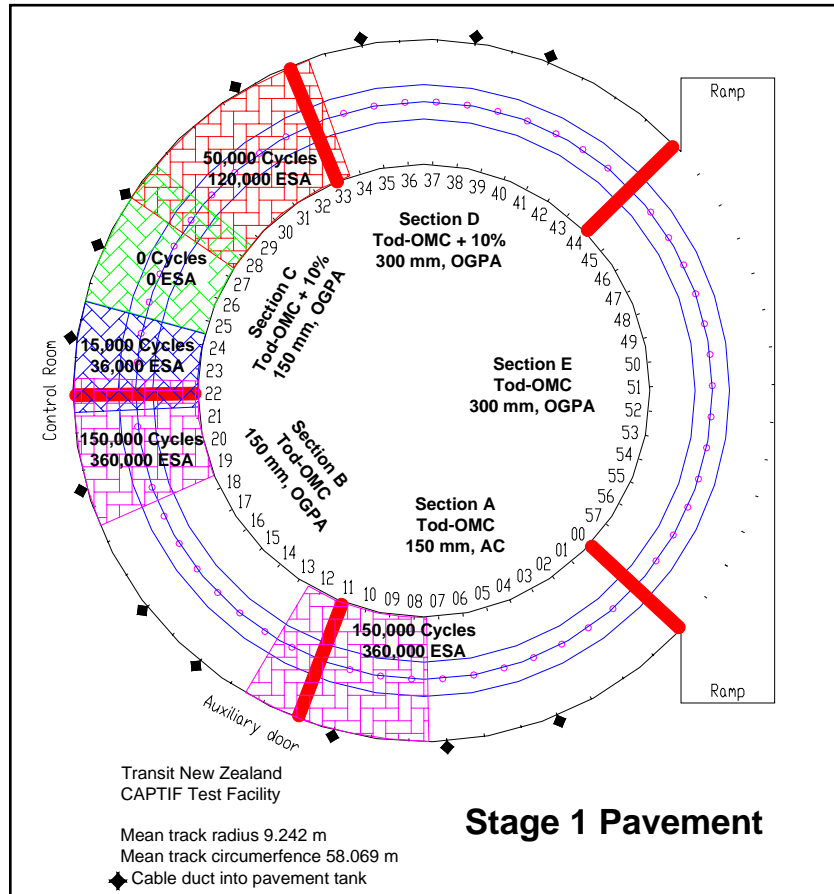
Between September 2004 and February 2005, 943,000 loading cycles were applied to the test pavement. Repeated and largely unexplained suspension failures in the SLAVEs at the end of the project resulted in a slightly shorter number of loading cycles. The inside 135 cm wheel path had been loaded to 50 kN and the outside 245 cm wheel path was loaded to 40 kN. Figure 2.6 indicates where and when failures were observed in the test pavement.

Figure 2.6 Positions of pavement failures on Sections A-E.

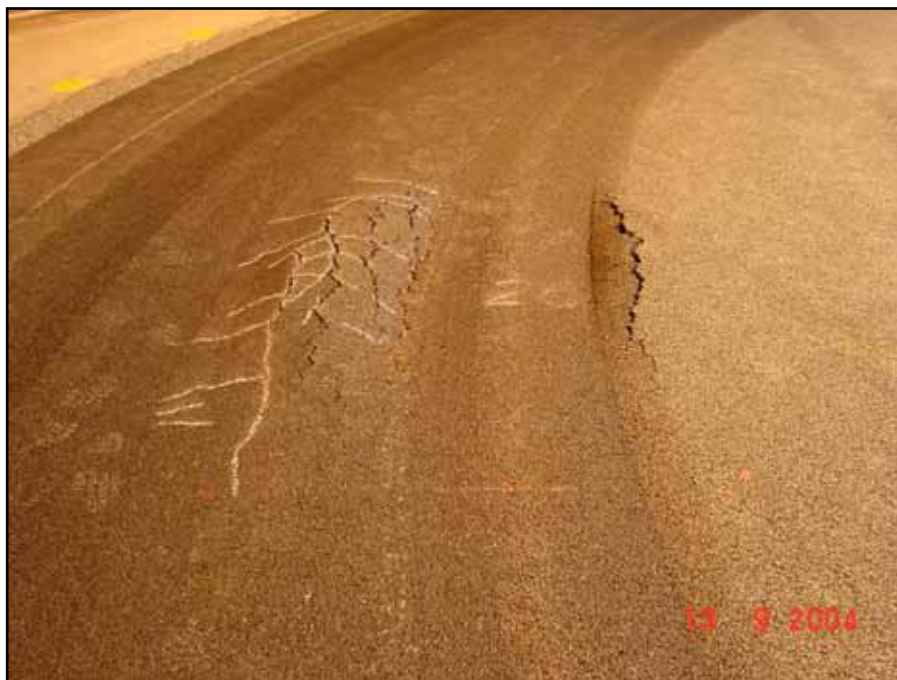
At first glance the location of the failures is reasonably consistent with the Austroads predictions, but on closer inspection of the failures (Figures 2.7-2.9), they are all deformation-related failures rather than the fatigue failures predicted by the Austroads Guide. Inspections at the regular testing intervals failed to find fatigue cracking before the deformation failures occurred. In this case a failure was defined as the point at which the vehicles could no longer traffic the pavement.

Figure 2.7 Failure between Stations 25-27 at 0 load cycles.

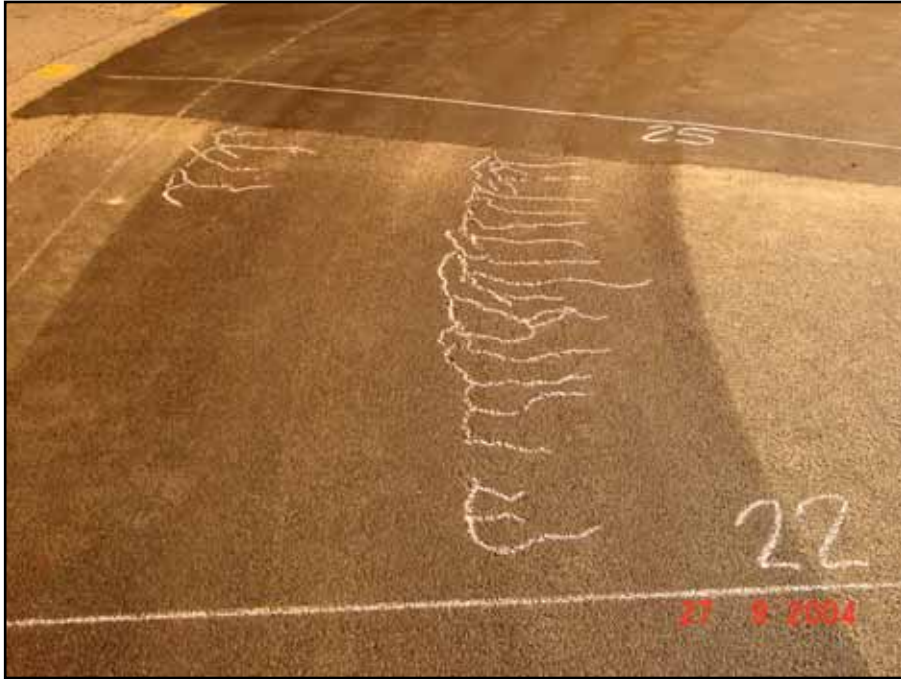
Figure 2.8 Failure at Stations 22–24 at 36,000 ESA.

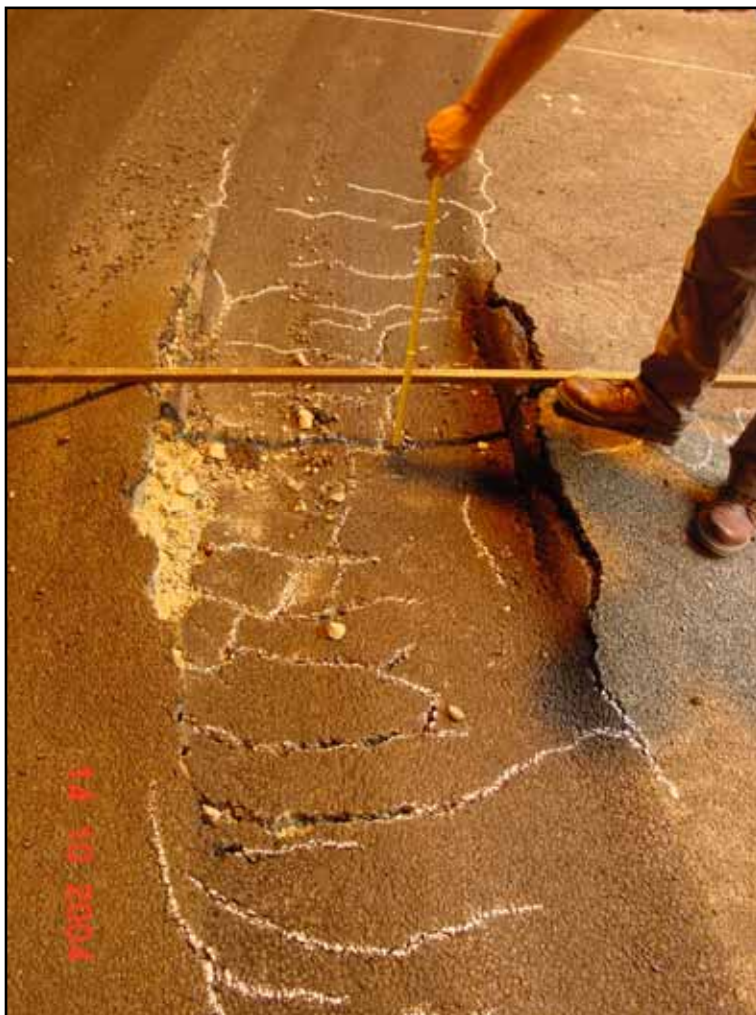
Figure 2.9 Failure between Stations 29–33 at 120,000 ESA.

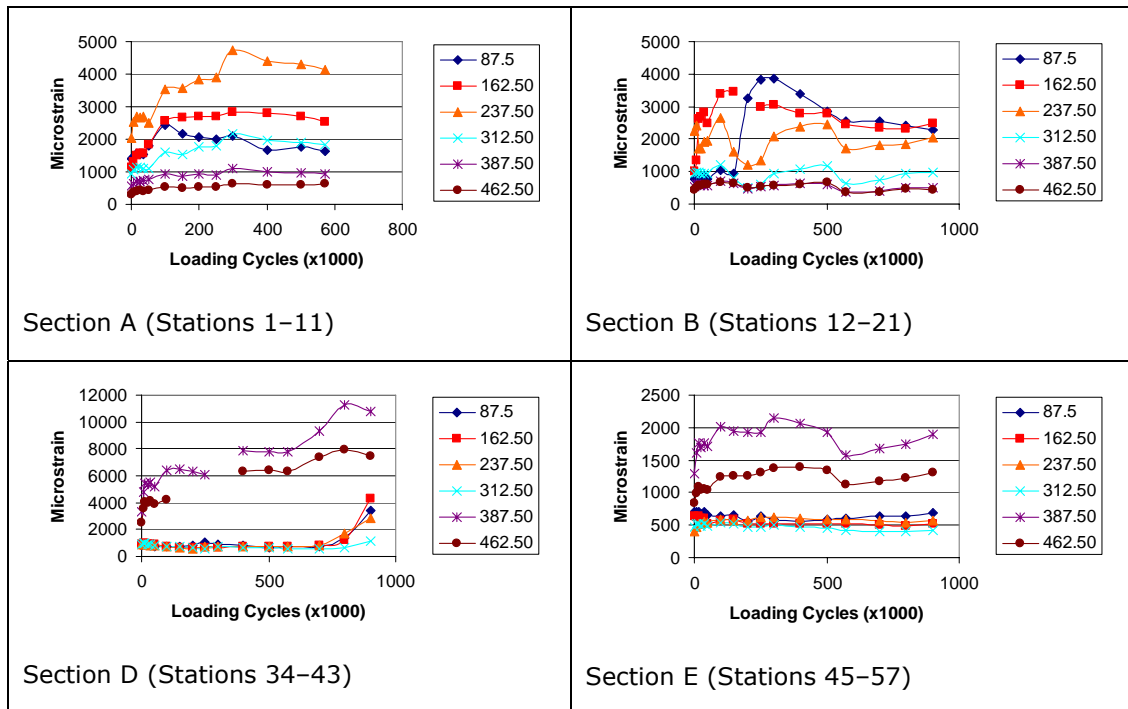
Figure 2.14 shows the vertical resilient strains measured by ϵ mu coils at different depths in each section during the test. The ϵ mu strain measurements shed additional light on the results, and show that Sections A and B perform in a similar manner with similar strains, while Section E with smaller strains on the same subgrade performs better. However Section D's performance calls into question the current Austroads Pavement Design subgrade strain criterion, because it had incredibly high strains recorded in the weaker subgrade (at 380–460 mm) yet it performed as well as Sections A and B. However the current Austroads Pavement Rehabilitation Guide (2004a) would estimate that this Section D would have failed well before Sections A and B.

Figure 2.14 ϵ_{mu} strains for 135 cm wheel path at 50 kN, for Sections A, B, D, E.

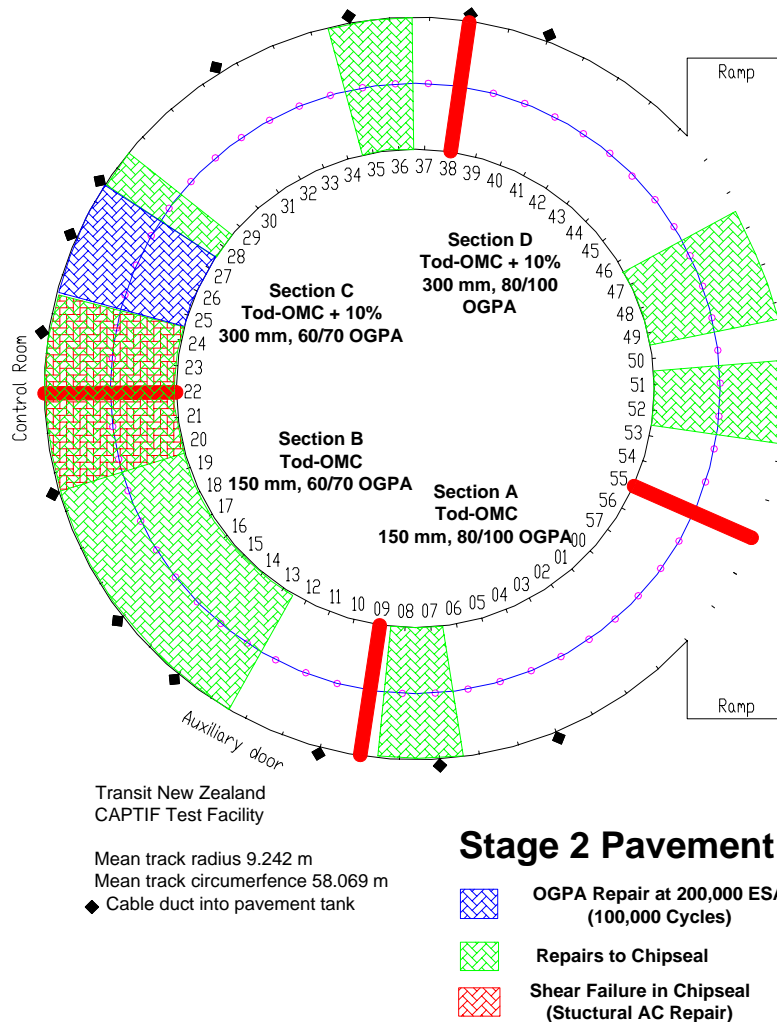
applied with the only incident being a debonding failure at stations 25–27 after 200,000 ESA (Figure 4.7). Figure 4.2 indicates where and when the failures were observed in the test pavement.

Figure 4.2 Pavement Test 2: positions of repair locations and when failures occurred.

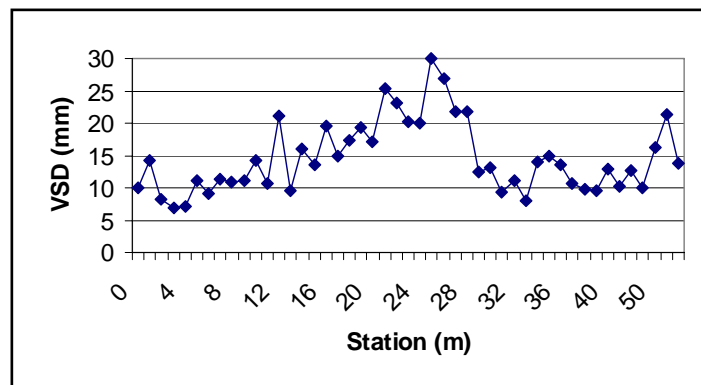
Figure 4.3 Initial Pavement VSD recorded after 10,000 ESA.

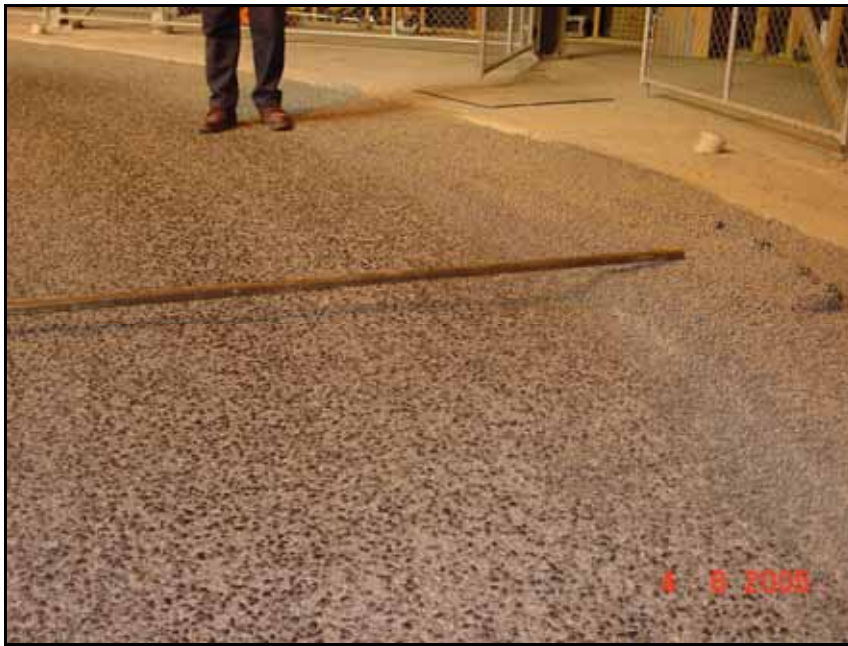
Figure 4.4 Initial construction shear failure between Stations 20–24.

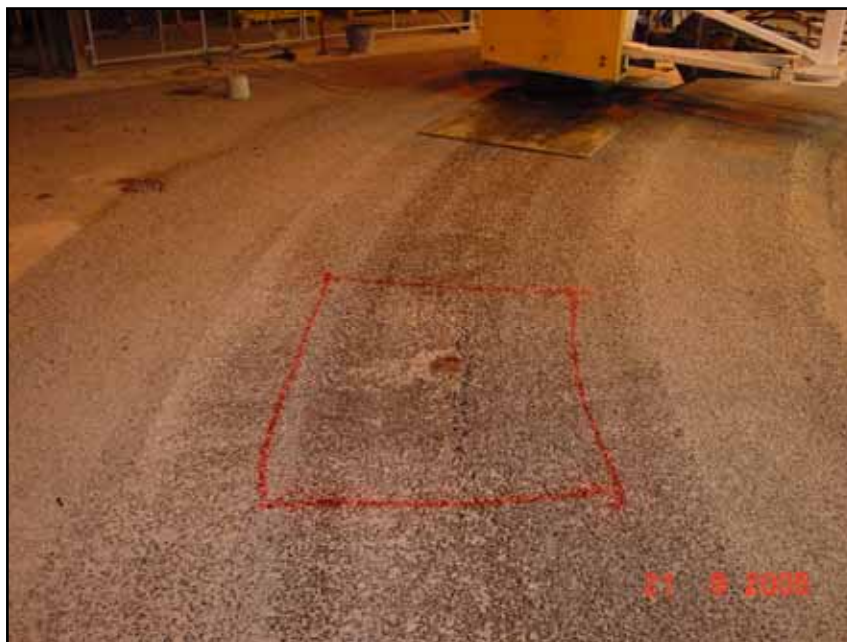
Figure 4.5 Typical surface failures that occurred at different stations during Pavement Test 2.

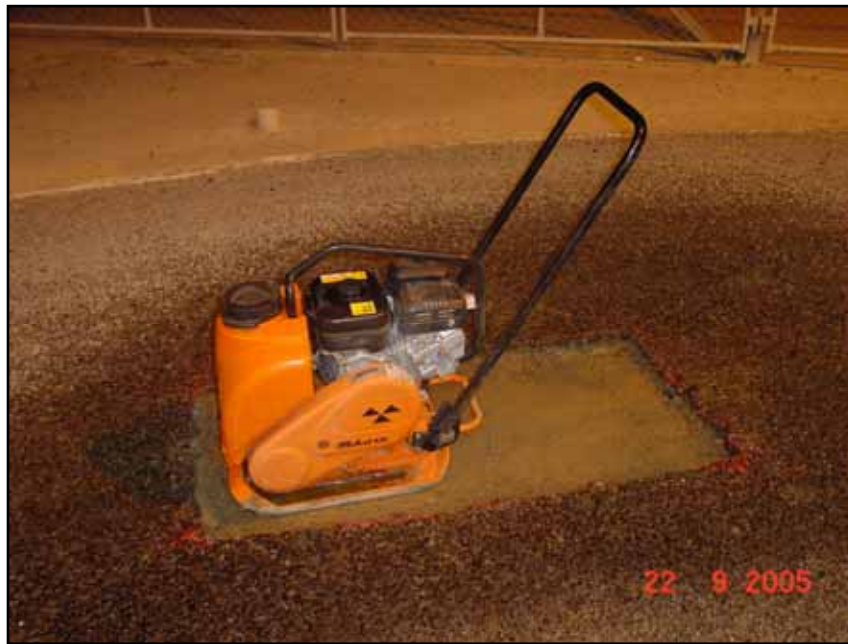
Figure 4.6 Typical surface repair of a failed area.

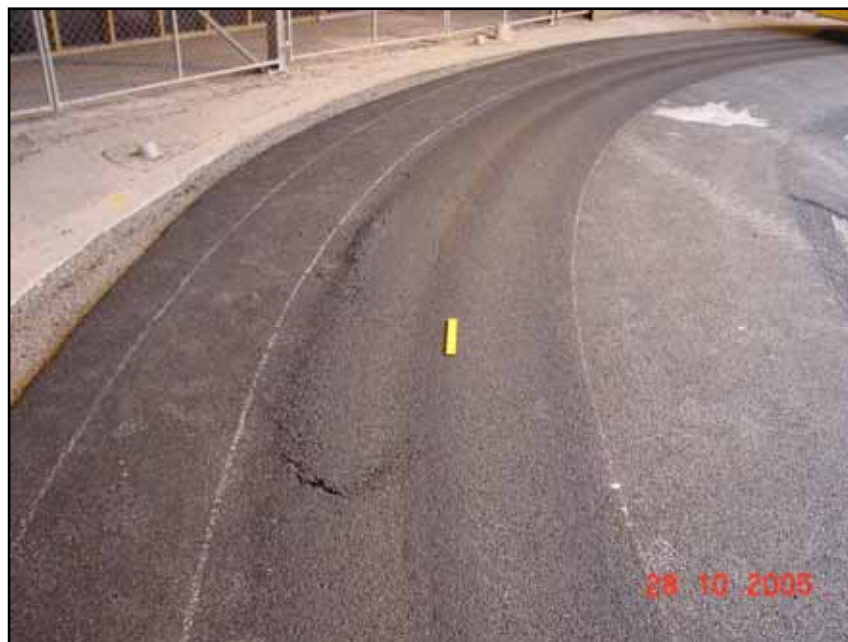
Figure 4.7 OGPA debonding failure at 200,000 ESA between Stations 25–27.

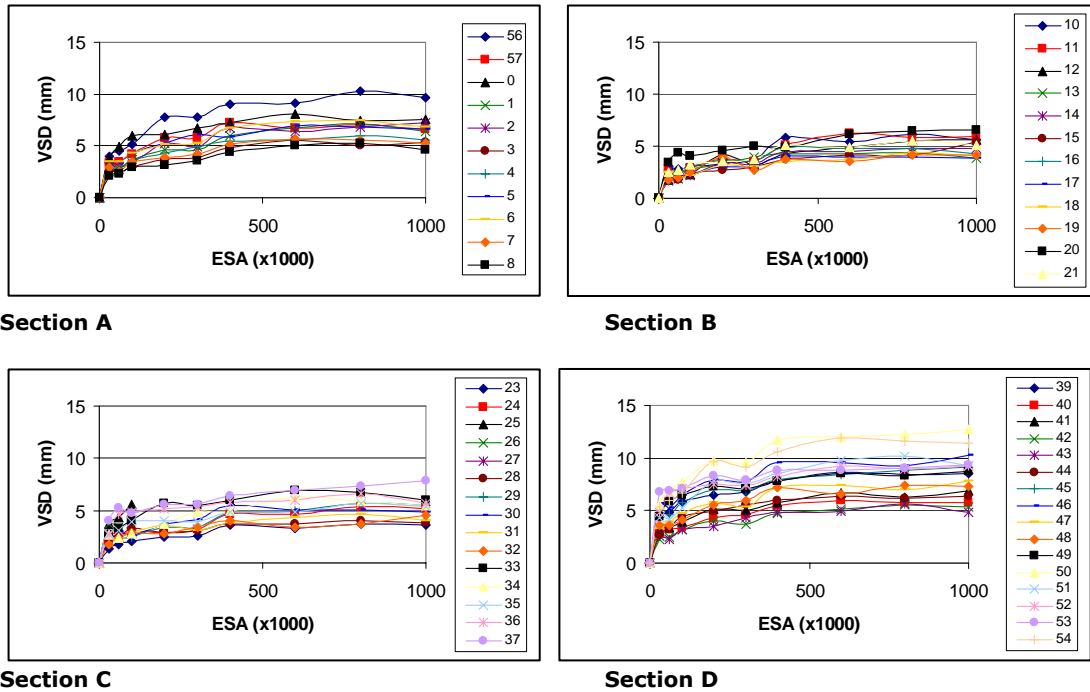
As noted above, the pavement performed very well. Figure 4.8 provides the VSD progression for each station, and shows that, with pre-trafficking and using the 40 KN load, none of the sections came close to the 15 mm VSD limit that was causing problems with deformation-related failures in Pavement Test 1. No cracking was observed despite the fact that a harder binder was used and failure had been predicted after trafficking as low as 50,000 ESA.

Figure 4.8 VSD progression in Sections A and D with standard OGPA, and Sections B and C with hard OGPA.

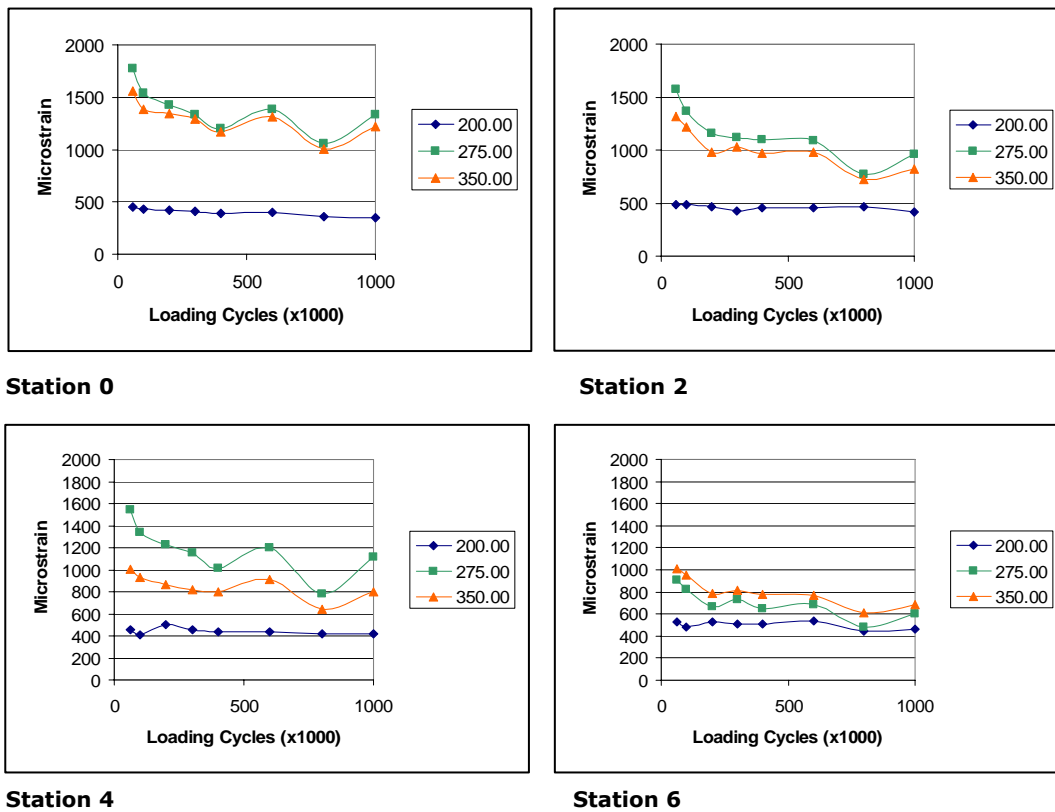
Figure 4.9 ϵ_{mu} strains between wheels at Stations 0, 2, 4, 6.

Figures 4.9–4.12 provide insight into why the second test had performed so well, as they show the progression of vertical strain at various depths within the pavement during the test. While there is significant variation within the measurements in each section, the downward trend in strains as the test progressed is the same at all the stations. This suggests that the pavements are strengthening in both the subgrade and the basecourse.

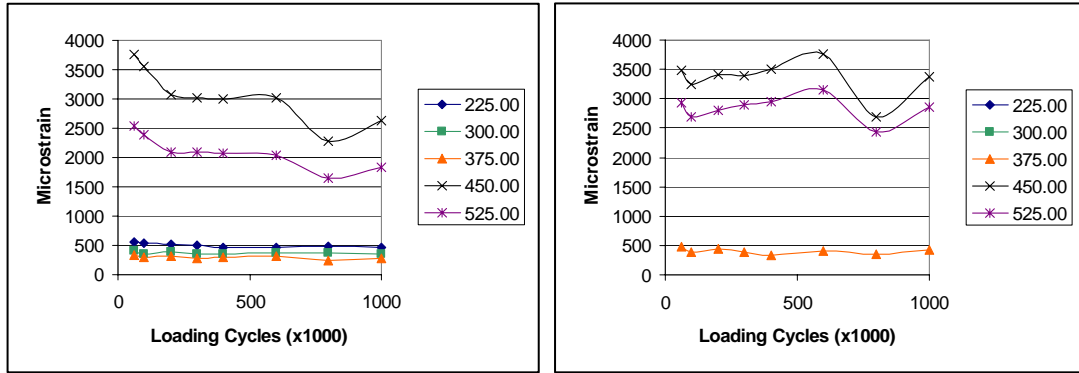
Figure 4.10 ϵ mu strains between wheels at Stations 38, 40, 42.
