Auditing public transport accessibility in
New Zealand
October 2010

C. O'Fallon

O'Fallon, C (2010) Auditing public transport accessibility in New Zealand. *NZ Transport Agency research report no.417*. 150pp.

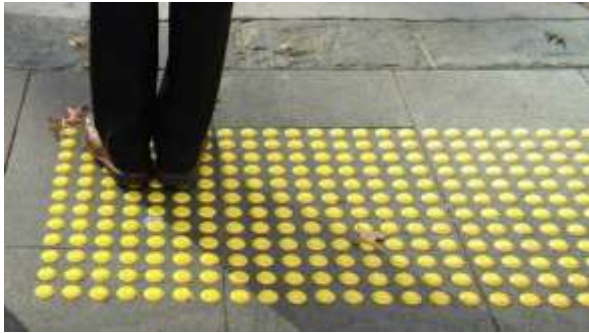
- Directional indicators 600mm deep should be installed where warning indicators are not located in the direct line of the continuous accessible route, so as to form a continuous path to the warning indicators.

Figure B7 Examples of tactile warning and directional indicators (source: NZTA 2007)

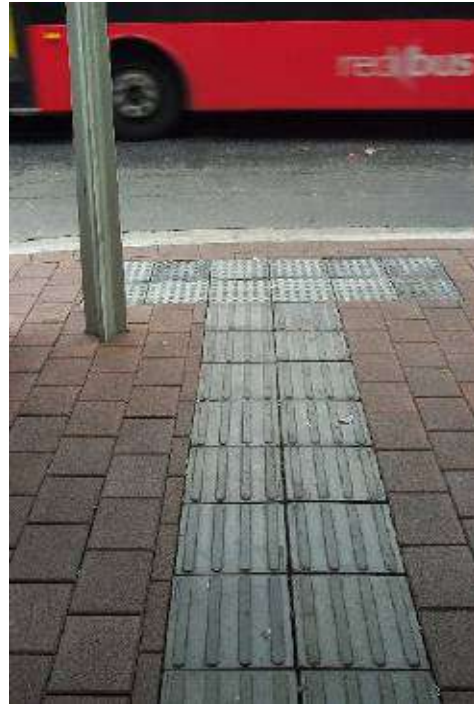
Warning indicators

Directional and warning indicators installed at a bus stop

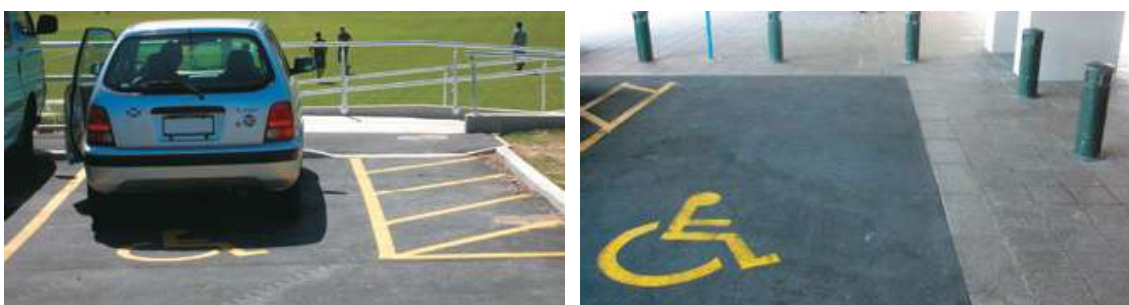
Accessible car parking spaces should have a maximum slope of 1:50; be 3500mm wide; and a minimum of 5000mm (angle park) or 6300mm (parallel park) in length. An accessible park should be level with the footpath or have a kerb ramp for wheelchair users to gain access to the footpath. As with accessible routes, the car park surface should be stable, firm and slip resistant, and the car park area adequately lit between dusk and dawn. The accessible car parks and the accessible route should be covered overhead.

Figure B9 Examples of accessible car parking (source: accessed August 2009 from dbh.govt.nz/accessible-carparks)

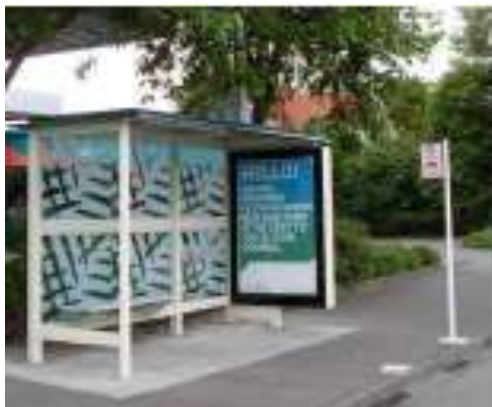
The use of existing posts around a bus stop for mounting the bus stop sign is also encouraged, in an effort to minimise obstacles in the path of users.

Figure B13 Example of accessible bus shelter and bus stop signage (source: PNCC 2009)

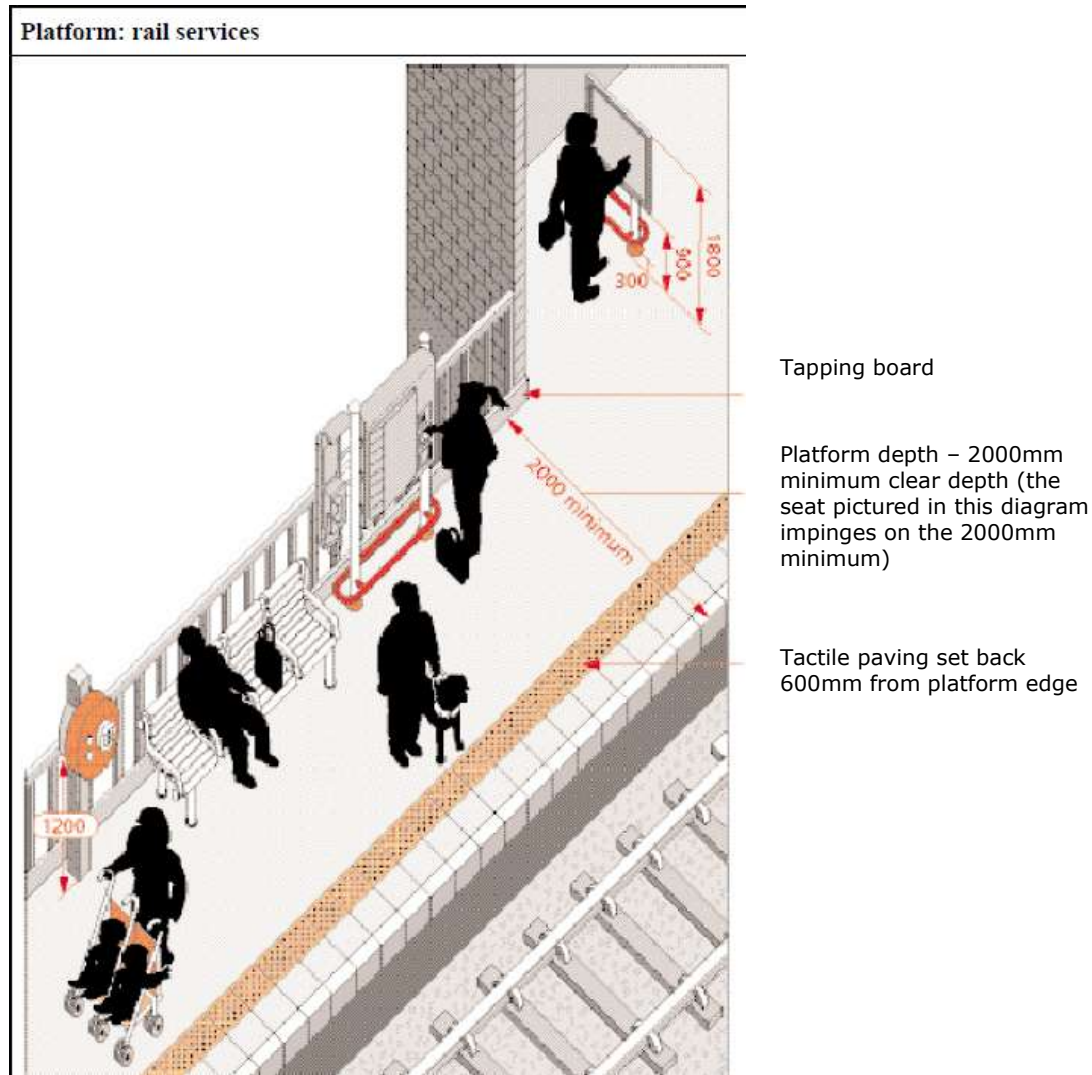
In the case of a bus station, the 'platform' may be a landing area with a kerb, similar to that of a street-based bus stop. If this is true, then appropriate characteristics from chapter B4 (bus stops) apply.

Figure B18 Station platform characteristics (source: UK DfT 2002)

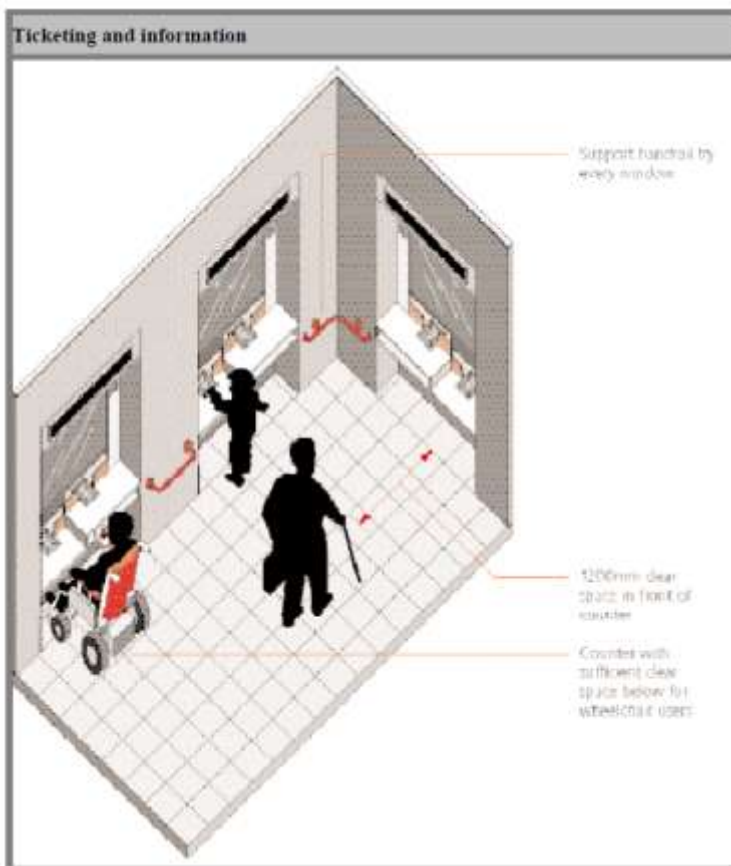
Where ticketing services are provided at a station, at least one service counter (ie ticketing booth, information desk, or ticket vending machine) should be on the accessible route, and be at a height (775mm) that can be accessed by a person in a wheelchair. There should be a clear space under the counter so that the wheelchair user can come right up to the counter/desk/machine, and a clear space of at least 1200mm by 1200mm in front of it.

Figure B19 Accessible ticketing and information service area (source: UK DFT 2002)

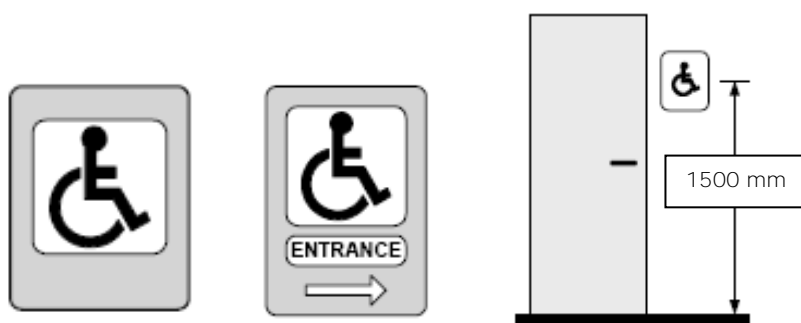
All accessible entrances to the station should display the 'international sign of access' at a height of 1500mm from the floor (NZS 4121: 2001 Design for Access and Mobility) as illustrated in figure B20.

Figure B20 International sign of access (Source: adapted from Kentucky Dept of Vocational Rehabilitation 2000)
