Effectiveness of transverse road markings on reducing vehicle speeds

October 2010

Martindale, A and C Urlich (2010) Effectiveness of transverse road markings on reducing vehicle speeds. *NZ Transport Agency research report 423*. 72pp.

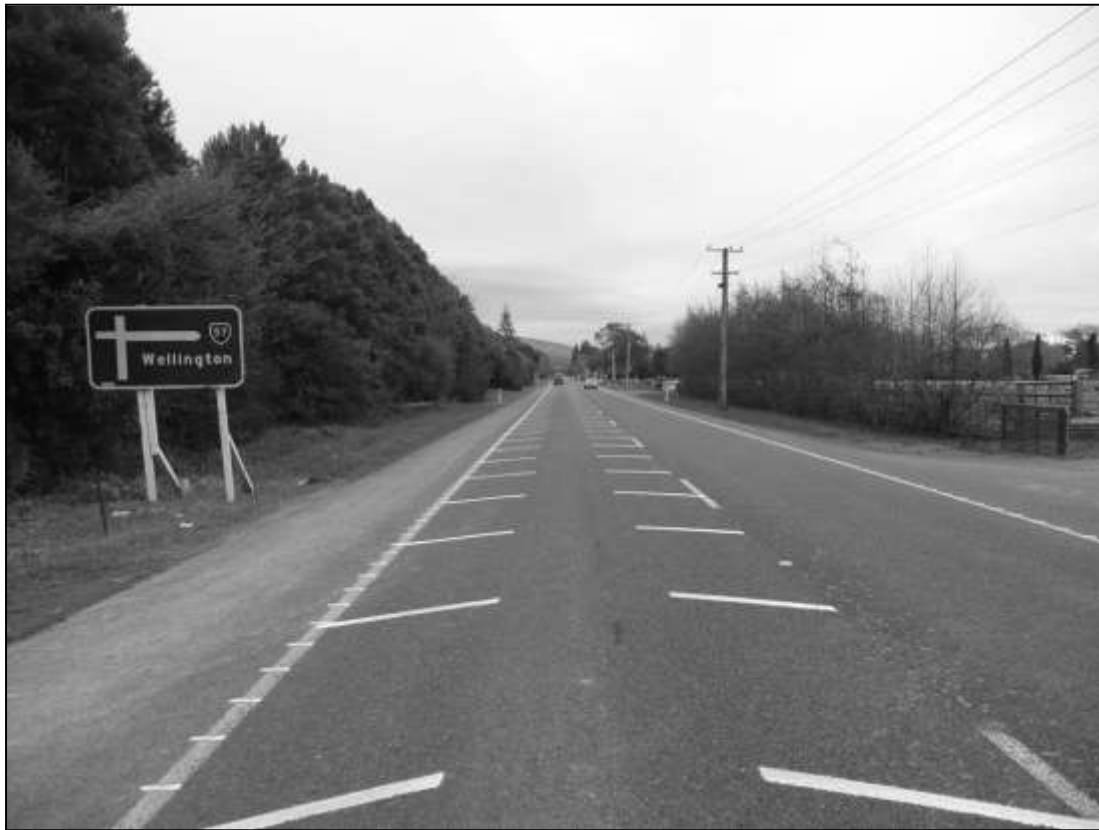
Figure 1.1 An example of transverse road markings

Transverse road markings can be defined as a series of marked (either flat or raised) transverse bars placed across the road in the direction of traffic flow (see figure 1.1). They can be called varying names such as herringbone, yellow bar and Wundt Illusion markings. The markings are used to assist drivers in raising their awareness of risk through perceptual optical effects, thus encouraging speed reduction to an approaching hazard. Consequently, drivers get an increased reaction time to respond to the situation in front of them.

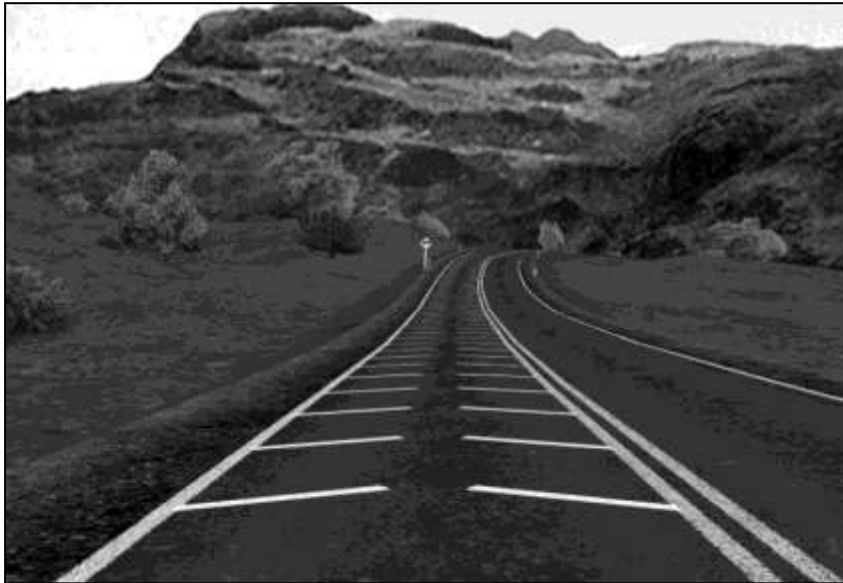
Figure 2.2 Transverse road marking used in a simulator trial (Charlton 2003)

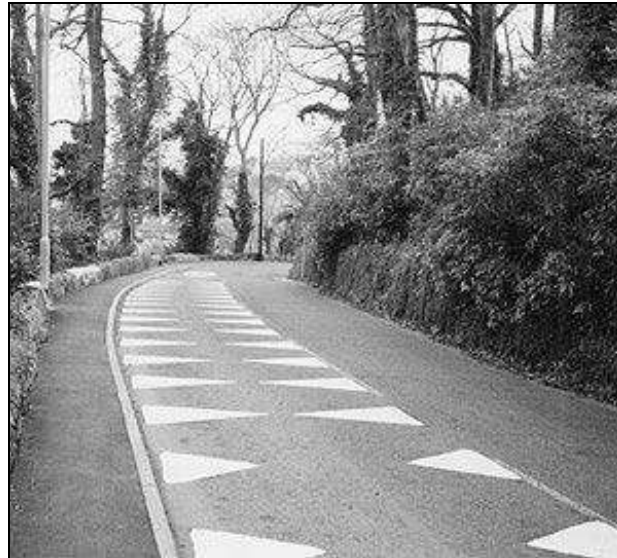
Figure 2.4 Example of dragon teeth road markings (Charlton and Baas 2006)

In 2006, Charlton and Baas published a research paper that evaluated speed change or speed maintenance methods to alter driver behaviour, particularly to reduce their approach speeds to a hazard. The research included the assessment of both self-explanatory road concepts and various perceptual countermeasures. As part of the investigations, the performance characteristics of raised transverse rumble strips and transverse marked lines (such as dragon teeth, as shown in figure 2.4) were reviewed. Specifically for

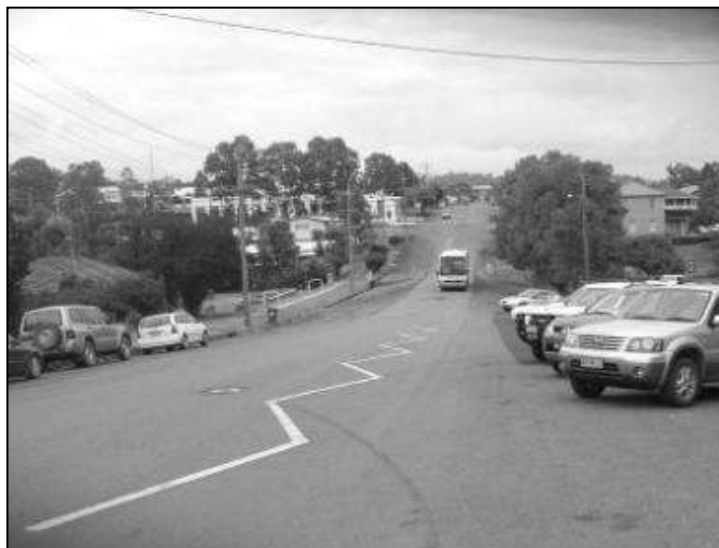
Figure 2.5 Zig-zag pedestrian warning in Australia

Experimental markings used in Australia at pedestrian crossings were trialled in Auckland, New Zealand, between May 2004 and December 2005. The markings are situated in the centre of a lane, providing a greater visual response than the existing diamond marking that is currently in use in New Zealand. The visual response of the road markings allows greater physical awareness of the approaching hazard and creates a perception of a change in environment.

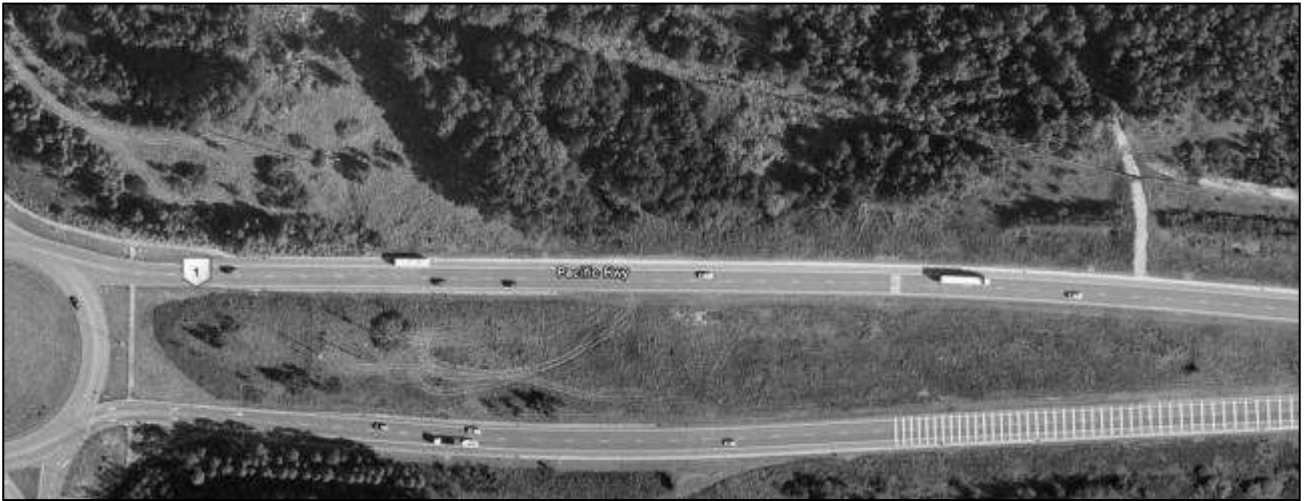
Figure 2.7 Transverse road markings used as a speed deterrent from a 100km/h to 70km/h speed zone on the Pacific Highway in New South Wales, Australia (photo courtesy of Google Earth Pro License)

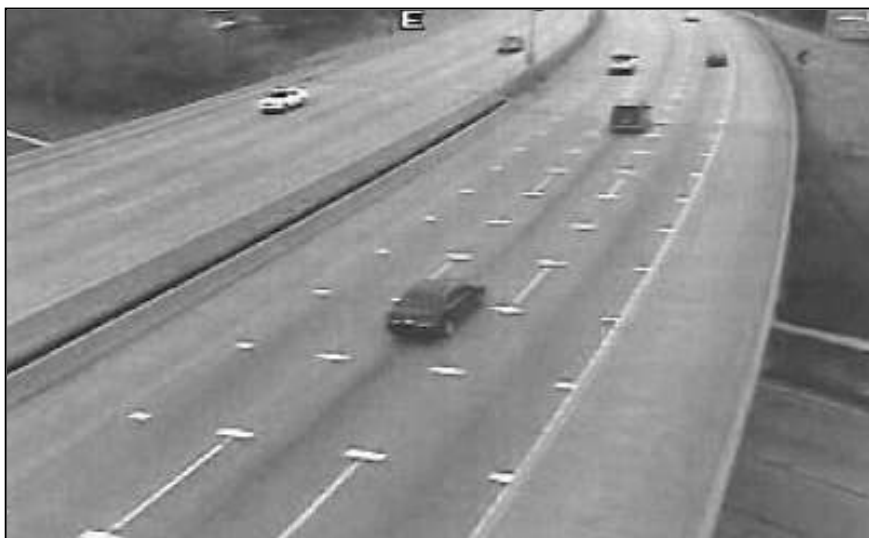
Figure 2.9 Example of high-speed curve layout (Gates et al 2007)

A similar arrangement was also adopted in American trials for a high-speed freeway curve in Milwaukee (Gates et al 2007). This trial used 18-inch by 12-inch (457cm by 305cm) squares that were placed on the edgelines to create the peripheral speed illusion, as can be seen in figure 2.9. In this case, the squares were applied at a decreasing rate 500 feet (152.4m) prior to and after the curve centre. The results from the curve were similar to those encountered by Godley in that speeds seemed to be reduced.

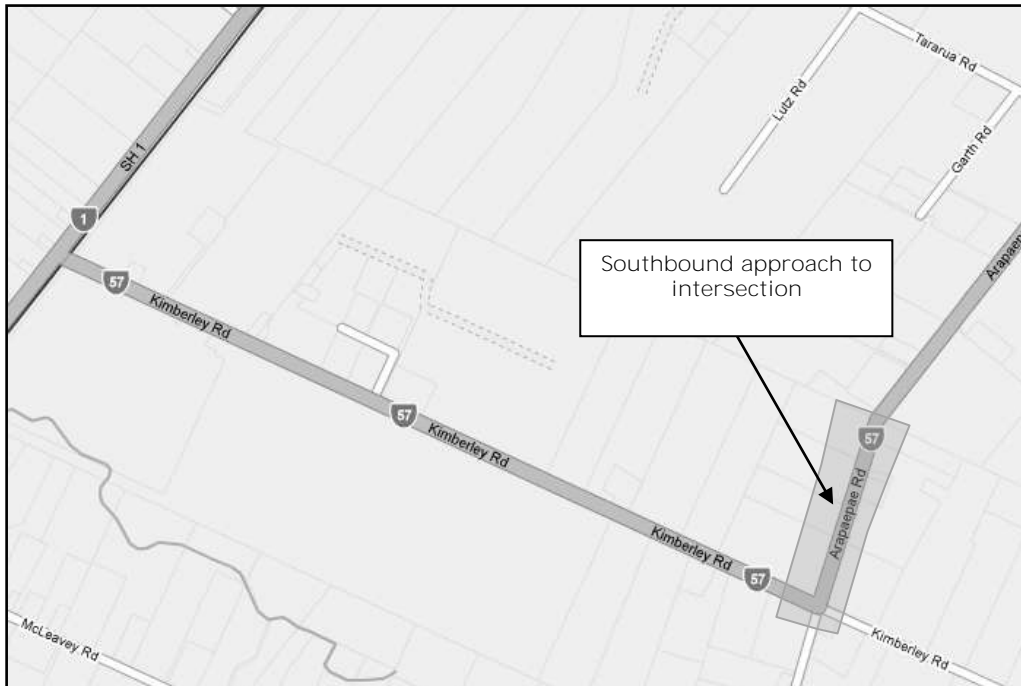
Figure 3.1 Location of the Kimberley/Arapaepae Road trial site (image courtesy of Google Earth Pro Licence)

The intersection is located near Levin on State Highway (SH) 57 (route position 0/2.083), approximately 2km to the east of SH1 (see figure 3.1). The intersection is arranged as an out-of-context curve, with SH57 traffic having priority. This effectively allows the northbound left-turning Kimberley Road traffic and southbound right-turning Arapaepae Road traffic to travel through the intersection, as can be seen in figure 3.2.

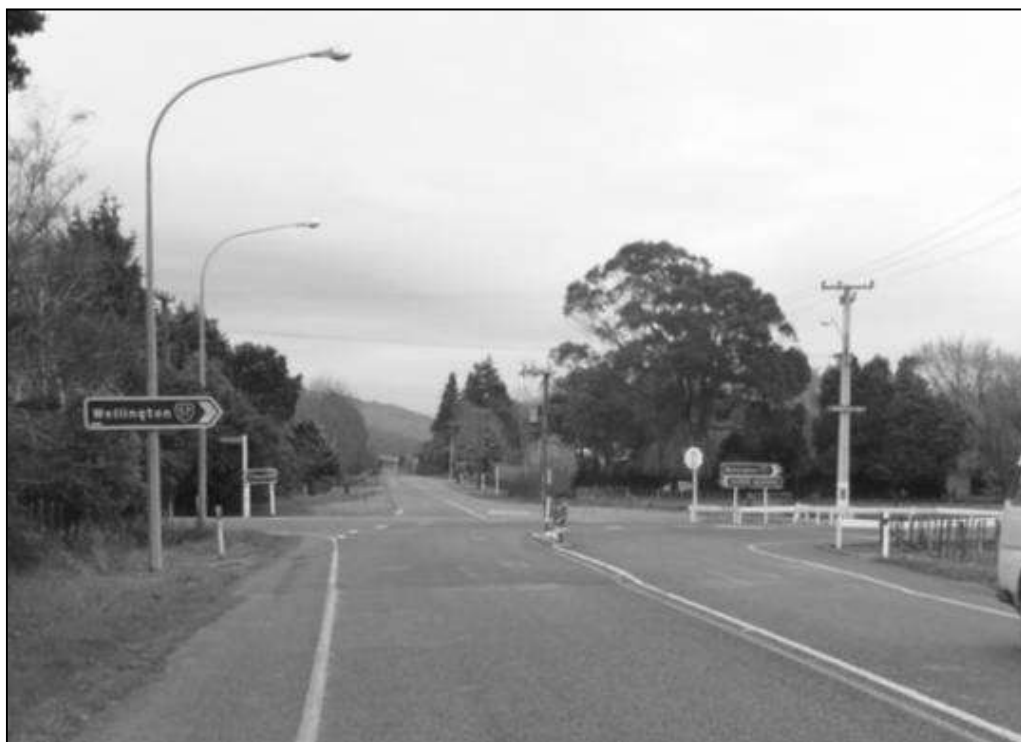
Figure 3.2 Southbound approach to the Kimberley Road/Arapaepae Road intersection

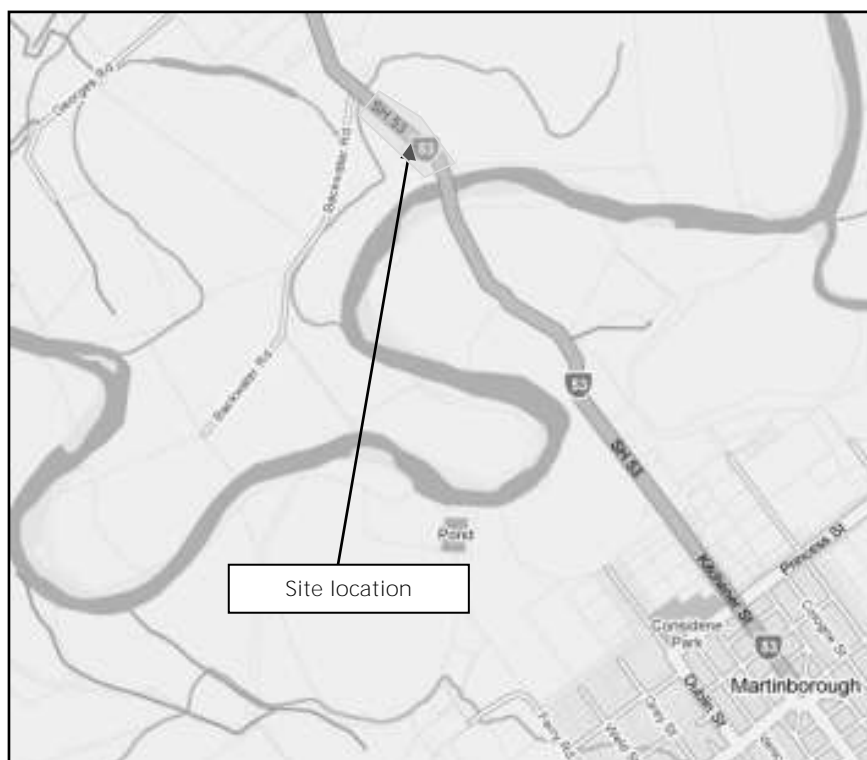
Figure 3.3 Location of bridge approach (image courtesy of Google Earth Pro Licence)

The Waihenga River Bridge is located on SH53 (route position 0/14.755) between Featherston and Martinborough (see figure 3.3). The bridge is situated approximately 575m to the east of the Jenkins Dip Floodway bypass. The eastbound bridge approach is characterised by a long, straight section approximately 580m in length prior to a right-hand horizontal curve leading up the bridge abutment, as can be seen in figure 3.4. The bridge is narrow and is regularly used by oversized farming vehicles. The approach operates with a 100km/h posted speed limit and requires a reduction in speed to drive over the bridge safely. The eastbound approach has an estimated two-way AADT of approximately 2500 vehicles (NZTA count site ID:05300016), 6.5% of which comprises HCV traffic.

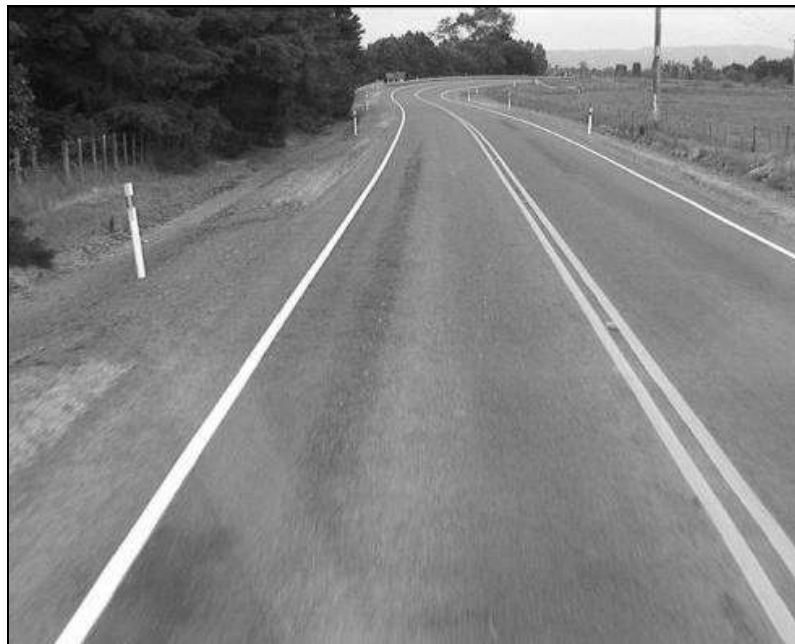
Figure 3.4 The straight section prior to the bridge approach (image from SH53 network video)

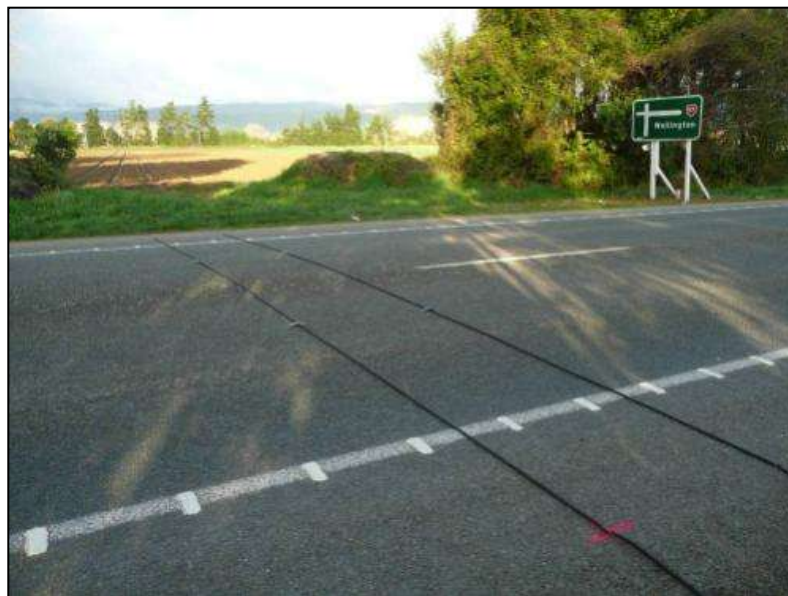
Figure 3.7 Example of typical speed tube set-up, including spray-painted nail holes

To ensure that the apparatus was placed in exactly the same location during the before-and-after speed measurement analysis, note was made of the nail hole locations in the road seal resulting from the installation of the speed tubes. The nail holes were spray-painted and maintained for this purpose, as can be seen in figure 3.7. During visits to the site, the location of the nail holes were re-marked to ensure that the long-term measurements were recorded at the same locations.

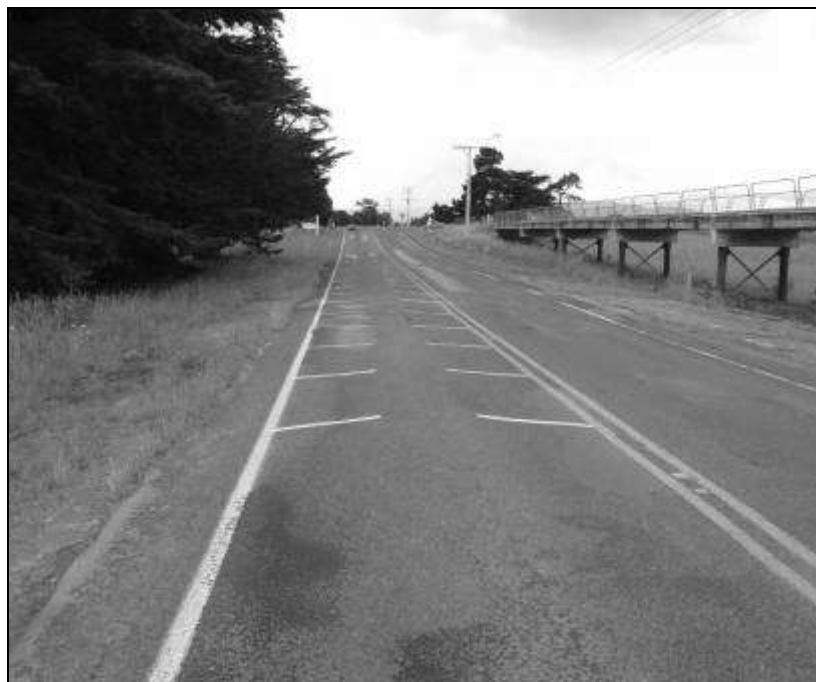
Figure 3.8 Jenkins Dip Floodway bypass on the marked section of the SH53 site.

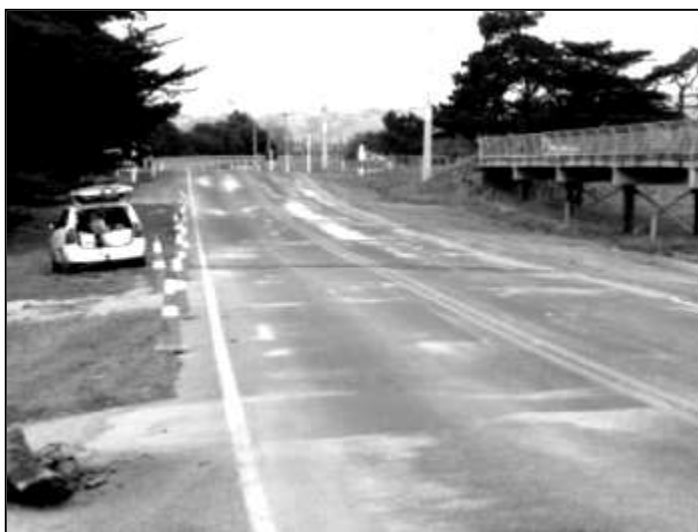
Figure 3.9 Cones observed at the start of the SH53 trial site

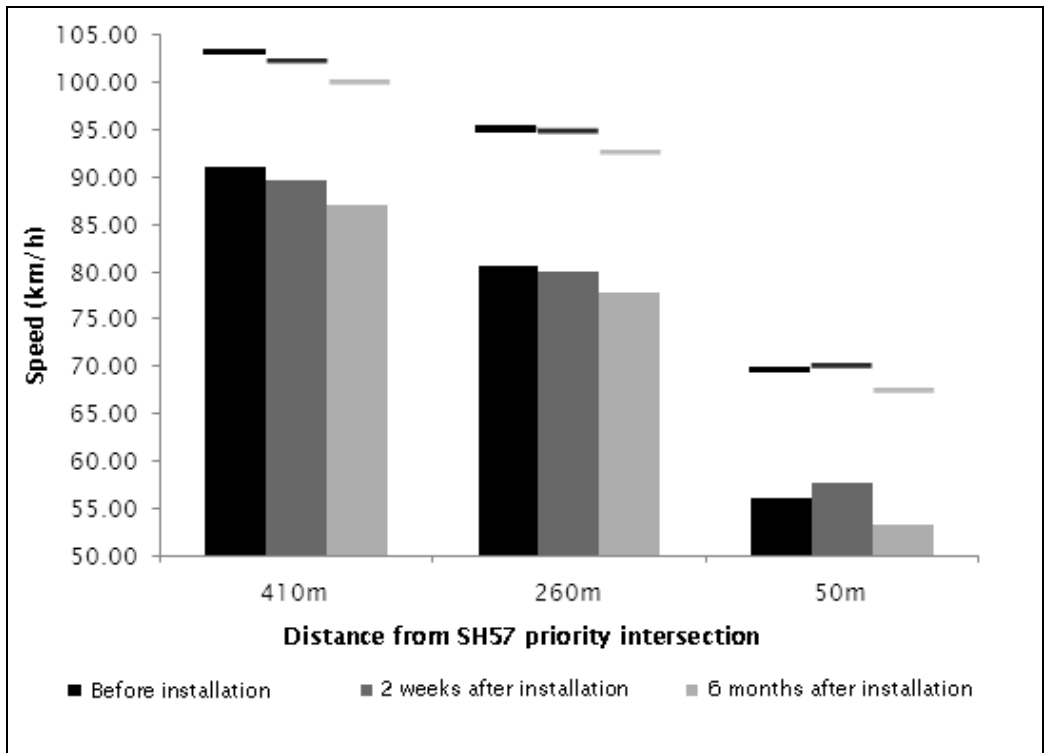
Figure 5.1 ANOVA-adjusted mean speeds (bars) and observed 85th percentile speeds (horizontal lines) before and after installation of transverse road markings at the SH57 trial site

As can be seen from the tabular and graphical outputs, the main short-term effect of the transverse marking arrangement at SH57 was to reduce mean speeds by approximately 1.3km/h at the start of the treatment (410m from the intersection). At 260m from the hazard, this speed reduction effect was found to wear off, with vehicle speeds being only slightly lower than they were prior to installation of the markings. At 50m from the hazard, mean vehicle speeds were slightly higher than those obtained prior to the installation of the lines. In the long term, mean speeds 410m from the intersection were found to be 3.9km/h less than the speeds recorded prior to the installation of the lines. However, in contrast to the short-term results, this statistically significant reduction was found to lessen only slightly through the remainder of the intersection approach. Statistically significant long-term reductions of 2.7km/h and 2.8km/h were recorded at the 260m and 50m positions prior to the intersection, respectively.

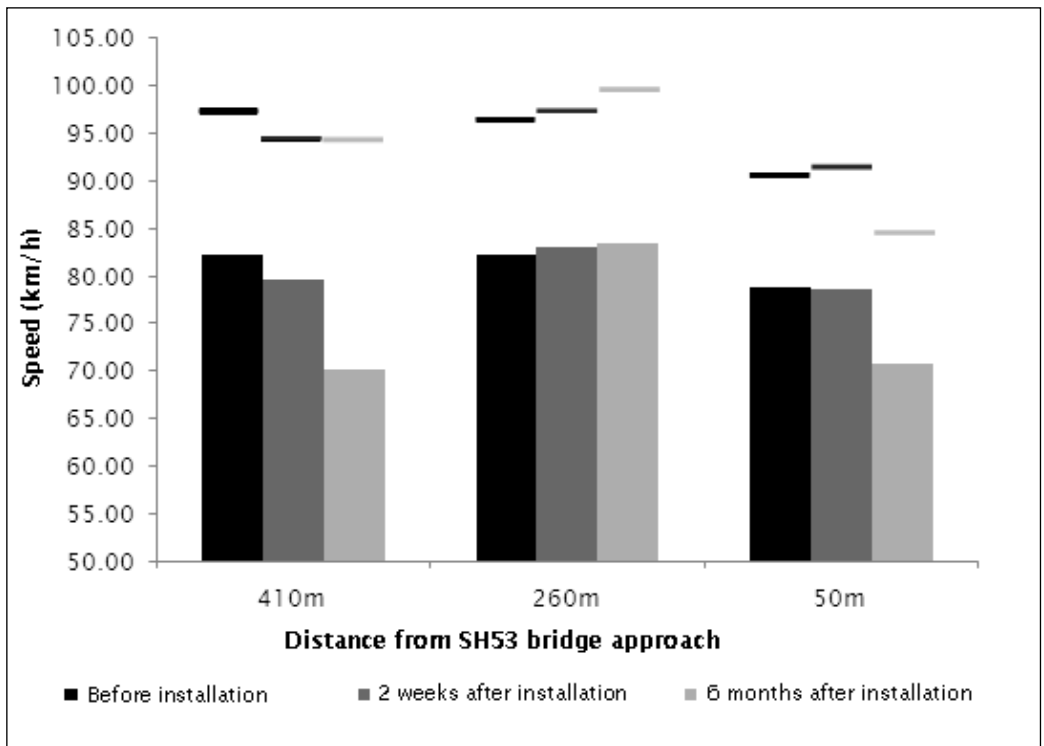
Figure 5.2 ANOVA adjusted mean speeds (bars) and observed 85th percentile speeds (horizontal lines) before and after installation of transverse road markings at the SH53 trial site

At SH53, the main short-term effect of the transverse marking arrangement was to reduce mean speeds by 2.6km/h at the start of the treatment (410m from the bridge). At 260m from the hazard, the speed reduction effect was found to wear off, with speeds being approximately 1.0km/h higher than before the lines were installed. At 50m from the hazard, the mean speeds were slightly higher than those obtained prior to the installation of the lines. Six months after the lines were installed at SH53, vehicle speeds appear to have greatly reduced at the start of the treatment length. It was found that at 410m from the bridge hazard, the mean speed was 12.2km/h less than the values recorded prior to the installation of the lines. However, as can be seen in table 4.1, long-term recorded data is distinctly lacking at this detector. Therefore, the results at this location should be taken with caution. As with the initial results, the speed reduction appears to be marginal within the next 150m. At 260m from the bridge, the mean speeds are slightly higher than they were before the markings were implemented; however, this change is statistically non-significant. At 50m from the bridge hazard, the long-term vehicle speeds were found to have decreased substantially and a statistically significant reduction in mean speed of 8.1km/h was determined at this location.

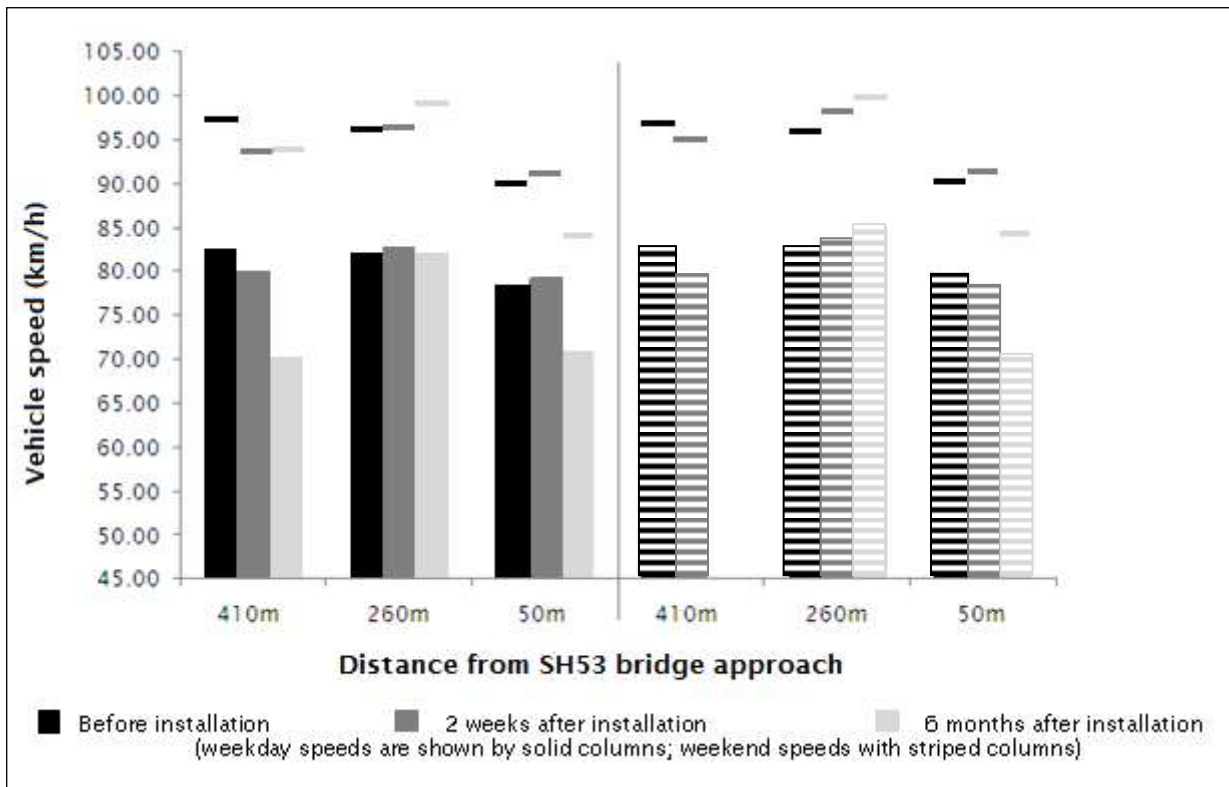
Figure 5.4 Mean weekday and weekend speeds (columns) and 85th percentile speeds (horizontal lines) before and after installation of transverse road markings at Waihenga Bridge eastbound approach (SH53)

Note: data was not available for weekends six months after installation at the 410m point

Regardless of the trial site, no interactive properties were found between the weekday/weekend factor and the short-term analysis period. That is, any difference between the changes in mean short-term weekday and weekend vehicle speed was possibly a result of chance. The results have thus indicated that in the short term, the marking arrangement has had the same effect on drivers (commuter or occasional) travelling over the treatment during either the weekday or weekend.

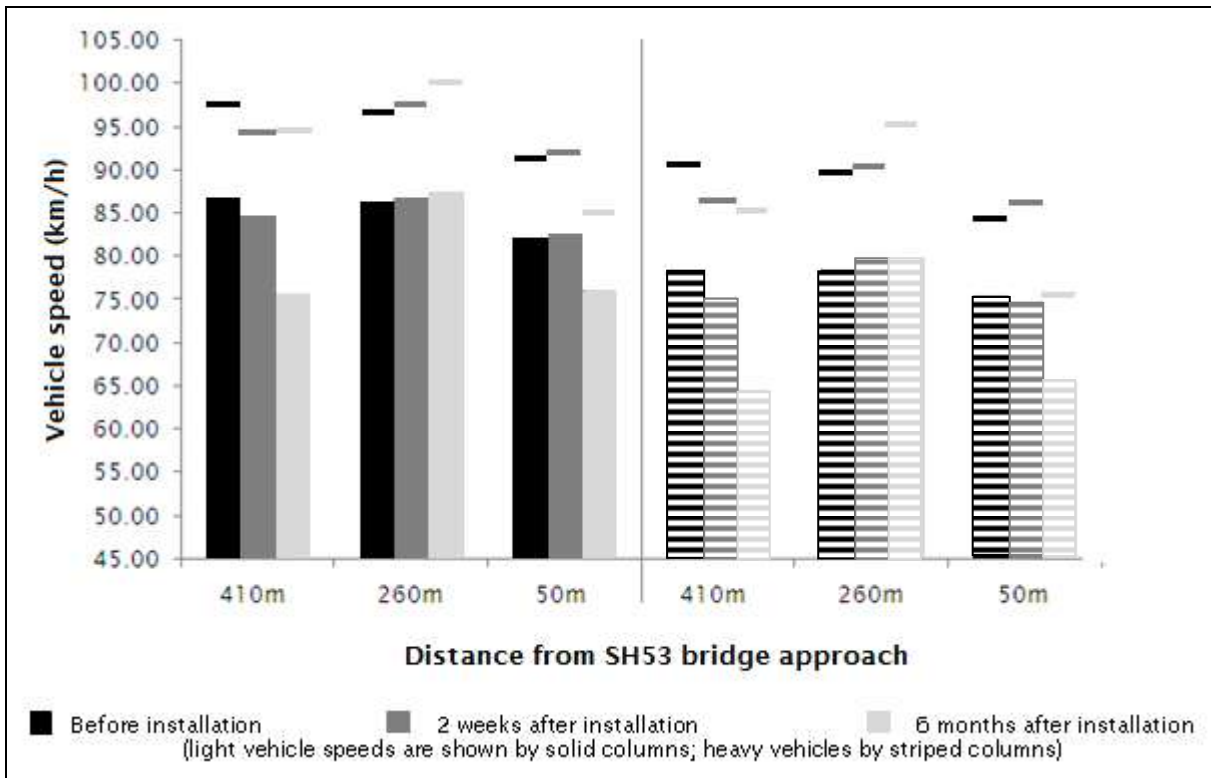
Figure 5.6 Mean light and heavy vehicle speeds (columns) and 85th percentile speeds (horizontal lines) before and after installation of transverse road markings at Waihenga River Bridge eastbound approach (SH53)

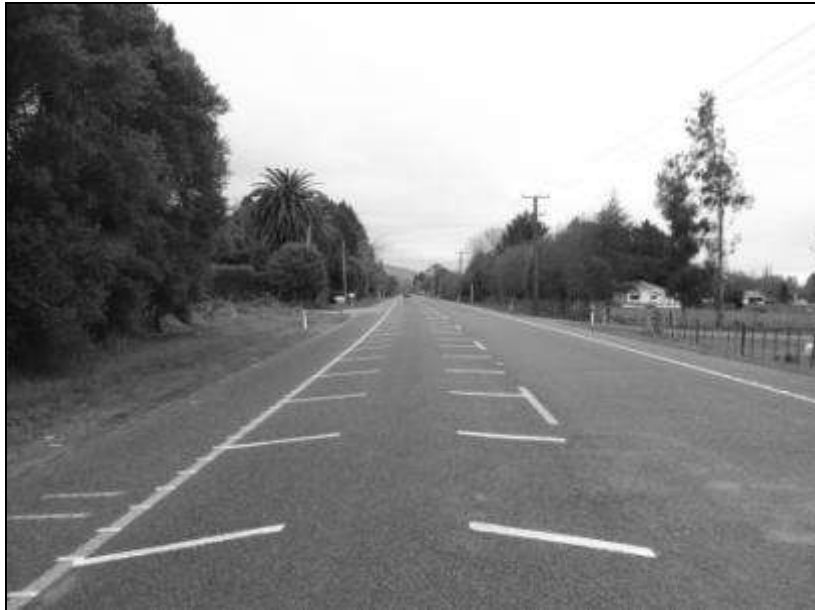
Figure 6.1 SH57 trial site with level geometric profile

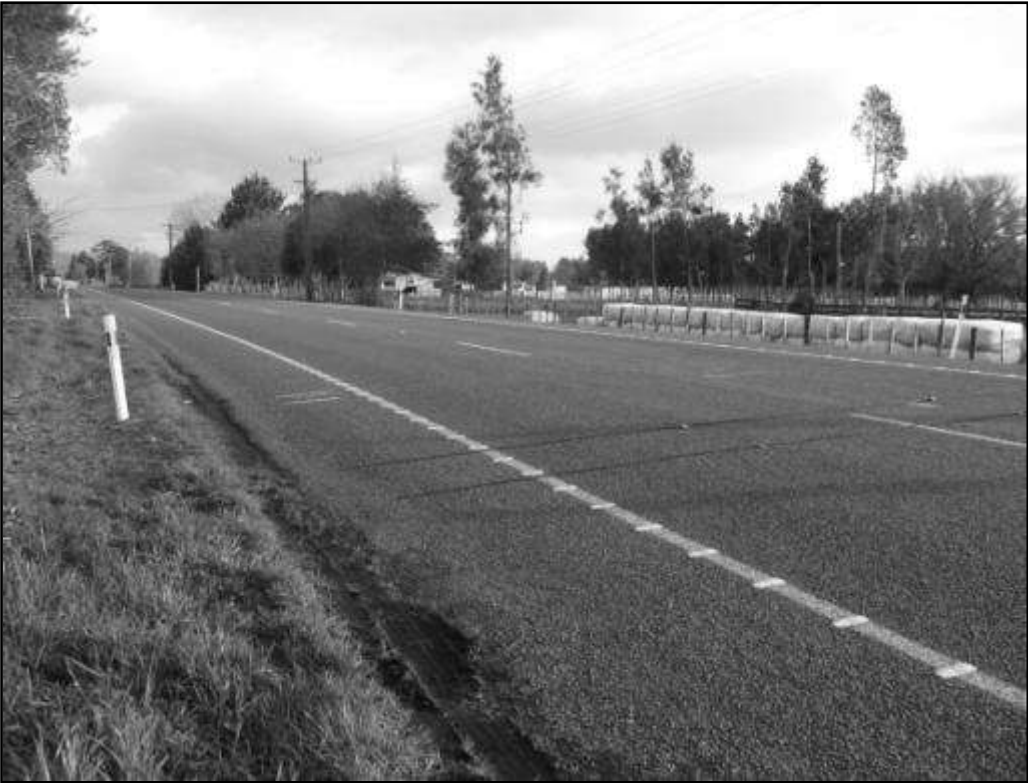
Figure A1 Arapaepae Road (SH57), 410m from the intersection prior to transverse marking installation

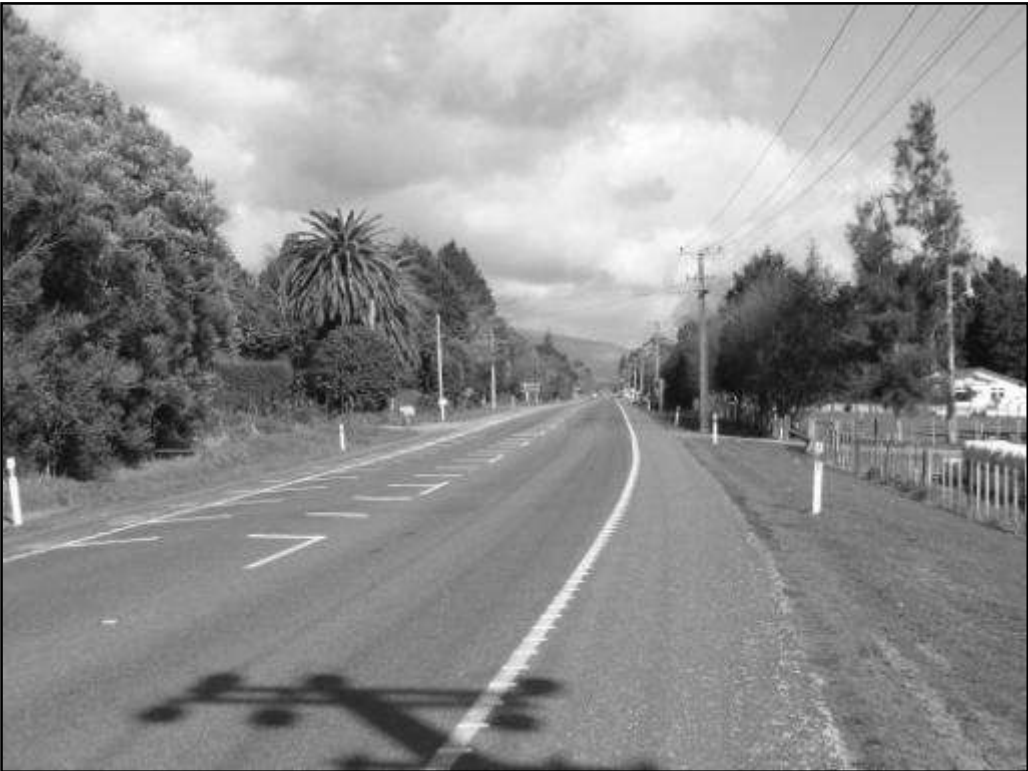
Figure A2 Arapaepae Road (SH57), 410m from the intersection after installation of the transverse markings

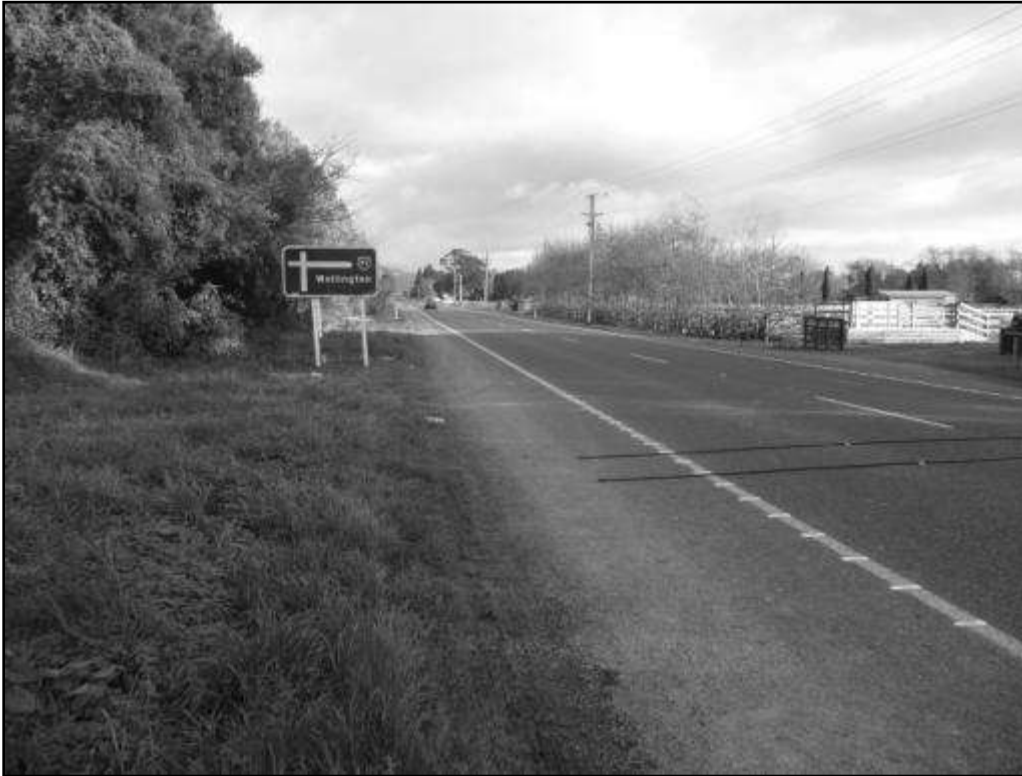
Figure A3 Arapaepae Road (SH57), 260m from the intersection prior to transverse marking installation

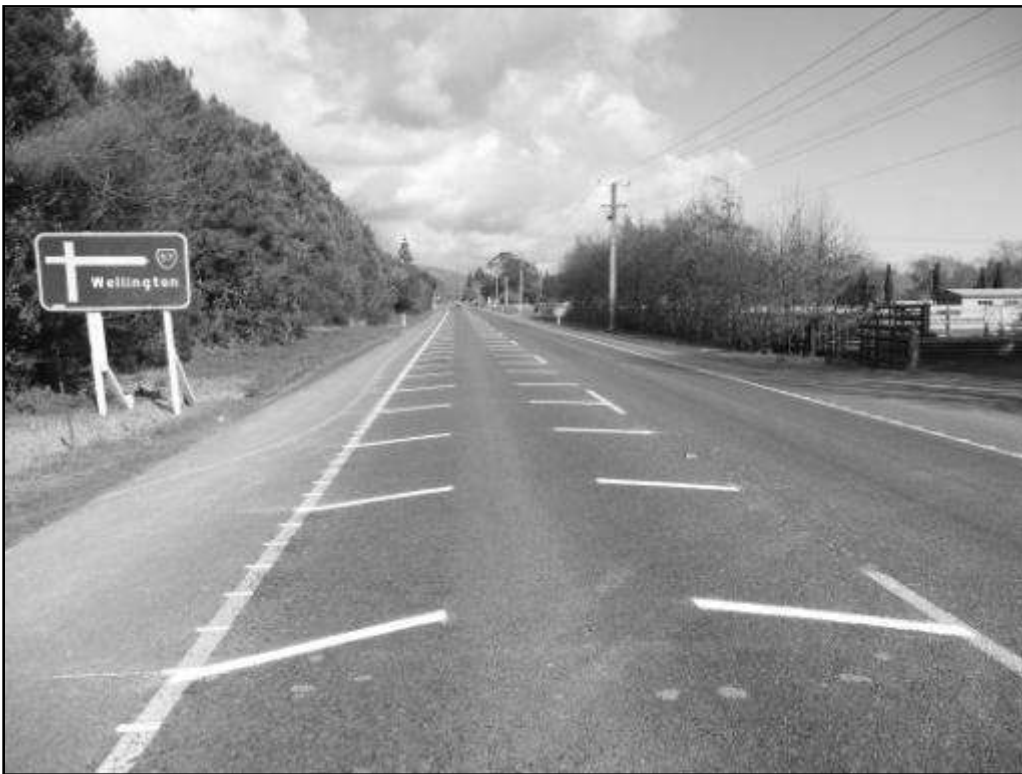
Figure A4 Arapaepae Road (SH57), 260m from intersection after installation of the transverse markings

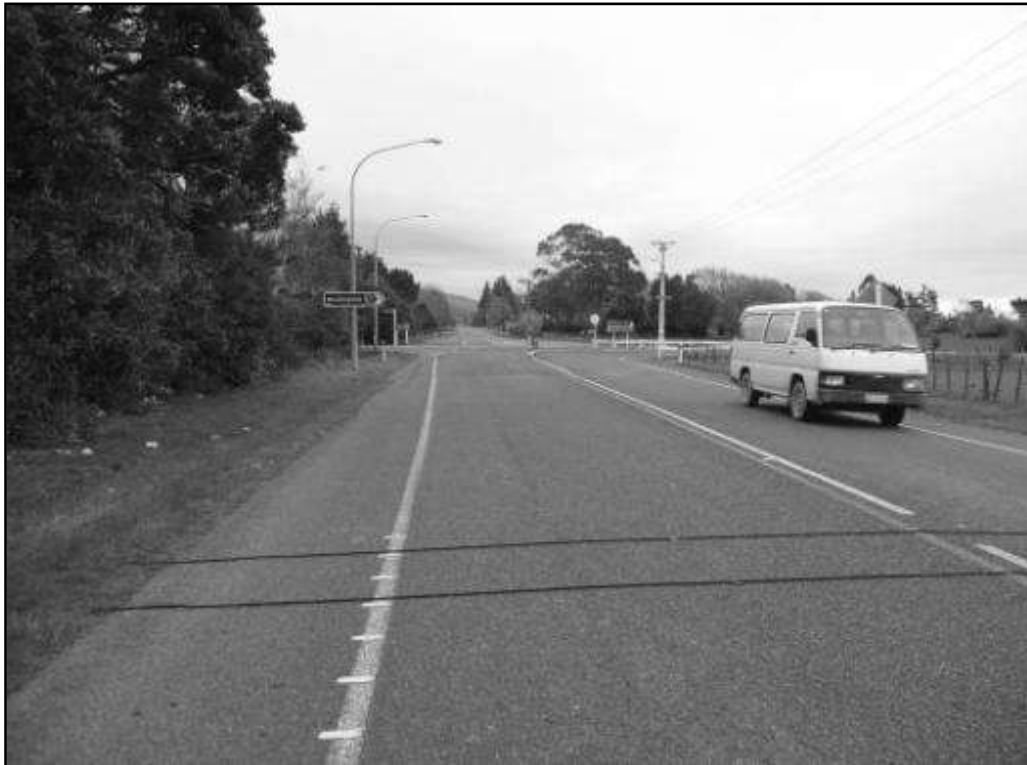
Figure A5 Arapaepae Road (SH57), 50m from the intersection

Note: This location looked the same before and after installation of the transverse markings.

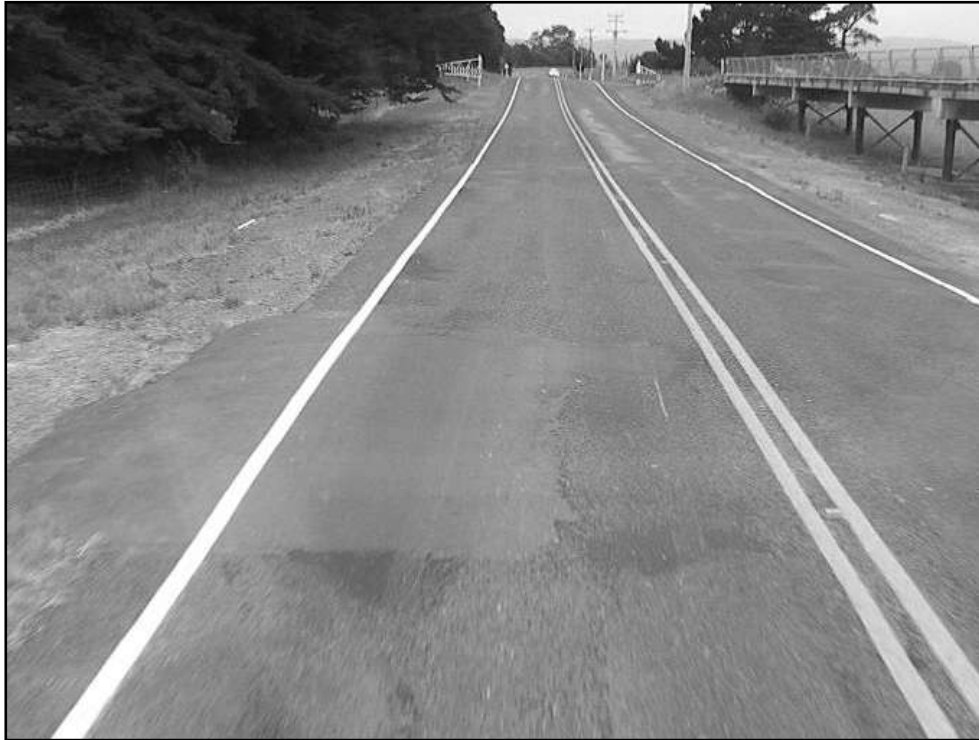
Figure B1 Eastbound Waihenga Bridge approach (SH53), 410m from the horizontal curve prior to transverse marking installation

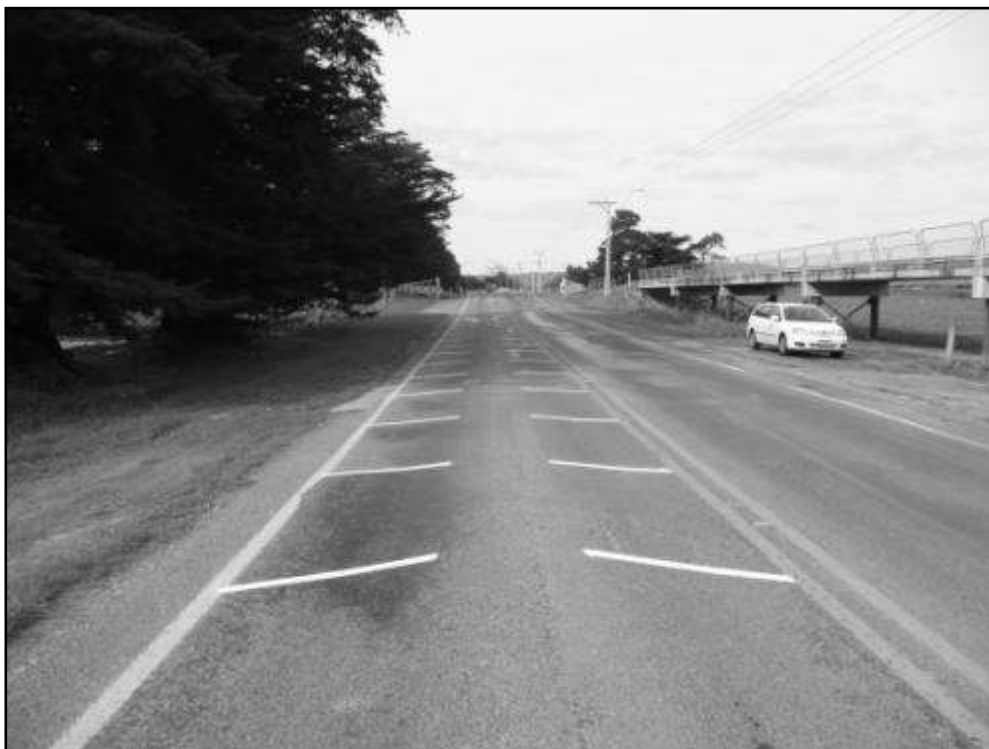
Figure B2 Eastbound Waihenga Bridge approach (SH53), 410m from the horizontal curve after installation of the transverse markings

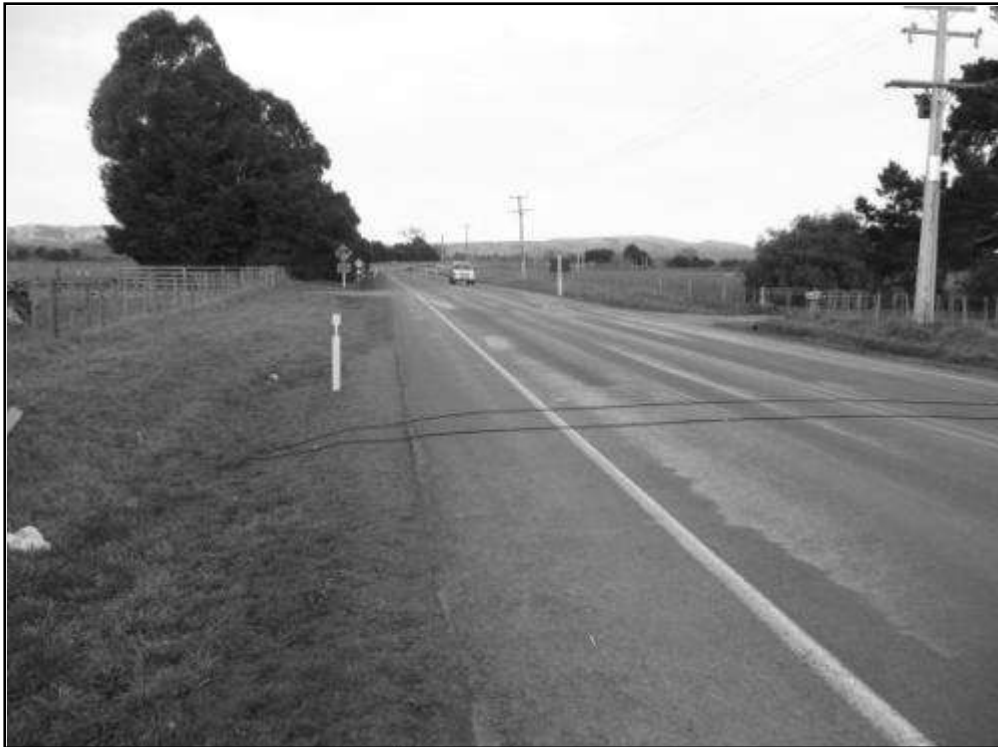
Figure B3 Eastbound Waihenga Bridge approach (SH53), 260m from the horizontal curve prior to transverse marking installation

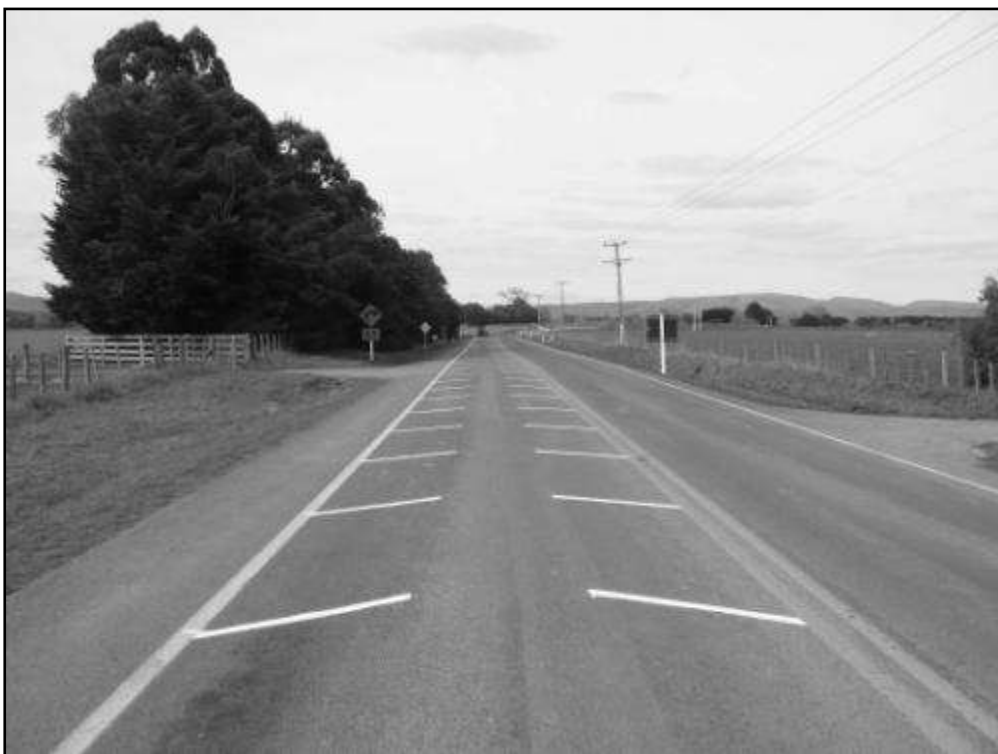
Figure B4 Eastbound Waihenga Bridge approach (SH53), 260m from the horizontal curve after installation of the transverse markings

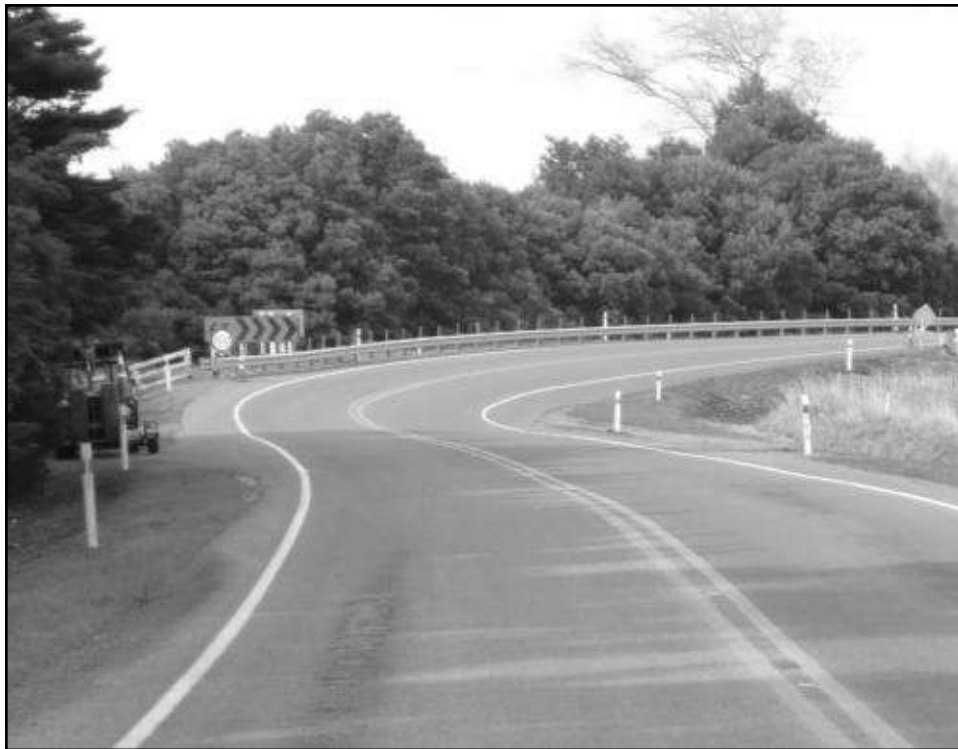
Figure B5 Eastbound Waihenga Bridge approach (SH53), 50m from the horizontal curve

Note: the appearance of this location was the same before and after installation of the transverse markings.

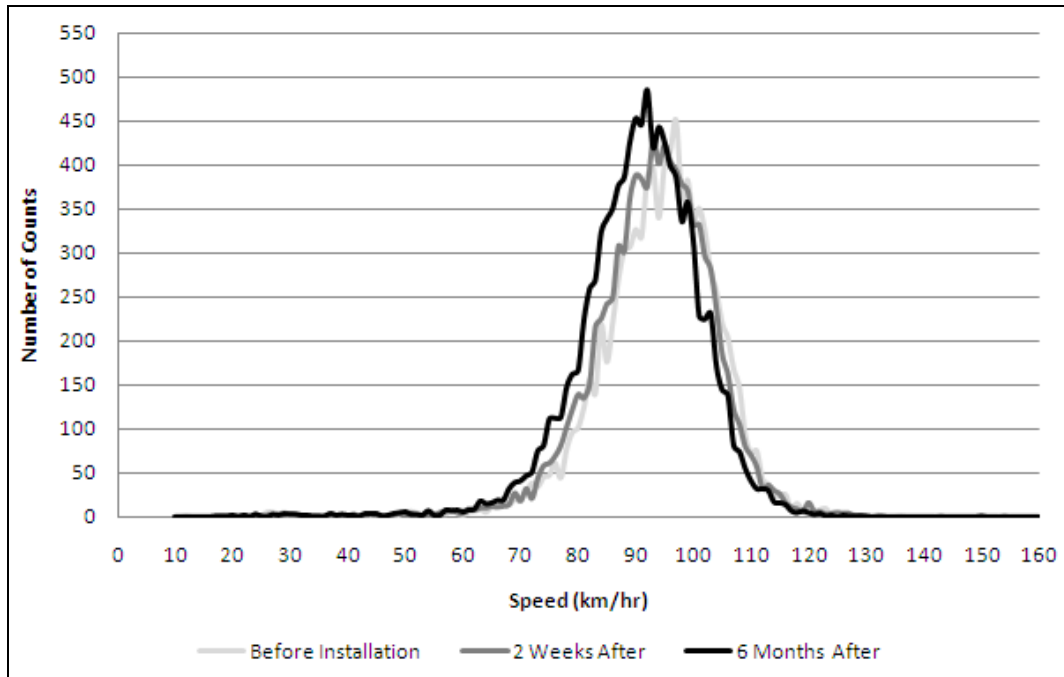
Figure D1 Frequency of vehicle speeds (all vehicles) at the SH57 trial site 410m from the hazard
