Effectiveness of transverse road markings on reducing vehicle speeds

October 2010

Martindale, A and C Urlich (2010) Effectiveness of transverse road markings on reducing vehicle speeds. *NZ Transport Agency research report 423*. 72pp.

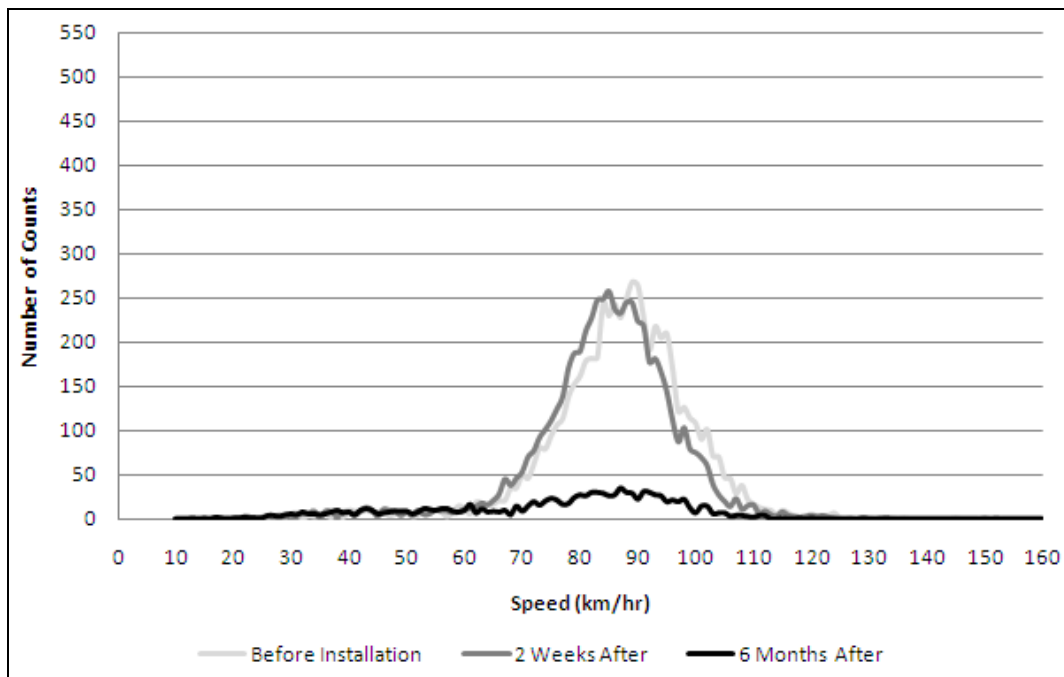
Figure D2 Frequency of vehicle speeds (all vehicles) at the SH53 trial site 410m from the hazard

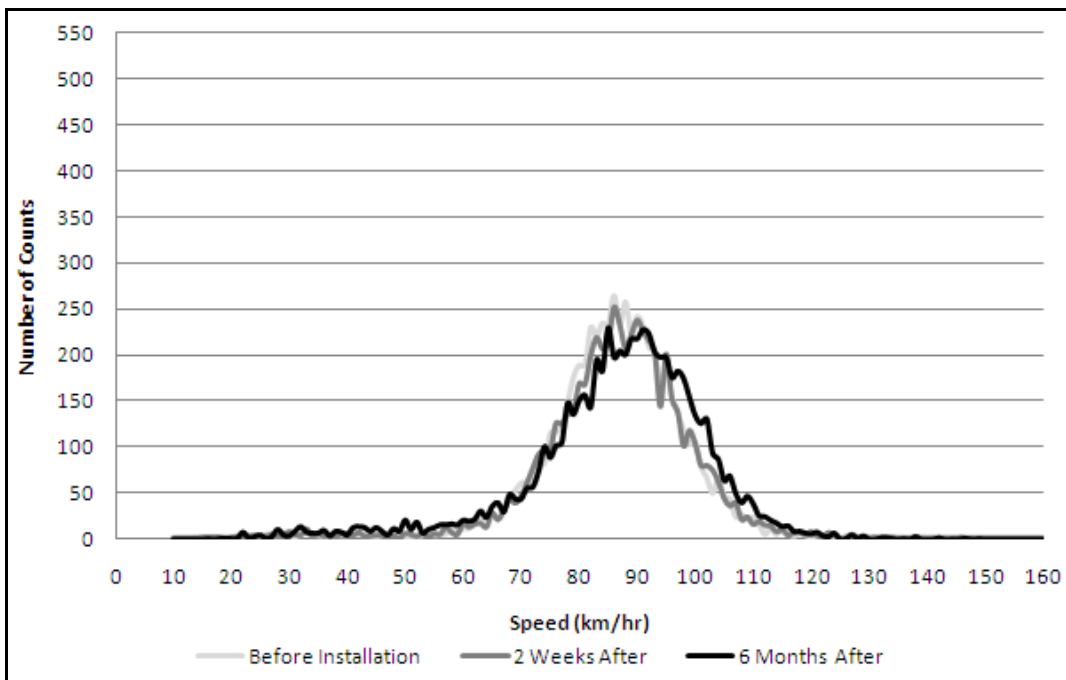
Figure D4 Frequency of vehicle speeds (all vehicles) at the SH53 trial site 260m from the hazard

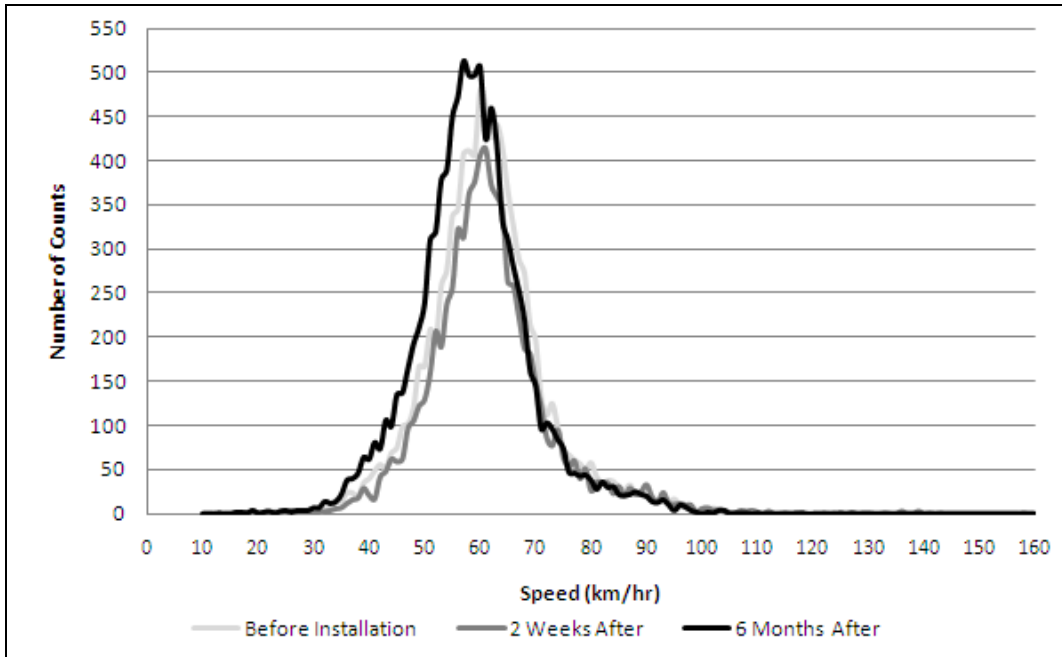
Figure D5 Frequency of vehicle speeds (all vehicles) at the SH57 trial site 50m from the hazard

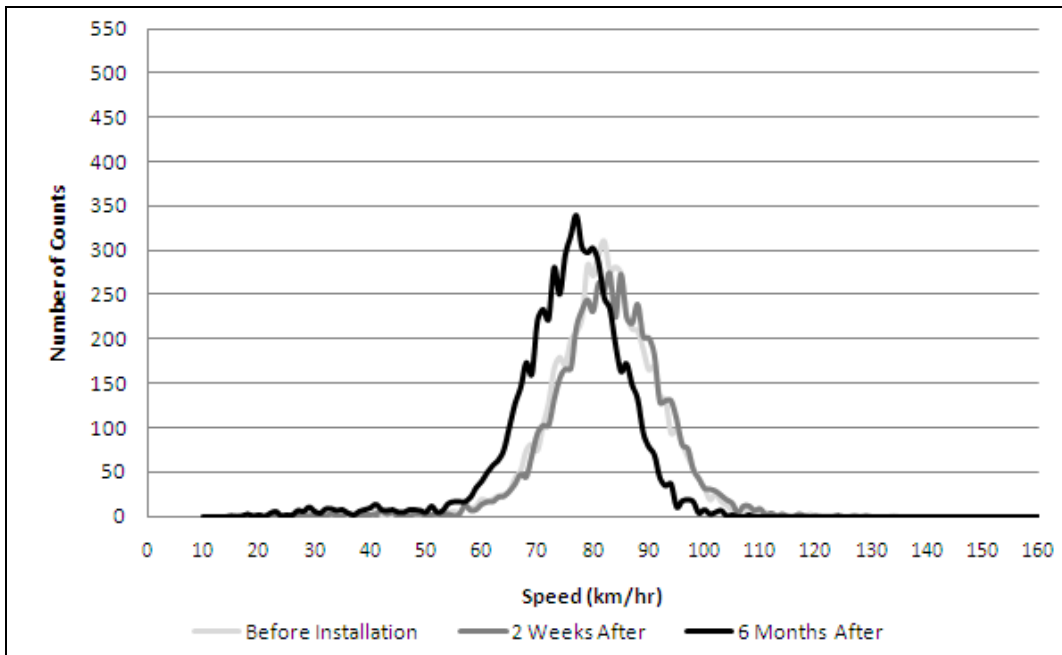
Figure D6 Frequency of vehicle speeds (all vehicles) at the SH53 trial site 50m from the hazard
