Abrasion resistance of aggregates in asphalt

December 2010

Bartley, FG¹, RJ Peploe¹ and PM Black² (2010) Abrasion resistance of aggregates in asphalt. *NZ Transport Agency research report 433*. 70pp.

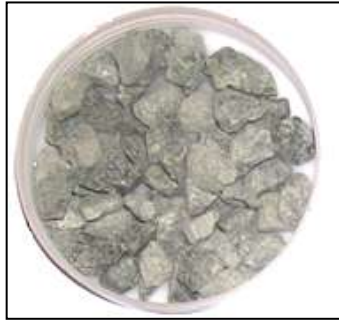
Figure 3.1 Sample of aggregate from Brookby Quarry

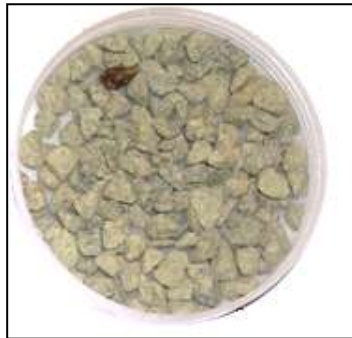
Figure 3.2 Sample of aggregate from Moutohora

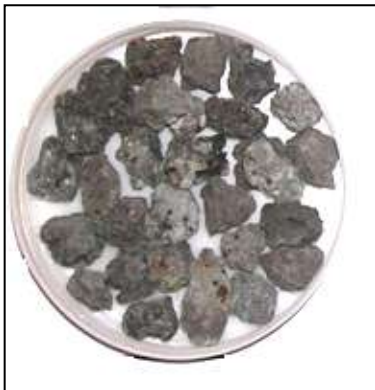
Figure 3.3 Sample of electric arc furnace slag

Electric arc furnace (EAF) slag is a by-product of the manufacture of steel reinforcing rods and wire at the Pacific Steel plant in Otahuhu. The process involves melting scrap steel in an electric arc furnace and adding lime to form a slag that contains oxidised impurities, and which provides a thermal blanket to the melt and helps to reduce erosion of the refractory lining. Later in the process, pulverised coal is added. The coal burns to form carbon monoxide gas, which causes the slag to foam on the top of the molten steel. This foam is permitted to overflow the melt vessel and fall into the slag pit below. The slag is allowed to cool to form a solid, glassy, vesicular, rock-like material that is subsequently broken up; any steel carried over is removed by magnetic separation, and then the material is crushed and screened to form aggregate and sealing chip.

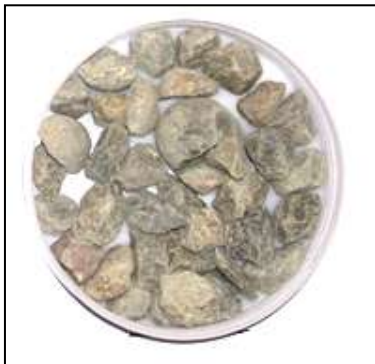
Figure 3.4 Sample of aggregate from Te Matai

The Te Matai aggregate was manufactured from river gravel, which was quarried from a pit in Te Matai Road, Palmerston North. The gravel was derived from Torlesse-type greywacke sandstone. The Torlesse greywacke is predominantly quartz and feldspar. It has undergone intense brittle deformation, and shearing, fracturing and faulting are common. It is strongly lithified by very low grade metamorphism. It shows widespread quartz veining, and chlorite and smectite can appear on the surfaces in shear zones. The clay minerals are predominantly illite; chlorite is minor and smectite is rare. These rocks are denser and generally stronger than the Waipapa rock types.

Te Matai aggregate is a very quartz-rich gravel that is typical of the Torlesse sandstone type. It shows some brown discolouration of the matrix caused by slight weathering. The clay minerals are kaolinite, illite and some chlorite. The naturally water-worn surface of the gravel is relatively smooth in comparison with the irregular surface of the crushed material. The grains in the surface of the crushed rock appear to be well cemented by the matrix.

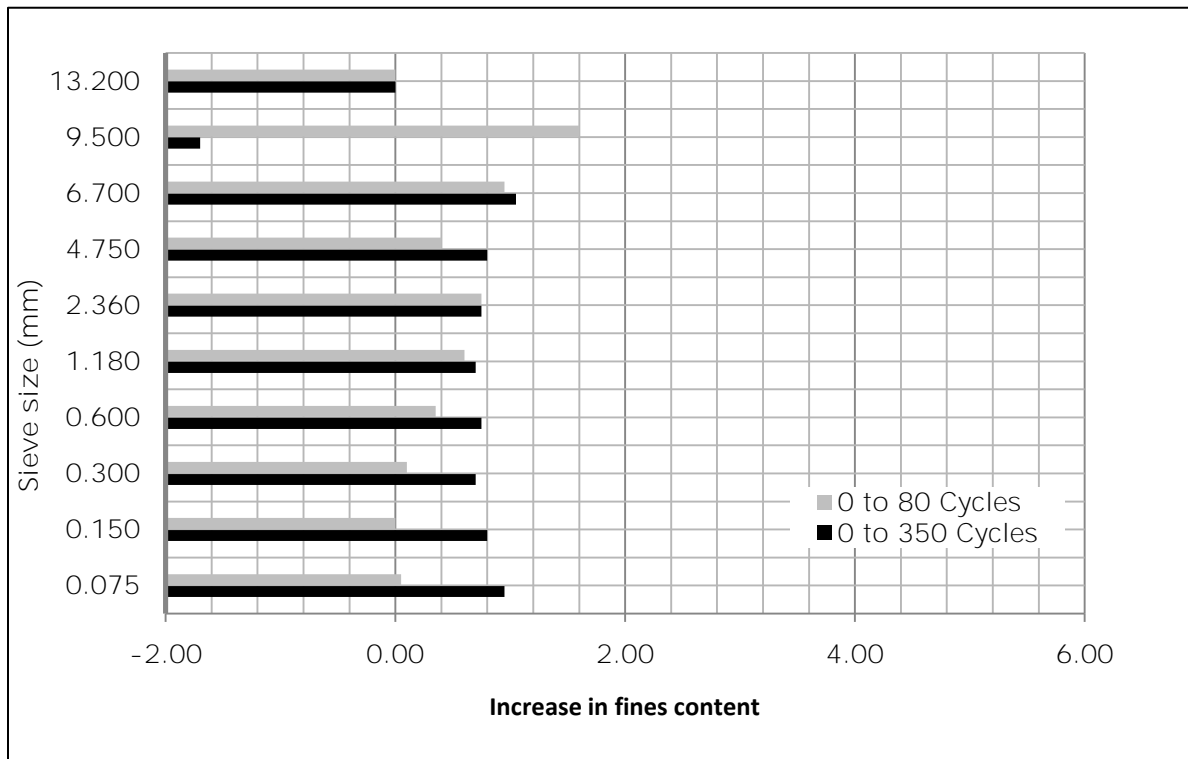
Figure 4.1 Increase in fines content after gyratory compactor tests for the Brookby sample.

These graphs show that some of the larger particles (predominantly 9.5–4.75mm) have been reduced in size and that the material produced is primarily fine sand that has passed through the whole nest of sieves. Note that the negative values shown in figures 4.1 and 4.3 are probably an aberration caused by possibly an elongated particle or two.

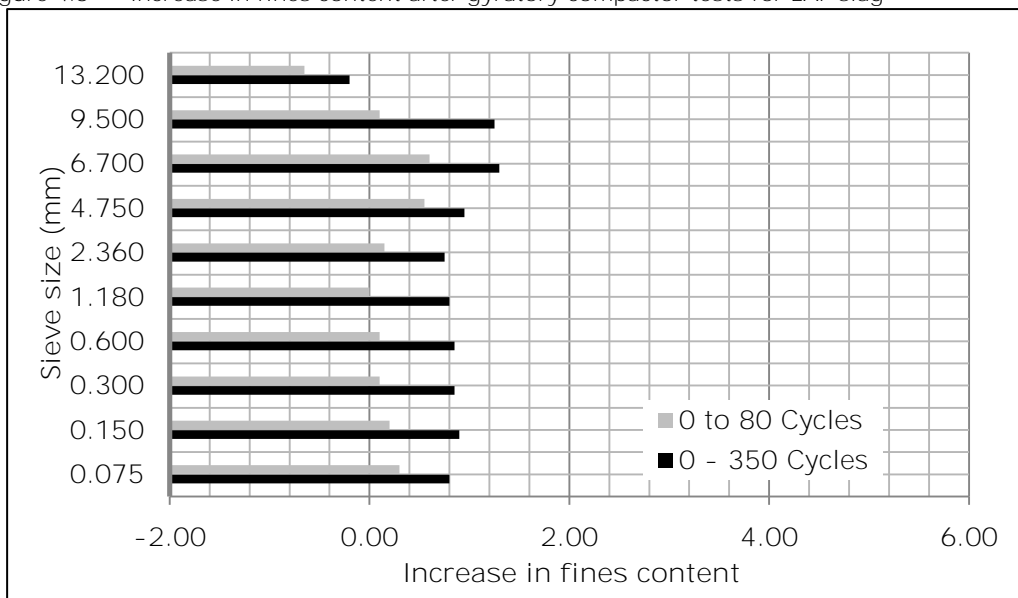
Figure 4.3 Increase in fines content after gyratory compactor tests for EAF slag

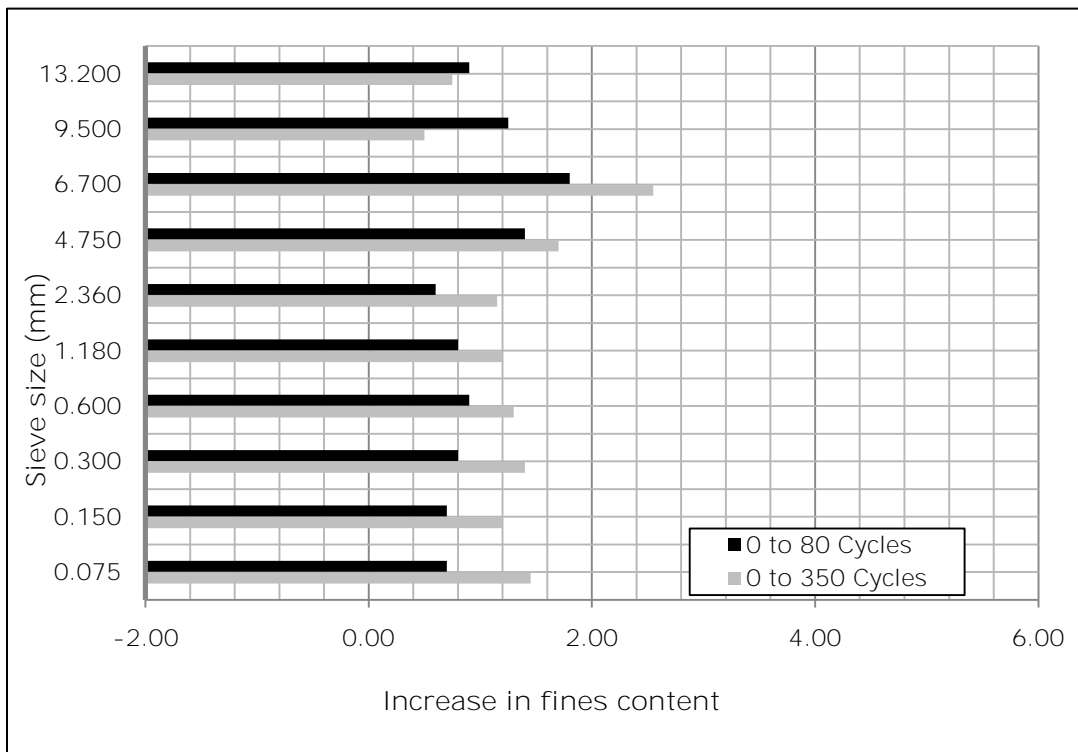
Figure 4.4 Increase in fines content after gyratory compactor tests for the Te Matai aggregate

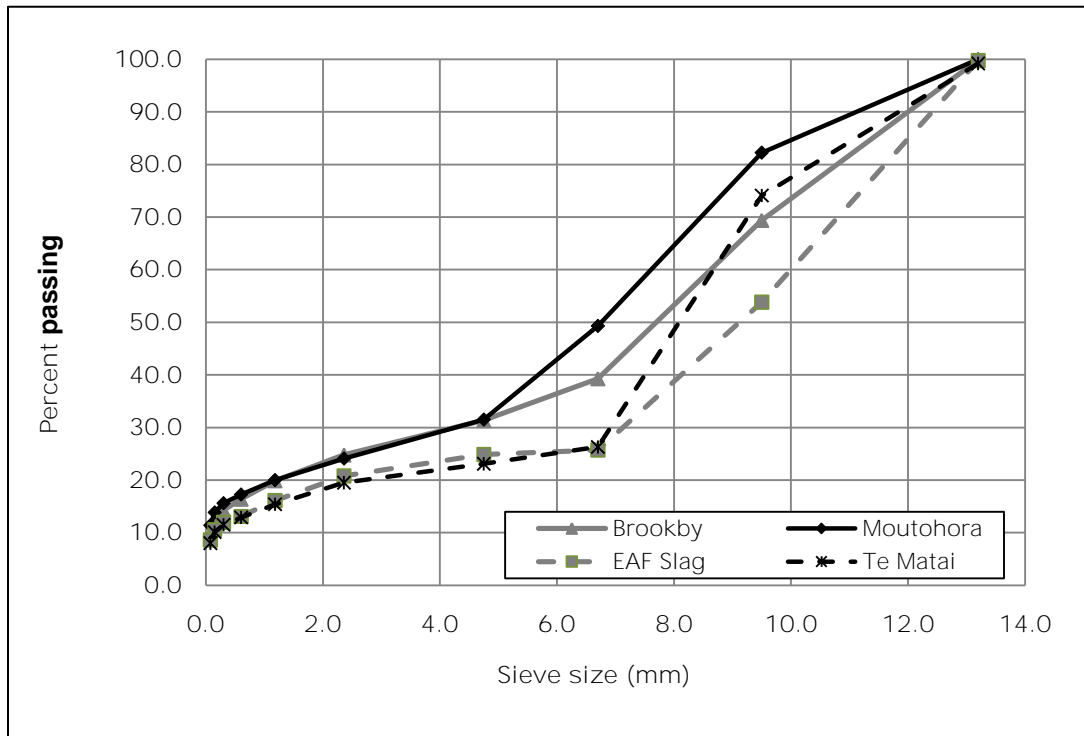
Note that the PSD of the aggregates prior to construction appear to fall into two groups. The Brookby and Moutohora samples make up in one group, while the EAF slag and the Te Matai samples make up the other. Such differences may have an influence on any degradation that may occur under load.

Figure 5.3 Particle size distribution of the core samples

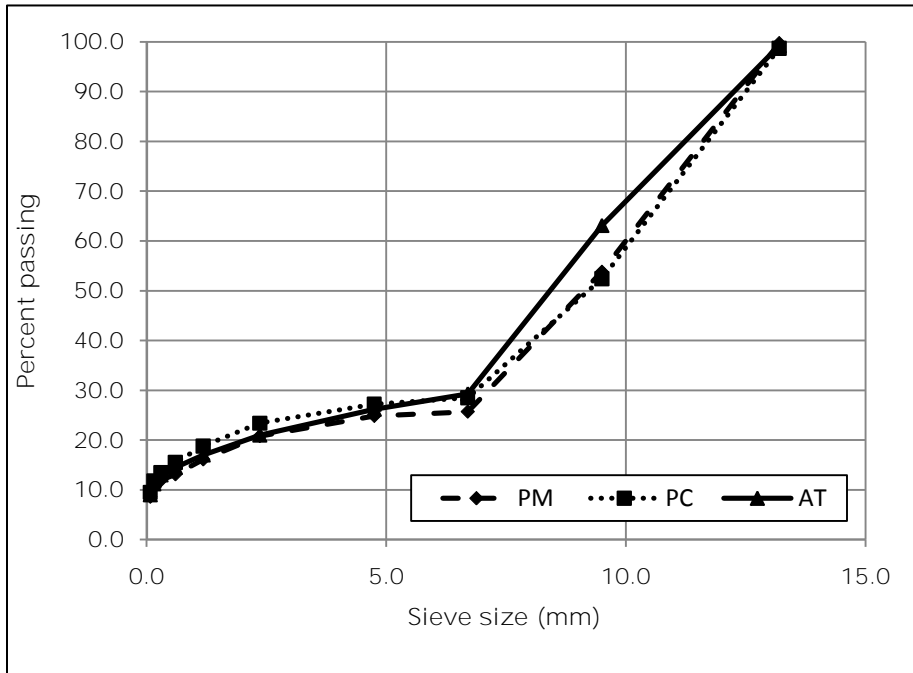
Figure 5.6 Means of the PSD for the production samples (PM), core samples post-compaction (PC) and after trafficking (AT) for the EAF slag

The change between the mean of the PSD for the production samples (PM), the mean of the core samples taken post-compaction (PC) and after trafficking (AT) are shown in figures 5.4-5.7.

The figures indicate that generally the sampling and test methods used provided reasonably consistent results. The two samples of each aggregate type taken from the feed chute conveyor (PM) gave results that lay within the allowable range for single operator precision as recommended by ASTM International for that test (2008b).

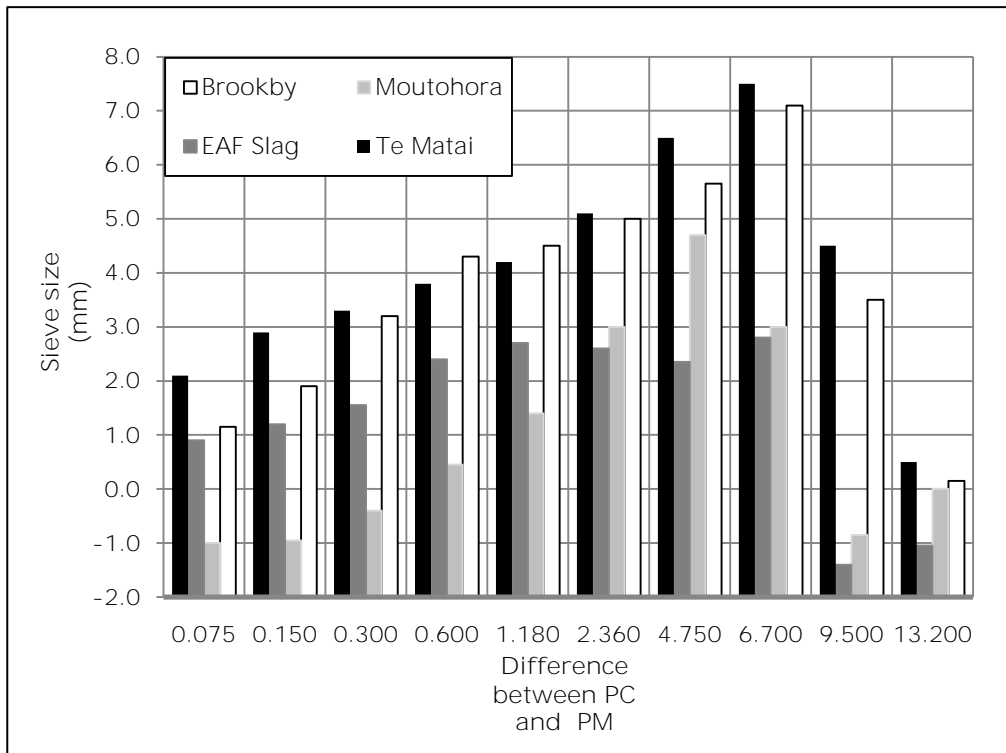
Figure 5.9 Degradation of sample aggregates caused by construction, measured as the difference between mean PSD for the production samples (PM) and post-compaction (PC)

Figure 5.9, based on the difference in the percentage passing each sieve, shows that all of the aggregates suffered some breakdown, particularly in the larger size range. Most of the material that was generated was sand. The negative values, particularly in the larger stone sizes, may result from test error or the presence of elongated particles. Such values for the smaller sieve sizes could be a result of the production of more fines.

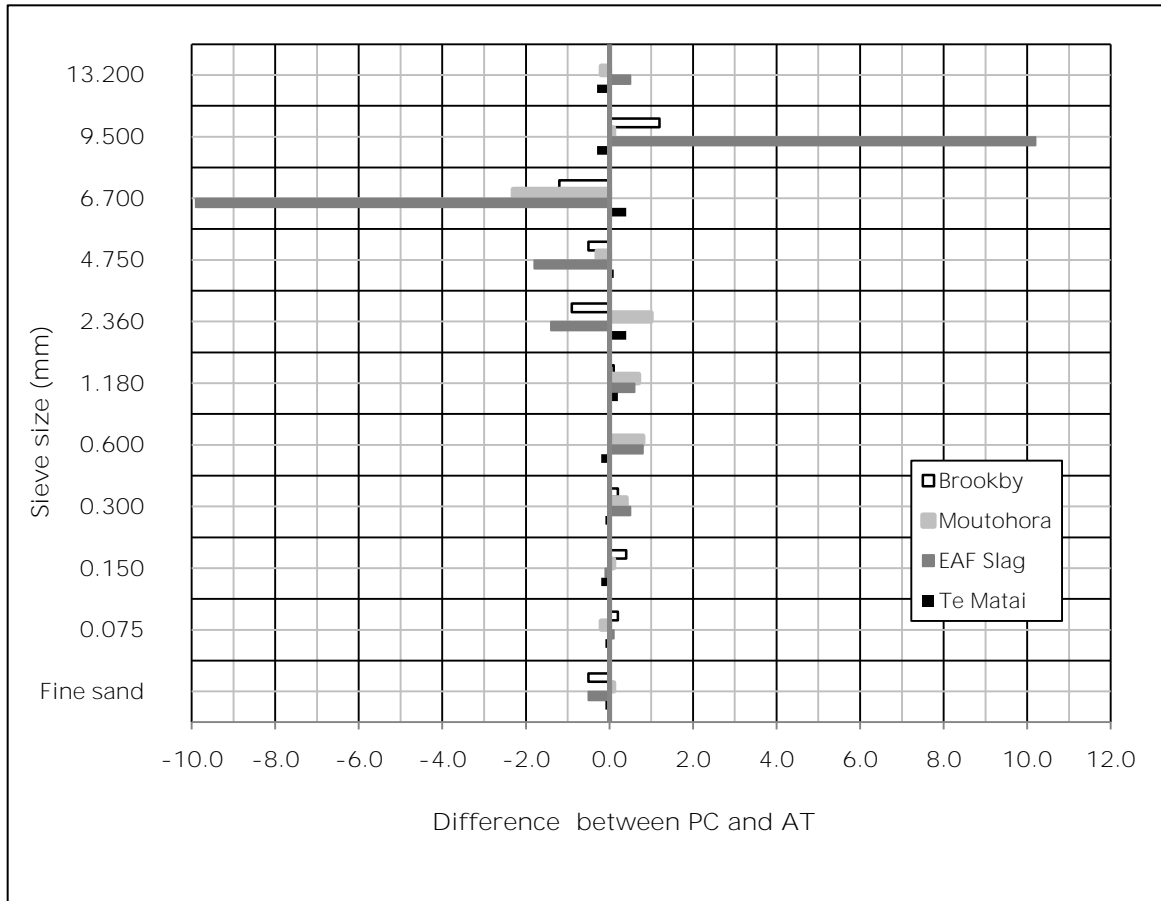
Figure 5.10 Degradation of sample aggregates caused by trafficking, measured as the difference between the mean PSD post-compaction (PC) and after trafficking (AT)

Figure 5.10 shows that little or no change was caused by traffic. Note that the extreme positive value for EAF slag could be an anomaly in the AT sample or may result from a collapse of particles during trafficking.

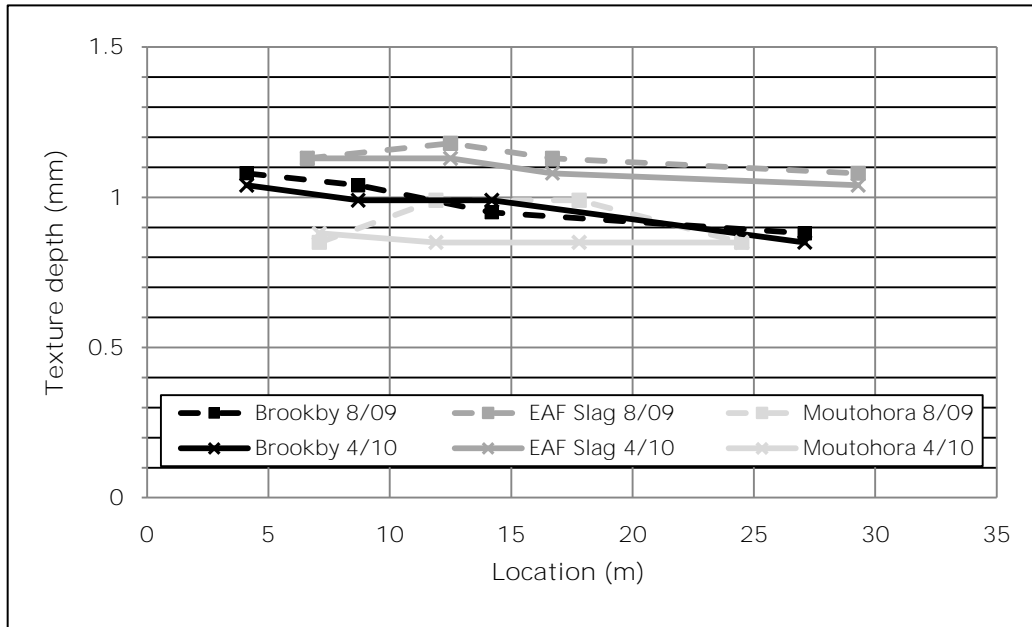
The results are set out in table B1 in appendix B and summarised in the graph shown as figure 5.11. The comparative texture at the time of construction is illustrated in figure 5.12.

Numbers indicate month and year of measurement

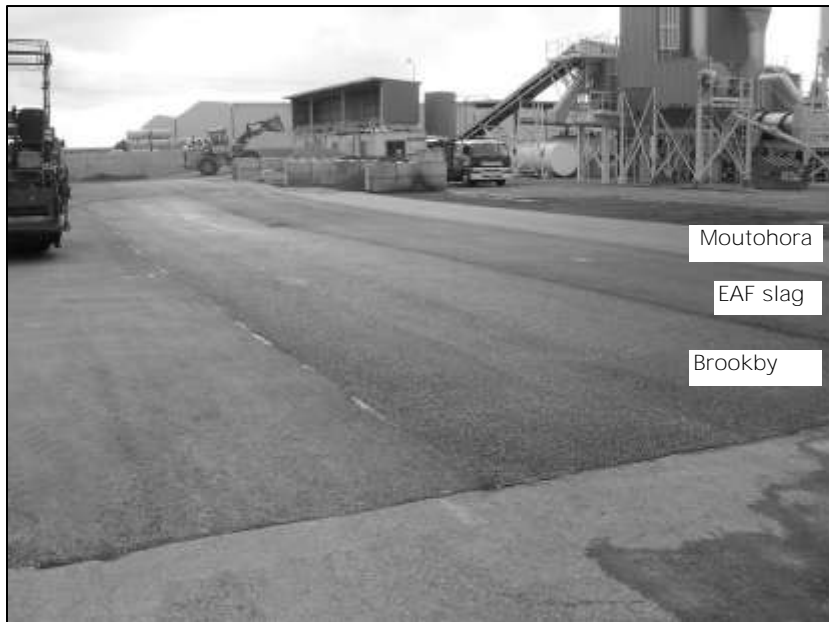
Figure 5.12 Comparative texture of the three sections laid in Auckland

Figure 5.12 shows the difference in the texture of each section immediately after laying and after eight months' trafficking. The EAF slag, being the aggregate with the coarsest grading, has the deepest texture. Initially, the texture of the Brookby and Moutohora aggregates was similar, although the Moutohora aggregate showed a greater variation. After trafficking, the texture of the Brookby and EAF slag sections showed little change but the surface of the Moutohora aggregate became almost uniform throughout its length. However, the change is in the order of 0.1mm, which is probably within the tolerance for this type of test.

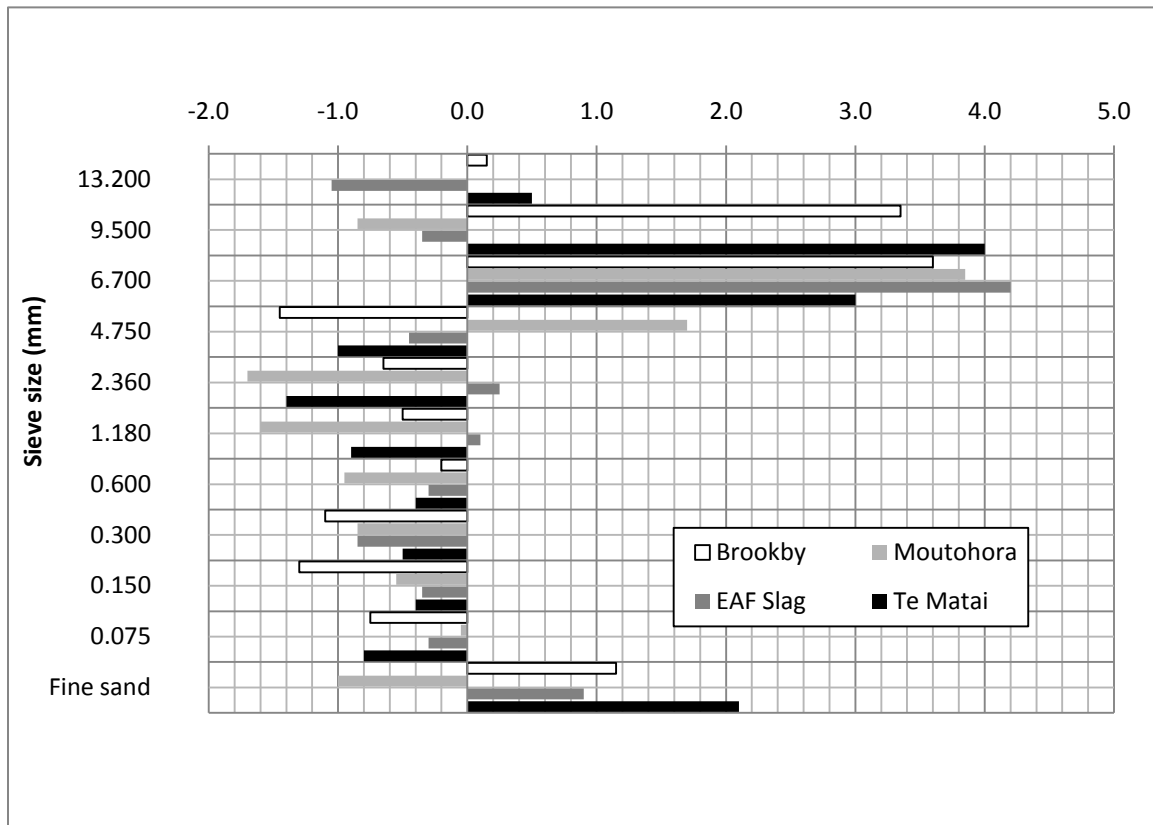
The research carried out during this project shows that the coarser particles of aggregate used in SMA degrade during compaction. Most of the breakdown occurs in the larger particles, which can be described as small to medium gravel. As these particles wear, they produce predominantly fine sand. This is illustrated in figure 5.13.

Figure 5.13 Degradation caused by construction (based on material retained on each sieve), defined as the difference between the mean PSD of the production samples (PM) and the post-conduction means (PC)

It is therefore concluded that the degradation process involves the removal of sharp corners and edges of the larger particles when one large particle moves against another as the mix consolidates under the action of the steel-wheeled rollers.

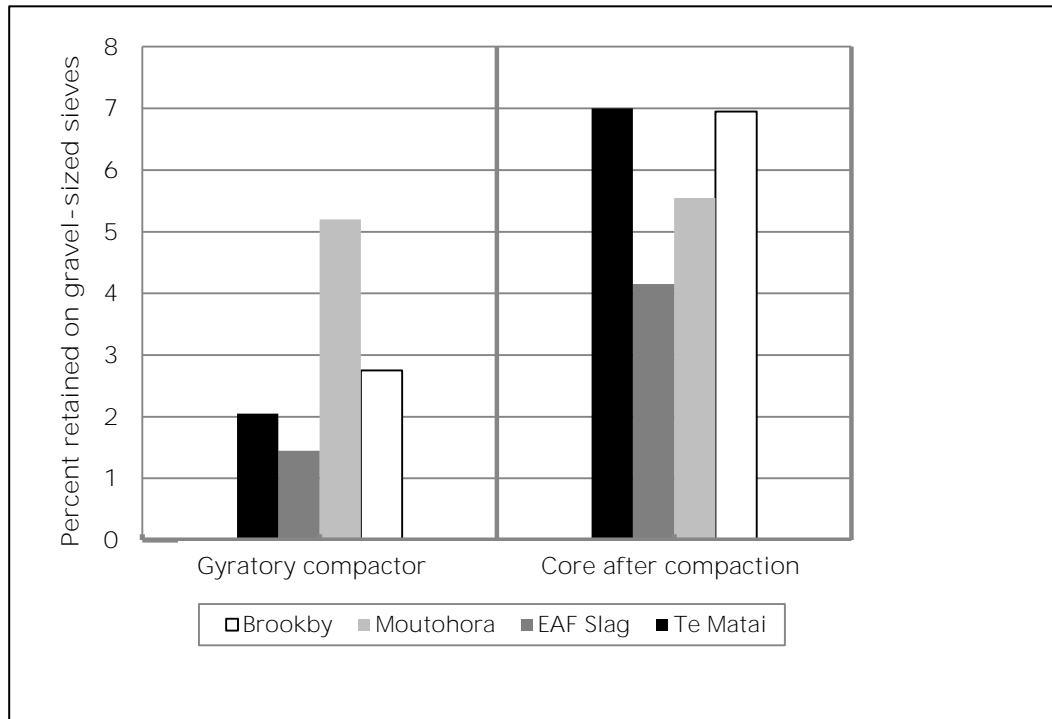
A comparison of the degradation generated during the compaction of the test sections and that generated during 350 revolutions of the gyratory compactor is shown in Figure 5.14. This graph is based on the sum of the material retained on the larger sized sieves rather than on one particular sieve.

Figure 5.14 Degradation of test sections versus laboratory results

This figure indicates that the gyrotory compactor could be used to provide a reasonably accurate indication of the breakdown (30–40% at 350 revolutions) for some (but not all) rock types.

For the Moutohora aggregate, the gyrotory compactor measurement was virtually equal to the field measurement. It was noted earlier that this rock type was more weathered than the others and it may have broken down more easily in the compactor than the others.

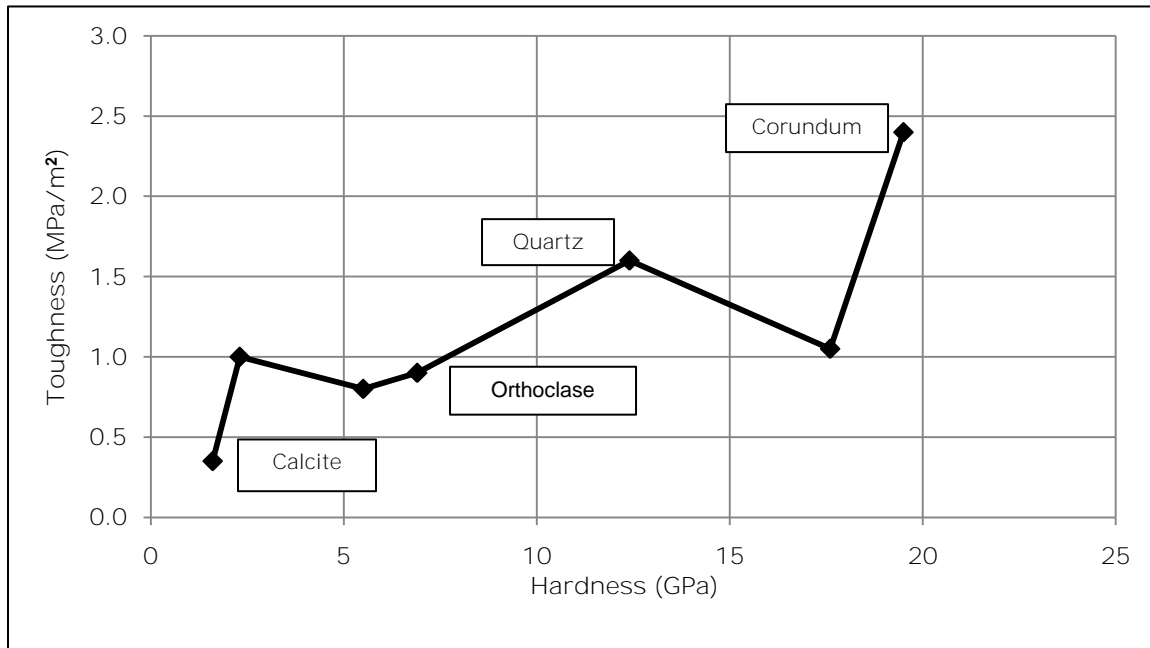
Natural volcanic glass has a Mohs value between 5 and 6, and has brittle fracture properties similar to that of quartz but notably higher than other silicate minerals in volcanic rocks. The layer silicates (clay minerals) are the softest and least competent components of rocks.

Figure B1 Mineral toughness and hardness of rock-forming materials
