# **Characterisation and use of stabilised basecourse materials in transportation projects in New Zealand December 2011**

Gray, W, T Frobel, A Browne, G Salt and D Stevens (2011) Characterisation and use of stabilised basecourse materials in transportation projects in New Zealand. *NZ Transport Agency research report* 461. 84pp.

**Keywords:** basecourse, life, lightly bound, pavements, recycling, stabilisation

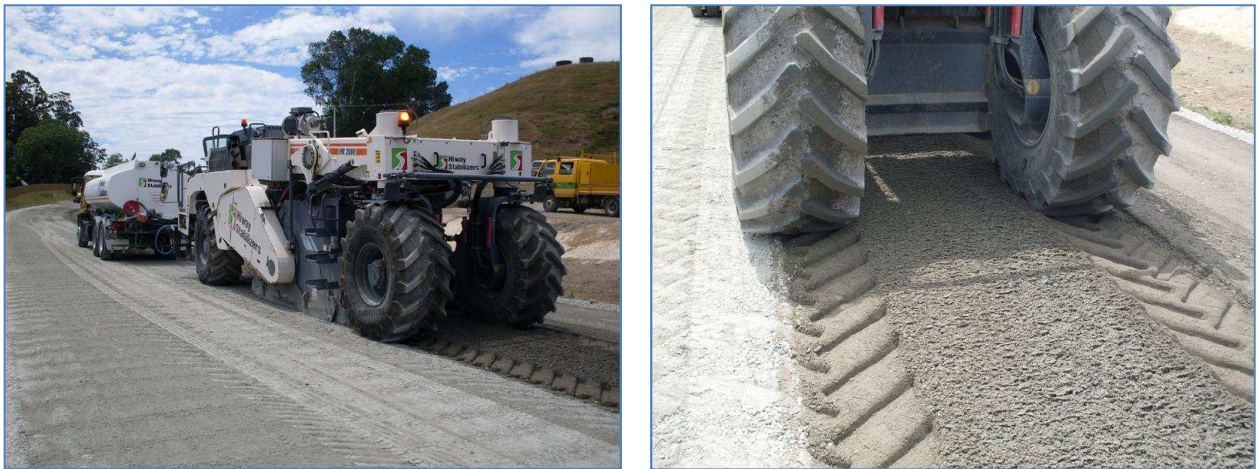
**Figure 1.1** Stabilisation of near-surface granular layers

Stabilisation can be used to improve the performance of various materials in a pavement structure, such as the foundation or subgrade. This research, however, is focused on the *stabilisation of the granular layers at or near the pavement surface within a pavement, with or without seal inclusion.*

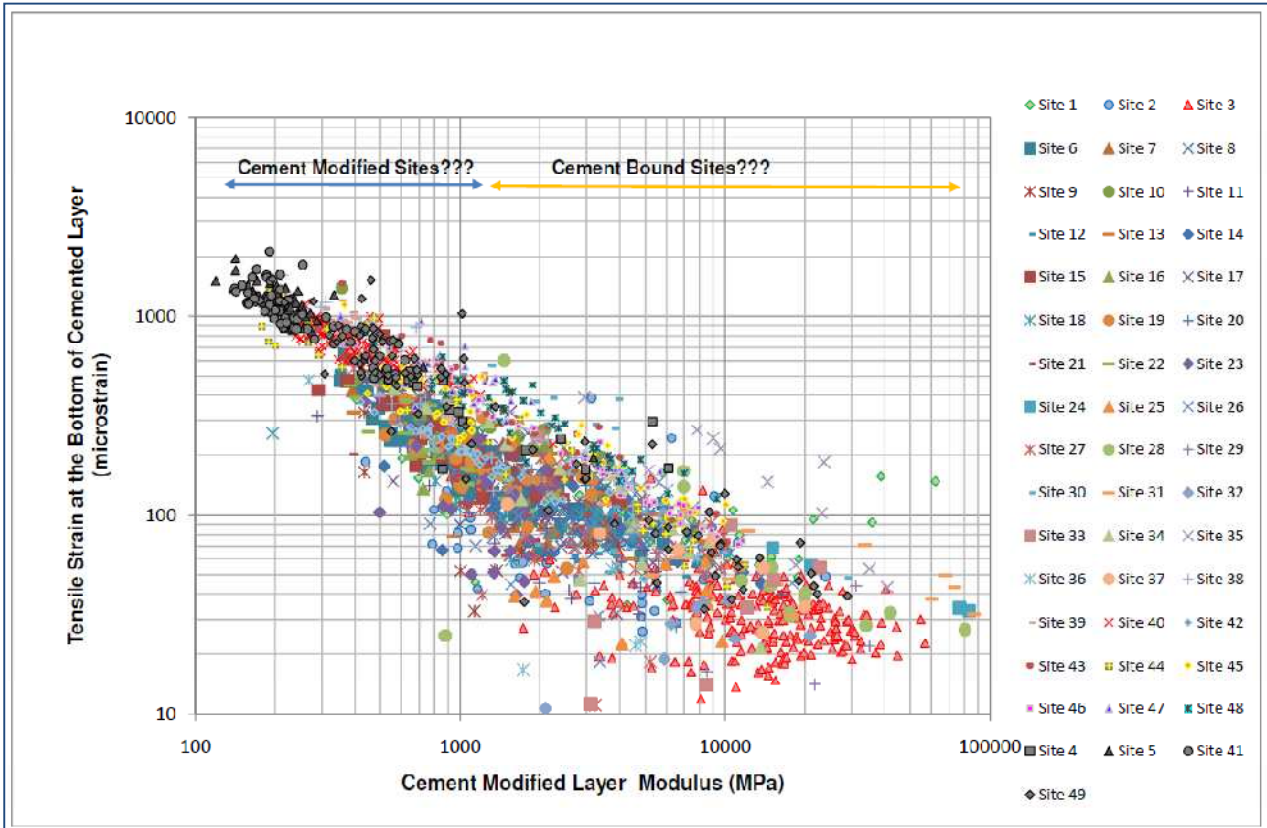
Figure 3.1 Cement-stabilised project data

Only isotropic modulus values are presented, firstly because they are able to be generated very rapidly using the ELMOD software, and secondly because this enables presentation of all types of materials as a continuous function of modulus (ranging from those with so little binder that they are virtually unmodified, through modified and including up to heavily bound materials).

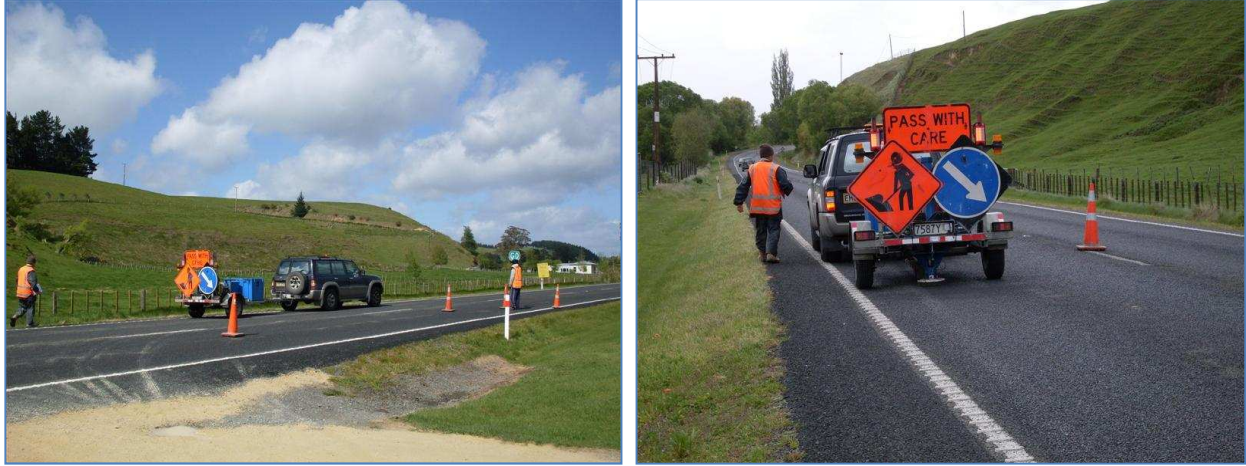
Figure 4.2 FWD test rig

The FWD test rig is shown in figure 4.2. The testing was completed in or very near the outer wheeltrack, in alternating directions.

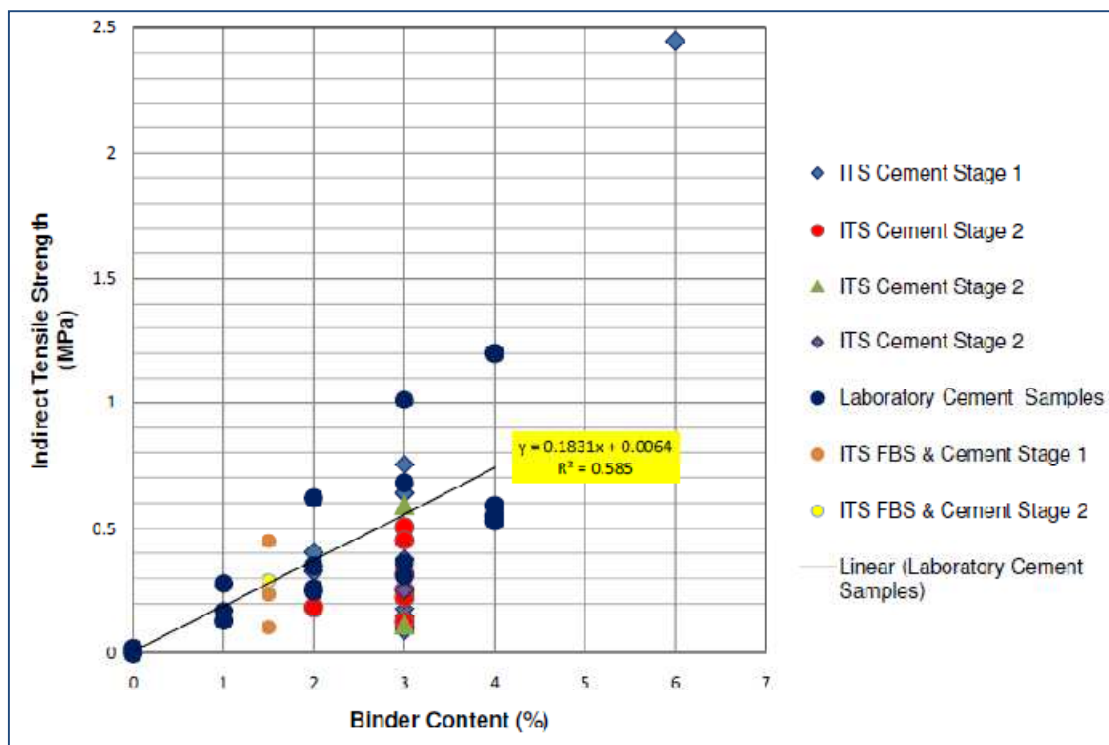
Figure 4.4 Comparison between ITS and binder content from core samples from laboratory testing

As expected, the reported ITS increased with increasing binder content. The spread of ITS results, at binder content of 3% in particular, was large.

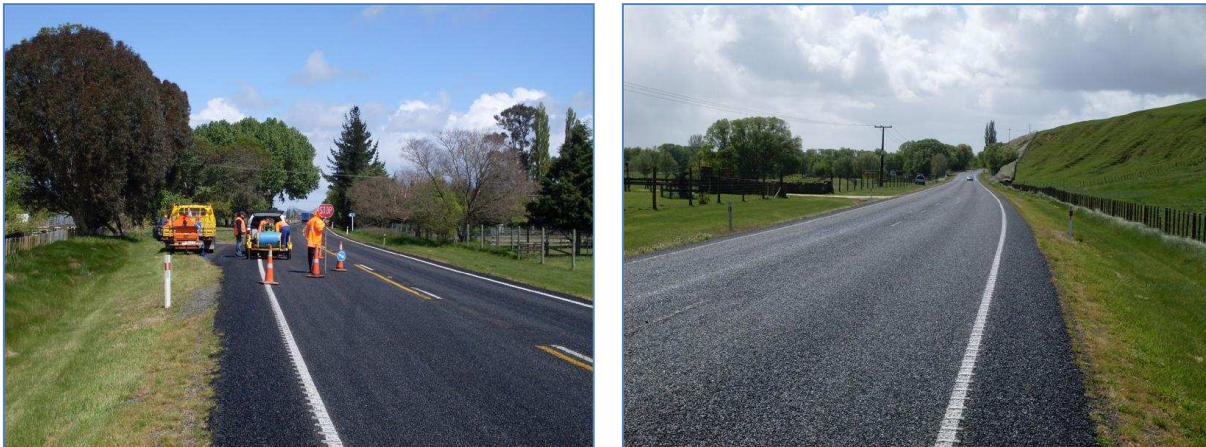
Figure 4.5 The Pukeora project

The Pukeora project was on SH 2 south of Waipukurau, on a relatively low-lying flat site (see figure 4.5) The original pavement consisted of 50–60mm of chipseal (multiple layers) overlying partially crushed granular pavement, giving an overall depth of approximately 500mm. AWPT was programmed to address SCRIM and top-surface-layer maintenance defects. The subgrade was gravelly SILT. The existing near-surface seal and pavement was stabilised to a depth of 200mm with 3% cement by dry weight. Following several reseals since construction, at the time of this research the existing pavement was slightly rough (this was also the case immediately following construction), and had required no unplanned intervention.

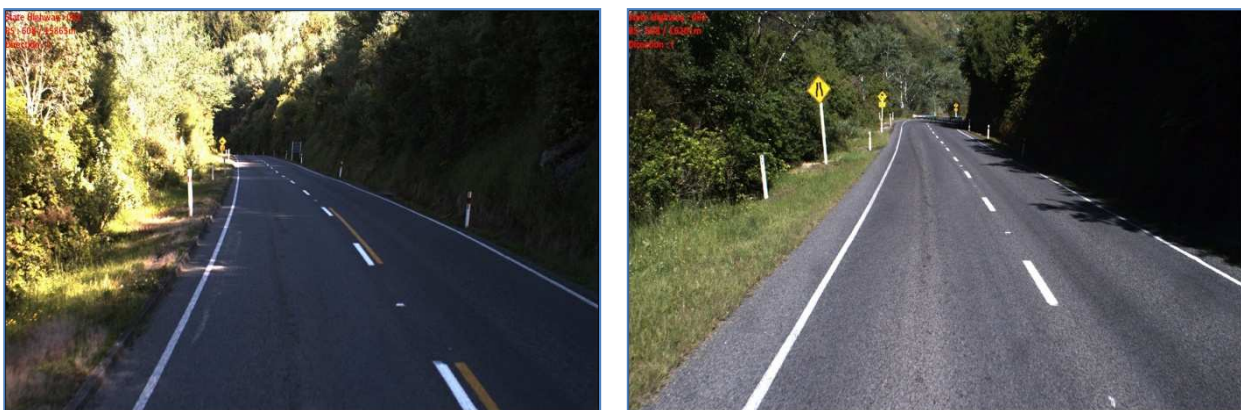
Figure 4.6 The Kareeara project

The Kareeara project was a hill-country site north of Napier (on the route to Wairoa/Gisborne), within a narrow valley. The original pavement had 45–75mm of chipseal, with the overall pavement structure being variable gravels of between 230mm and 270mm, in some places overlying sub-base gravels, including limestone to a total depth of approximately 400mm. A subgrade CBR of 5% was indicated by FWD. The underlying subgrade is sandstone. The adjoining water tables were wet. AWPT was programmed to address SCRIM and top-surface-layer maintenance defects.

The existing near-surface seal and pavement was stabilised to a depth of 200mm with 3% cement by dry weight. Following several reseals since construction, the pavement had had no unplanned maintenance.

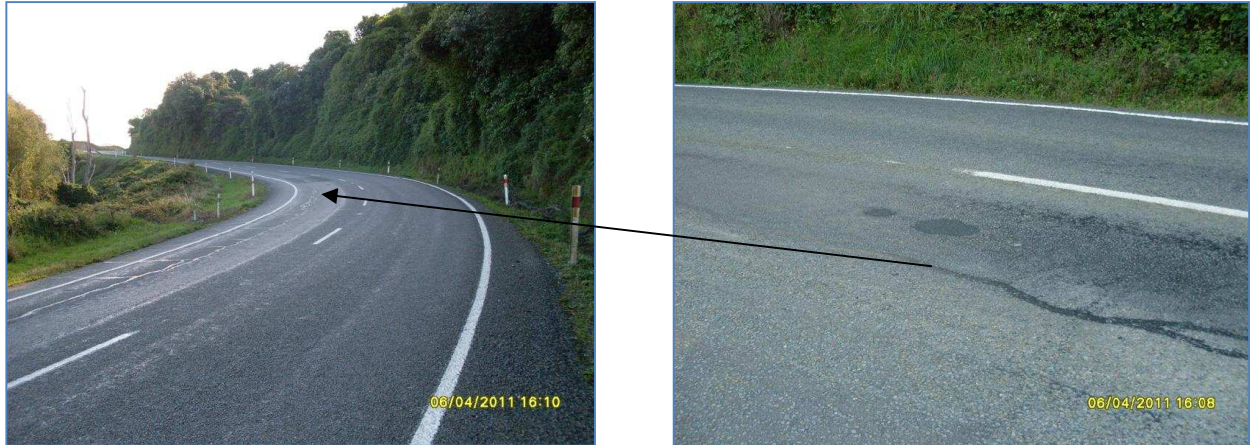
**Figure 4.7 The Territorials project**

The Territorials project was a ‘truck-ride’ treatment site on rolling hill country north of Lake Tutira, on the route to Wairoa from Napier. The original pavement composition was not investigated. The existing pavement was overlaid with 100mm of crushed aggregate (AP40) and then the combined upper-pavement layers were stabilised to a depth of 250mm with 3% cement by dry weight.

Soon after construction, widely spaced transverse and longitudinal cracks were cracked-sealed. After that, the pavement remained reasonably stable (including reseals) until early 2010, when wheeltrack cracking, shallow shear/shoving occurred, notably along the outer wheeltrack. Whilst lateral creep within the underlying substrate could have contributed to the cracking, lateral shear is the most likely cause.

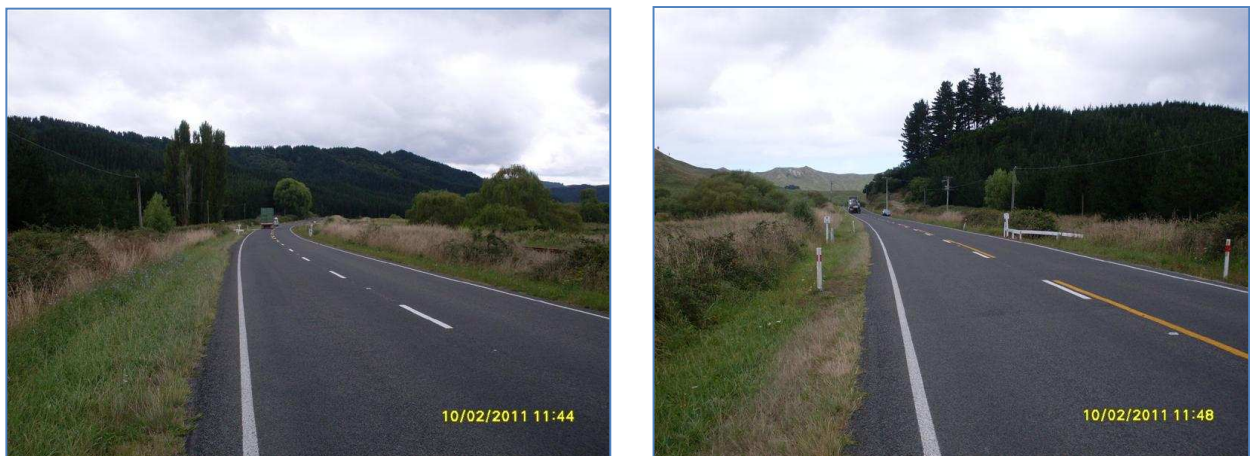
**Figure 4.8 The Awaho Culvert project**

The Awaho Culvert project was a low-lying, flat valley just south of Wairoa on SH 2. The original pavement consisted of 40–60mm of chipseal overlying 320–380mm of variable gravels. The subgrade, alluvial SILT with CBR of 3–5%, had a higher winter water table. The existing near-surface seal and pavement was stabilised to a depth of 200mm with 3% cement by dry weight, from RP 3.56 to 4.00. From RP 4.00 to 4.4, the existing pavement was first overlaid with 100mm of crushed aggregate (AP40).

The pavement had been resealed several times since construction. At the time of this research, minor wheeltrack rutting and pavement repairs suggested that the stabilised pavement layer was reverting back to an unbound state.

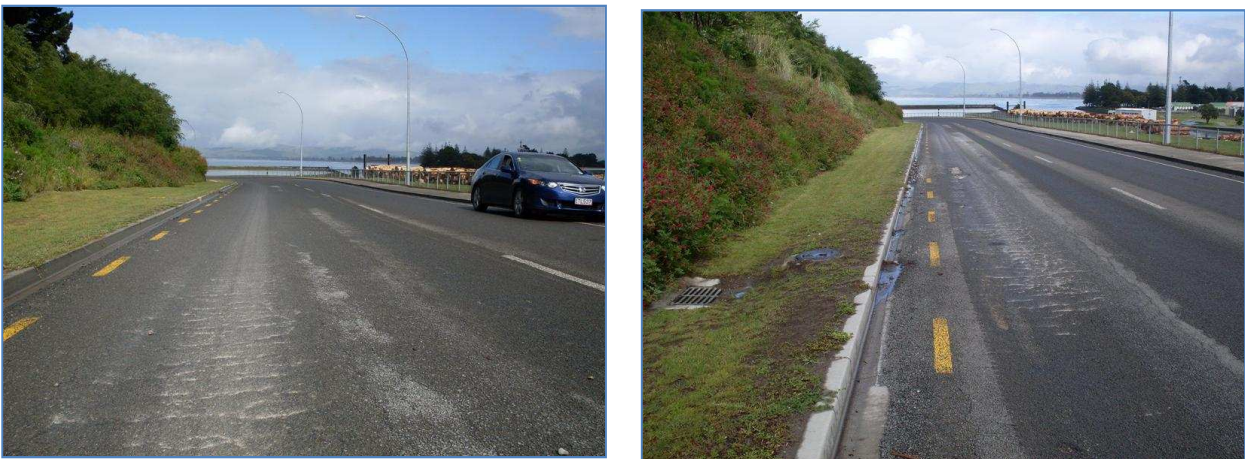
**Figure 4.9** The Hirini Street project

Hirini Street was first constructed in 2008 using unbound granular pavement (M/4 basecourse overlying sub-base). Within the first year, rutting in the basecourse on the more heavily trafficked port inbound lane was treated, using stabilisation with 2% cement by dry weight to 200mm depth. Then again in 2010, rutting and cracking in the cement-stabilised upper pavement prompted further investigation. The more heavily trafficked inbound lane had much more distress, Traffic loading records for that lane were then used to estimate ‘loading to failure’.

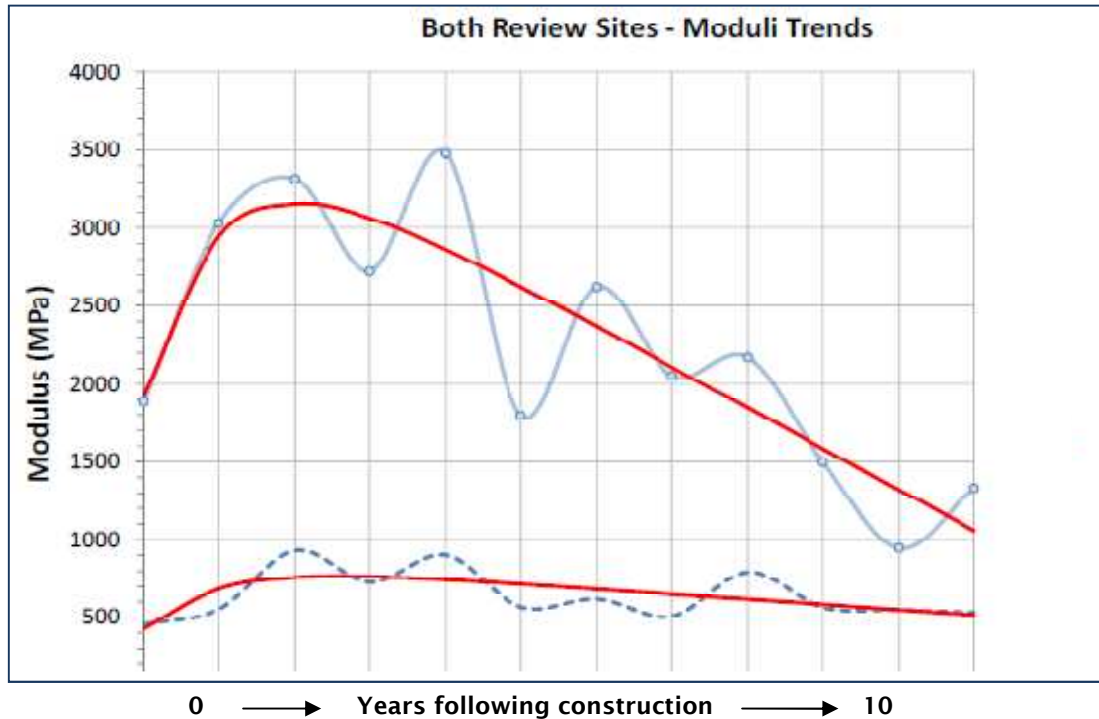
Figure 4.10 Time-related changes in stabilised-layer modulus

Trend lines (—) were fitted to this data, based on our expectation that the stabilised-layer modulus should increase initially and then decrease over time with the wear and degradation induced by ongoing trafficking; therefore, convex upward trend lines were subjectively fitted to the data collected so far.

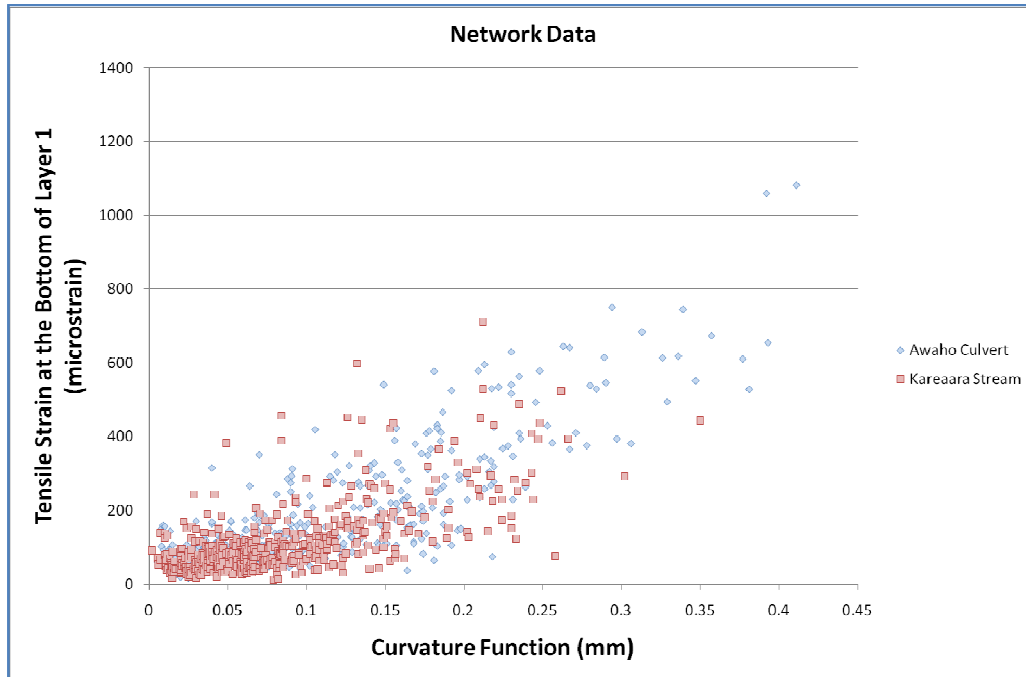
Figure 5.3 Comparison between tensile strain and curvature function

We investigated whether a relationship could be found between the back-calculated tensile strain in the cement-stabilised layer and curvature, using data from the Awaho and Kareeara sites (see figure 5.3).

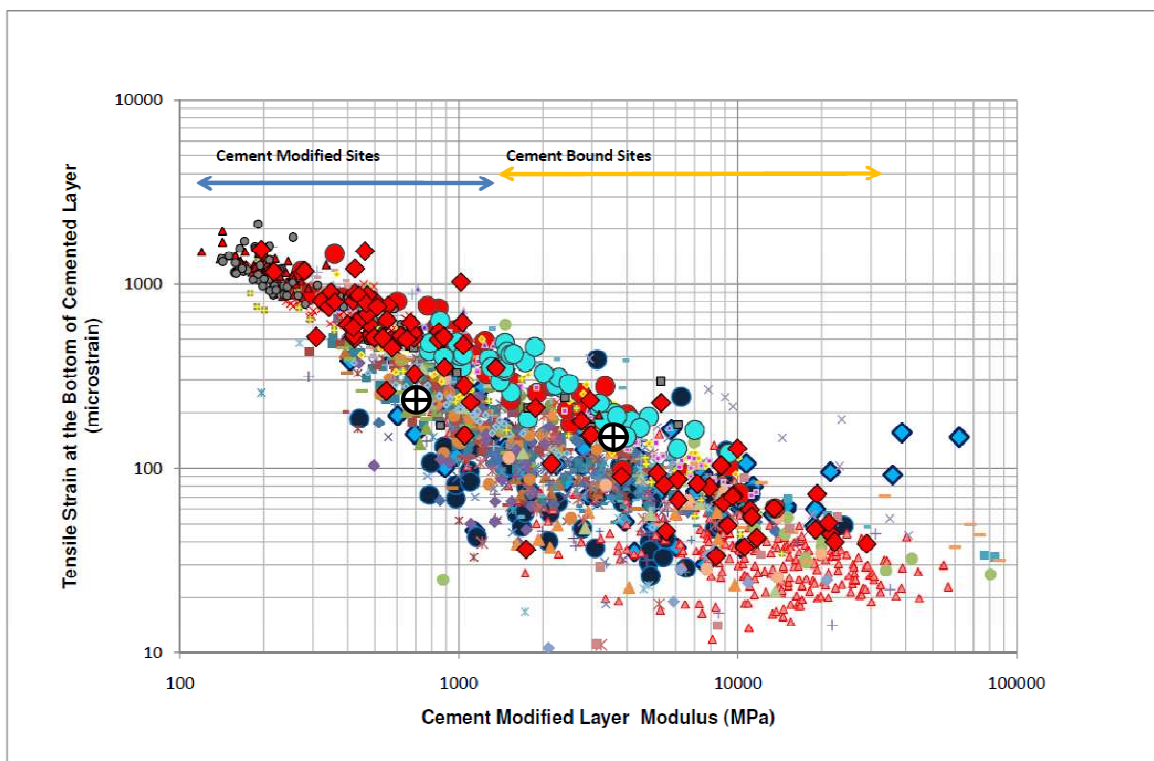
**Figure 5.7 Comparison of stabilised-layer tensile-strain data with the Austroads fatigue equation – cement-modified layer modulus of 700MPa and 3500MPa, N = 1MESA**

The presentation in the above figure initially created some confusion for the research team. It *appeared* to suggest that the existing Austroads fatigue equations for the selected layer modulus of 700MPa and 3500MPa could be aligned quite well to our performance data. However, this was not our experience. Many of the project sites we studied had outlived, by a significant margin, the life predictions delivered by the Austroads equation 6.4. For example, the Awaho and Kareera sites had not required any significant maintenance intervention, nor shown any evidence of cracking, after more than 10 years, which is more than 10 times the predicted fatigue life for these pavements.

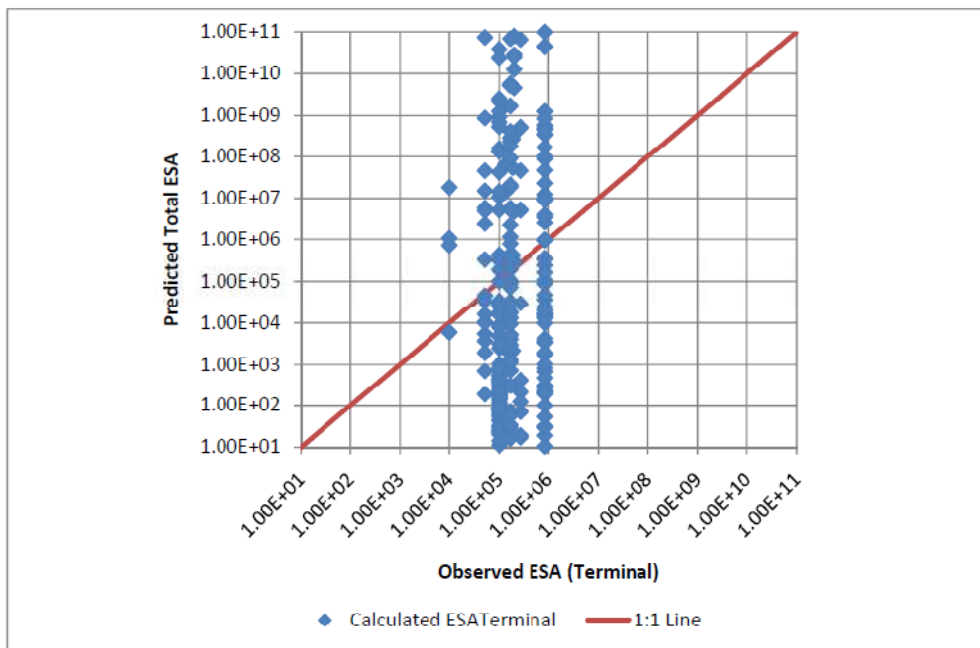
Figure 5.10 Spread of predicted pavement life vs observed pavement life from phase 2 modelling

The research team then set about using ideas to refine the modelling equation to better fit the observed performance data, as discussed in section 5.4.

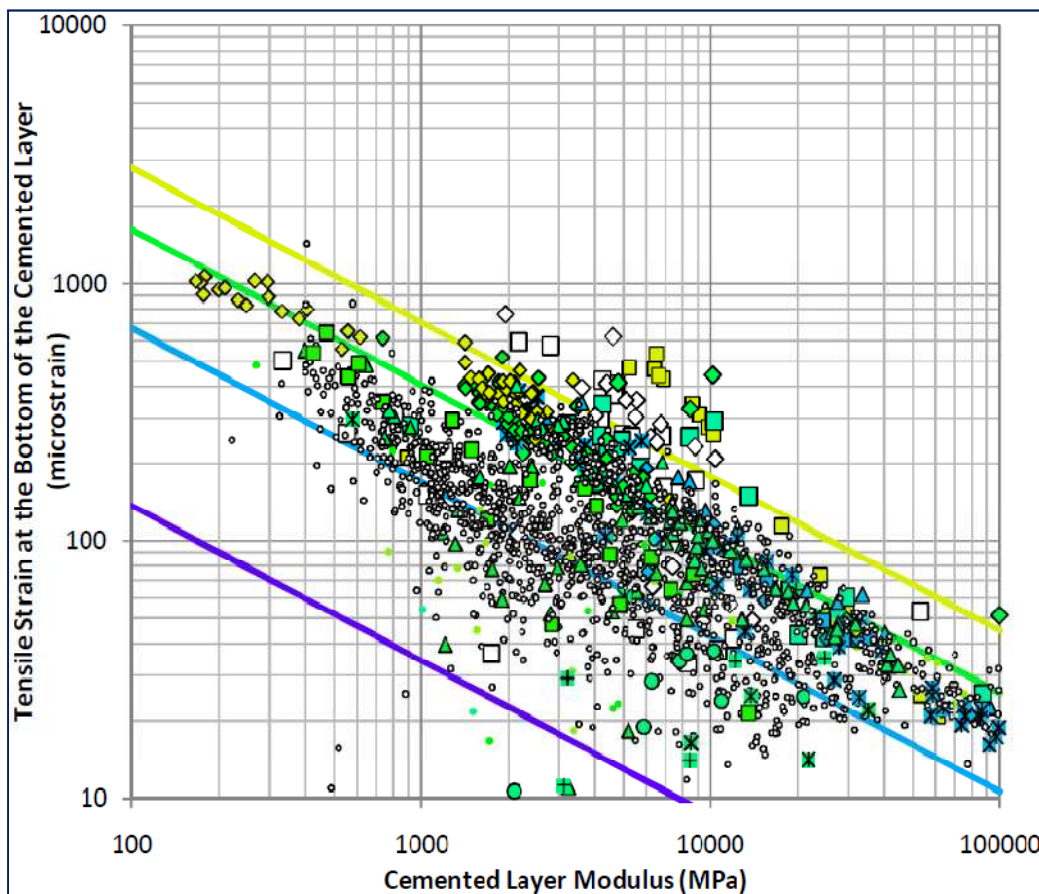
**Figure 5.13 Conceptual performance curves for cement-stabilised pavements**

In the curve above, the conceptual performance curves range from 100,000 ESA ( $10^5$ ESA) (yellow line) to 10,000,000ESA ( $10^7$ ESA) (dark-blue line). The light-blue line represents the conceptual performance curve for 1,000,000ESA (1MESA or  $10^6$ ESA). The curve for 100MEA (green line) plots below the x axis in the curve above.

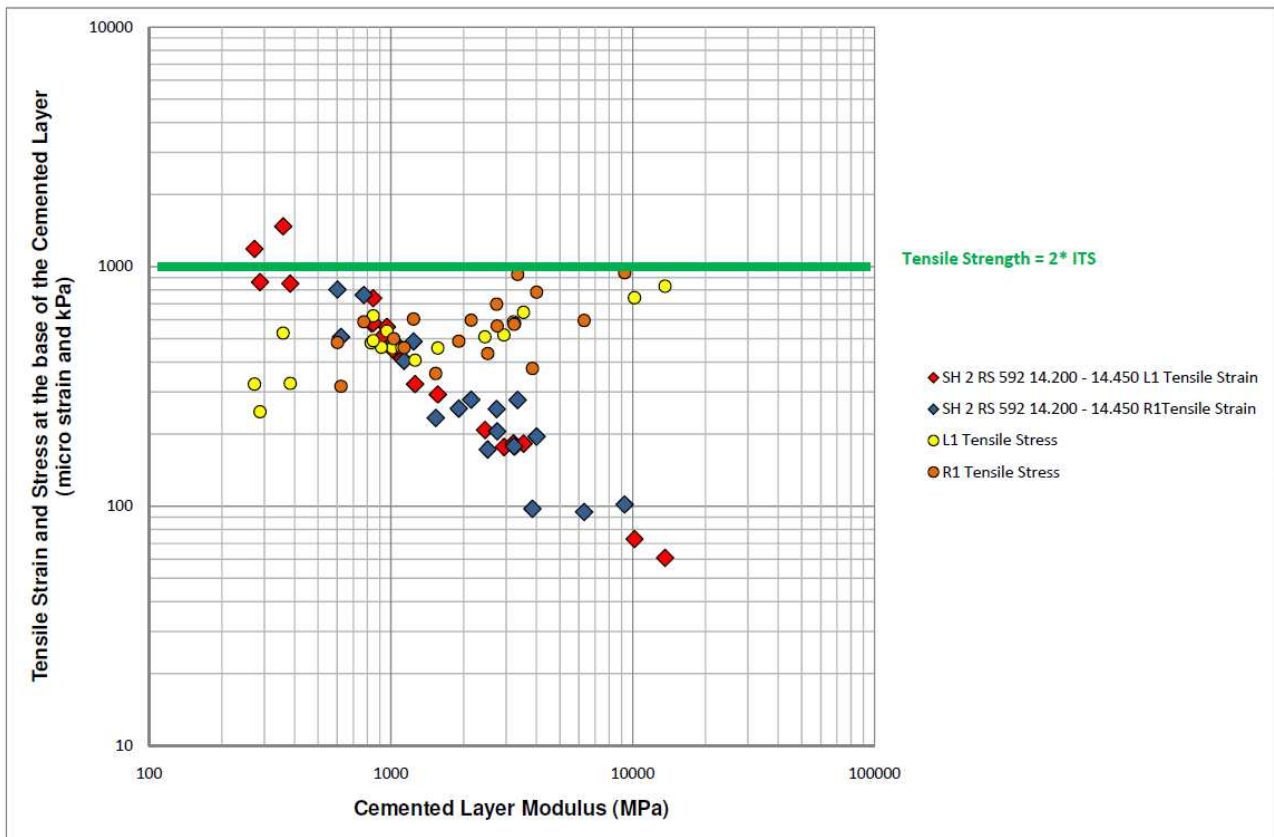
**Figure 5.19 Layer stress and strain conditions for site 9 (SH 2 RS 592 14.2 – 14.45)**

At the time of this research, site 9 required urgent maintenance intervention for wheeltrack cracking and shallow shear problems. The pavement-layer stress conditions here appear to lie between 50% and 100% of the assumed layer tensile strength.

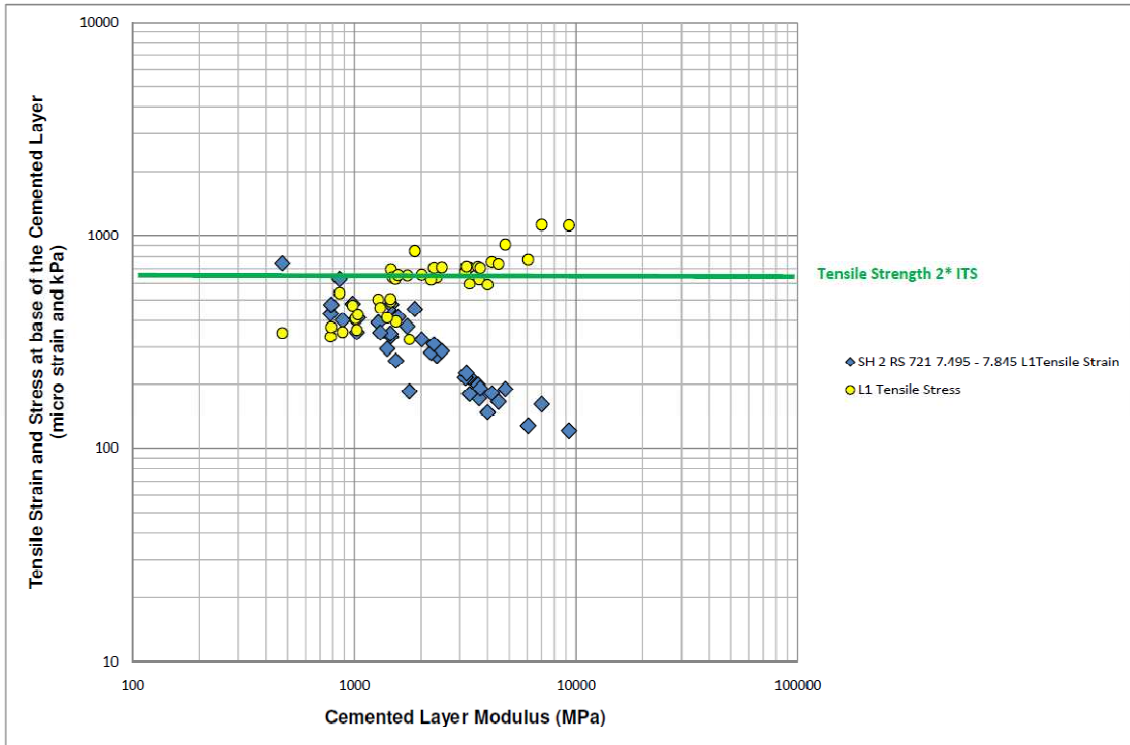
Figure 5.20 Layer stress and strain conditions for site 15 (SH 2 RS 721 7.495 – 7.845)

At the time of this research, site 15 was in a relatively stable condition after nearly 14 years. The pavement layer stress conditions here appear to lie between 75% and over 100% of the assumed layer tensile strength. The latter was based on 2\*ITS (ITS of 318kPa). These results seem to suggest that a change in pavement condition is imminent.

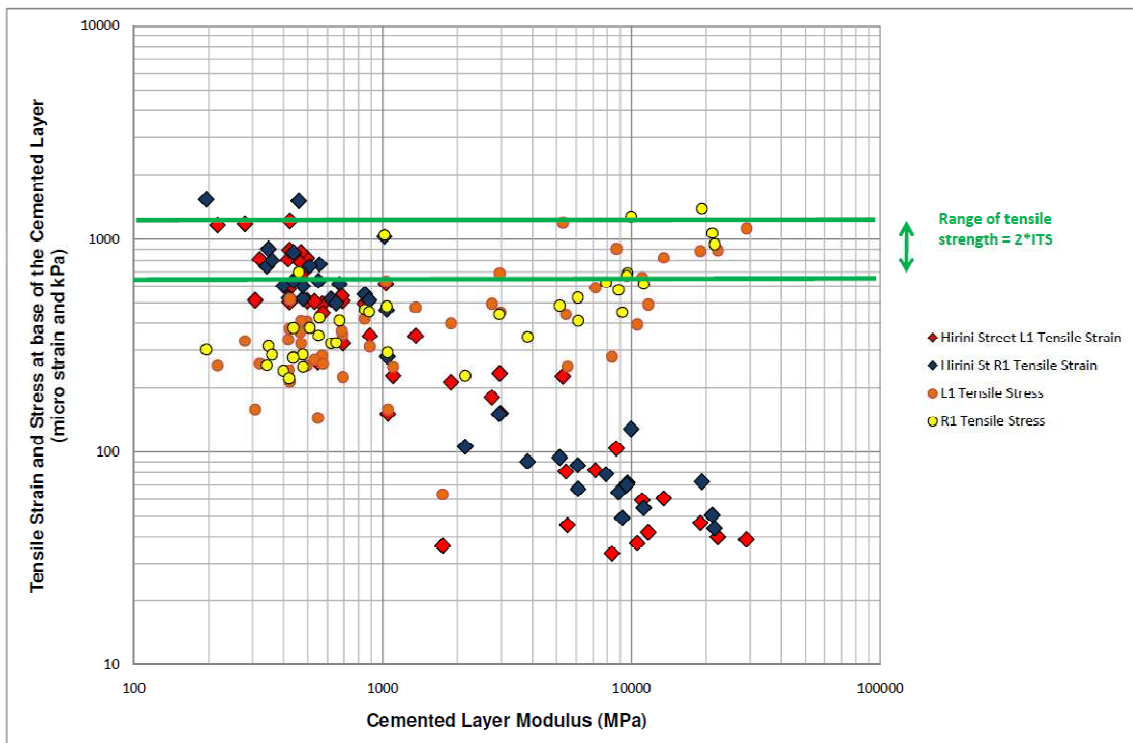
Figure 5.21 Current stress and strain conditions for site 16 (Hirini St)

Site 16 had failed over approximately 30% of the left-hand lane (L1) soon after construction, and this required urgent maintenance intervention. The back-calculated modulus and strain outcomes will have been affected by the distressed condition of the pavement in a number of locations.

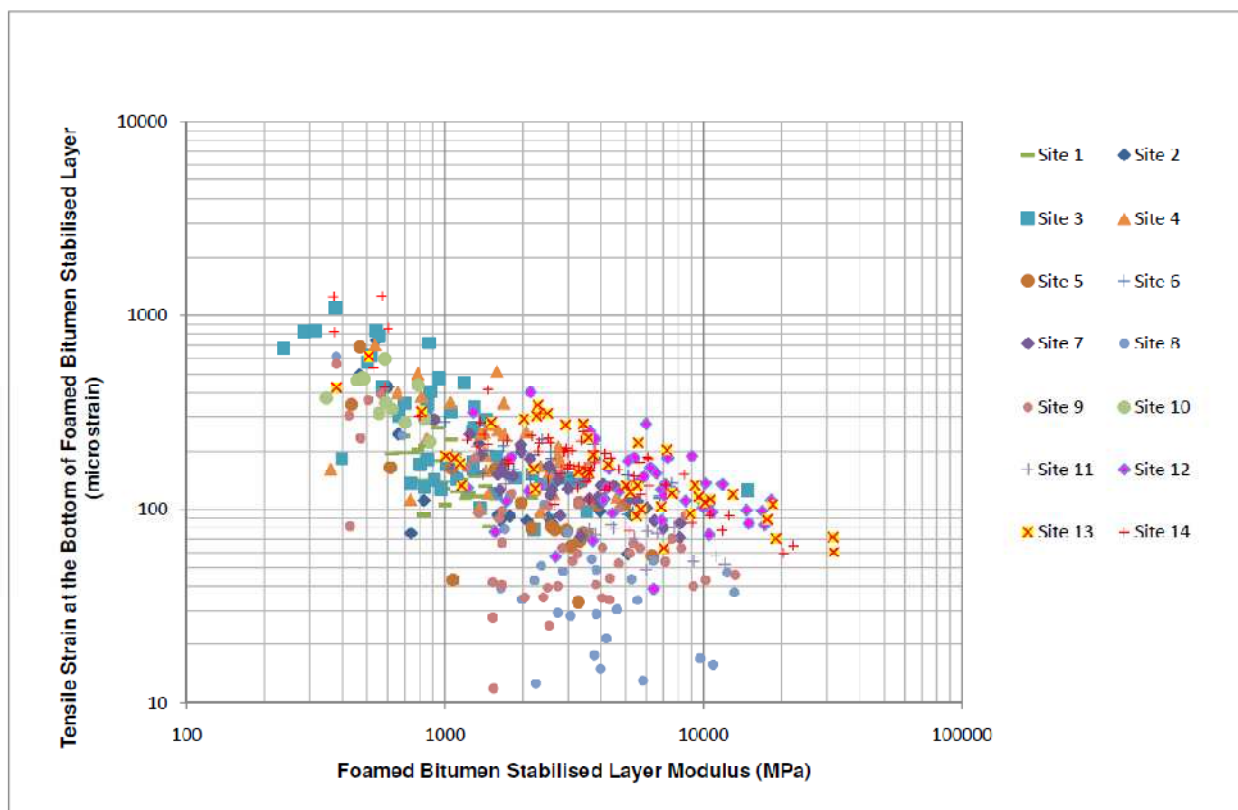
Figure 7.1 FBS project data

We initially postulated that as there was some cement in the mix, it could be a reasonable starting place to use the Austroads equation 6.4 (Austroads 2008) that was presented in section 5.3 of this report. We hoped to find a value of SF that made reasonable sense in relation to the plot of the layer 1 modulus and the tensile strain at the bottom of the layer, for all areas that were performing well (see figure 7.2).
