Improved multi-lane roundabout designs for urban areas

May 2012

Campbell, D¹, I Jurisich² and R Dunn³ (2012) Improved multi-lane roundabout designs for urban areas. *NZ Transport Agency research report 476*. 284pp.

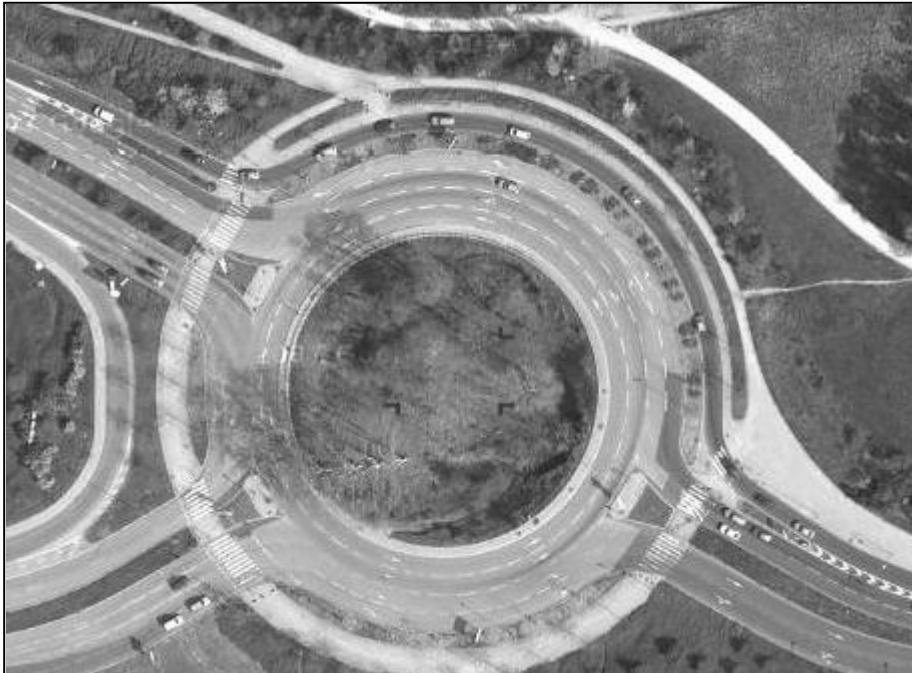
Figure 2.8 A signalised roundabout in Villeurbanne, France (aerial photo courtesy of Google maps)

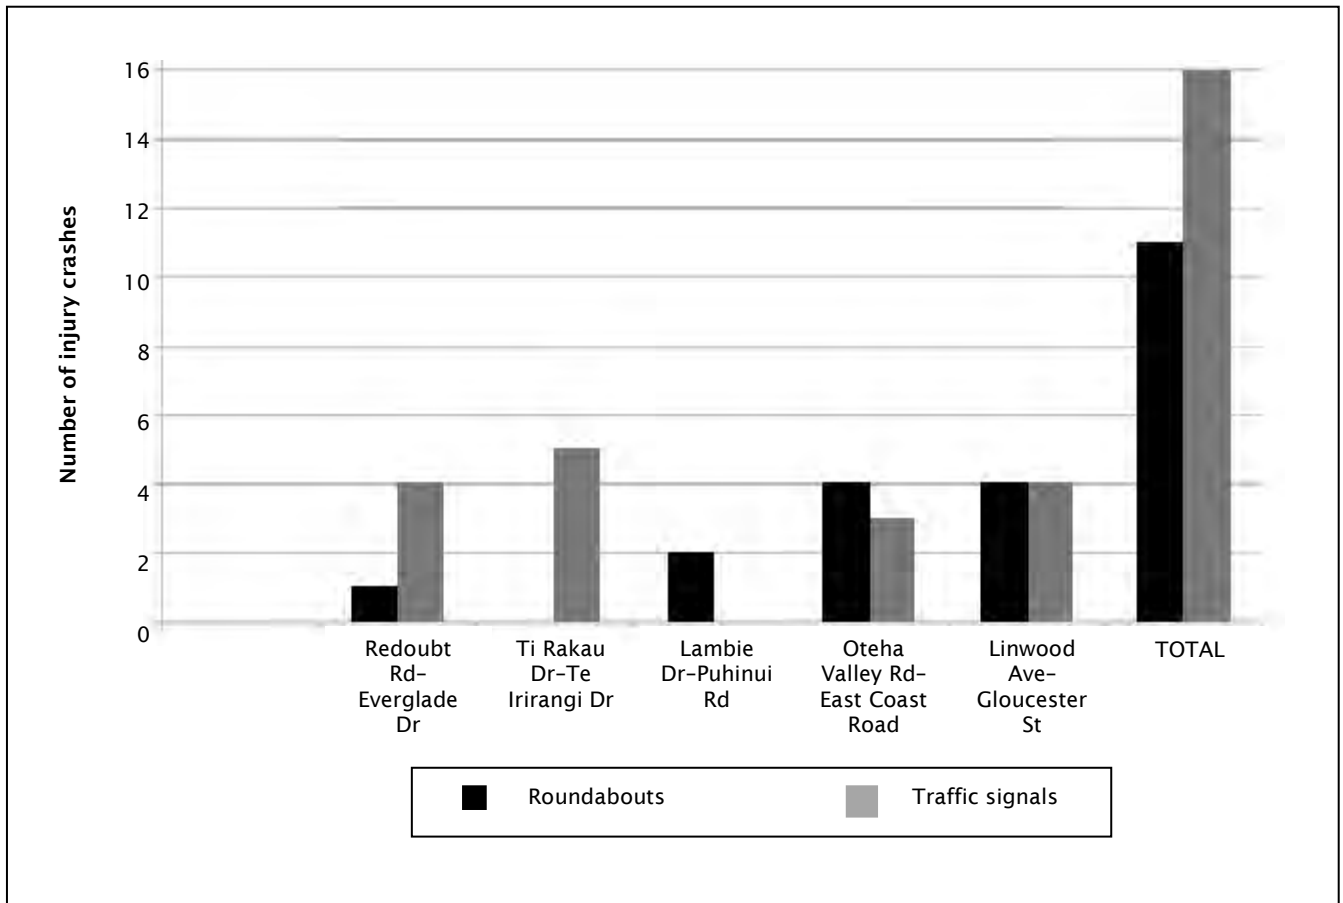
Figure 3.3 Total vehicle injury crashes for the five sites converted from multi-lane roundabouts to traffic signals for the five years before and after conversion

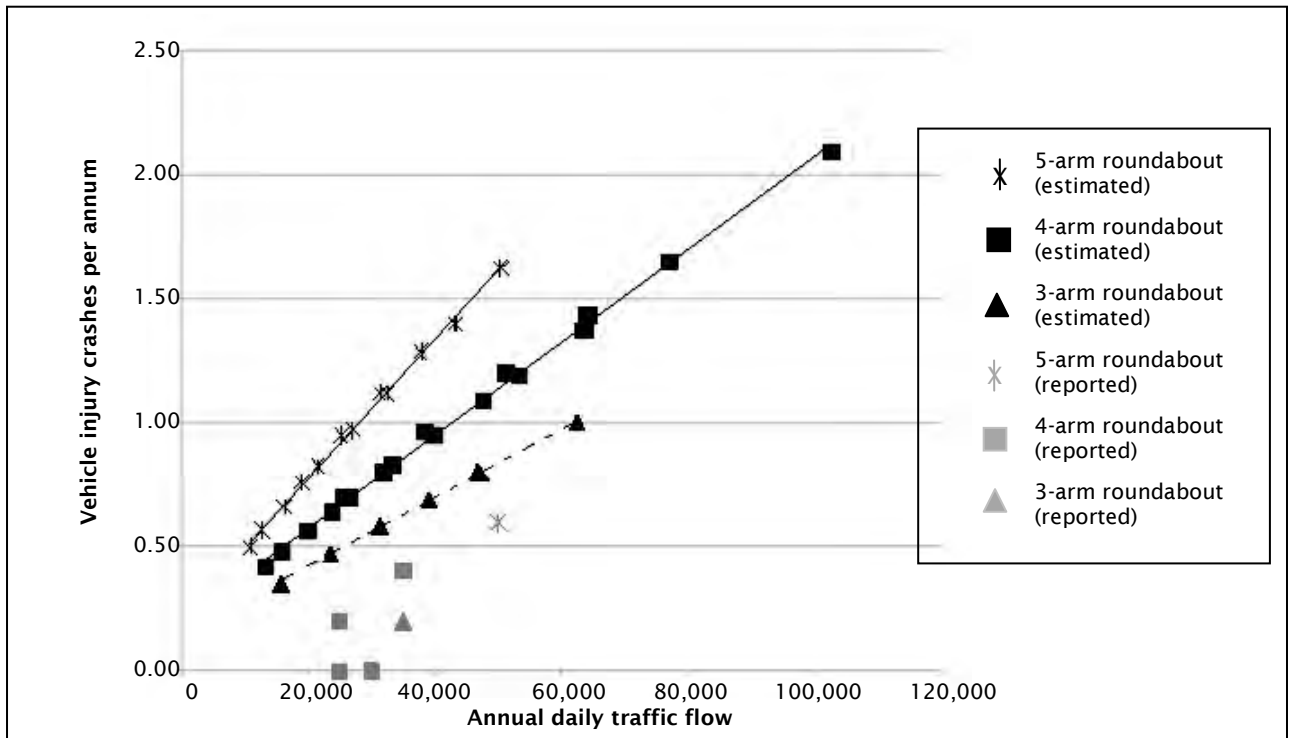
Figure 3.12 Comparison of seven multi-lane roundabouts in Auckland City with the APM results

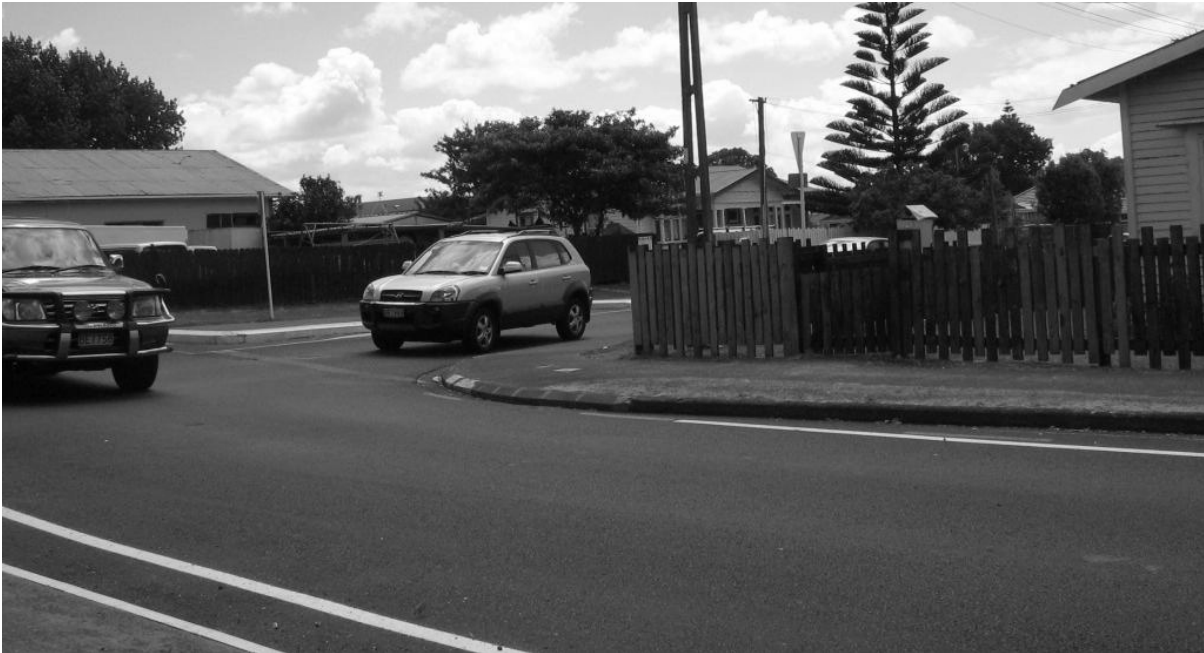
Figure 4.14 View taken on approach D at a point 10m from the roundabout limit line, showing the corner boundary fence which severely restricts visibility of opposing vehicles coming from approach C to the right

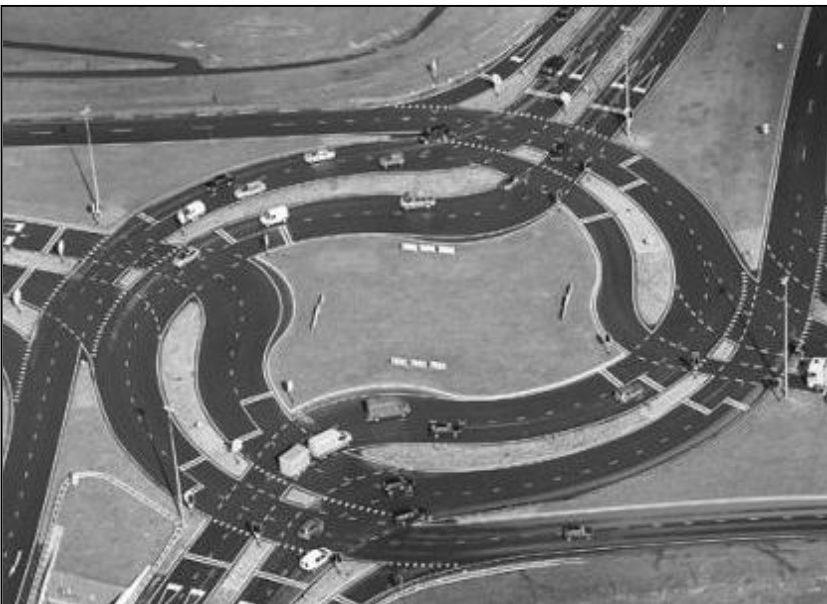
Figure 5.11 Model of a signalised turbo-roundabout (see chapter 8) currently operating in The Netherlands

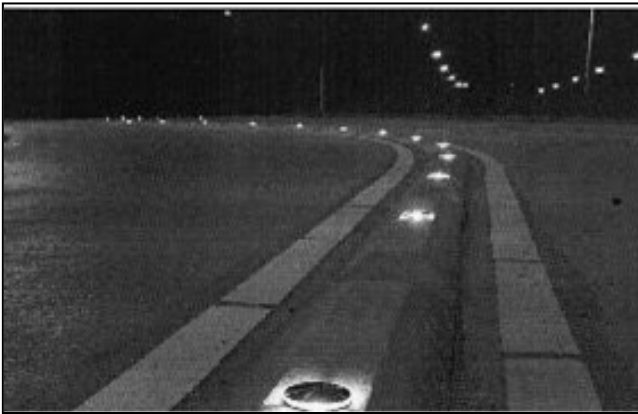
Figure 8.26 Photo of the damage that can occur if lane dividers are glued onto the roadway instead of cast in situ (CROW 2008)
