# **The design of stabilised pavements in New Zealand**

## **February 2013**

Alabaster, D, J Patrick, H Arampamoorthy and A Gonzalez (2013) The design of stabilised pavements in New Zealand. *New Zealand Transport Agency research report 498*. 197pp.

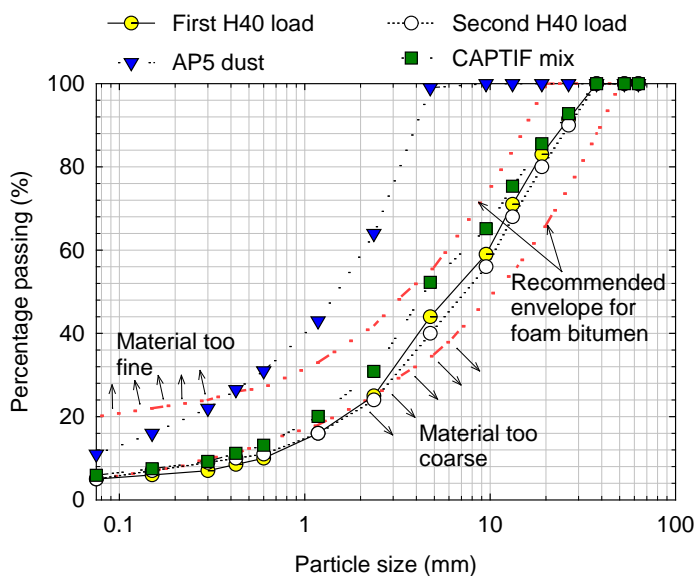
Figure 2.1 Material grading curves

The industry steering group suggested using a GAP65 aggregate from Auckland. The GAP65 aggregate, designated as H40 for the project, was too coarse for foamed-bitumen stabilisation without adjustment. The material was mixed with a local crushed dust (AP5) available from Fulton Hogan's Pound Road quarry in Christchurch. A blend of 85% AP65 and 15% of AP5 brings the AP65 grading curve into the recommended foamed-bitumen grading envelopes (figure 2.1).

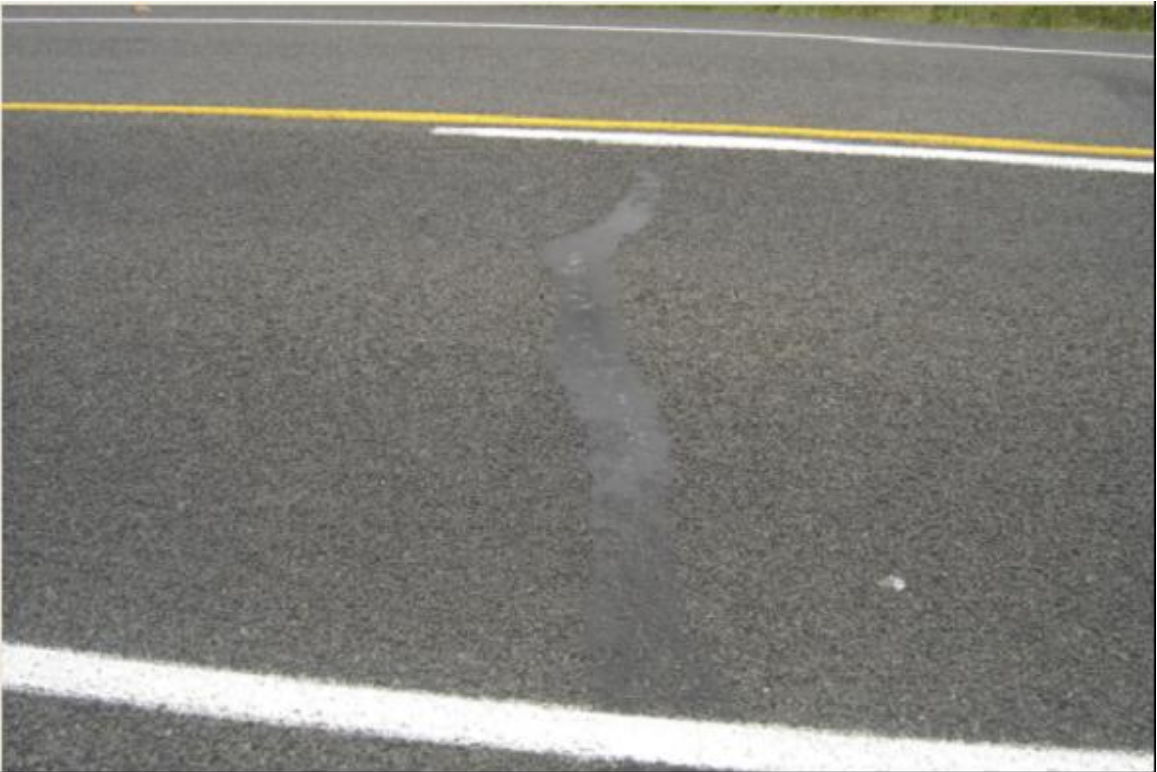
**Figure E.5** SH50 RS 17/12.31 - a few cracks appear up to the centreline from the edge

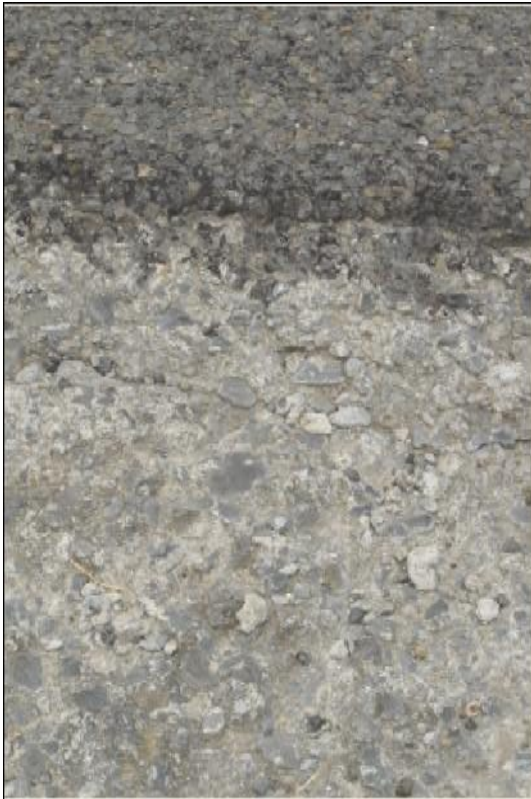
**Figure E.7** SH50 RS 17/12.31 – cracks have appeared between the layers

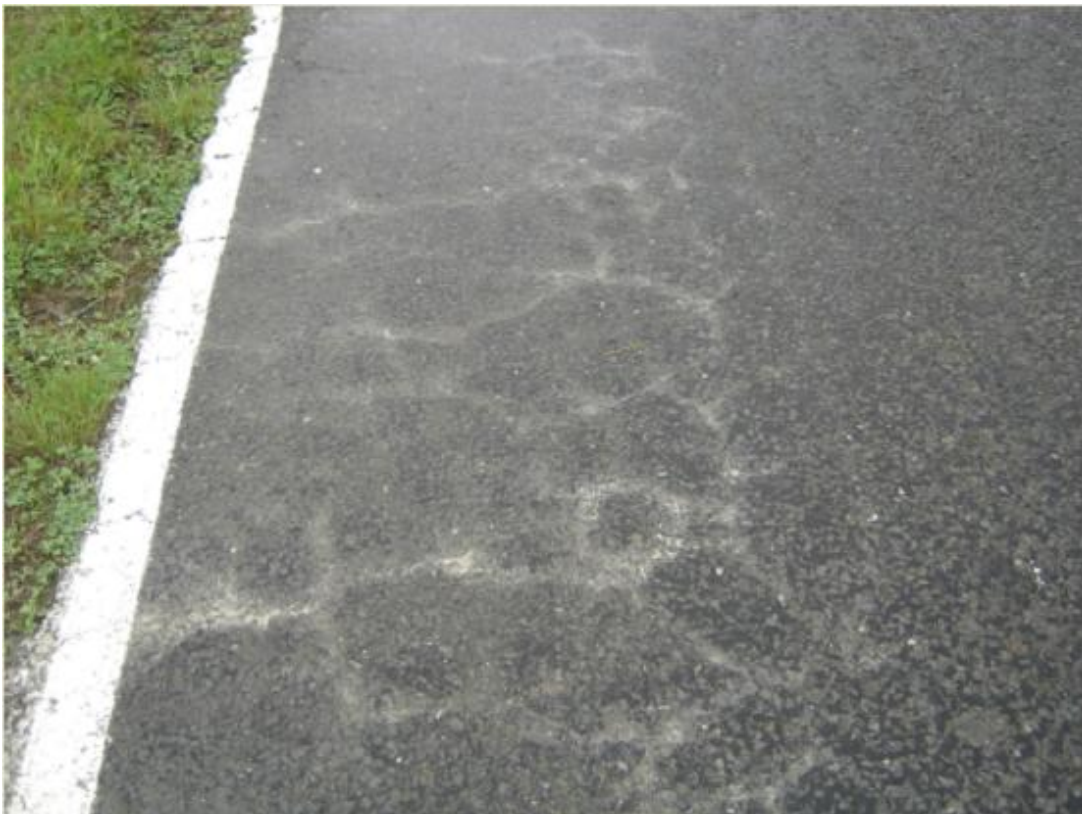
Figure E.24 Mangatu Road 10.07km – alligator cracks

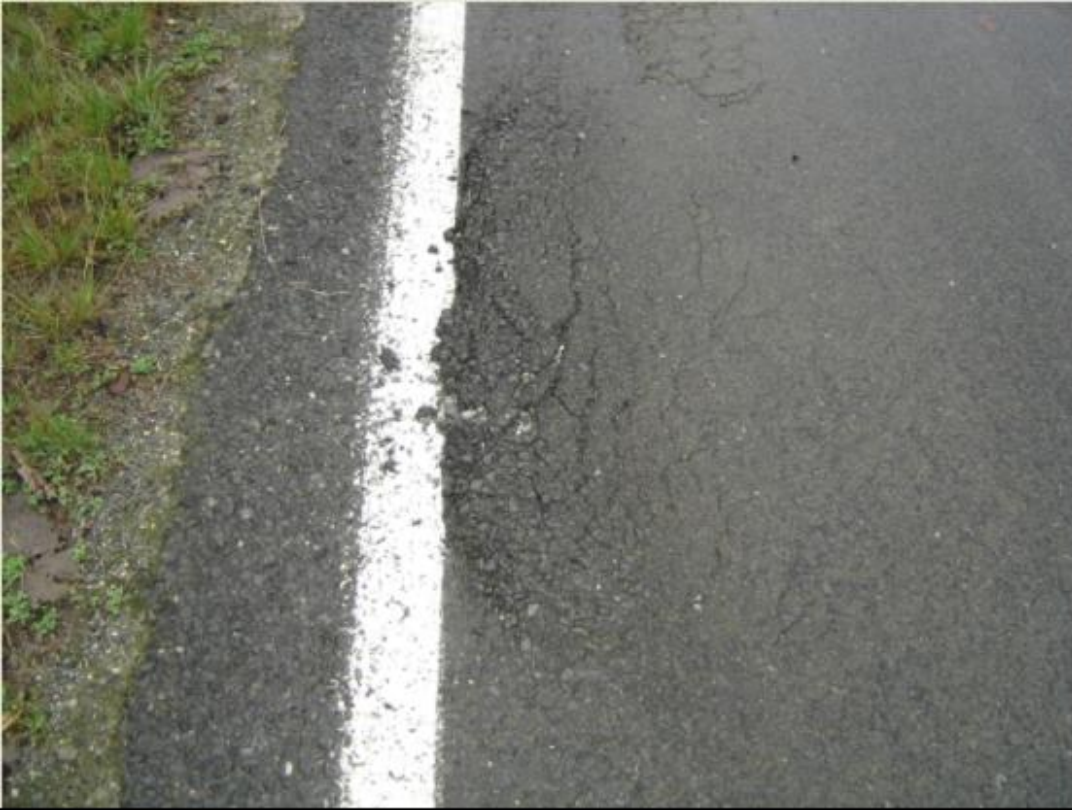
Figure E.27 Mangatu Road 10.94km – a shear and fatigue failure

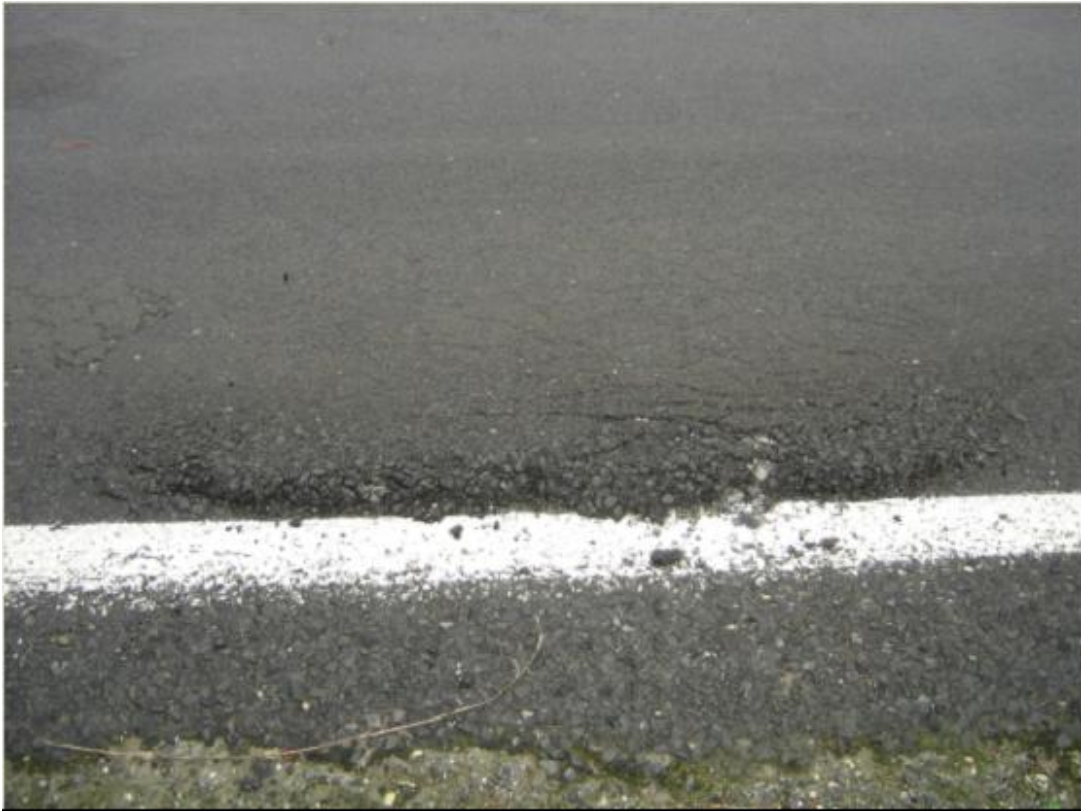
**Figure E.29 Mangatu Road 10.94km - shear failure with strong shoulder support**

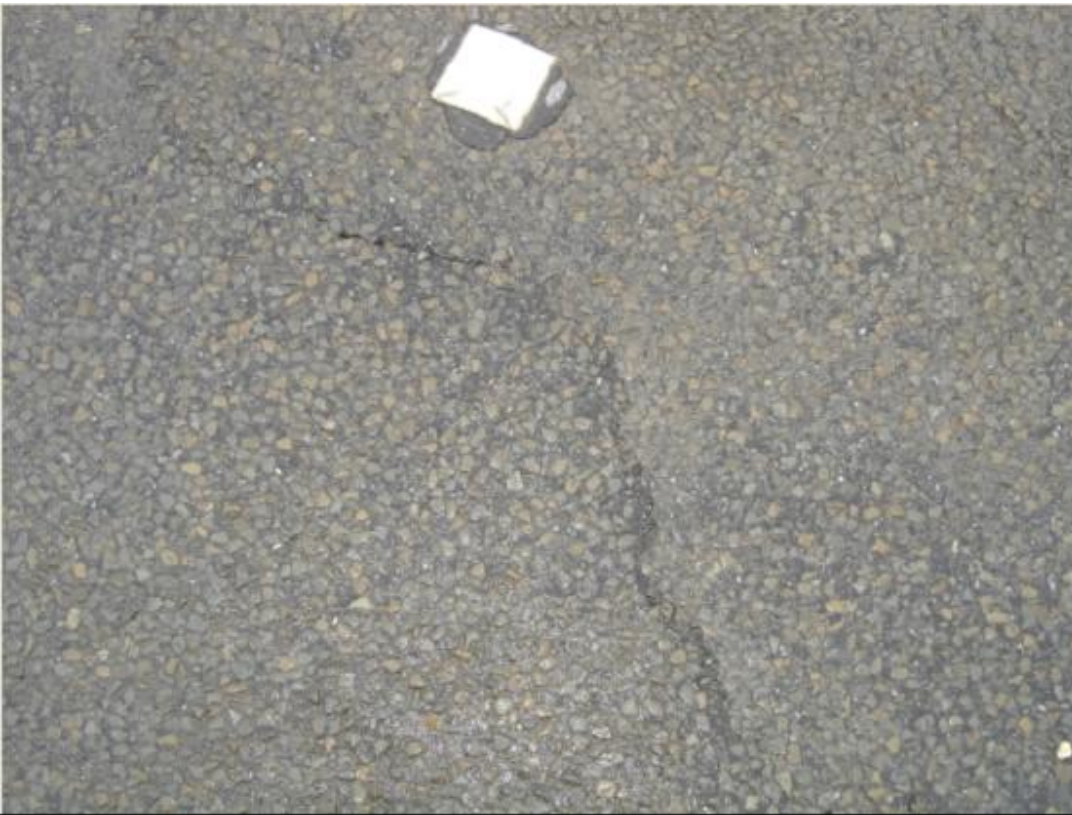
Figure E.31 Mangatu Road 12.43km – level difference in this crack indicates a slip in the near future)
