Effects of water on chipseal and basecourse on high-volume roads

March 2015

NZ Transport Agency research report 564

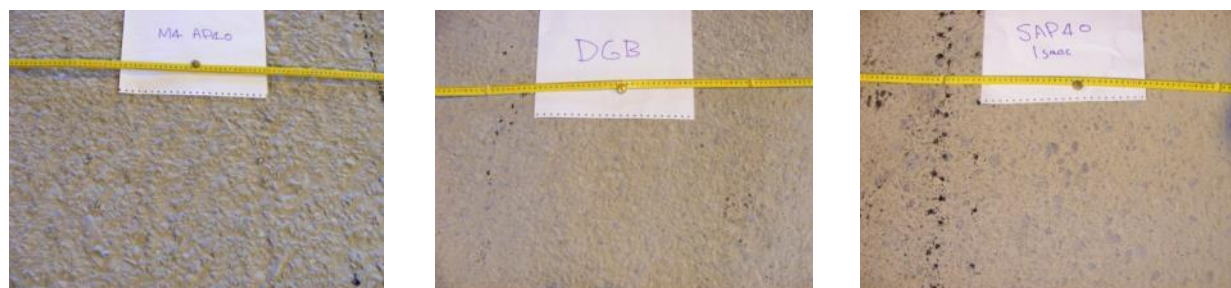
Figure 2.8 Basecourse surface finish

Before sealing, layer profiles and density and moisture measurements were taken on 5 October 2009. The percentage of maximum dry density (%MDD) and saturation (%Sat) results are provided in table 2.6 and layer thicknesses in table 2.7. The mosaic surface finish can be seen in figure 2.8. The densities are lower than would be expected in the field but are typical of CAPTIF construction where the circular track makes it difficult to achieve field compaction levels as the rollers need to turn continually. Previous research (Henning et al 2007) in comparing the long-term pavement performance (LTPP) programme with CAPTIF suggested the rate of rutting at CAPTIF was typical of New Zealand pavements. The current study in particular is a comparative study and thus the densities should not impact on the results.

The prime coat was applied to sections B, C, and D on 14 October 2009 (see figure 2.8). The target application rate was 0.5 l/m² and actual application rate was 0.4 l/m².

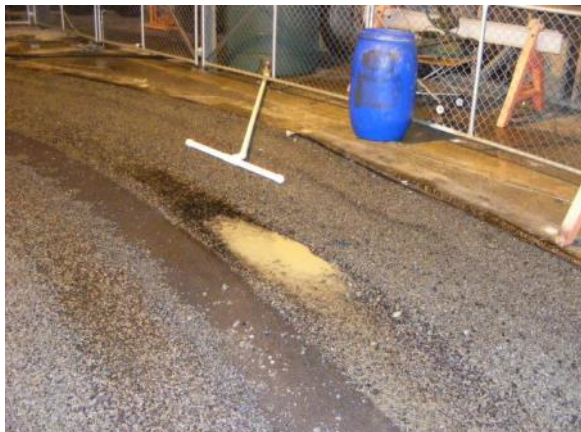
Figure 2.15 Watering manifold

Water was applied across the track at discrete locations in each test section. The water was applied from a 1 m long manifold placed on the outside of the track (figure 2.15). Each manifold had its own 5,000 litre storage tank. The water flowed across the track, into the kerb and channel where it was collected in a sump and pumped back into the storage tanks. Losses were continuously topped up from the mains water supply using a valve controlled by a float.

The water film thickness was adjusted by placing sized restrictors in the pipe supplying the manifold. The restrictors were disks with different sized holes drilled in them.

The rate of flow from each sized disc was estimated by measuring the volume of water applied over a set time and the film thickness was estimated by measuring the water film thickness above the chips and creating a regression relationship between disc size and film thickness (table 2.11).

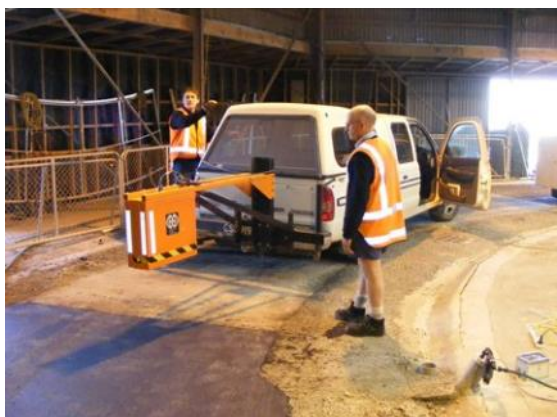
Figure 2.16 Air launched ground penetrating radar

The TDR results in figure 2.17 follow what we would generally expect to see; however, it was apparent the flow paths to the drain were more complex than we had expected. Often the TDR gauges at the intermediate and edge locations did not measure any increase and occasionally the central TDR also measured no increase. Additional efforts were made to understand these readings, from surface resistivity measurements, back scatter nuclear density measurements and the air launch ground penetrating radar shown in figure 2.16 below. Unfortunately none of these methods assisted in understanding the flow paths.

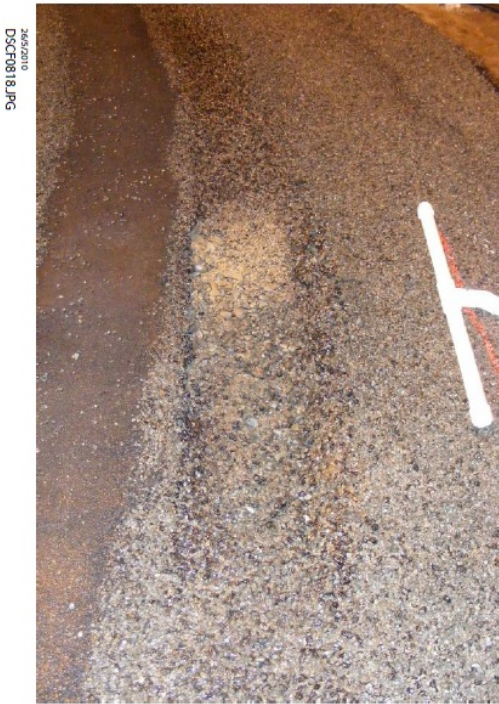
Figure 2.18 Test 1 – first failure

The first failure occurred in section A after 1,186 laps of loading had been applied at the manifold. The basecourse started to pothole and eventually failed in shear as seen in figure 2.18. At this point only 132 laps had been applied with water flowing across the surface, and with a 9mm restrictor in place.

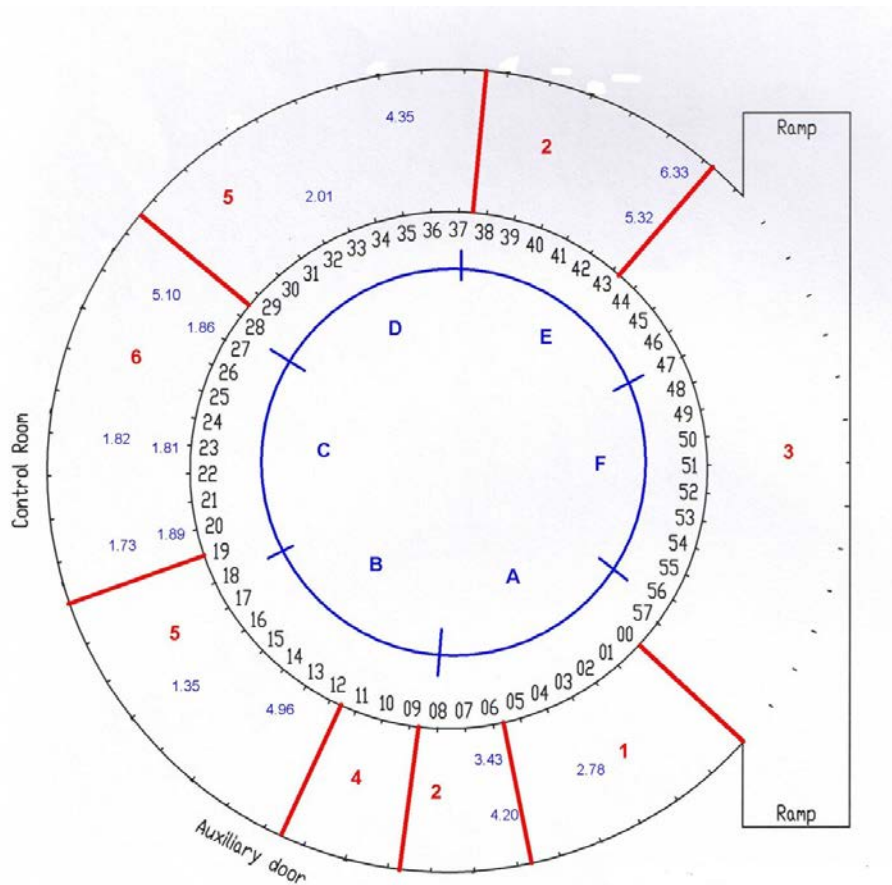
Figure 2.21 Failure map test 1

A final layout for the failures is shown in figure 2.21. As can be seen from the timeline of failures and the initial values of the TDR readings in appendix A, the moisture in the test sections was allowed to stabilise after each test.

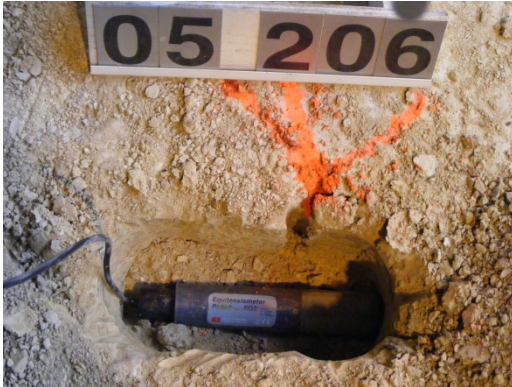
Figure 3.1 Equitensiometer

The TDR and 3D CAPTIF transducers are described in chapter 2. The Equitensiometer is a Delta-T Devices EQ2 device, placed 50mm below the subgrade surface at station 5 (figure 3.1) to measure changes in suction in subgrade that would indicate changes in moisture content and a lowering of the subgrade's strength.

for which a sensor does not yet exist. The EQ2 Equitensiometer’s equilibration time is typically several days and extension tubes can be used to position it at depth.

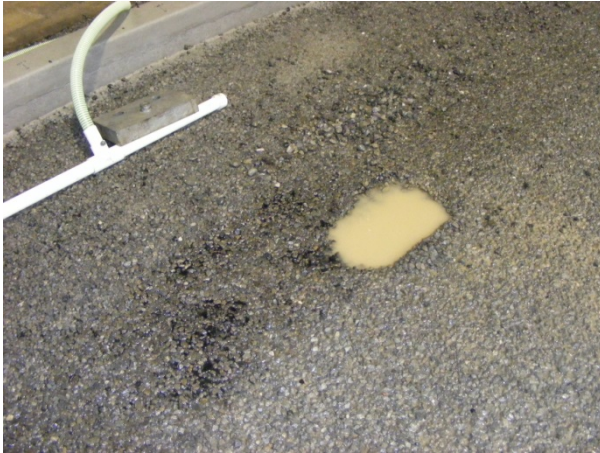
Figure 3.2 Test 2 – first failure

The TDR gauges in figure 3.3 show there was no change in moisture content observed in the basecourse in section A during the first failure.

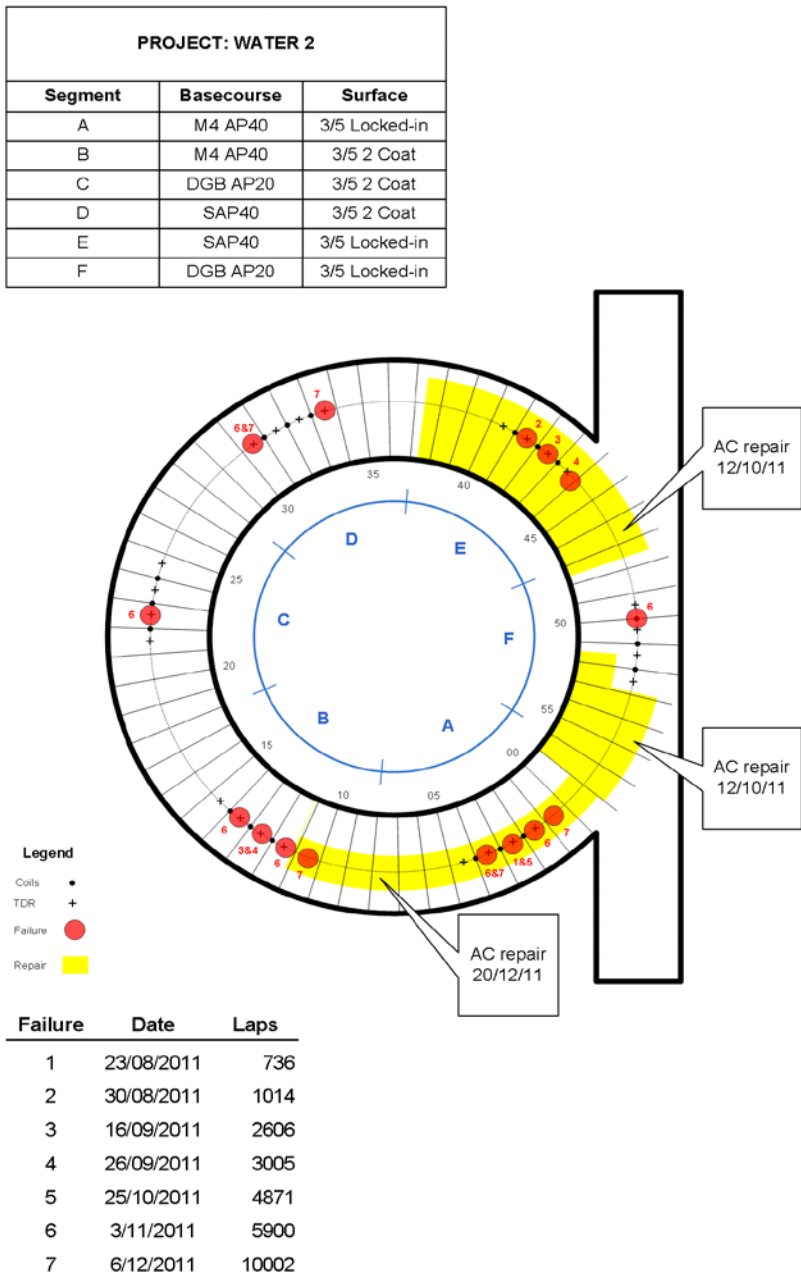
Figure 3.4 Test 2 failure map

Table 3.5 shows where and when the failures occurred. It lists:

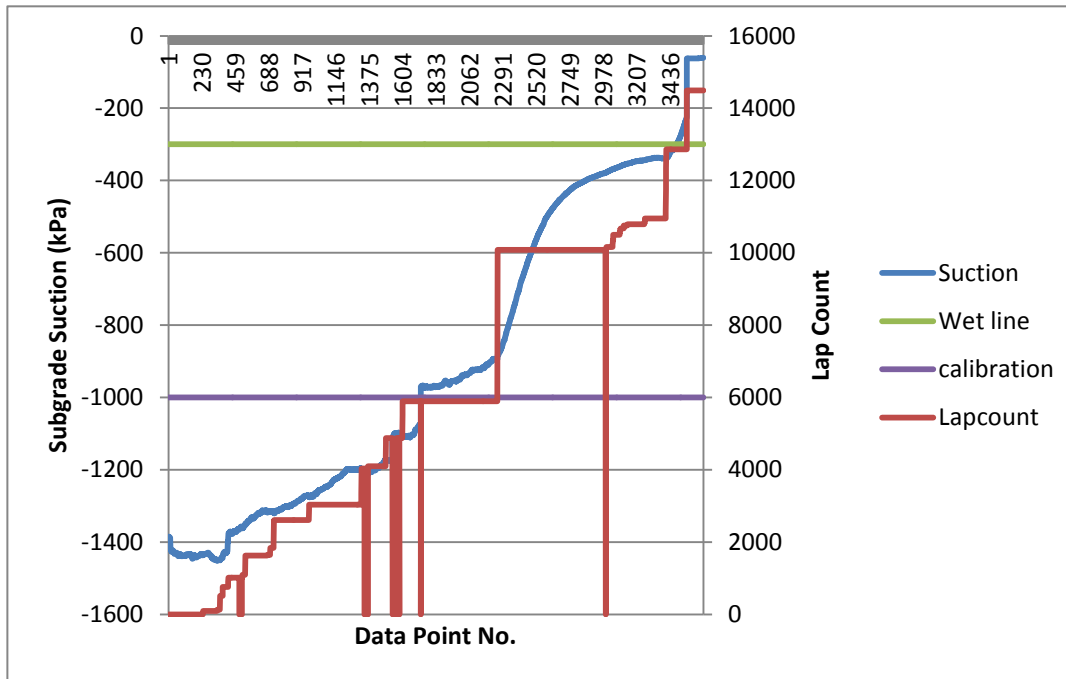
Figure 3.5 EQ2 Equitensimeter at station 5

The results of the EQ2 Equitensimeter at station 5 (figure 3.5) show that the moisture entering the pavement was being sucked towards the subgrade as well as exiting via the subsoil strain system and that potentially explains why the non-wheel path TDRs in test 1 were not reading the moisture changes.

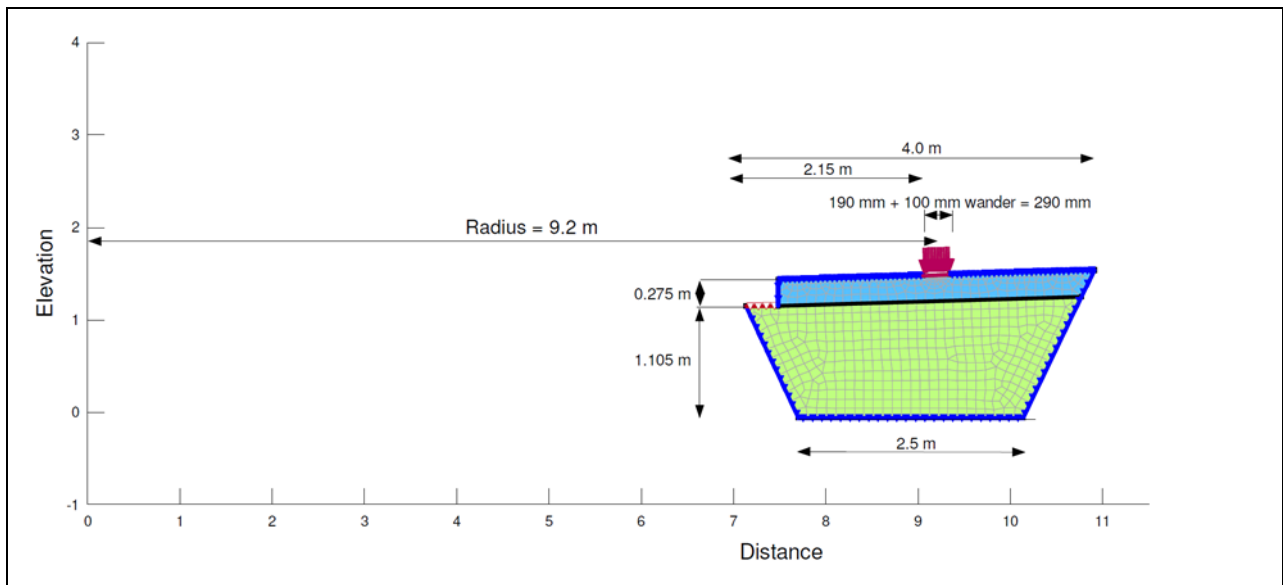
Figure 4.4 Model A geometry

The same infiltration rate of $1 \times 10^{-6} \text{ m}^3/\text{m}^2/\text{sec}$ was then applied to the average and long-term basecourse permeability cases to study the effect of the basecourse permeability on the overall drainage performance of the pavement.

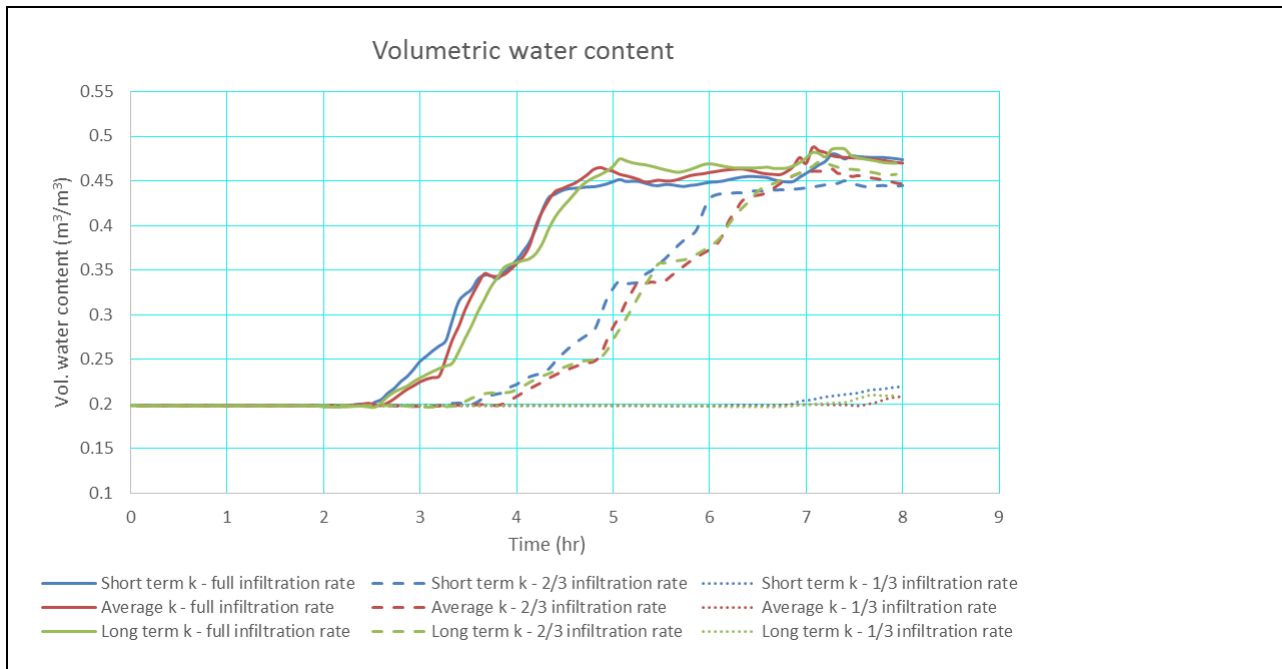
Figure 4.6 Volumetric water content over time at chosen point of interest in model A

The values of volumetric water content shown in figure 4.6 are indicative only and may not equate accurately to their gravimetric counterparts recorded by the TDR gauges during the CAPTIF testing, due to the assumptions made regarding the SWCC and initial dry density of the basecourse material.

Nevertheless, the figure shows that the volumetric water content increased by about 2.3 times from its initial value towards the end of the modelling duration, which is comparable to the increase recorded in the CAPTIF TDR gauges not long after pavement failure was noted to have commenced.

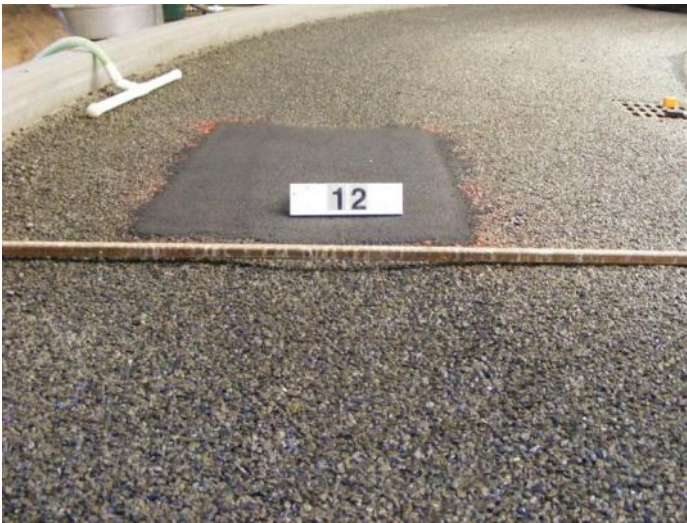
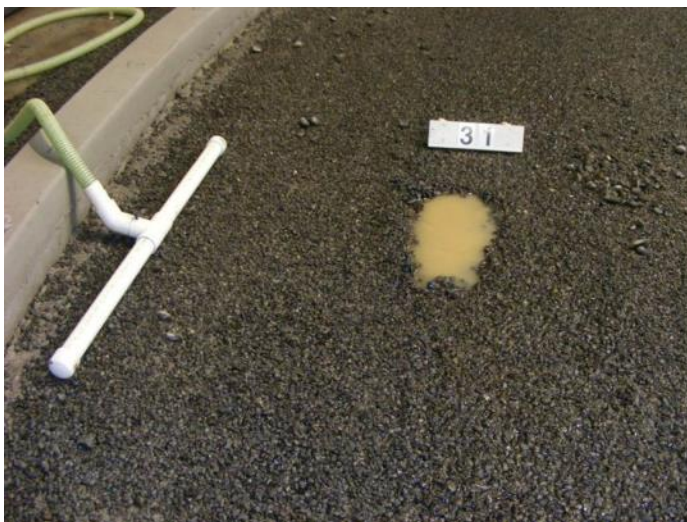
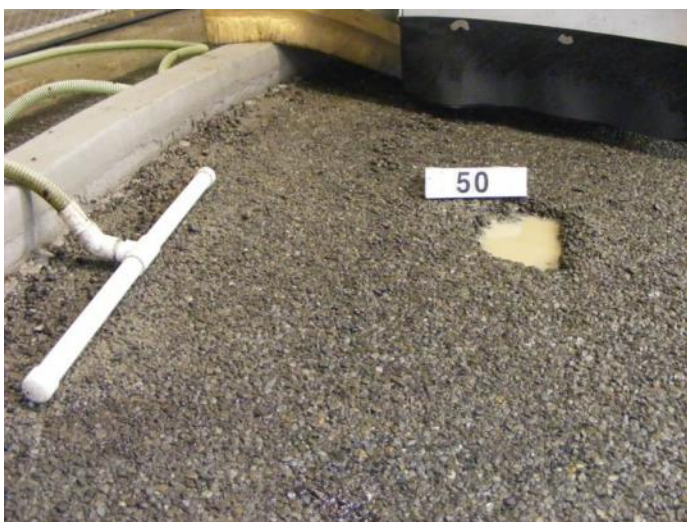
3 November 2011 repairs

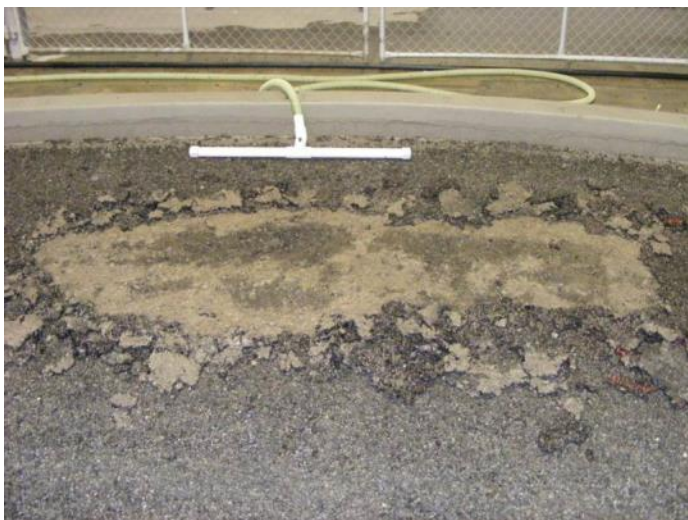
24 January 2012 section B top scraped back to dry material

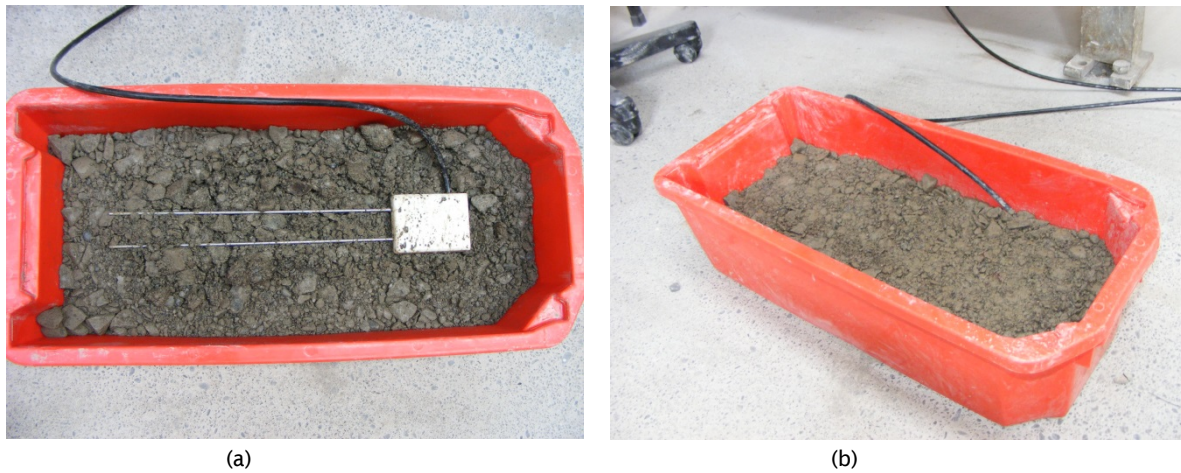
Figure E.1 Calibration of TDR sensor

The sensors were monitored for about 24 hours to establish an output for the moisture content.
