Seismic design and performance of high cut slopes

July 2018

P Brabhakaran, D Mason and E Gkeli
Opus International Consultants Ltd

NZ Transport Agency research report 613

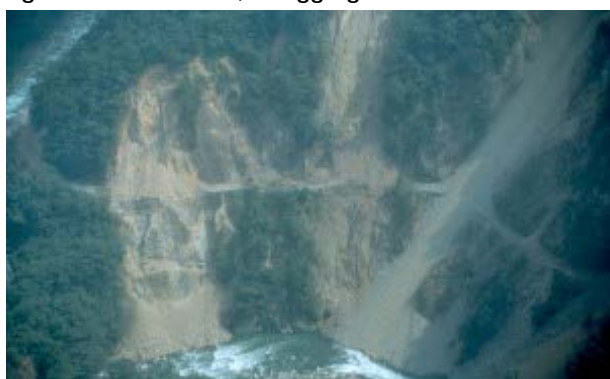
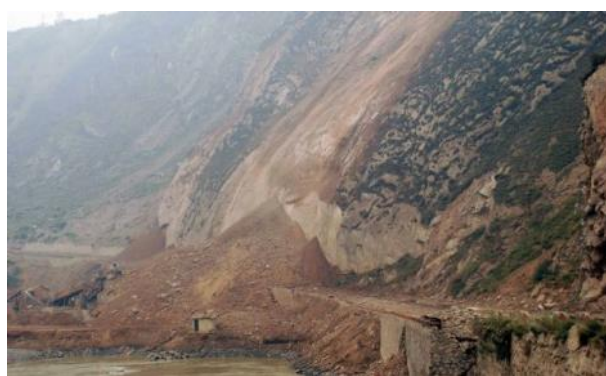
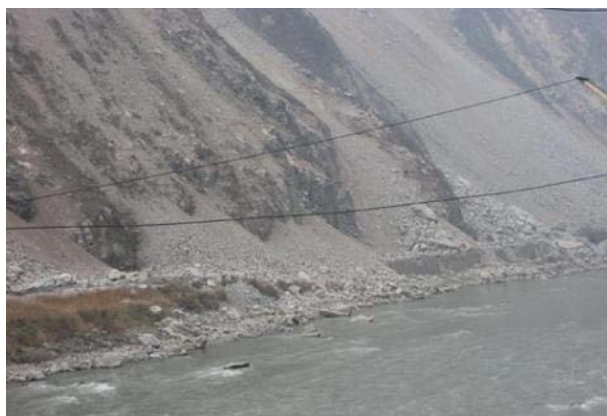
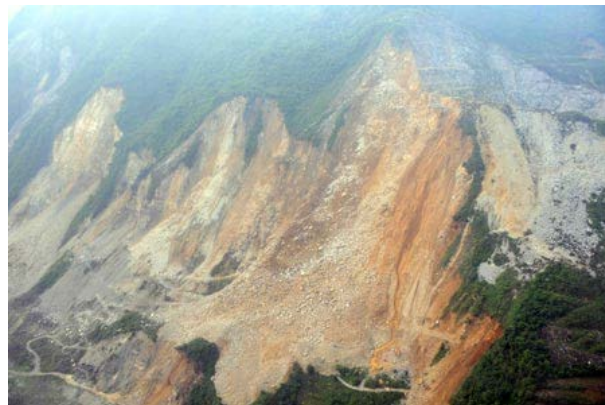
Figure 5.1 Shallow, disaggregated landslides –1999 Chi-Chi and 2008 Wenchuan earthquakes

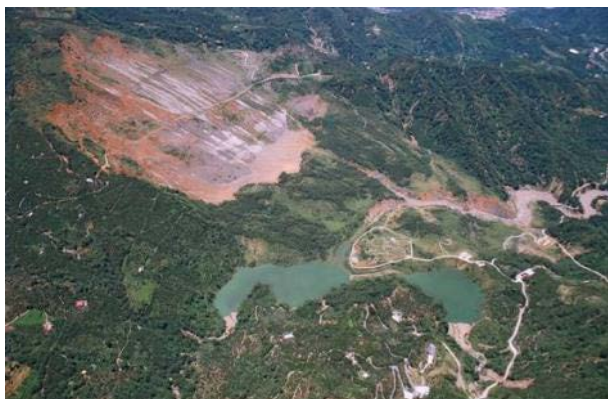
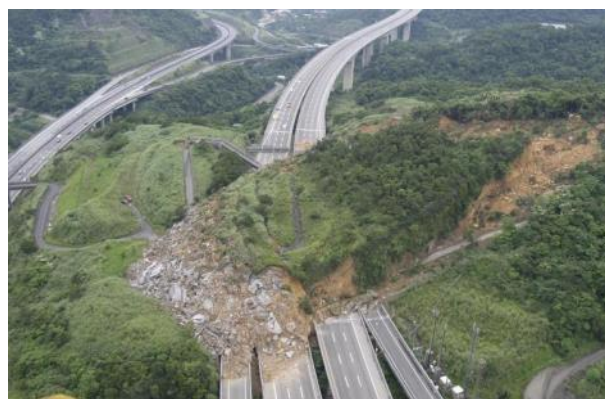
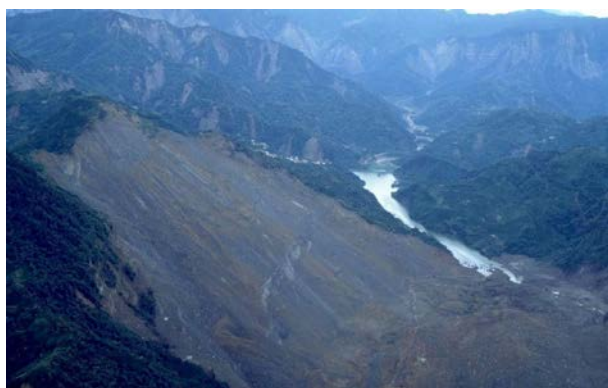
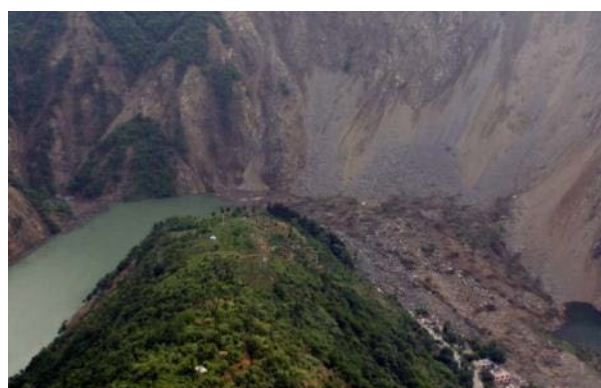
Figure 5.2 Large, deep-seated landslides – 1999 Chi-Chi and 2008 Wenchuan earthquakes

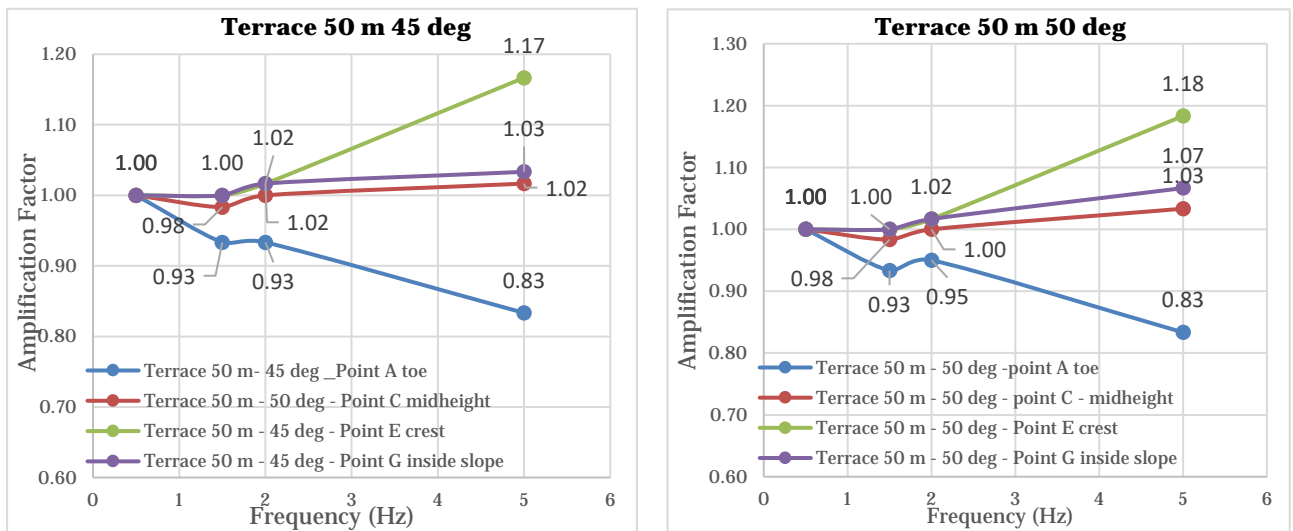
Figure 6.1 Amplification factors for terrace 50m high – 45° and 50° slopes

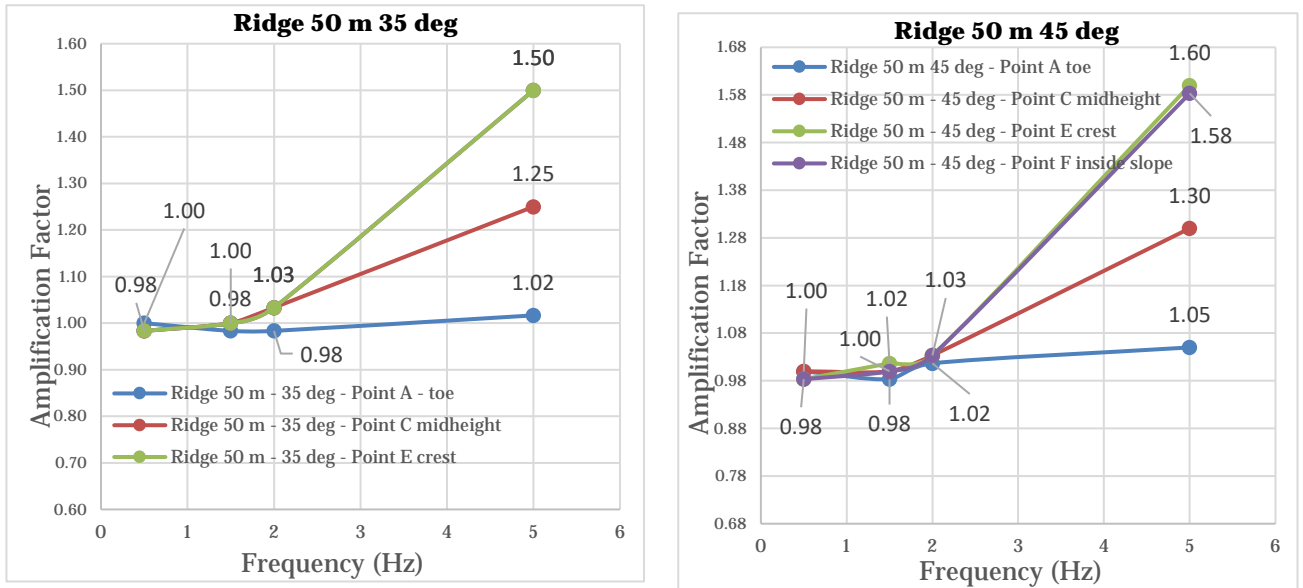
Figure 6.3 Amplification factors for ridge 50m high – 35° and 45° slopes

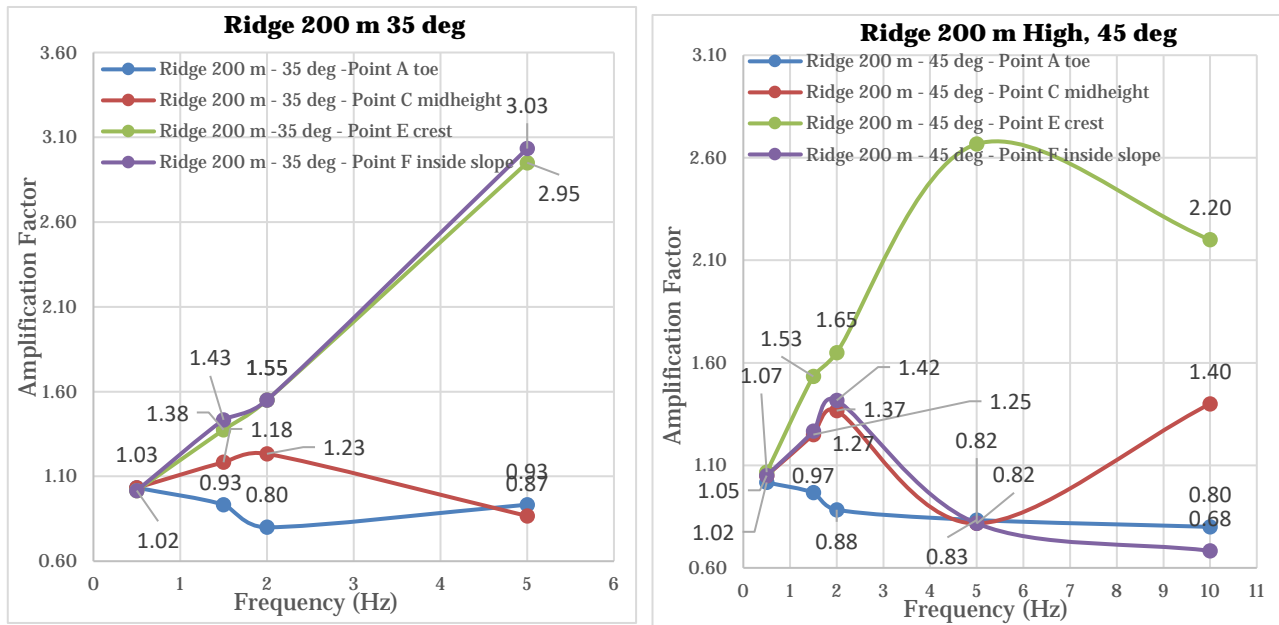
Figure 6.4 Amplification factors for ridge 200m high – 35° and 45° slopes

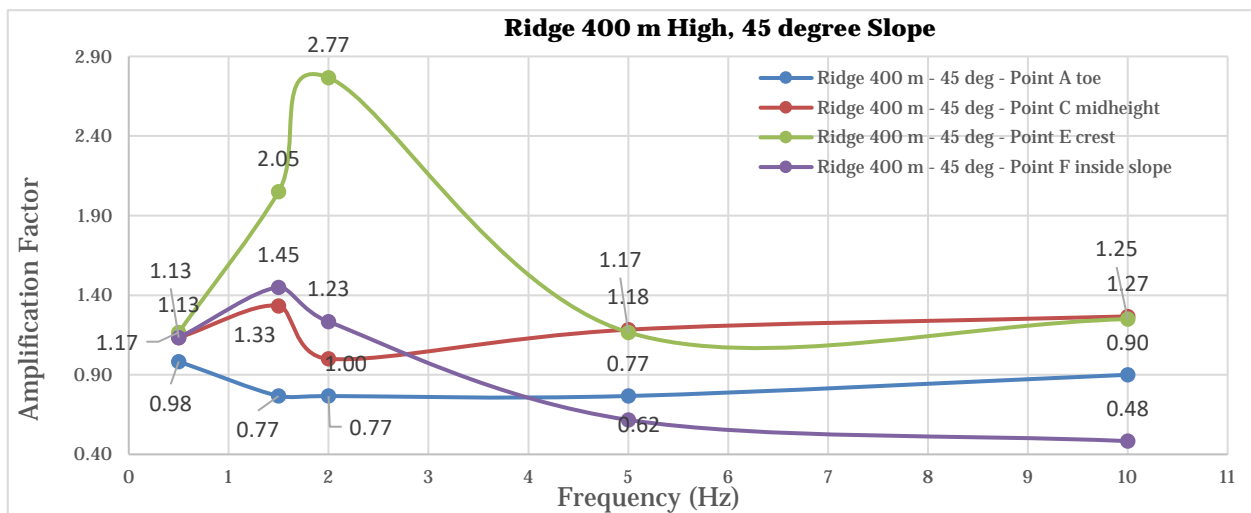
Figure 6.5 Amplification factors for ridge 400m high, 45° slope

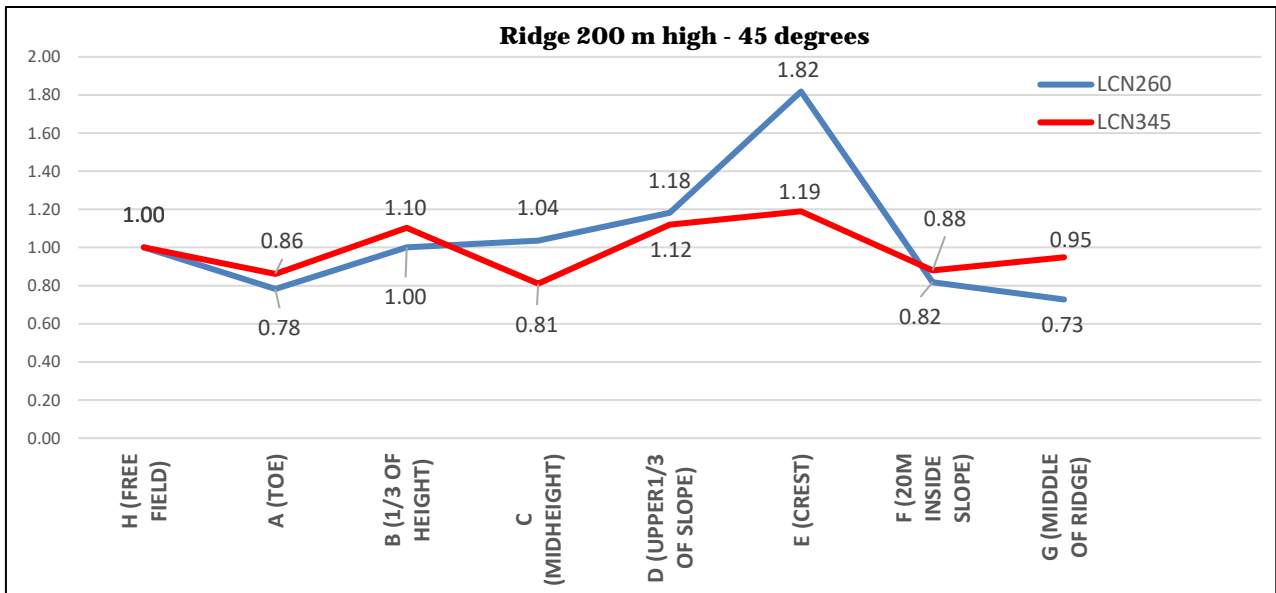
Figure 6.6 Amplification factors for the ridge 200m high (45° slope angles) using the 1992 Landers earthquake recordings

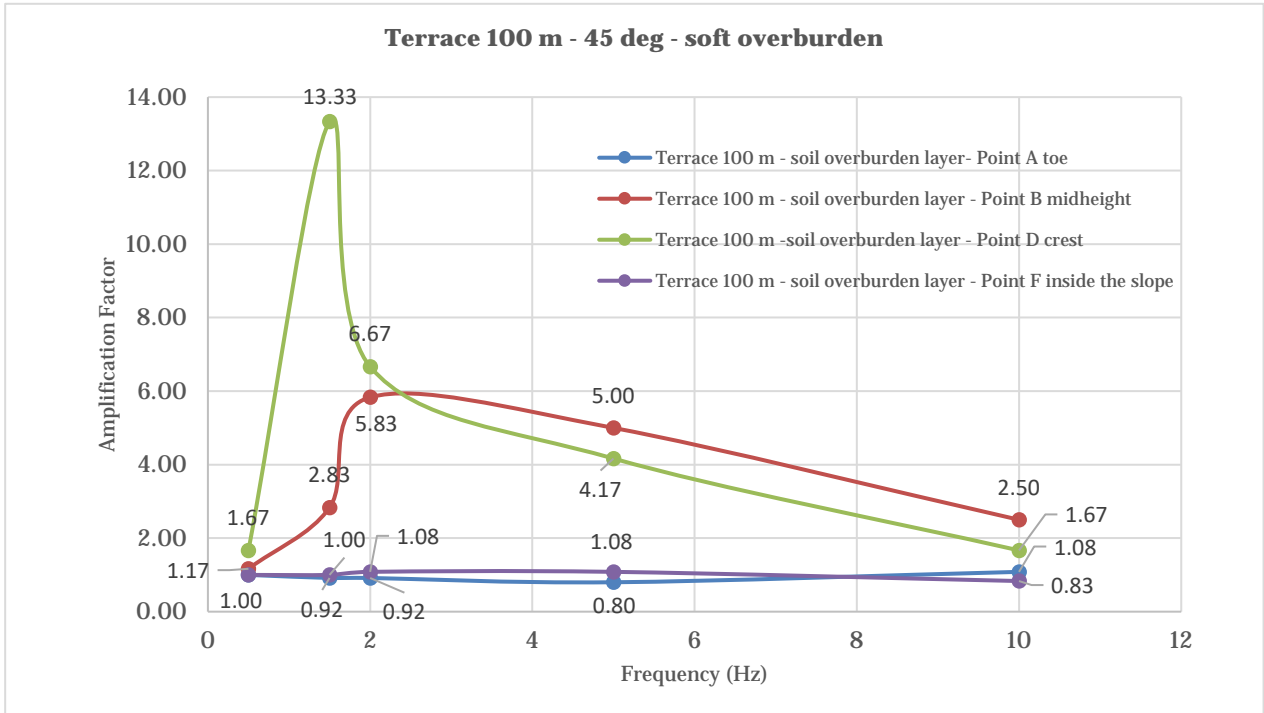
Figure 6.7 Amplification factor: terrace 100m high with soil overburden (45° slope)

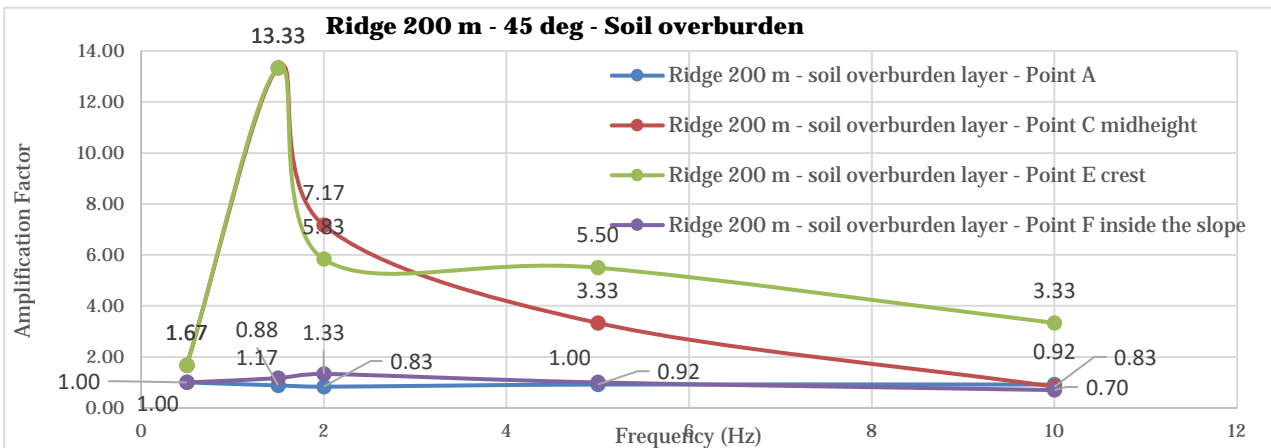
Figure 6.8 Amplification factors for ridge 200m high with soil overburden – 45° slopes

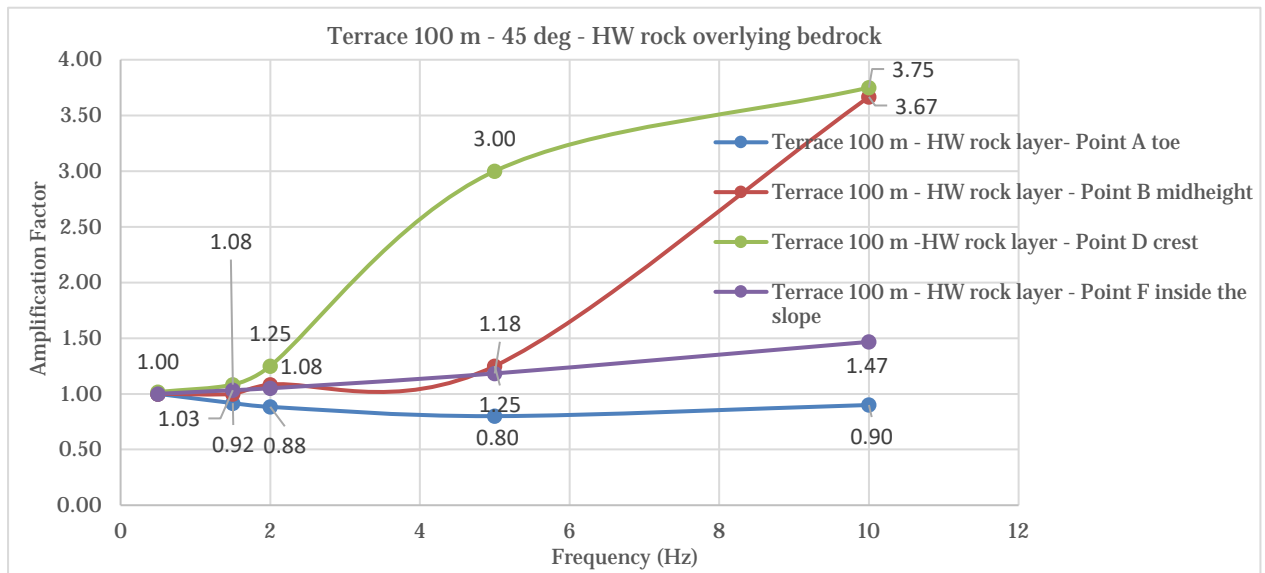
Figure 6.9 Amplification factor: terrace 100m high with HW rock overlying bedrock (45° slope)

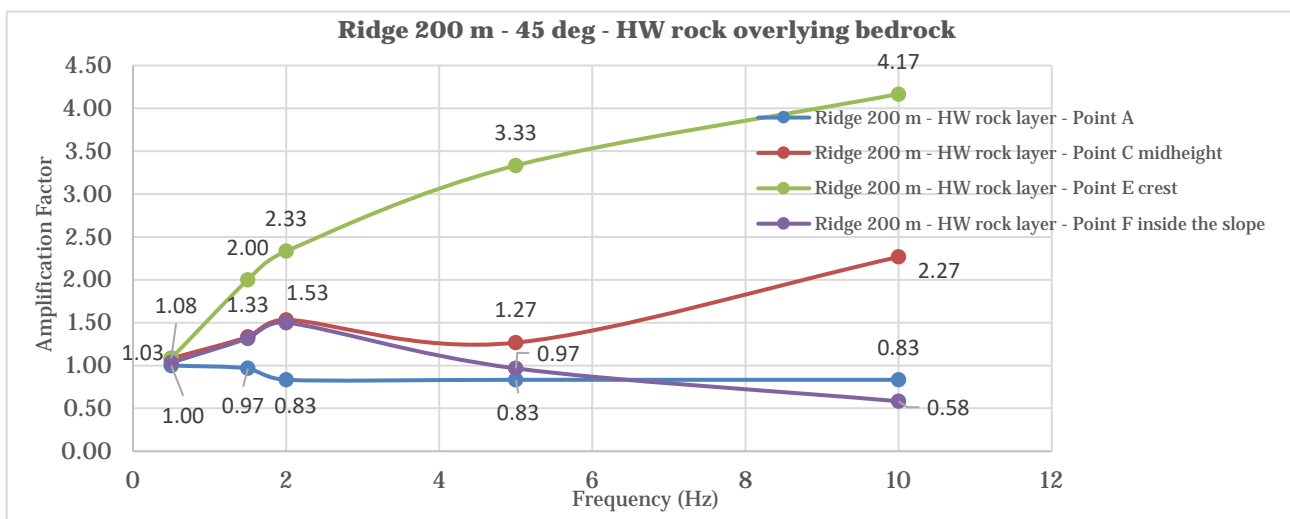
Figure 6.10 Amplification factor: ridge 200m high with HW rock overlying bedrock (45° slope)

The results in figure 6.10 for ridge topography also indicate a high topographical amplification, where weathered rock is present, compared with the situation where the rock is uniform and unweathered in figure 6.11. The amplification is again pronounced at the higher frequencies of motion, similar to the terrace topography.

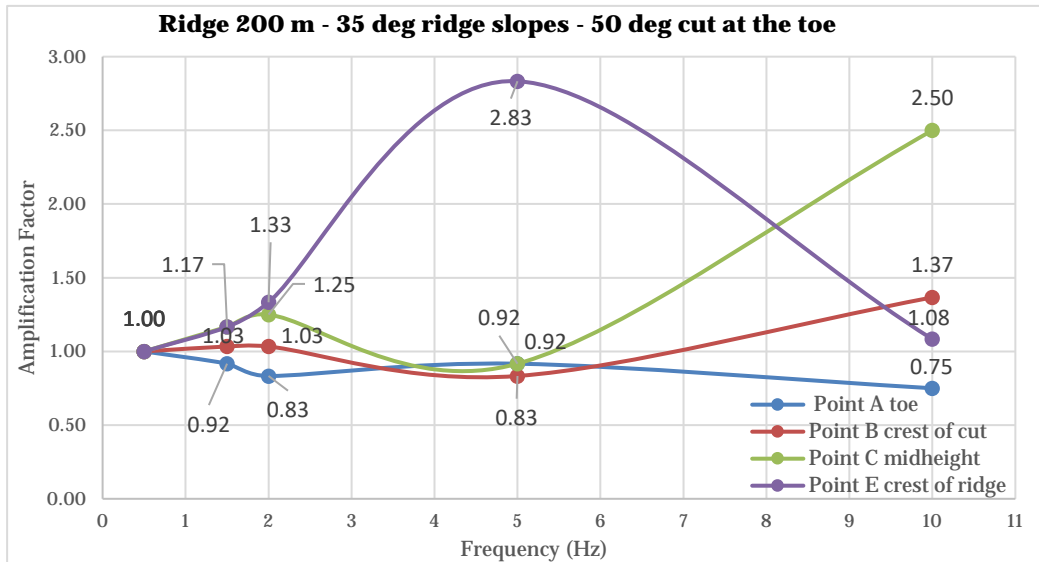
Figure 6.11 Amplification factors for the ridge 200m high, with 35° slopes and 50° cut 50m high at the toe

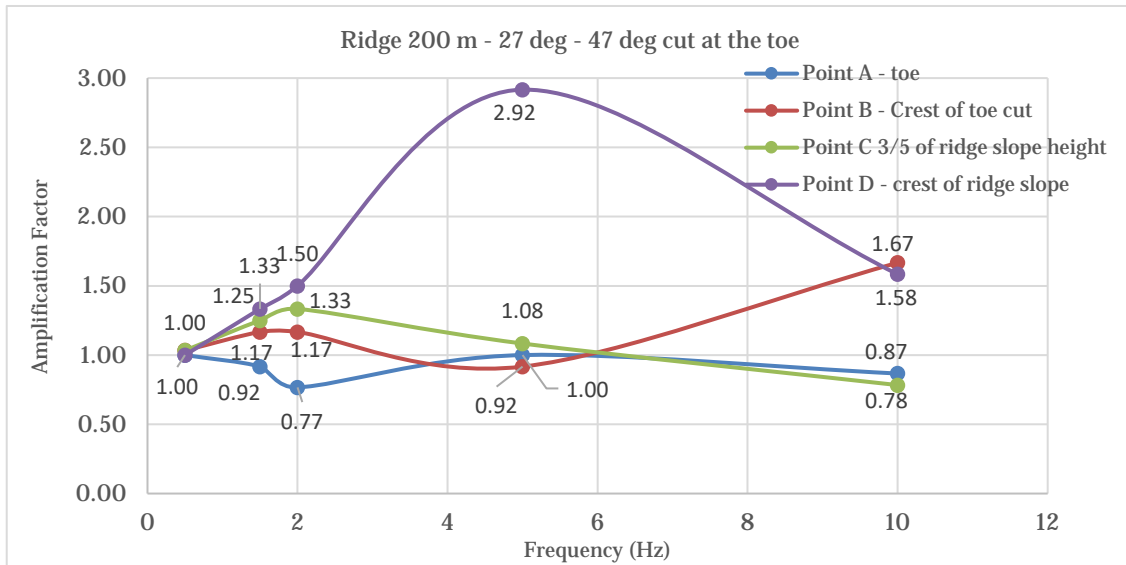
Figure 6.12 Amplification factors for the ridge 200m high, with 27° slopes and 50° cut at the toe, 100m high

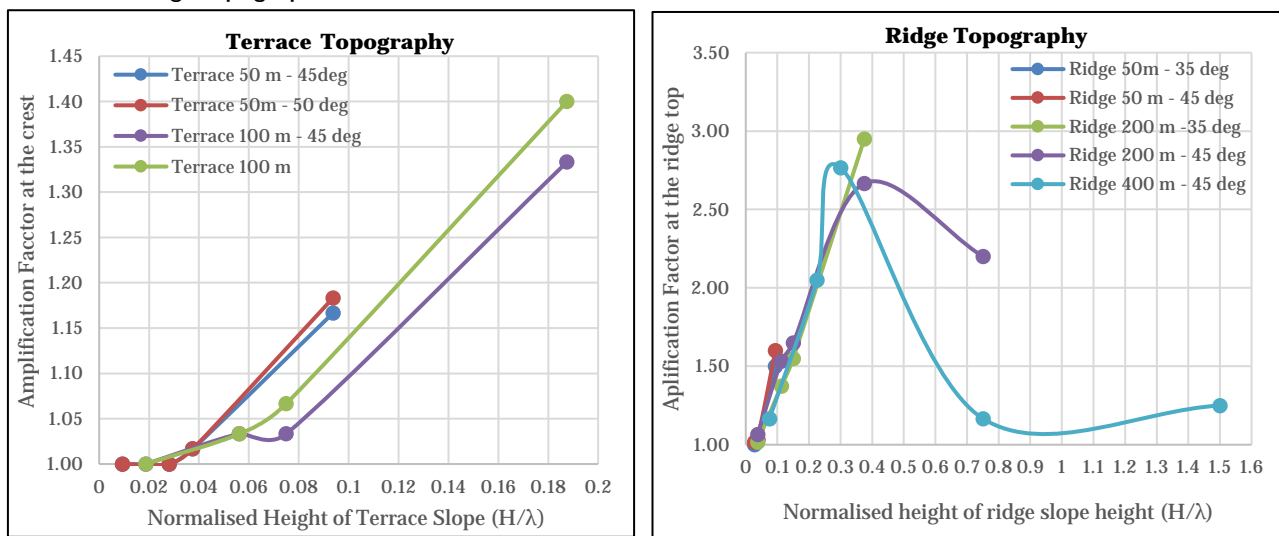
Figure 6.13 Influence of the normalised slope height (H/λ) to the amplification factor at the slope crest for terrace and ridge topographies

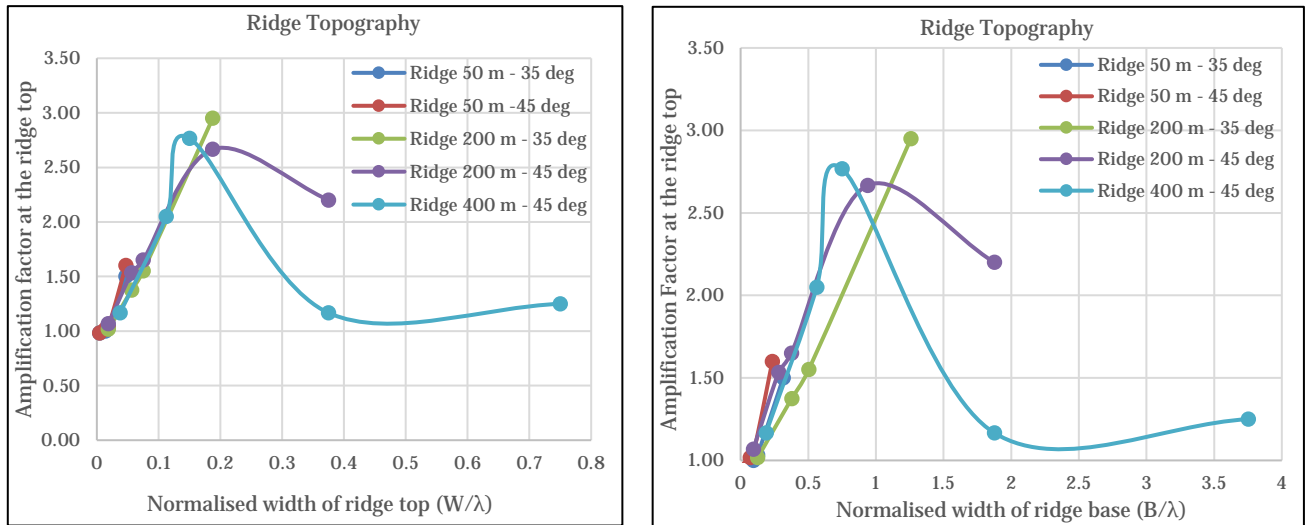
Figure 6.14 Influence of the normalised width of top (W/λ) and normalised width of base (B/λ) to the amplification factor at the slope crest for ridge topographies

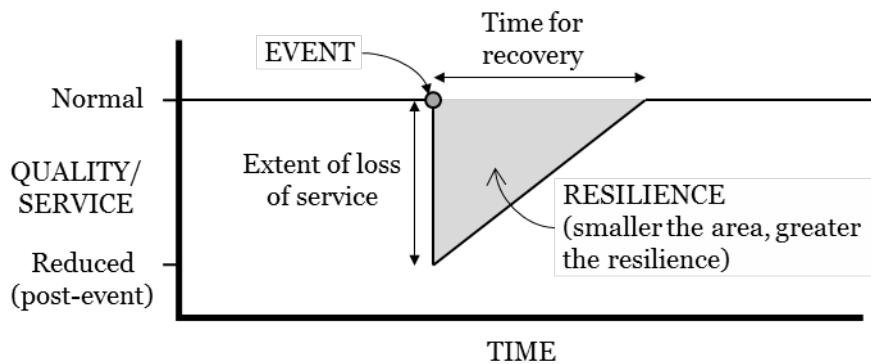
Figure 7.1 Resilience of route/network

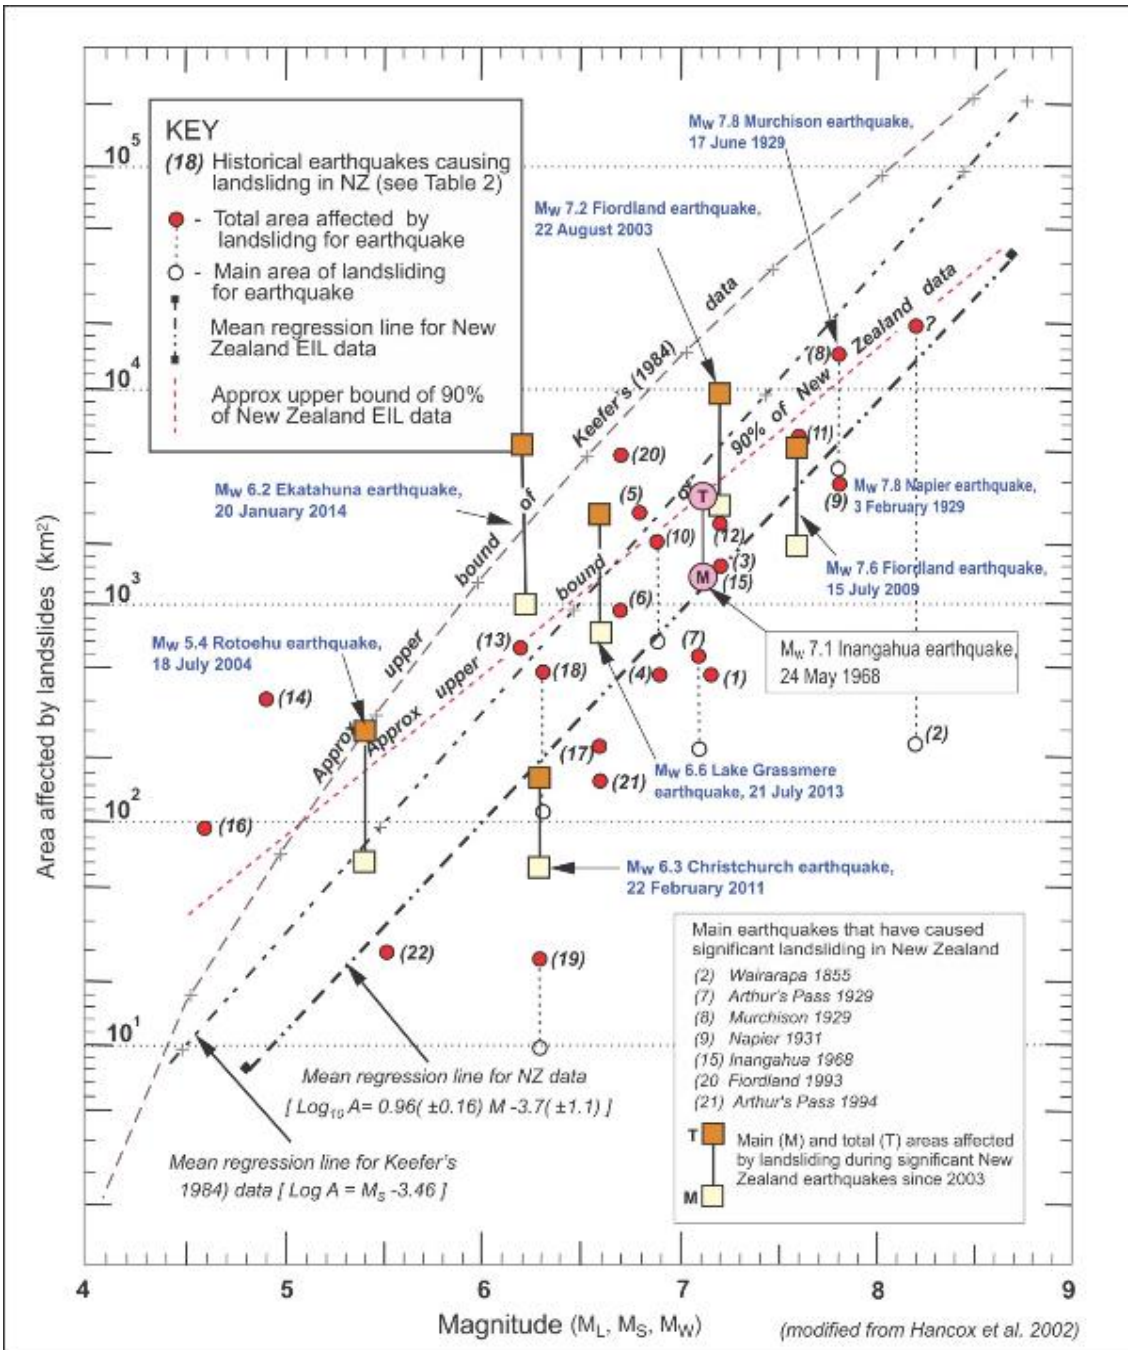
Figure A.2 Area-magnitude graph showing the relationship of the main and total areas affected by landslides during the 1968 Inangahua earthquake determined in this study (pink), compared with historical New Zealand earthquakes (Hancox et al 2002; 2004), overseas data (Keefer 1984), and six recent New Zealand earthquakes that have caused significant landsliding since 2003 in Fiordland 2003 and 2009, Lake Rotoehu 2004, Christchurch 2011, Lake Grassmere 2013 and Eketahuna 2014.

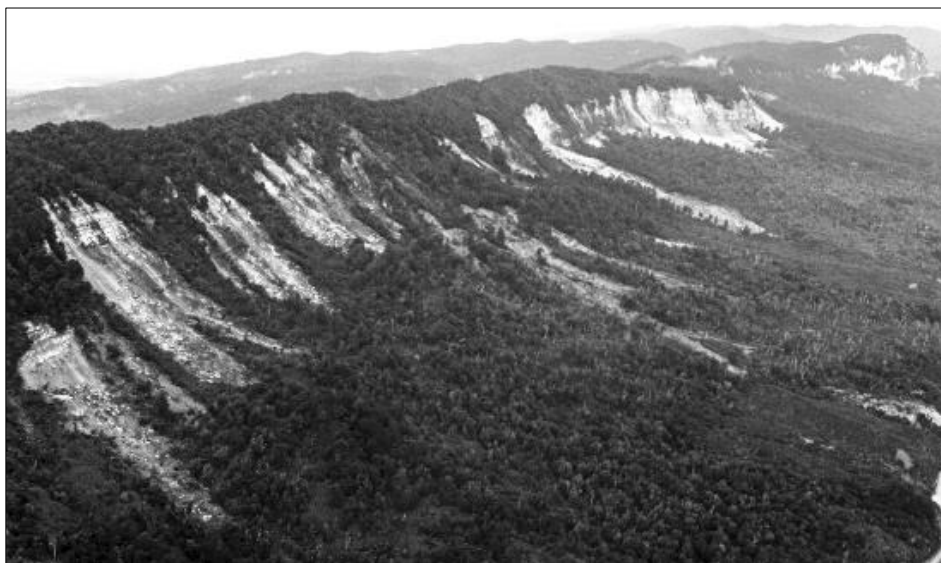
Figure A.3 During the 1968 Inangahua earthquake extensive large rock falls occurred on the Tertiary limestone escarpment within the MM9 isoseismal 5km west of Inangahua

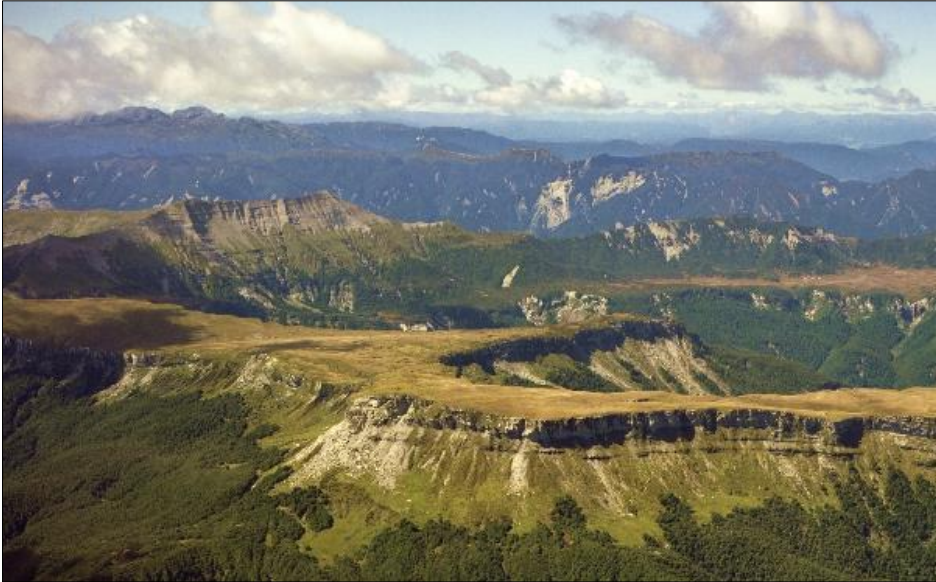
Figure A.4 The Matiri Valley was extensively damaged by landslides during the 1929 Murchison earthquake. The scars of rock falls from Tertiary limestone cliffs bordering the 'Thousand Acres Plateau' (foreground) and many other landslides within the MM10 isoseismal are still visible today

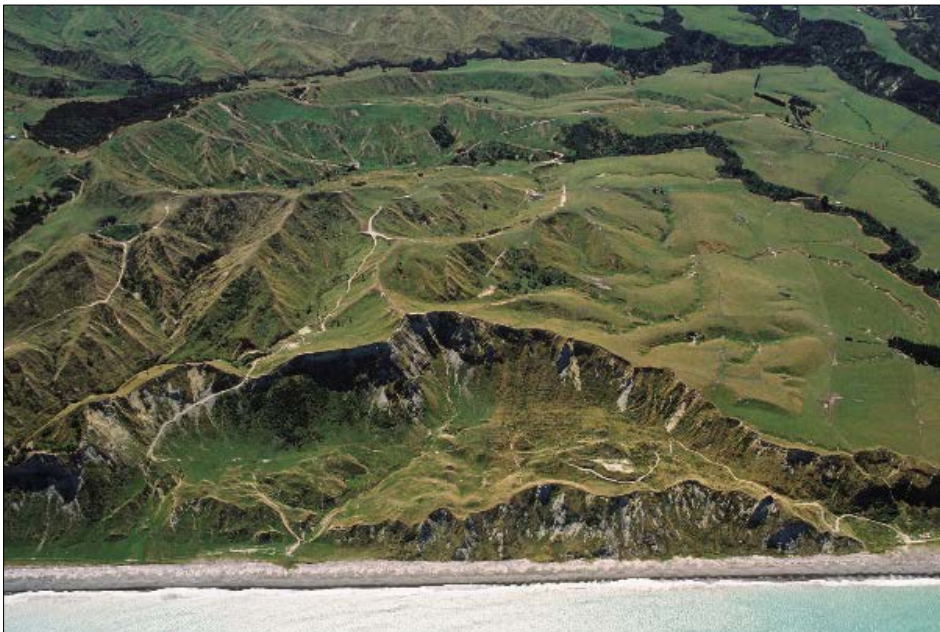
Figure A.5 This very large (~33Mm³) rotational landslide in Tertiary mudstone on the coastal cliffs near the Mohaka River mouth in Hawke's Bay, occurred during the 1931 Napier earthquake within the MM9 isoseismal. The toe of the slide debris, which is 300–400m wide and extends about 1.3km along the coast, originally pushed 200–300m out into the sea, but it has since been cut back by wave action

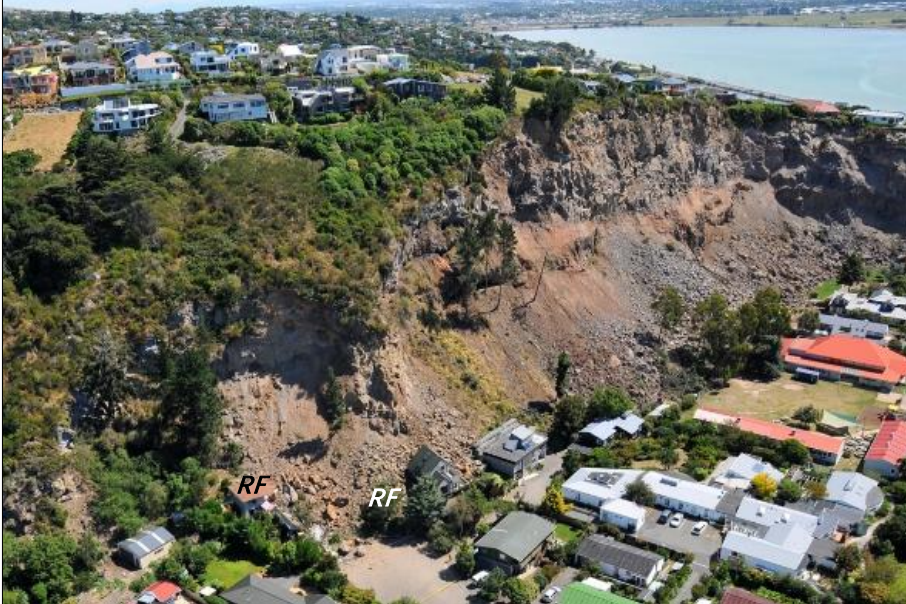
Figure A.6 The February 2011 Christchurch earthquake triggered extensive falls of volcanic rocks on the 60m high cliff behind Redcliffs School (a former quarry site, right) and nearby houses. Two of the five fatalities due to coseismic rock falls occurred in two houses (RF, bottom centre). Although these fatal slope failures were relatively small (~10–100m³) they were highly hazardous because of the proximity of the houses. The shaking intensity on the cliff and ridge crest in this area is estimated to have been MM8 to MM9, with a PGA of greater than 0.4g.

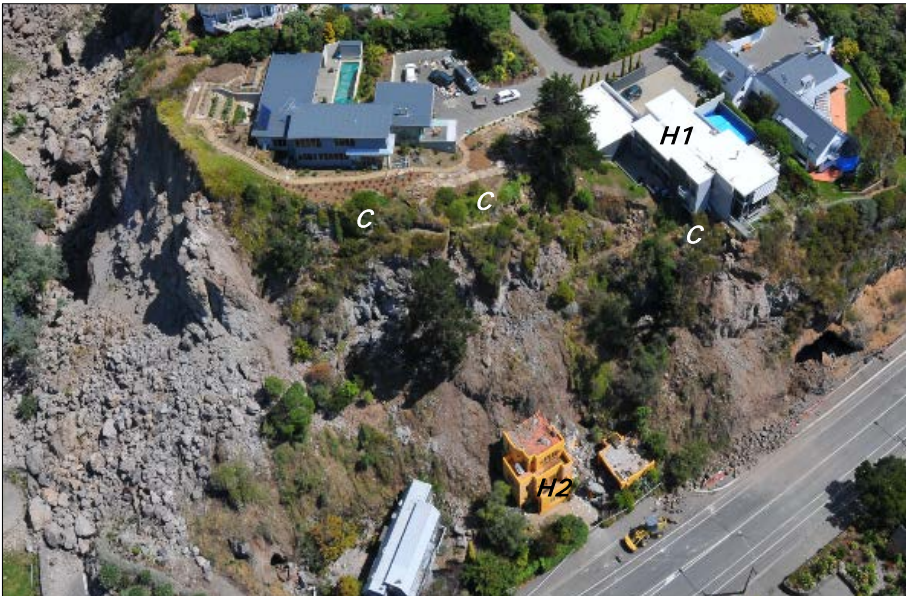
Figure A.7 Houses at the foot of the old sea cliff at Redcliffs were damaged by rock falls, and houses at the top of the cliff were damaged by ground cracking (*C*) during the 22 February mainshock and were undermined during subsequent cliff collapses during aftershocks. Two houses (*H1*, *H2*), had to be demolished at this site.

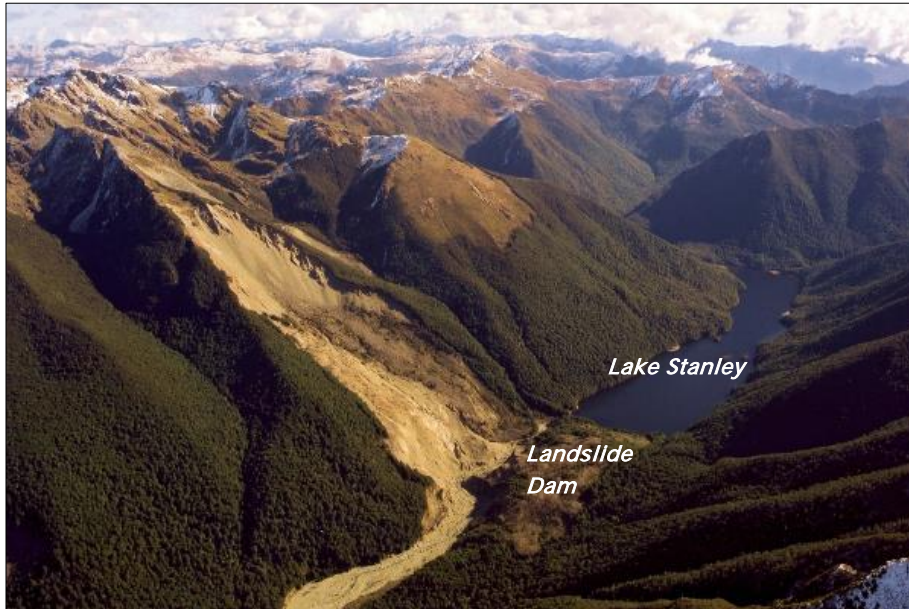
Figure A.8 The Lake Stanley rock avalanche (18Mm^3) in Palaeozoic conglomerate and volcanics is one of several very large rock avalanches and landslide dammed lakes formed during the 1929 Murchison earthquake, and is located in the Tasman Mountains ~90km north of the epicentre within the MM9 isoseismal. The avalanche had a runout of ~2km and a vertical fall of about 800m from the top of the head scarp to the valley floor.

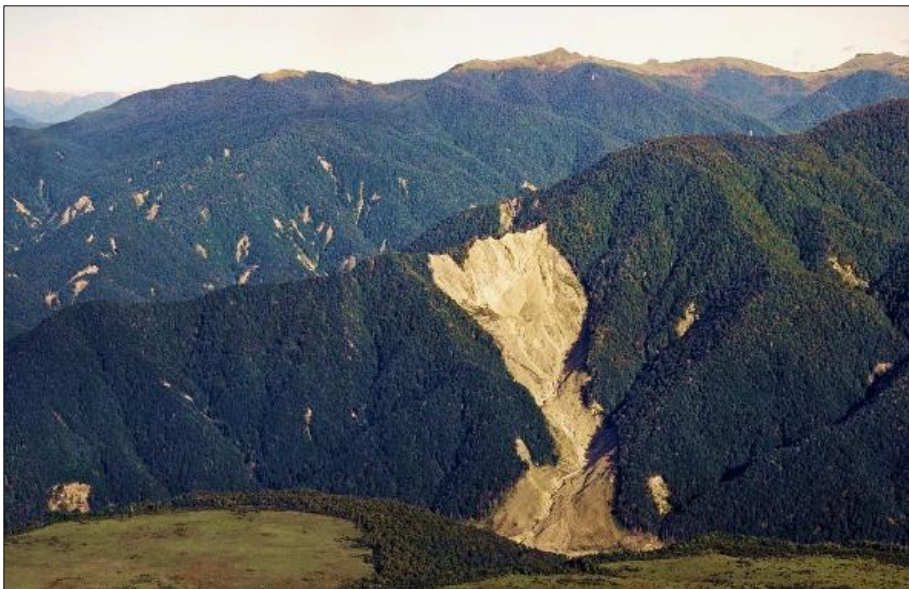
Figure A.9 During the 1968 Inangahua earthquake a $\sim 5\text{Mm}^3$ rock avalanche of weathered granite occurred in the Buller Gorge within the MM10 isoseismal. Landslide debris dammed the Buller River for a day between Inangahua and Murchison, and the road through the Buller gorge (SH6) was severely damaged (see figure A.10). Boulders and wind blast damaged vegetation up to 50m above road level.

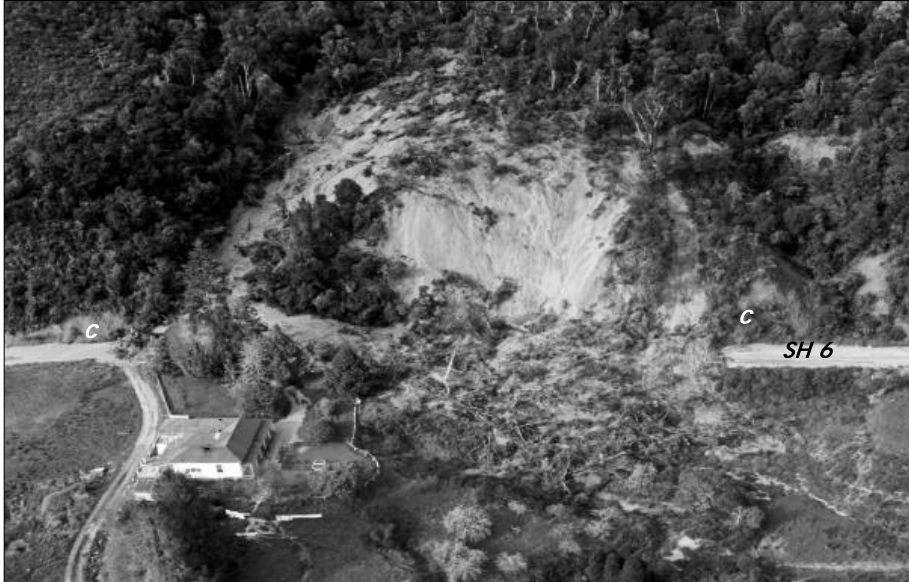
Figure A.11 The Inangahua earthquake triggered this large (~120m wide) rotational slide and earth flow in Tertiary mudstone which closed SH6 at Walker Flat 5km west of Inangahua and almost hit a farm house. The failure occurred where the toe of the slope had been cut back (c) to widen the road.

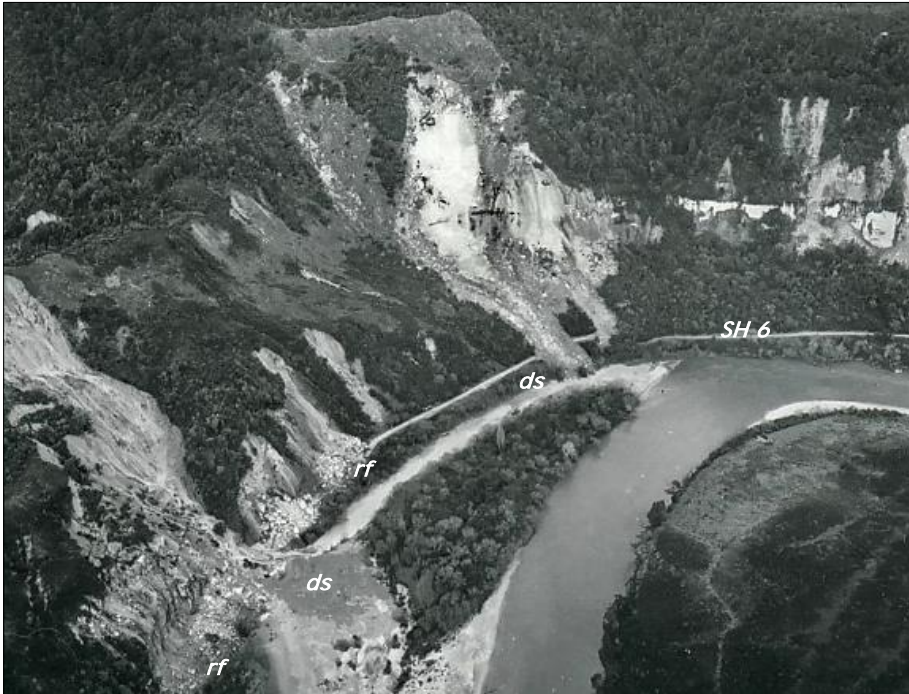
Figure A.13 Rock falls (*rf*) and debris slides (*ds*) from road cuts and bluffs of Tertiary limestone during the Inangahua earthquake buried SH6 for a length of about 1km along the Buller River at White Cliffs, 4km northwest of Inangahua, causing that section of the highway to be relocated well out from the base of the cliffs.

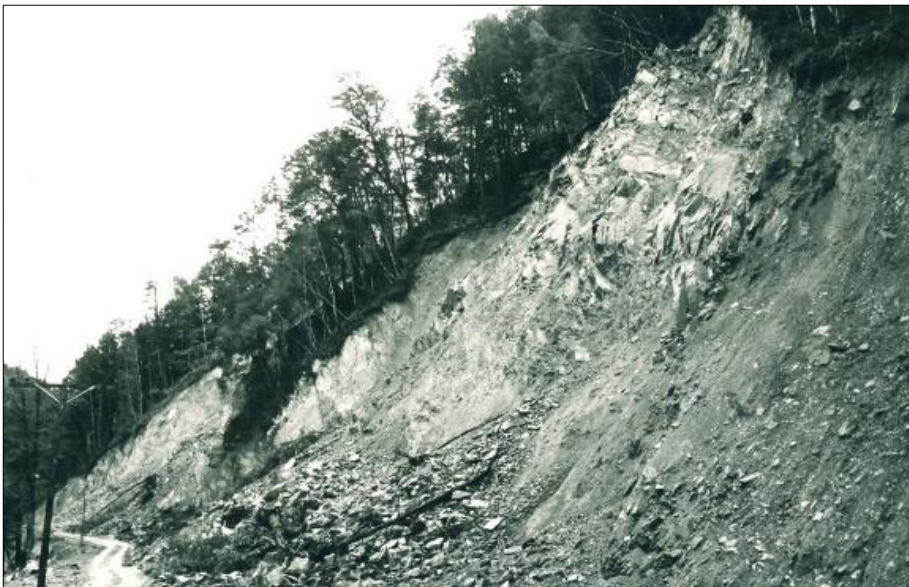
Figure A.14 One of the many steep unsupported SH6 road cuts in the upper Buller Gorge which were badly damaged by rock and debris falls during the Inangahua earthquake. In this photo much of the rock fall debris has been cleared away, allowing the highway to be re-opened to one-lane traffic 10 weeks after the earthquake.

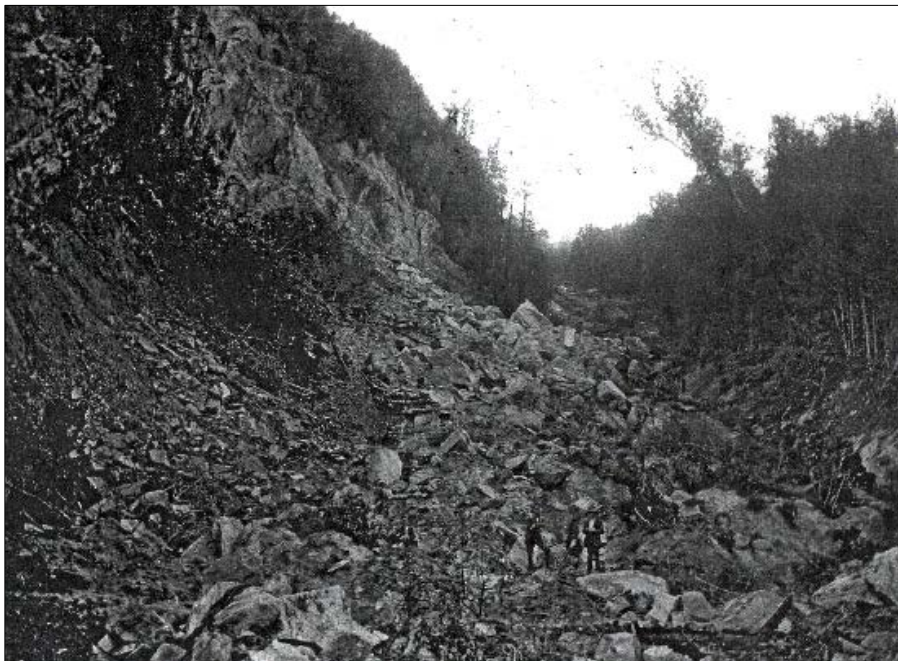
Figure A.16 Extensive rock falls triggered by the 1929 Murchison earthquake completely buried parts of the road in the upper Buller Gorge. Below, the extensive rock falls that covered the gorge road near Lyell Creek.

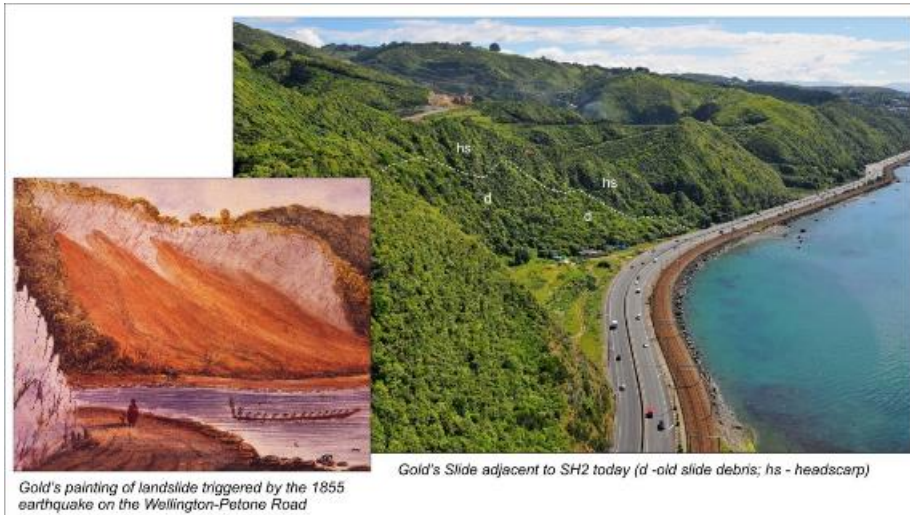
Figure A.17 'Gold's Landslide' ($\sim 300,000\text{m}^3$) on the Hutt Road (SH2), which was triggered by the 1855 Wairarapa earthquake, illustrates the potential for similar failures to occur during a Wellington fault earthquake.

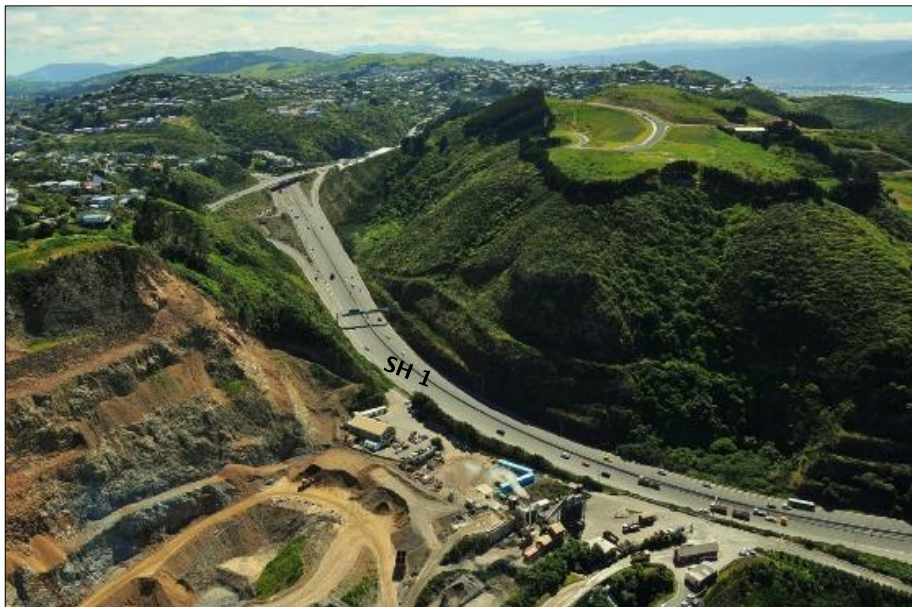
Figure A.18 The steep ($60\text{--}65^\circ$) 60m cut slopes along SH1 in the Ngauranga Gorge (bottom right) are believed to be vulnerable to landsliding during a Wellington fault earthquake (MM9-10, with PGAs of ~ 0.5 to $1.0g$ or $>$). These cuts have not been tested by a large earthquake since they were constructed in the 1950s.

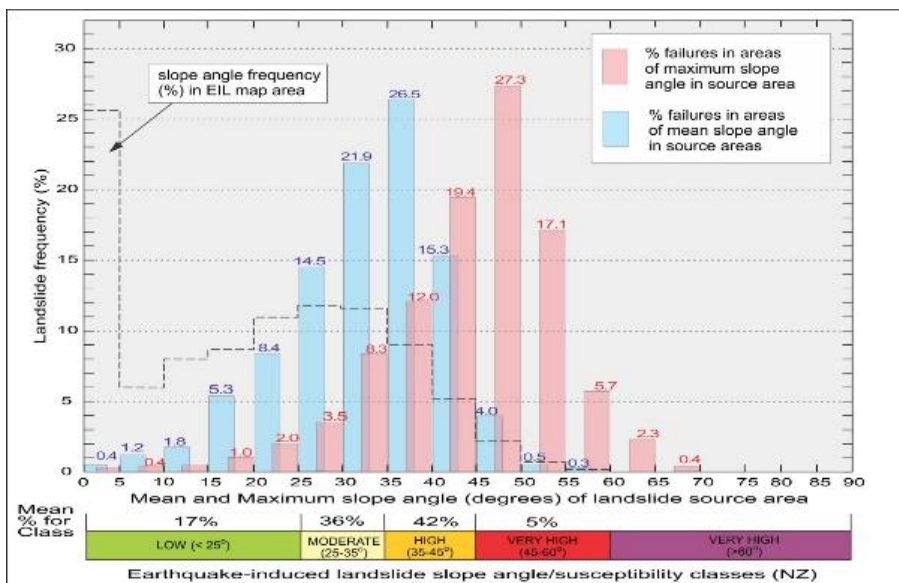
Figure A.20 Graphs showing landslide frequency (%) in relation to mean and maximum slope angles in the source areas of landslides triggered by the Inangahua earthquake, slope angle frequency and the slope angle/landslide susceptibility classes.

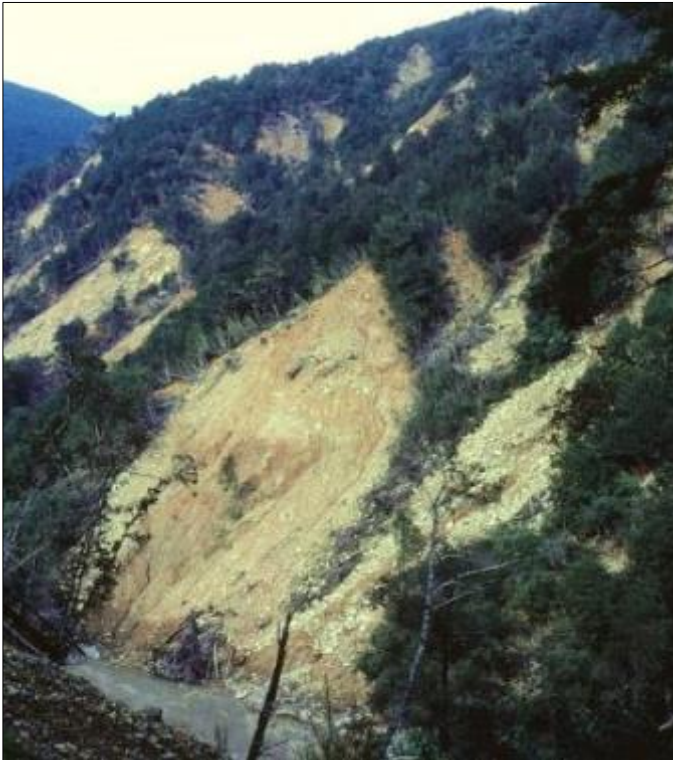
Figure A.22 Multiple shallow debris slides occurred in weathered granite in the upper Buller Gorge during the 1968 Inangahua earthquake.

Figure A.22 shows multiple debris slides in weathered granite which occurred during the Inangahua earthquake in the upper Buller Gorge. Typical rock falls triggered by the 2011 Christchurch earthquake are shown in figures A.6 and A.7, and figure A.23 shows joint controlled rock falls of granite which occurred on many SH6 road cuts during the Inangahua earthquake. Other types of disrupted landslides are shown in figures A.6 to A.9 and A.12 to A.16.
