Seismic design and performance of high cut slopes

July 2018

P Brabhakaran, D Mason and E Gkeli
Opus International Consultants Ltd

NZ Transport Agency research report 613

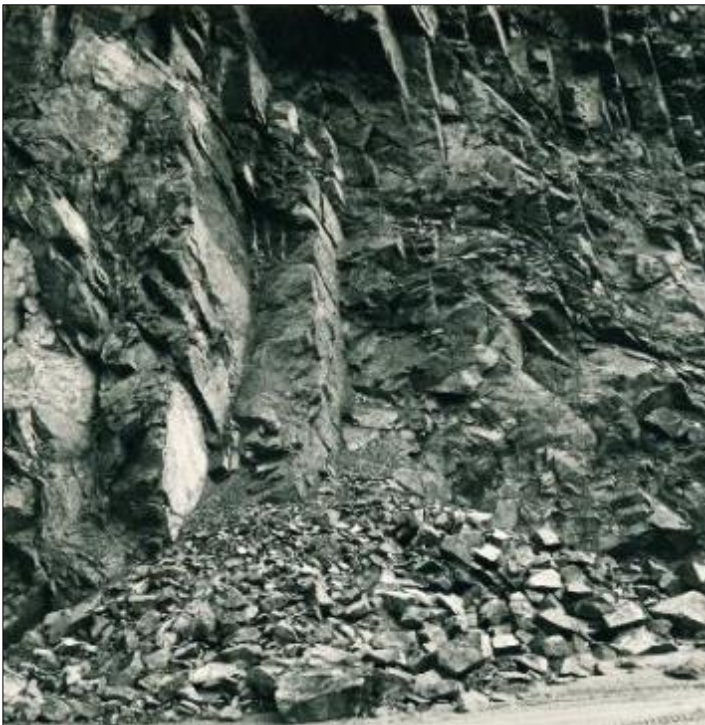
Figure A.23 Joint-controlled rock falls in weathered granite damaged many SH6 road cuts in the upper Buller Gorge during the 1968 Inangahua earthquake. In this photo most of the rock fall debris that initially blocked the road has been cleared away, but the cut slope is still highly vulnerable to further rock falls.

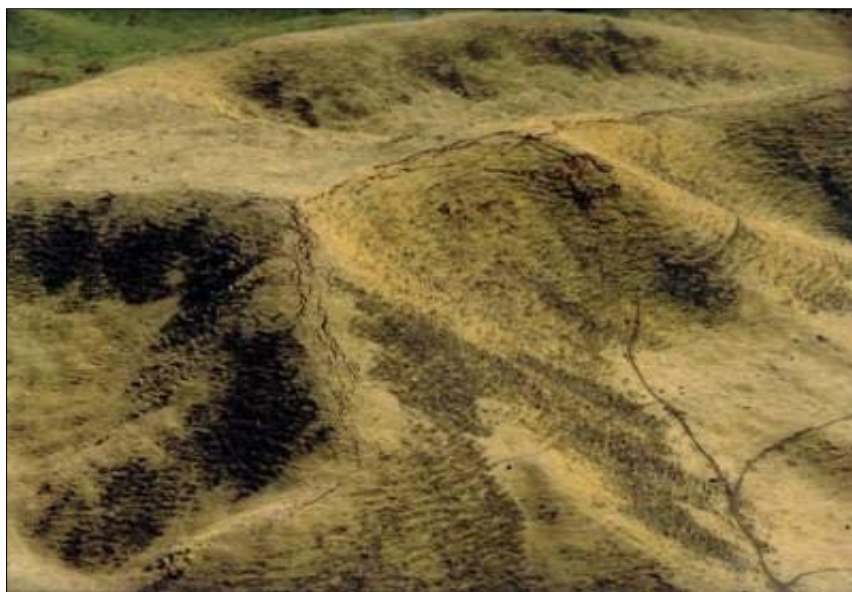
Figure A.24 Typical ridge crest cracking (incipient coherent landslide) formed in cohesive soils (weathered tephra deposits) on hills during the 1987 Edgecumbe earthquake.

- *Coherent landslides* involve rock, debris, and slumps and rotational slides, in which the movement is typically slow with little internal disruption and small displacements (< 2m), and often involving open cracking on the ground surface. Observations in New Zealand suggest that coherent landslides typically occur on slopes of fine, cohesive soils in areas of Tertiary mudstone (eg 2013 Cook Strait earthquake, 2014 Eketahuna earthquake) and also weathered volcanic tephra deposits (eg 1987 Edgecumbe earthquake). Typical slope and ridge crest cracking associated with incipient coherent landslides that occurred during the 1987 and 2013 earthquakes is illustrated in figures A.24 and A.25.

Fewer coherent landslides have been identified during coseismic landslide reconnaissance studies in New Zealand. This may be because open cracks on slopes are more difficult to recognise as a coherent landslide. Ridge crest cracking was noted after the 1987 Edgecumbe earthquake and similar features were mapped following the 2013 Cook Strait and Lake Grassmere earthquakes, and the 2014 Eketahuna earthquake. Figure A.24 shows ridge crest cracking associated with an incipient coherent landslide that developed on the hills west of the Tarawera River during the Edgecumbe earthquake. Figure A.25 shows similar slope cracking that occurred during the 2013 Lake Grassmere earthquake. Typical coherent landslides (partly developed rotational slides) in Tertiary mudstone are illustrated in figures A.26 and A.27.

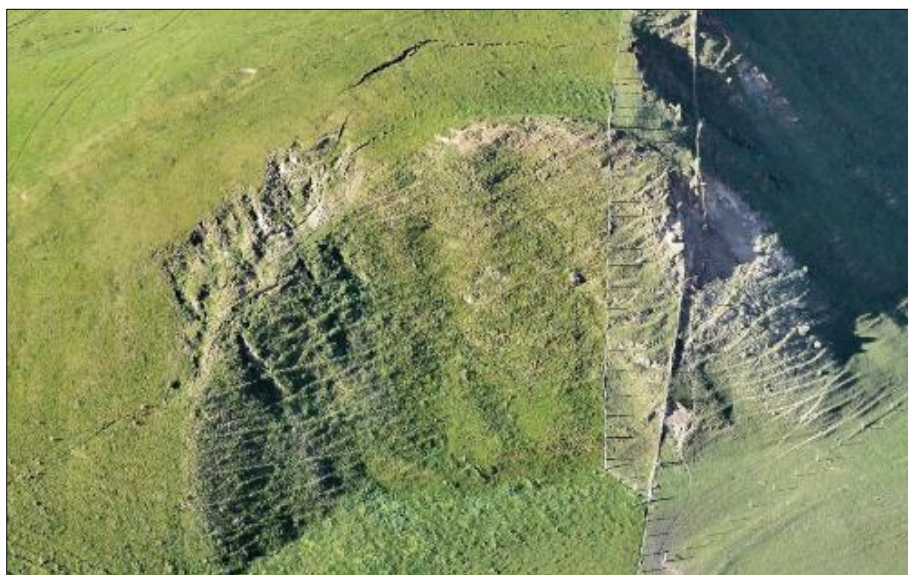
Figure A.25 Slope crest cracking (incipient coherent landslide) which occurred in the Ward area during the 2013 Lake Grassmere earthquake.

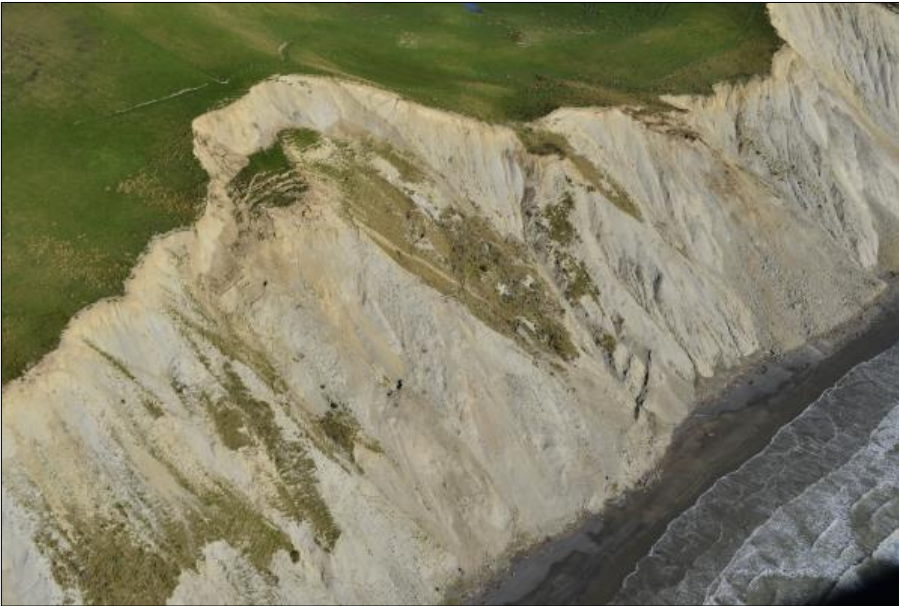
Figure A.26 Typical coherent landslide: $\sim 100,000\text{m}^3$ rotational slide in mudstone which occurred on the 100m high cliffs 1km west of Cape Campbell during the 2013 Cook Strait earthquake.

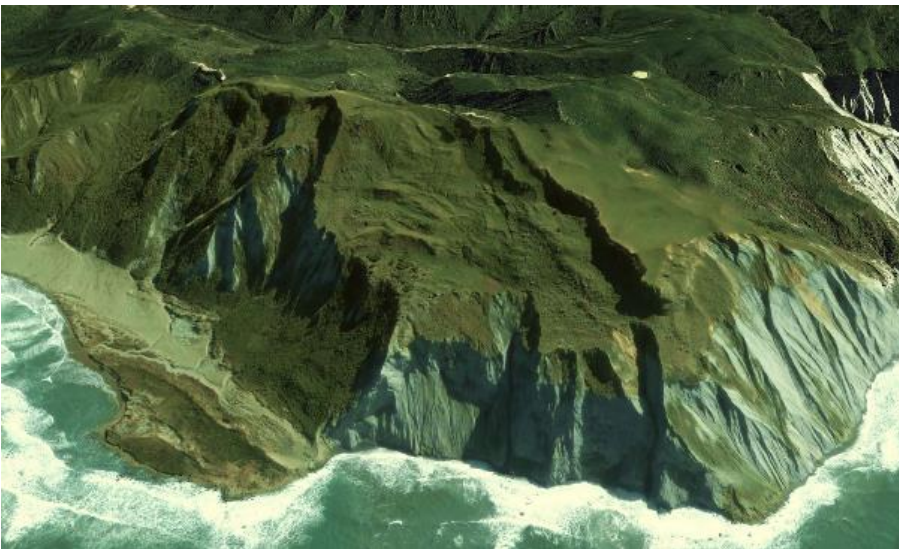
Figure A.27 Google Earth image (2004) of a very large ($\sim 30\text{Mm}^3$) partly-developed rotational (coherent) landslide in Tertiary mudstone on the $\sim 150\text{--}250\text{m}$ high cliffs at Cape Turnagain on the Wairarapa coast. This landslide may have occurred in 1855 and was reactivated during the 1904 Cape Turnagain earthquake.

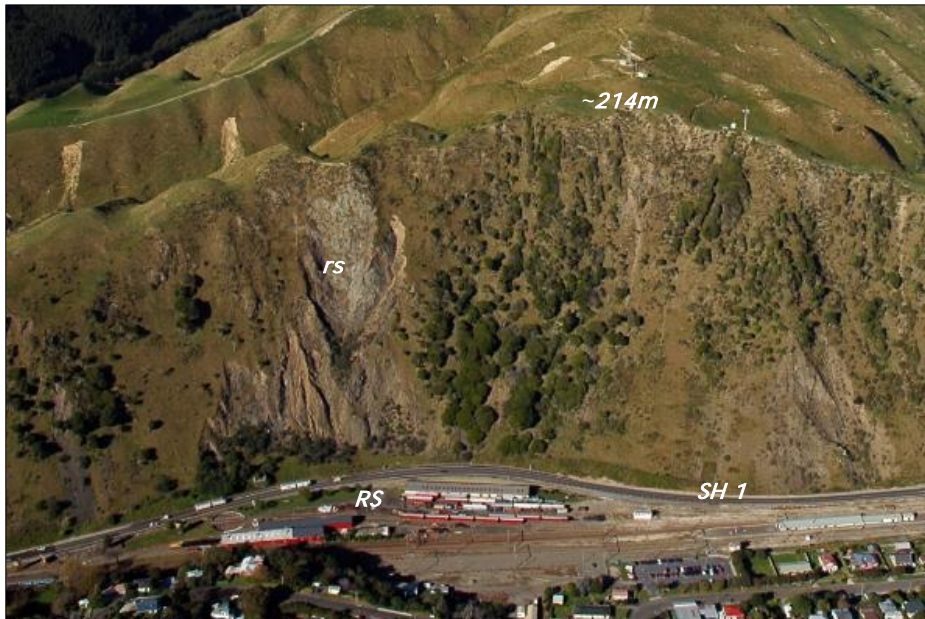
Figure A.28 Aerial view of the large (100,000m³) rock slide (*rs*) caused by the 1855 earthquake on the ~45°, ~200m high slope above the railway station (*RS*) and SH1 highway at Paekakariki.

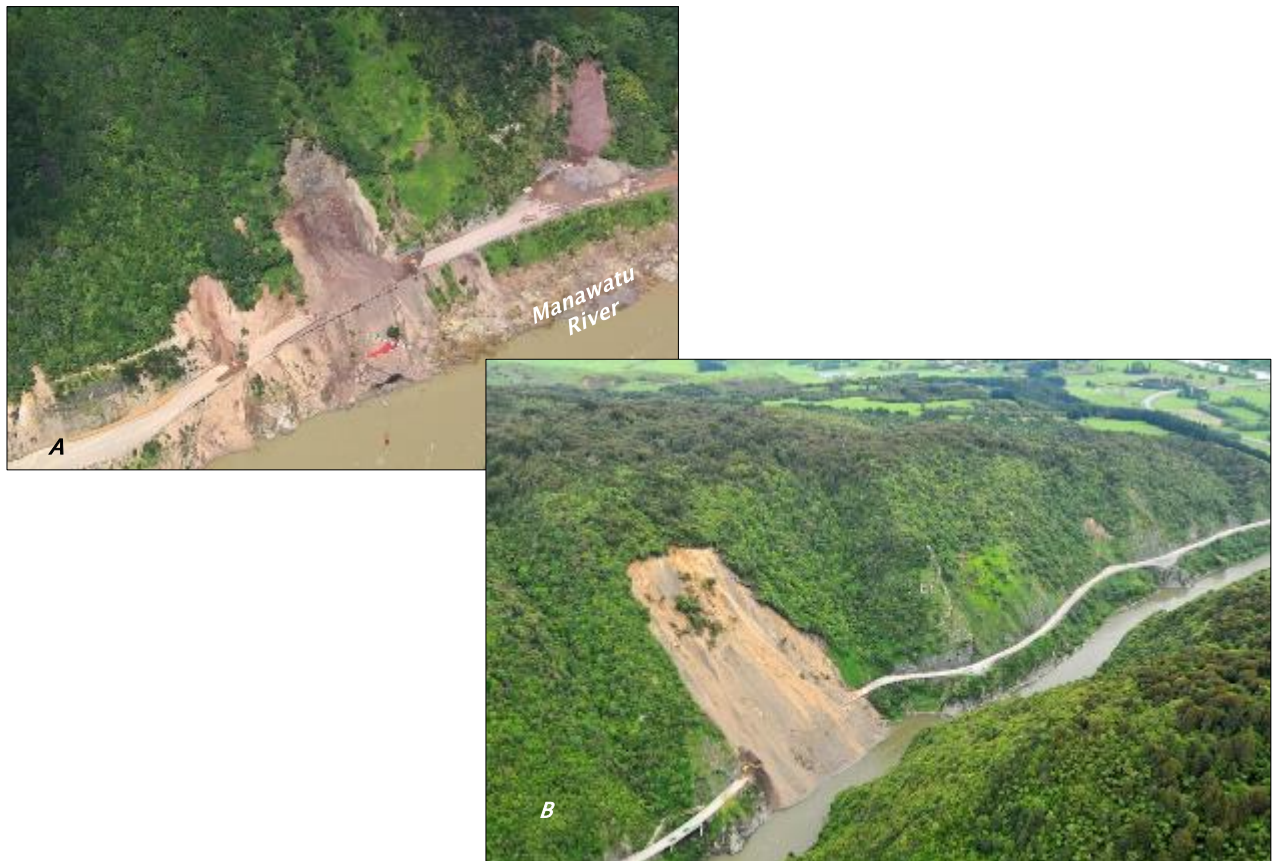
Figure A.29 Large landslides triggered by rainstorms closed SH3 in the Manawatu Gorge for 3 months in 2004 (A), and at another site for 13 months in 2011 (B). A large earthquake could trigger similar landslides at a number of sites within the gorge where the steep marginally stable slopes have been cut back for road widening.

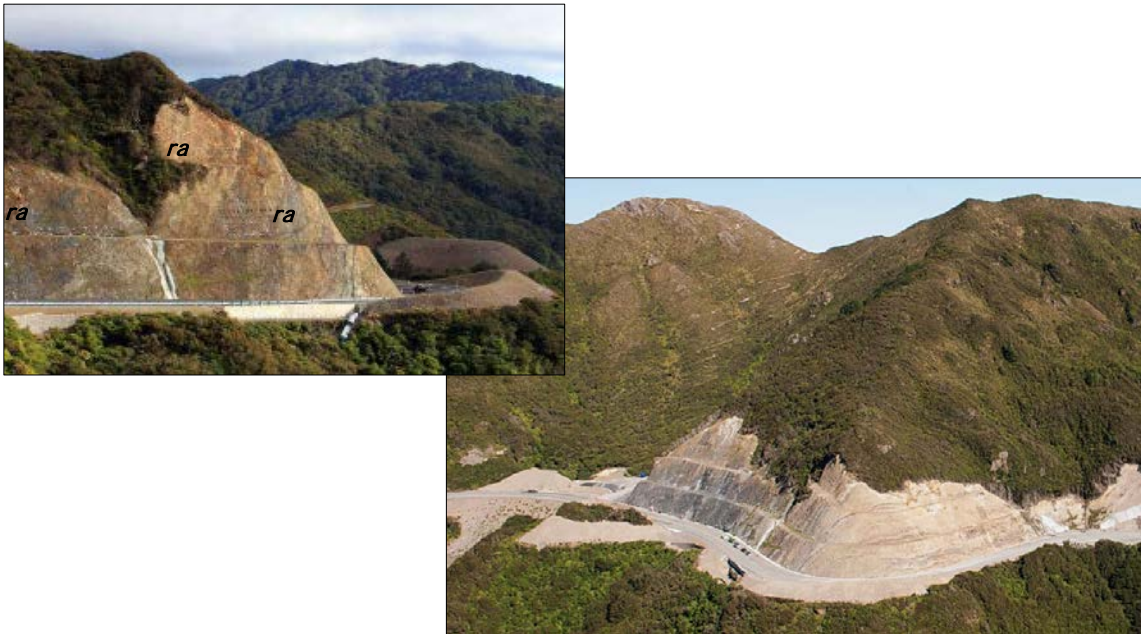
Figure A.30 Photos showing the major earthworks completed in May 2012 to ease bends at Muldoon's Corner on the Rimutaka Hill road (SH2). The cuts are up to 55m high with batters up to 55° and an overall slope of ~50°, which is steeper than the long-term angle for greywacke slopes (~40–45°). Grouted rock anchors (*ra*) are likely to have reduced the potential for coseismic batter failures in this area.

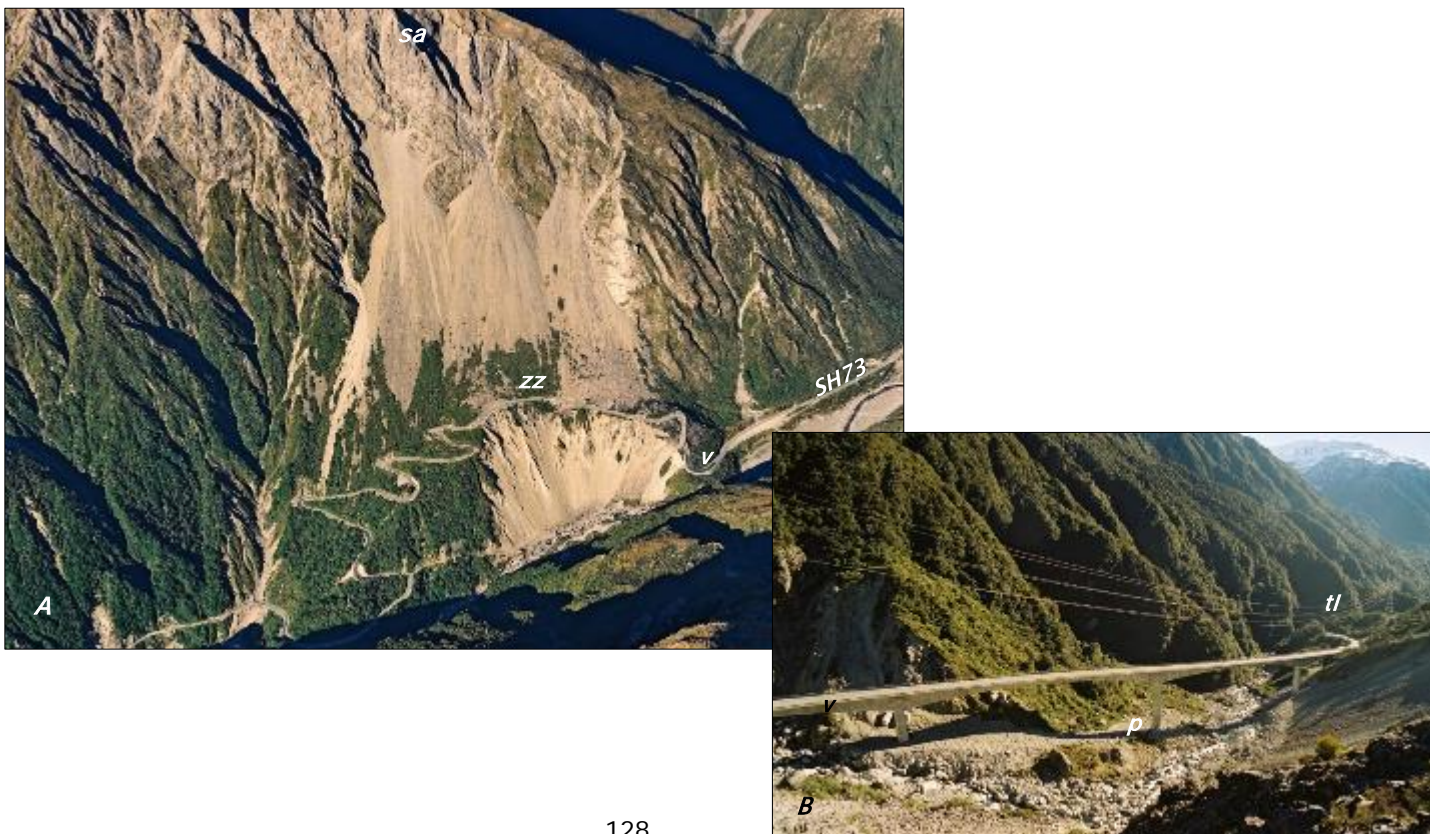
Figure A.31 Built below a prehistoric rock avalanche source area (*sa*) at the 'zig-zag' (*zz*) on SH73 at Arthur's Pass, the viaduct (*v*) and electricity transmission lines (*tl*) are at significant risk from another rock avalanche at this site during the next alpine fault earthquake and other large earthquakes in the region.

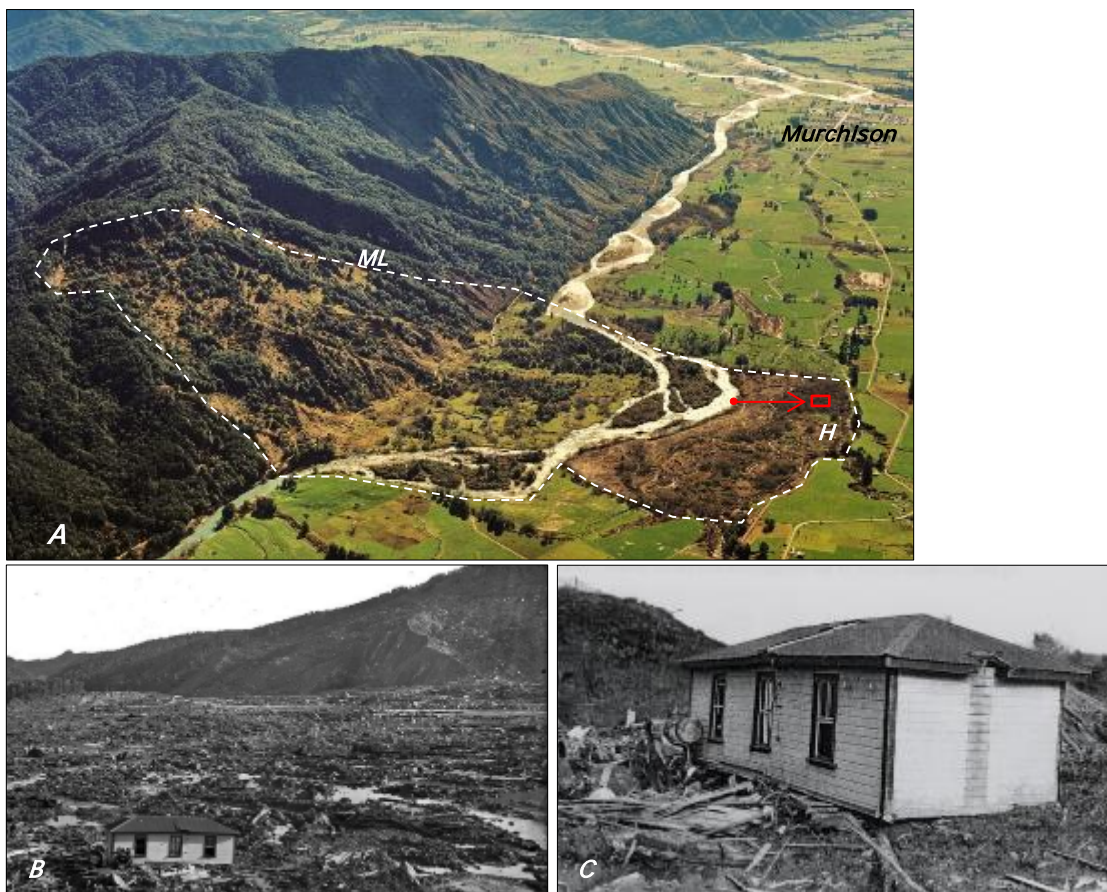
Figure A.32 (A) Located in the Matakītaki Valley 5km south of Murchison, the Matakītaki landslide (*ML*) was triggered by the 1929 Murchison earthquake. (B) and (C) show the top story of a house (*H*) which was carried ~100m across the valley floor by the rapidly-moving slurry of rocks, mud, and water.

(1) During the 1929 *Murchison earthquake* landslides destroyed four farm houses and killed 14 people. The largest of these coseismic failures was the Matakītaki Landslide, a ~18 million m³ rock-slide avalanche of Tertiary sandstone and mudstone formed on a ~35° dip-slope. The failure ran out ~1km across the Matakītaki Valley, destroying two houses and killing four people (figure A.32). One of the houses destroyed by the landslide was on the eastern side of the river, about 800m from the base of the slope that failed (figures A.32B and C).

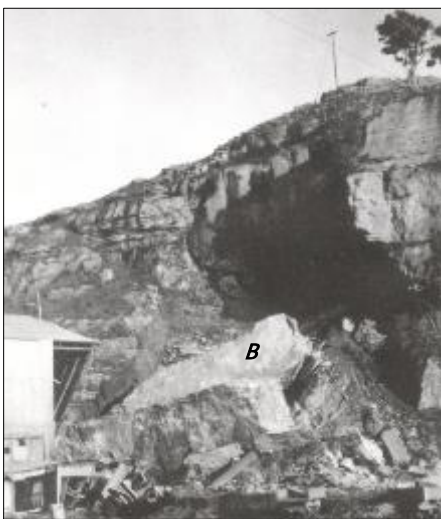
Figure A.33 The Murchison earthquake triggered a fall of large blocks (B) of Tertiary limestone on a cliff at the Tarakohe Cement Works near Takaka. The rock fall buried and destroyed the powerhouse and killed an engineer.

Other buildings destroyed by landslides during the Murchison earthquake were at Kahurangi Point (110km north of epicentre), where a landslide destroyed the lighthouse keeper's house, and near Takaka (120km from the epicentre) a limestone cliff collapsed onto the powerhouse of the Tarakohe Cement Works. That failure destroyed the building and killed an engineer (figure A.33).

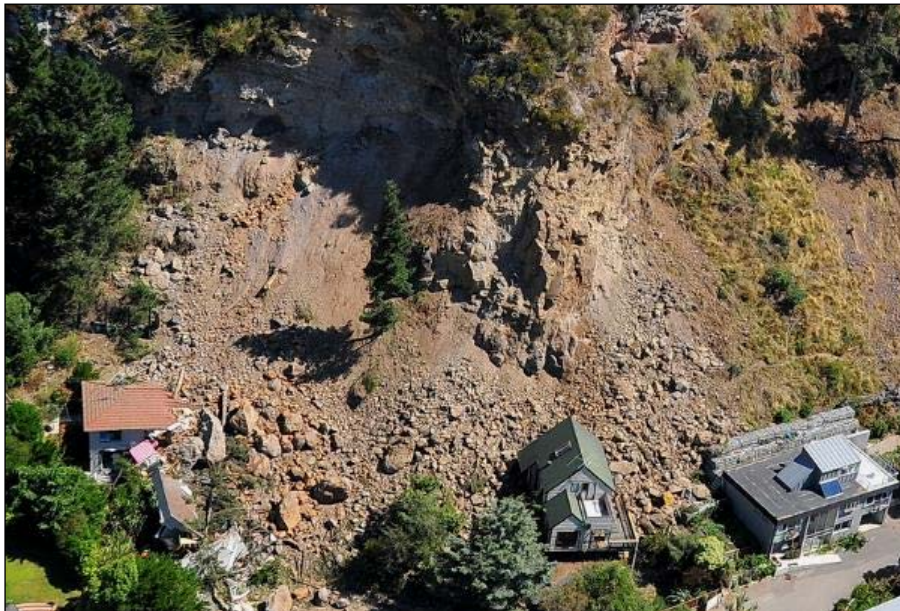
Figure A.35 One house (left) was destroyed and another (centre) badly damaged by cliff collapses at Redcliffs during the 2011 Christchurch earthquake. Fatalities occurred at both of these sites.

(3) *The 2011 Christchurch earthquake*: The shallow M_w 6.2 earthquake on 22 February 2011 located 6km southeast of Christchurch caused widespread building damage and liquefaction in Christchurch city and numerous landslides and rock falls throughout the Port Hills. Five deaths resulted from earthquake-induced rock falls, one during an aftershock four hours after the mainshock. Hundreds of houses were damaged by earthquake-induced rock falls and ground cracking, particularly in the suburbs of Sumner and Redcliffs where many coastal cliff collapses occurred (Dellow et al 2011; Hancox et al 2011). The extensive building damage caused by rock falls has been attributed to the extremely high ground shaking associated with the earthquake, with recorded peak ground accelerations (PGA) ranging from 0.3–1.4g (horizontal) and 0.4–2.2g (vertical) in the Port Hills area (Bradley and Cubrinovski 2011; Kaiser et al 2012). Rock fall damage in the worst affected areas appears to have been associated with a PGA of greater than 0.4g and MM shaking intensities of MM8 to MM9 (Hancox et al 2011; Bradley and Cubrinovski 2011). Examples of buildings that were extensively damaged by rock falls during the 2011 Christchurch earthquake are shown in figures A.35, A.36 and A.37.

The most significant rock fall damage to houses occurred where large masses (hundreds to thousands of cubic metres) of basaltic rocks collapsed onto houses built at the foot of steep former quarry faces (figure A.6) and old (Holocene) coastal cliffs (figures A.35 and A.36). However some houses in the valley bottoms, often several 100m from steep slopes and bluffs, were damaged by individual boulders ranging in size from 0.1m^3 to more than 10m^3 . At one site in Raupaki a house was struck by four rocks, including a $\sim 15\text{m}^3$ boulder which smashed right through the house (figure A.37). Significant damage to houses was also caused by tension cracks and vertical ground displacements associated with incipient (coherent) landsliding along the tops of coastal cliffs and headlands, and the crests of ridges, for example in the Clifton, Heathcote and Redcliffs areas (Dellow et al 2011).

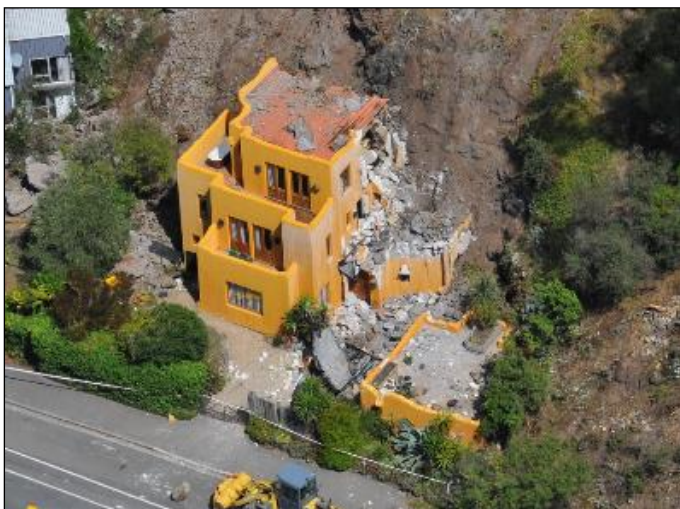
Figure A.36 The back section of this house located at the foot of the old sea cliff at Redcliffs was severely damaged by rock falls and had to be demolished.

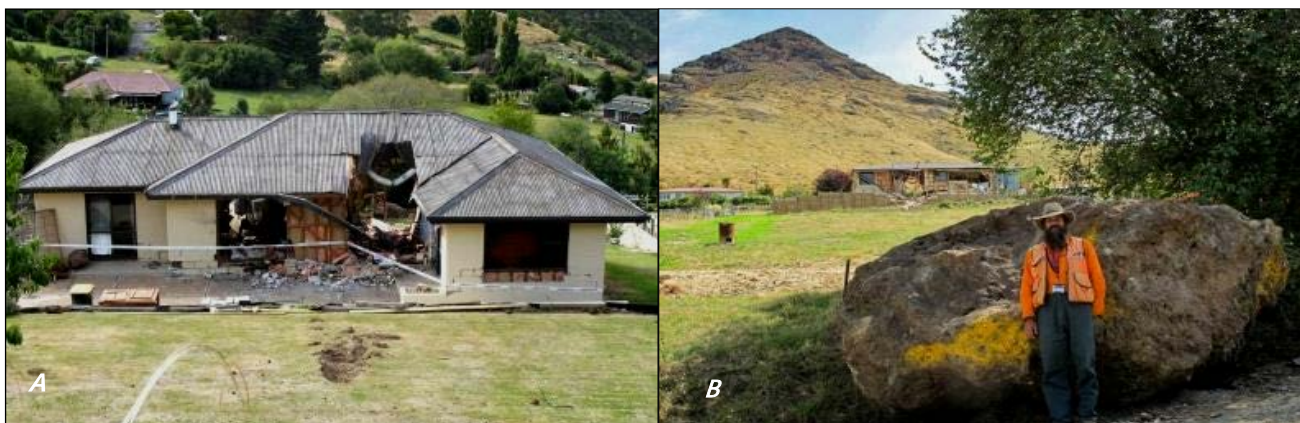
Figure A.37 This house at Raupaki (A) was hit by four rocks, including a 15m³m boulder (B) which bounced and rolled ~600m downslope and smashed right through the house.
