RTS 14 – Guidelines for facilities for blind and vision impaired pedestrians

3rd Edition - May 2015

Road and Traffic Standard Series

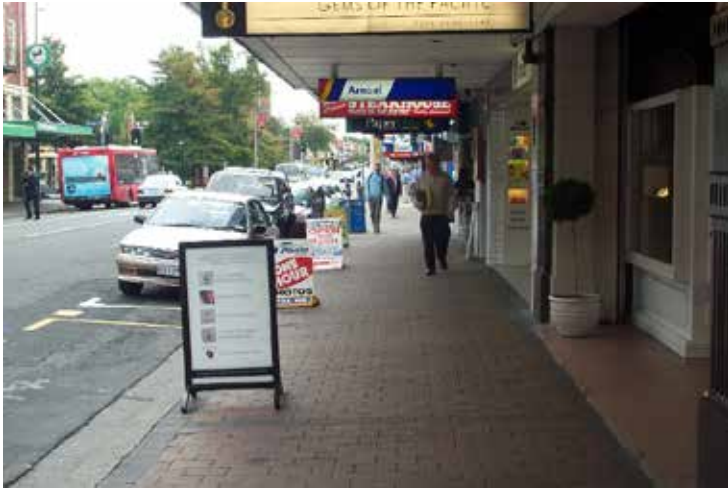
Photo 4.1 While no footpath obstacles would be preferable, these advertising signs are located on the kerb edge, outside the continuous accessible path of travel (Photo: Tim Hughes).

Advertising signs on the footpath should be avoided if possible. Where advertising is permitted, signs shall be located away from the continuous accessible path of travel, i.e. on the kerb edge, as shown in Photo 4.1 and always placed consistently in the same location.

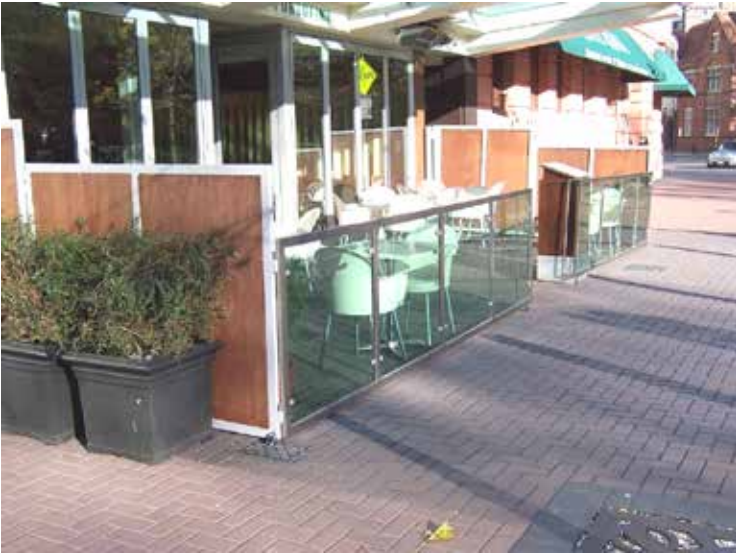
Photo 4.2 Good Practice – street furniture is located in an enclosed area which can readily be detected by the use of a long cane (Photo: Tim Hughes).

Photo 4.2 below is an example of good practice with seating outside a restaurant that is enclosed by a structure that meets the aforementioned requirements of NZS 4121: 2001 Clause 13.5.1 (figure 49) where all street furniture shall be placed clear of the accessible path of travel. On the other hand, Photo 4.3 shows seating and signage outside a bar that encroaches on the continuous accessible path of travel with the table in particular being a nasty obstacle for pedestrians who are blind or have low vision.

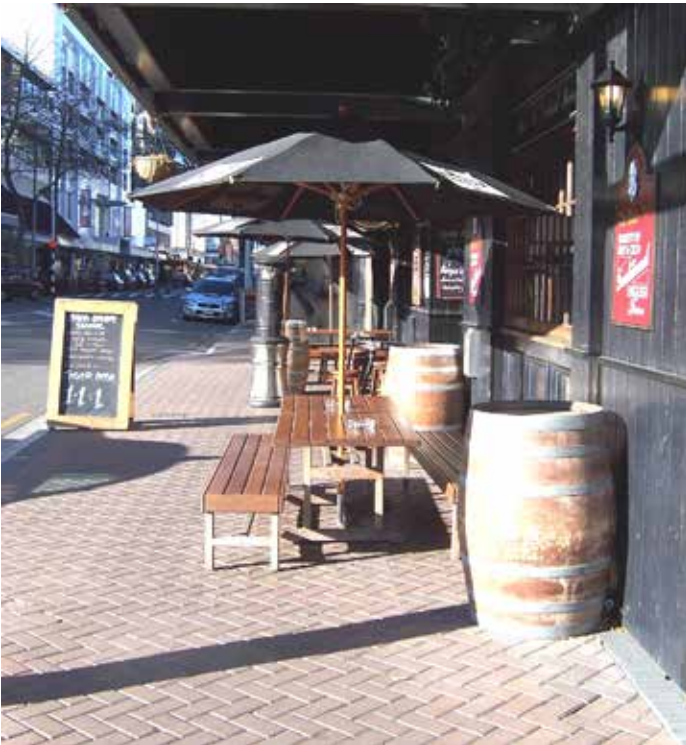
Photo 4.3 Poor Practice – street furniture that sprawls out onto the footpath is a hazard for all pedestrians. Note the umbrella at head height, which also poses a potential hazard (Photo: Tim Hughes).

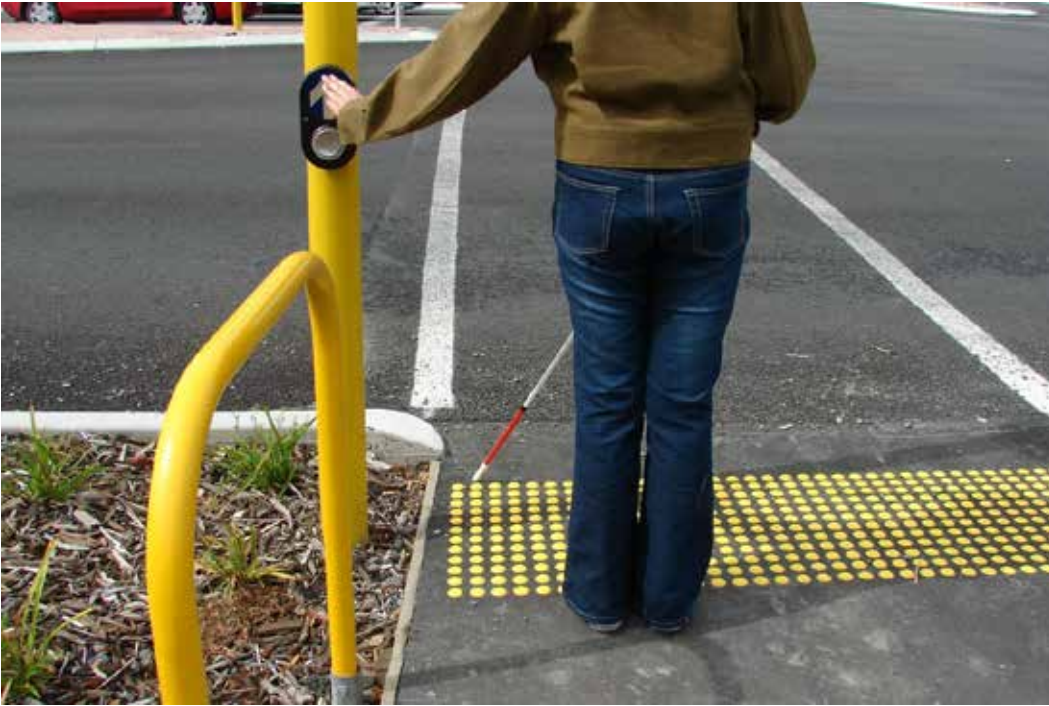
Photo 5.1: View of warning indicators. Note how the domes have been located to maintain equal spacing between domes across the entire warning indicator surface. (Photo: Carina Duke)

Photo 5.1 shows a typical arrangement of warning indicators.

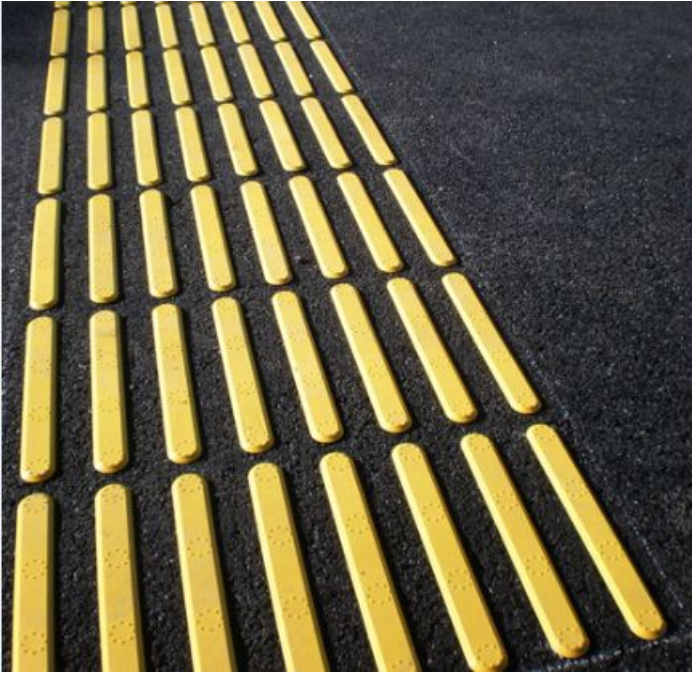
Photo 5.2: View of directional indicators (Photo: Michael Brown).

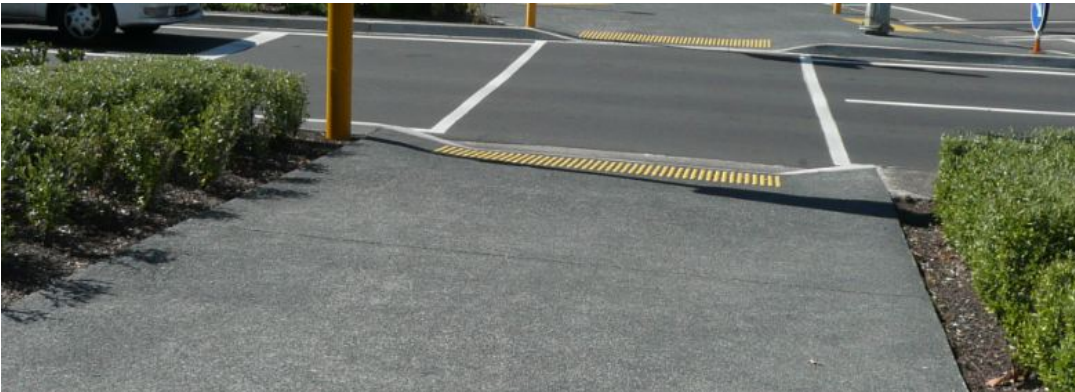
Photo 5.3: Example of directional/physical cues (Photo: Michael Brown).

An example of other visual and tactile cues can be employed, rather than the use of directional tactiles is shown in Figure 5.3.

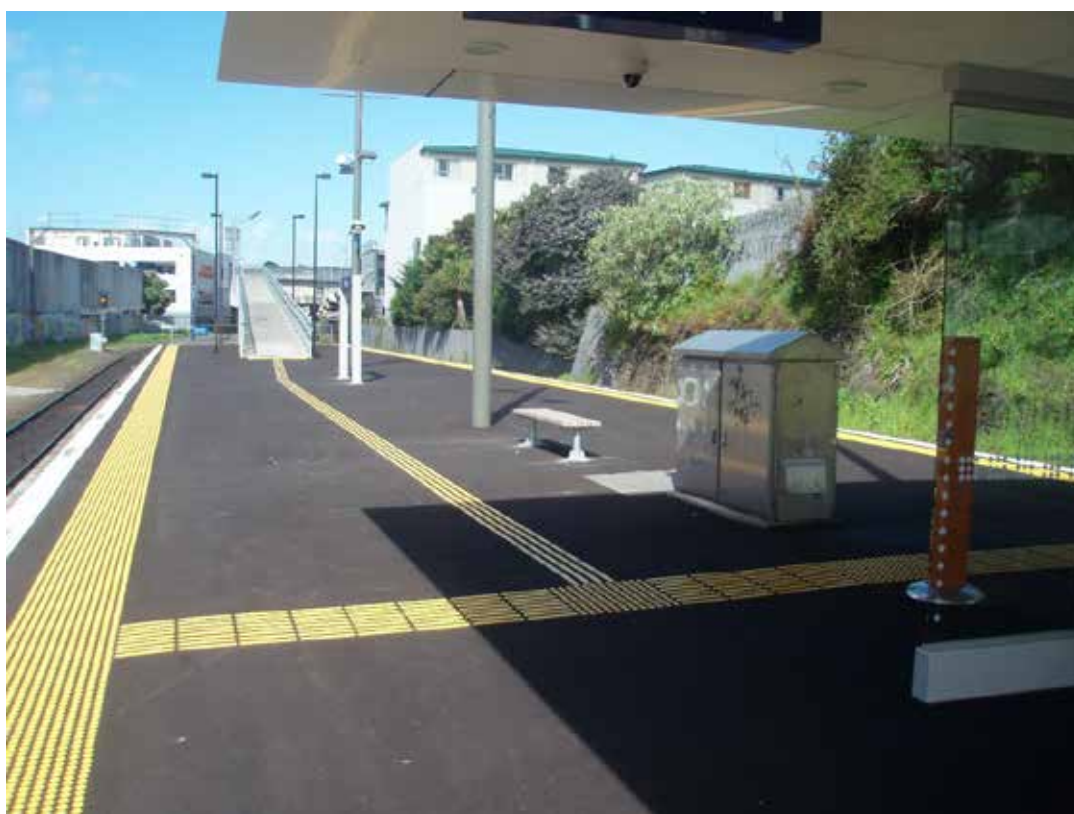
Photo 5.4: The warning indicators at this railway station are 600mm deep and set 600mm back from the platform edge (Photo: Michael Brown)

The set-back distances of warning indicators provide people who are blind or have low vision with a safe tolerance to stop upon encountering the warning indicators without stepping into the hazard or hazard area. A greater set-back distance of 600mm is provided at railway platforms and wharves given the serious fall that could occur at these locations. An example of the typical tactile layout arrangement at a train station is shown in Photo 5.4

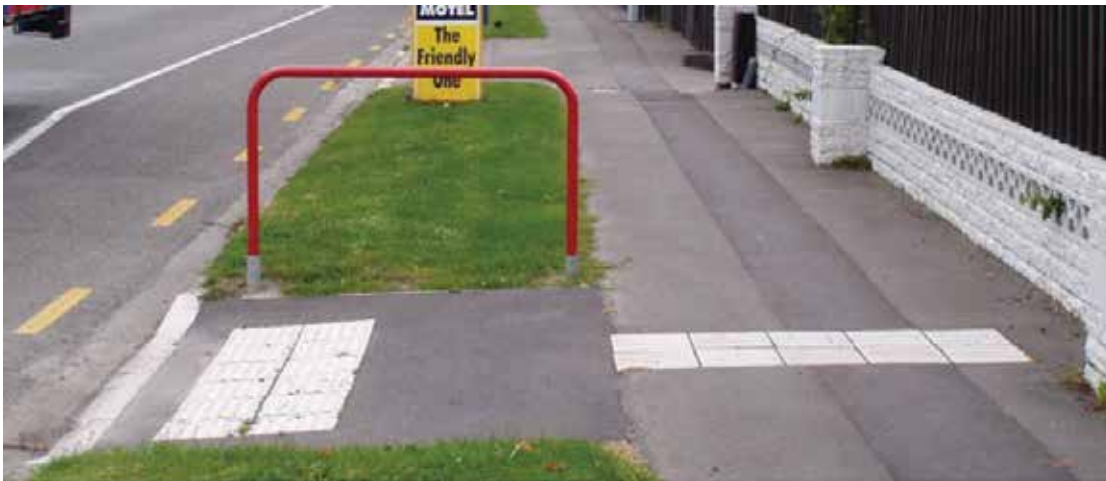
Photo 5.5: The directional indicators shown in this installation cover the full width of the path while other features, including the planting and a handrail provide cues to the road crossing point (Photo: Tim Hughes).

Where used to provide direction guidance all the way to kerb ramps, directional indicators should terminate at the top of the ramp. An example of this type of installation is shown in Photo 5.5.

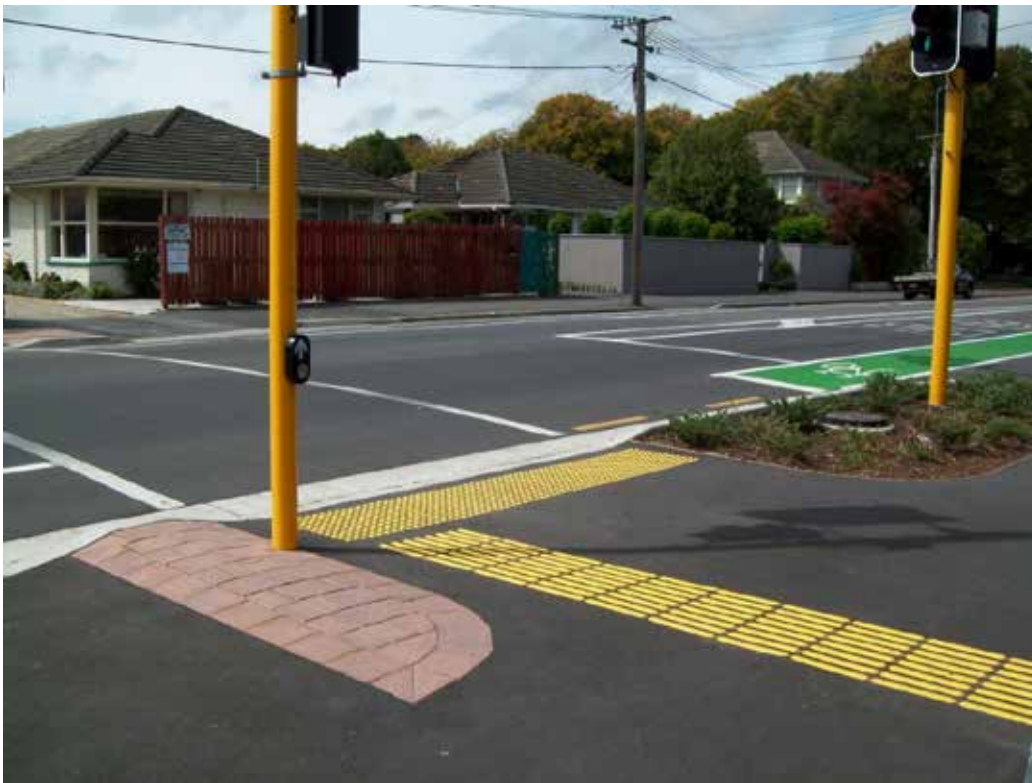
Photo 5.6: These directional indicators intercept all pedestrians on the continuous accessible path of travel. They lead directly to the warning indicators, and aligned for the use of the pedestrian push button. (Photo: Carina Duke).

In most cases, the footpath will run parallel to the roadway and thus the crossing point will not be on the continuous accessible path of travel (Photo 5.6).

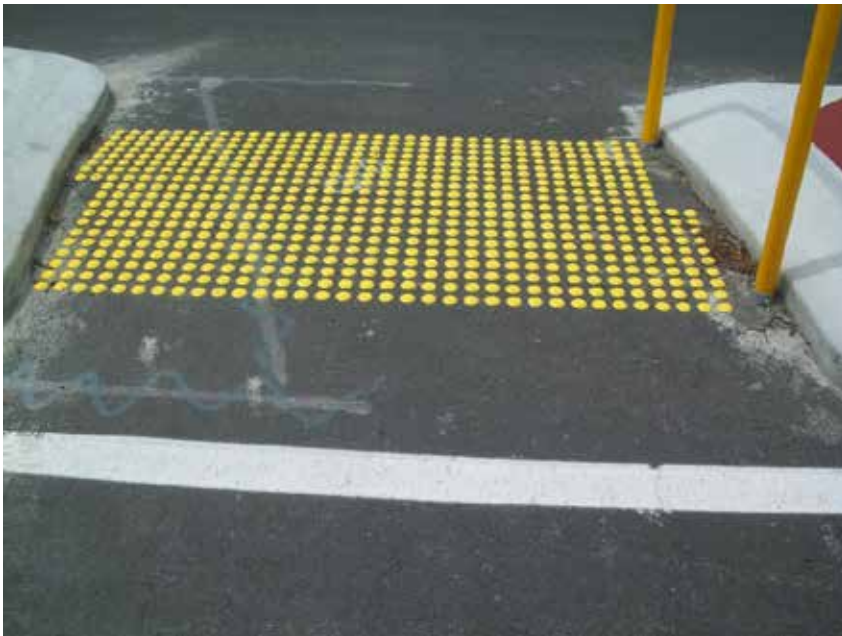
Photo 5.7: Warning indicators correctly installed across the full depth of this pedestrian median island (1.2 - 1.8m deep (Photo: Carina Duke).

Where the median is from 1.2 metres to 1.8m deep, warning indicators shall be installed across the full depth, set back at least 300mm from the roadway (Photo 5.7).

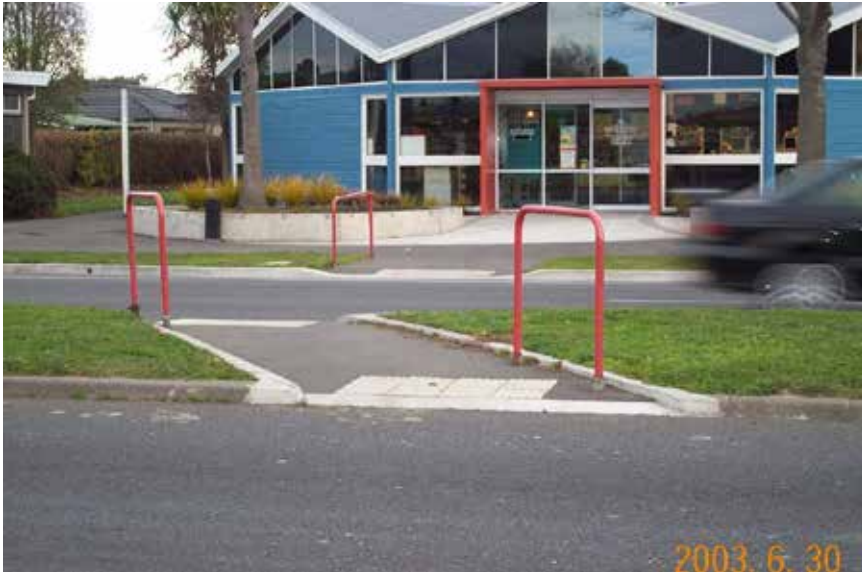
Photo 5.8: On deep medians, two sets of warning indicators are installed. (Note: not quite full width.) (Photo: Susan Cambridge)

Where the median is more than 1.8 m deep, two sets of warning indicators each 600mm deep, shall be installed, set back 300mm from the roadway (See Photo 5.8).

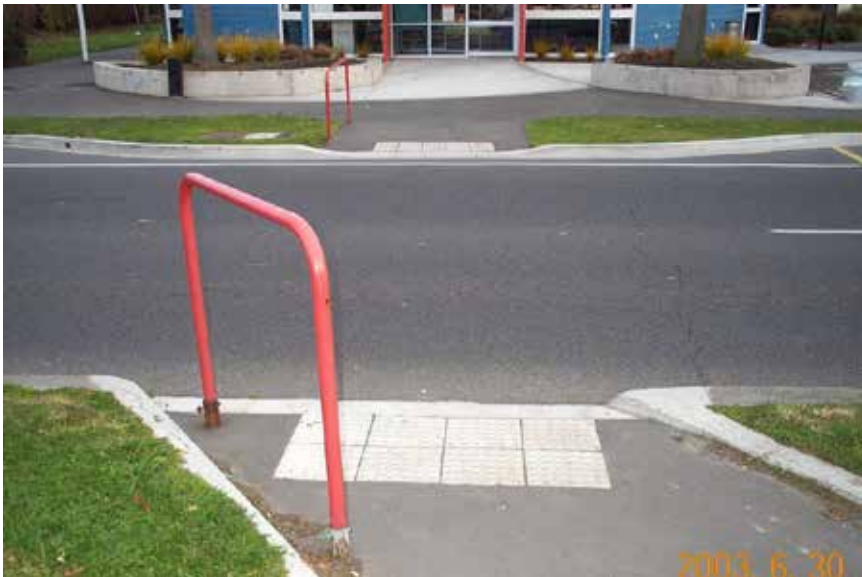
Photo 5.9: The warning indicators are aligned with the road crossing direction. (Note: not quite full width) (Photo: Susan Cambridge)

Where the cut through of a median is angled, the warning indicators must be installed so that they are aligned with the direct road crossing line (See Photo 5.9).

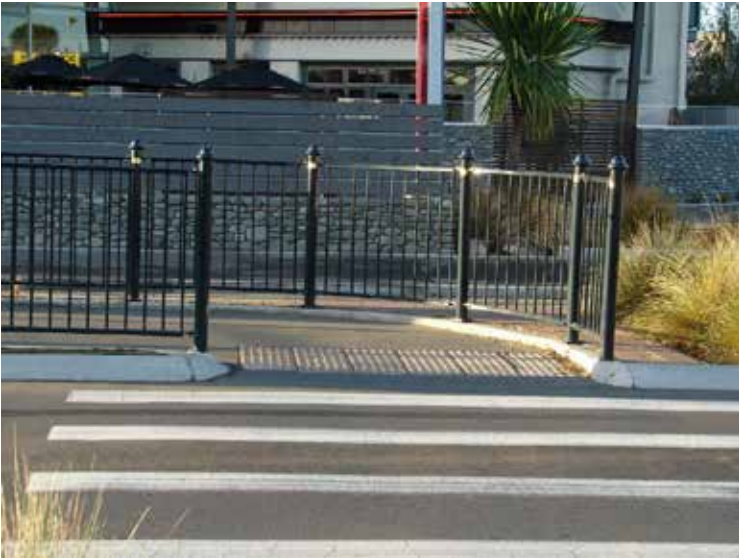
Photo 5.10: Example of a staggered median crossing with marked pedestrian crossing over the traffic lanes, (note: the barrier contrast could be better) (Photo: Tim Hughes).

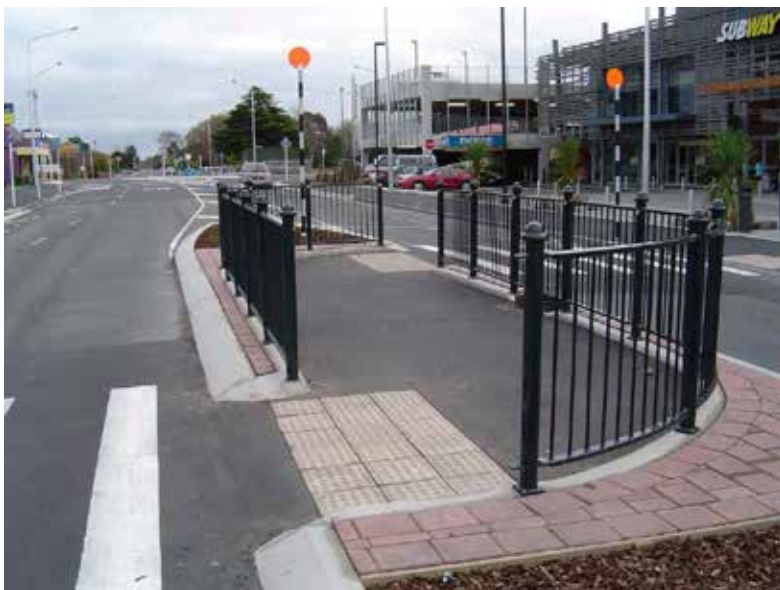
Photo 5.11: The kerb and fencing provides tactile cues within the staggered median to assist pedestrians who are blind or have low vision, so there is no need for directional indicators. (Photo: Tim Hughes).

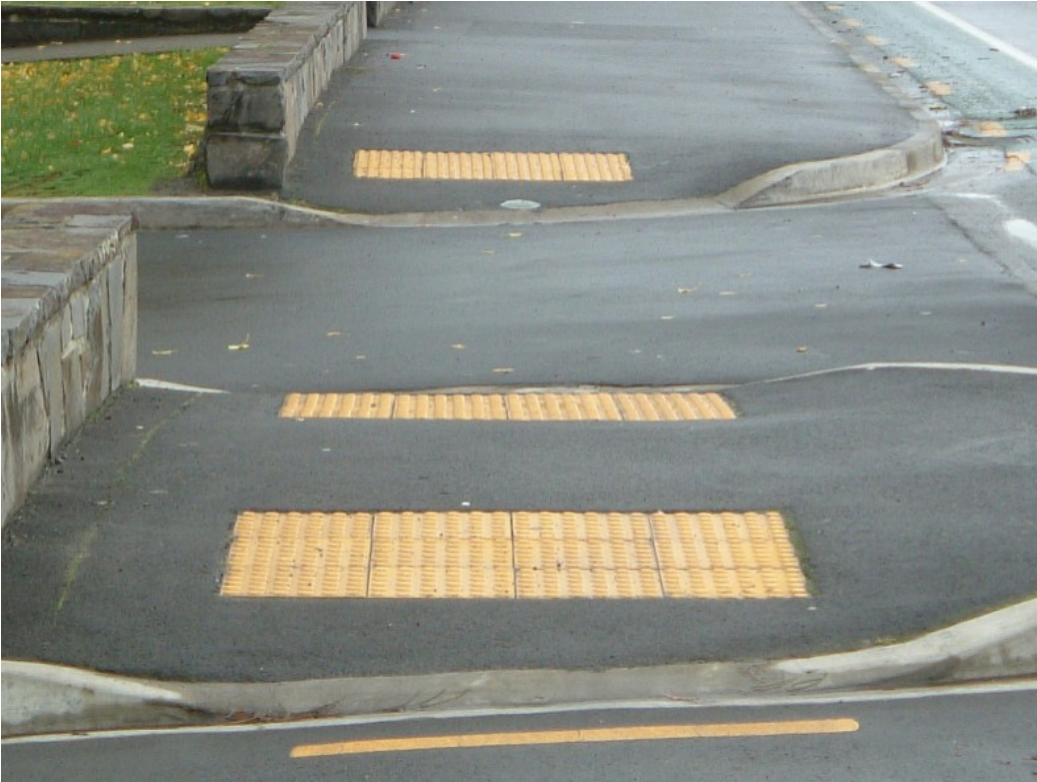
Photo 5.12: Example of warning indicators at minor intersections

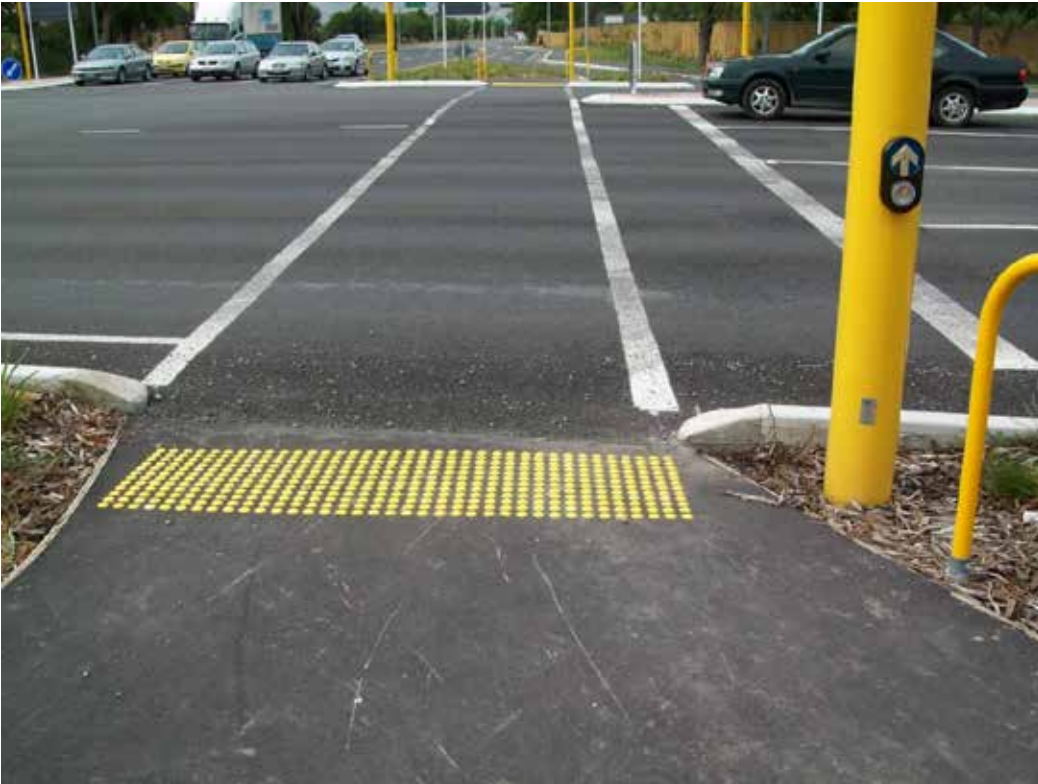
Photo 5.13. This installation is an example of “Best Practice” with the warning TGS and pedestrian call box both aligned with the crossing direction. The gap between the TGS and signal pole is so small that a person cannot inadvertently enter the road without receiving tactile warning. (Photo: Carina Duke)

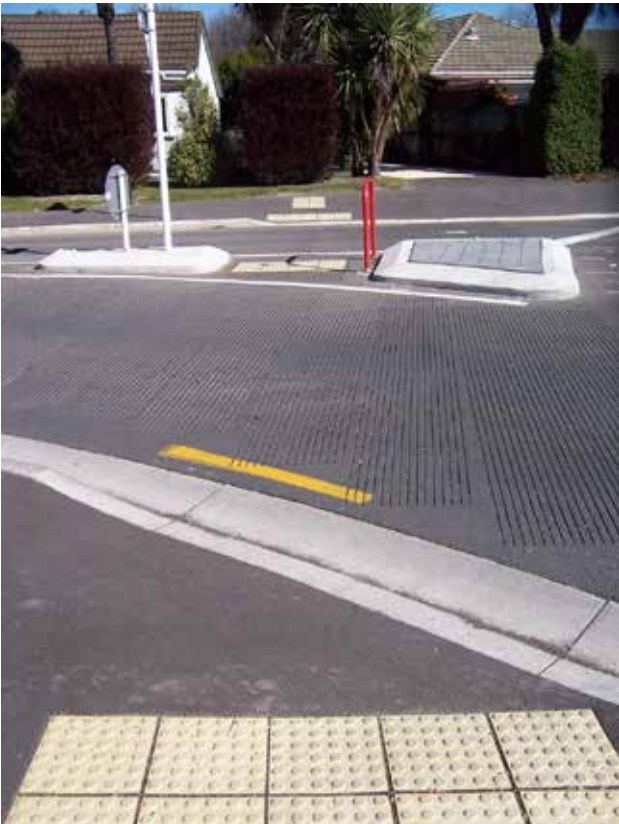
Photo 5.14: Actual example of the TGS layout shown in Figure 5.13
(Photo: Tim Hughes)

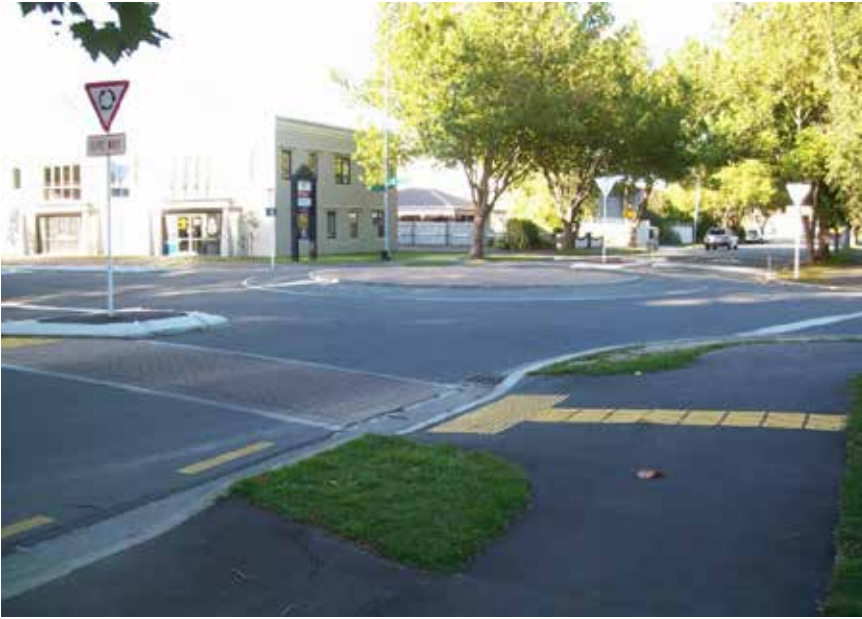
Photo 5.15: Example of the TGS layout at a roundabout (Photo: Carina Duke)

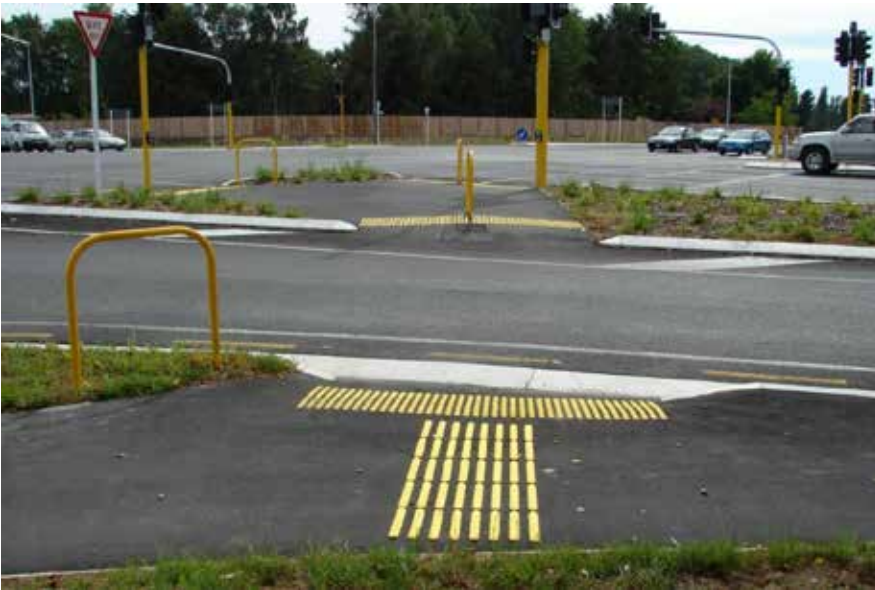
Photo 5.16: Actual example of TGS Layout (Photo, Carina Duke)

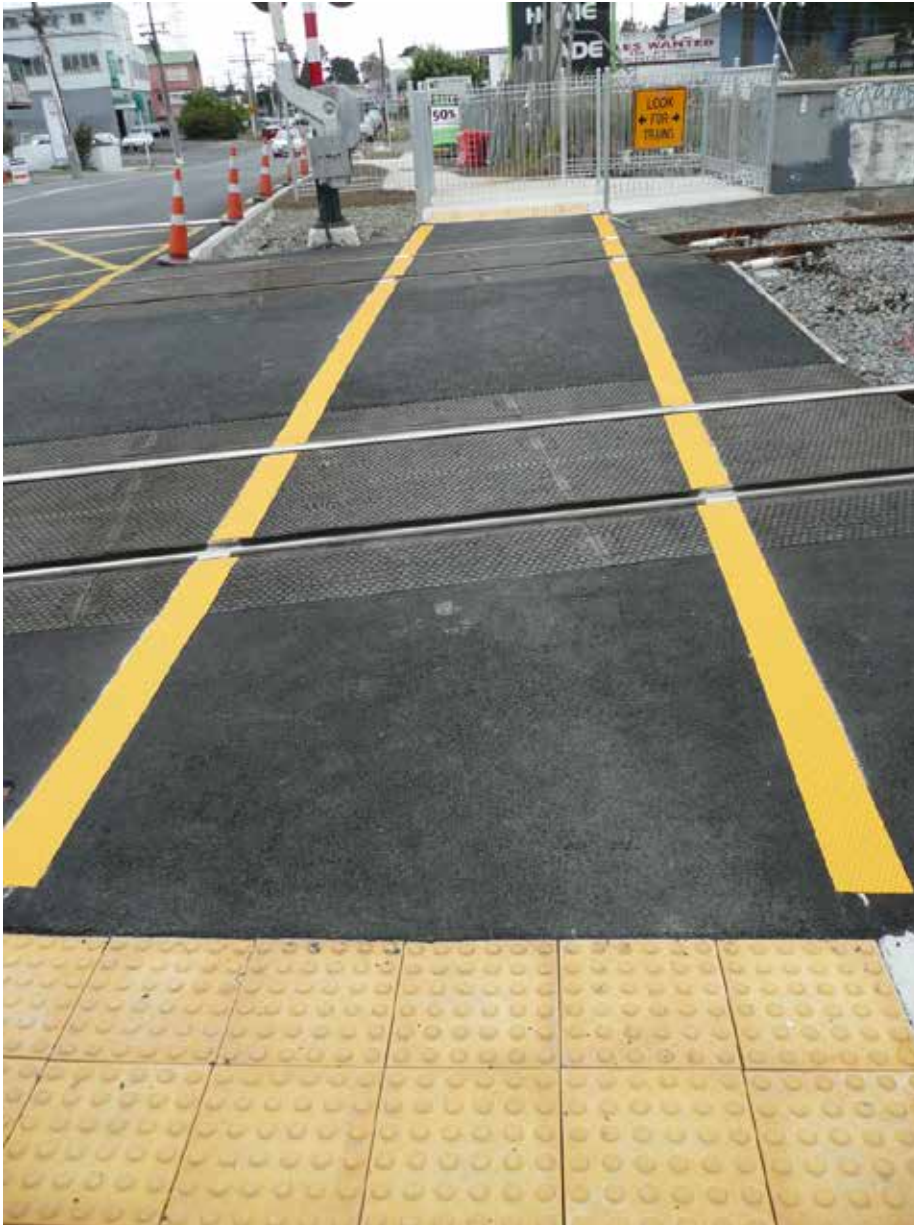
Photo 5.17: Tactile arrangement at a rail crossing (Photo: Michael Brown)

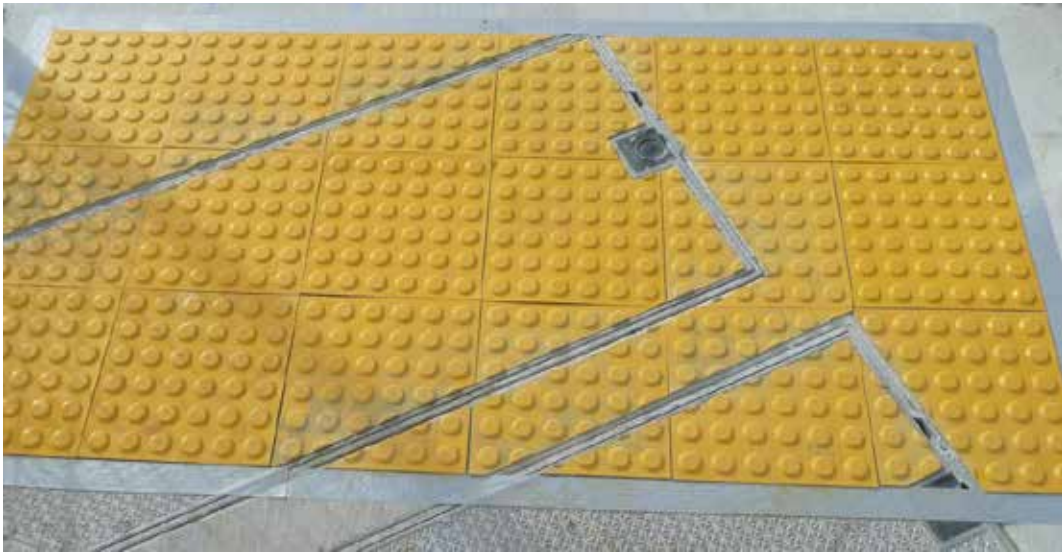
Photo 5.18: An example of how warning TSGI can be integrated into the design of utility service cover (Photo: Michael Brown).

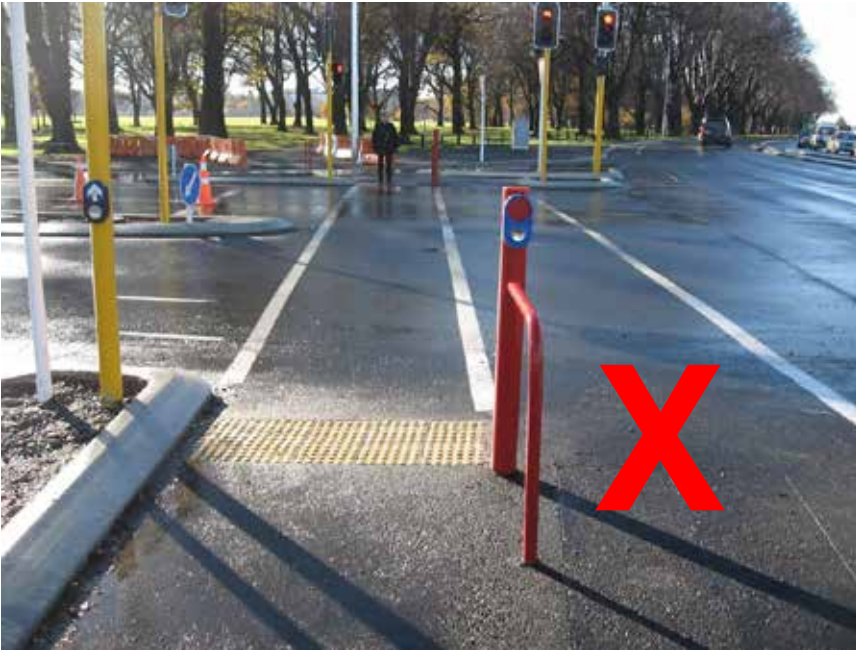
Photo 5.19: The TGSIs at this signalised pedestrian and cyclist crossing are installed across the pedestrian area only. The TGSIs should extend across the entire facility to ensure that a person who is blind or has low vision receives tactile warning if they mistakenly enter the cyclist crossing area.

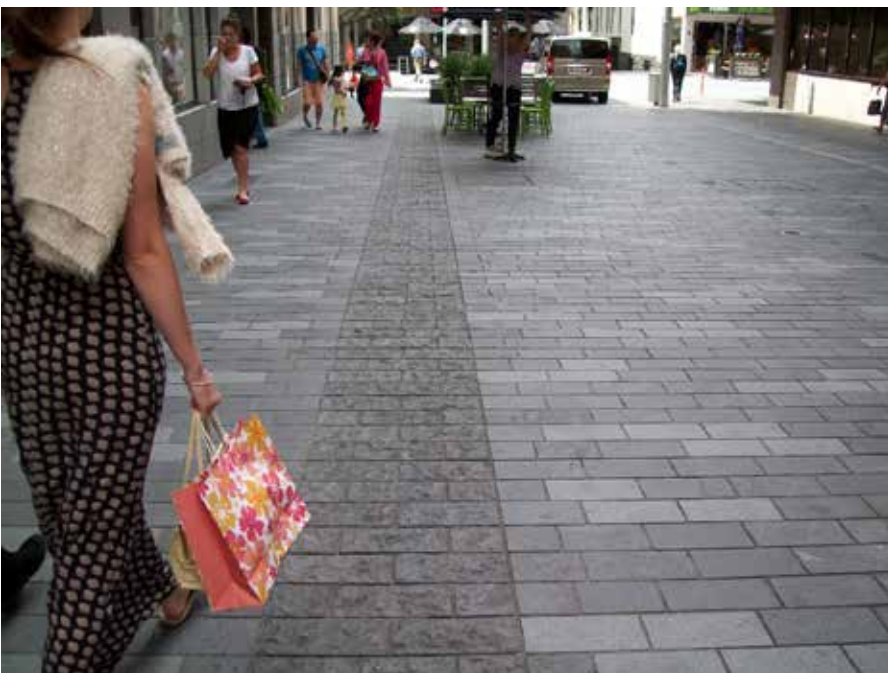
Photo 5.20: Auckland Shared Space Example

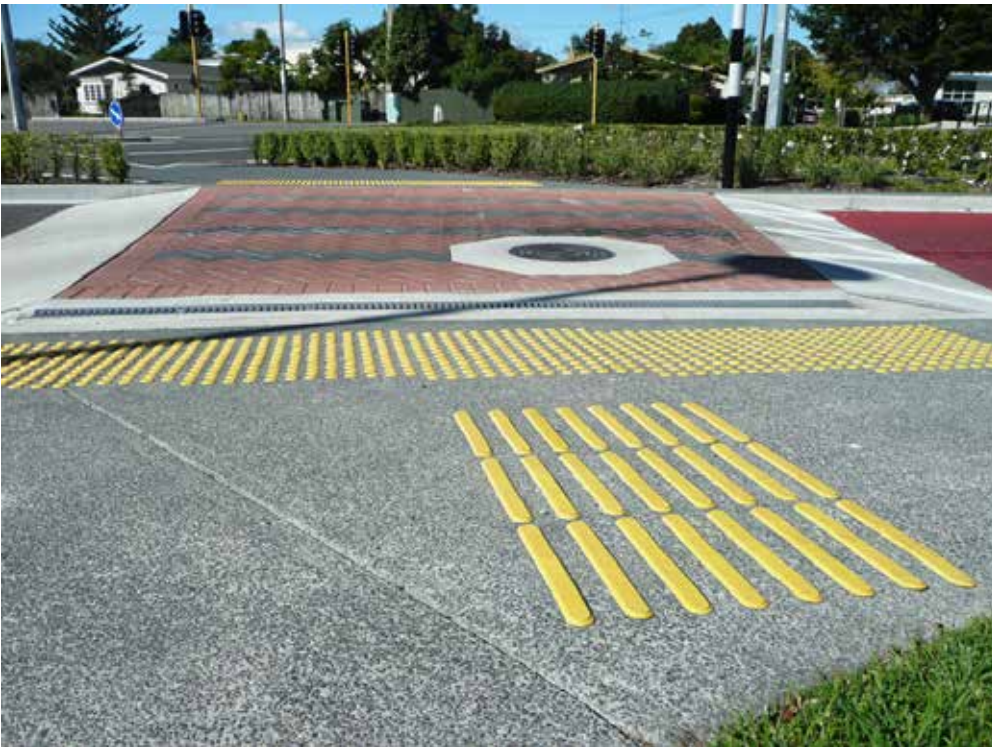
Photo 5.21: This installation shows a textured and raised crossing surface to inform pedestrians who are blind or have low vision of the boundaries of the crossing point. Note the change in texture and colour at the edge of the platform (Photo: Michael Brown).

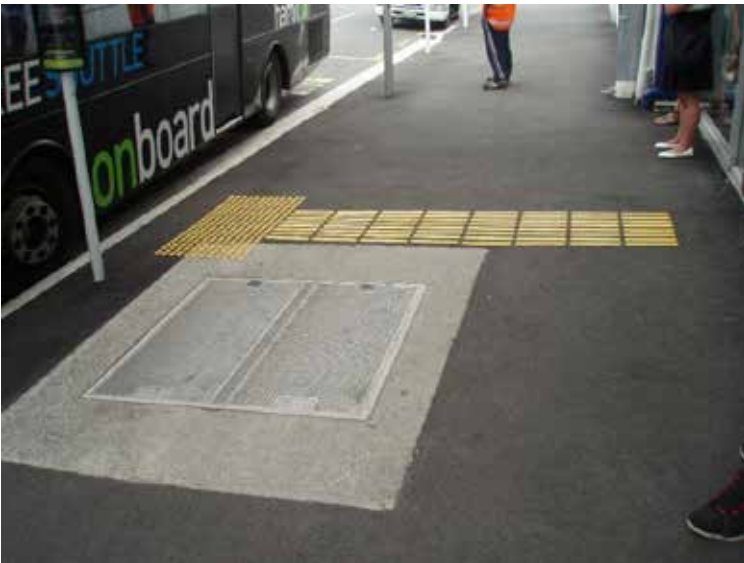
Photo 5.22: Directional indicators lead to warning indicators at a bus stop (Photo: Michael Brown).

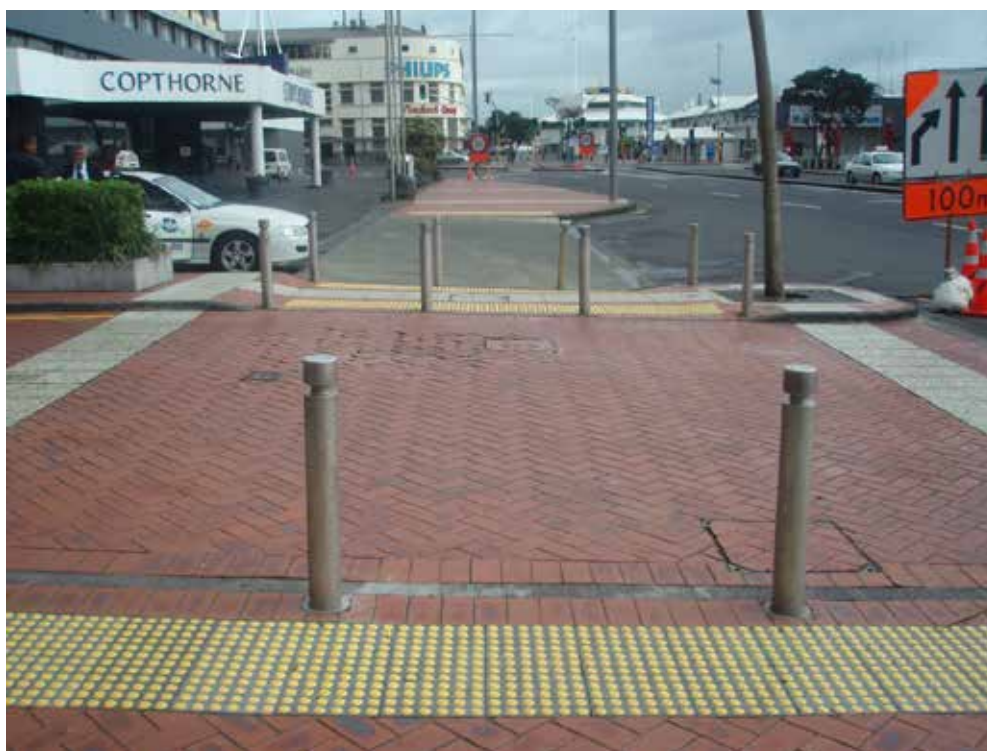
Photo 5.23: Warning indicators extend across the full width of the footpath outside a busy car park building (Photo: Michael Brown).

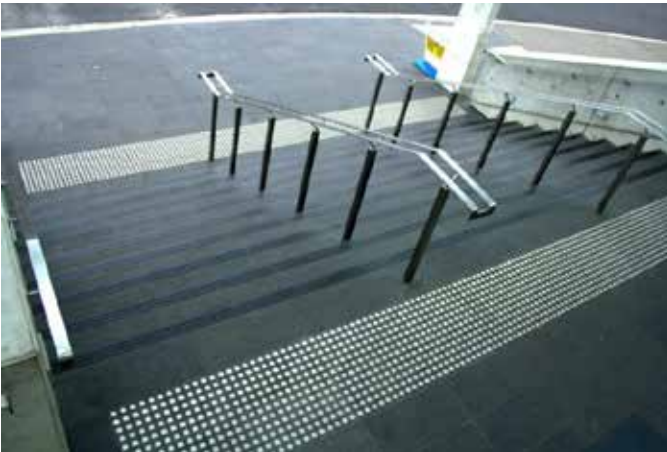
Photo 5.24: Example of TGS at the top and bottom of stairs (Photo: Michael Brown)

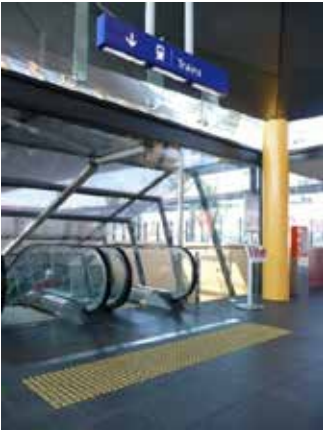
Photo 5.25: TGSIs at escalators (Photo: Michael Brown)

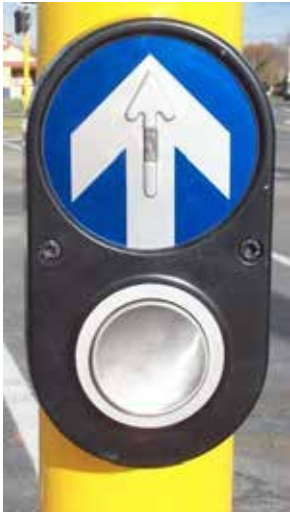
Photo 6.1: Pedestrian push-button assembly.

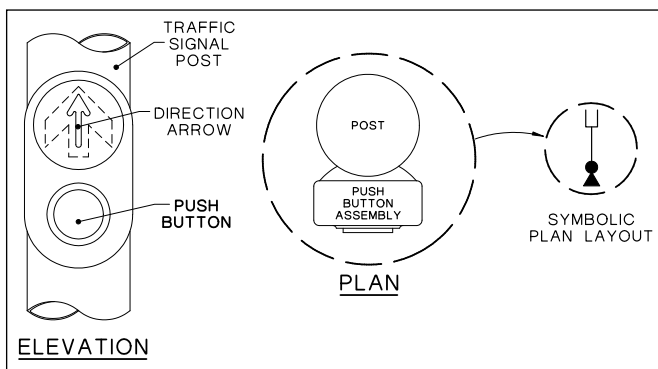
Figure 6.1: Diagram of pedestrian push-button assembly
