Medium-term evaluation of variable speed limit signs at rural schools

Prepared for NZ Transport Agency
(Road Safety Fund)

Final Report

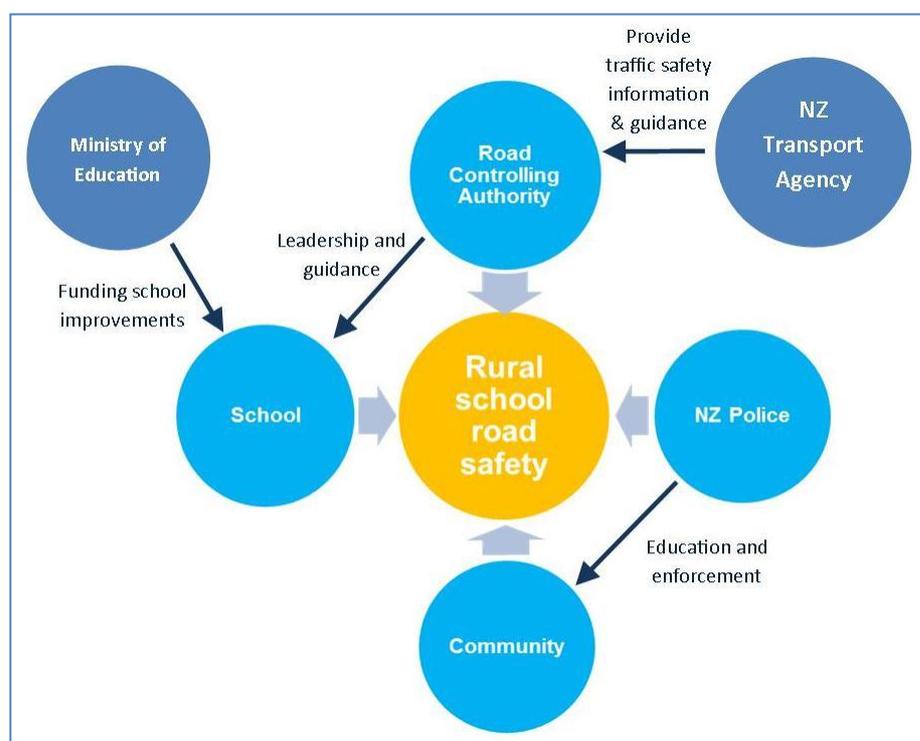
Figure 2 Joint Responsibility Model for rural school road safety (Mackie 2011)

Based on these two areas of concern, a joint responsibility model (Figure 2) was recommended, reflecting that most rural schools will have both highway and school property/procedural issues that need resolving, and that both road controlling authorities and schools (or Ministry of Education) will have responsibility for these different areas.

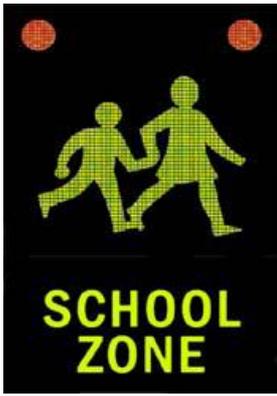
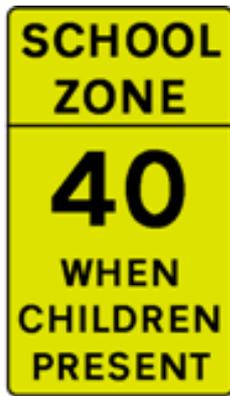
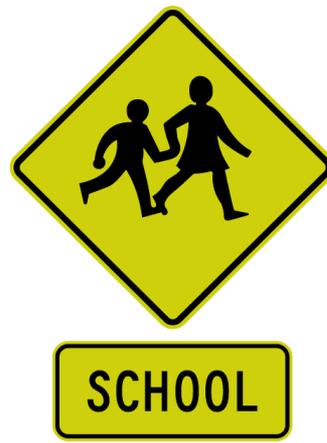
Figure 3. Other school signs in use or being trialled

There are currently various symbolic static/active and speed advisory school sign options (Figure 3) in operation or being trialled. However, illuminated mandatory speed reduction signs are likely to be more effective than symbolic sign variations (static or active) at reducing traffic speed (Mackie 2010³), as they clearly communicate a speed which is legally required of motorists. The implementation of this trial at five rural schools will provide more concrete evidence for the effectiveness of variable speed limit signs at rural schools. Comparisons with datasets from evaluations of other signs could then be carried out to determine the relative effectiveness of various school signs.

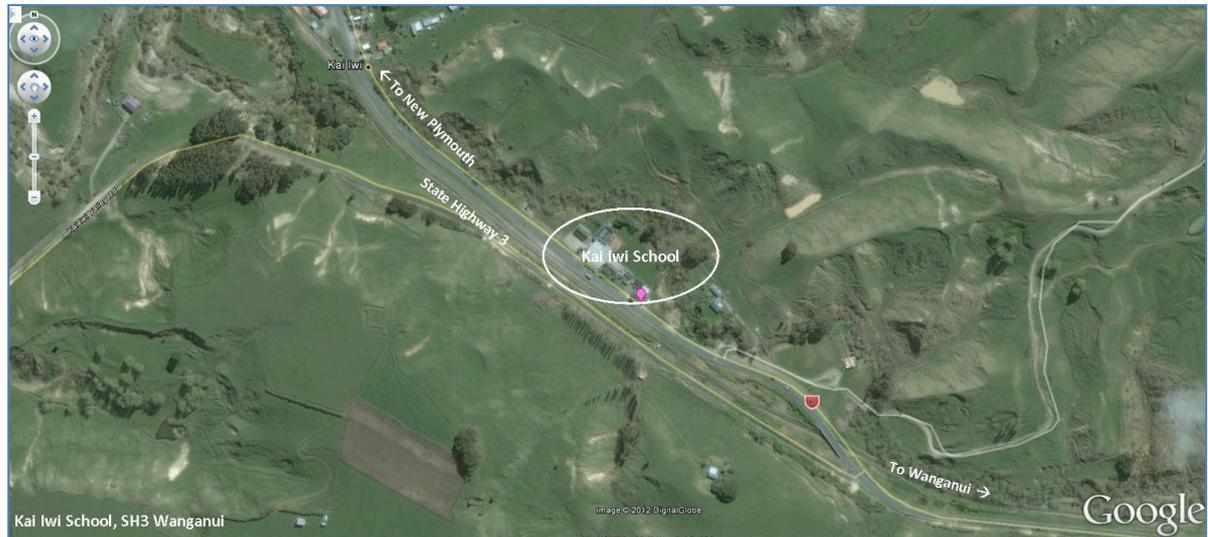
Figure 5. Kai Iwi School, State Highway 3 Northwest of Wanganui

Kai Iwi School is located in a rural setting on State Highway 3 approximately 15km northwest of Wanganui (Figure 5).

The school is situated in a valley on a straight section of highway with slight to moderate curve approaches. The school side of the highway has a wide shoulder with a footpath running parallel to the road from the school grounds to the Kai Iwi Tavern 500m north-west. The opposite shoulder contains a weigh pit, suitable for heavy vehicles. The Annual Average Daily Traffic (AADT) is 4418 vehicles/day with 16.8% heavy vehicles. The existing speed limit past the school, prior to this trial, was 100 km/h at all times.

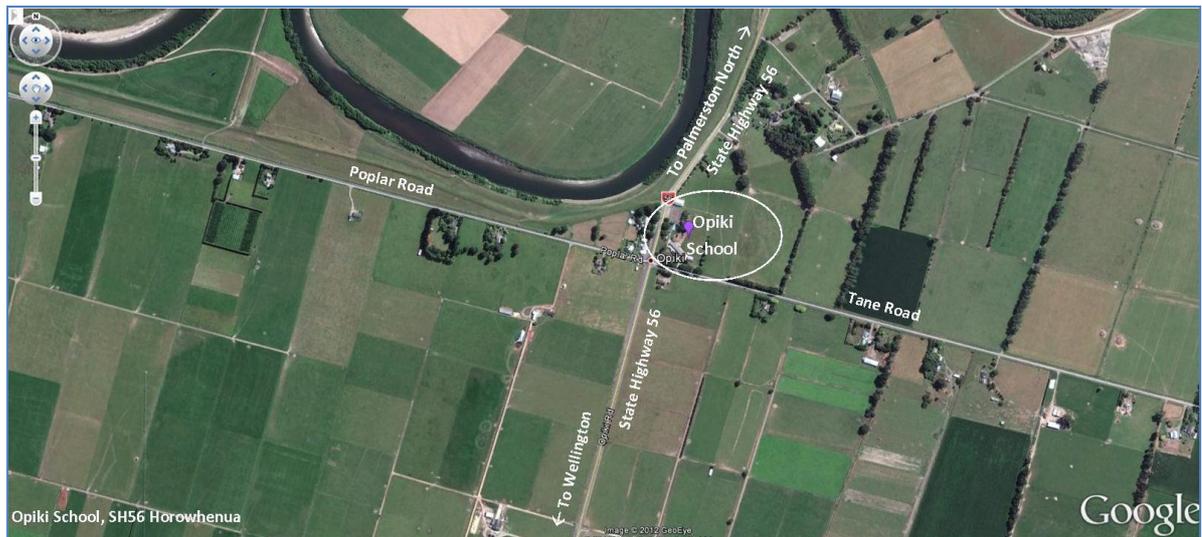
Figure 6. Opiki School, State Highway 56, Southwest of Palmerston North

Opiki School is located on the intersection of State Highway 56 and two local roads, Tane and Poplar Roads, 18km southwest of Palmerston North (Figure 6). The surrounding landscape is rural although there is a limited settlement surrounding the school.

The school is situated on flat terrain with moderate winding curves to the north and a relatively straight long section of highway to the south of the school. Public access to the school is off Tane Road which is controlled by a Stop sign. The Annual Average Daily Traffic (AADT) on State Highway 56 is 8188 vehicles/day with 13.6% heavy vehicles. The existing speed limit on the State Highway past the school prior to the trial was 80 km/h (recently reduced from 100 km/hr).

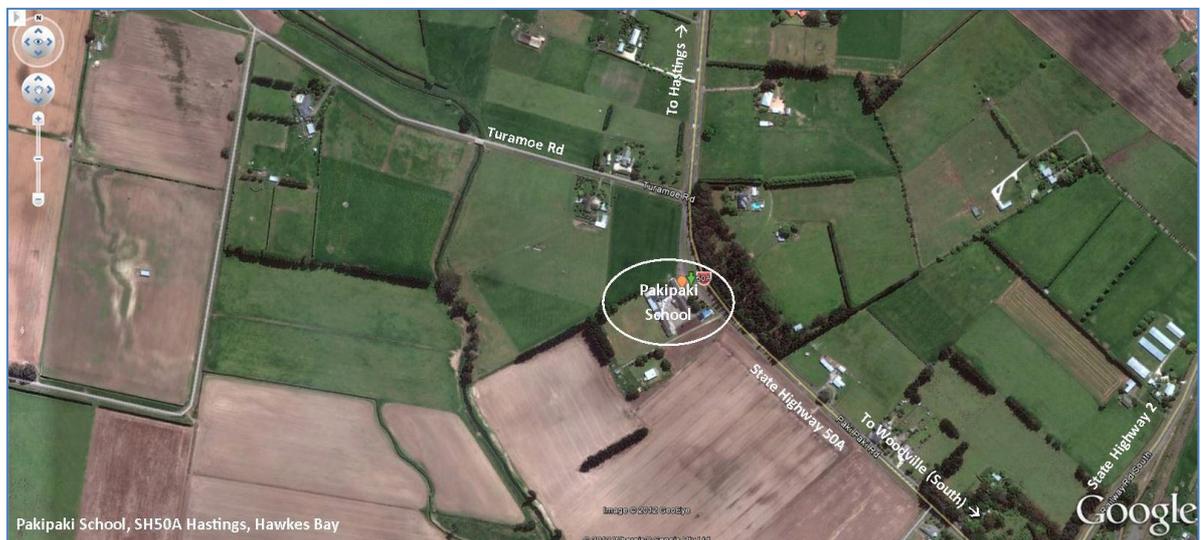
Figure 7. Pakipaki School, State Highway 50A South of Hastings

Pakipaki School is located on State Highway 50A, 9km southwest of Hastings (Figure 7). The surrounding landscape is rural.

The school is located on the west side of a moderate curve on flat terrain with a straight section of highway to the north. The approach from the south passes the small settlement of Pakipaki where State Highway 50A intersects with State Highway 2. State Highway 50A is one of three southern state highway links from Hawkes Bay to Wellington. The speed limit outside school prior to the trial was 100 km/hr. The Annual Average Daily Traffic (AADT) is 4665 vehicles/day with 14.1% heavy

vehicles. The school drop off/pick up area consists of a layby area separated from the State Highway by a low level wooden railing.

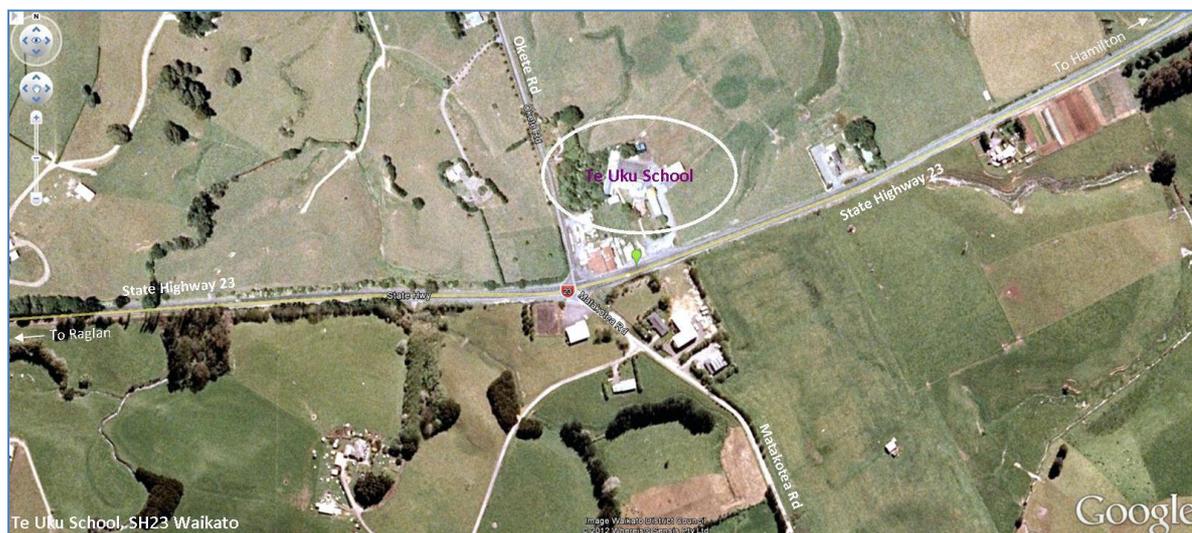
Figure 8. Te Uku School, State Highway 23 West of Hamilton

Te Uku School is located on State Highway 23, 35km west of Hamilton (Figure 8). State Highway 23 is the main access road to Raglan Township and Raglan beaches.

The school is located next to a local service station and cafe on the north-eastern corner of the intersection of State Highway 23 and local roads Okete & Matakotea Roads. The school itself is set back from the highway with a large yet rough car parking area adjacent to the highway. The surrounding landscape is predominantly rural.

The westbound highway alignment is relatively straight with a gentle left-hand curve on the eastbound approach. The Annual Average Daily Traffic (AADT) is 3508 vehicles/day with 5.8% heavy vehicles. The speed limit outside school sign prior to the trial was 100km/hr, but a symbolic school sign (children) with flashing beacons was operational when the trial commenced.

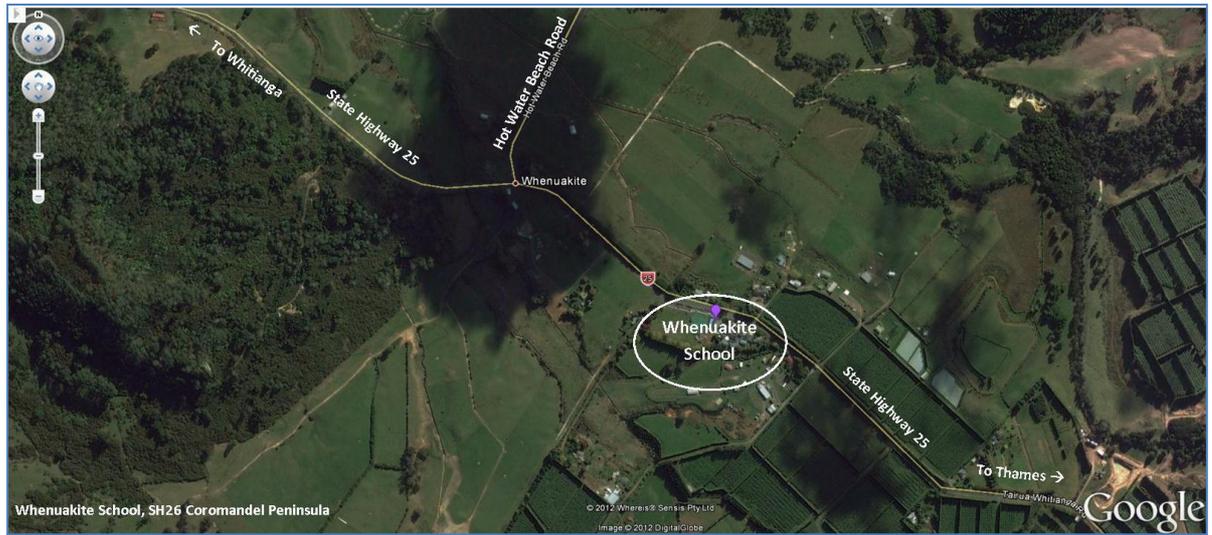
Figure 9. Whenuakite School, State Highway 25 South of Whitianga

Whenuakite School is located on State Highway 25, 27km south of Whitianga and approximately 500 metres south of the Hot Water Beach Road intersection (Figure 9).

The highway alignment approaches to the school are through rolling undulating topography with moderate to tight curves often requiring lower vehicle speeds. The Annual Average Daily Traffic (AADT) is 2660 vehicles/day with 11.8% heavy vehicles. Prior to the trial the speed limit past the school was 100 km/hr. The school drop off/pick up area consists of a lay-by area separated from the main highway by a wide planted island. There is also a separated bus turning area.

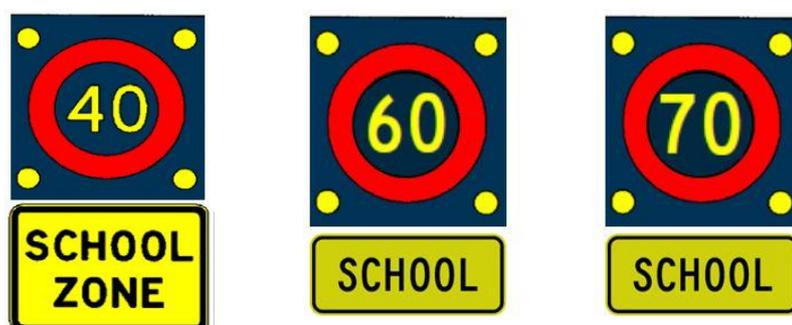
Figure 10 School variable speed limit signs used in the trial.

Figure 10 shows the layout of the variable speed limit signs used on the approaches to each school and Figure 11 shows an example of the static signs used on side roads located within the speed restricted area. For all signs only one sign was located on each approach. Please see Appendix A for the trial speed limit layout for each school.

The variable speed limit signs were installed by HMI Technologies. The roundel diameter of each sign was 750mm and each sign was solar powered with a radio transmitter providing communication with a controller at each school. Various sign operation programmes were available, offering varying levels of automation. Most schools opted for a programme that required staff to activate the sign system on Monday morning and then turn it off on Friday afternoon (with the precise times of sign activation occurring automatically). Another option was for staff to turn the sign on each school day.

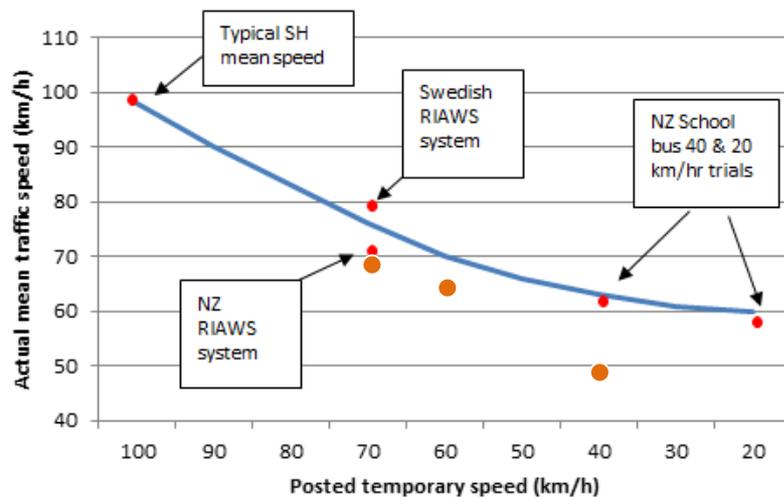
Figure 12. Typical operating speed responses to various variable speed limit systems, with the typical rural school variable speed limits from the present trial overlaid (orange dots).

In a previous report (Mackie 2010), investigating the likely speed responses to electronic variable speed limit signs as part of the development of a Rural Intersection Active Warning System (RIAWS), a graph of sign-posted vs actual speeds for various previous trials was presented. In Figure 12 below, the typical findings from this school sign trial are overlaid onto this graph as a comparison (with the latest NZ RIAWS example included). It appears that the speeds from the present trial were consistently lower than those presented from other variable speed limit trials, although there was a similar high level of compliance for both the rural school and RIAWS 70 km/h examples. Some of this may be due to the naturally lower speed of some of the roads in the present trial, although it does also seem that the signs in the present trial were particularly effective. This trend may be explained by a high degree of credibility associated with the current signs, reinforced by the fact that many motorists slow down past rural schools during these times, to some degree, even without a lower variable speed limit.

The relatively high level of compliance with these signs suggests that it may be possible to aim for lower speed limits than one might normally consider acceptable, while still maintaining credibility and compliance by motorists – depending on the natural operating speed of the road and the presence of other cues that indicate why slowing down is necessary (such as a visible school environment with relevant commuter activity).

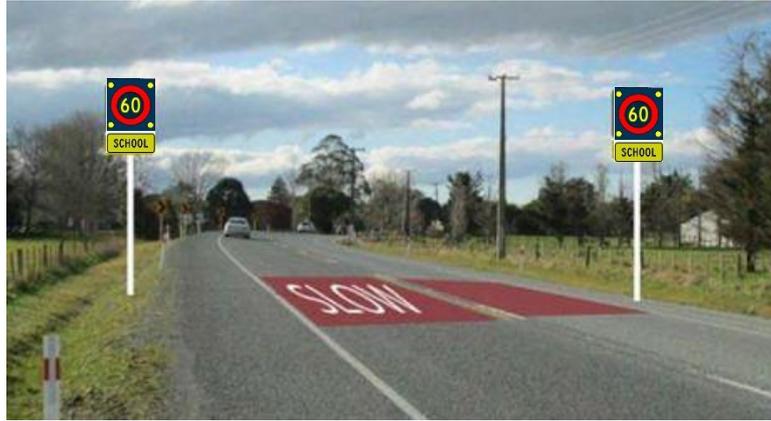
Figure 13. Variable speed limit configuration soon to be trialled by Auckland Transport

As mentioned earlier, other school signs are also in use or are being trialled, including a more substantial version including gated signs and associated road marking, planned by Auckland Transport (Figure 13).

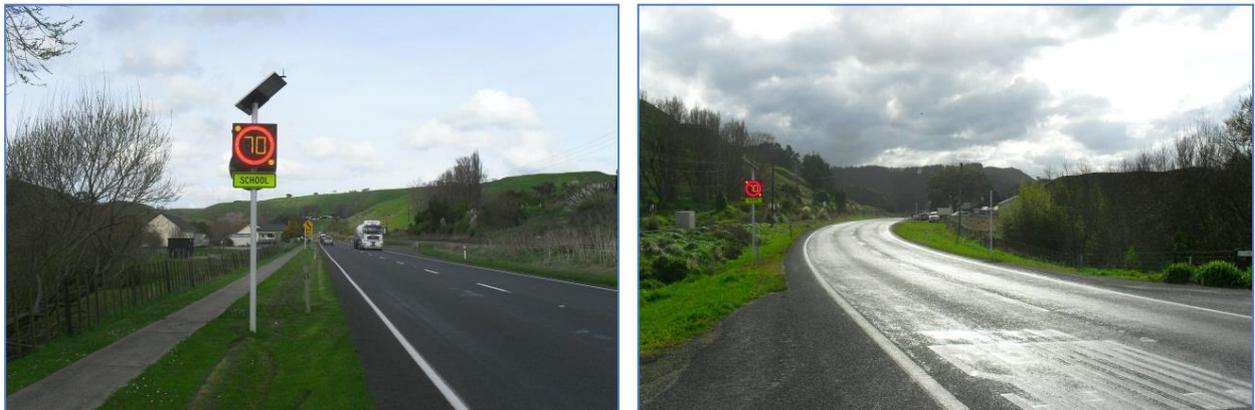
Figure 15 70km/h LED Mandatory Speed Sign Installed - Left: Eastbound, Right: Westbound

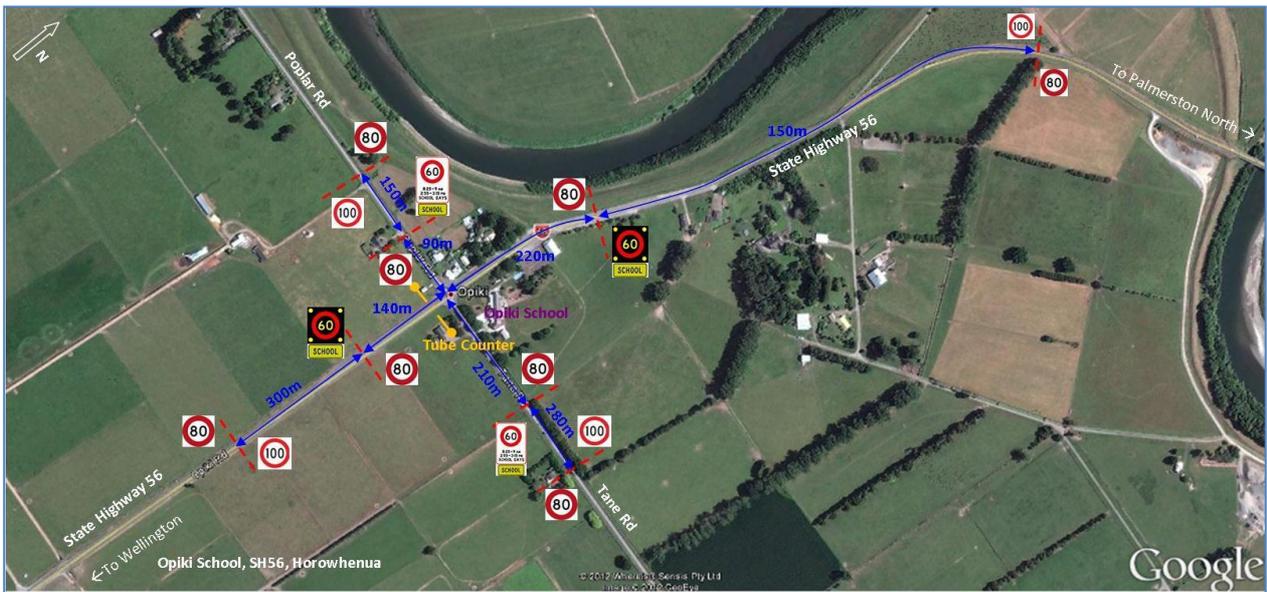
Figure 16 Opiki School - Trial Signs Location & Layout

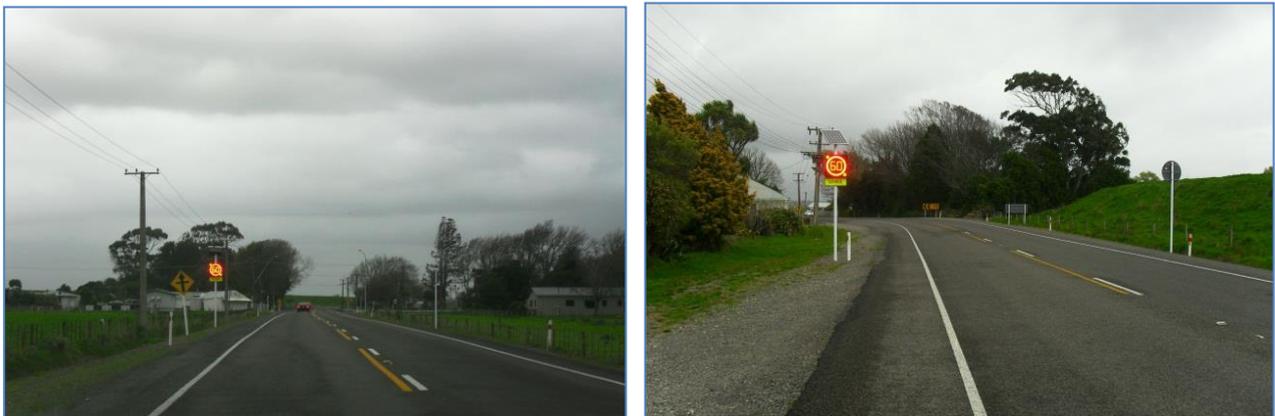
Figure 17 (i&ii) 60km/h LED Mandatory Speed Sign Installed - Left: Northbound, Right: Southbound

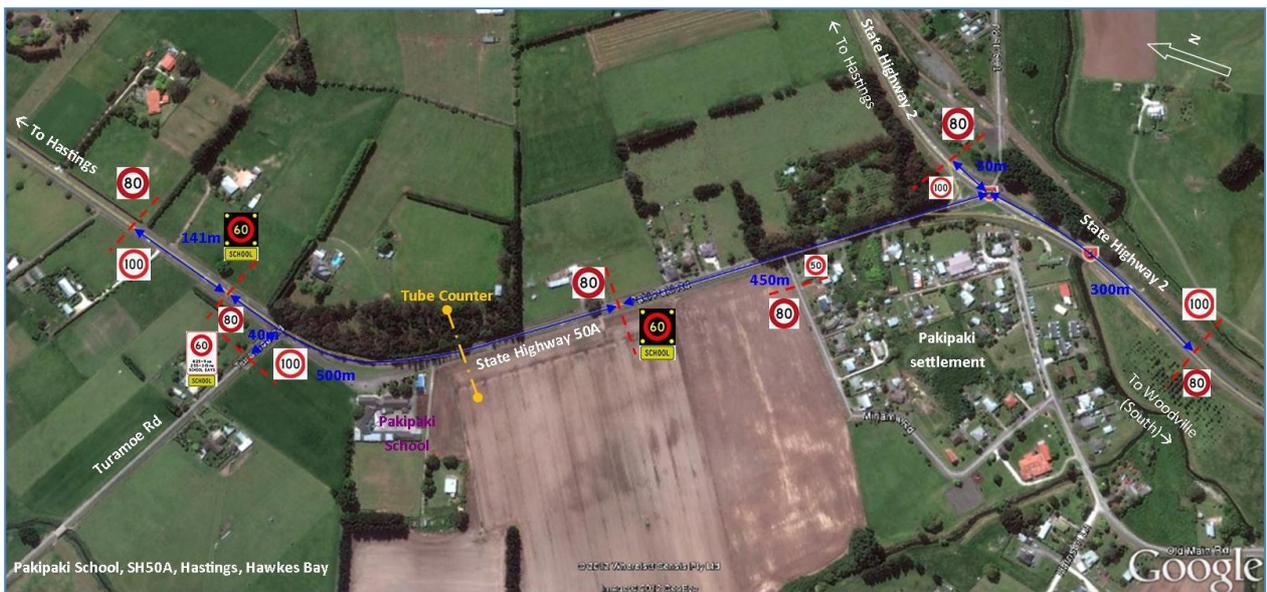
Figure 18 Pakipaki School - Trial Signs Location & Layout

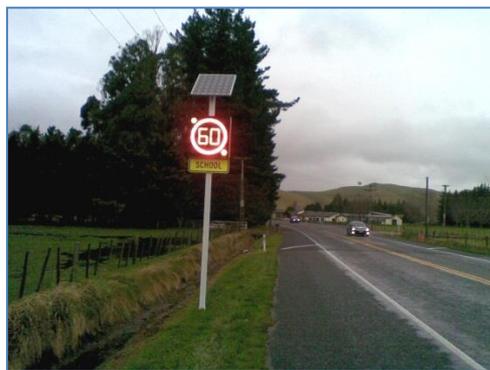
Figure 19 60km/h LED Mandatory Speed Sign Installed - Southbound

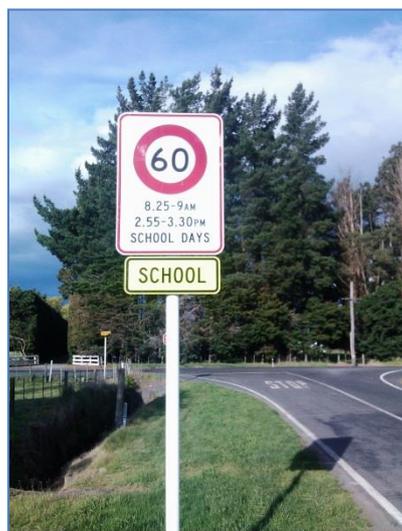
Figure 20 Pakipaki School - Side Road Warning Signs on Turamoe Road

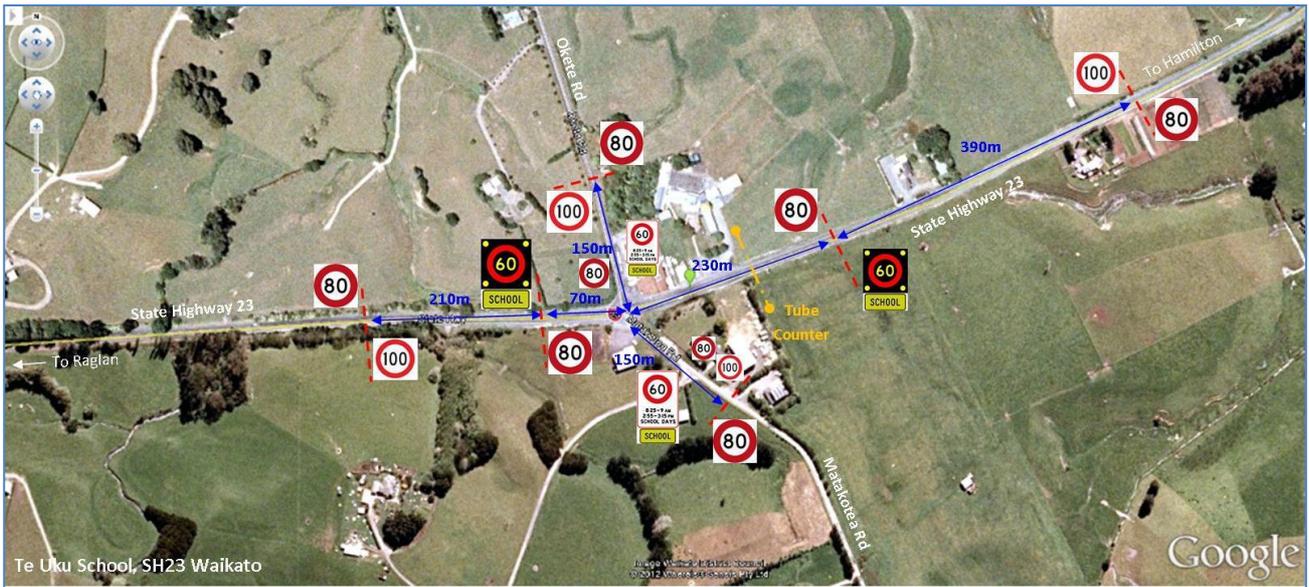
Figure 21 Te Uku School - Trial Signs Location & Layout

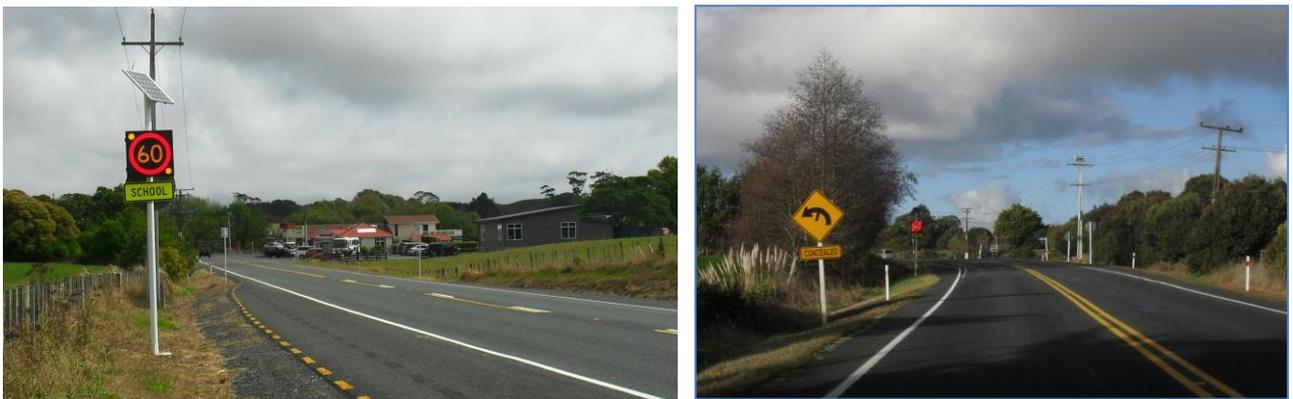
Figure 22 (i&ii) 60km/h LED Mandatory Speed Sign Installed - Left: Westbound, Right: Eastbound

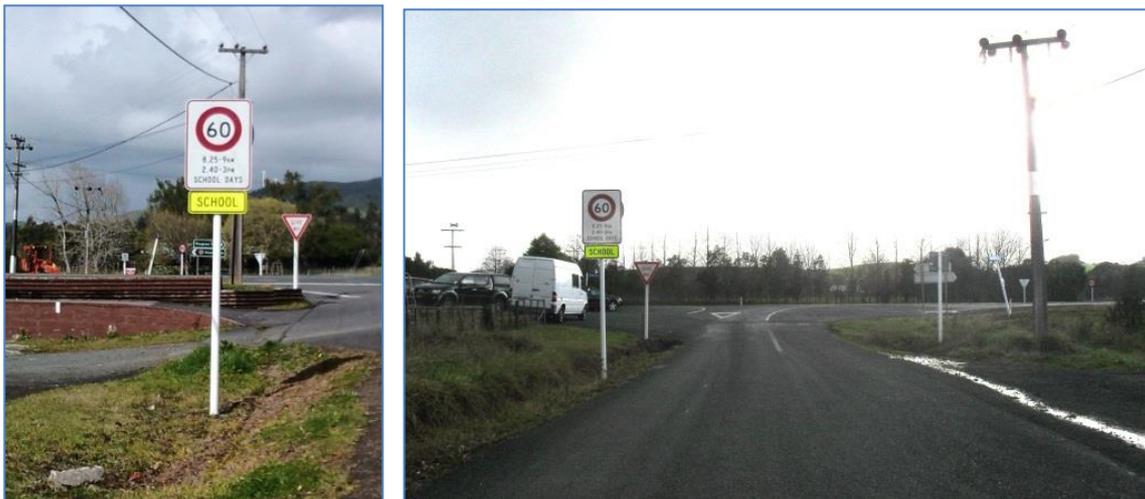
Figure 23 (i&ii) Te Uku School - Side Road Warning Signs on Okete Rd (left) and Matakotea Road (right).

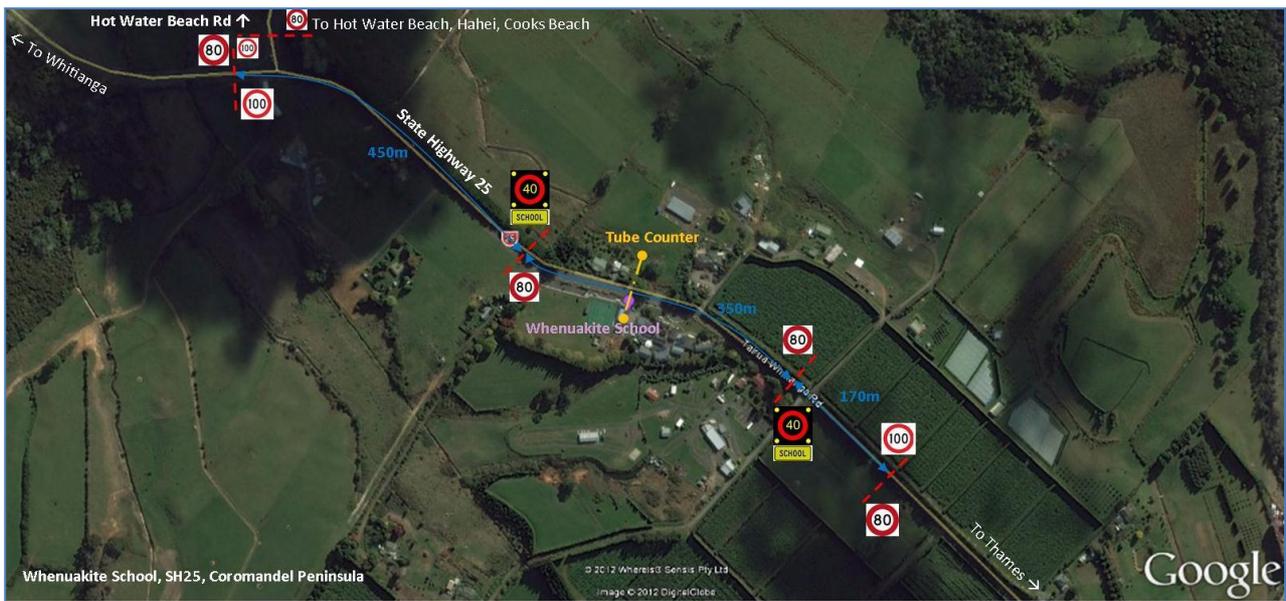
Figure 24 Whenuakite School - Trial Signs Location & Layout

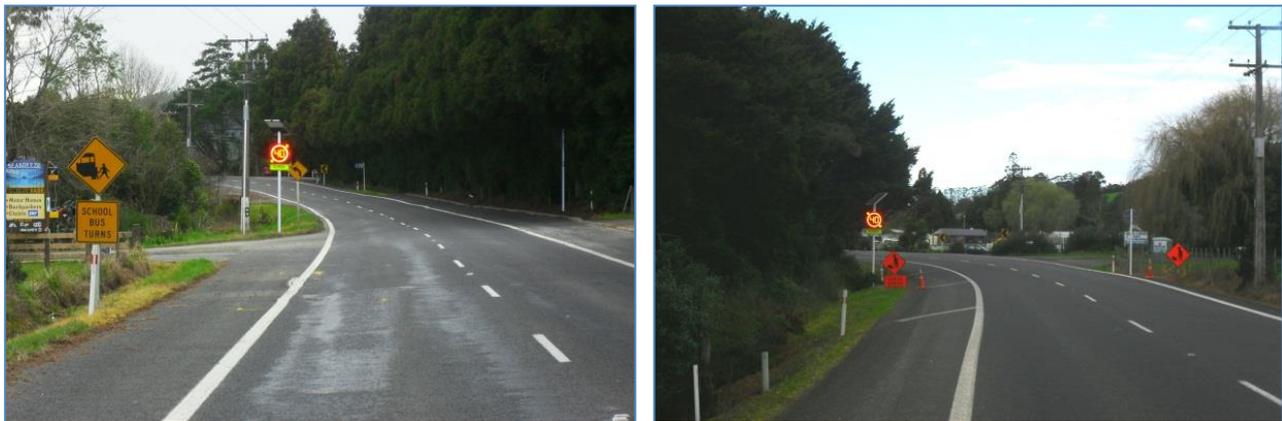
Figure 25 (i&ii) 40km/h LED Mandatory Speed Sign Installed - Left: Northbound, Right: Southbound

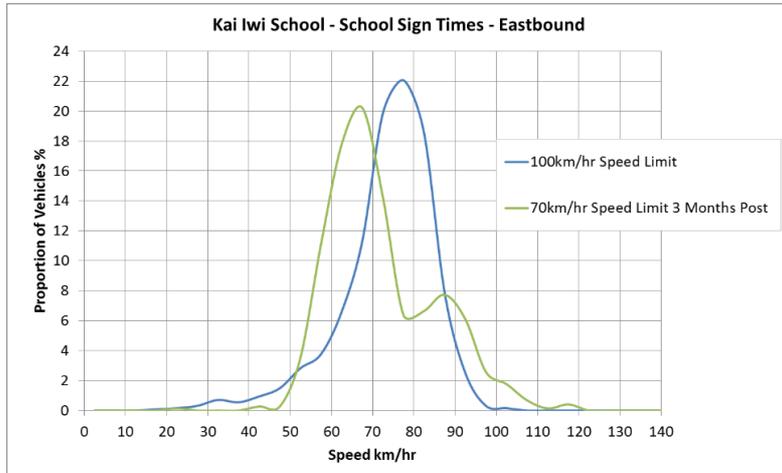
Kai Iwi School – Eastbound

School Sign Times – 8.20am-8.55am / 2.50pm-3.10pm

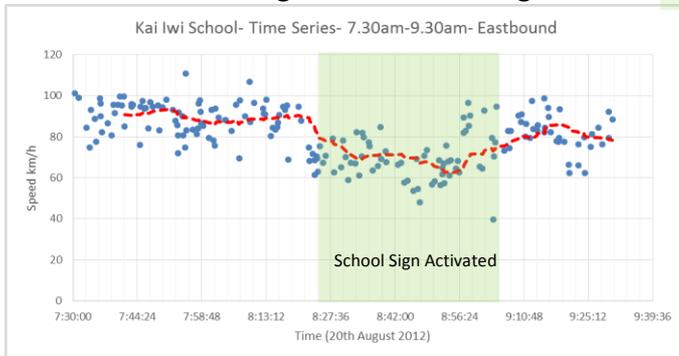
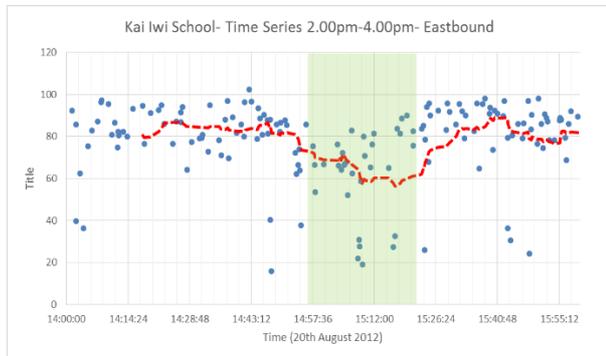
Time Series - School Sign Installed – 20 August 2012

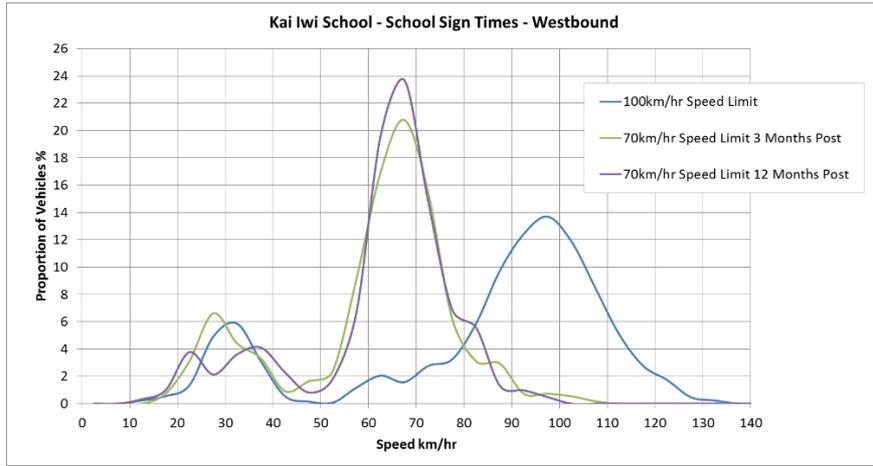
Kai Iwi School – Westbound

School Sign Times – 8.20am-8.55am / 2.50pm-3.10pm

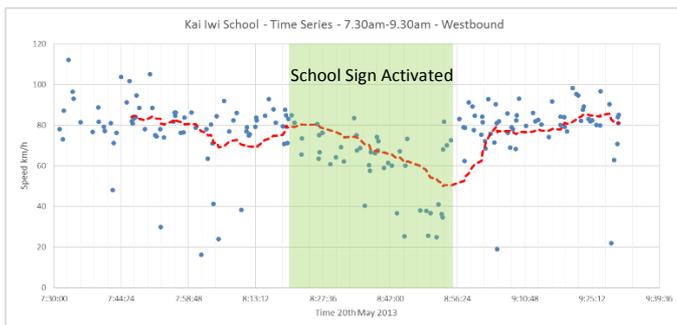
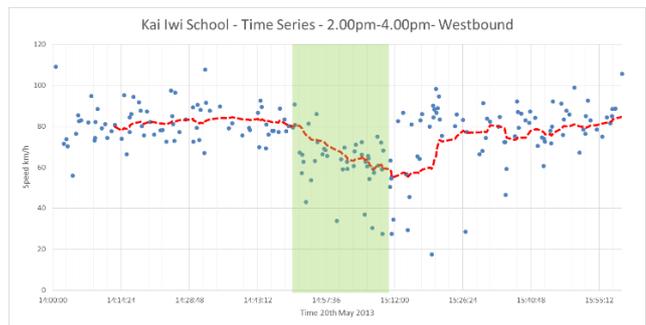
Time Series - School Sign Installed – 20th May 2013

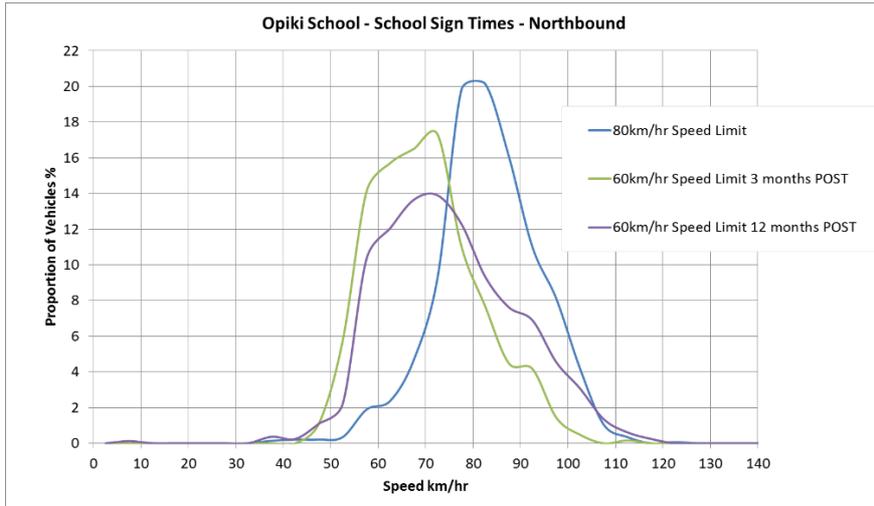
Opiki School – Northbound

School Sign Times – 8.25am-9.00am / 2.50pm-3.10pm

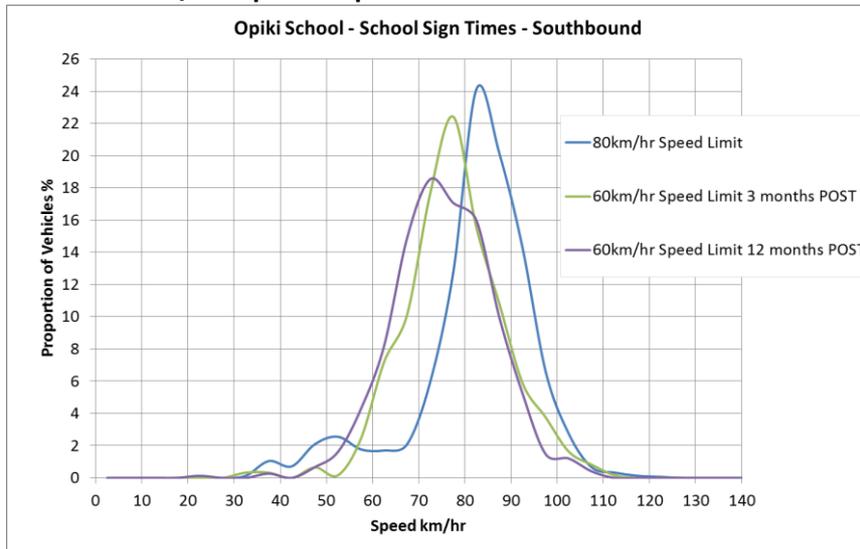
Opiki School – Southbound
School Sign Times – 8.25am-9.00am / 2.50pm-3.10pm

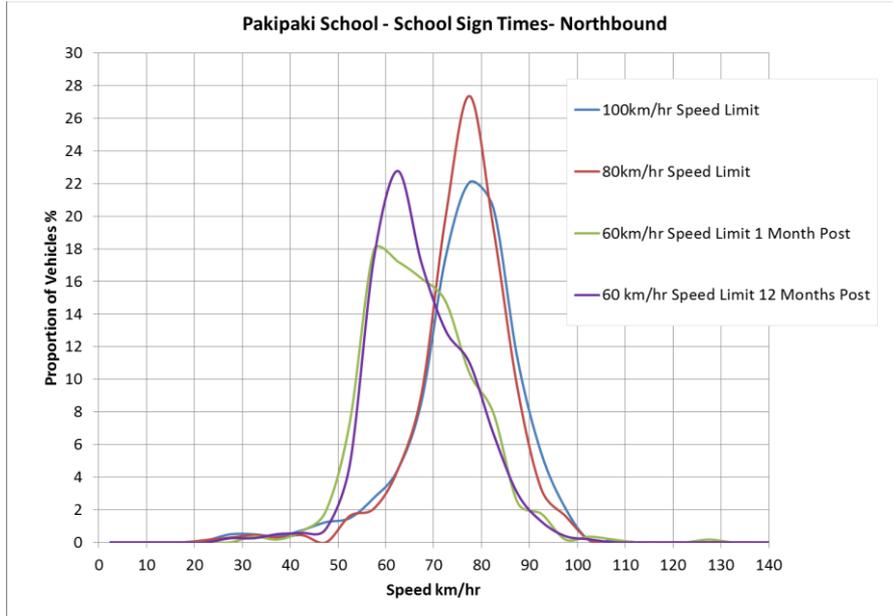
Pakipaki School – Northbound

School Sign Times – 8.25am-9.00am / 2.55pm-3.20pm

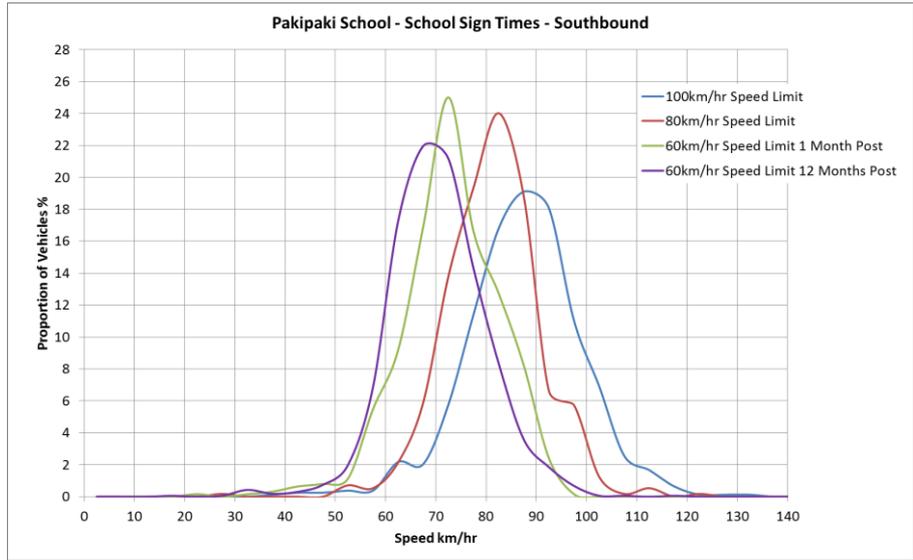
Pakipaki School – Southbound

School Sign Times – 8.25am-9.00am / 2.55pm-3.20pm

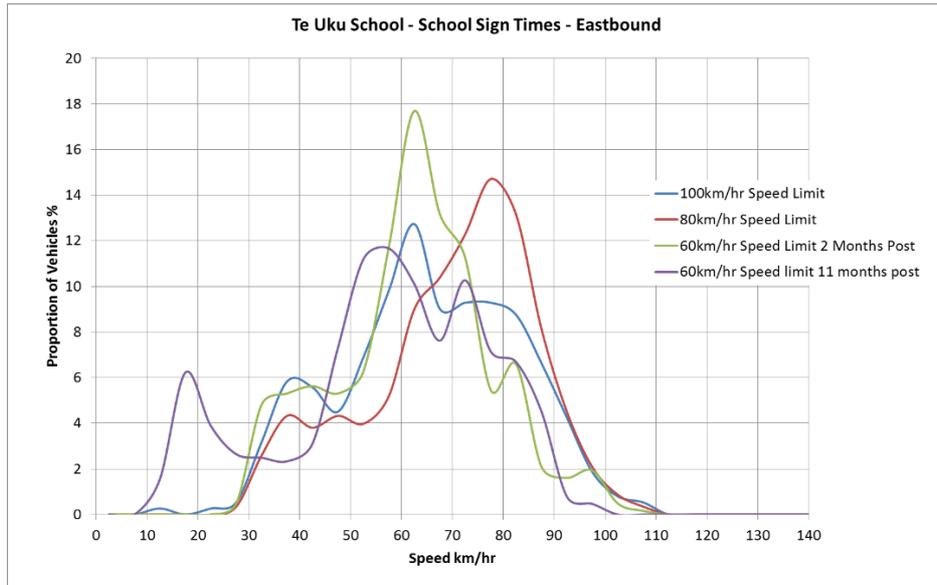
Te Uku School – Eastbound

School Sign Times – 8.35am-9.10am / 2.45pm-3.05pm

Traffic speeds for Te Uku School (Table 8) show that the vehicle speeds during school drop-off and pick-up times are lower than the general speed data shown in Table 9 (more so than for the previous three schools). Interestingly speeds went up in the eastbound direction in particular following the implementation of the 80 km/h signs, however, the speeds are well below the posted speed limit and there may have been varying conditions when the speeds were measured.

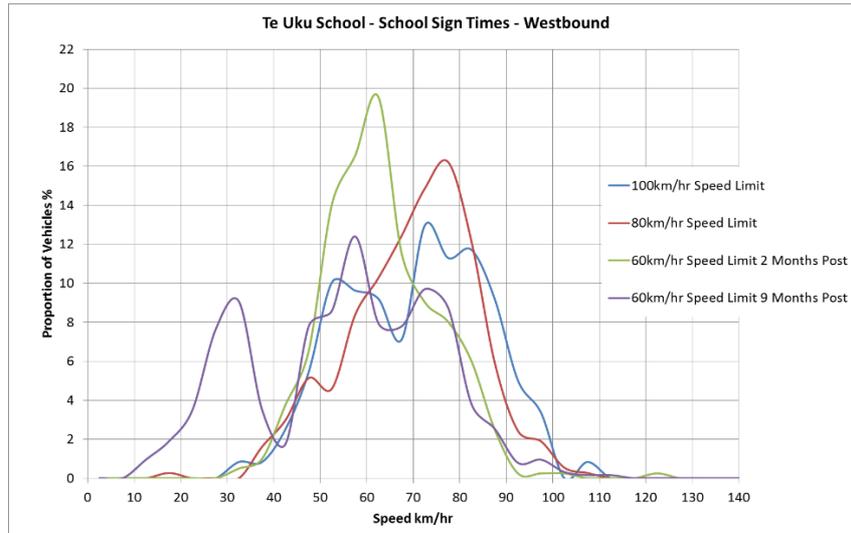
Te Uku School – Westbound

School Sign Times – 8.35am-9.10am / 2.45pm-3.05pm

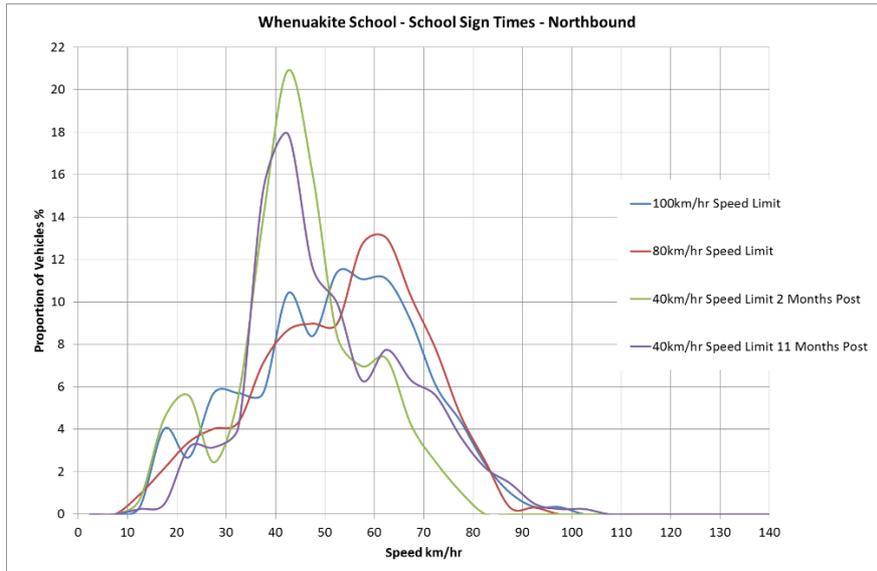
Whenuakite School – Northbound

School Sign Times – 8.25am-9.00am / 2.55pm-3.15pm

Traffic speeds at Whenuakite School (Table 10) show that the natural traffic speed during school times is significantly lower than the 100 km/h or even 80 km/h speed limits. The introduction of the 40 km/h variable speed limit signs has resulted in a 10% reduction in the 85th percentile speeds of southbound vehicles and 8% reduction in northbound vehicles (compared with 100km/h speed limit). There was a 15% reduction in the average speeds of northbound vehicles between the 80km/h and 40km/h speed limit conditions, but only a 2% reduction in southbound vehicle speeds. In the southbound direction, the sign was reported being shaded by a nearby hedge and may have meant that the sign was not working as effectively as the northbound sign. In the northbound direction, traffic speed reduced to within 3-5 km/h of the posted 40 km/h speed limit.

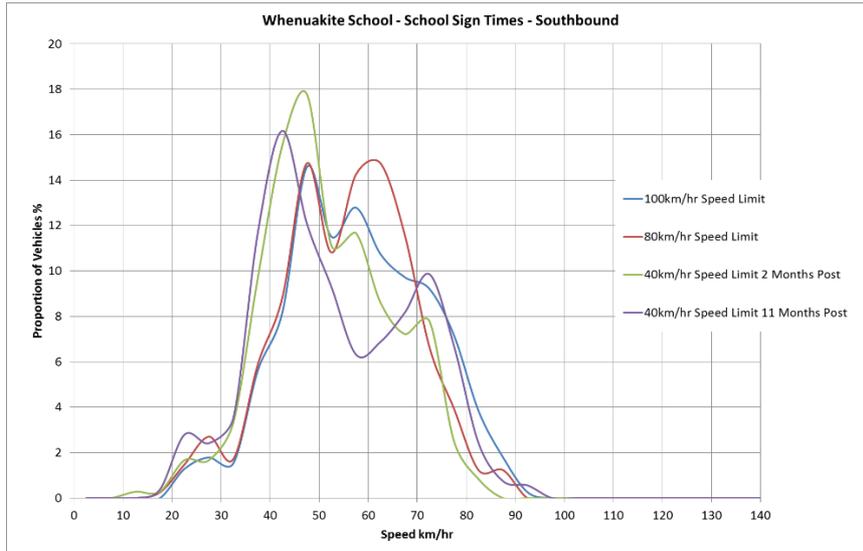
Whenuakite School – Southbound

School Sign Times – 8.25am-9.00am / 2.55pm-3.15pm
