## Evaluation of variable speed limit signs at rural schools

Prepared for the  
Road Safety Trust

19 November 2012

Preliminary Report

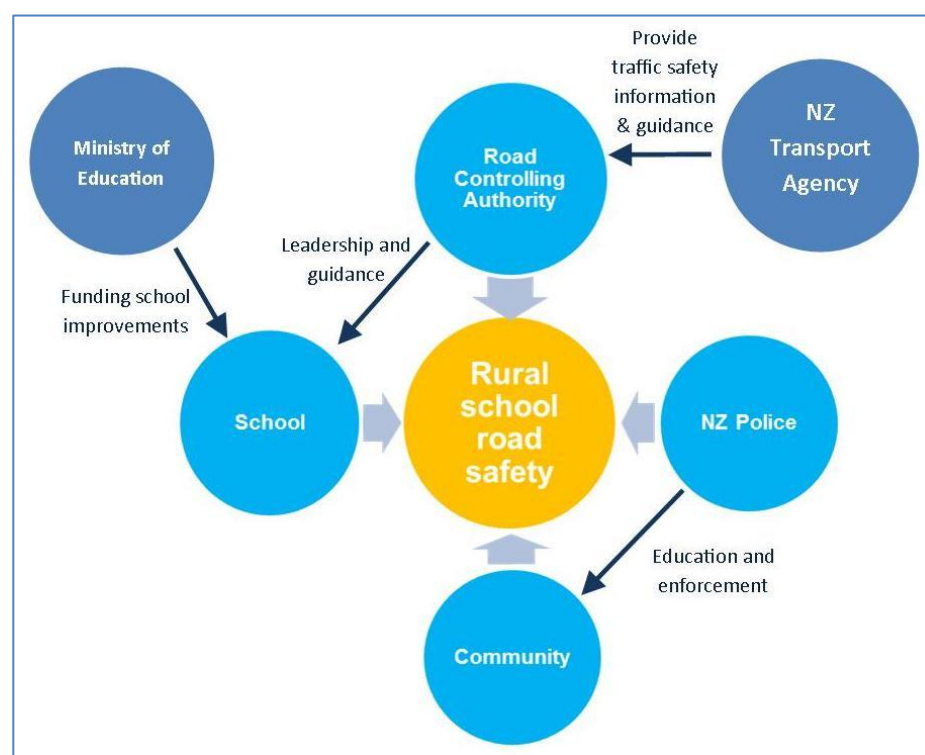
Figure 2 Joint Responsibility Model for rural school road safety (Mackie 2011)

Based on these two areas of concern, a joint responsibility model (Figure 2) was recommended, reflecting that most rural schools will have both highway and school property/procedural issues that need resolving, and that both road controlling authorities and schools (or Ministry of Education) will have responsibility for these different areas.

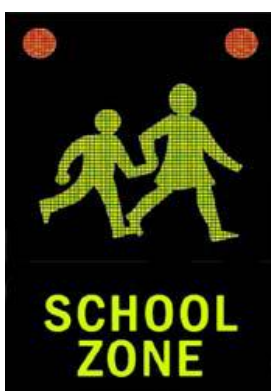
Figure 3. Other school signs in use or being trialled

There are currently various symbolic static/active and speed advisory school sign options (Figure 3) in operation or being trialled. However, illuminated mandatory speed reduction signs are likely to be more effective than symbolic sign variations (static or active) at reducing traffic speed (Mackie 2010<sup>3</sup>), as they clearly communicate a speed which is legally required of motorists. However, the implementation of this trial at five rural schools will provide more concrete evidence for the effectiveness of variable speed limit signs at rural schools. Comparisons with datasets from evaluations of other signs could then be carried out to determine the relative effectiveness of various school signs.

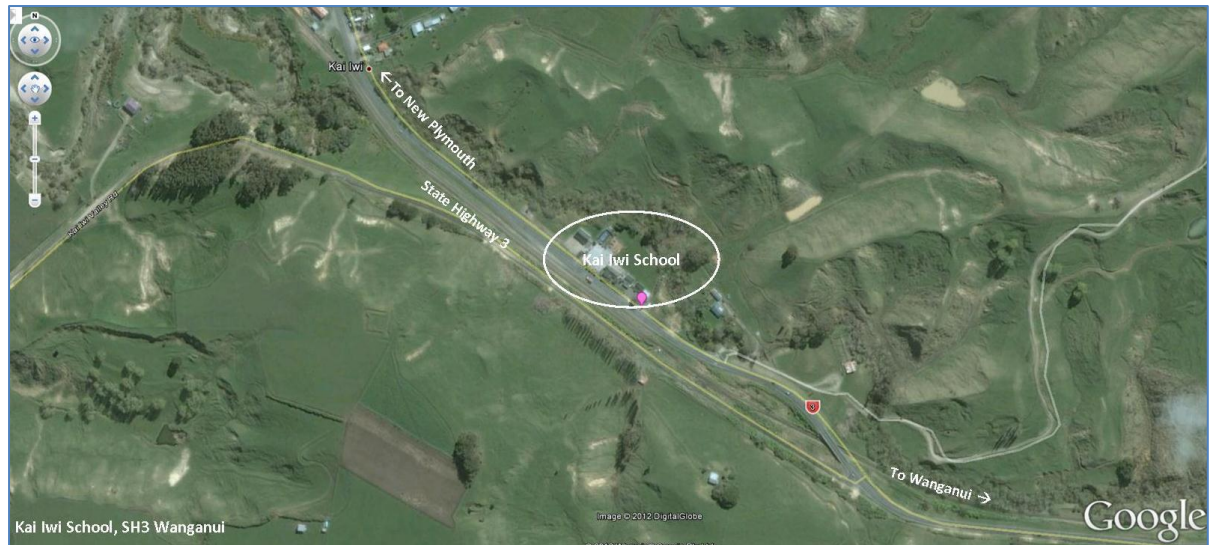
Figure 5. Kai Iwi School, State Highway 3 Northwest of Wanganui

The school is situated in a valley on a straight section of highway with slight to moderate curve approaches. The school side of the highway has a wide shoulder with a footpath running parallel to the road from the school grounds to the Kai Iwi Tavern 500m north-west. The opposite shoulder contains a weigh pit, suitable for heavy vehicles. The Annual Average Daily Traffic (AADT) is 4418 vehicles/day with 16.8% heavy vehicles. The existing speed limit past the school, prior to this trial, was 100 km/hr at all times.

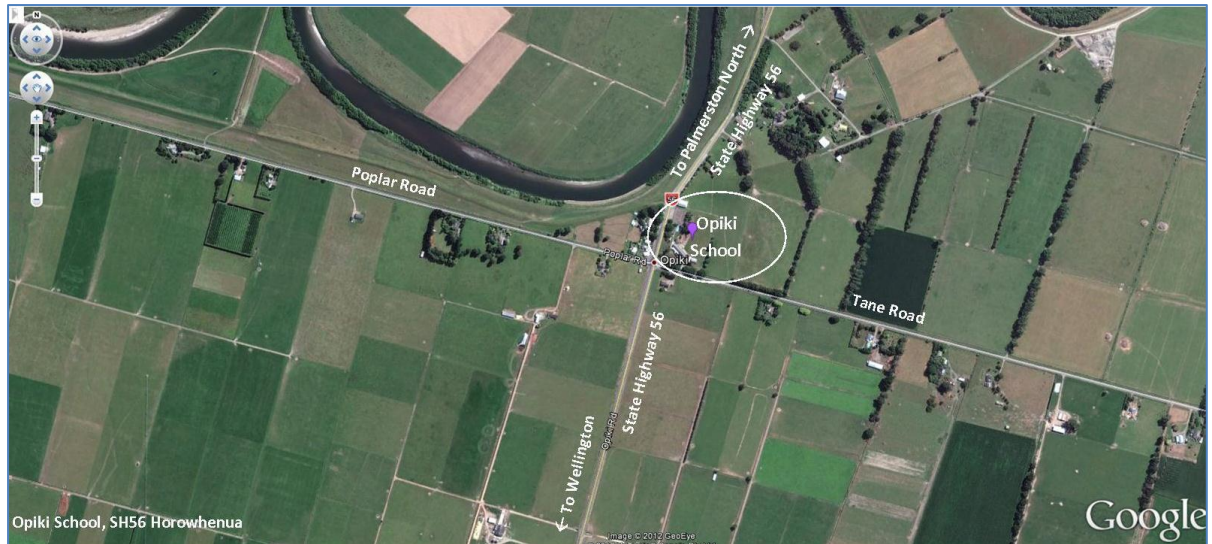
Figure 6. Opiki School, State Highway 56, Southwest of Palmerston North

The school is situated on flat terrain with moderate winding curves to the north and a relatively straight long section of highway to the south of the school. Public access to the school is off Tane Road which is controlled by a Stop sign. The Annual Average Daily Traffic (AADT) on State Highway 56 is 8188 vehicles/day with 13.6% heavy vehicles. The existing speed limit on the State Highway past the school prior to the trial was 80 km/hr (recently reduced from 100 km/hr).

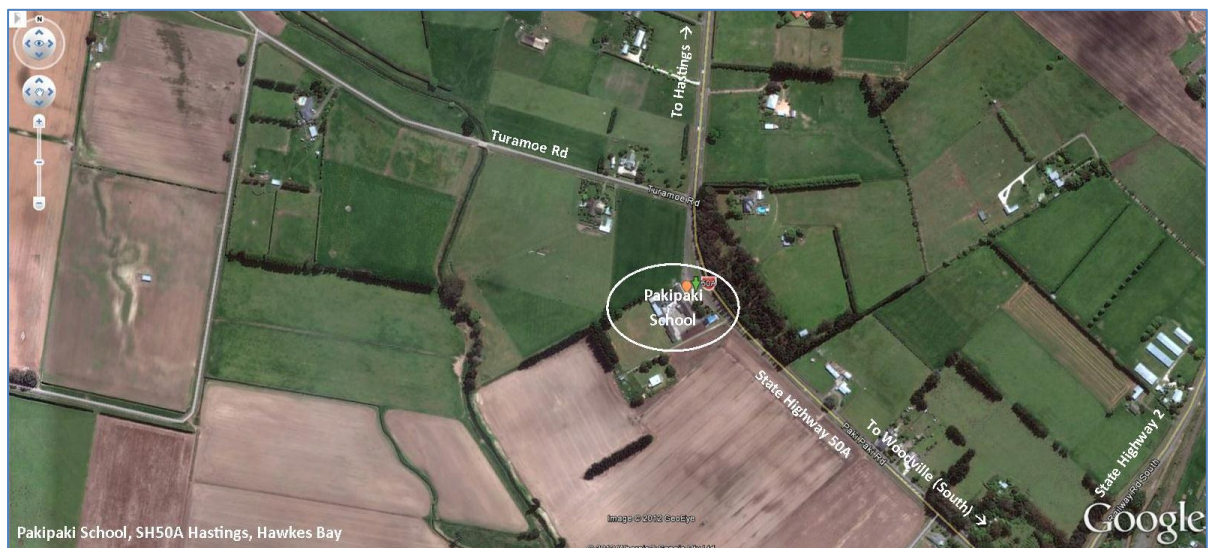
Figure 7. Pakipaki School, State Highway 50A South of Hastings

The school is located on the west side of a moderate curve on flat terrain with a straight section of highway to the north. The approach from the south passes the small settlement of Pakipaki where State Highway 50A intersects with State Highway 2. State Highway 50A is one of three southern state highway links from Hawkes Bay to Wellington. The speed limit outside school prior to the trial was 100 km/hr. The Annual Average Daily Traffic (AADT) is 4665 vehicles/day with 14.1% heavy

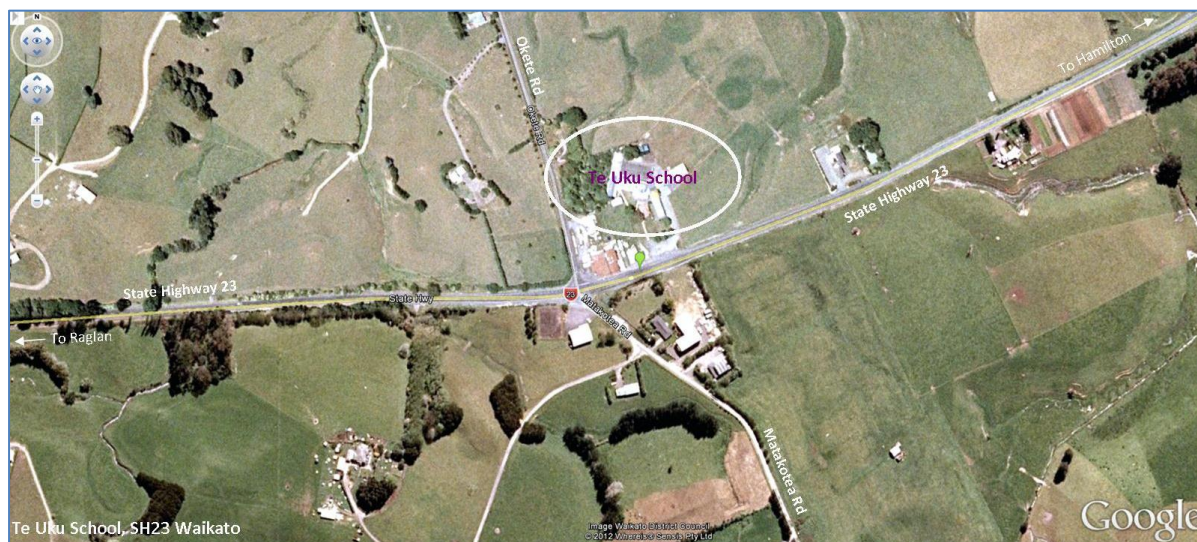
Figure 8. Te Uku School, State Highway 23 West of Hamilton

The school is located next to a local service station and cafe on the north-eastern corner of the intersection of State Highway 23 and local roads Okete & Matakotea Roads. The school itself is set back from the highway with a large yet rough car parking area adjacent to the highway. The surrounding landscape is predominantly rural.

The westbound highway alignment is relatively straight with a gentle left-hand curve on the eastbound approach. The Annual Average Daily Traffic (AADT) is 3508 vehicles/day with 5.8% heavy vehicles. The speed limit outside school sign prior to the trial was 100km/hr, but a symbolic school sign (children) with flashing beacons was operational when the trial commenced.

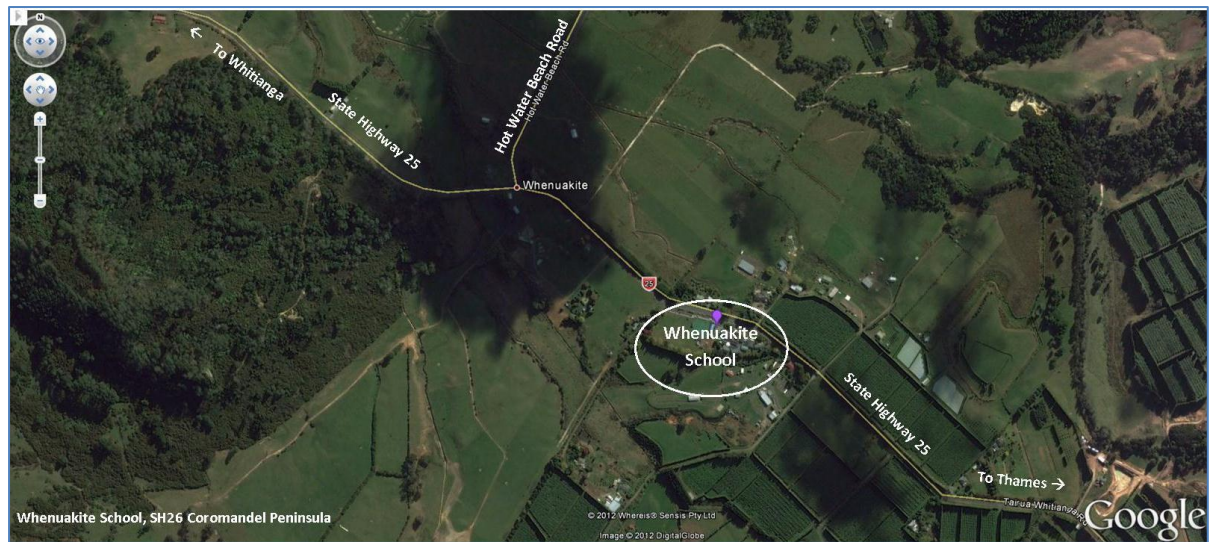
Figure 9. Whenuakite School, State Highway 25 South of Whitianga

The highway alignment approaches to the school are through rolling undulating topography with moderate to tight curves often requiring lower vehicle speeds. The Annual Average Daily Traffic (AADT) is 2660 vehicles/day with 11.8% heavy vehicles. Prior to the trial the speed limit past the school was 100 km/hr. The school drop off/pick up area consists of a lay-by area separated from the main highway by a wide planted median island. There is also a separated bus turning area.

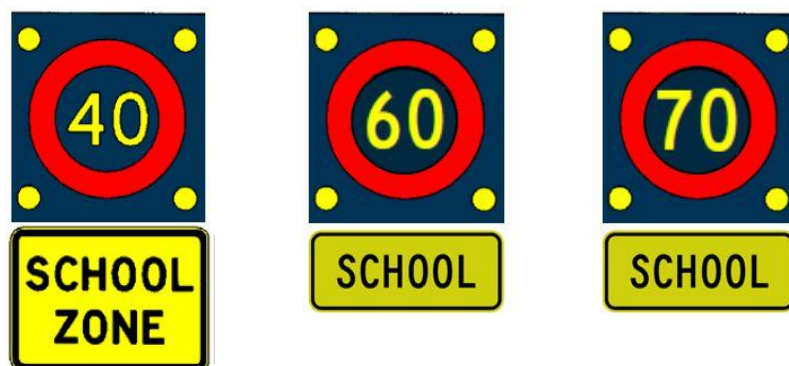
Figure 10 School variable speed limit signs used in the trial.

Figure 11 Static variable speed limit signs installed on side roads within variable speed limit area.

Figure 10 shows the layout of the variable speed limit signs used on the approaches to each school and Figure 11 shows an example of the static signs used on side roads located within the speed restricted area. For all signs only one sign was located on each approach. Please see Appendix A for the trial speed limit layout for each school.

The variable speed limit signs were installed by HMI Technologies. The roundel diameter of each sign was 750mm and each sign was solar powered with a radio transmitter providing communication with a controller at each school. Various sign operation programmes were available, offering varying levels of automation. Most schools opted for a programme that required staff to activate the sign system on Monday morning and then turn it off on Friday afternoon (with the precise times of sign activation occurring automatically). Another option was for staff to turn the sign on each school day.

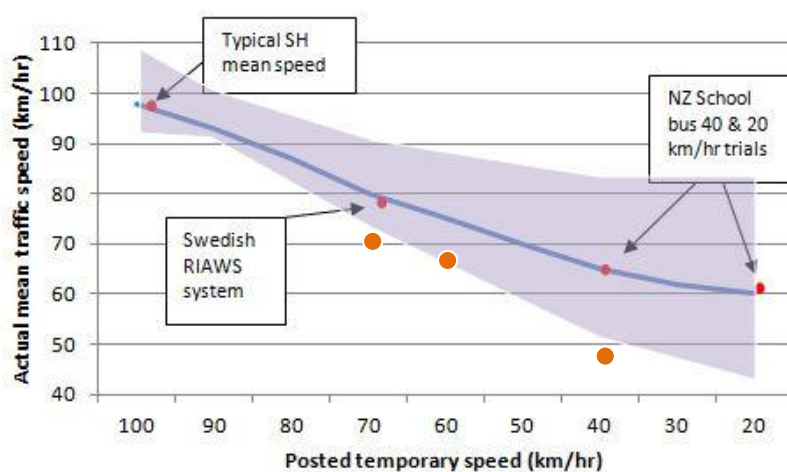
Figure 12. Typical operating speed responses to various speed limit systems (purple shaded area shows variability), with the generalised results from the present trial overlaid (orange dots).

In a previous report (Mackie 2010), investigating the likely speed responses to electronic variable speed limit signs as part of the development of a Rural Intersection Active Warning System, a graph of signposted vs actual speeds for various previous trials was presented. In Figure 12 below, the generalised findings from this school sign trial are overlaid onto this graph as a comparison. It appears that the speeds from the present trial were consistently lower than those presented from other variable speed limit trials. Some of this may be due to the naturally lower speed of some of the roads in the present trial, although it does also seem that the signs in the present trial were particularly effective. This trend may be explained by a high degree of credibility associated with the current signs, reinforced by the fact that many motorists slow down past rural schools during these times, to some degree, even without a lower variable speed limit.

The relatively high level of compliance in response to these signs, suggests that it may be possible to aim for lower speed limits than one might normally consider acceptable, while still maintaining credibility and compliance by motorists – depending on the natural operating speed of the road and the presence of other cues that indicate why slowing down is necessary (such as a visible school environment with relevant commuter activity).

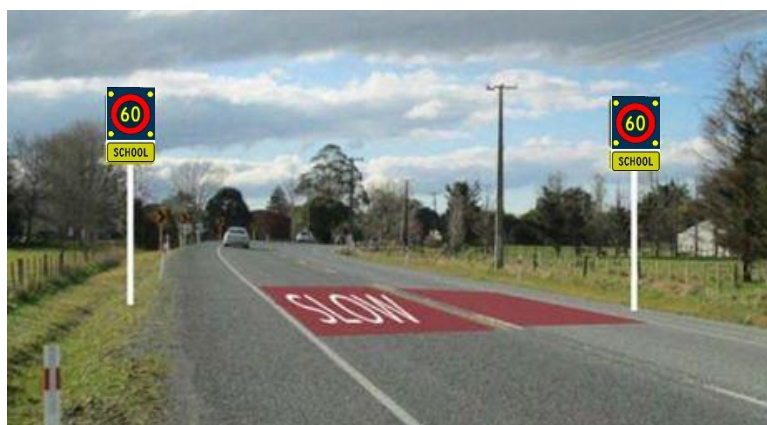
Figure 13. Variable speed limit configuration soon to be trialled by Auckland Transport

As mentioned earlier, other school signs are also in use or are being trialled, including a more substantial version including gated signs and associated road marking, planned by Auckland Transport (Figure 13).

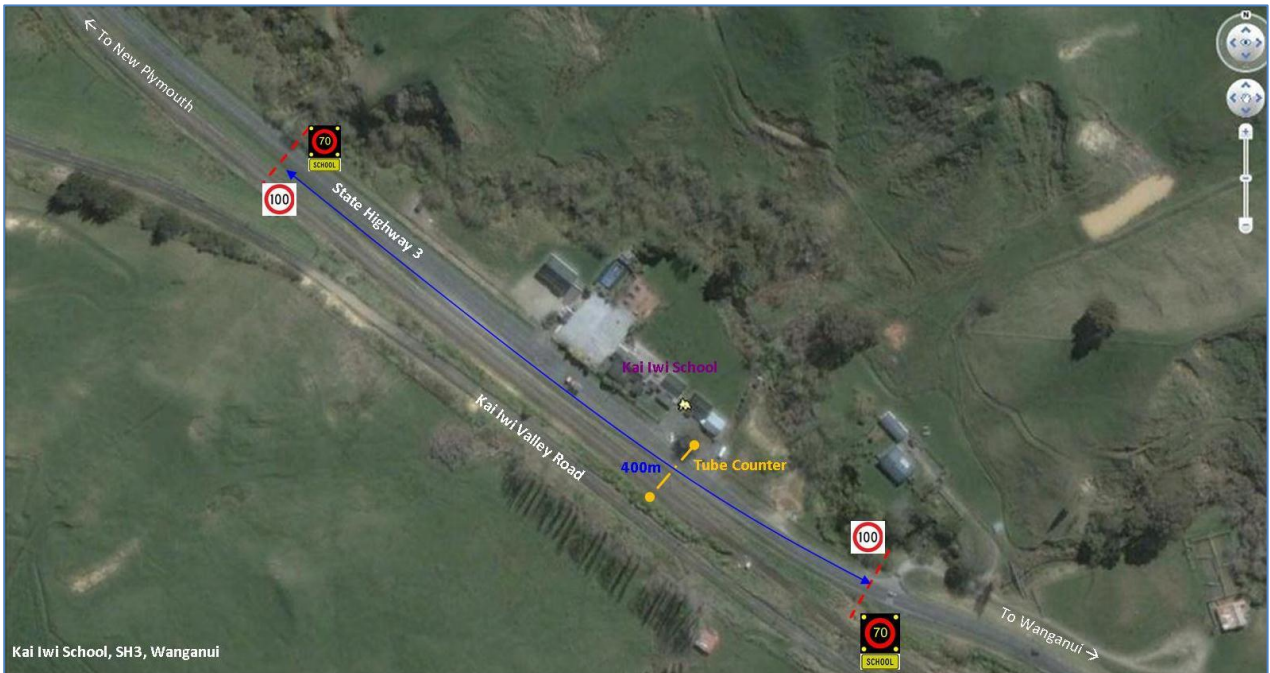
Figure 14 Kai Iwi School - Trial Signs Location & Layout

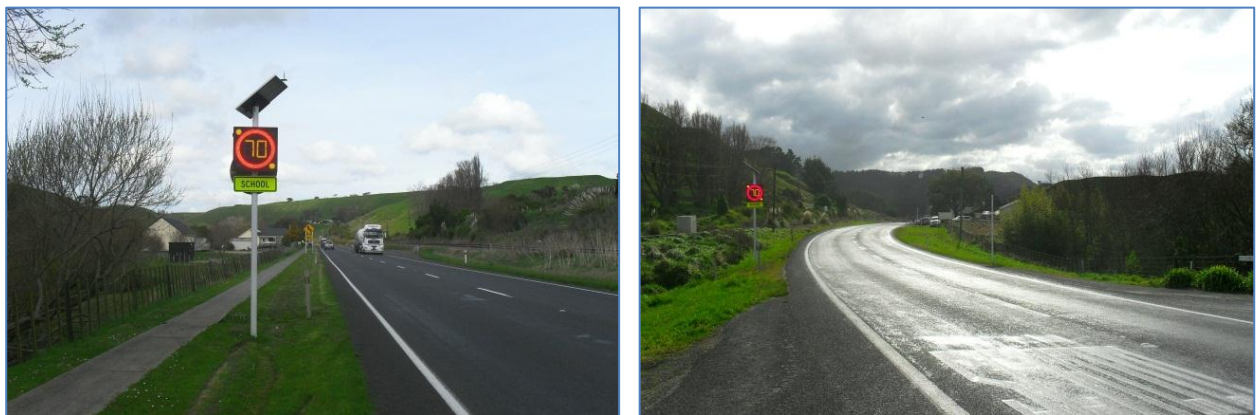
Figure 15 70km/hr LED Mandatory Speed Sign Installed - Left: Eastbound, Right: Westbound

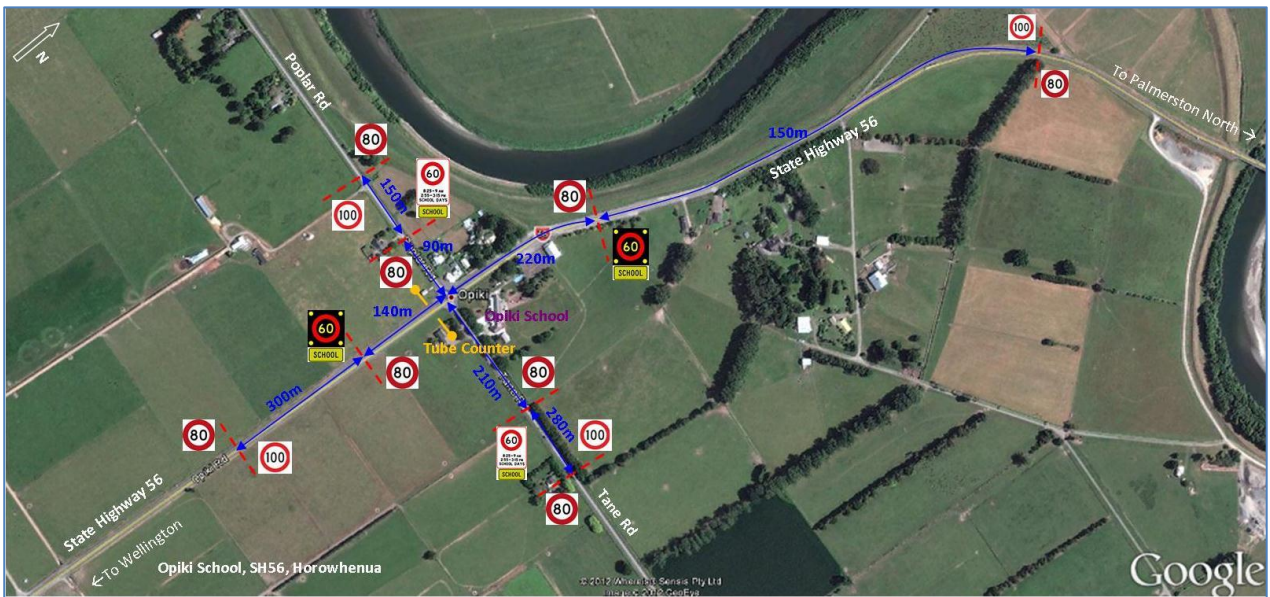
Figure 16 Opiki School - Trial Signs Location & Layout

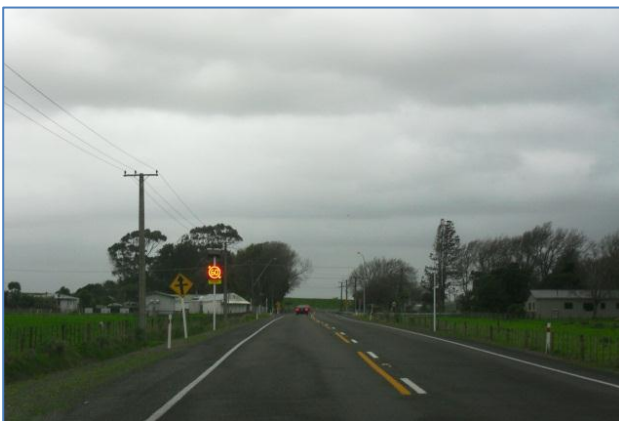
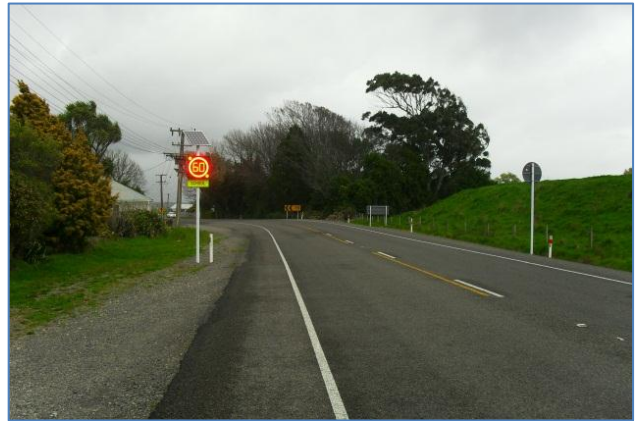
Figure 17 (i&ii) 60km/hr LED Mandatory Speed Sign Installed - Left: Northbound, Right: Southbound

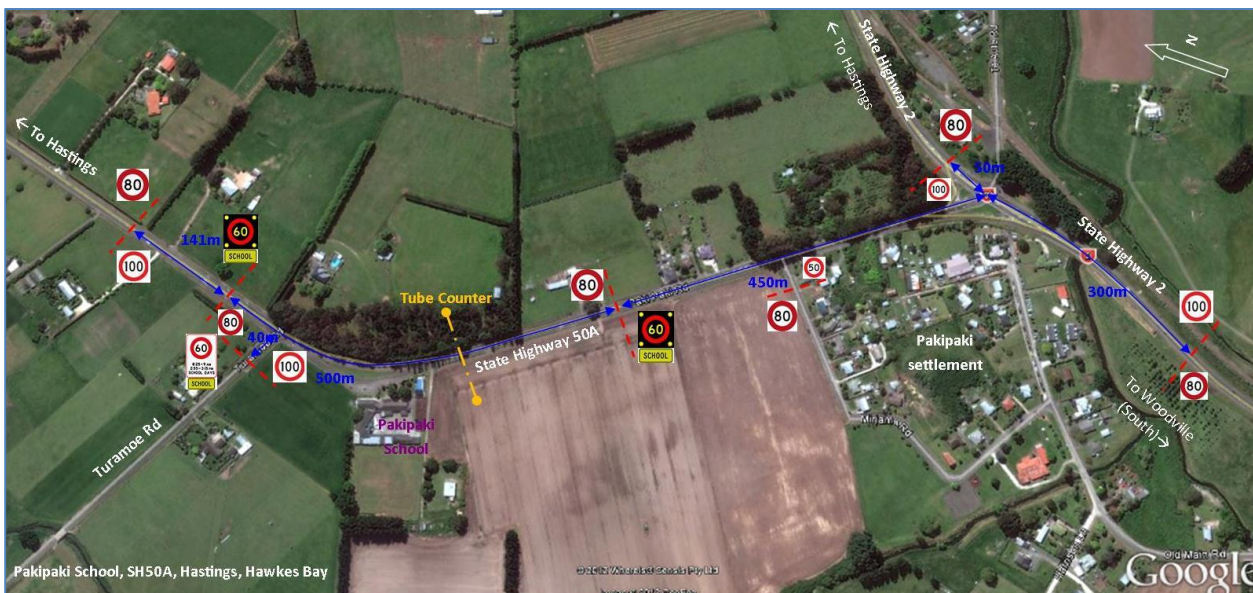
Figure 18 Pakipaki School - Trial Signs Location & Layout

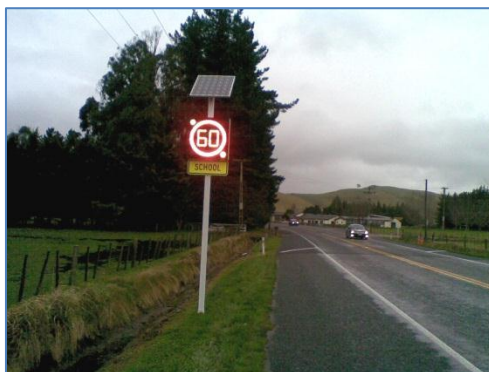
Figure 19 (i) 60km/hr LED Mandatory Speed Sign Installed - Southbound

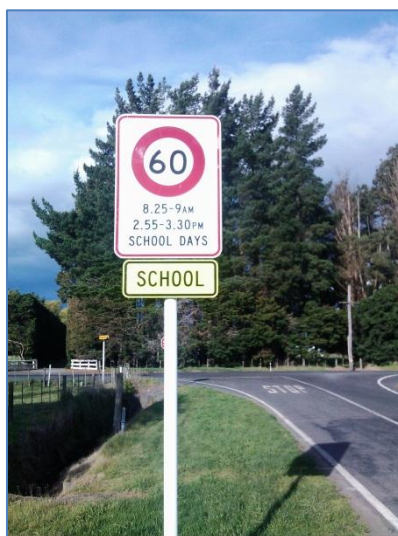
Figure 20 Pakipaki School - Side Road Warning Signs on Turamoe Road

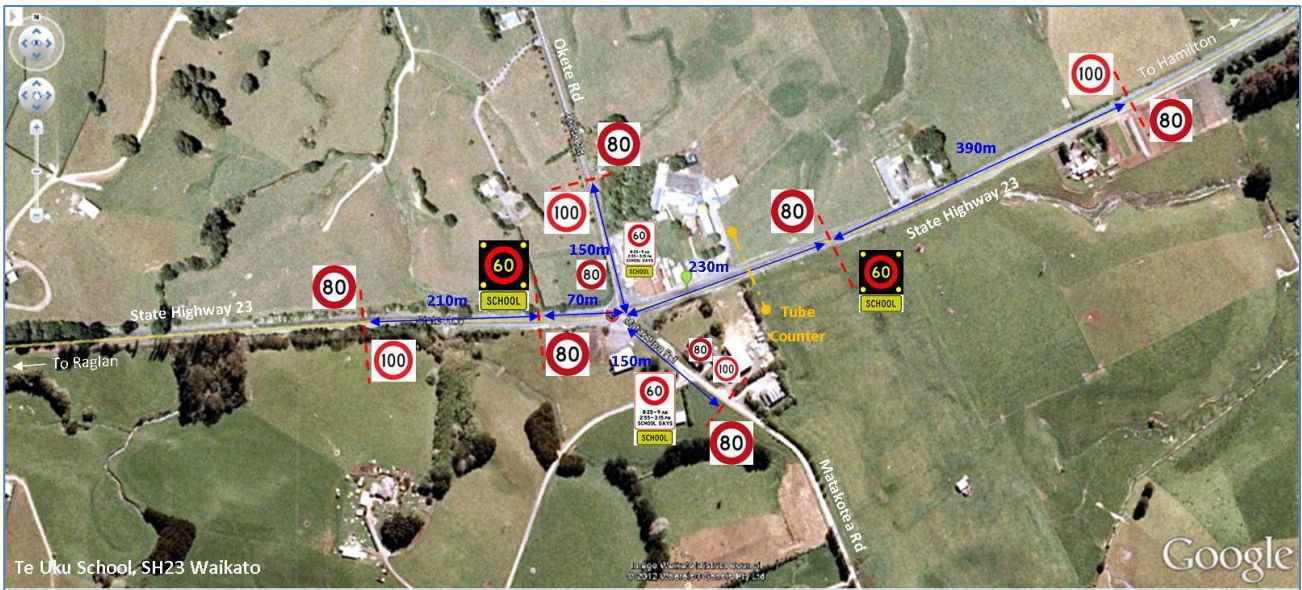
Figure 21 Te Uku School - Trial Signs Location & Layout

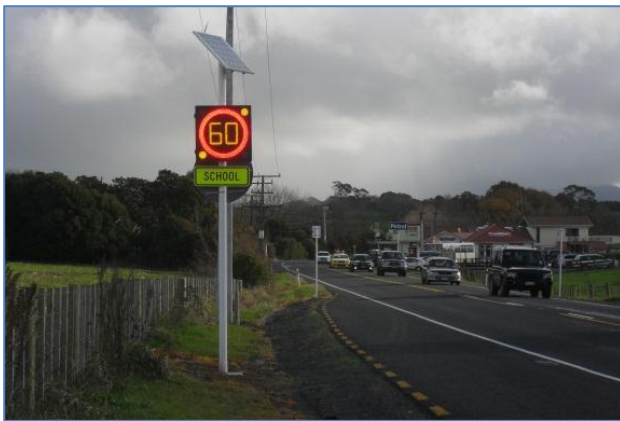
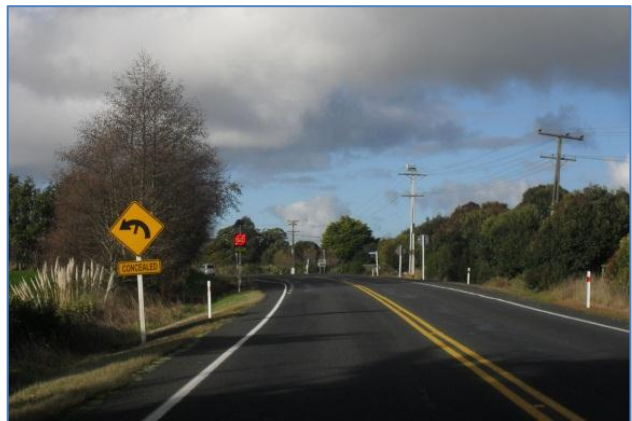
Figure 22 (i&ii) 60km/hr LED Mandatory Speed Sign Installed - Left: Westbound, Right: Eastbound

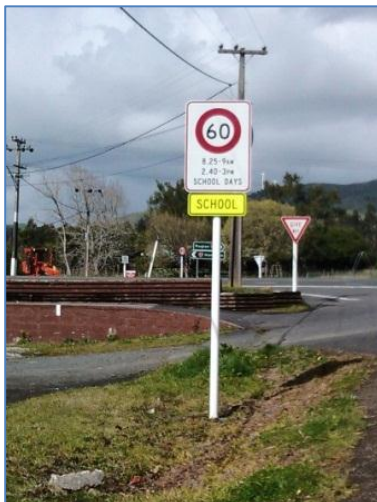
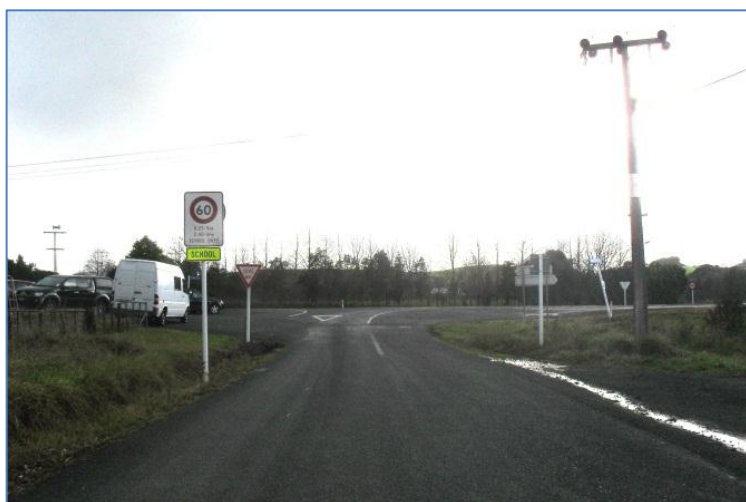
Figure 23 (i&ii) Te Uku School - Side Road Warning Signs on Okete Rd (left) and Matakotea Road (right).

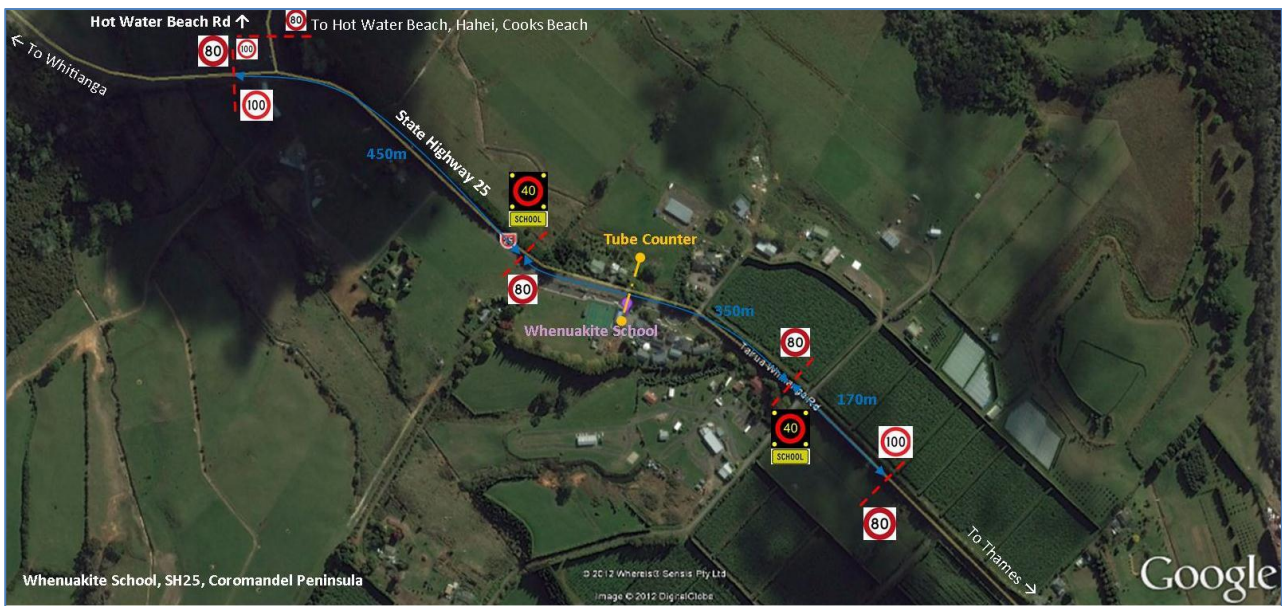
Figure 24 Whenuakite School - Trial Signs Location & Layout

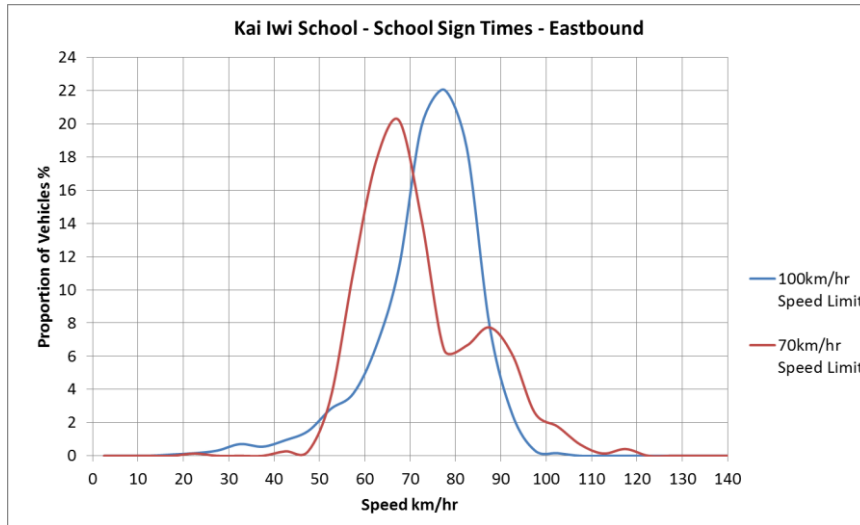
## Kai Iwi School – Eastbound

School Sign Times – 8.20am-8.55am / 2.50pm-3.10pm

The eastbound traffic showed very little change in average speed once the 70km/hr speed limit was implemented (dropping by 1.3km/hr) and the 85<sup>th</sup> percentile speed increased by 5 km/hr to 88km/hr. However, the median and modes dropped much more significantly. Also, prior to the operation of the 70 km/hr signs, the eastbound traffic was travelling well below the maximum operating speed of 100km/hr during school times, which means that any large drop in speed would be unlikely. The speed distribution graphs for Kai Iwi school during school times show that a double-peak distribution has emerged following the implementation of the signs. This should be treated with caution as it may be that there two separate set of expectations about the appropriate speed when the sign is activated, which may not be beneficial to road safety.

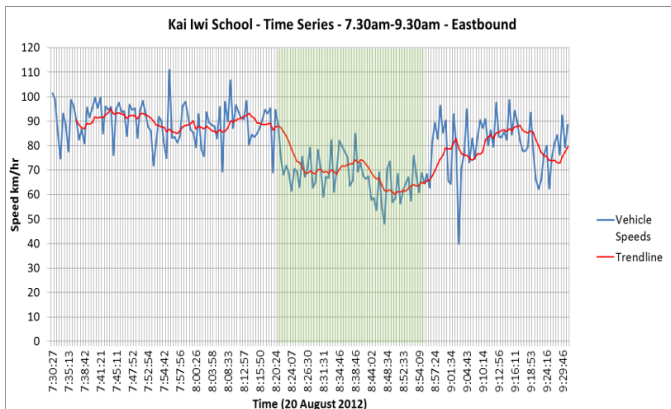
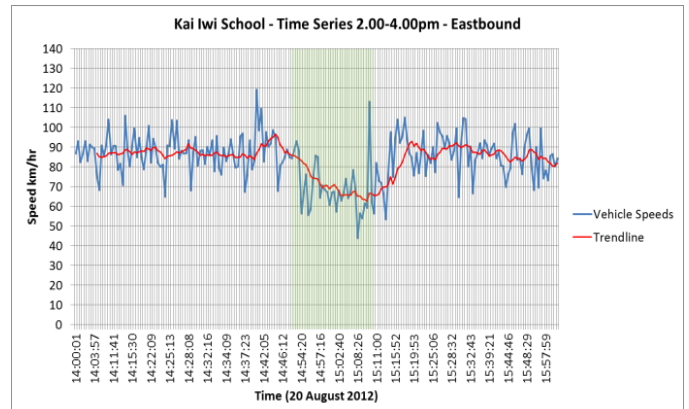
## Time Series - School Sign Installed – 20 August 2012

School Sign Activated

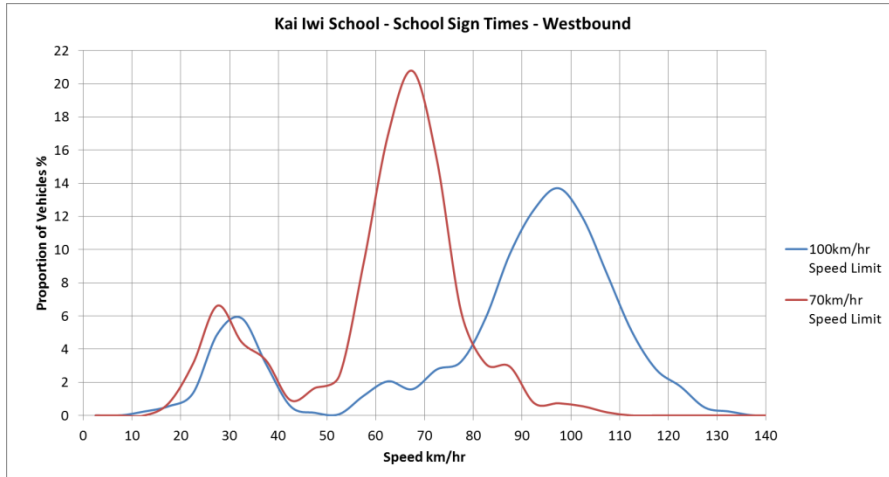
# Kai Iwi School – Westbound

## School Sign Times – 8.20am-8.55am / 2.50pm-3.10pm

Speed data collected at Kai Iwi School during school sign activation periods (70km/hr speed limit) showed significant reductions in speed for westbound vehicles as shown in Table 2. The 85<sup>th</sup> percentile speed reduced by 30% from 107km/hr to 75km/hr and the average speed reduced by 27% from 84km/hr to 61km/hr.

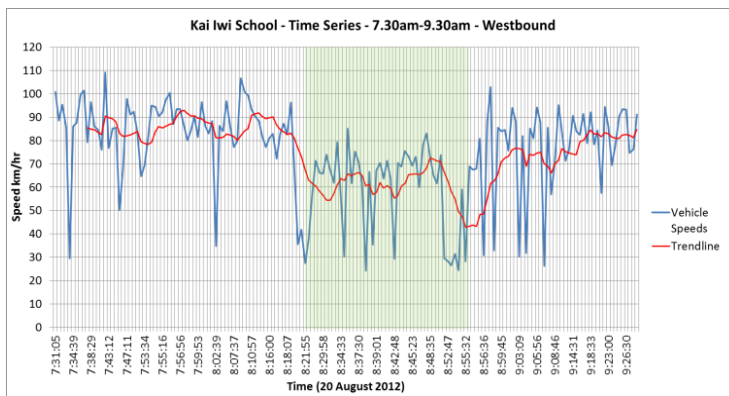
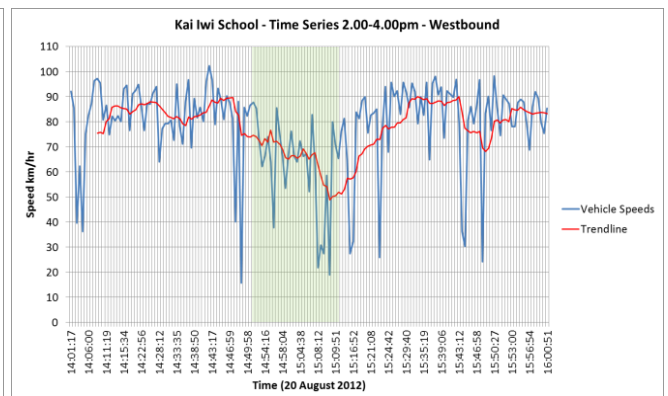
## Time Series - School Sign Installed – 20 August 2012

School Sign Activated

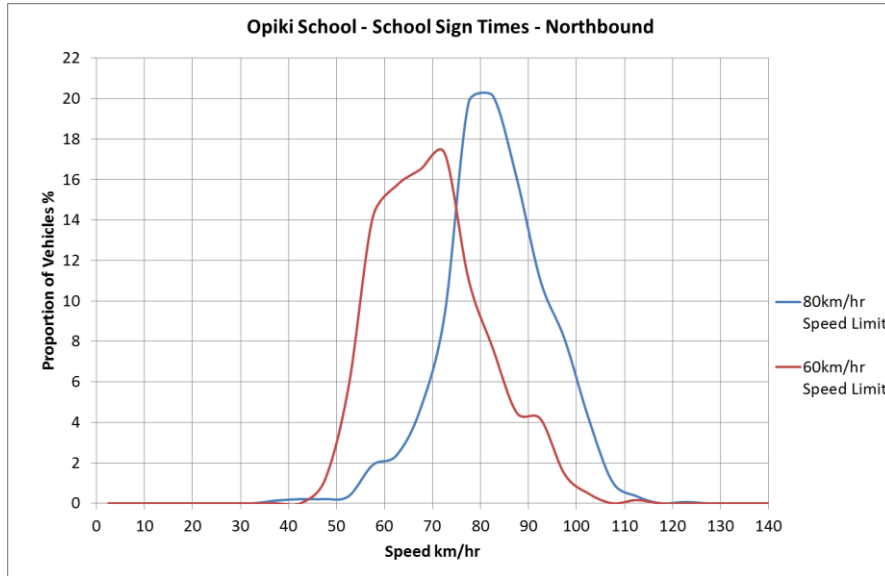
# Opiki School – Northbound

School Sign Times – 8.25am-9.00am / 2.50pm-3.10pm

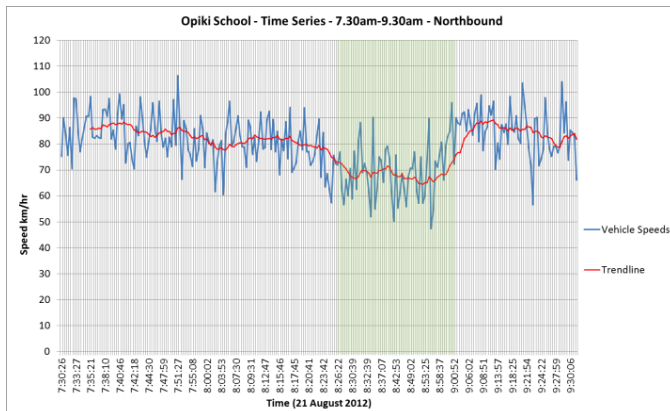
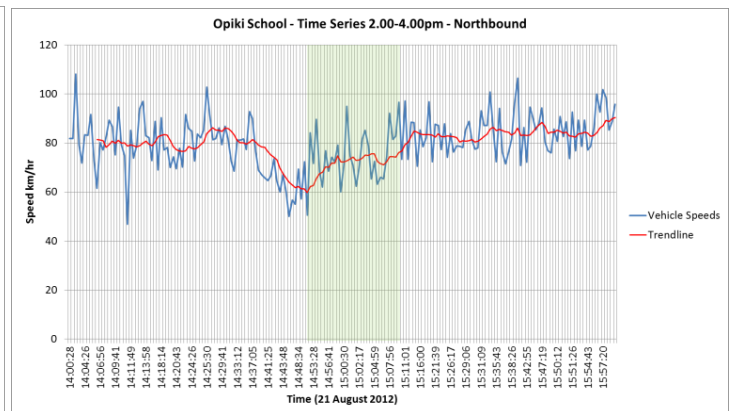
## Time Series - School Sign Installed – 21 August 2012

School Sign Activated

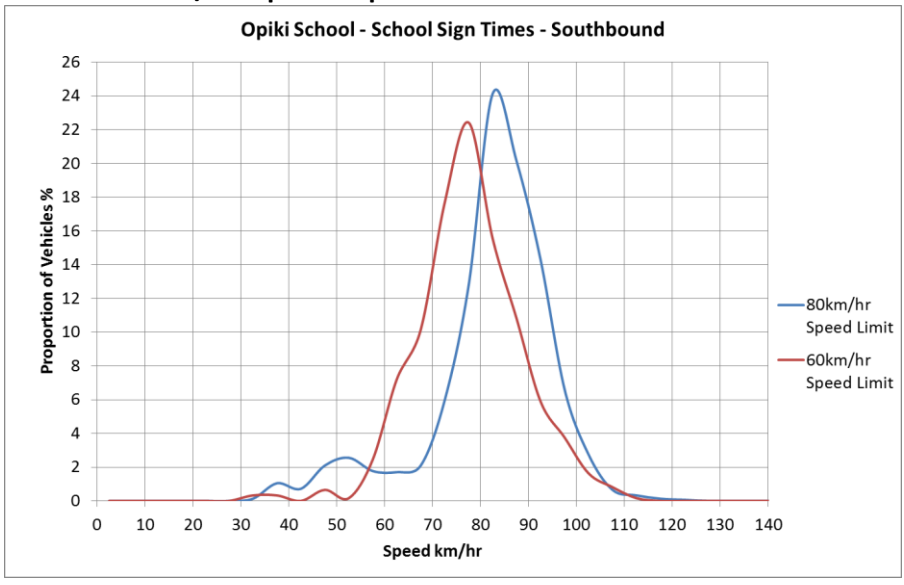
# Opiki School – Southbound

School Sign Times – 8.25am-9.00am / 2.50pm-3.10pm

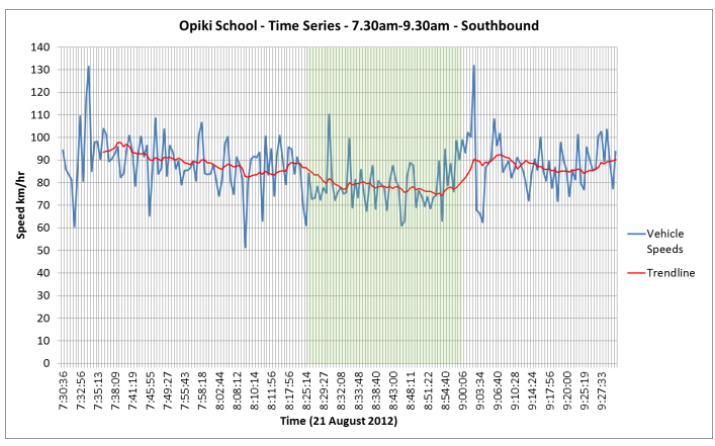
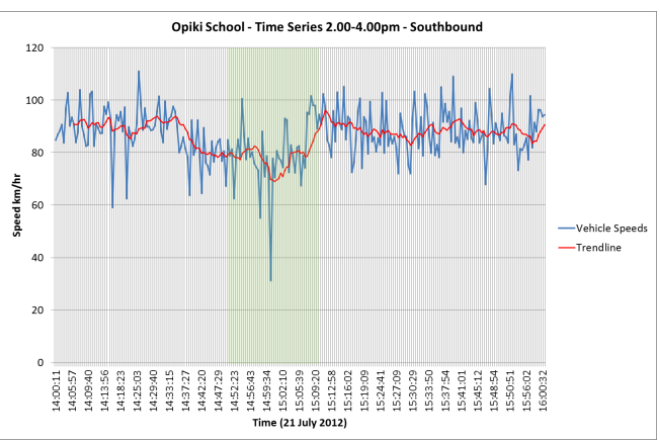
## Time Series - School Sign Installed – 21 August 2012

School Sign Activated

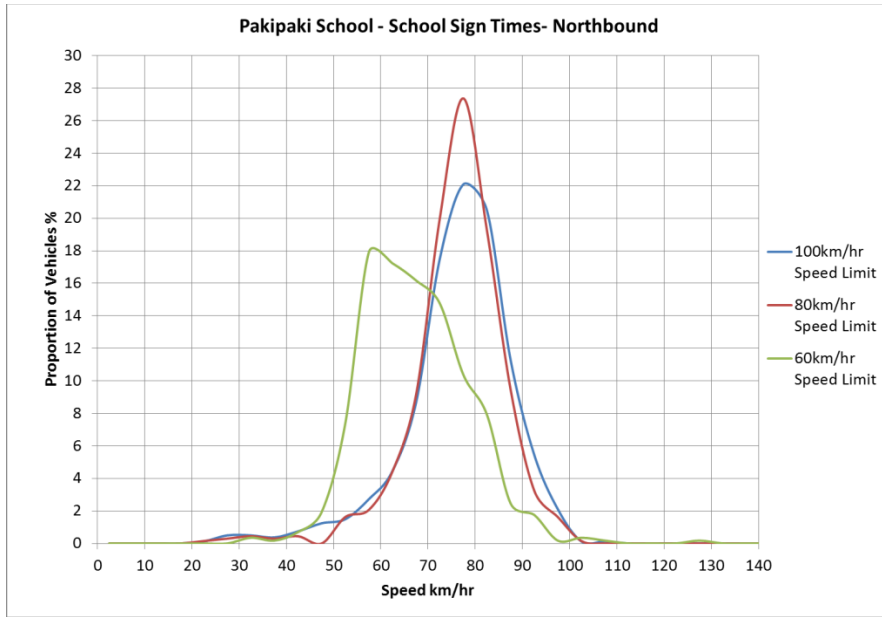
# Pakipaki School – Northbound

School Sign Times – 8.25am-9.00am / 2.55pm-3.20pm

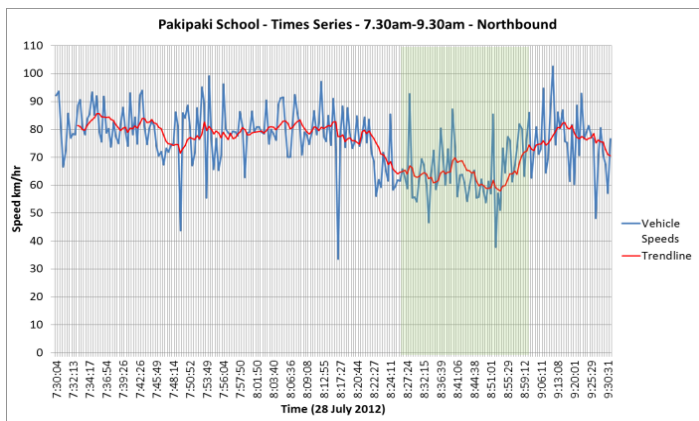
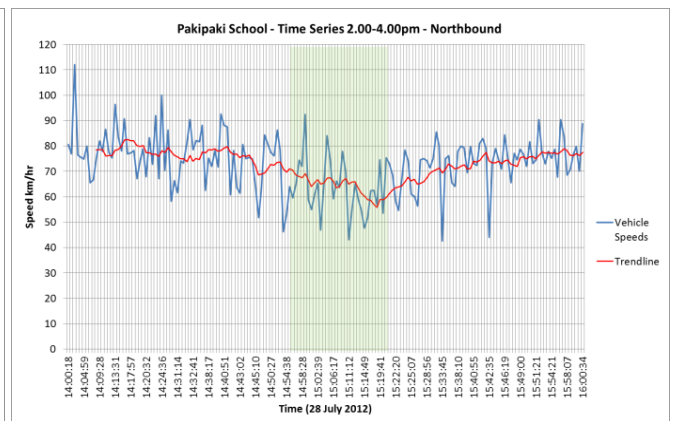
## Time Series - School Sign Installed – 28 July 2012

School Sign Activated

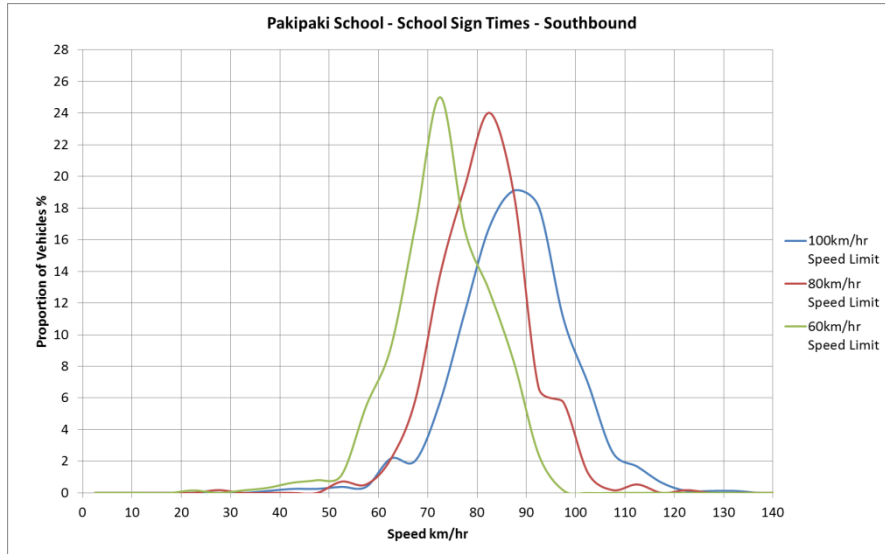
# Pakipaki School – Southbound

School Sign Times – 8.25am-9.00am / 2.55pm-3.20pm

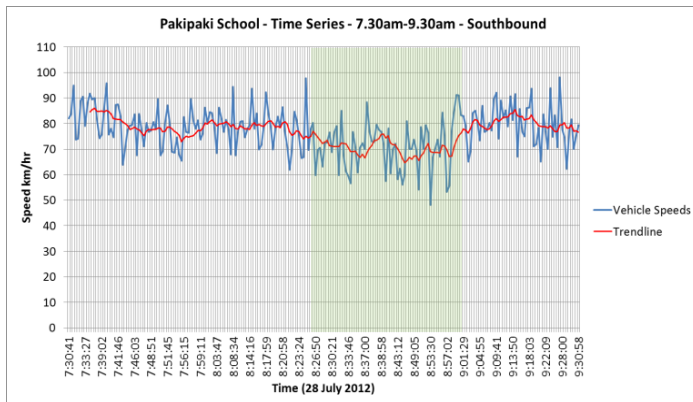
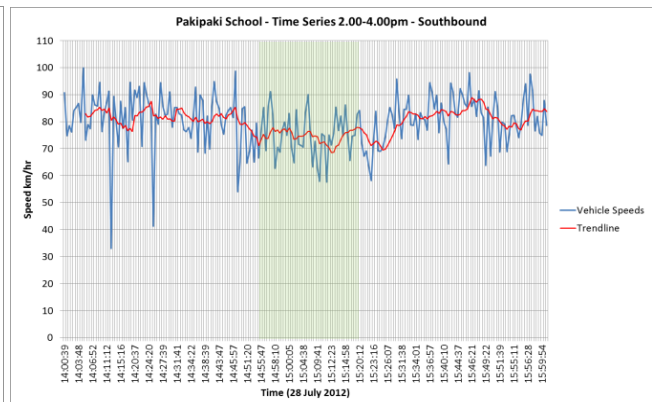
## Time Series - School Sign Installed – 28 July 2012

School Sign Activated

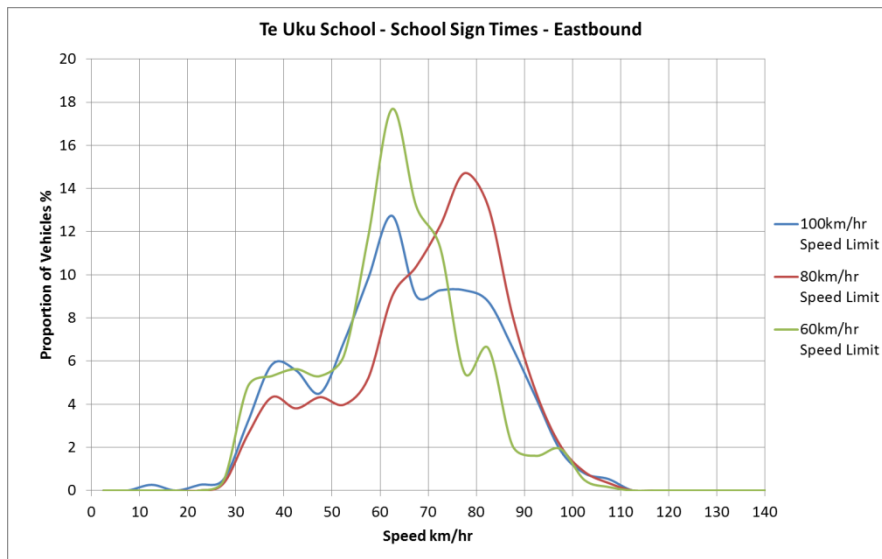
# Te Uku School – Eastbound

School Sign Times – 8.35am-9.10am / 2.45pm-3.05pm

Traffic speeds for Te Uku School (Table 8) show that the vehicle speeds during school drop-off and pick-up times are lower than the general speed data shown in Table 9 (more so than for the previous three schools). Interestingly speeds went up in the eastbound direction in particular following the implementation of the 80 km/hr signs, however, the speeds are well below the posted speed limit and there may have been varying conditions when the speeds were measured.

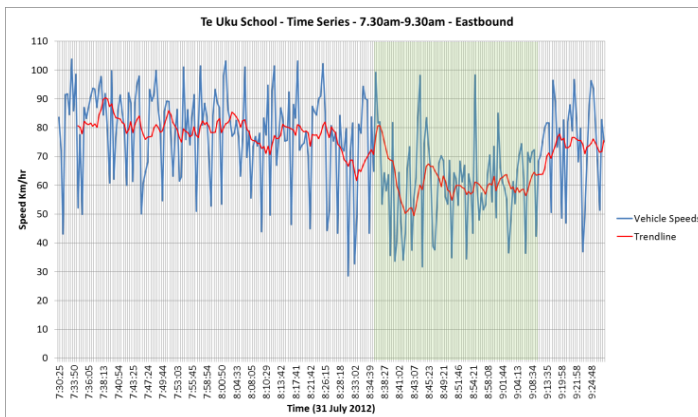
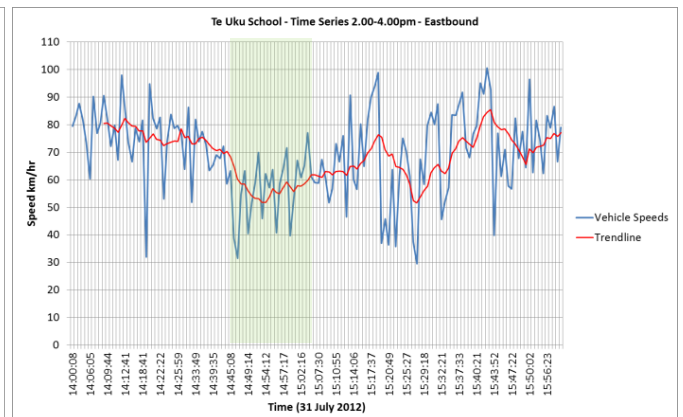
## Time Series - School Sign Installed – 31 July 2012

School Sign Activated

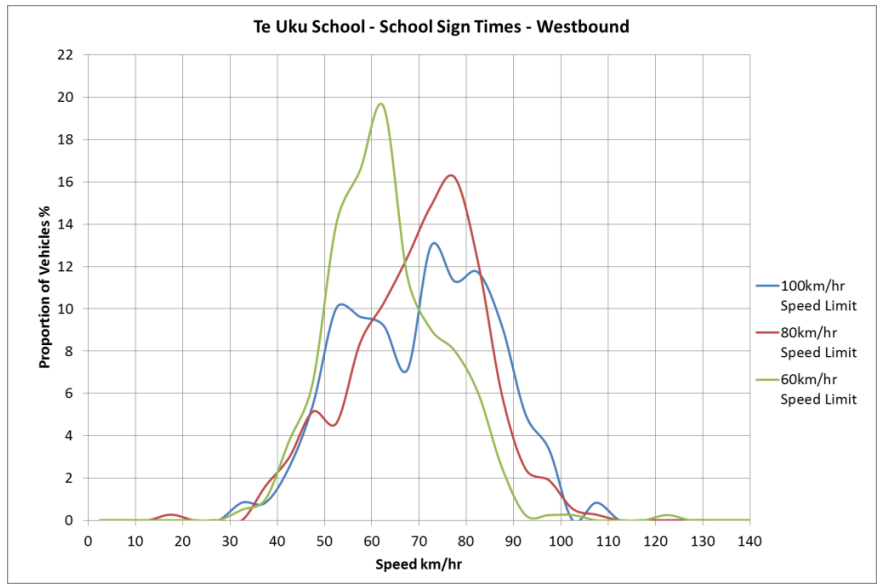
# Te Uku School – Westbound

School Sign Times – 8.35am-9.10am / 2.45pm-3.05pm

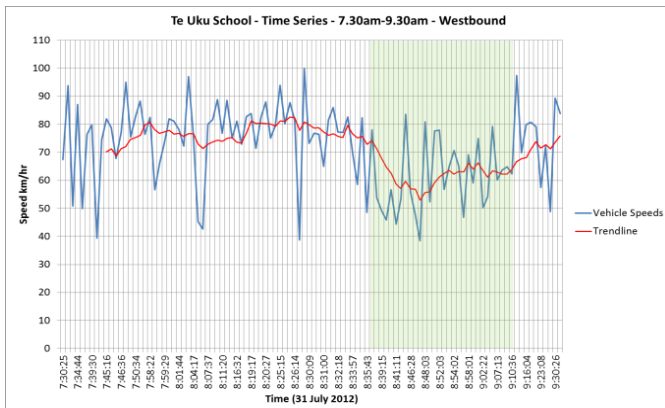
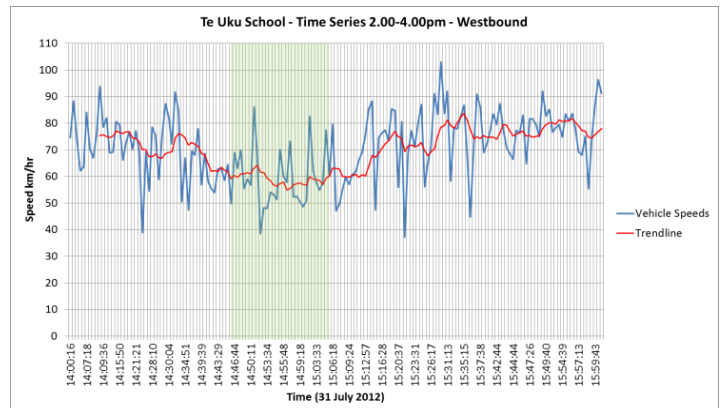
## Time Series - School Sign Installed – 31 July 2012

School Sign Activated
