## Evaluation of variable speed limit signs at rural schools

Prepared for the  
Road Safety Trust

19 November 2012

Preliminary Report

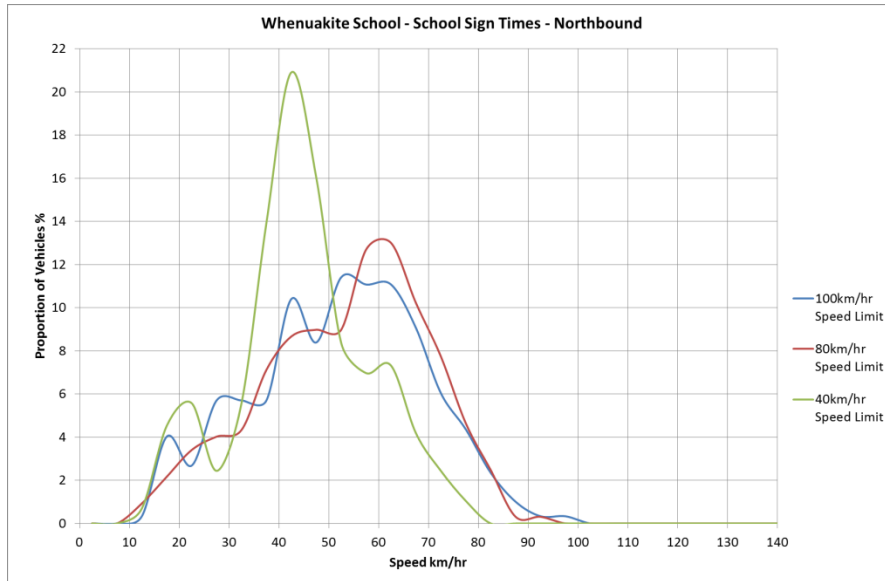
# Whenuakite School – Northbound

School Sign Times – 8.25am-9.00am / 2.55pm-3.15pm

Traffic speeds at Whenuakite School (Table 10) show that the natural traffic speed during school times is significantly lower than the 100 km/hr or even 80 km/hr speed limits. The introduction of the 40 km/hr variable speed limit signs has resulted in a 10% reduction in the 85<sup>th</sup> percentile speeds of southbound vehicles and 8% reduction in northbound vehicles (compared with 100km/hr speed limit). There was a 15% reduction in the average speeds of northbound vehicles between the 80km/hr and 40km/hr speed limit conditions, but only a 2% reduction in southbound vehicle speeds. In the southbound direction, reported issues related to the sign being shaded by a nearby hedge, may have meant that the sign was not working as effectively as the northbound sign.

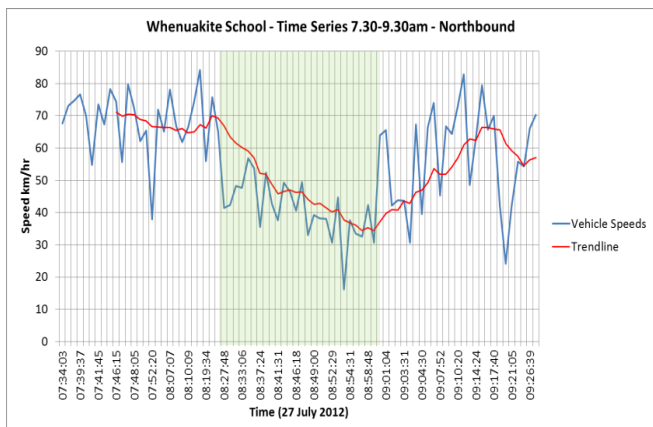
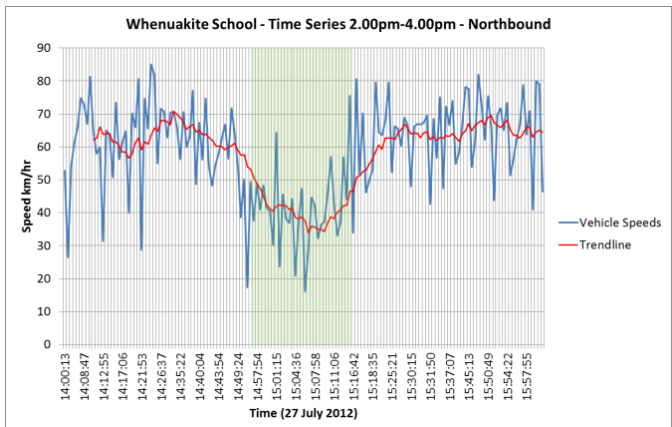
## Time Series - School Sign Installed – 27 July 2012

School Sign Activated

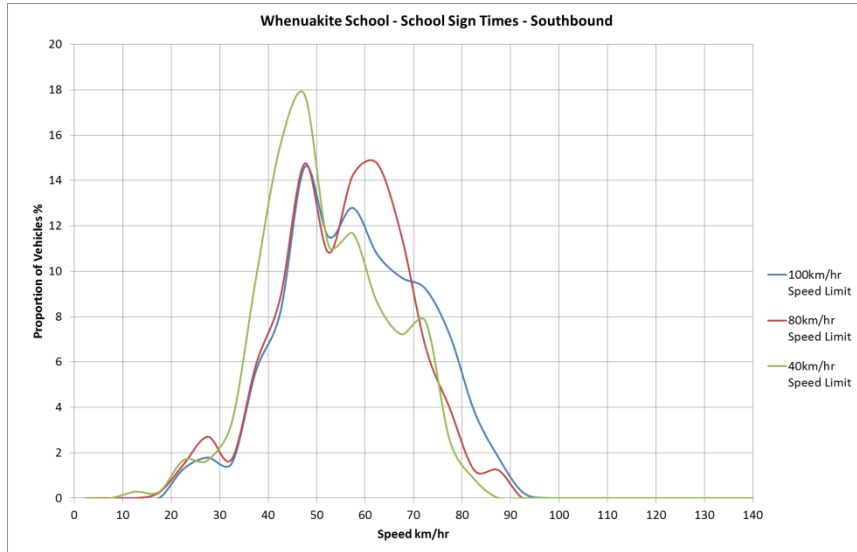
# Whenuakite School – Southbound

School Sign Times – 8.25am-9.00am / 2.55pm-3.15pm

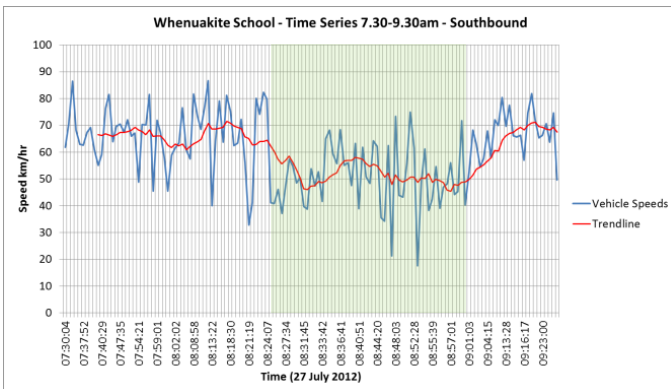
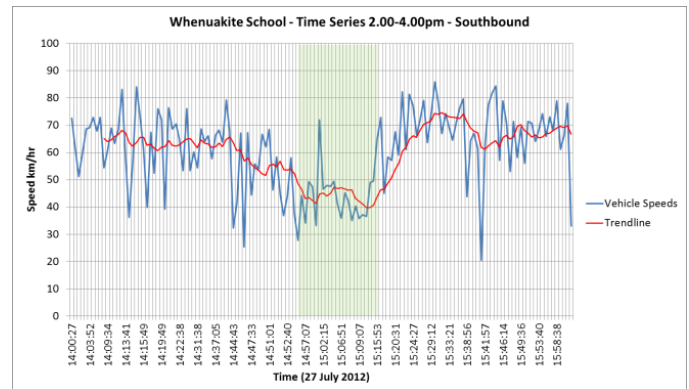
## Time Series - School Sign Installed – 27 July 2012

School Sign Activated
