Project Number: 5-C4708.00

SH2 Remutaka Slow Vehicle MACT 1982 Bays Post Construction Safe System Audit

14 June 2024

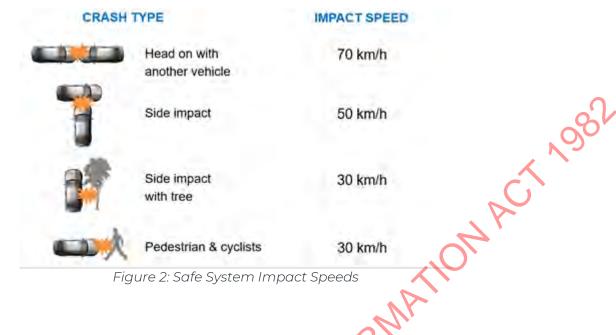
The impact speed in a collision is a significant factor that affects the probability of a person being killed or seriously injured in a crash. Safe System impact speeds are speeds below which the chances of survival are high, and the likelihood of serious injury is low.

Figure is a guide to Safe System impact speeds for common crash types. It should be noted that the angle of impact of a collision is also a factor that affects the severity of a crash. As far as is practically possible, infrastructure should be designed, and travel speeds managed so that the impact speeds when a crash occurs are below the thresholds show in Figure

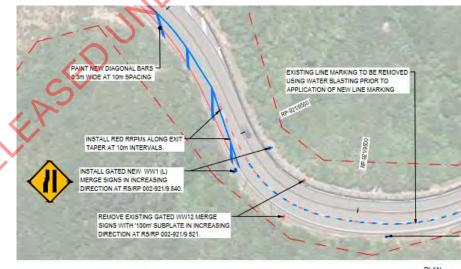
Figure 5: Location of end hatching relative to geometry making returning to the through lane challenging.

Limited visibility occurred on both left hand and right-hand curves. On left hand curves the wing mirror view is either into the hillside or over the cliff rather than over the lane. On right hand curves the roadside topography can obscure visibility. The challenging visibility distracts drivers attention away from the carriageway ahead of them, increasing handling errors or potentially striking an object. Some SVB users may come to a stop to identify a gap in traffic.

Recommendation: Consider remarking slow vehicle bay terminal merge(s) to reduce conflict between various road users, particularly; extend short slow vehicle bays,

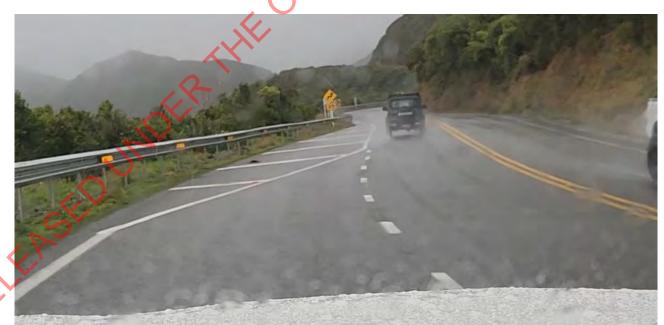
Figure 7: Continuity lines marked to end of Slow Vehicle Bay

The continuity line marking on site is marked throughout the full length of the Slow Vehicle Bay, unlike what is shown on the plans. This reinforces that SBV users need to giveway to through traffic.

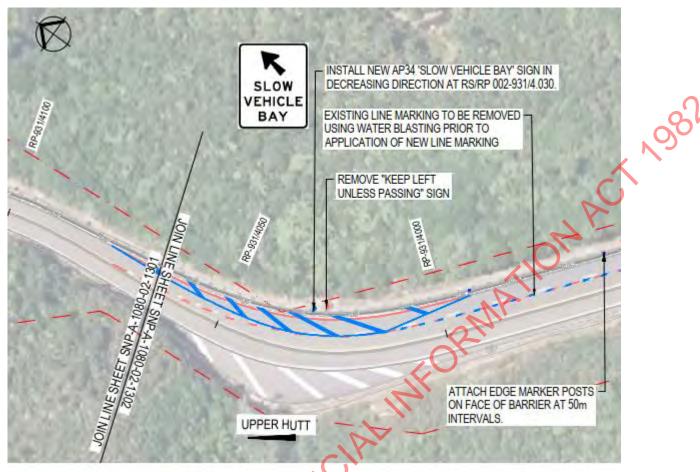
Figure 8: Curve geometry and hatched entry/taper for Slow Vehicle Bay

If entering over the entry hatching, vehicle handling is simpler typically consisting of a single movement. However, the hatched markings may cause some drivers to refrain entering this area as it is perceived as an area for emergency / wider vehicle turning use.

Recommendation: Consider removine hatching having taper at the current diverge. If hatching retained, consider shifting the AP34 "Slow Vehicle Bay" sign to the start of the hatched area to encourage direct entry over the hatching to improve entry negotiation.

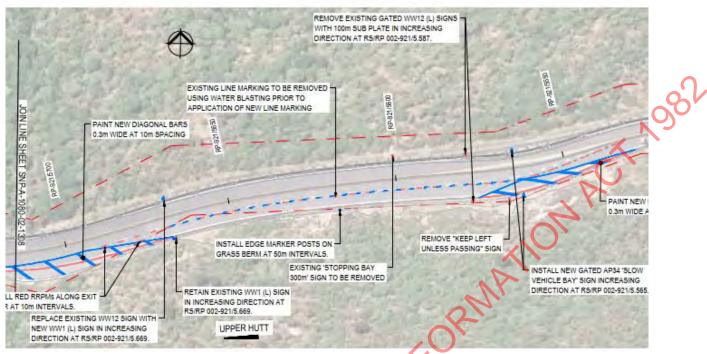
Figure 9: Reduced offset between through traffic lanes.

Under the previous layout, within the passing lanes, the through traffic lane was on the left-hand side of the carriageway. With a Slow Vehicle Bay, the through traffic lane is in the centre of the carriageway, reducing the offset between the opposing through traffic lanes, increasing the head-on crash risk when road users lose control. SH2 Remutaka has a high number of loss of control crashes.

Recommendation: Encourage through vehicle movement into left hand lane by diverging from the centre line rather than the edgeline.

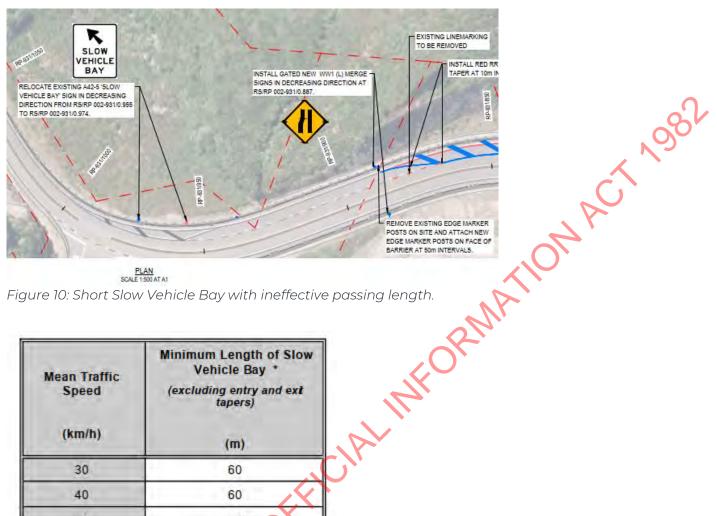
Figure 10: Short Slow Vehicle Bay with ineffective passing length.

Most of the Slow Vehicle Bays have a continuity line length of approximately 150 m to 250 m. However, three are short with continuity line lengths of approximately 100 m or less. Short Slow Vehicle Bays limit the number of vehicles which can be safely passed, unsafe passing manoeuves increase the head-on crash risk. Locations with short lengths include:

For short Slow Vehicle Bays the relative potential speed differential, vehicle lengths, and acceleration rates on significant slopes limit the ability of effective Slow Vehicle Bay use. Austroads Guide to Geometric Design² refers to MOTSAM Part 1 & Part 2 for lengths (see Figure 11 below).

Recommendation: Carry out speed surveys on entry into all Slow Vehicle Bays to determine if there is adequate length for a safe passing manoeuvre based on vehicle speeds, if not convert into hatched area.

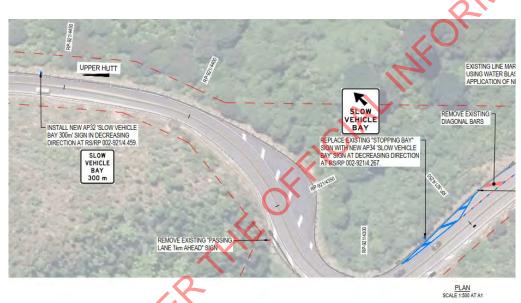
Figure 12: Long offset between advanced notification of Slow Vehicle Bay and bay location.

Due to low operating speeds, 300 m is between 20 and 40 seconds ahead of the slow vehicle bay. Road users are not adequately able to judge the distance travelled over this period and may attempt to use an inappropriate facility for being passed.

Recommendation: Consider relocating advanced warning sign to start of hatched area at RP4.35 and RP3.1 to reduce confusion for slow vehicle bays identified above.
