HI-LAB Pavement Testing at CAPTIF

Data Report

21 May 2024

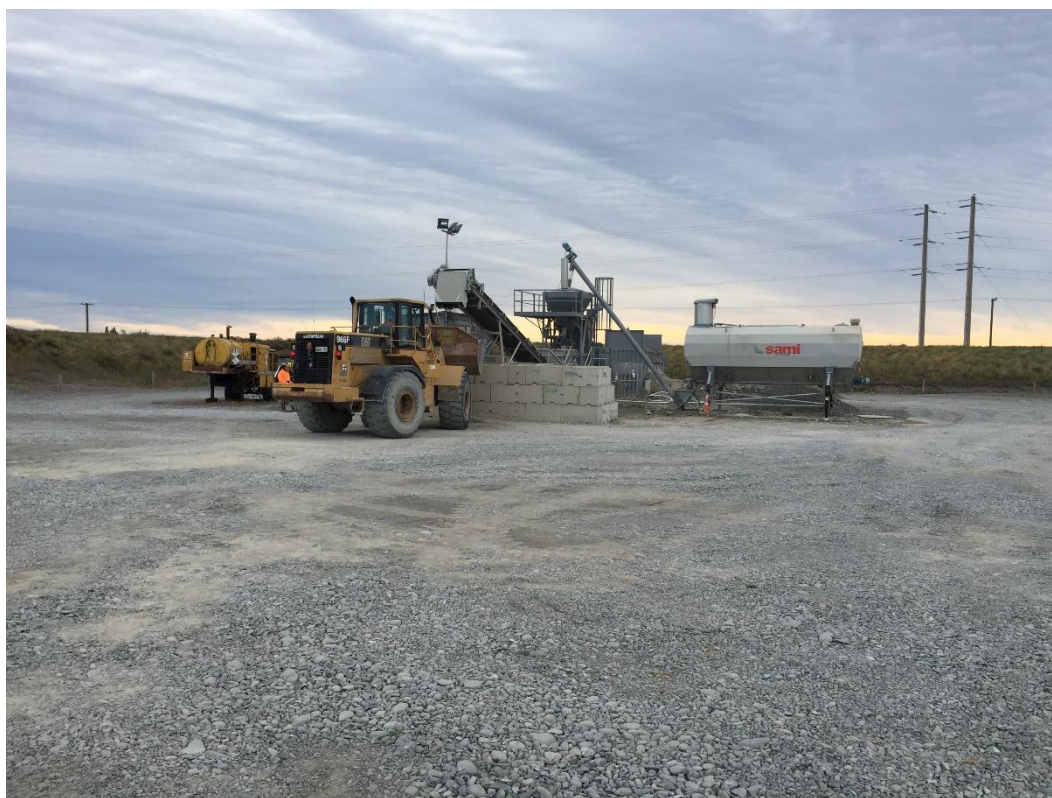
The aggregate for the Hi-Lab layers was sourced from J Swap Taotaoroa Quarry in the Waikato. Hi-Lab 40 and Hi-Lab 65 aggregate was trucked to Fulton Hogan Canterbury where 3% cement by mass and water for compaction were added to the aggregate via a pugmill (Figure 9).

Figure 9 Hi-Lab Pug Mill

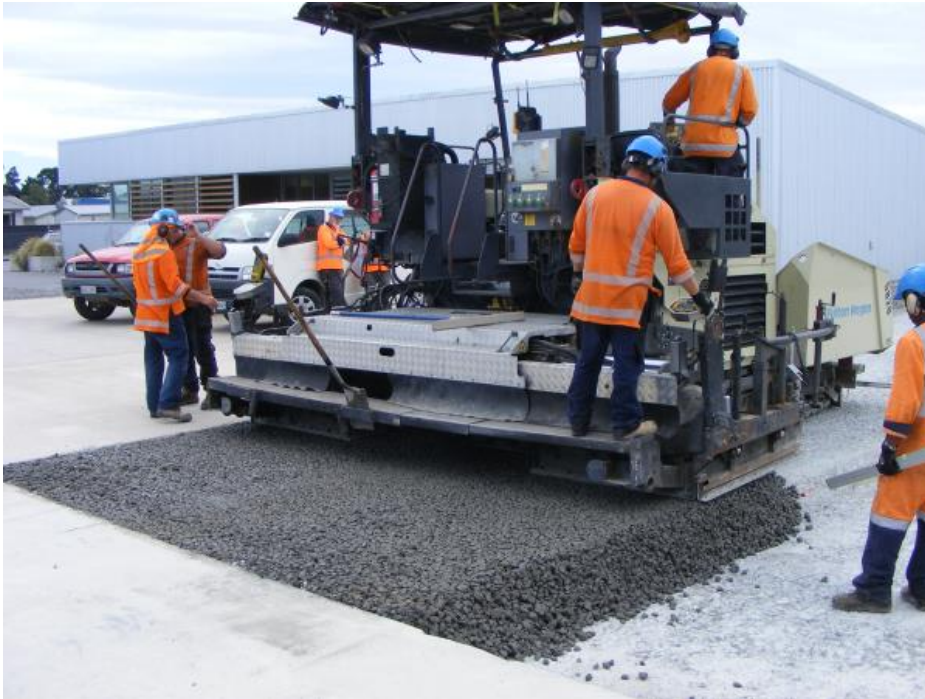
Figure 12 Hi-Lab 40 Paved in CAPTIF Yard

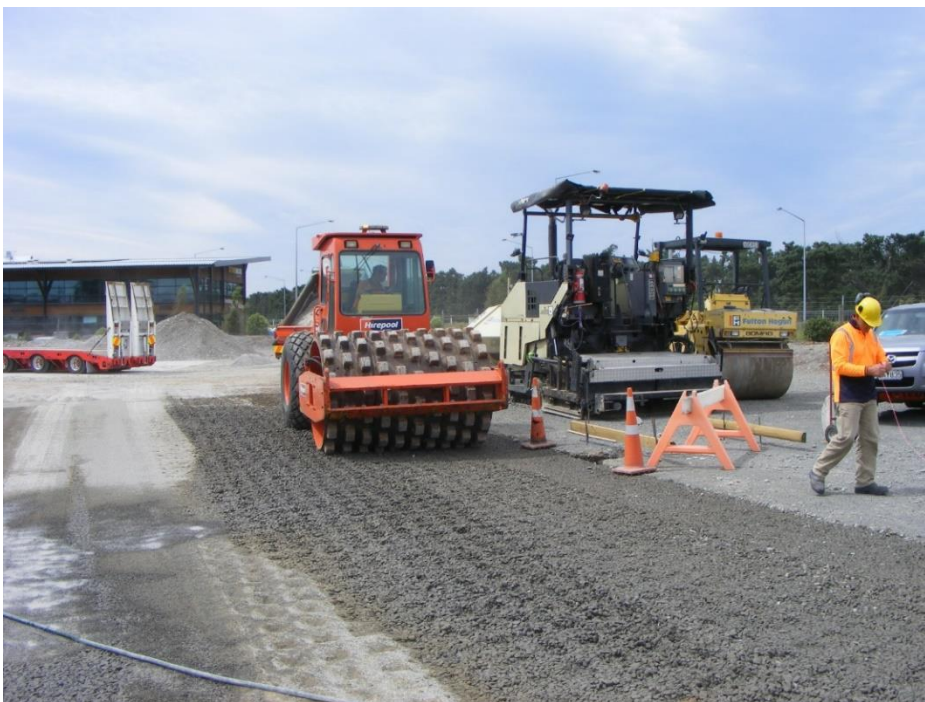
Figure 13 Hi-Lab 40 Primary Rolling with Padfoot

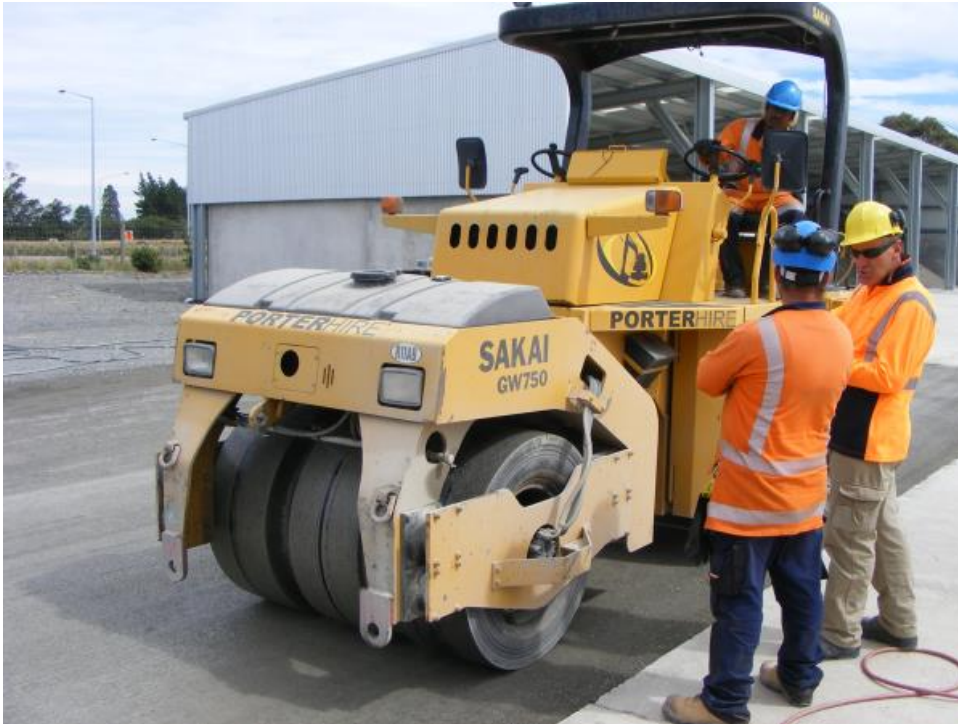
Figure 14 Hi-Lab 40 Secondary Rolling with Pap 7 to choke the surface

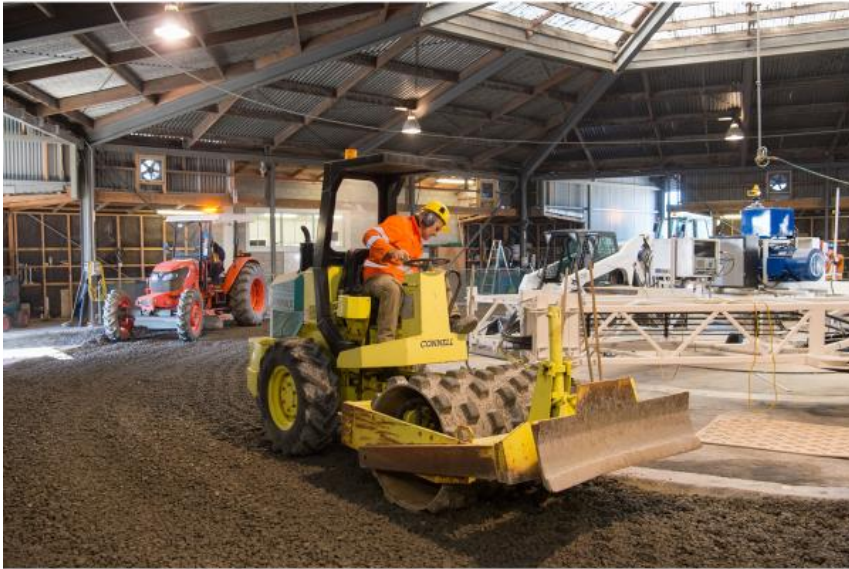
Figure 15 Hi-Lab 40 Laid in Track

The final construction approach at CAPTIF was to mix the cement and water into the Hi-Lab using a pug mill. The material was transported to CAPTIF, placed in a stockpile and a loader was used to “turn” the materials within the stockpile over to improve mixing and to immediately run the material into the shed for placement. Primary compaction was complete with the 3.3 ton pad foot roller and trimming was completed with a mid-mounted blade on a tractor (Figure 15). Further compaction was completed with a 4 ton dual smooth drum roller.

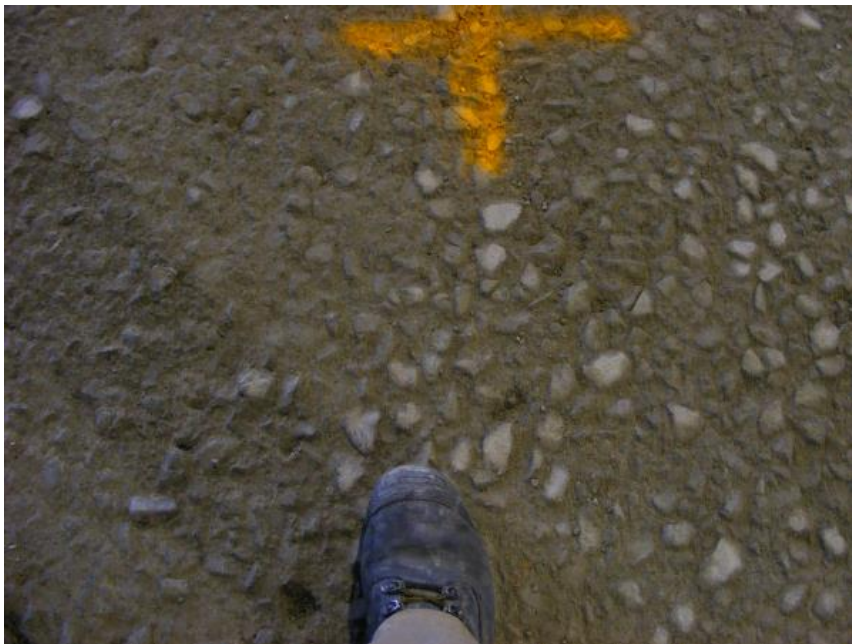
Figure 16 Hi-Lab 40 finished surface prior to sealing

Figure 16 shows the completed surface prior to sealing.

The final Hi-Lab surfaces were then tack coated with 180/200 bitumen with 2% kerosene at a nominal rate of 0.2 l/m² and a nominal 25mm DG10 asphalt running surface applied.

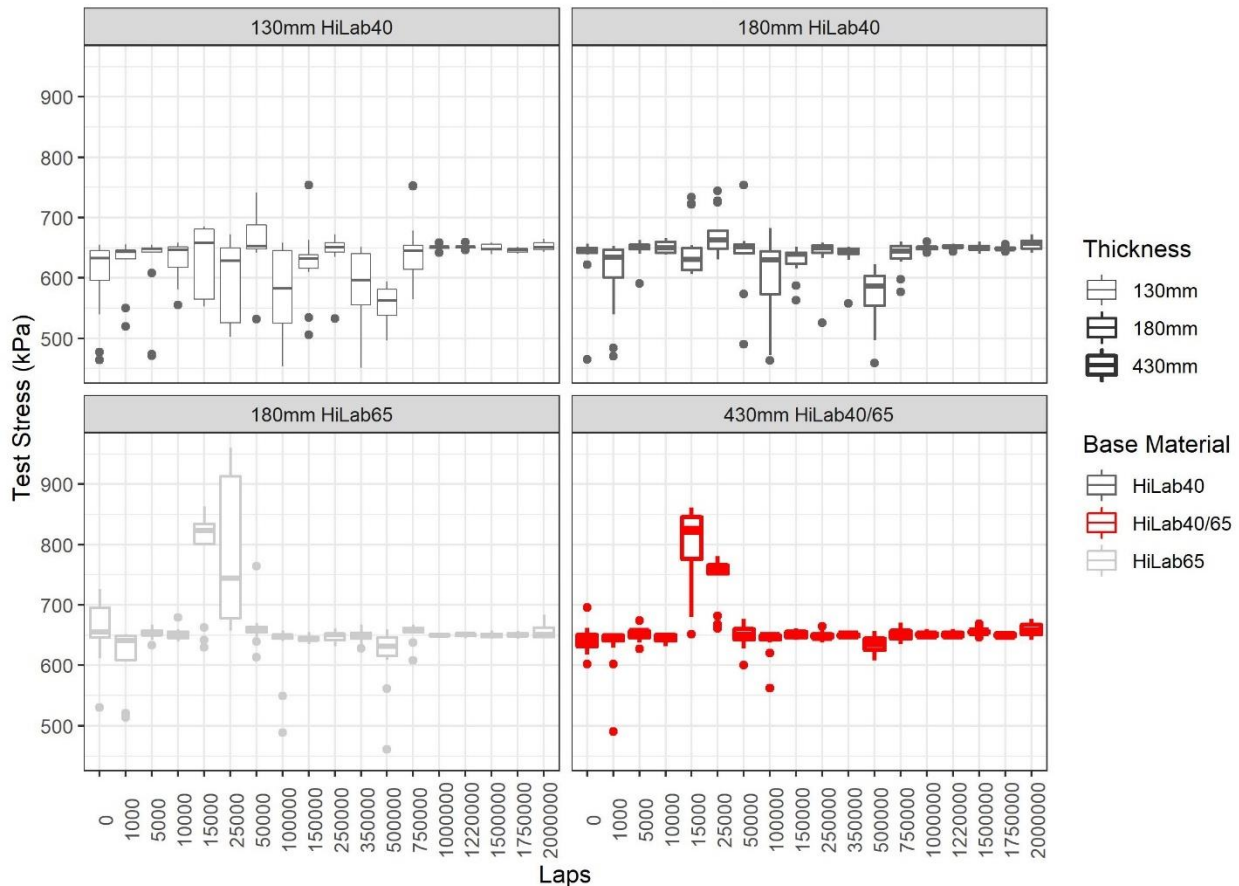
Figure 18 presents a box plot of the Stress results of the FWD testing during loading. Observations from Figure 18 are:

- The early FWD testing consistently struggled to meet the target 650 kPa testing stress.

Figure 18 FWD Stress readings during loading, faceted by test section.

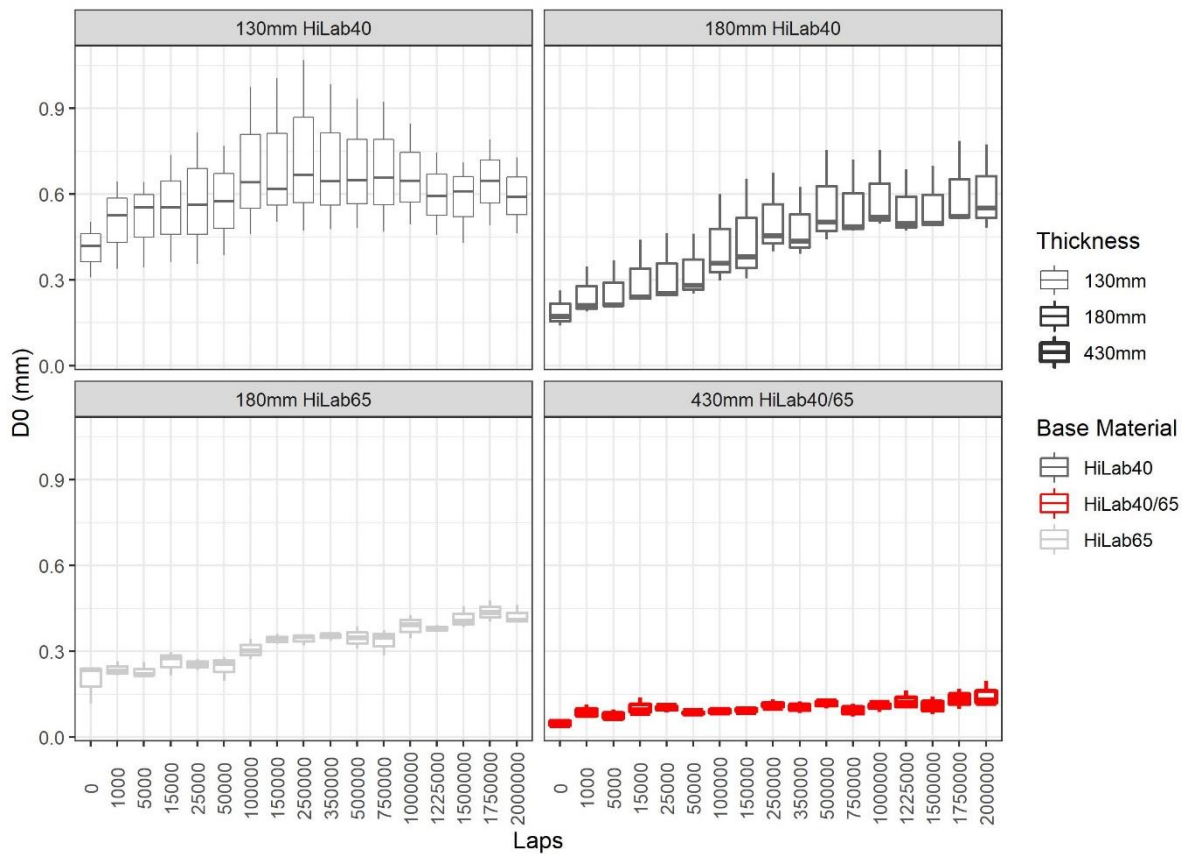
- The weakest section (top left) is the thin 130 mm Hi-Lab section. The BB D0 readings rise quickly as loading progresses then plateau, as the cement bonds are broken, to a value of 600 microns.
- The 180 mm of Hi-Lab 40 deteriorates more slowly than the 130 mm Hi-Lab and reaches a similar plateau D0 value of 600 microns.
- The 180 mm of Hi-Lab 65 also deteriorates more slowly and reaches a similar but slightly lower plateau D0 value of 450 microns.
- The 430mm of Hi-Lab 40/65 deteriorates the slowest and it does not appear to plateau, however the average D0 value only reaches 150 microns, which is a very small value.

Figure 20 Benkelman Beam D0 readings during loading, faceted by test section.

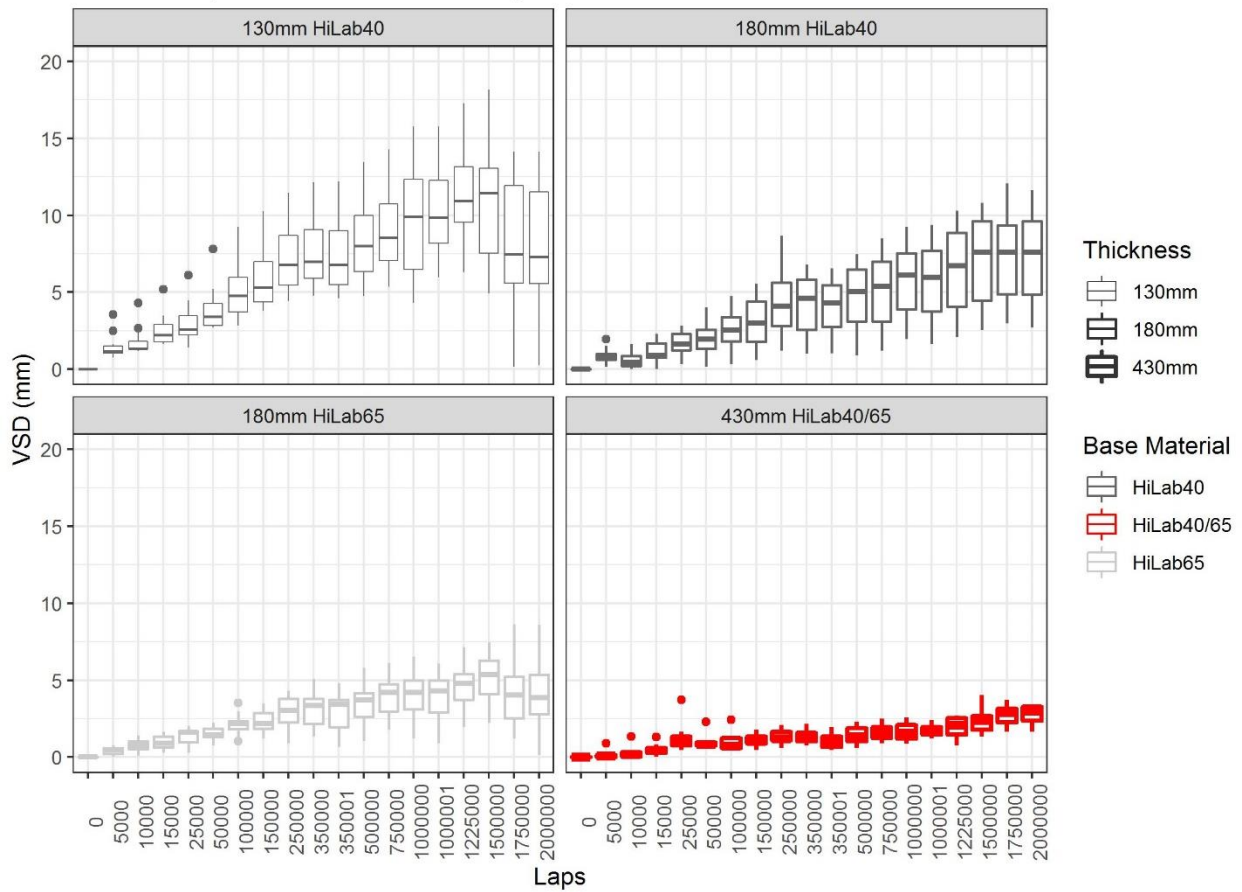
- The weakest section, 130 mm of Hi-Lab 40, exhibits the highest rutting observed in the experiment. Repairs were made at 1,000,000 and 1,500,000 loading laps.
- The 180 mm Hi-Lab 40 section deteriorates more slowly than the 130 mm Hi-Lab.
- The 180 mm Hi-Lab 65 section deteriorates more slowly than the 180 mm Hi-Lab 40 and appears to be less variable. Repairs were made at 1,500,000 loading laps
- The 430mm of Hi-Lab 40/65 performs remarkably well and is the least variable.

Figure 25 VSD readings during loading, faceted by test section.

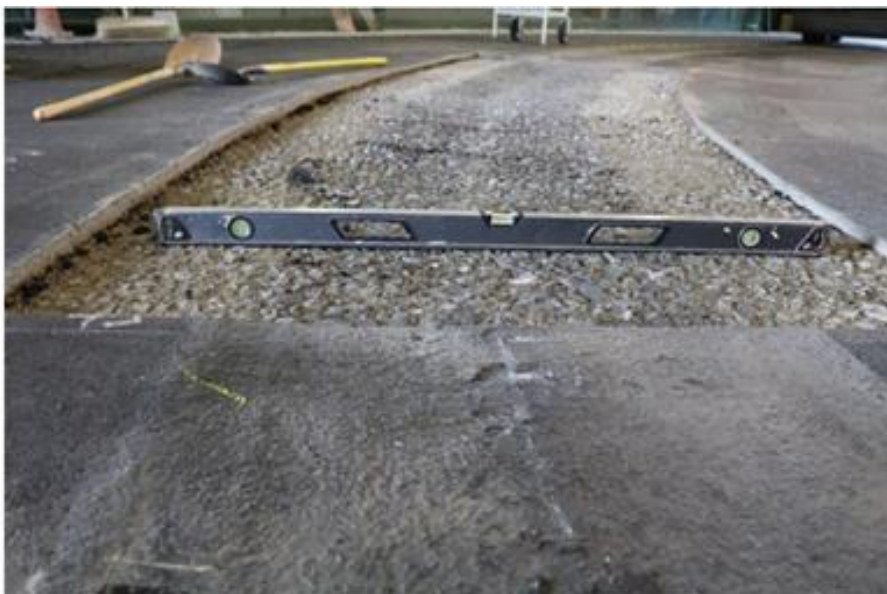
Repairs were made in the surfacing of the 130mm Hi-Lab 40 section during loading at 1,500,000 laps. Figure 27 shows a straight edge placed on the Hi-Lab surface beyond the saw cut face. The rutting can be seen in the asphalt edge but not under the straight edge on the Hi-Lab.

Figure 27 Repairs during loading

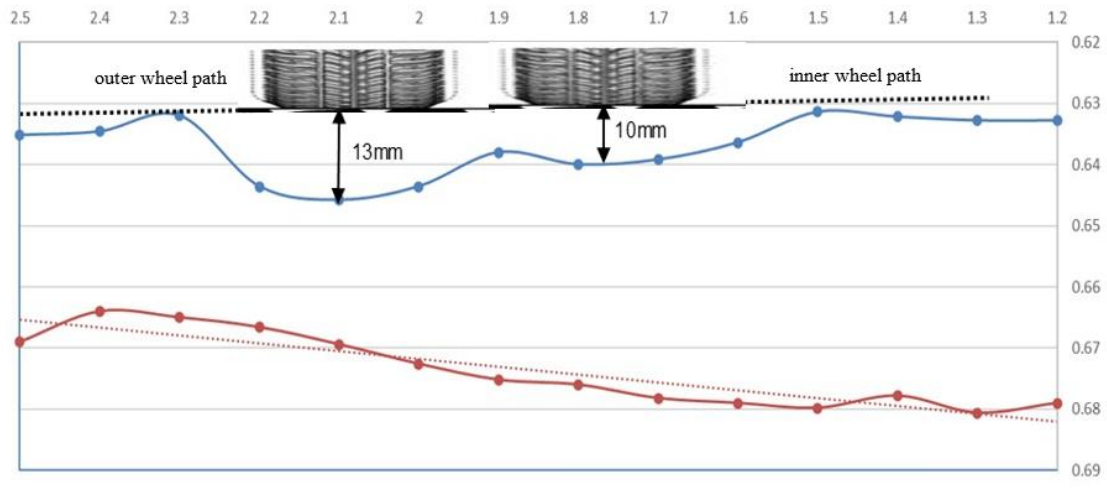
The asphalt had been profiled prior to removal and the underlying 130mm Hi-Lab 40 was also profiled during the repair. The transverse profiles are presented in Figure 28. From the profiles it appears that the bulk of the rutting has occurred in the asphalt layer. The profile plot below of the Hi-Lab 40 layer (red line) shows no deformation (rutting) with the as-built cross-fall of approximately 2% sloping toward the centre of the test track. Hence, the Hi-Lab 40 layer does not mirror the asphalt surface rut profile, with little indication of rutting within the Hi-Lab 40 layer.

Figure 28 Repair layer profiles (AC in Blue, Hi-Lab in Red)

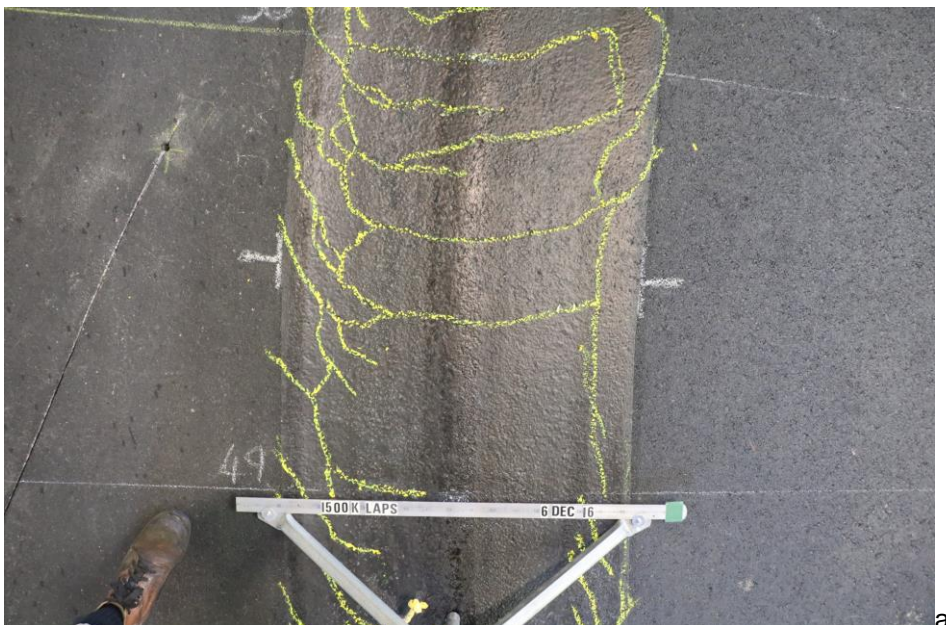
Cracking was monitored during the project at major intervals when transverse profiles were undertaken. On crack initiation photographs were taken to record crack progression (Figure 30 and Appendix A Crack photos) and records kept of when the cracking required repair (Figure 31).

Figure 30 Cracking monitored with Photos

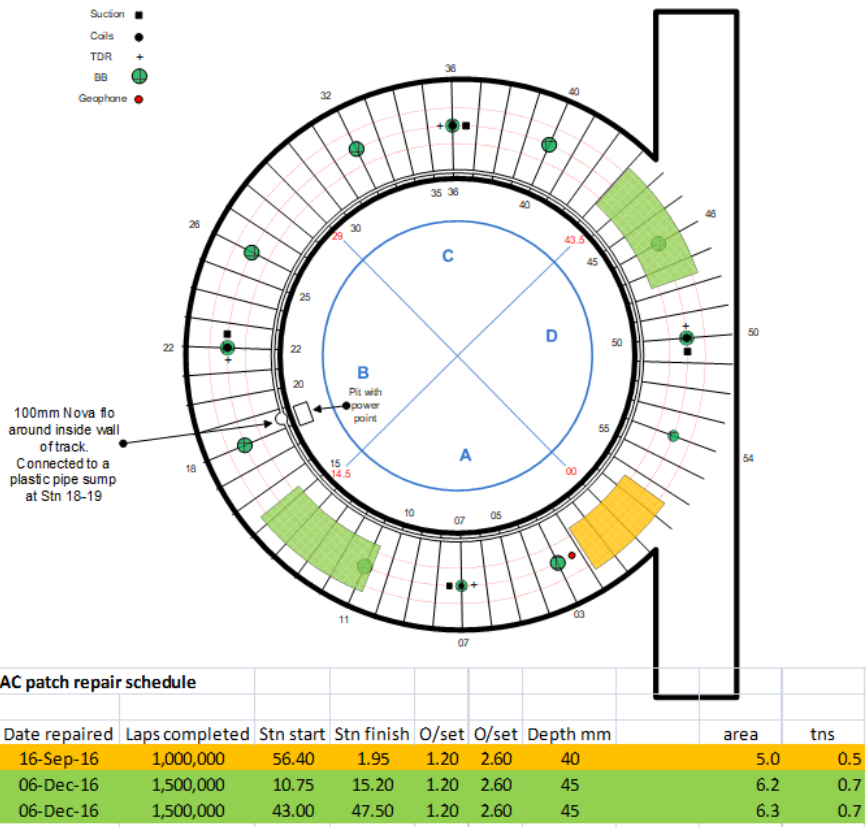
Figure 31 Cracking related surfacing failures

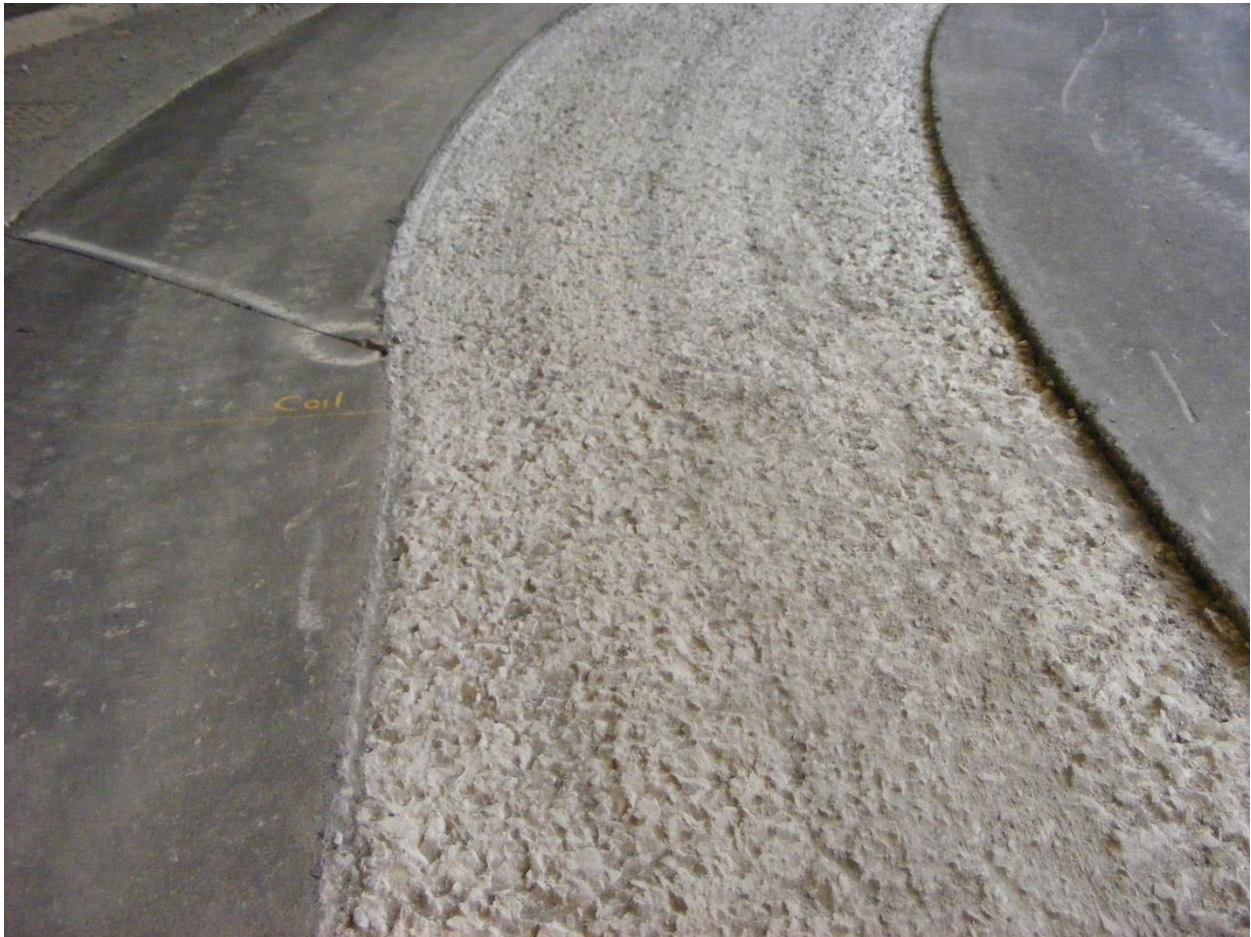
The existing dense asphalt surface was milled out in a 2m wide strip. The Hi-Lab surface is intact with little evidence of rutting (Figure 32).

Figure 32 Milled out Dense Graded Asphalt

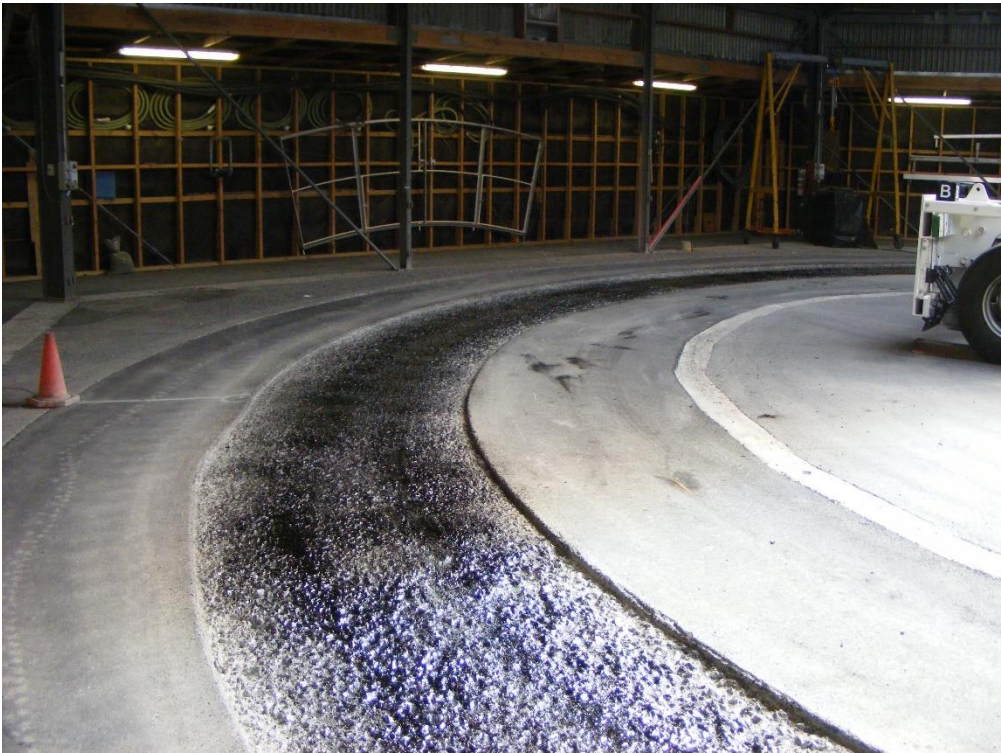
The milled surface was primed with emulsion containing 180/200 (30%), white spirits (25%) and water (45%) along with emulsifying chemicals (Figure 33). The target application rate was 0.5 l/m². Then it was sealed with a 180/200 binder with 4 parts kerosene and 1 part of adhesion with no AGO (Diesel fuel). The first coat was applied at 1.1 l/m² (hot) and a Grade 3 chip was applied. A 2nd coat was applied at 1.00 l/m² (hot) and a grade 5 chip was applied. After rolling and five days later a 3rd coat was applied at 1.35 l/m² (hot) and a final grade 5 chip was applied. The final coat contained 3 parts kerosene (Figure 34).

Figure 33 Priming of milled surface

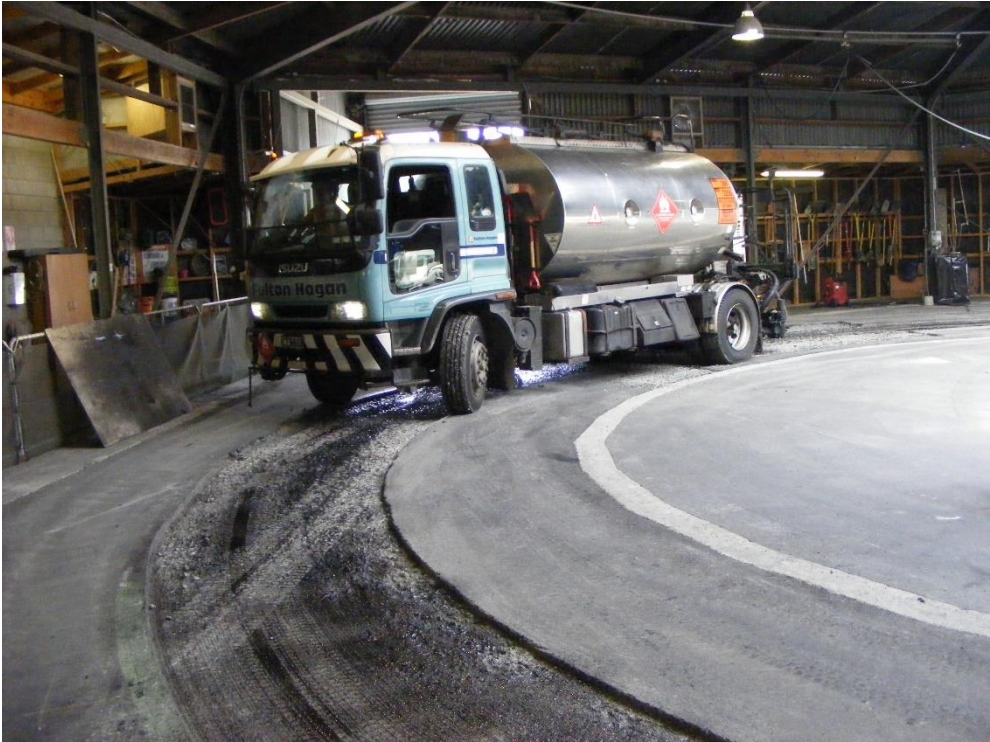
Figure 34 Membrane Chipsealing

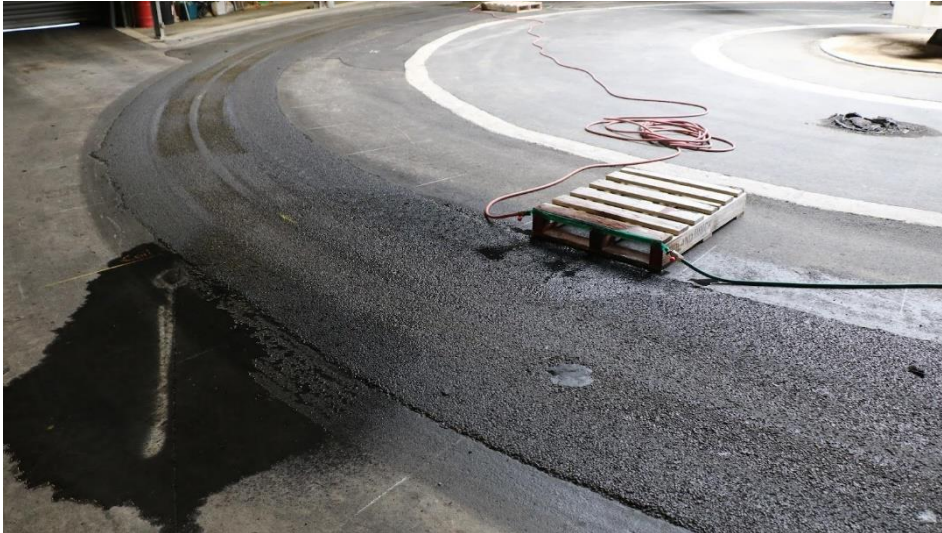
Figure 35 illustrates the damp running condition. Figure 36 shows fines pumping to the surface and was observed in sections A, C and D during the 100,000 laps of damp loading. This supports the observation that the stiffness loss in these sections had compromised the previous dense graded asphalt surface and the newly applied OGPA surface. Section B, the Huntly design, showed no signs of distress and wetter conditions were introduced.

Figure 35 Damp Running conditions

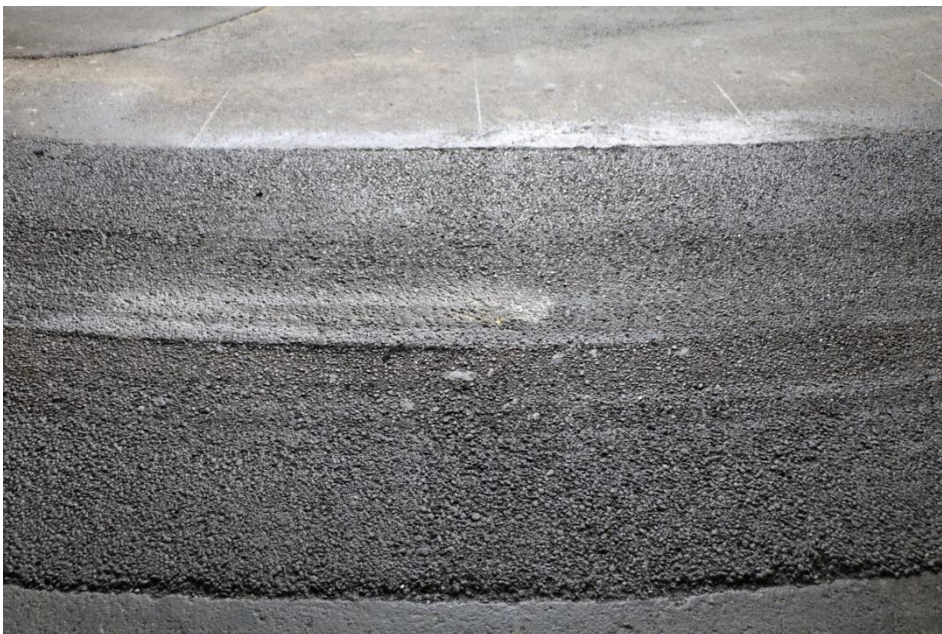
Figure 36 Fines observed pumping to surface in sections A, C and D

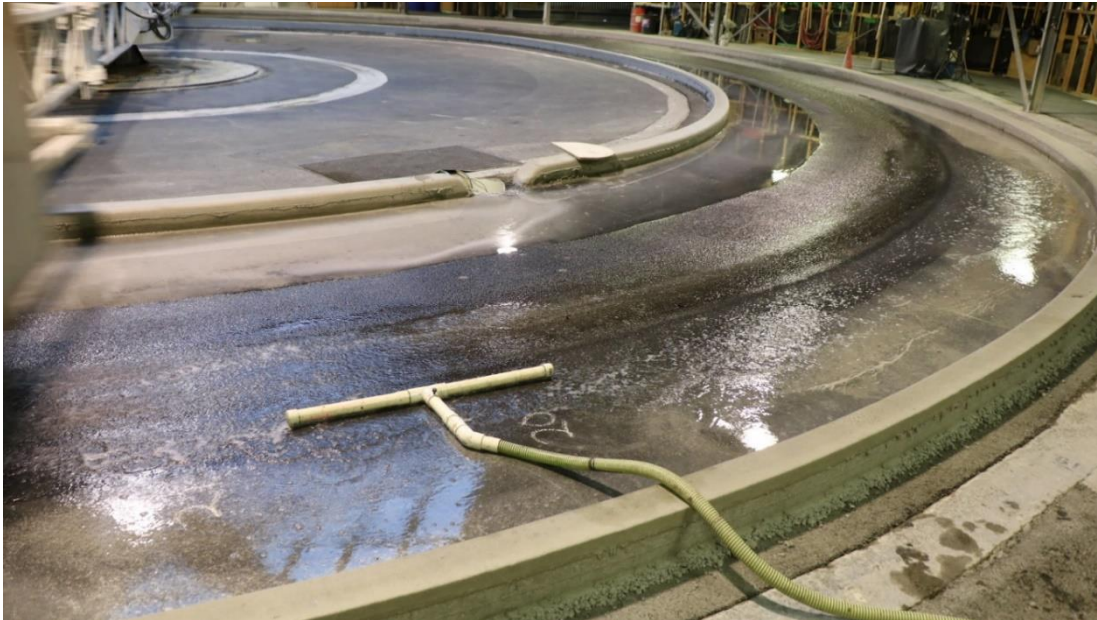
Figure 37 illustrates the wet running condition with water pooled on the surface of the OGPA. It was impossible for the OGPA to drain as it had been laid in the strip milled in the original dense asphalt. Figure 38 illustrates the Huntly Hi-Lab design (Section B) undamaged after 100,000 laps of wet running.

Figure 37 Wet Running Conditions

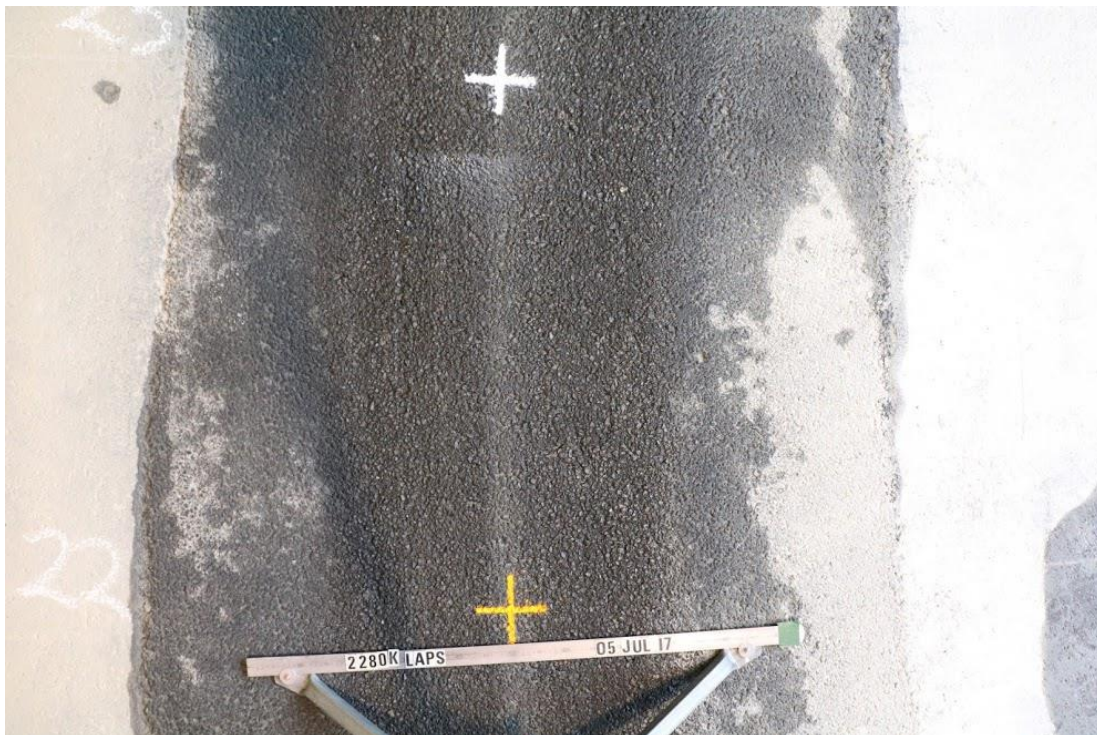
Figure 38 After Wet Running

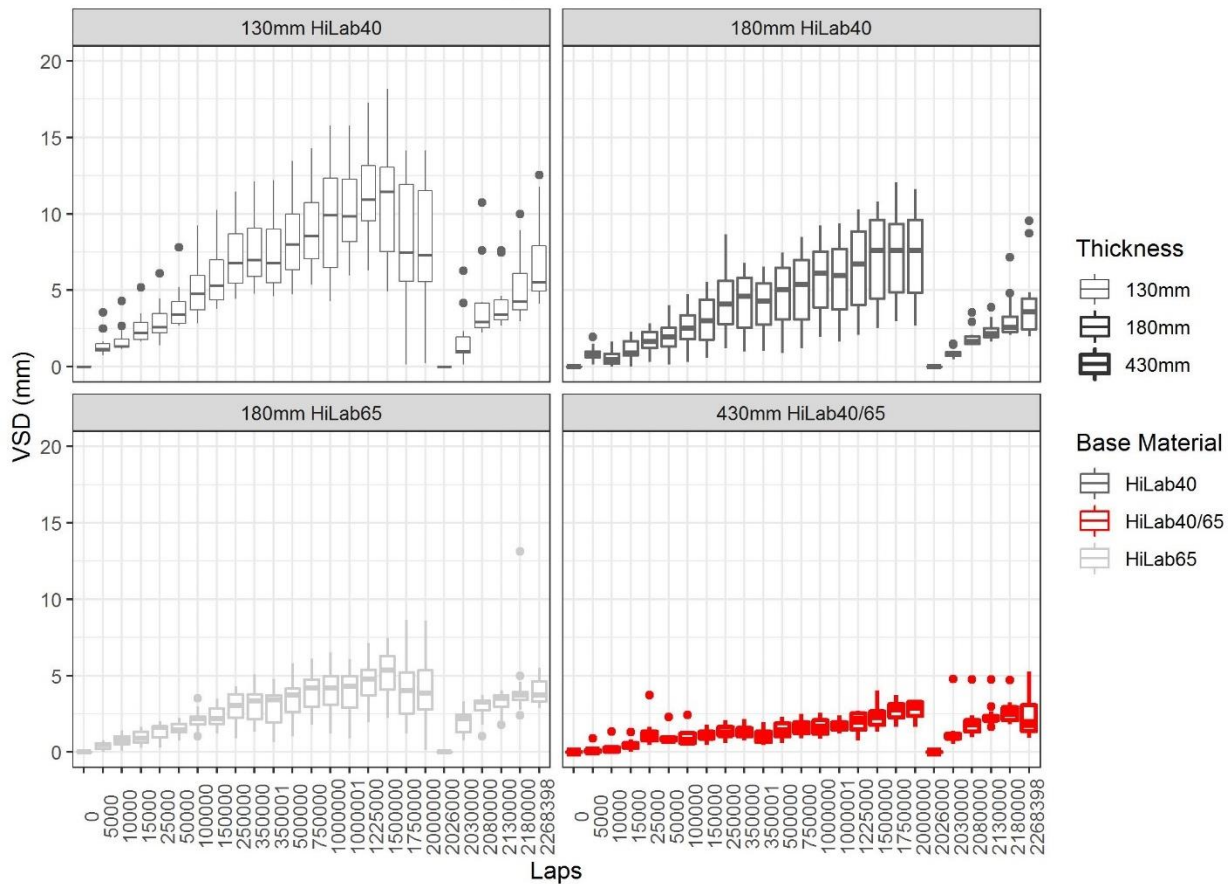
The VSD results in Figure 39 show that all the sections performed well in the damp and wet loading conditions with the OGPA surfacing.

Figure 39 Damp and Wet Running VSD results

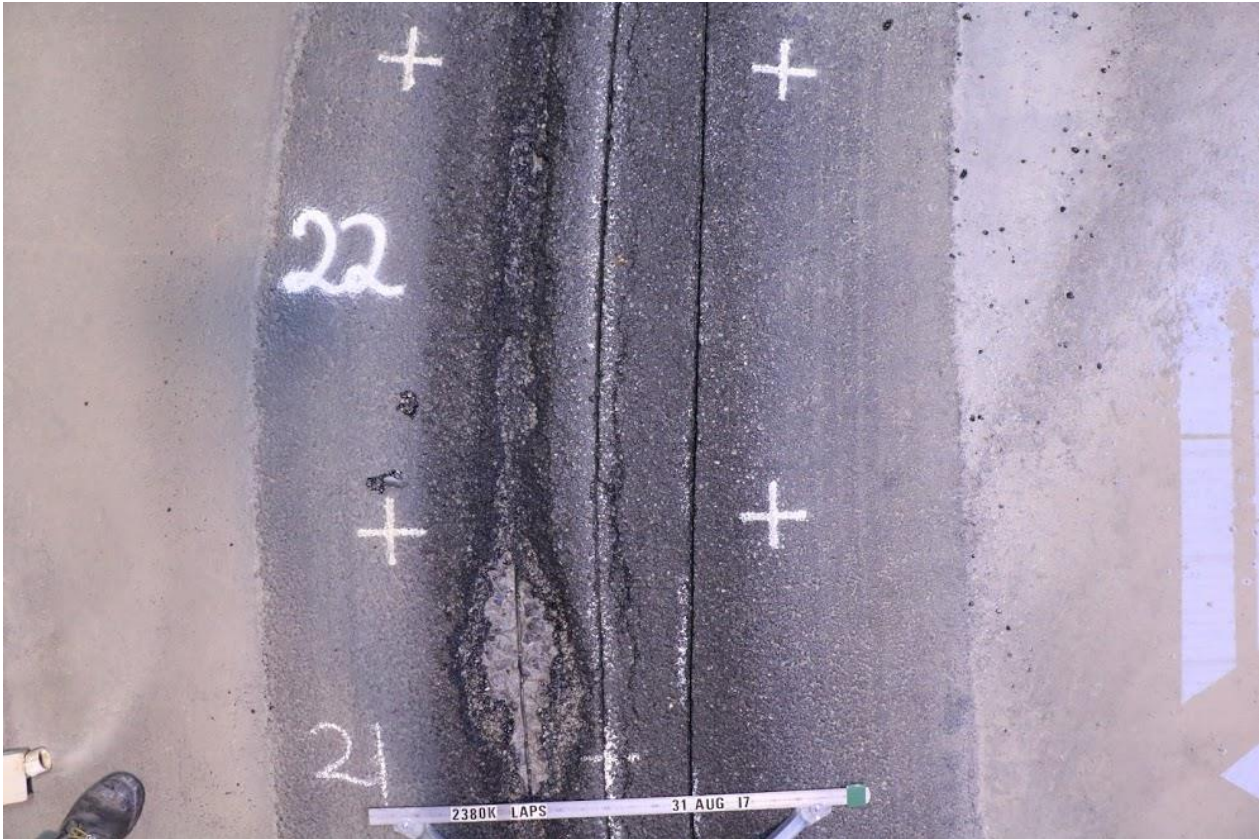
Figure 40 illustrates the final test of Section B with 2xHi-Lab layers like the Huntly Hi-Lab design. The surface and upper Hi-Lab layer were saw cut to allow water into the pavement. The objective was to observe the Hi-Lab behaviour in the event of a surfacing failure. A small pothole appeared after 150,000 laps of wet loading.

Figure 40 100,000 Laps of Wet Running after saw-cutting surface

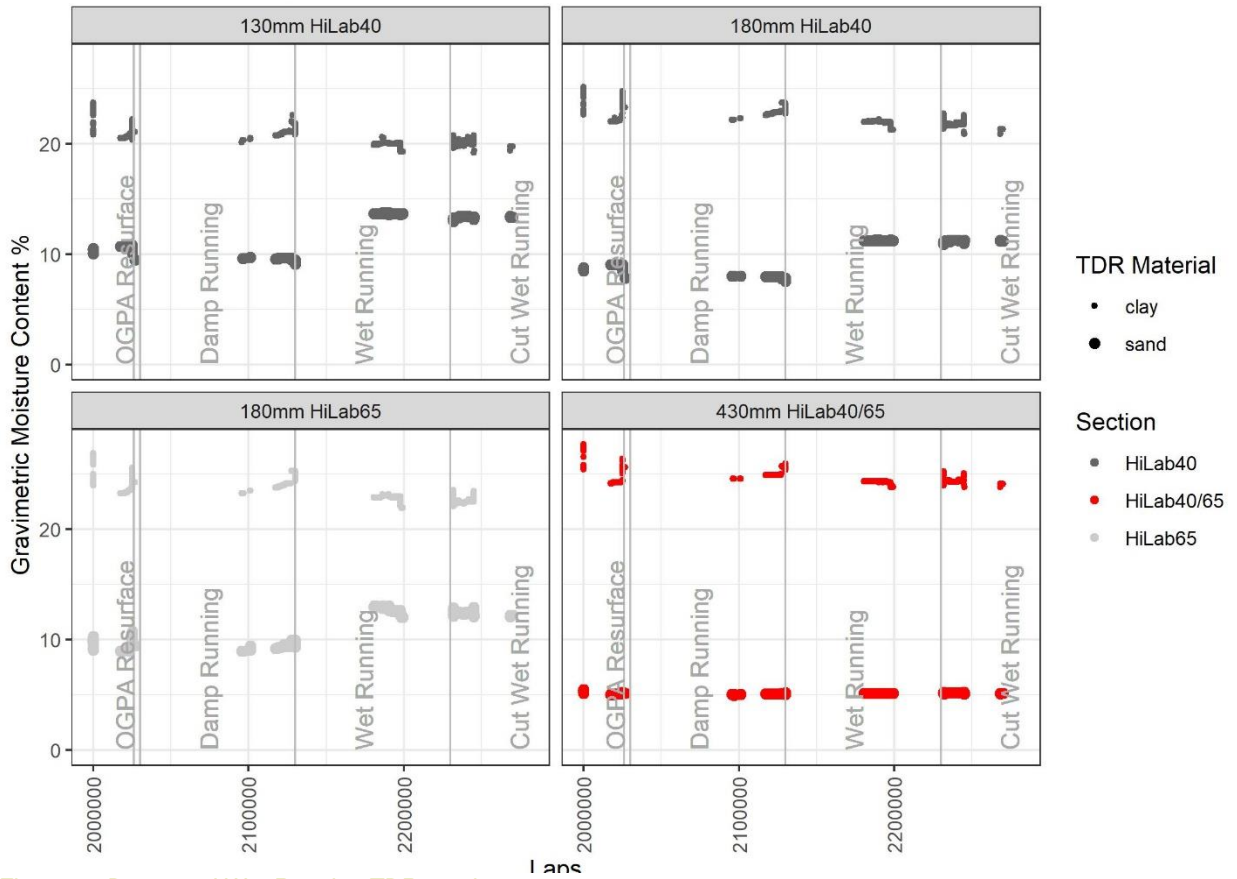
The TDR results in Figure 41 show that the thinner sections, which had shown signs of cracking earlier, all allowed water into the Sand Subgrade Improvement Layer only when wet running began. The Huntly Hi-Lab section maintained its moisture content under damp and wet running conditions and even saw cutting the surface and upper Hi-Lab layer did not allow water to penetrate to the Sand layer. This shows the Hi-Lab layers for Section B being impermeable.

Figure 41 Damp and Wet Running TDR results
