TECHNICAL REPORT 15

COASTAL PROCESSES ASSESSMENT

NOVEMBER 2016

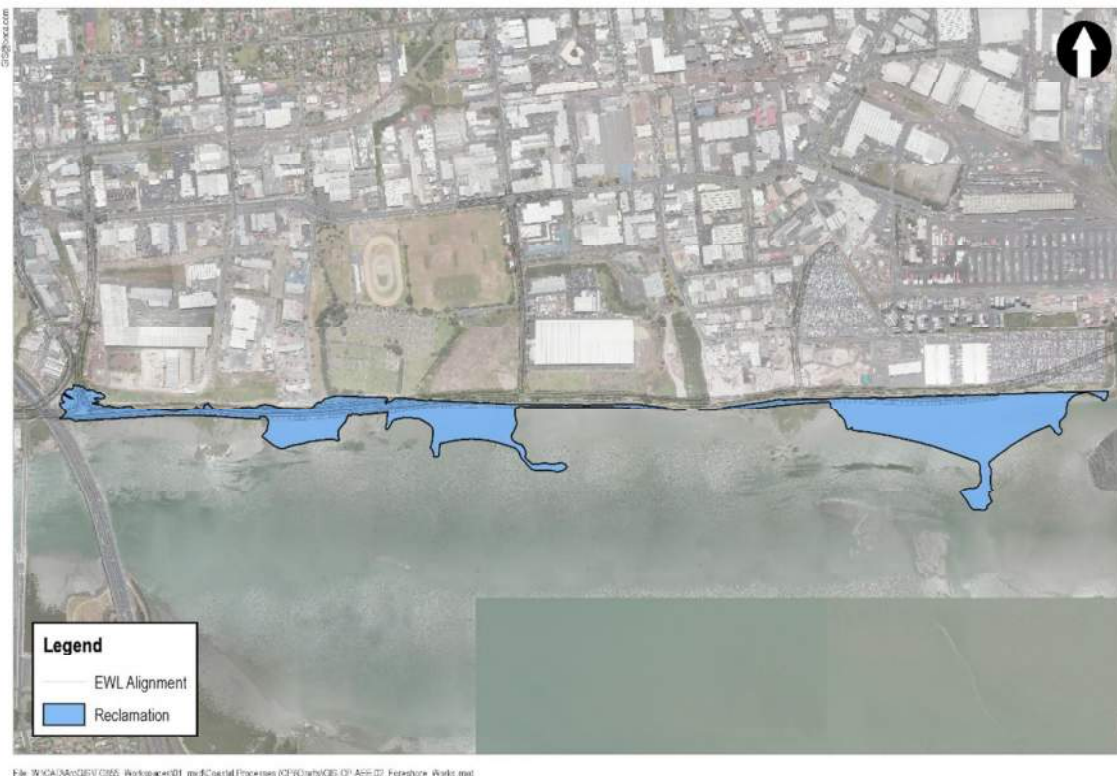
Figure 1-1: Foreshore Works

- Drawings referenced AEE-LA-103 to AEE-LA-107 and cross sections referenced AEE-LA-202 to AEE-LA-204 in Plan Set 4: Landscape;
- Drawings referenced AEE-CMA-101 to AEE-CMA-104 in Plan Set 5: Coastal Occupation; and
- Drawings referenced AEE-C-321, AEE-C-323 and AEE-C-324 in Plan Set 7: Typical Cross Sections.

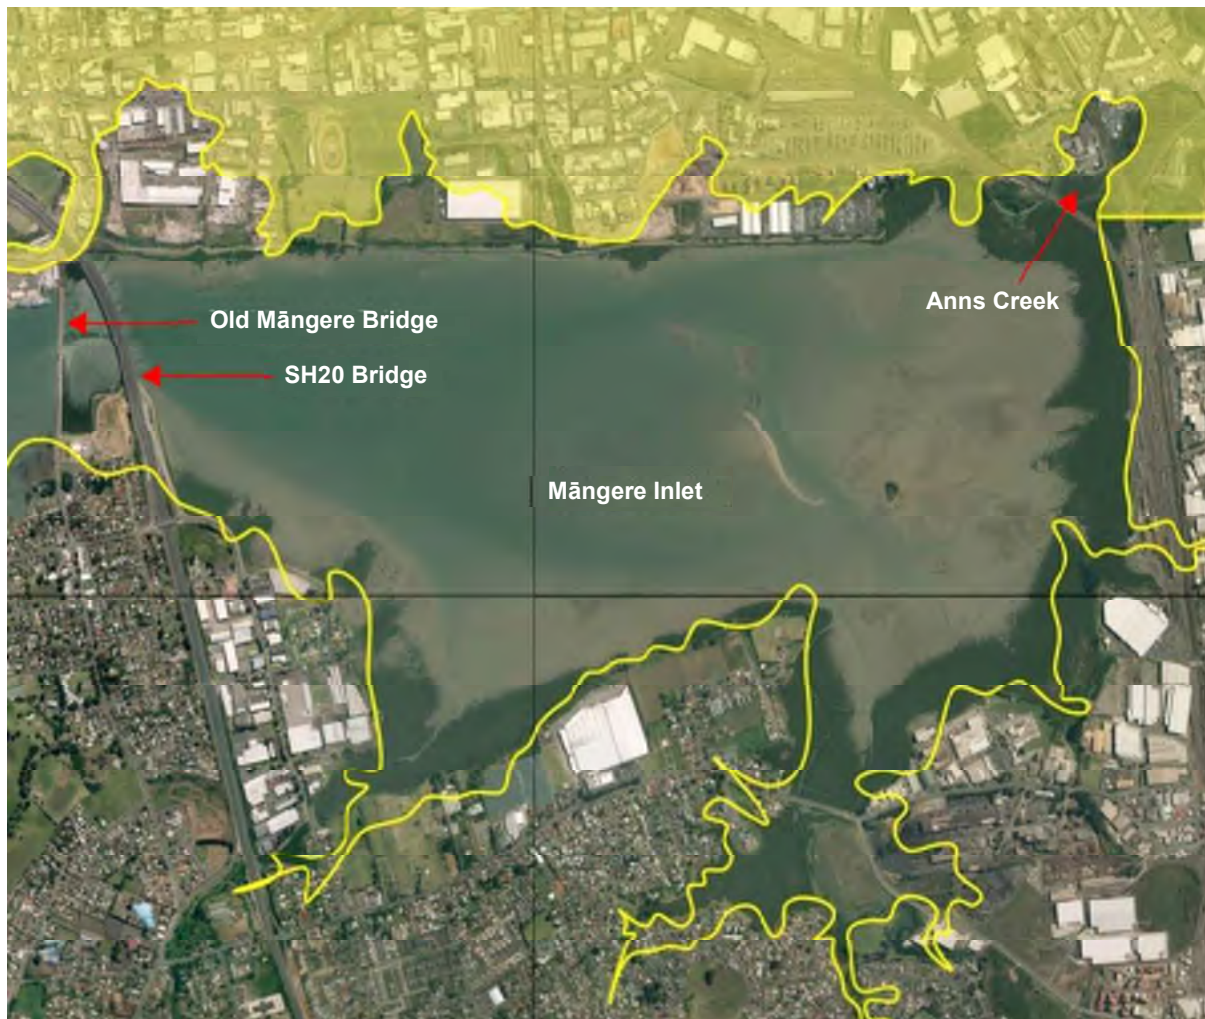
Figure 5-1: Changes in the northern shorelines between 1853 (yellow outline) and 2010. Source LINZ.

The northern coastline has undergone extensive urban development and reclamation since the 1940s as illustrated in Figure 5-1. It lies east of Onehunga Bay where it is sheltered from strong tidal currents and a moderate wave climate, making it a site for sediment deposition. Historic reclamation has led to the loss of three embayments and the loss of tidal inundation to the Hōpua volcanic crater.

Extensive reclamation along the eastern shore of Māngere Inlet was also carried out in the 1960s with the development of the Westfield rail yards (Matthews et al. 2005). Overall it has been estimated that 1.8km² (24% of the Inlet surface area) of land has been reclaimed within the bay since 1940.

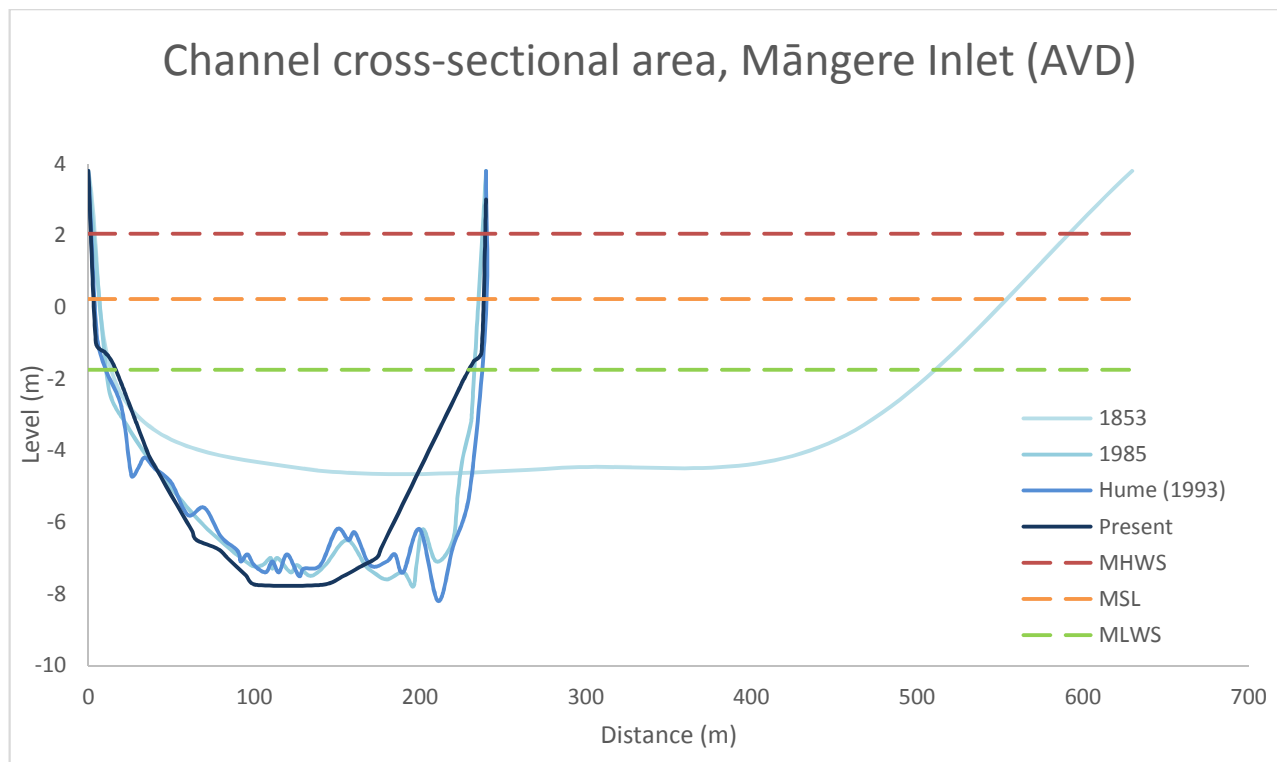
Figure 5-5: Changes to Māngere channel entrance over time

A sounding chart completed in 1853 (Drury et al.) shows that the inlet was an open basin (Figure 2.2) with an estimated entrance 630m wide. However with construction of the impervious rock causeway at the south end of the Old Māngere Bridge (first built in 1875) the width of the entrance is estimated to have been reduced to 240m. Using a transect taken along the alignment of the old Māngere Bridge, Figure 5-5 shows how the entrance has changed over time.

It is estimated that the construction of the Māngere Bridge causeway in 1875 reduced the original cross-sectional entrance area by over 60%. Although scouring has deepened the entrance over time the cross-sectional area is still much less than in 1853.

The inlet acts as a sediment sink but the channel inlet entrance has experienced scouring (Figure 5-5) over time. The inlet has adjusted to unnatural morphological changes by a combination of entrance scouring and potentially sedimentation within the inlet. These processes appear to be ongoing. It is noted however that the large sediment fluxes experienced within the inlet and its entrance are a natural phenomenon. A description of likely sedimentation rates within the Inlet was provided in Section 5.2.5.

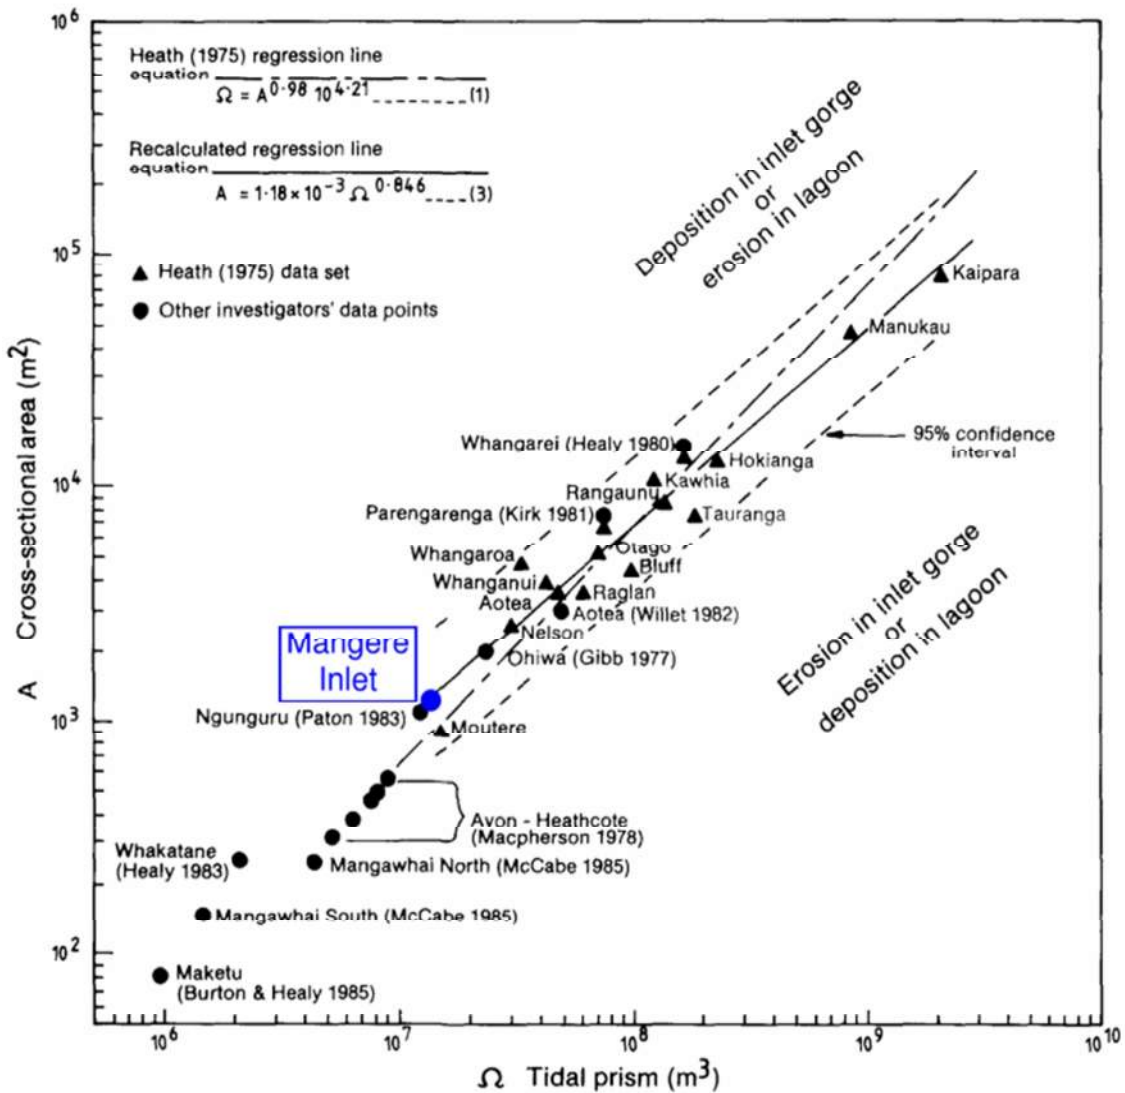
Figure 5-6 : Tidal Prism/Cross-sectional Area Relationship (Hume and Herdendorf 1988)

Based on the 2016 hydrographic/LiDAR survey (Appendix B), the tidal prism of Māngere Inlet is 11,900,000m³ to MHWS at Māngere Bridge. Based on work of Hume and Herdendorf (1988), the tidal prism/cross-sectional area regression line is $A=1.18 \times 10^{-3} \Omega^{0.846}$ as illustrated in Figure 5-6. When Māngere Inlet was plotted using the cross sectional area (A) versus the tidal prism (Ω) it was at the lower end of the regression and indicating it is in equilibrium.

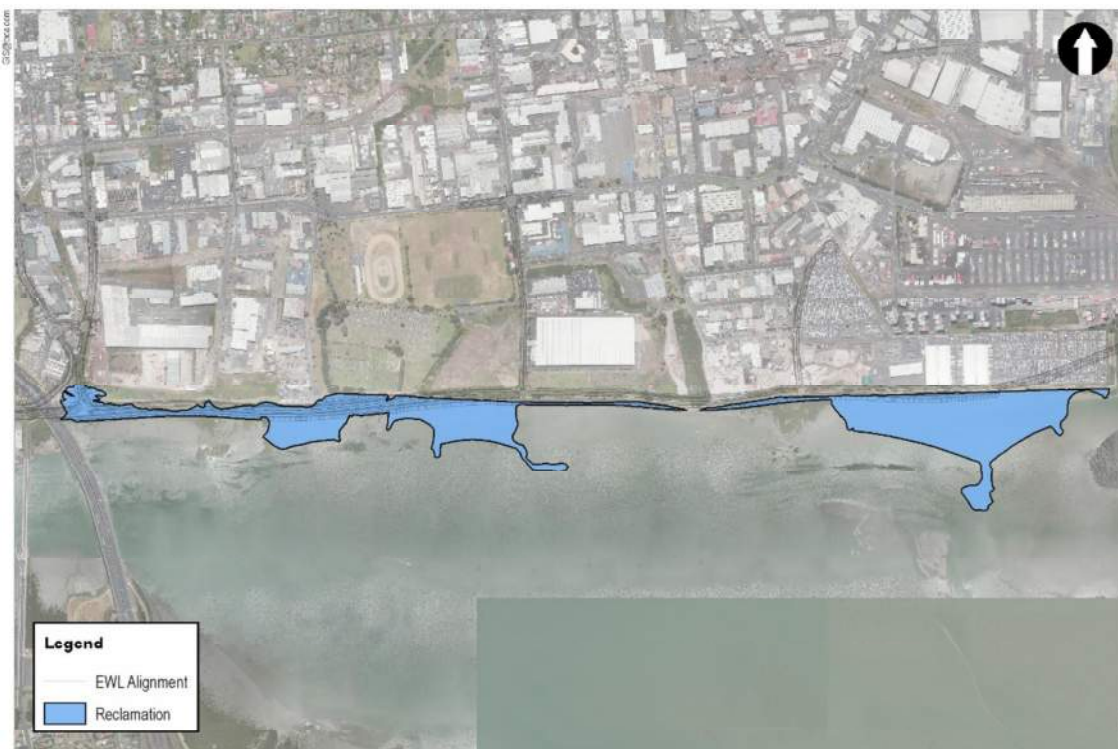
Figure 7-1: Foreshore Works

The layout of the project is shown in Figure 7.1.

The Project has a reclamation area (above MHWS) of 18.3ha and a footprint of 24.2ha, compared to the existing CMA surface area of the Inlet of 5.7km². The new reclamation represents a change of 3.2% in area. (It is noted that the reclamation due to the road embankment of the Project is 5.6ha whereas the wetlands and recreated coastline is 12.7ha.) The Project also reduces the tidal prism by 3.5% to 11.5 million m³.

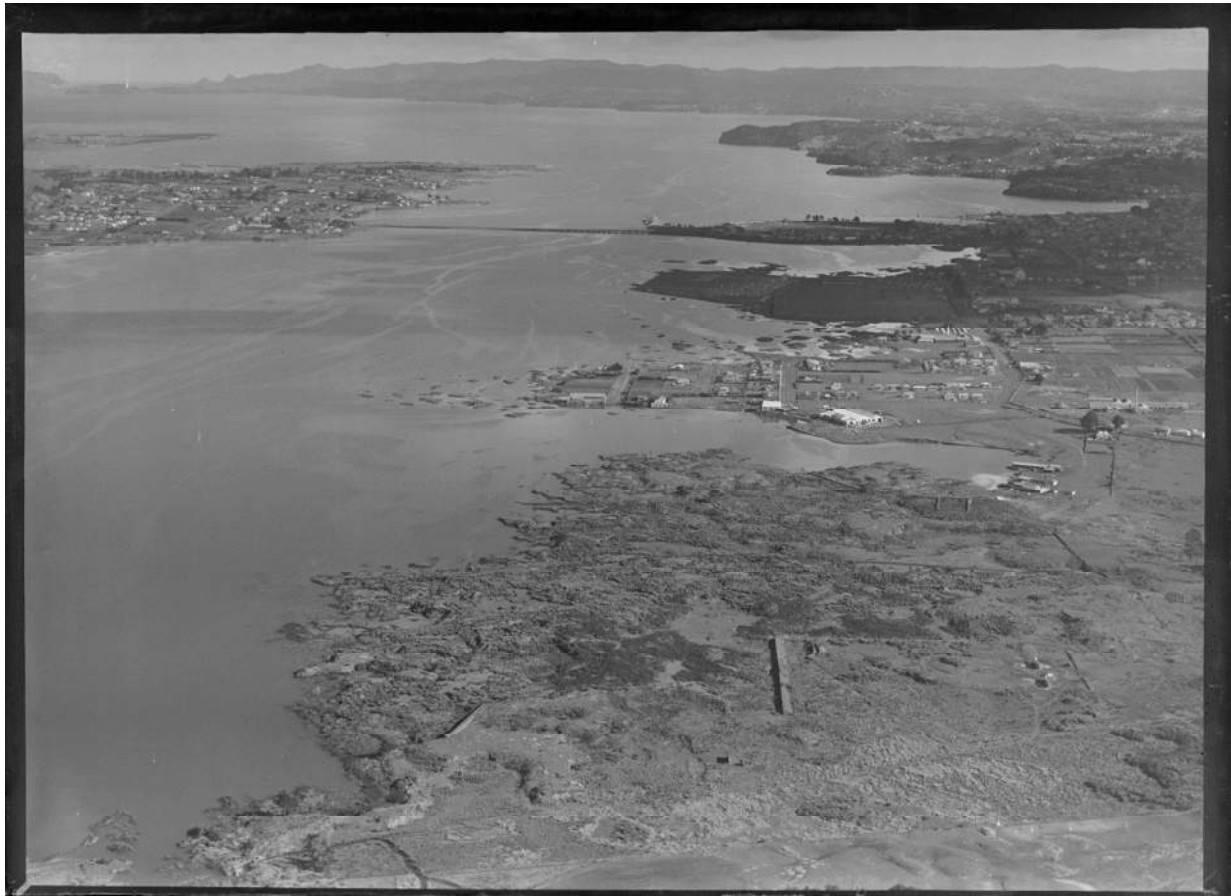
Figure 7-2: Māngere Inlet Foreshore (1949)

While the reclamation associated with the recreated coastline does have adverse effects on the existing environment, the recreation of coastal features such as headlands and shingle beaches is beneficial in terms of the coastal processes related to natural character. As shown in Figure 7-2, although reclamation has already taken place, the remaining original coastline in 1949 was a mixture of headlands and embayments, delineating a non-linear coastline.

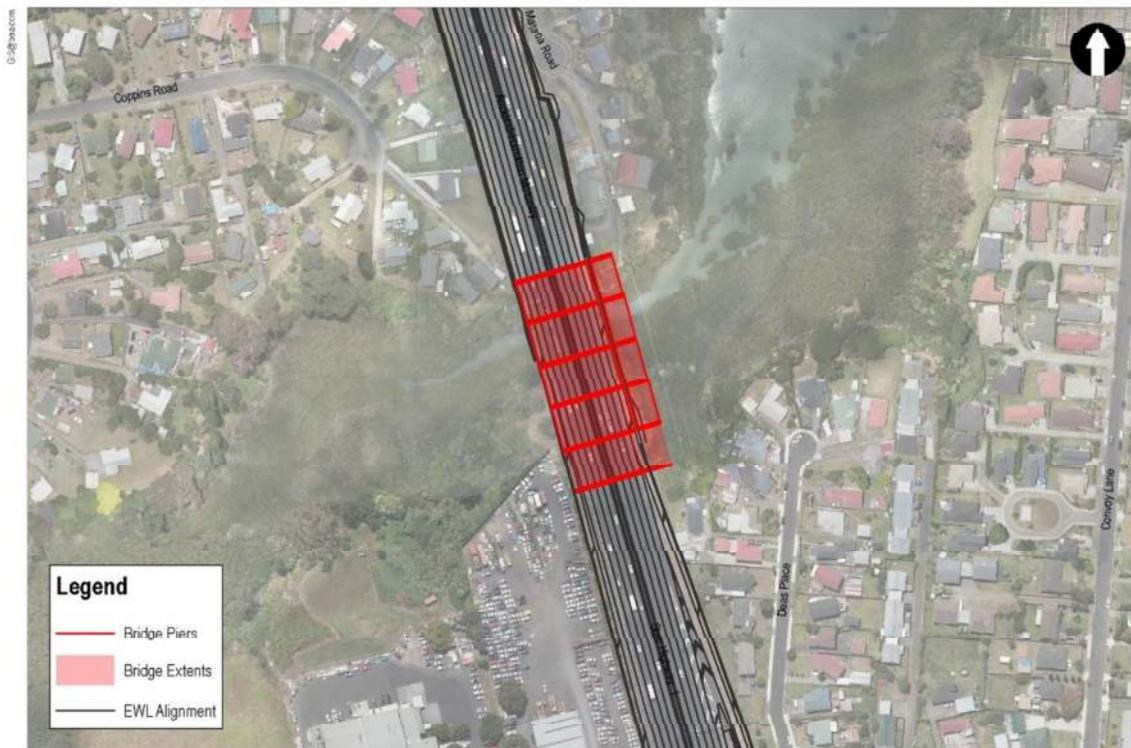
Figure 8-1: Ōtāhuhu Creek Bridge

Although the existing culverts perform their hydraulic function, the Transport Agency has agreed to replace the culverts with a new bridge as part of this Project. The proposed bridge is shown in Figure 8-1 and comprises five 22.5m spans to give a total bridge length of 112.5m and width of 50m. There are proposed to be 19 No. 900mm piles which will occupy an area of about 10m² or 0.02% of the upstream CMA.

The proposed bridge will span the original creek to effectively reclaim the area. On the northern side, the abutment more-or-less follows the original landform. On the southern side the new landform will reclaim about 0.5ha of land. Complete reclamation was not feasible as it would interfere with private property. Some 20,000m³ of material will need to be removed to form a new landscape similar to the original landform.

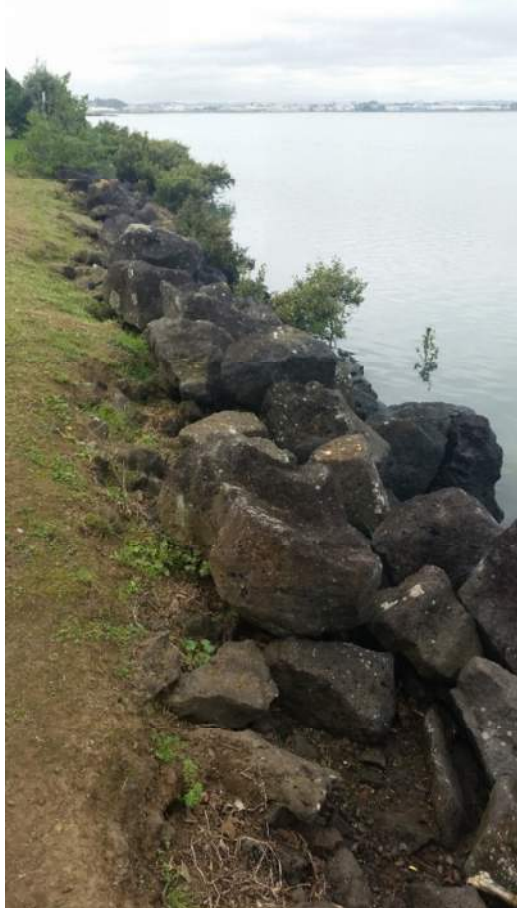
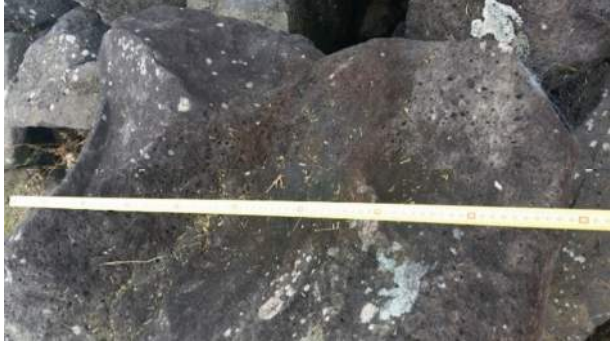
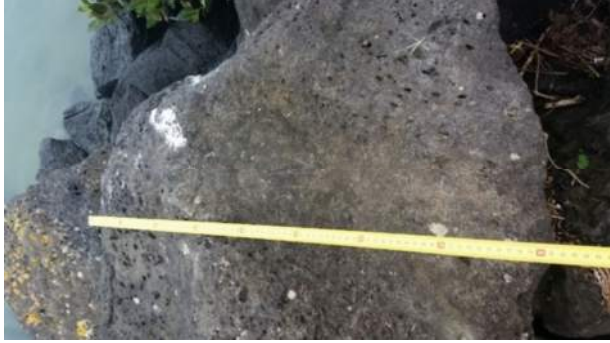
Location	Site Images	Notes
<p>Site 2 - Manukau Foreshore East Walkway Riprap (western end)</p>

<p>Inspected at 12.30pm on 5/6/2016</p> <p>Low tide/ebbing tide</p> <p>Riprap ~1.5m high</p> <p>Rock Diameter 80-90cm at top</p> <p>Rock Diameter 20-30cm at base</p>

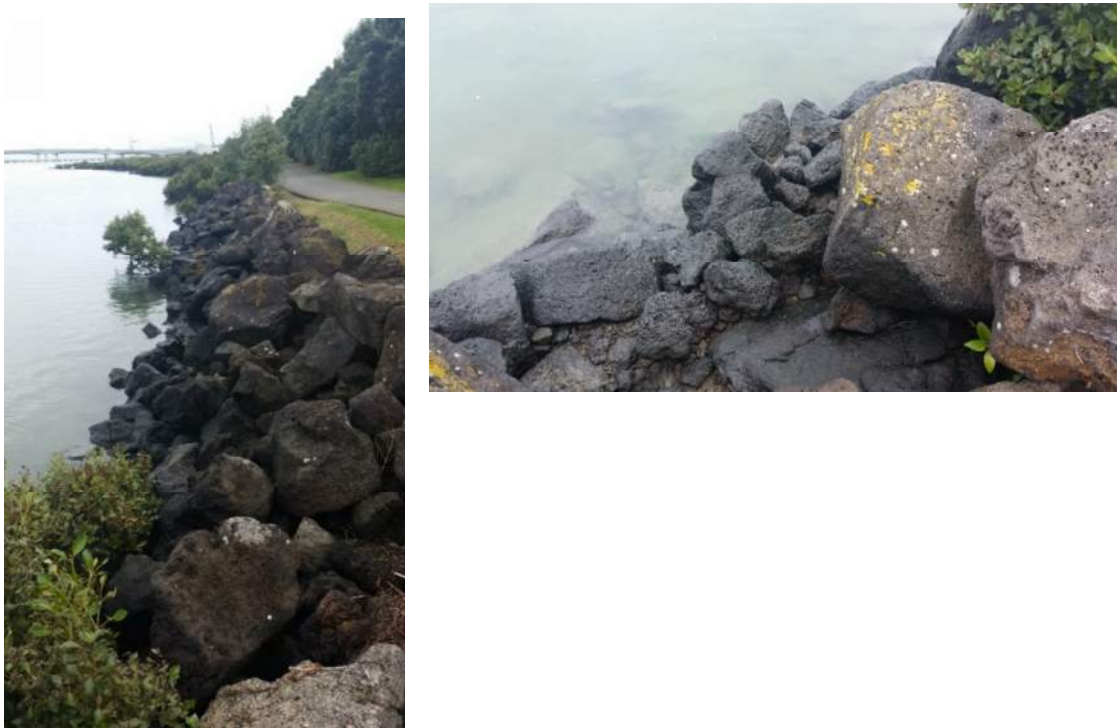
Location	Site Images	Notes
<p>Site 3 - Manukau Foreshore East Walkway Riprap (western end)</p>

<p>Inspected at 12.30pm on 5/6/2016</p> <p>Low tide/ebbing tide</p> <p>Riprap ~1.5m high</p> <p>Rock Diameter 80-90cm at top</p> <p>Rock Diameter 20-30cm at base</p>

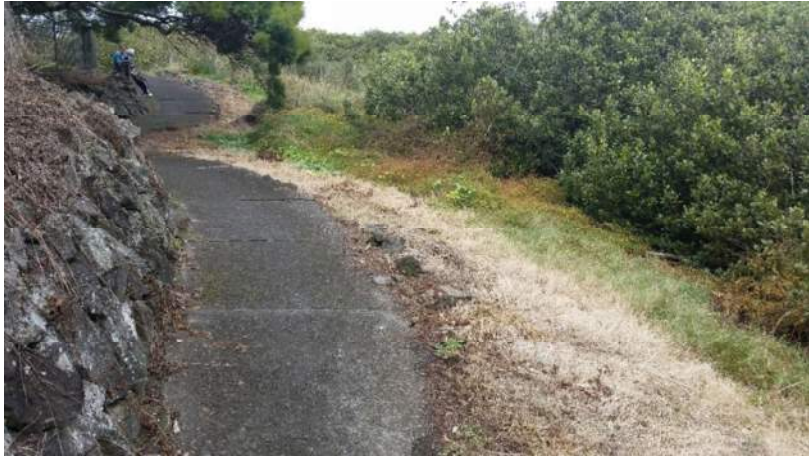
Location	Site Images	Notes
<p>Site 6 - Eastern end of Manukau Foreshore East Walkway</p>

<p>Very low lying ground, possible site of inundation especially with sea level rise.</p> <p>No wall in places</p> <p>Wall height varies along path some have lost wall structure all together.</p>

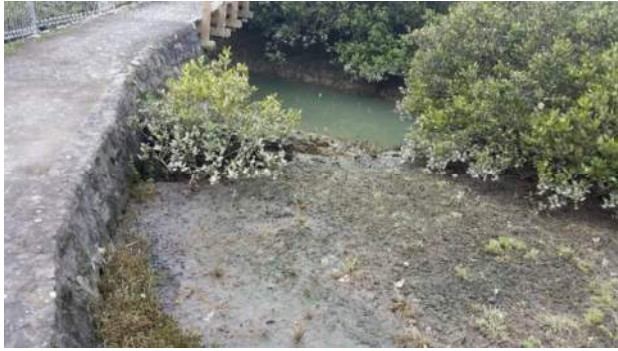
<p>Wall and bridge in good condition</p>

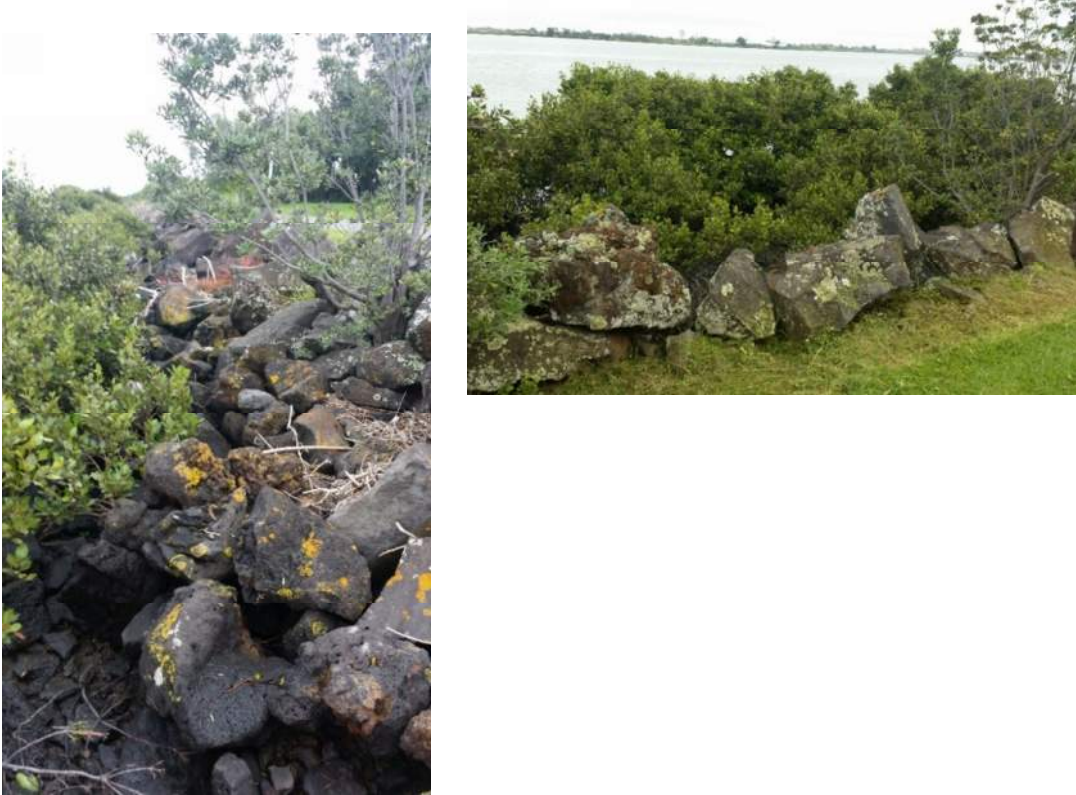
Location	Site Images	Notes
<p>Site 9 - Manukau Foreshore East Walkway rip rap (eastern end)</p>

<p>Inspected at 1.00pm 5/6/2016</p> <p>Low tide</p> <p>Riprap ~1.5m high</p> <p>Fair amount of debris trapped in Rip Rap</p>
