# The Bulletin Kaikoura earthquake update

This weekly bulletin provides the latest information about the rebuild of road and rail networks damaged by the Kaikōura earthquake in November 2016. The bulletin is produced by the North Canterbury Transport Infrastructure Recovery (NCTIR) – an alliance representing the NZ Transport Agency and KiwiRail, on behalf of Government.

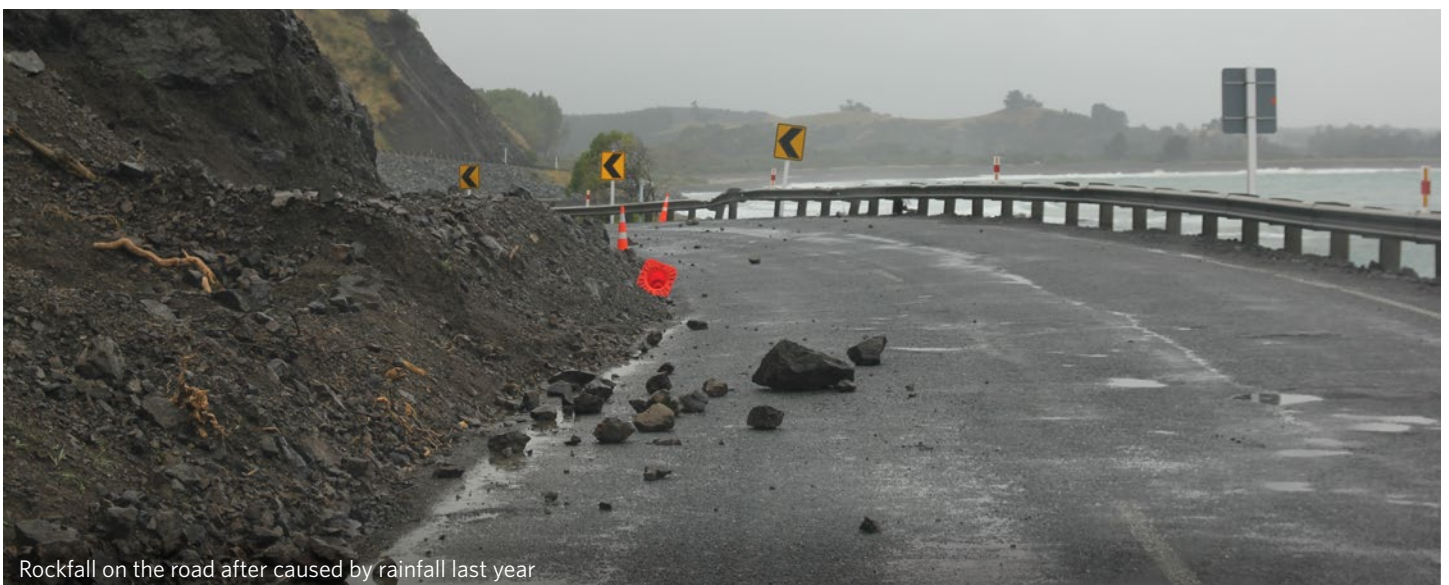
Rockfall on the road after caused by rainfall last year

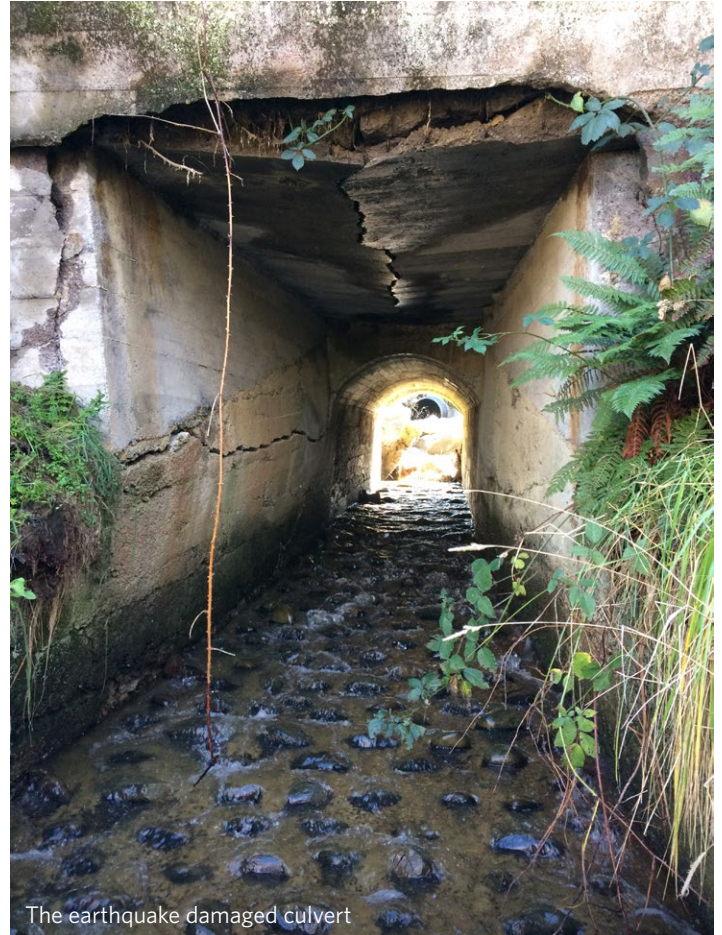
The earthquake damaged culvert

Working since early September 2017 to replace the existing culvert, which had cracked and collapsed during the 2016 earthquake, the crew built a temporary road diversion around the site to allow traffic to keep flowing while construction got underway. Water from the creek, which flowed through the culvert, was dammed and pumped at low levels through piping downstream of the new structure and all fish were relocated before the piping began.

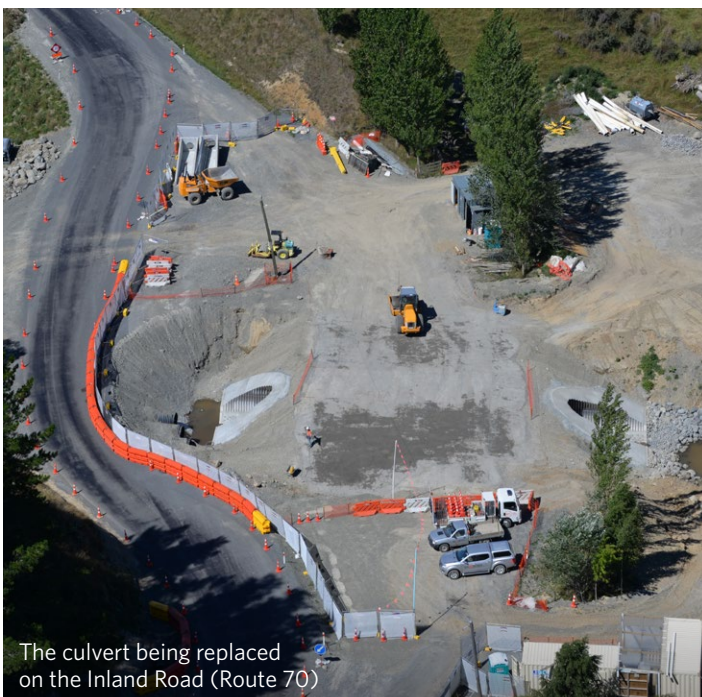
The culvert being replaced on the Inland Road (Route 70)

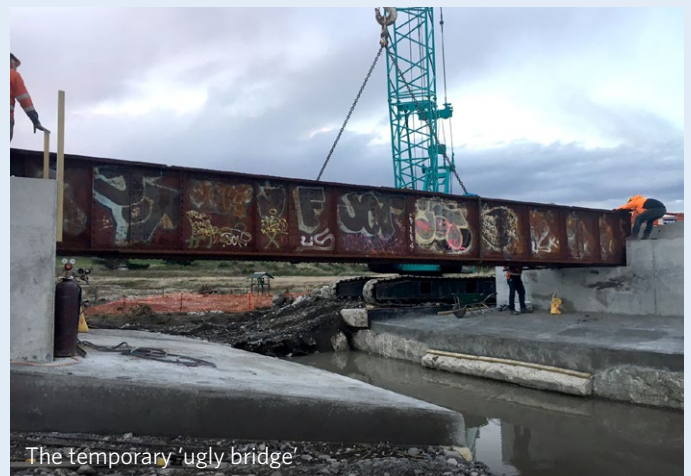
The temporary 'ugly bridge'

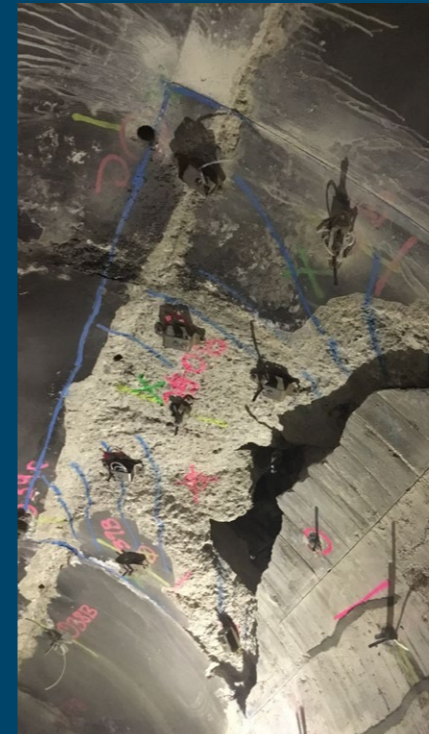
**Innovation 1**

The **propping system** implemented in Tunnel 13 was the first of its kind to be used in New Zealand, and serves as a prime example of the type of innovation and excellence that earned this award. This innovation was born out of necessity, to prevent the collapse of damaged rail tunnel sections while enabling crews to safely clear slip material and excavate on top of the tunnel, a temporary support structure was required. A collaborative effort between the site team and temporary works designer created and implemented this Tunnel Propping system to provide the required support at high-risk areas of the damaged tunnels, while keeping simple assembly and easy relocation in mind.

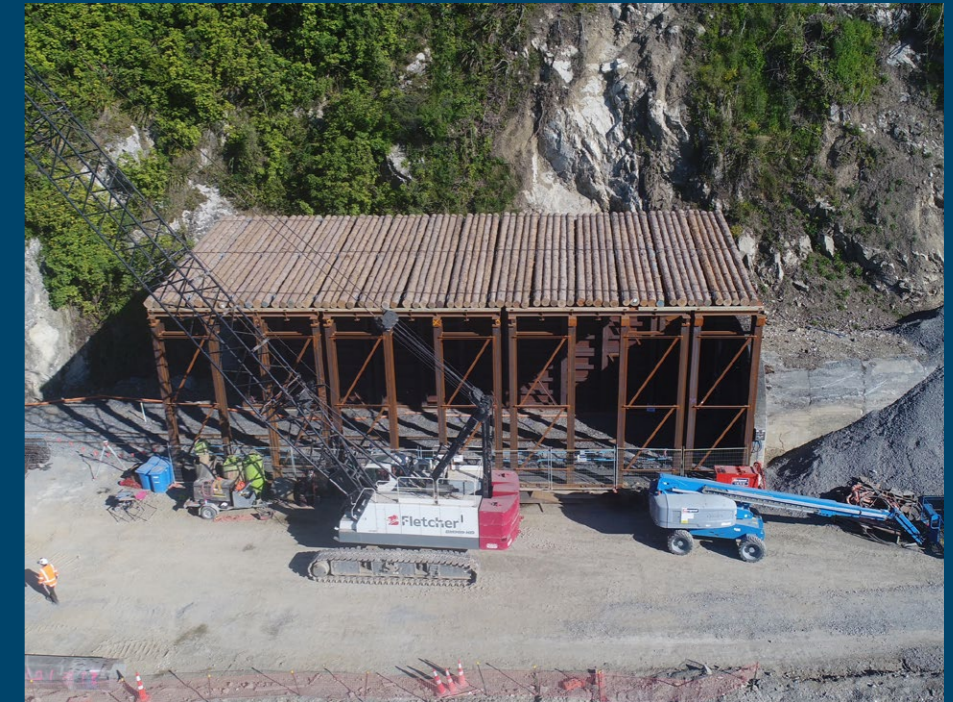
**Innovation 2**

The **grouted anchor support plates** were another applauded innovative solution. They not only worked as temporary mechanical anchors (creating a self-supporting roof) to hold the lining in place while the void between the rock face and lining could be filled, but they also made it possible to grout the anchors afterwards, turning temporary works into permanent solutions. The cost effectiveness over time was remarkable. These plates supported the roof and maintained the integrity of the structure lining, keeping our crews safe at all times. This enabled feeding tubes and breathing tubes to be kept in place for grouting. These grouted anchor support plates were designed, fabricated, and used to stabilise five KiwiRail tunnels. They also prevented grout loss, and maintained a small enough profile so that they did not interfere with train clearance.

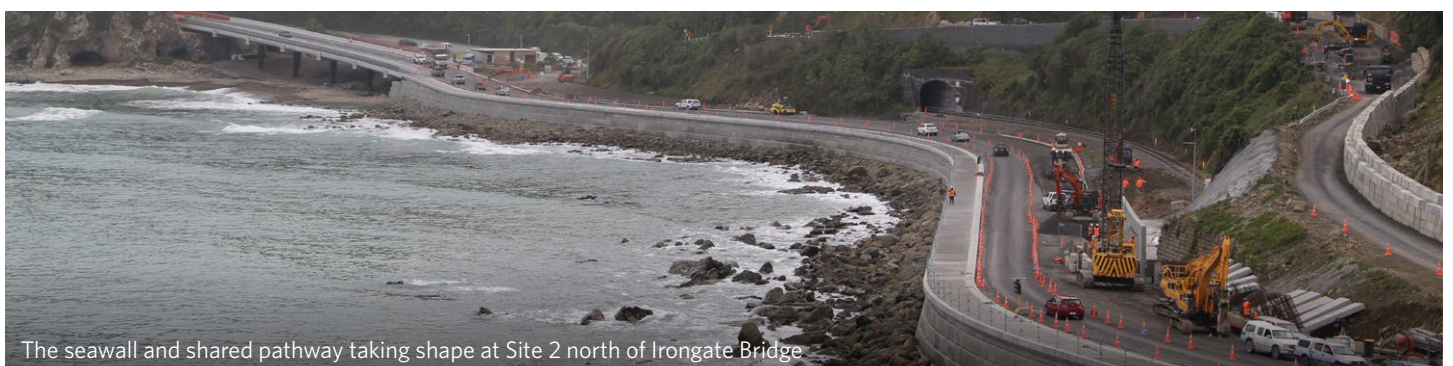
The seawall and shared pathway taking shape at Site 2 north of Irongate Bridge

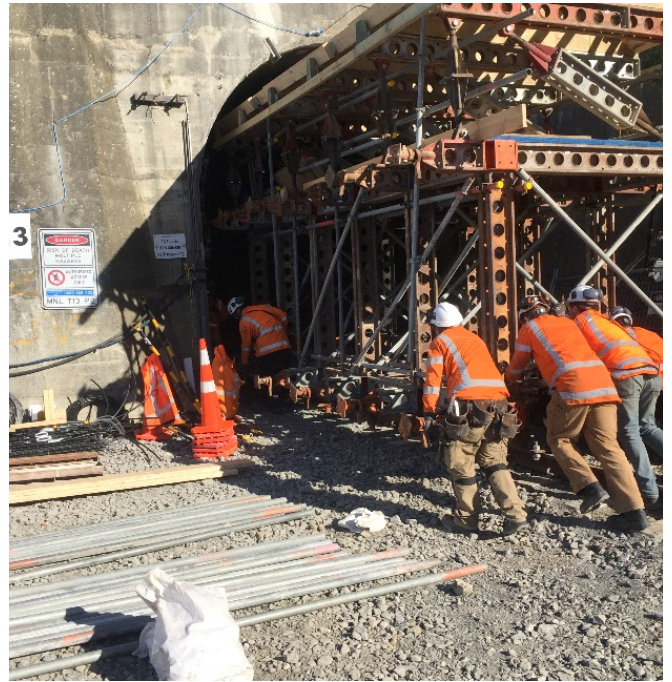
Safety first: The tunnel propping system can be rolled into place to keep tunnel repair workers safe.
