KAIKOURA EARTHQUAKE UPDATE

WEEKLY BULLETIN – no. 10

31 March 2017

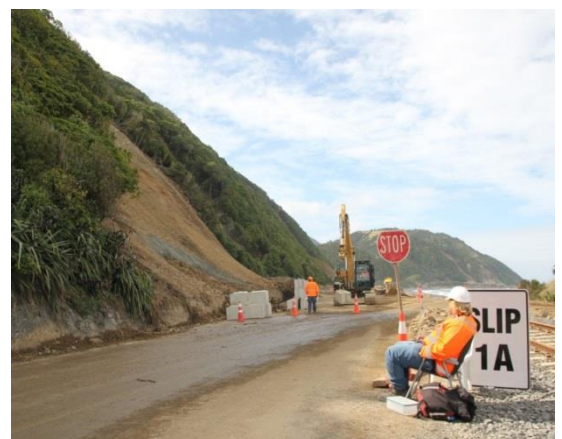
- With the earthworks now completed at Site 1A and the temporary concrete block bund built (*see photo on the right*) work will begin next week to build the new road

and rail alignment around this site. This is a significant milestone for the programme.

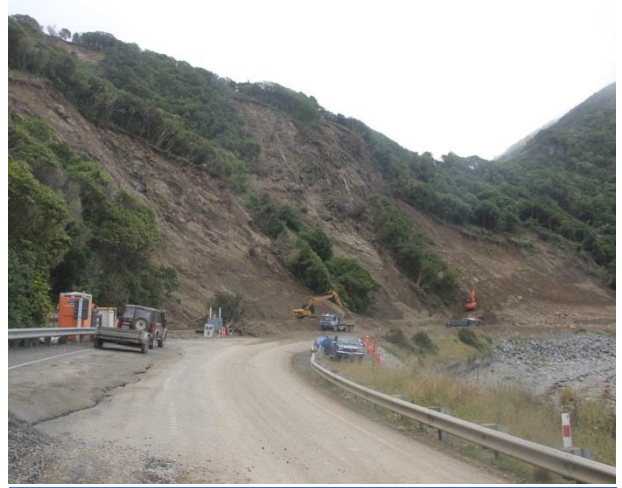
- At Site 3, we have brought down another 10,000 cubic metres of material to stabilise the slip face after the recent heavy rain. Sluicing and earthworks will continue at this site over the next few weeks.

See photo on the right.

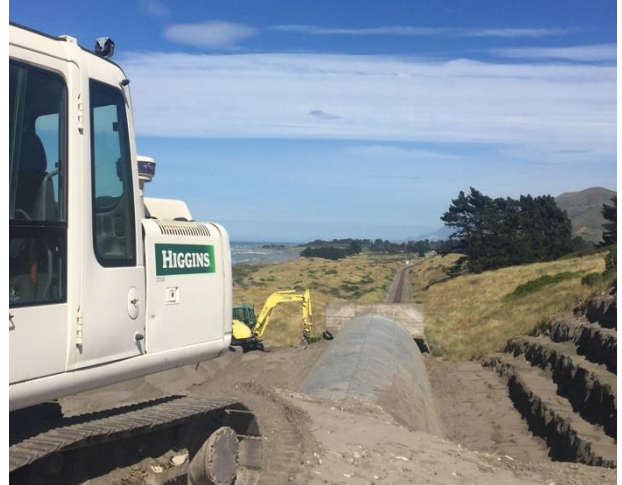
- At Site 6 (Ohau Point), two excavators are working to the south, pulling down the slip and creating a work bench along the bottom for truck access to remove this material. Good progress is also being made on the northern side.
- Work continues bringing down the third slip shoot at Site 7. This material is being carted to the crusher for stockpiling and use as a sub-base for the road repairs. Sluicing and scaling continues at the other two shoots of this slip, along with the blasting of large rocks.
- At Site 8, we have spent the last two weeks at the top of the slip pushing the material down the slip face and have now started to cart this away to a temporary stockpile.
- Excavation work at the Waima overbridge is now complete. This has created a 35m long and 12m deep hole in which mechanical props will be used to help reshape the structure. ***See photo on the right.***

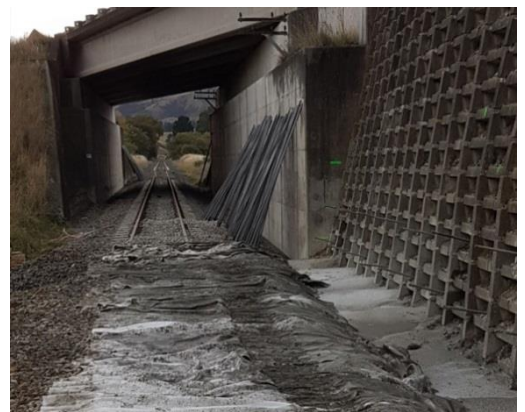
- Strengthening work of the Parnassus overbridge is progressing well. We have now drilled 69 of the 110 soil nails in the south-west wall which secure the abutments and enable work to get underway on deck repairs. We expect to have completed the south-western wall this week and begin on the north-eastern wall next week. ***See photo on the right.***

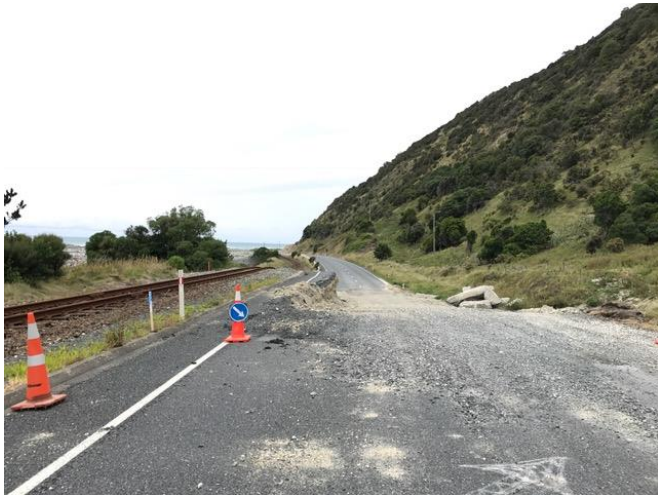
- Work is underway at Pines, south of the Clarence River, removing the railway track and ballast for realignment of both SH1 and the Main North Line to begin early next month. The ground in this area rose up four metres and moved five metres in the earthquake. **See photo above, left.**
- Major repair work is currently underway at tunnels 6, 16 and 18 – all north of Kaikoura and near the fault line – where crews have now arrived onsite. **See photo above, right.**
- To the south, minor repairs are underway to the portals at tunnels 1 and 2.
- Work trains are now operating on the Main North Line between Picton and Clarence. These trains are carrying ballast and other materials to work sites along the railway line for the rebuild. Please take extra care when near the railway lines – **use safety info sheet**

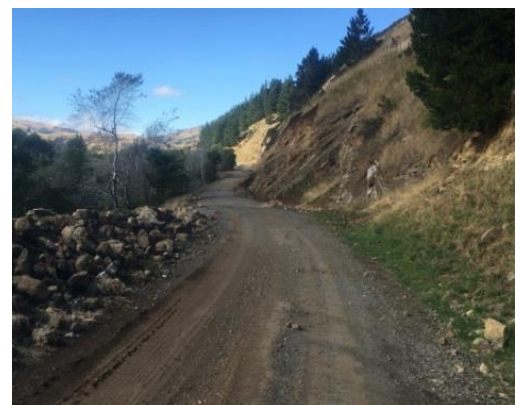
- Slope stabilisation and rock fall mitigation work is scheduled to start at the Whalesback slip early April and be completed before winter. The work will involve helicopter sluicing, scaling and rock bolting of the rock face. Two-way traffic will continue to use the temporary carriageway around this site. **See photo right.**

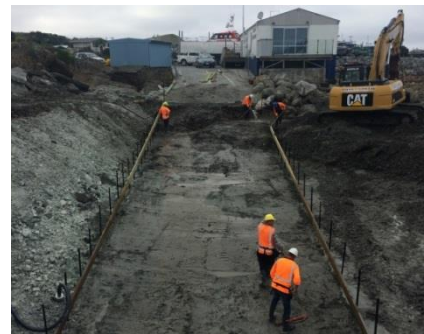
- The coastguard ramp has now been demolished and excavated to the subgrade level of the seabed. *See photo on right*
- Dredging of the inner harbour is 75% complete.
- Dredging of Berth 4 is complete. At present both Berth 3 and 4 are operational, until we need to close them off for the piling works. Whale Watch continues to operate from these berths, rather than from a trailer. Dolphin Encounter continues to operate their daily services from within the harbour area, by using their trailer via the boat ramp.
