# KAIKOURA EARTHQUAKE UPDATE

KAIKOURA EARTHQUAKE UPDATE - no. 18

26 May 2017

This weekly bulletin provides the latest information about the rebuild of road and rail networks damaged by the Hurunui/Kaikoura earthquake in November 2016. The bulletin is produced by the North Canterbury Transport Infrastructure Recovery (NCTIR) – an alliance representing the NZ Transport Agency and KiwiRail, on behalf of Government. We're keen to hear your questions about our work, or any feedback on this bulletin. Drop us a line via email at [info@nctir.com](mailto:info@nctir.com) or give us a call on **0800 NCTIREQ** (0800 628 4737) – we'd like to hear from you.

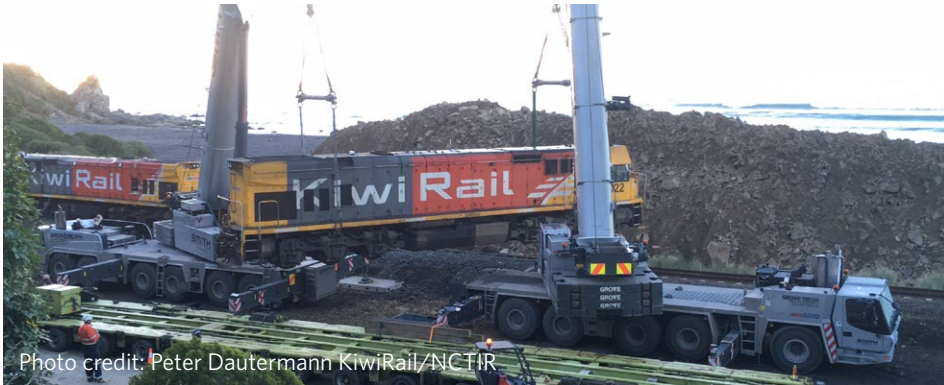
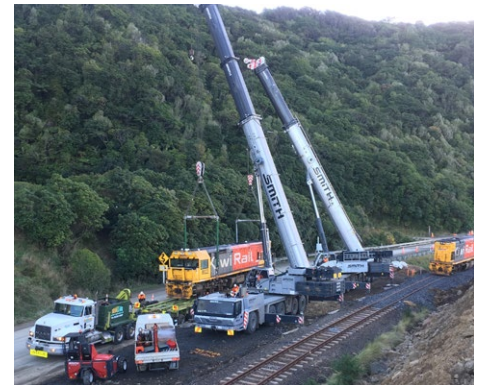
KiwiRail brought in a 132-wheel transporter to tackle the huge job of moving two 102-tonne locomotives that were stranded by the Kaikoura earthquake. The engines had been stranded on a stretch of track between Hapuku and Rakautara – North of Kaikoura – since November.

The first of the locomotives was lifted onto the transporter on Thursday and taken to Kaikoura. The other made the same journey on Friday.

KiwiRail Engineering Manager Peter Dautermann says moving the locomotives was a massive job. "A team of specialists was needed to manage the shift. The logistics involved in preparing to move these locomotives is enormous," he said. The locomotives can now get 'back to work' helping with the job of rebuilding railway tracks.

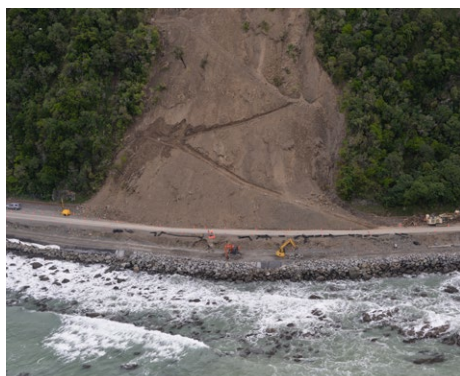
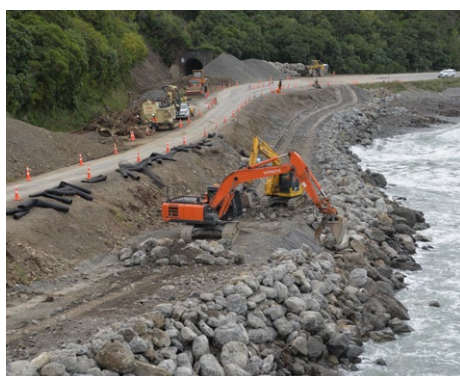
State Highway 1 between Peketa and Oaro south of Kaikoura is expected to remain closed until the end of the month to finish the building of a temporary road and rail alignment around the base of a large landslide that came down during April's cyclones.

The 300-metre road and rail diversion around the bottom of this large landslip is being worked on during all available daylight hours. This includes raising the surface of the rocky beach by four metres to provide a shelf for the new road. The 'cutting-in' of the ramps has begun to connect the new road to the existing one. A bitumen spraying machine is also scheduled to arrive on site next week followed by the final step of applying stone chips to the new section of road.

Rock armour is currently being placed on the seaward face of the new embankment for protection from coastal erosion. Rail tracks will also be diverted around the toe of the slip, alongside the new road. This is in preparation for the arrival of the engineering train due to be on site at the end of the month. This will travel between Oaro and Peketa in the short term to assist with recovery works.

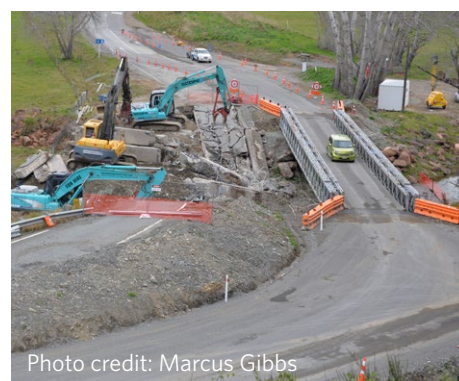
The demolition of the old bridge required careful planning and coordination because it was so close to the Bailey Bridge. Two cranes were used to first lift the Bailey Bridge away from the fall zone of the old concrete bridge before demolition could take place.

A 36-tonne and two 20-tonne excavators were then used to demolish the old bridge with the Bailey Bridge returned to its position in time for the road to reopen on Monday, 22 May at 7am as planned.

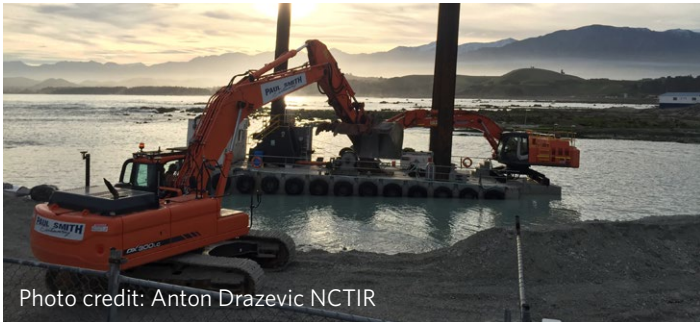
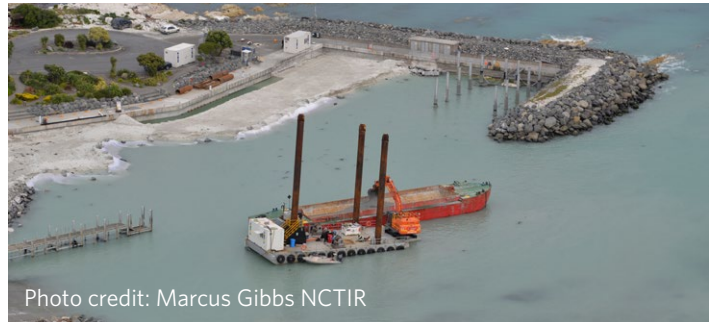
The latest in hi-tech satellite technology is being used to dredge the Kaikoura harbour ensuring it is cleared as efficiently and precisely as possible. This has allowed solid progress to continue to the point where dredging is now complete in the coast guard channel and the outer harbour.

In the Kaikoura harbour the seabed rose by more than two metres making access to the South Bay Marina and the Coastguard boat ramp impassable. This has had a huge impact on the marine and tourist businesses in the region.

Seatools is an electronic dredging system that allows operators to know in real time exactly where their bucket is underwater, where it needs to go, and whether it has cleared what was needed.

To make sure it does not bump into beacons, wharves or the foreshore, satellite receivers on board the dredging vessel give out this important hydrographic information as well as the extent of dredge areas, pre-dredge seabed contours, and most importantly where the machine is relative to the features.

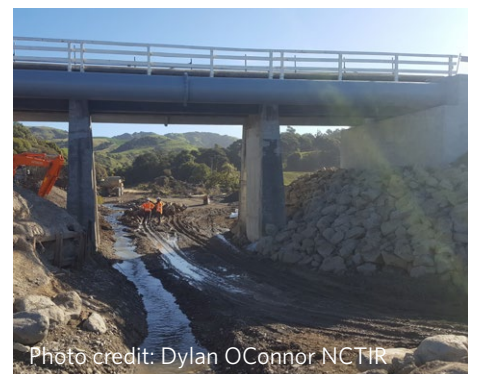
12 May marked a major milestone for the re-instatement of the Main North Line when a work train was able to pass over Bridge 90 at Boundary Stream, just north of Ferniehurst. This is the first major rail bridge site to have a work train.

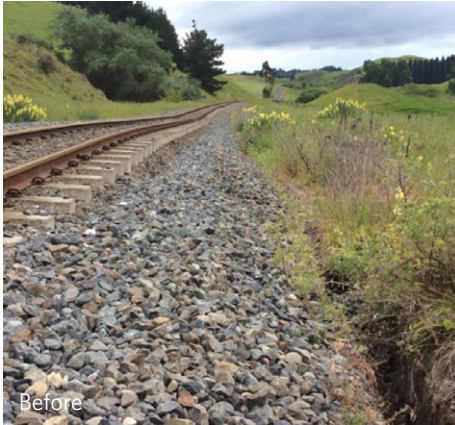
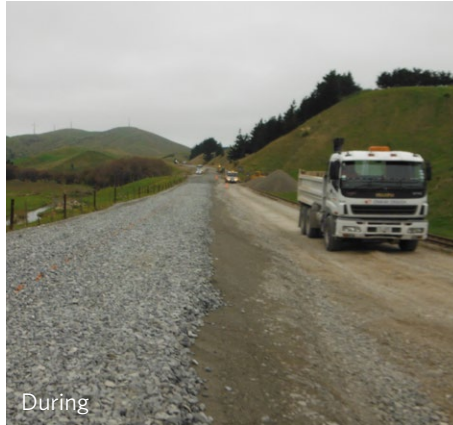
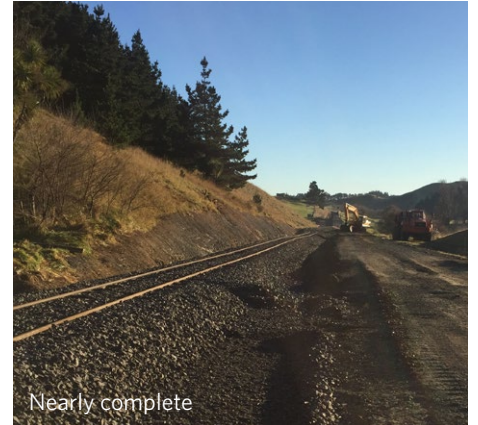
The 700m of railway tracks at Tar Barrel near Mirza Creek are now realigned and ready for the work train to come through. Completing this project has been critical to the rail programme because it means work trains can move through and help prepare the coastal corridor from Ward to Clarence. Congratulations to the rail crews who have worked hard day and night (under lights) to make this milestone.

The following photos show progress at the site.

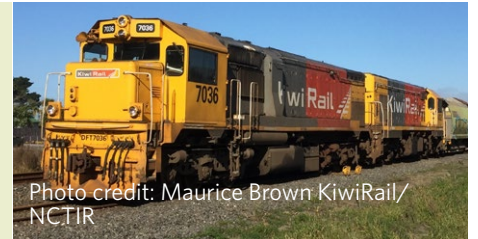
Work trains lay the ballast that forms the track bed upon which railway sleepers are laid. They also help deliver other materials to site like rails and sleepers. The work train is followed by a tamper track machine which compacts the ballast under the sleepers and corrects the track alignment.

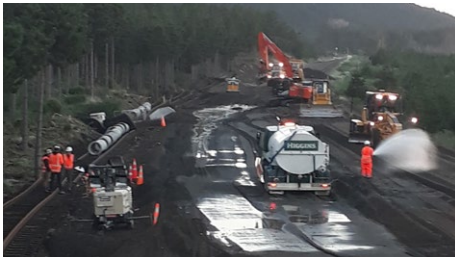
Bulk earthworks have been underway at Pines north of Waipapa since April to repair this 700m long damage site.

The up thrust caused by the November earthquake at Pines caused a section of the road and rail to end up much higher than the surrounding area. The preparation work - which includes cutting, filling and compaction - is taking place at the northern end of this up thrust area and design work has now been completed for the 400m southern section where work will start shortly.

Large box culvert units, measuring 3 metres by 2.5 meters and weighing 17 tonnes each, are currently being manufactured in the south, and the first of 10 units are expected to arrive onsite next week. There will be a total of 21 culvert units, and installation is due to start in the next few weeks.
