KAIKOURA EARTHQUAKE UPDATE - no. 25

14 July 2017

MILESTONE: MOMENT OF TRUTH FOR THE HISTORIC CLARENCE RIVER BRIDGE

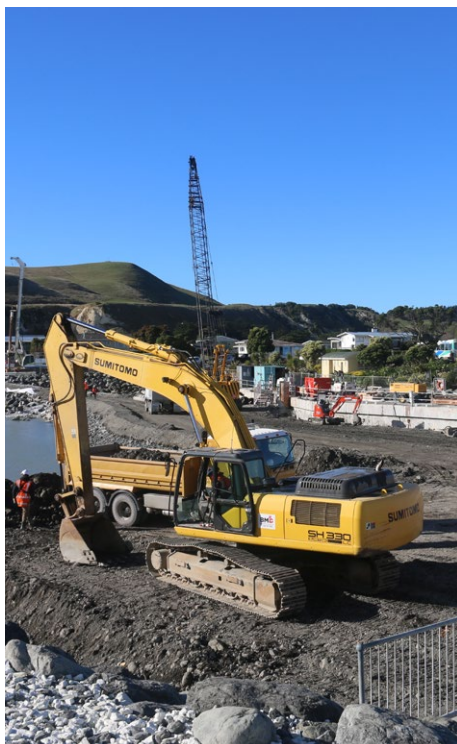
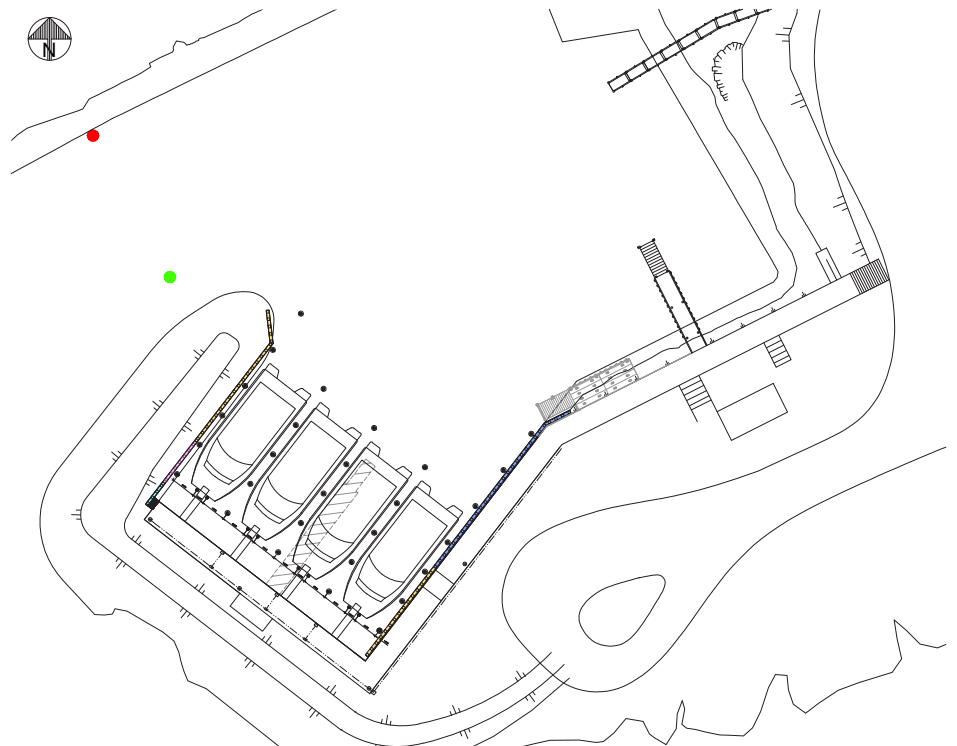
Getting this machinery in place is critical to installing the piles which will form the promenade retaining wall along the eastern edge of the harbour (see harbour design drawing below).

The first phase of creating this working platform reused the excavated marina floor material. Additional fill was used west of the promenade wall to extend the working platform that will enable machines to access the groyne.

The work on the retaining walls is one of the most challenging parts of the harbour project because to build them, the rock groyne has to be lowered on the harbour side, effectively stepped down several metres to water level. This will protect the work area from rocks falling in. The 35 piles will then be drilled into place along the groyne to form the wall.

Great progress continues to be made at the Kaikoura Harbour. The berthing area is now completely dry and temporarily filled with material that has created a 'hard stand' working area (platform, pictured) from which the 50-tonne crane, a drill rig and an excavator can operate.

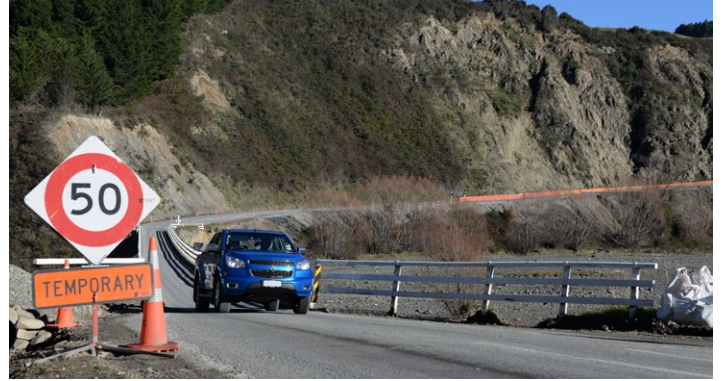
Conway Bluff needs to be heavily 'scaled' to remove loose material falling on the road below. This involves abseiling teams moving down the bluff and forcing unstable rocks and other materials down the slope.

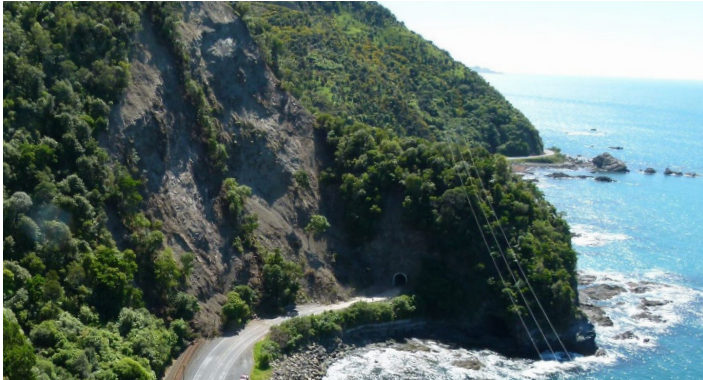
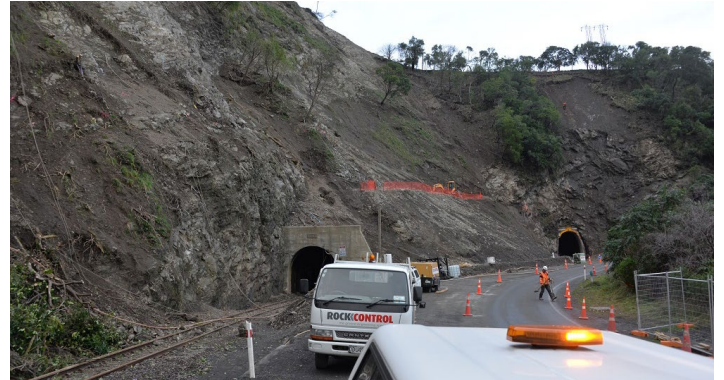
A huge amount of material came down at this site during the November earthquake completely covering the Main North Line and blocking the railway tunnel (see before and after photos below), the north-bound lane of SH1 and part of the south-bound lane.

The slopes were first sluiced (helicopters dumping sea water from monsoon buckets) to remove loose material followed by scaling where abseil teams scaled down the cliff and forced unstable rocks and other material down the slope.

A bench was then excavated about 6m above road level to create a work platform as well as temporary fences installed to catch rock falls.

The team has just completed construction of the concrete plinth that will be the foundation for the permanent rock fall fence and looks forward to completing work at the site in the next couple of weeks.

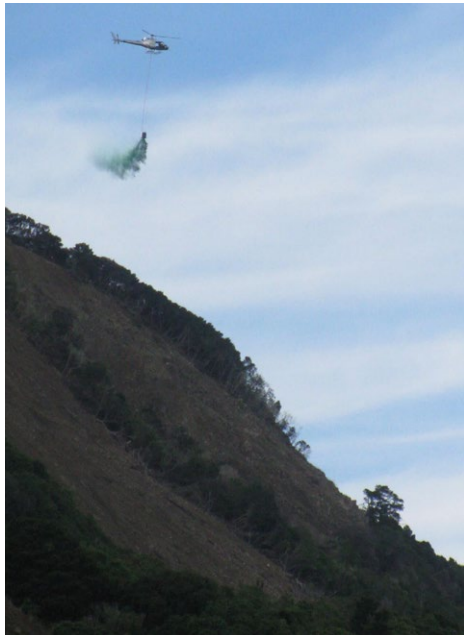
In May, RST Environmental Solutions, in partnership with Amuri Helicopters, undertook the grass seeding trial in which Bonded Fibre Matrix (BFM) hydroseed was applied to the slip faces with helicopter monsoon buckets.

The main difference between standard hydroseed and the BFM applied is that Vital Polykelp was used as the 'tackifier'. The material is rain fast, with a kelp fertiliser component giving instant-to-medium term soil stabilisation while the grass establishes. Another part of the mix in the BFM was grass seed and a 100% recycled wood mulch.

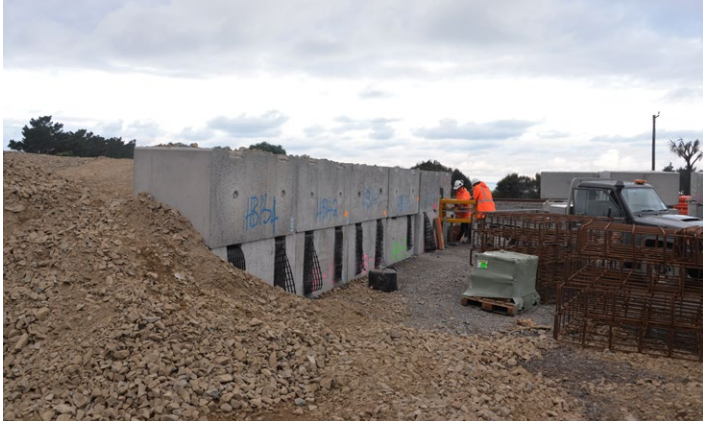
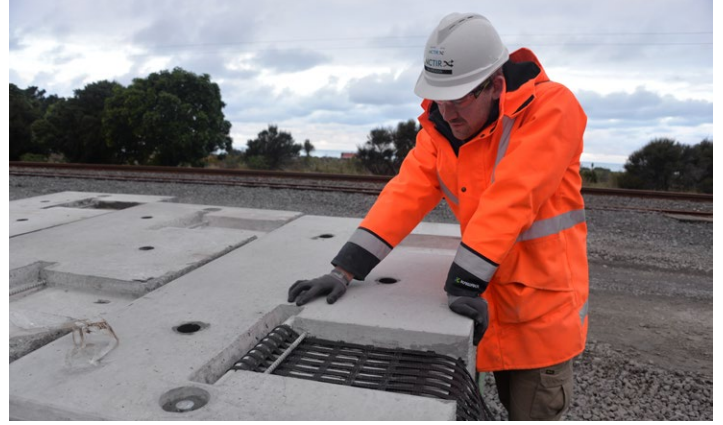
NCTIR site engineer Tim Dreadon and designer Hugh MacMurray have been tasked with making sure the sea walls meet the design specifications. A mini seawall (pictured) has been built at the Hapuku stockpile site and the pair have been deliberately stressing each block until it breaks.

Using a special machine, the friction between the soil and the block is tested to determine the level of force required to pull the wall to pieces.

A plastic strapping mesh, used to connect blocks to the gravel wall behind it, is pulled until a fibreglass reinforced plastic dowel that it is connected to it snaps in half and the concrete around it crumbles.

'The bar is breaking at a much higher load than we designed it to which is perfect,' he says. The test is a close representation to how the wall will work.

A fibreglass reinforced plastic dowel is being used as the walls are designed for a marine environment and steel dowels would rust away compromising the integrity of the walls.

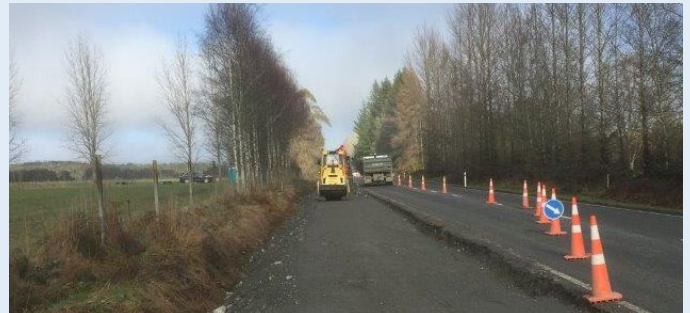
One such improvement project underway is the slow vehicle bay near Maruia (pictured) – one of seven currently programmed for this route. With up to a four-fold increase in traffic in some parts, traffic can quickly build up and drivers become impatient to pass slower vehicles. This can result in poor decisions and crashes. Once completed, these bays will provide slower vehicles – typically trucks, buses and campervans – with a place to safely pull over and let traffic pass.
