KAIKOURA EARTHQUAKE UPDATE - no. 26

21 July 2017

MILESTONE: WORK TEAMS SET TO FINISH CONSTRUCTION-ONLY ACCESS TRACK AROUND OHAU POINT

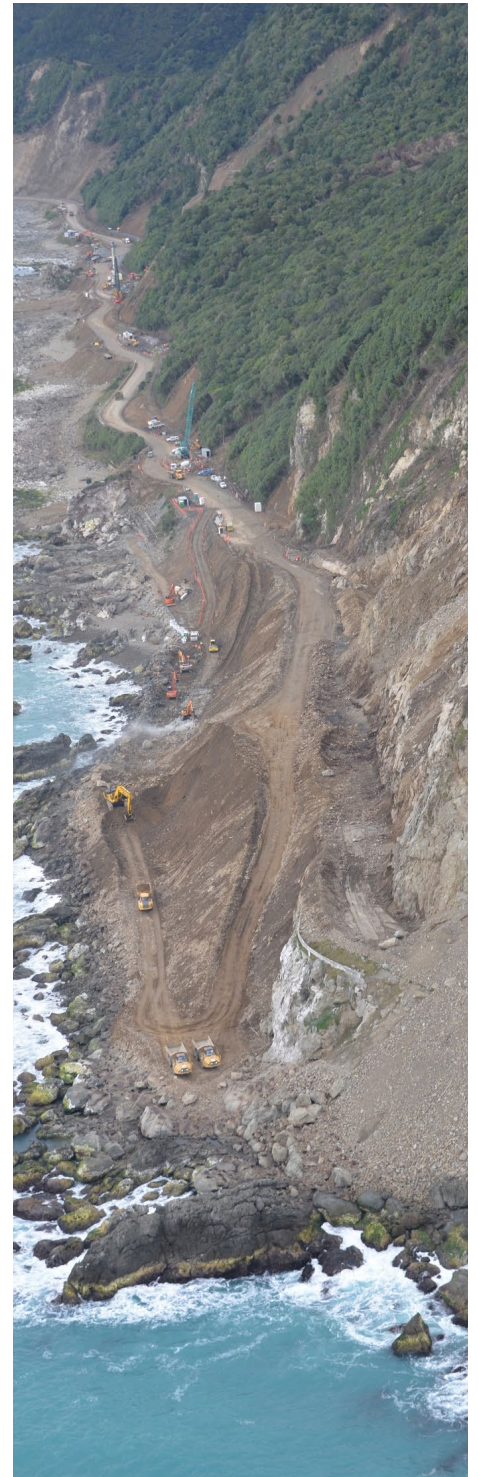
WE ARE MAKING PROGRESS AT OHAU POINT

3D image of Ohau Point immediately following the November 2016 earthquake

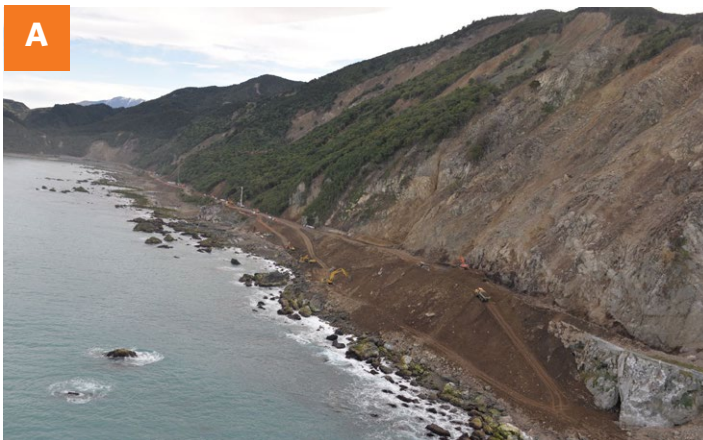
Photo showing the extent of work done to date on the road south of Ohau Point.

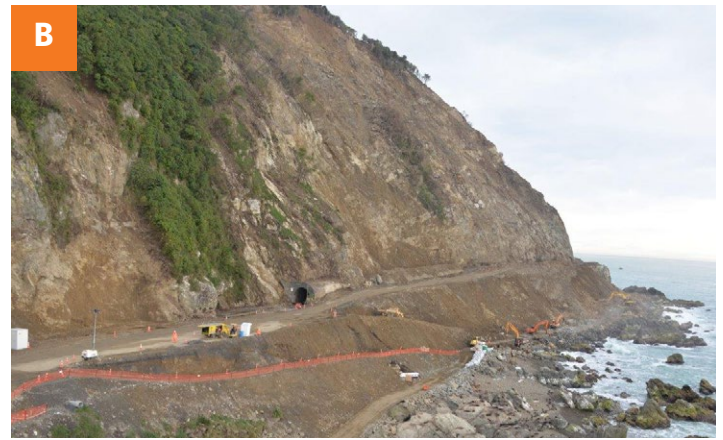
The south side of Ohau Point has been slliced, scaled and an access track is being built around the outside of the point for construction traffic.

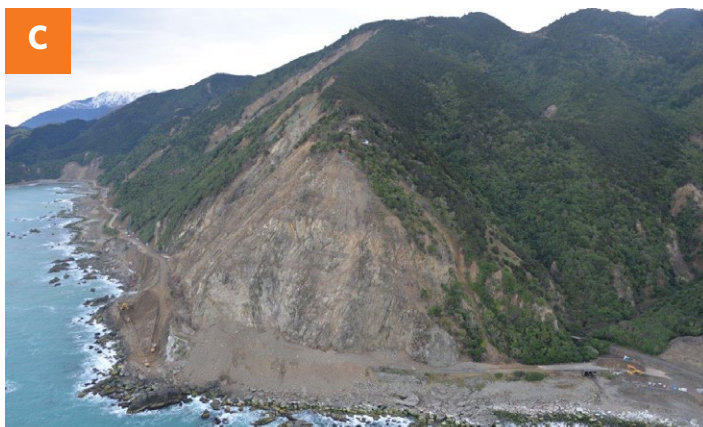
Photo showing the north side of Ohau Point and the extensive work done to clear the slips. The abseiler's base can be seen at the top of the hill.

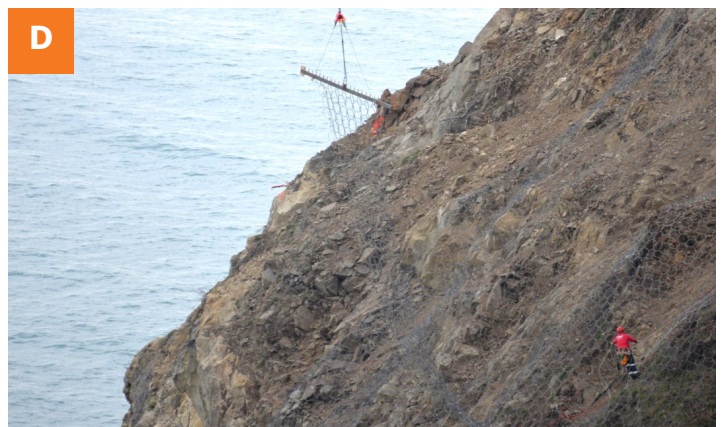
Abseilers working to secure rock mesh netting high up on the north face of Ohau Point.

'On the north side helicopter teams and abseilers have been installing a layer of steel mesh over the slip face to make this area safe,' says earthworks north project manager Mike Reilly.

From now until the end of September, teams will be installing a significant number of bolt anchors to lock 4500 m² of two types of mesh drapes into place at the site.

The loose and fractured rock has slowed down the drilling process, with numerous anchors being installed in a triangle shape over which the mesh is draped. The mesh wire is similar to a knight's chainmail, linked together with rings.

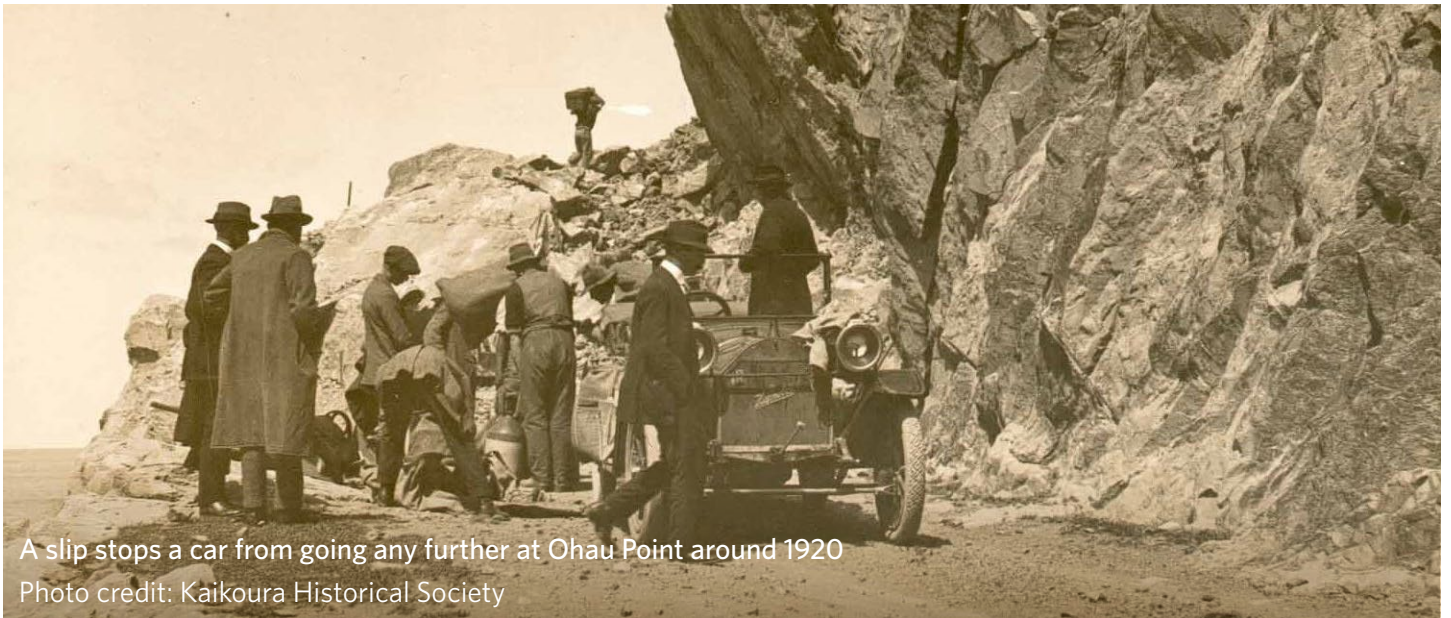
A slip stops a car from going any further at Ohau Point around 1920
 Photo credit: Kaikoura Historical Society

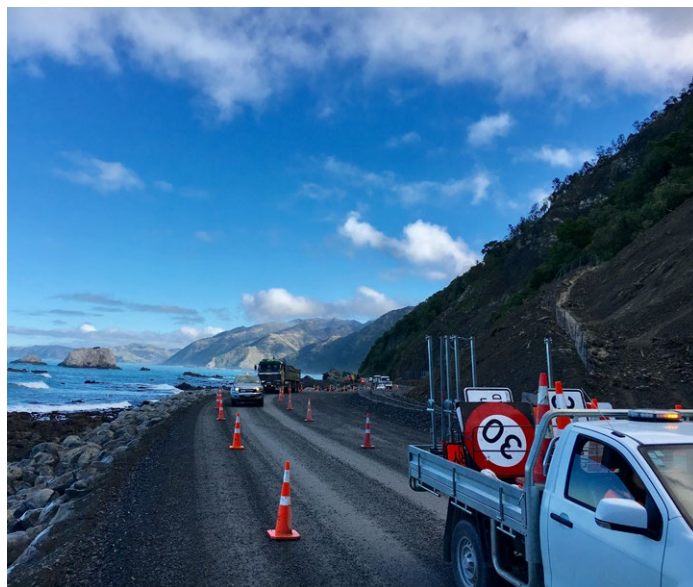
The 300-metre temporary road realignment around landslide 29A near Rosy Morn has been completed ahead of schedule although the final sealing will be done when the weather warms up in spring.

Initial approaches to clear the material and reinstate the road were changed in favour of constructing a new 300m section of road around the base of the slip. Above the road and rail, rock fences have been installed and the exposed slip face will be replanted.

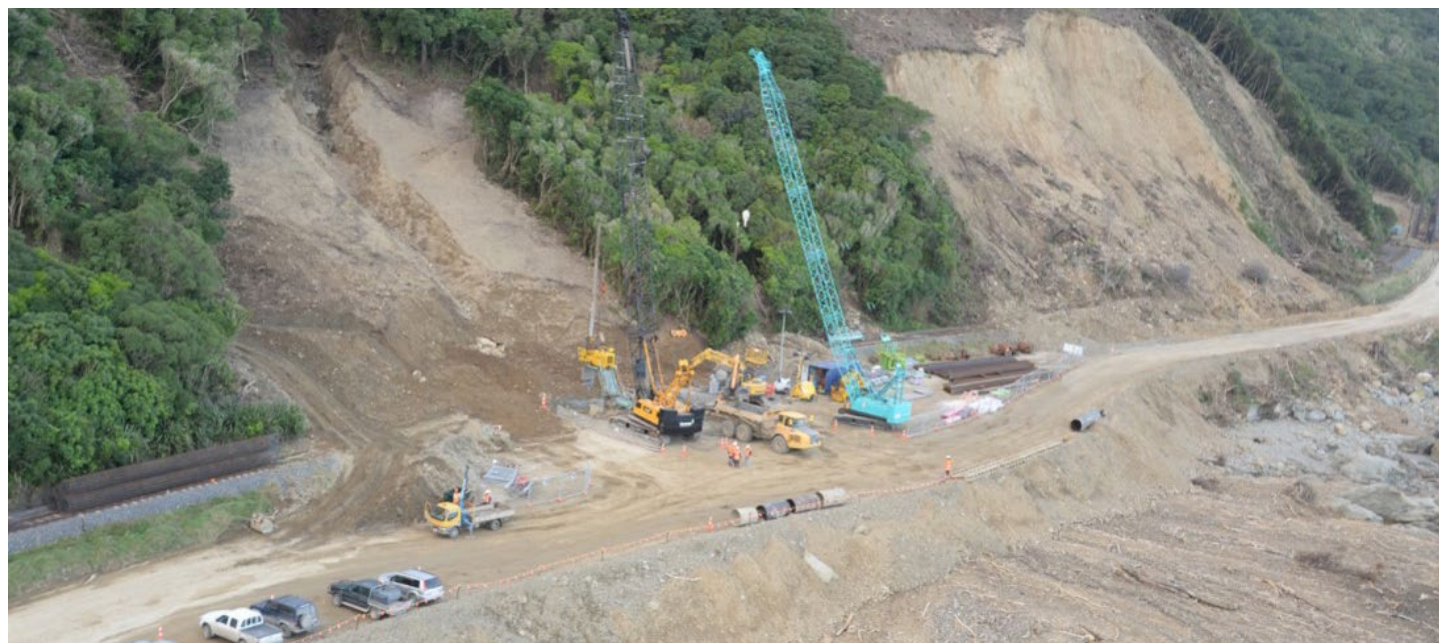
Three bridges have been designed and installed at the base of an earthquake damaged hill between Half Moon Bay and Ohau Point, north of Kaikoura.

These rail bridges are designed to allow for potential material from high on the slopes above to divert under the structures and 'flow out' underneath.

The massive construction project involves 12 huge piles of 1200mm diameter with steel casing being hammered down to bedrock using vibration pile drivers.

Each concrete deck is supported by two concrete abutments, spanning 12m and weighing 100 tonne.
