KAIKOURA EARTHQUAKE UPDATE - no. 30

18 August 2017

MILESTONE: REINSTATEMENT SH1 NORTH OF KAIKOURA

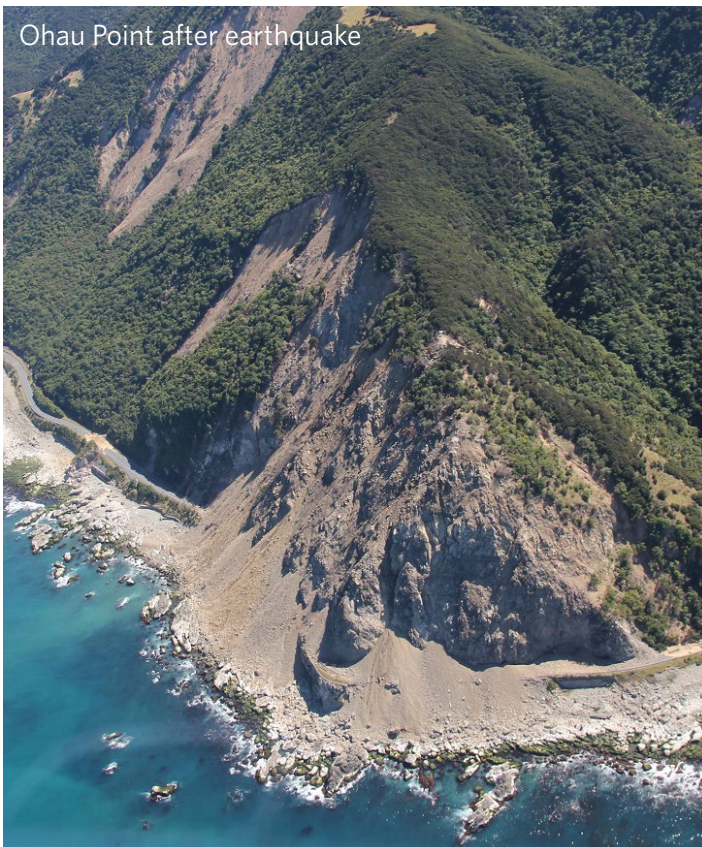
Ohau Point after earthquake

Teams working from the north and south of the significant slip at Ohau Point have now met up, marking a significant point in the effort to restore the road and rail links along the Kaikoura coast.

A construction track is being built around Ohau Point, which means work crews can begin a new phase of reconnecting State Highway 1 north of Kaikoura. This includes installing around 9000 square meters of steel mesh 'drapes' to protect the area from further rock falls. This rockfall mitigation work will also allow rocks closer to the road to be cleared, an area that could not be accessed before because of risks to workers.

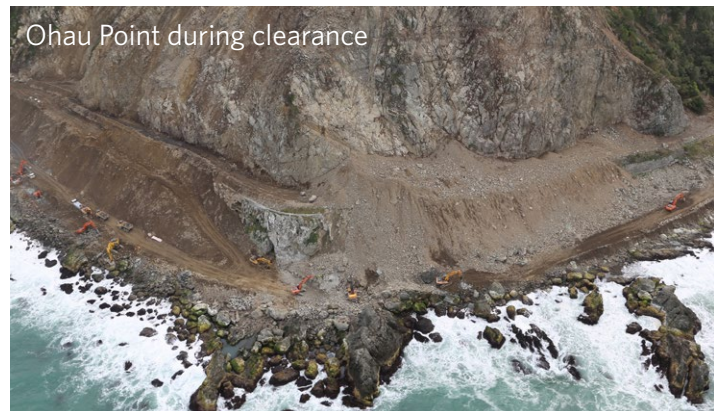
Ohau Point during clearance

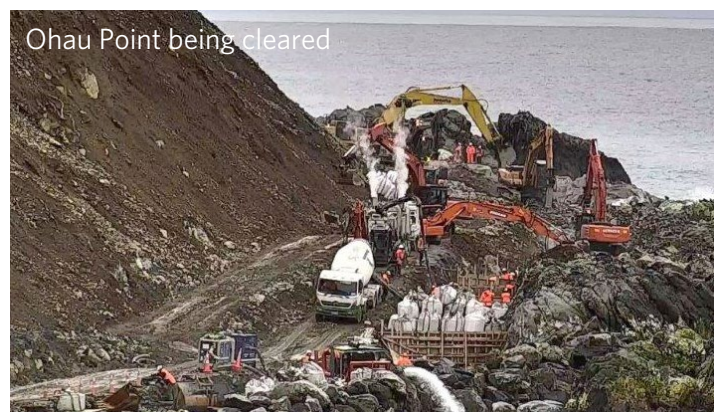
Ohau Point being cleared

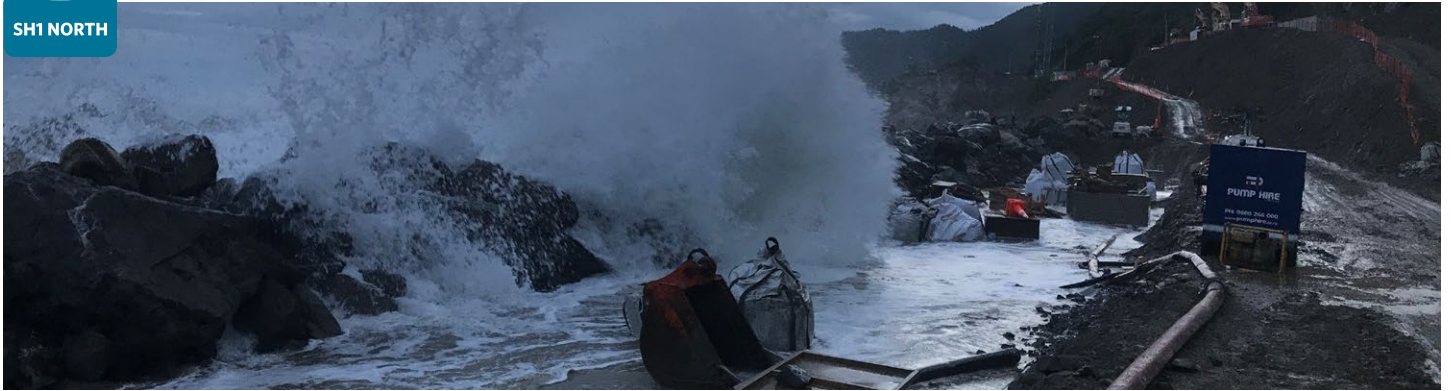
SITE 6 SEAWALL

The new seawall at site 6 near Ohau Point will eventually be more than a kilometre long and will have to be finished for SH1 to open by Christmas. It is a high-pressure project in an ever-changing environment, with ground conditions and water levels daily factors (see photo above).

The growing team has crews working 24 hours a day, six days a week, and this is a huge effort on their part. Sam says that in order to construct the seawall, excavators first have to remove landslip material back to bedrock, then cut a key for a footing so that when the concrete foundation is poured it will be stable.

‘Once the key has been dug, we then box up sections with form work (plywood frames and two tonne sandbags) to provide support, pump out the water that has come in with the tide, and come back with the concrete and pour. All this during that 2.5 hour window either side of low tide,’ Sam says. This seawall is the main focus at this challenging site right now, and the crew is making incredible progress.

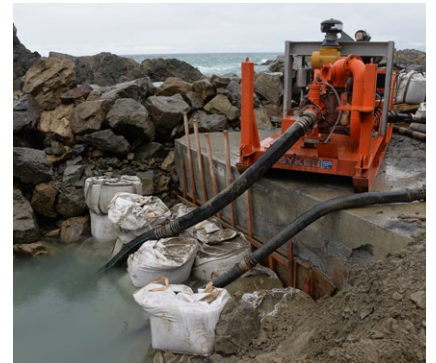
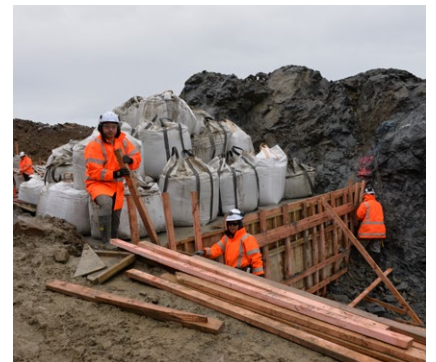
SITE 7 SEAWALL

By the end of this week, the crew at site 7 just around the corner from Ohau Point will have finished building/pouring the footing for this seawall.

The first pour for the footing was on 20 July, and they are now nearly 70% finished with the foundation of the seawall. This part of the project makes up about 35% of the total work required to complete a seawall.

‘Yes, there have been challenges but we’ve busted through,’ says lead hand Cam Brockie (pictured right). The crew is now grouting under blocks to level up the seawall blocks

so that layers of blocks leading to the top of the road alignment will reach their proper height. Brockie says the experience has been fantastic. ‘We’ve done this before at slip 2, so this is the same kind of work, but faster,’ he says.

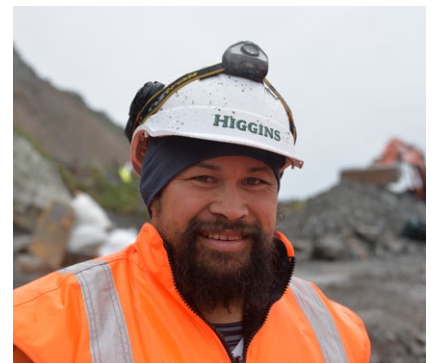
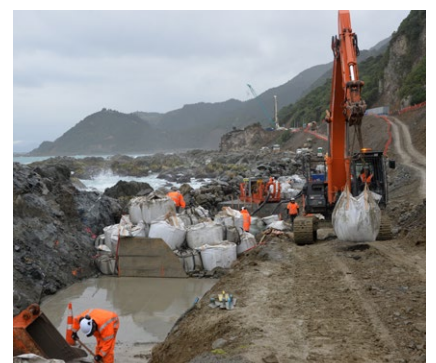
We're making progress – sea walls are being built

Seawall heights range from **5m - 10m+**

Each seawall block measures **2m long x 1m wide x 1m high**

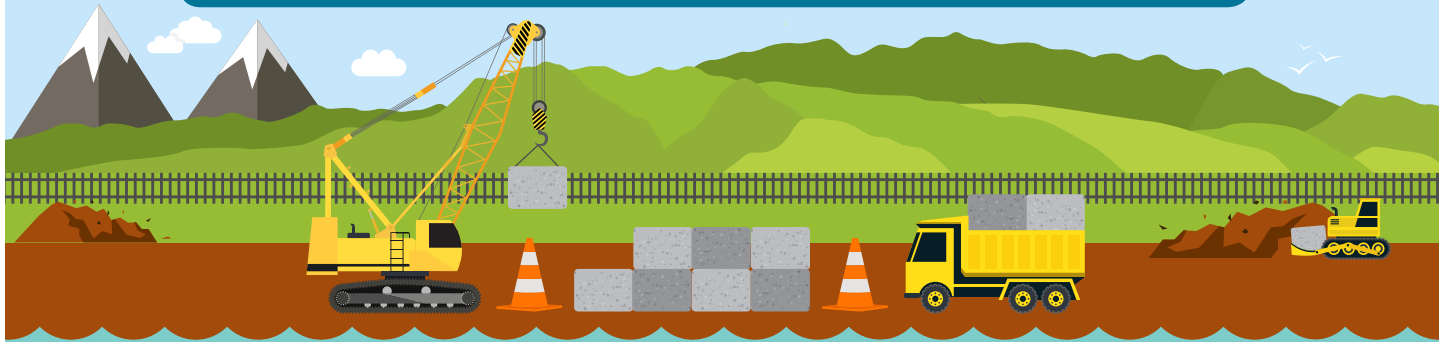
Each block weighs **5 tonne**

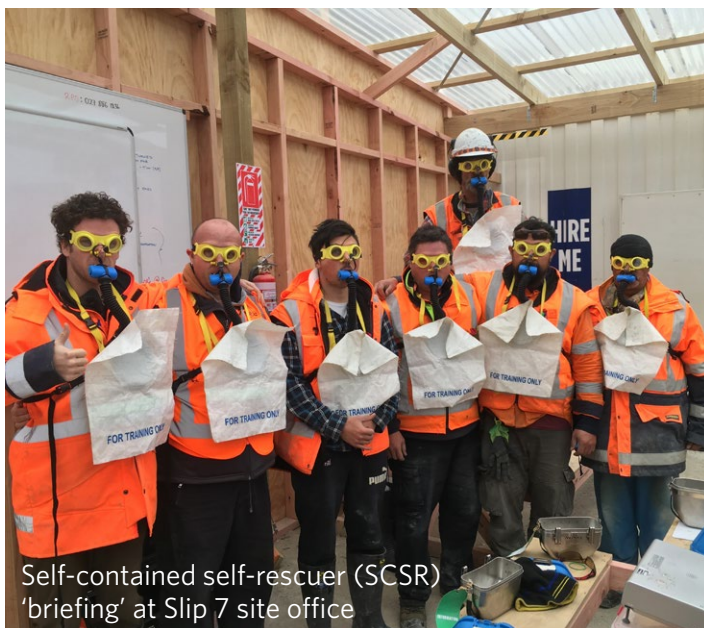
Self-contained self-rescuer (SCSR) 'briefing' at Slip 7 site office

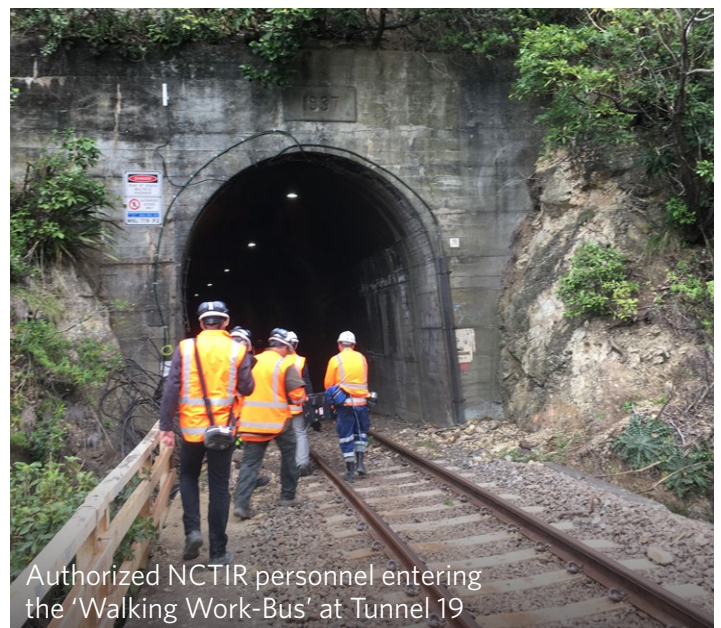
Authorized NCTIR personnel entering the 'Walking Work-Bus' at Tunnel 19

Located underneath Ohau Point, it is the last impassible point between the northern and southern areas of the NCTIR works area. Linking these areas is vital, and Tunnel 19 is the last link in the chain. Work trains are running through the tunnel, and authorised personnel are now able to be safely escorted through it.
