The Bulletin Kaikoura earthquake update

The North Canterbury Transport Infrastructure Recovery (NCTIR) alliance was set up by the Government under the Hurunui/Kaikoura Earthquakes Recovery Act 2016 to repair and get the road and rail networks reopened by the end of 2017 and repair the Kaikoura marina.

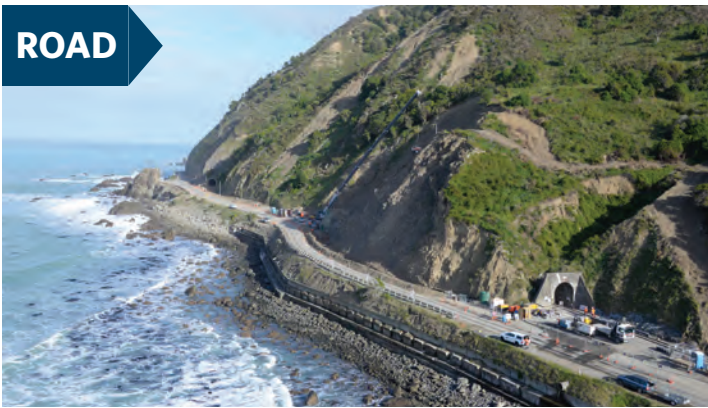
ROAD

Significant progress has been made on repairing earthquake damage that affected 194 kilometres of State Highway 1 between Leithfield and Blenheim. During the first few months the focus has been on recovery and clearing slips both north and south of Kaikoura.

North of Kaikoura the major challenge has been clearing nine significant slips between Mangamaunu and Wainui. 85% of this slip material has now been cleared. At the same time engineers have worked behind the scenes on rail, road, bridge culvert and seawall designs which are being built as soon as material is cleared.

Geotechnical experts have designed and installed rockfall protection measures and things are looking good for a reopening the entire length of SH1 by Christmas 2017.

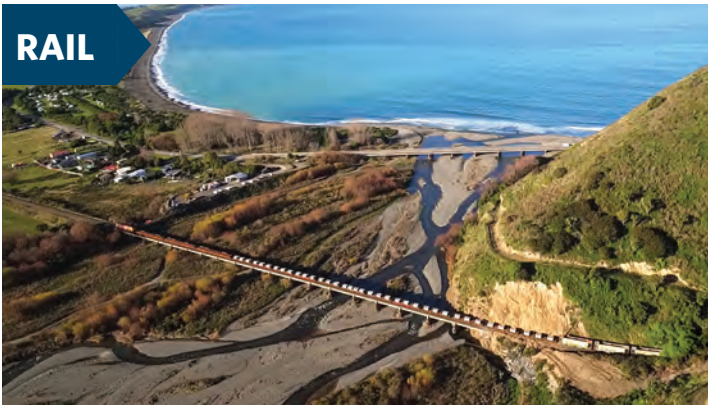
RAIL

Repairs on the Main North Line (MNL) have progressed quickly and rail was reconnected on 8 August.

The MNL was buried under more than 100 slips and landslides and repairs are happening at more than 750 sites including 60 damaged bridges.

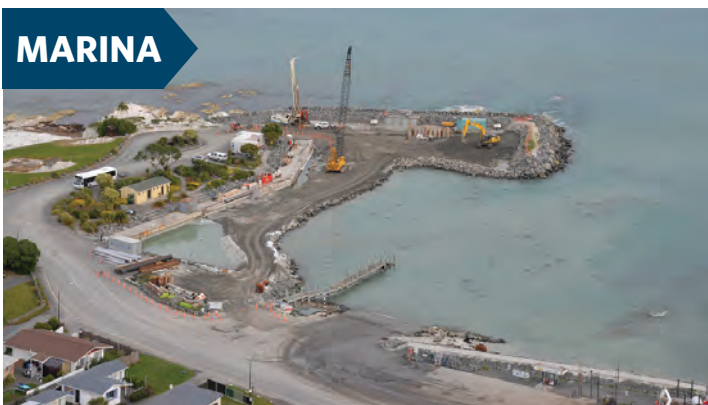
MARINA

The Kaikoura marina was badly damaged during the earthquake when the seabed rose by up to two metres. It is on track to reopen in November 2017. The sea channel and harbour floor have been dredged back to their original depth and new retaining walls are being built along the promenade and rock groyne walls. A new Dolphin Encounter jetty and tender (small boats that ferry cruise passengers to shore) jetty are also being built.

The harbour has been filled with material to create a 'hard stand' for machinery to work from. Once work is completed, this working platform will be removed and the area restored to a berthing area for four large boats.

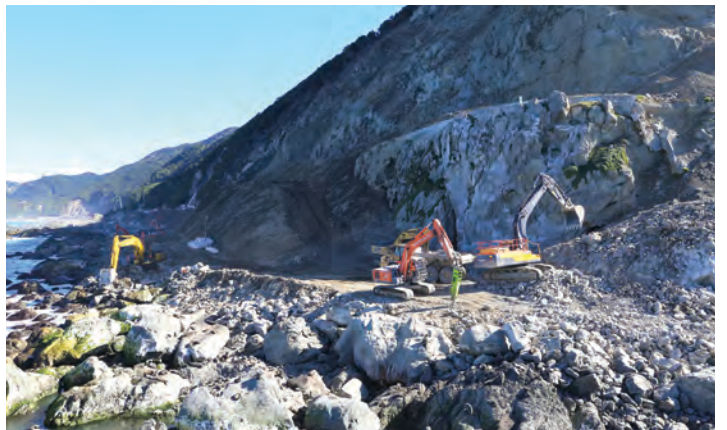
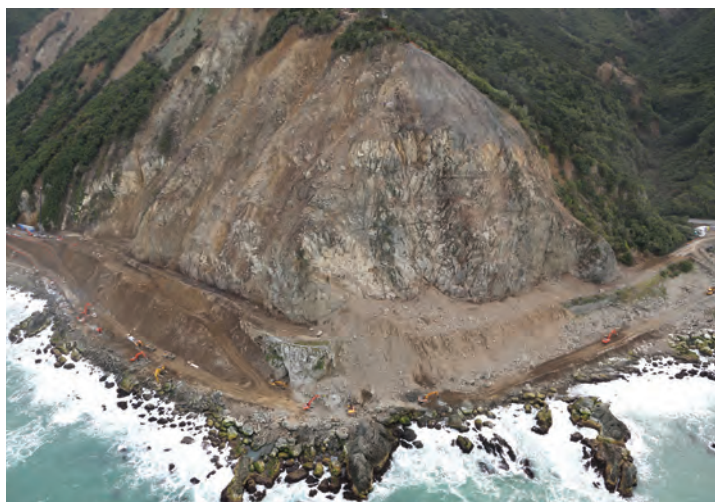
Ohau point access track

A major milestone was reached in August with the final stages of an access track cut around the edge of Ohau Point north of Kaikoura.

Using a boulder layer and slip material, crews have carefully built the track, which will now be built up to seven metres above sea level using material from Site 7a and existing beach gravel to fill it.

Rock armour on the outside of the track will protect it from being washed away during high swells. This coastal protection is similar to what was used on the edge of the new road alignment built at Site 29a, south of Kaikoura.

'A 50-tonne crane, excavators and loaders will be working along this track, preparing the foundation, pouring concrete and installing seawall blocks for a new road to be built 7.5 m high around the base of Ohau Point,' says David.
