The Bulletin Kaikoura earthquake update

WORK ON STATE HIGHWAY 1 RAMPS UP

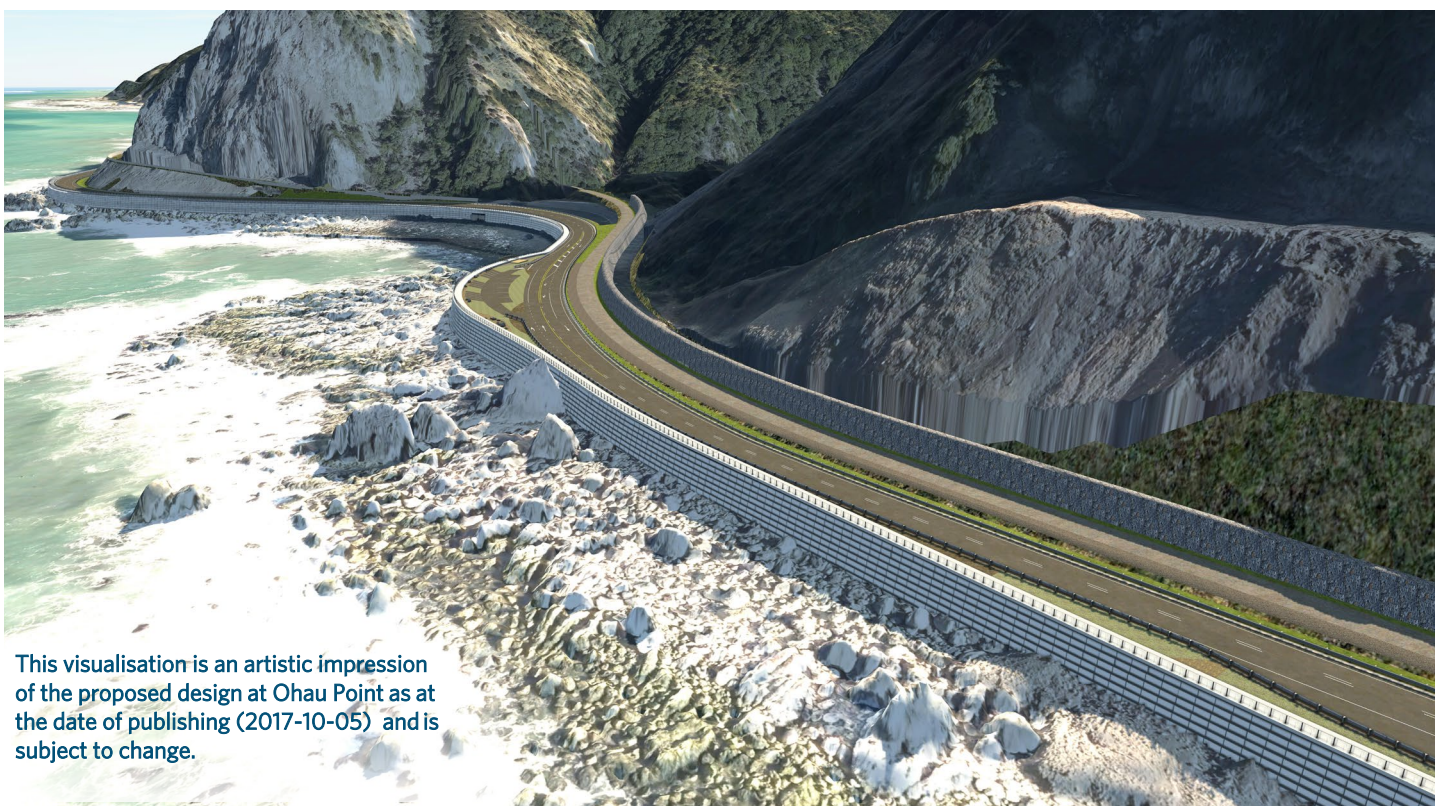
This visualisation is an artistic impression of the proposed design at Ohau Point as at the date of publishing (2017-10-05) and is subject to change.

Site 6 - (Ohau Point) - this is the most challenging of the projects requiring retaining walls, seawall construction and road realignment (see visualisation next page).

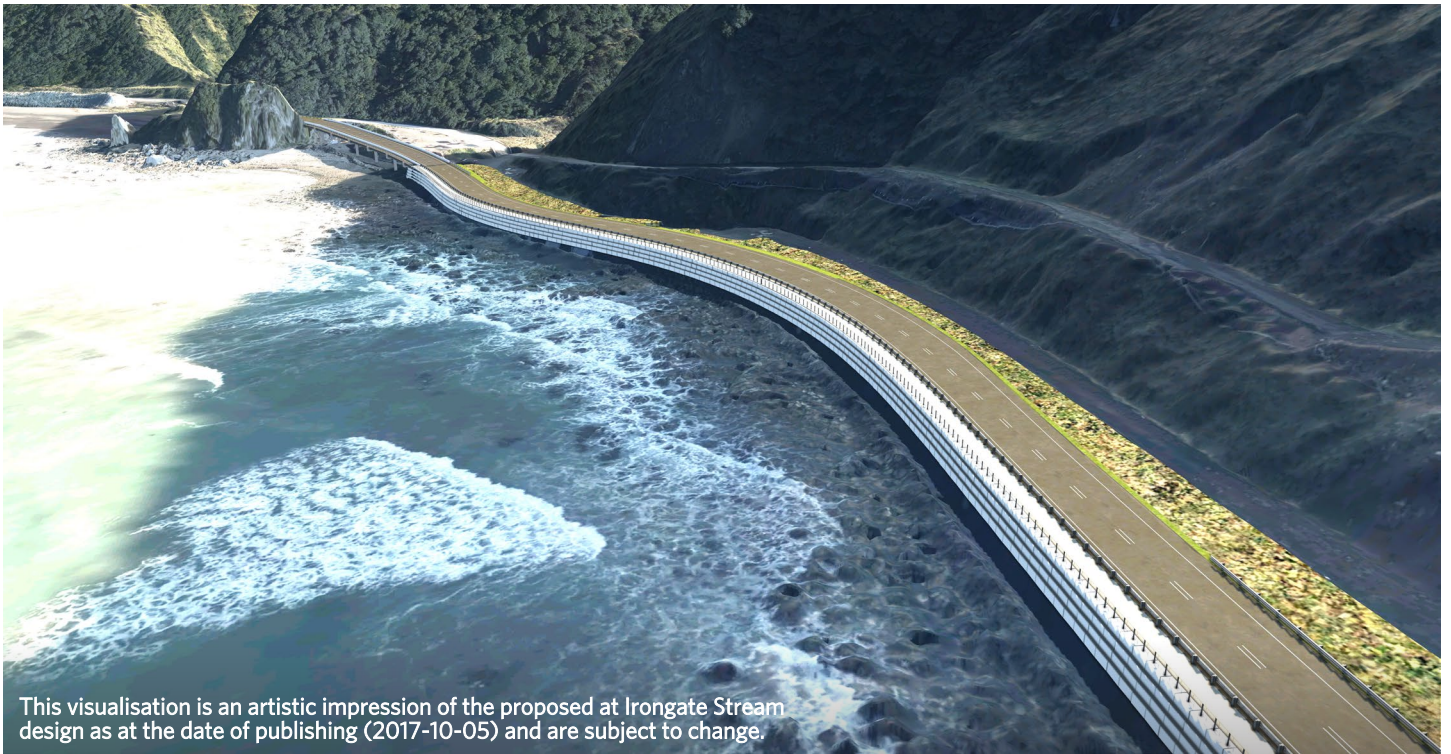
This visualisation is an artistic impression of the proposed at Irongate Stream design as at the date of publishing (2017-10-05) and are subject to change.

Site 2 - (Irongate) - a 144m long bridge is being built here, along with a retaining wall, seawalls and a new road alignment (see visualisation).

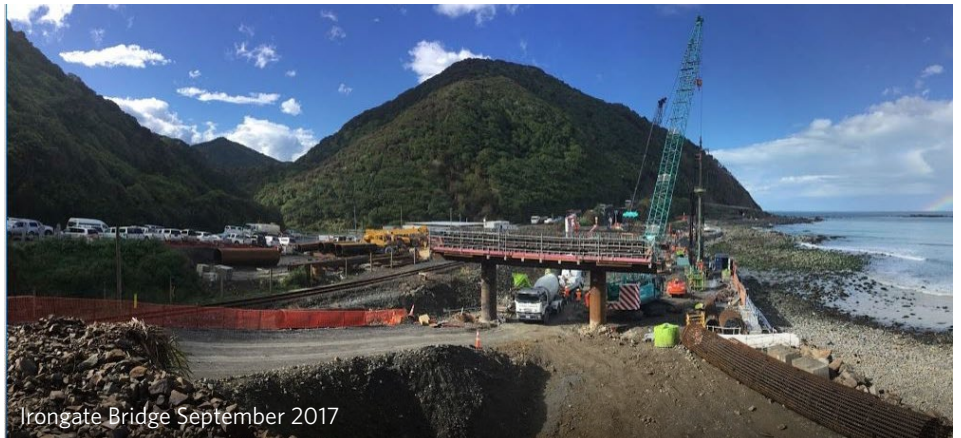
Irongate Bridge September 2017

Work at Irongate Stream to build a 144m long bridge is going well. This page features historical photos of the site including the months after the November 2016 earthquake.

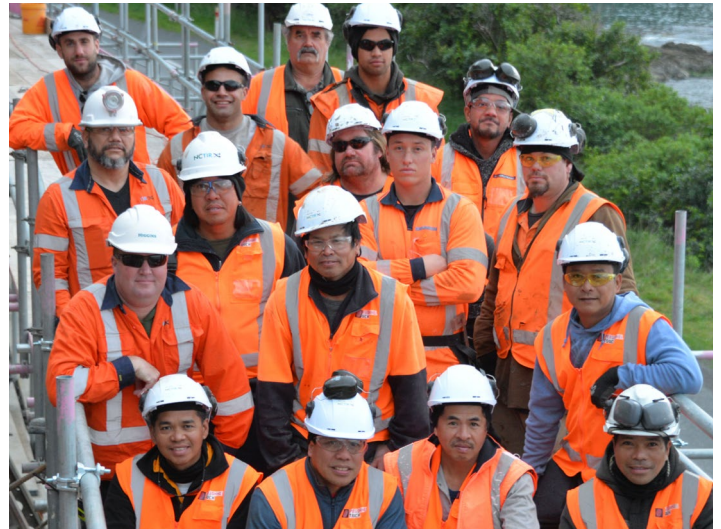
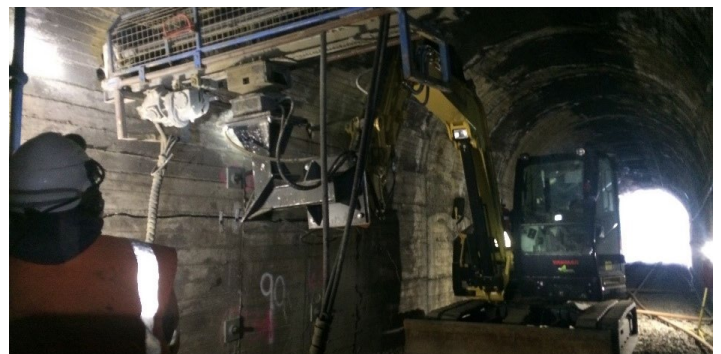
TEAM WORK AT TUNNEL 6

As a result of the November 2016 earthquake, the tunnel was displaced between 50 and 100mm seaward. In response to the damage, the design approach included 127 anchors, concrete repairs, and an external buttress.

This multicultural crew from New Zealand, the Pacific Islands, the Philippines, the United Kingdom, France, and Australia, have been working together as a team; 100% of rock anchors and about 90% of concrete repairs, and 55% of the buttress work has been completed at this stage.

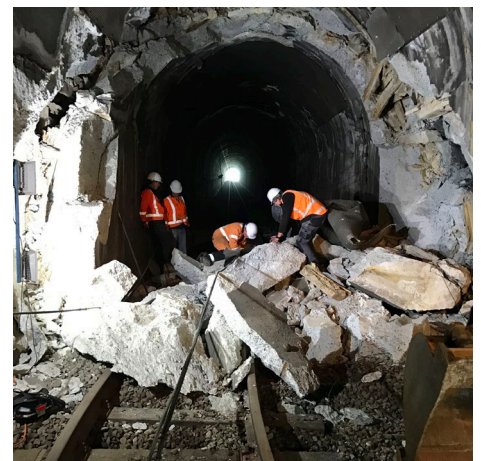
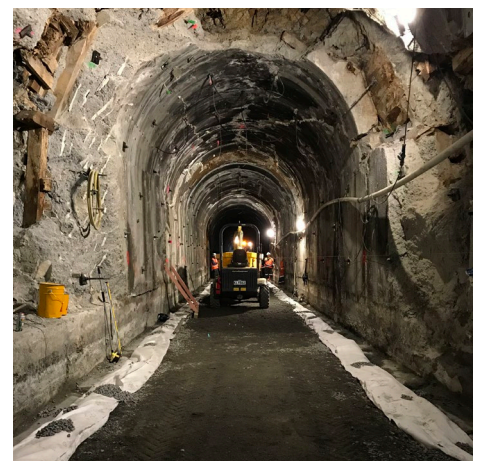
UP TO THE CHALLENGE AT TUNNEL 18

During the November 2016 earthquake the tunnel was separated into two parts, lifting the north end of the tunnel 500mm and shifting it 180mm seawards.

‘When we came to inspect the tunnel, it was obstructed by large pieces of concrete lining from the walls and roof, and rail that had been twisted and thrown out of alignment,’ says tunnel manager Rafael Ballen. This tunnel was one of the most seriously damaged tunnels in the earthquake, along with Tunnel 6, 13, and 16.

After debris was cleared, repairs began, with 230 anchors are being installed and concrete repairs. The tunnel was lowered, in order to create space for trains to pass through again by 1 July 2017.

‘Future works include reshaping the concrete lining and constructing new lining inside the tunnel around the fault zone. Every metre between the steel ribs, we will place reinforced concrete,’ says Project Engineer James Thompson.

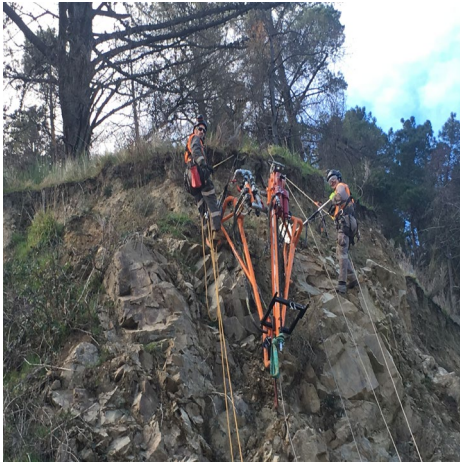
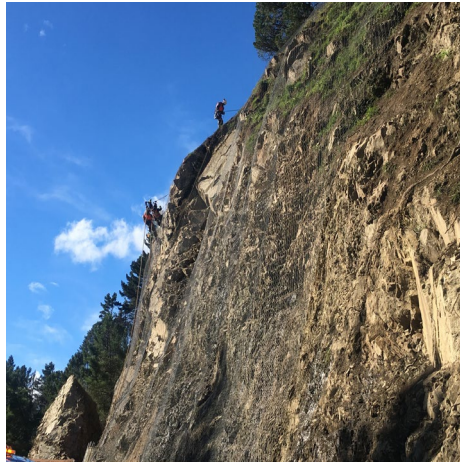
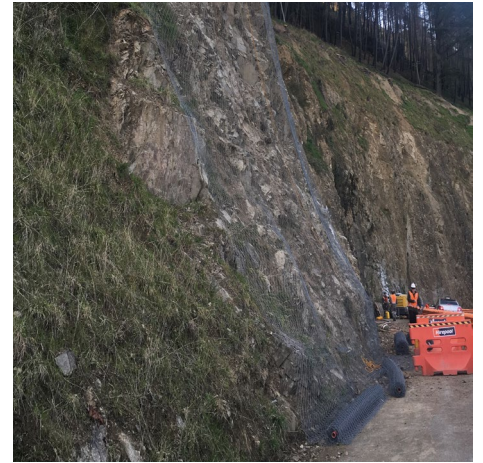
WAIAU BLUFFS WORK UPDATE

A team has drilled almost 300 steel bars into the rock face over which 5000m² of safety netting will be installed. Another team is installing a 130m long concrete beam on which new guard rails will be bolted replacing the old and broken wooden sight rails. A crib wall at the site is also being removed and replaced with a 130m³ gabion retaining wall, along with repairs to a retaining wall damaged in the earthquake.

The existing road surface for the westbound lane will be rebuilt and resurfaced. It is being dug up to install the concrete beam and the gabion wall. All of this work is scheduled to be completed by the end of October.

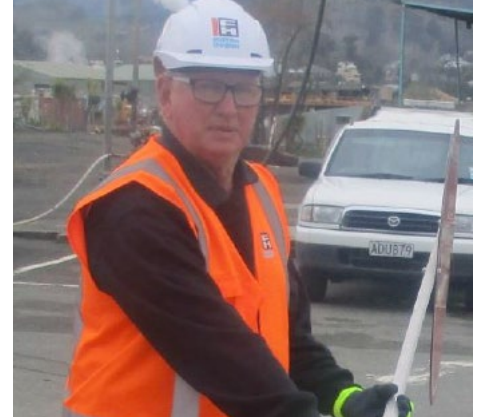
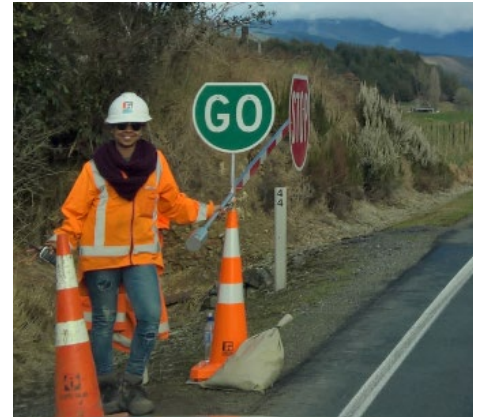
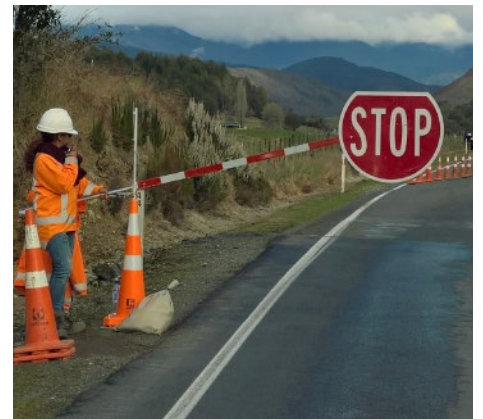
'The Gibney' stop/go barrier arm helps the TC remain well away from moving traffic. The 'go' looks pretty much like a standard 'go' - a sign on a pole. The big difference is the 'stop'. The 'go' is swung out of view while a barrier arm with a larger than normal 'stop' swings in to the middle of the lane directly in front of the driver (see photos).

After showing his prototype to colleagues, the NZ Transport Agency and road control authorities through initial trials and adjustments, Mike refined his idea and successfully applied to have it endorsed as a standard tool within the very strict NZ Code of Practice for Temporary Traffic Management.
