The Bulletin Kaikōura earthquake update

This bulletin provides the latest information about the rebuild of road and rail networks damaged by the Kaikōura earthquake in November 2016. The bulletin is produced by the North Canterbury Transport Infrastructure Recovery (NCTIR) – an alliance representing the NZ Transport Agency and KiwiRail, on behalf of Government.

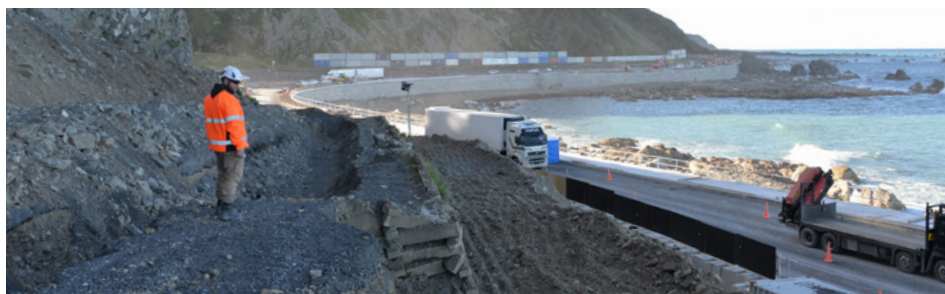
The crews at site 6 and 7 around Ōhau Point recently achieved a massive goal of getting the seawall up to height, as well as shaping it to accentuate the surrounding reef and beach, and they are already hard at work on their next project.

Around Ōhau Point, the new alignment of State Highway 1 (SH1) has been lowered by 14 metres at the Ōhau Point corner, and shifted about 30 metres away from the cliff face. It is difficult to imagine the old alignment, which was almost entirely covered by the massive slip caused during the November 2016 earthquake.

Project engineer Tomislav Diklan says the crews will be busy clearing slip and debris material from the old alignment of SH1 as well as shaping and trimming an earth bund to three to four metres high as protection against any future movement.

One team will be forming a green terramesh bund 80 metres long, south of Ōhau Point, just before the tunnel. At the same time a shotcrete crib wall north of Ōhau Point about 60 metres long will be constructed to blend in with the surrounding landscaping just below the earth bund. Crews working from both ends of the slip will meet in the middle as their projects near completion.

An 800 metre long rockfall catch-fence will be installed as primary road protection, while the roading team works to complete the sealing of the road and streetscaping of the new SH1 alignment. Embankments between the old and new culverts at Ōhau Stream require completion.

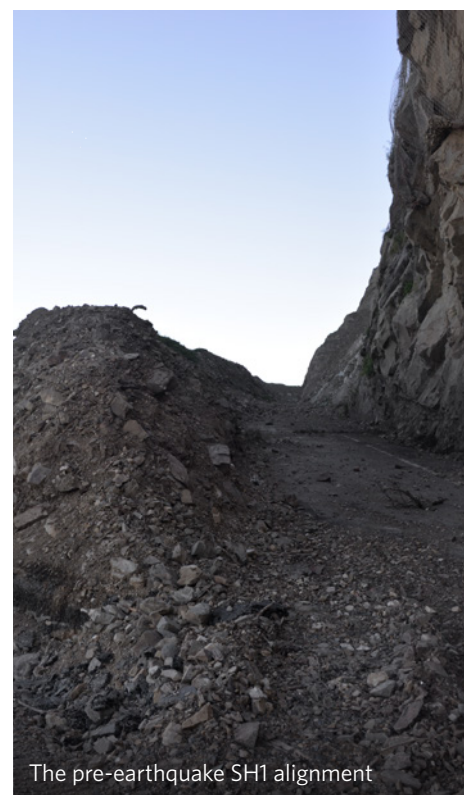
The pre-earthquake SH1 alignment

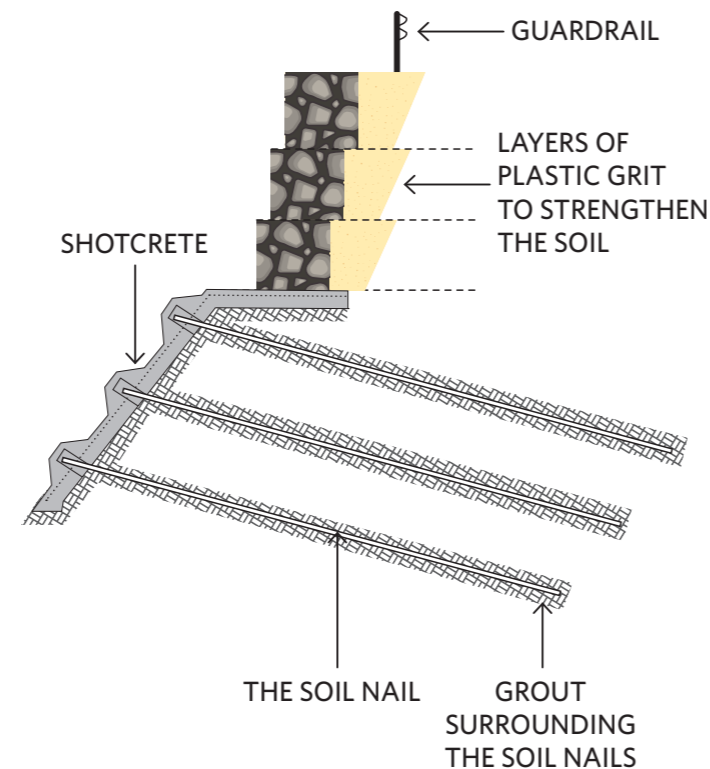
Soil nails stabilise the hillside lying under the road. Typically six to nine metre long steel bars are drilled into the hillside slope. Grout is pumped into the drill hole with the steel bar to fill voids and surround the nail. How many nails used at any given site will depend on the stability of the soil and the site topography. Steel reinforcing mesh is laid over the surface of the slope over the tops of the nails. Then a layer of shotcrete – a spray on concrete – is applied on the exterior over the nails to create extra stability and protect the slope. The road is then rebuilt over the newly stabilised earth below it. At the area on the Hundalee Hills gabion baskets have been used on top of the soil nail sections to build up the road height to achieve the required road ride improvements.

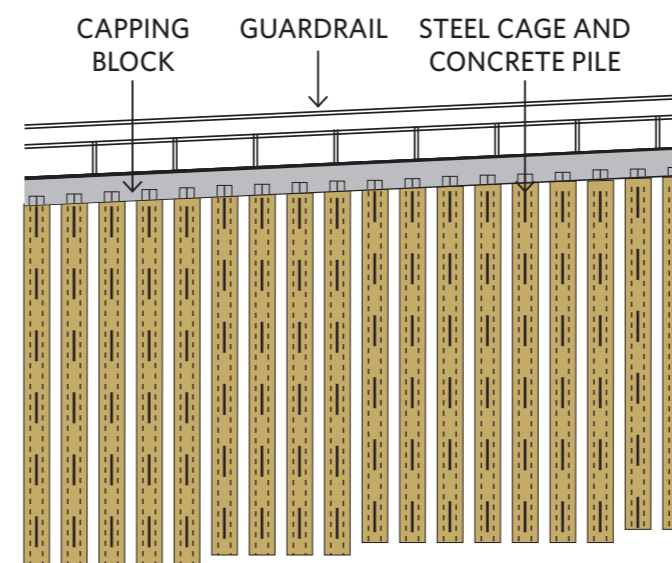
Bored concrete pile retaining walls

Another structure designed to bring stability to the Hundalee Hills route and the traffic which moves over it are bored concrete pile retaining walls. The cranes, diggers, and rigs drivers and passengers can see on the side of the one way sections over the Hundalee Hills are being used to build two of these walls. Metal tubes, called casings, up to 800mm wide are pushed into the ground 12 metres deep. The material captured inside the casing is bored out, circular steel cages are inserted inside the now empty holes, and concrete is poured in with the steel cages, the casing is then removed. The concrete sets around the cage with the soil surrounding it. On one of the walls anchors are used near the tops of the piles and are placed horizontally under the road. Capping blocks are put on top of the piles before the road is built across the top of the piled walls.

Before work could begin at this site our crews had to do temporary works so the heavy machinery could fit. Sheet piling holds up the side of the hill so work can be done. Once the retaining walls are completed the sheet piling will be removed and reused as part of the walls creating extra stability.

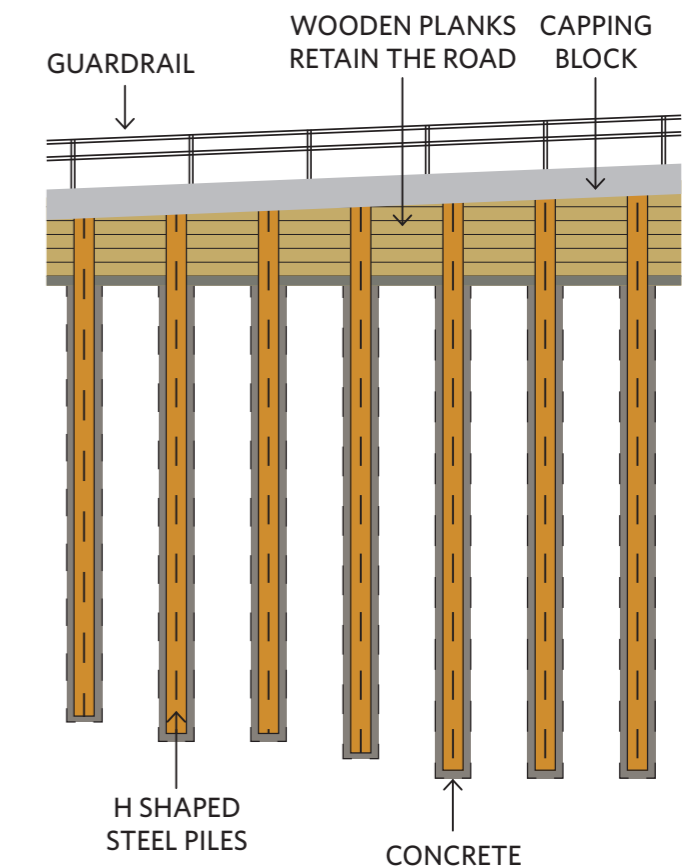
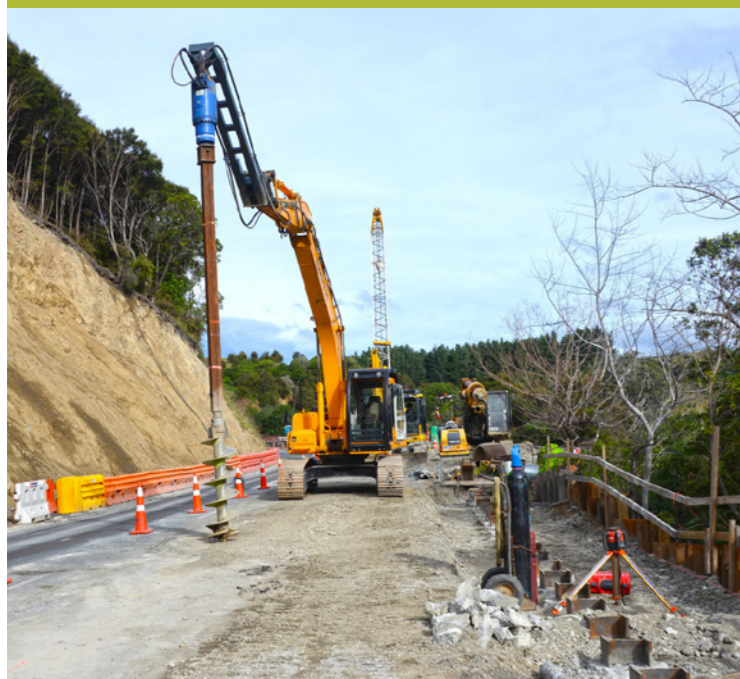
King post walls

These walls are often built using H shaped steel piles. As with the bored concrete pile walls metal casings are pushed into the ground. The material captured inside the casings is bored out, the H shaped steel beams are placed inside the now empty holes, and concrete is poured around the beams, the casing is then removed. Treated wooden planks are placed between these steel piles in the top three or so metres of the wall to retain the road. The balance of the structure is below ground. The retaining wall holds the soil behind it in place – this type of wall is relatively easy to build and have been built where there is suitable geology and the safety of crews constructing them could be guaranteed.

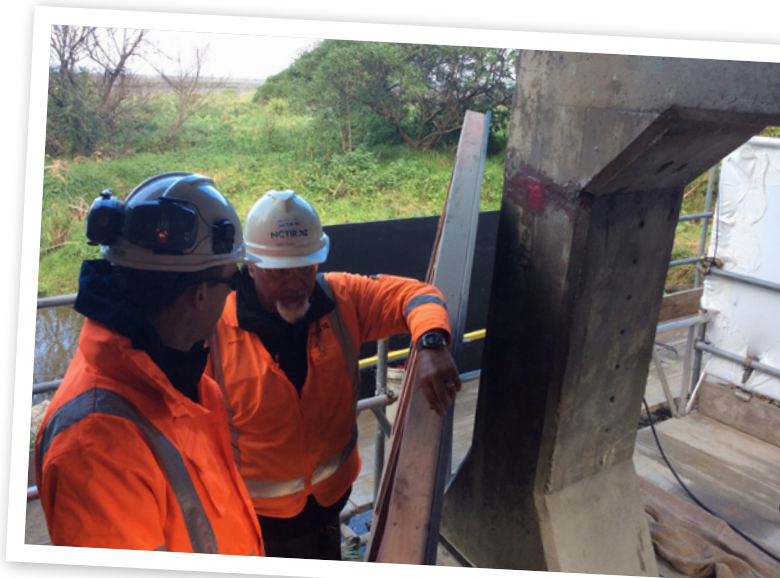
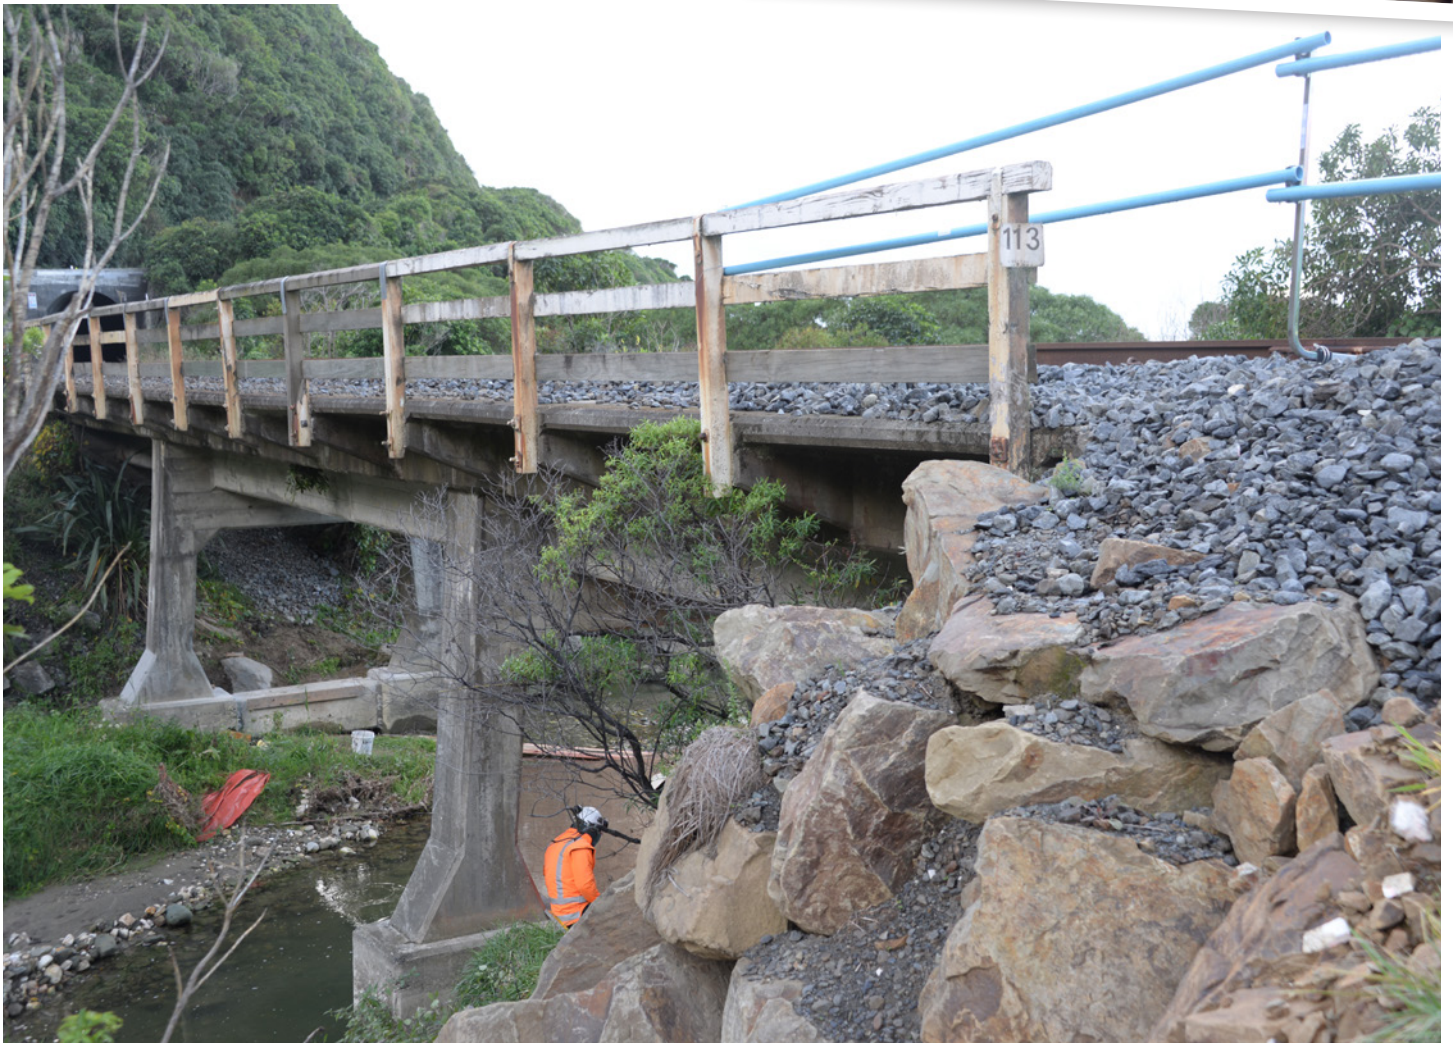
Trains will soon be able to travel faster through an area north of Kaikōura as repairs of Rail Bridge 113, just south of Irongate Bridge, are getting underway.

Trains have had to slow down considerably to cross the bridge because its piers were cracked in the 2016 earthquake.

‘While the cracks are significant trains have still been able to use the bridge, but at a reduced speed to minimise vibrations,’ says structural engineer, Fabrizio Biserna.

The team on-site has repaired the cracks and will now build intermediate pier infill walls, filling the existing gap between the columns. This will make the cracked piers redundant as it will shift the load onto the pier infill.

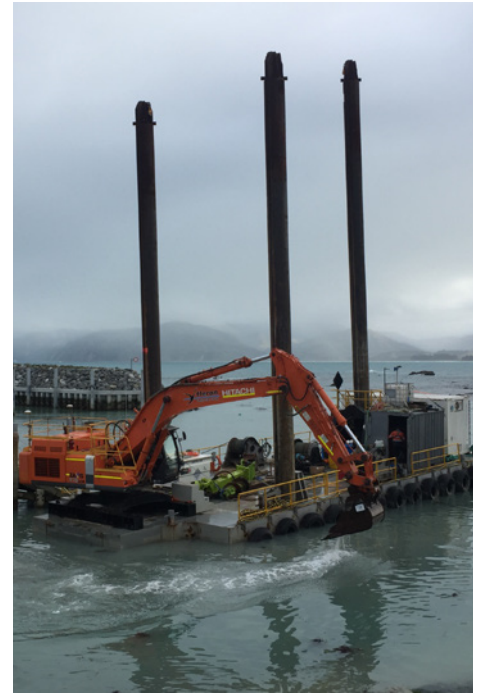
The weather isn't making it easy, but NCTIR is working towards putting the finishing touches on repair works at the South Bay marina. The distinctive specialist dredging vessel (pictured) arrived at Queen's Birthday Weekend to do a final sweep of the harbour to confirm the basin's depth. The final work will be the installation of navigational aids to mark the approach to the marina.

The marina sustained extensive damage in the November 2016 earthquake when the seafloor under it lifted by about one metre, resulting in significant new navigation hazards. The marina, and Coastguard Kaikōura's neighbouring boat ramp, were largely unusable outside of high tides.

Both the inner and outer harbour required excavation, in particular the breaking up and removal of limestone bedrock. This work had to be completed before the replacement structures such as the mooring piles, vertical seawalls and jetties were constructed.

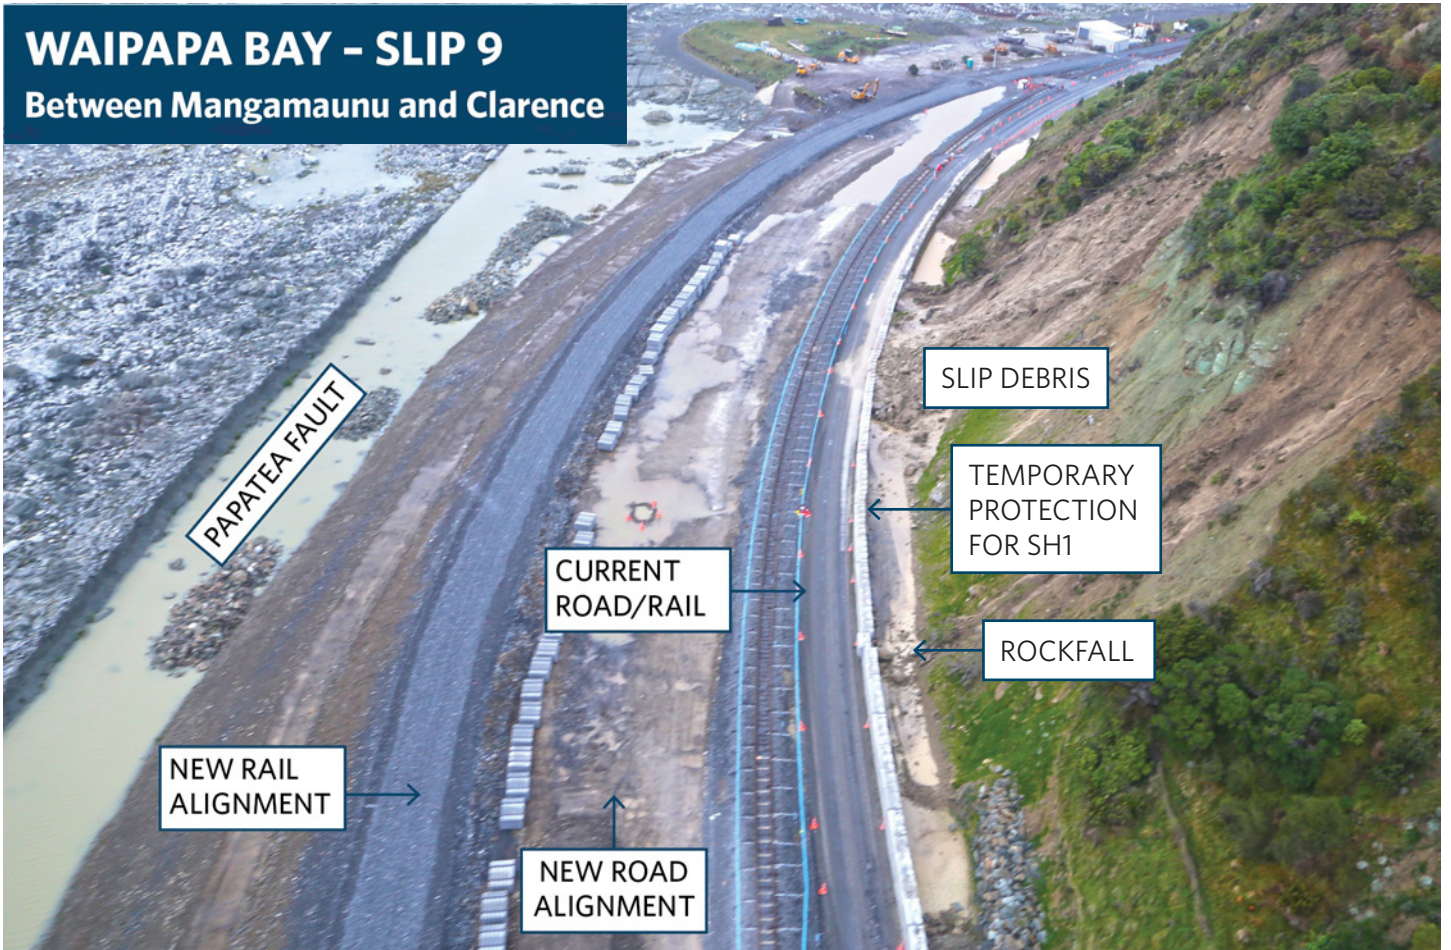
Intense rainfall brought down rockfall at site 9 near Waipapa Bay last week, and again this week during the wet weather. A temporary concrete wall, installed last year, provided the necessary rockfall protection doing exactly what it was intended to do in such a situation - stop the falling rocks from reaching the rail and road. This temporary rockfall protection wall is due to be replaced by a higher bund offering permanent protection to the road and rail, both of which will soon be realigned closer to the coast line and further away from the vulnerable hillsides.
