The Bulletin Kaikōura earthquake update

CRANES RISE OUT OF THE COUNTRYSIDE - BRIDGE 103

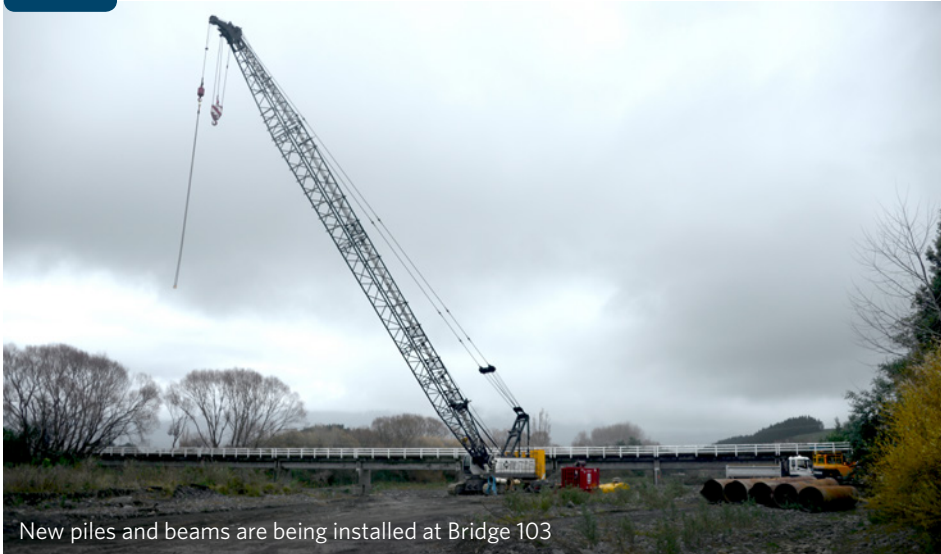
New piles and beams are being installed at Bridge 103

Permanent repairs to rail Bridge 103 over the Kowhai River, just south of Kaikōura, are getting underway - if you're passing Kaikōura's golf course on SH1, you may see cranes rising out of the countryside.

New piles and a crosshead beam will be installed and fixed to the existing bridge to allow trains to pass over the bridge at higher speeds. Giving the bridge its 'new legs' is expected to take about six months, with the team working from one end of the bridge to the other.

Each pier will have two new 900mm diameter piles with a crosshead beam connecting the two. The piles will be about 20m deep and will be constructed using a steel case with reinforced concrete. The beam between the piles will also be reinforced concrete.

Bridge 103, a 12-span bridge, sustained damaged to its piles in the November 2016 earthquake. Last year temporary repairs were carried out to enable trains to pass over the bridge under a 25km/hr speed restriction. This involved injecting epoxy resin into the cracked piles. Damage to the northern abutment was also repaired with core drilling work and a new concrete collar.

Once the new piles and beams have been constructed, the existing piles will be cut away from the bridge. This is done to transfer the load from the bridge through the new piles instead of the old ones.

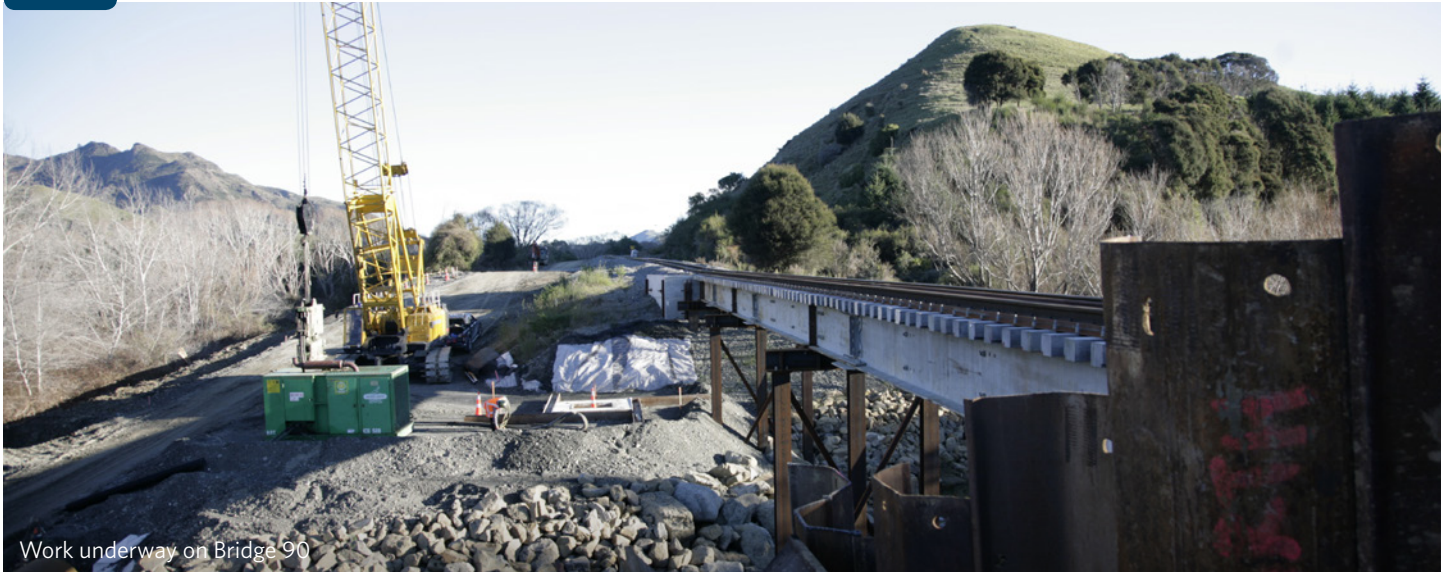
Work is getting underway to build a permanent rail bridge over a tributary of the Conway River. It is at one of the transport rebuild’s most remote work sites, accessible only by a farm track on the southern flank of the Hundalees. And although few people will ever see the bridge, its story gives insight into necessary infrastructure recovery works after a natural disaster.

The piers of the original bridge, known as Bridge 90, were so severely damaged in the November 2016 earthquake, it had to be demolished.

KiwiRail needed to get its specialised construction work trains to the Kaikōura coast, so a temporary bridge was built in the early months of 2017. The bridge was able to be built quickly because KiwiRail keeps bridge spans on hand, precisely for the purpose of emergency repairs.

A permanent replacement bridge will now be built adjacent to the temporary structure, enabling trains to travel faster along this stretch of the railway. The temporary bridge will then be dismantled. The construction team aims to finish this work by November.

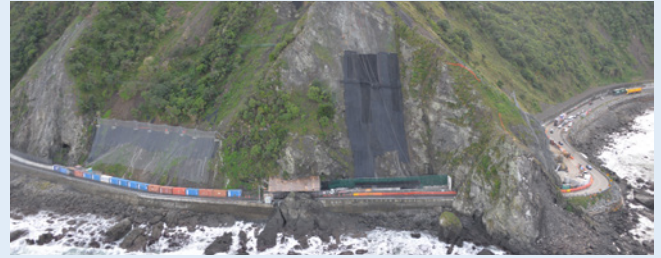
While traffic flows south of Kaikōura, work continues at Sites 16 and 17 above the Parititahi Tunnels, and at Sites 18 and 19, south of the tunnels.

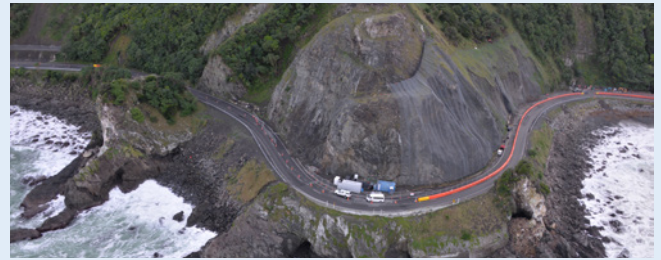
The crown of mesh adorning the Punch Bowl helps to prevent rock fall and slip movement, keeping the road below safer for travellers.

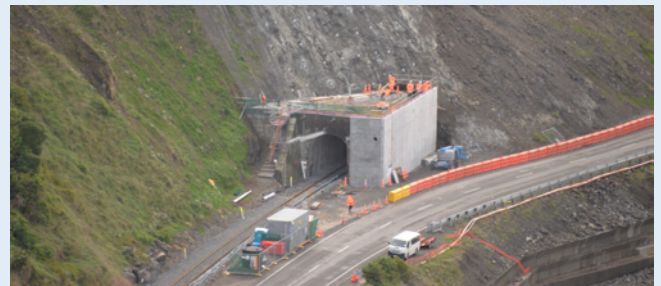
Tunnel 13 just south of the Kahutara Bridge is being transformed by the hard work of the tunnel crews involved.

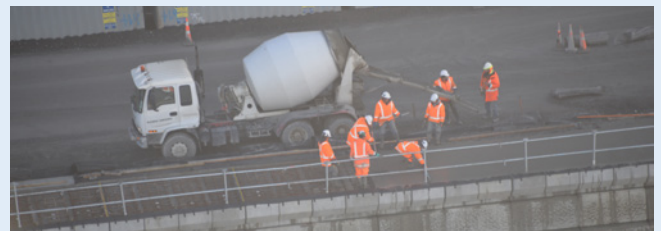
Crews are pouring concrete for the shared path at Ōhau Point north of Kaikōura – this will also act as the capping beam for the seawall. This is the location of one of the massive slips that cut off Kaikōura from northern access to State Highway 1 last year.

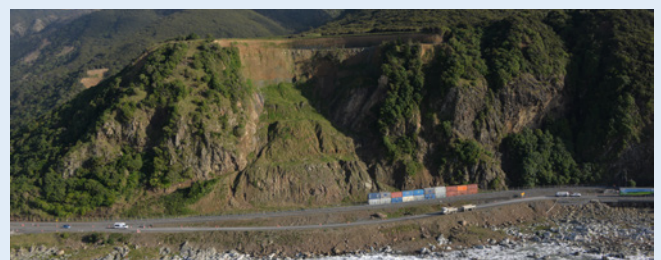
The hydroseeding on Site 8 at Waipapa Bay is proving successful as it's looking less like the site of a major slip and more like an integral part of the scenic coastal route.
