The Bulletin Kaikōura earthquake update

Three years on for NCTIR

This Bulletin provides the latest information about the rebuild of road and rail networks damaged by the Kaikōura earthquake in November 2016. The Bulletin is produced by the North Canterbury Transport Infrastructure Recovery (NCTIR) - an alliance representing the NZ Transport Agency and KiwiRail, on behalf of Government.

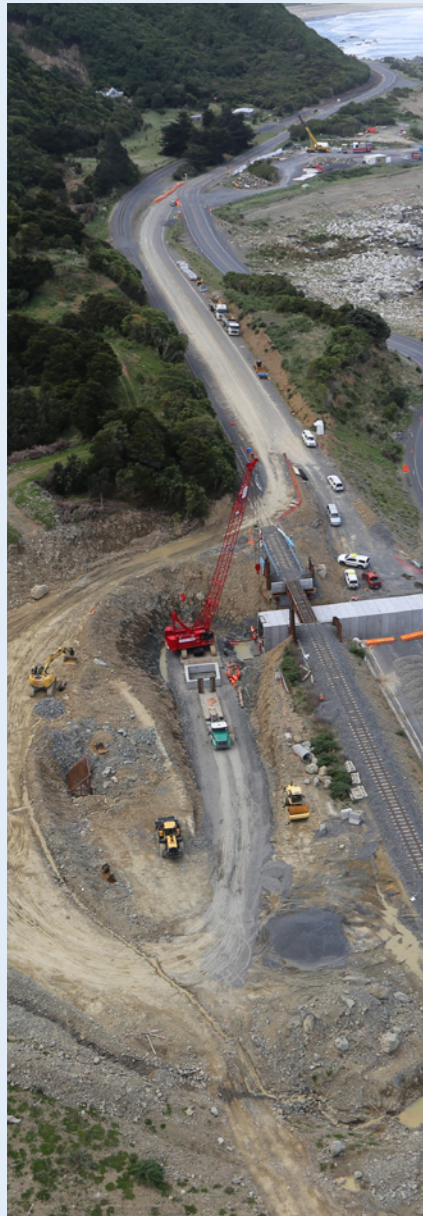
Jacob's Ladder temporary rail bridge removed

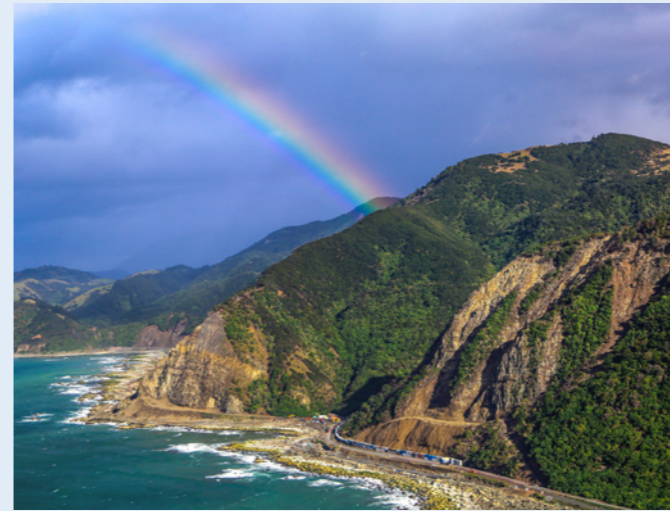
AUGUST At Ōhau Point a construction access platform was cut around the hillside allowing crews from both sides to work together for the first time

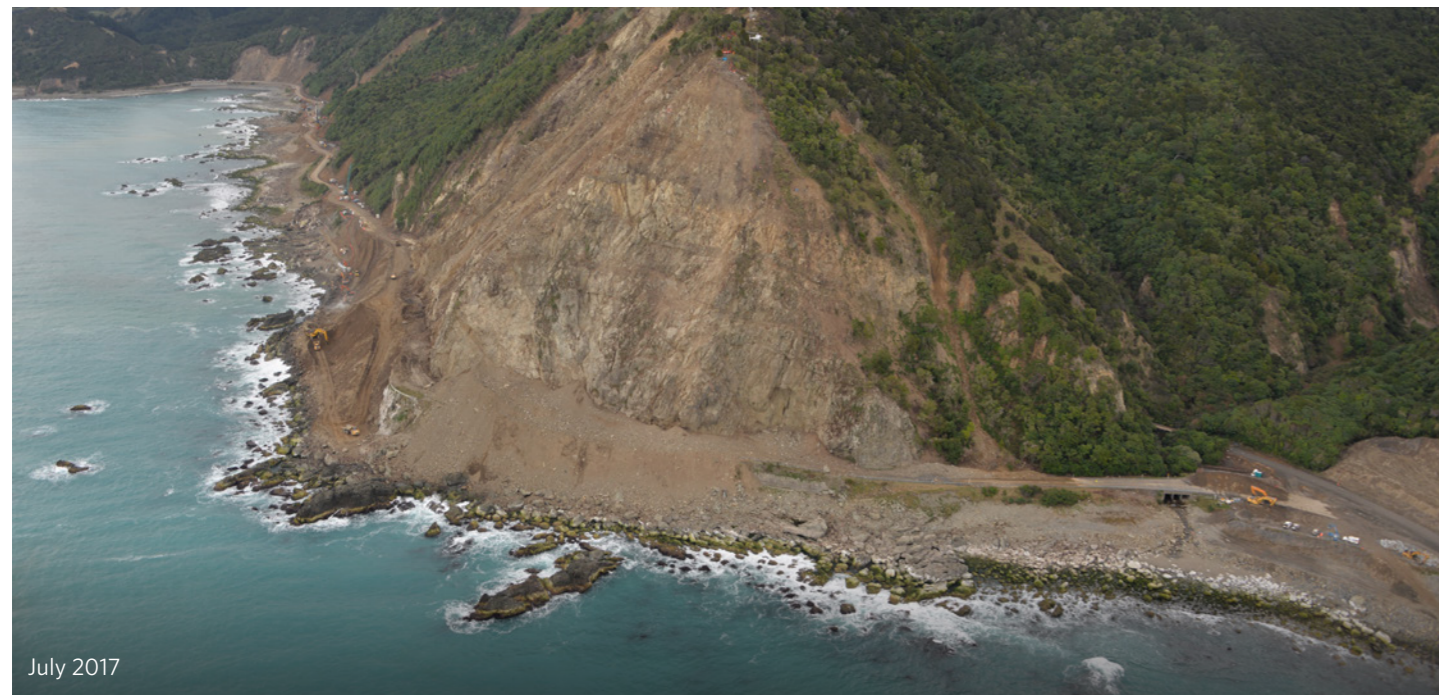
July 2017

For the majority of the 3.2km, the wall has matched the modelling - but there is a 50m section at Ōhau Point which has proven to be affected by strong 3D wave effects, generating the few 'overtopping' events that we have seen.

The seawall has been constructed close to the maximum height possible, as to go higher meant that the wall would have needed to go further out into the sea. While there is a long term provision to increase the current wall by 1m, going any higher in the current location would make the wall too tall and skinny and it would not survive well in an earthquake.

To mitigate the effects of waves coming over the road along that short section of seawall a number of measures are being taken. These include:

- Installing and testing a temporary steel wall with a wave return in place of the hand railing, which will be monitored to measure performance - this is reliant on further wave events, so may take some time for results to come through. This will be used to develop a permanent wall.

- Installing a monitoring buoy and camera and correlating the observations with weather patterns to develop a Trigger Action Response Plan (TARP - see page 5) with warning thresholds - this information gets fed back to Waka Kotahi NZ Transport Agency allowing them to make the call to manage traffic or close the road for a short period of time, until the event passes.

- Undertaking physical model testing at a hydraulics laboratory in Sydney to supplement the onsite observations and provide further certainty over the events which cause overtopping. The model testing will also assess whether a rock revetment or armour unit type solution at the base of the wall could be effective for consideration into the future.

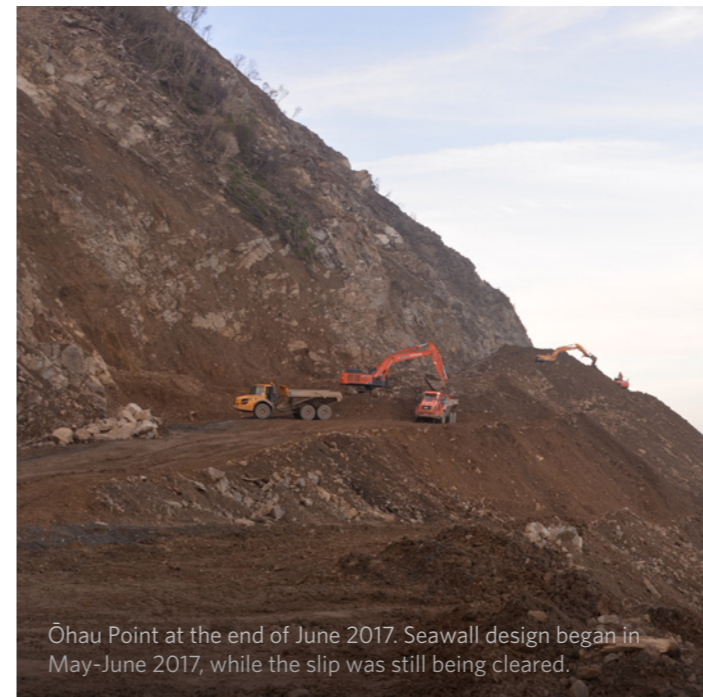
Ōhau Point at the end of June 2017. Seawall design began in May-June 2017, while the slip was still being cleared.

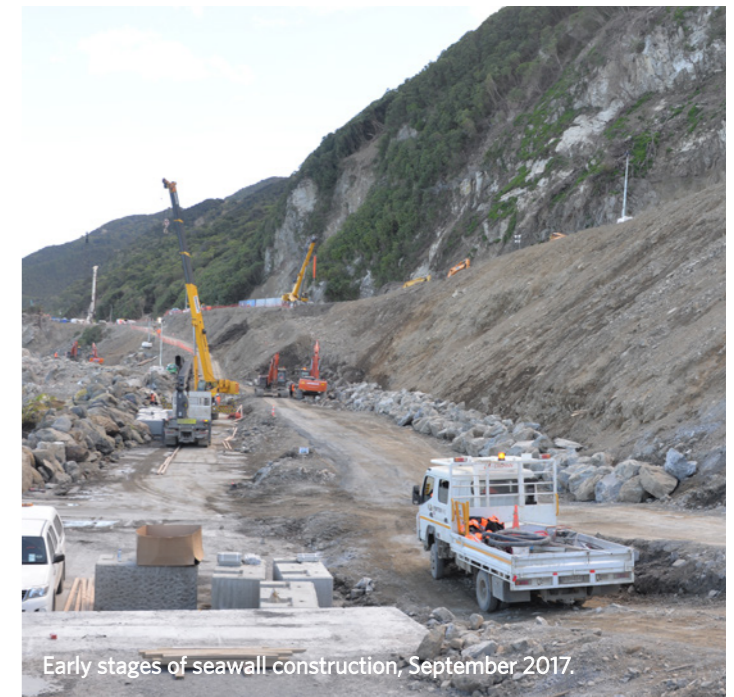
Early stages of seawall construction, September 2017.

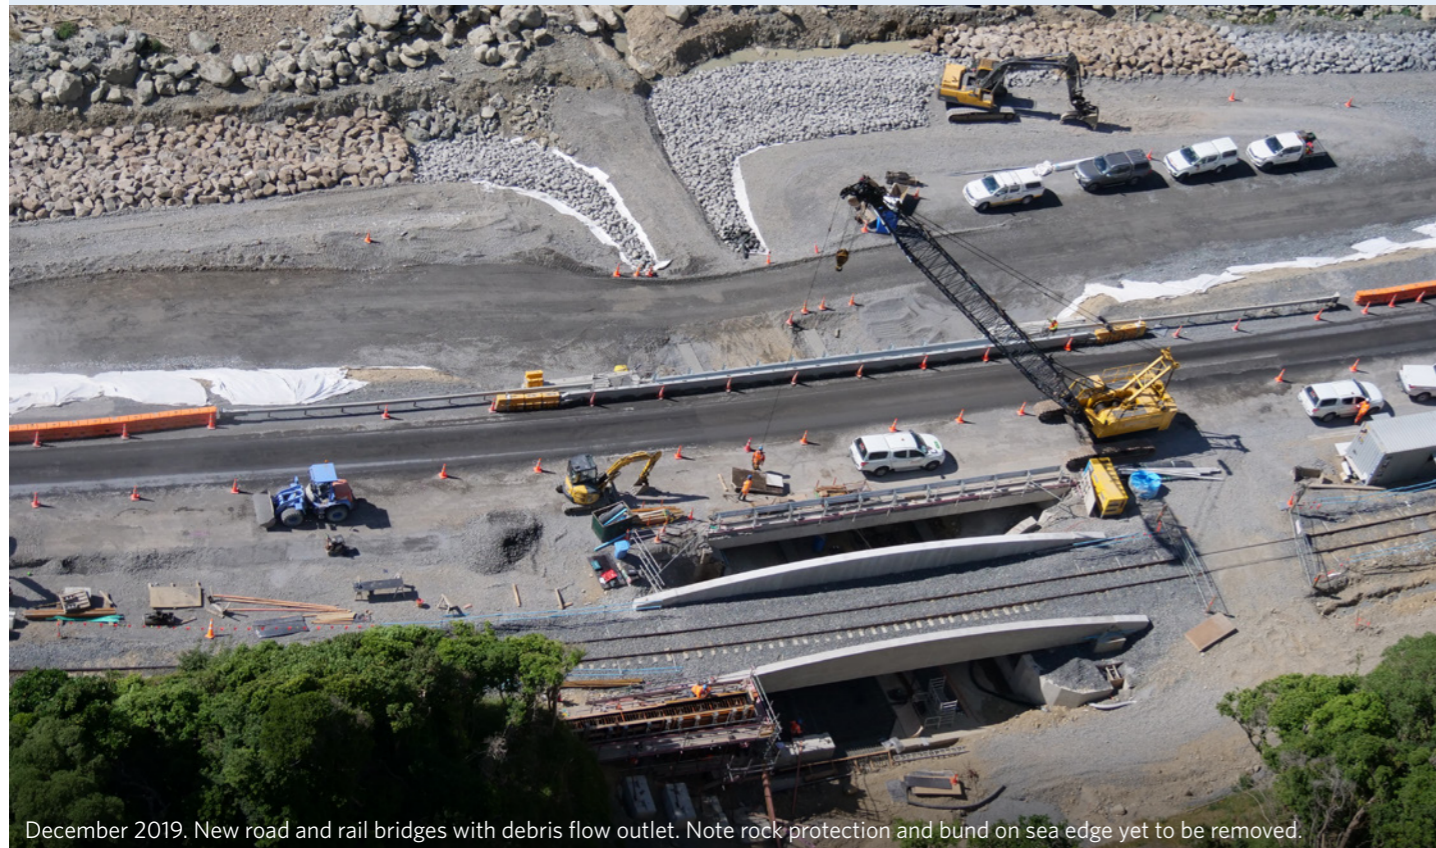
December 2019. New road and rail bridges with debris flow outlet. Note rock protection and bund on sea edge yet to be removed.

The debris flow bridges are built to an appropriate size to pass rock and other material under the road and rail corridors and allow that material to continue on its natural course. To direct flow from the hillside

under the bridges there is a need to construct and maintain channels, bunds and walls.

During construction of the debris flow bridges, rock protection

in the form of a large bund was constructed at the outlets to retain the naturally eroded ex-cyclone Gita material and minimise sediment discharge into the sea. To ensure the debris flow bridge at this site performs as designed, the rocks, bund and temporary works will be removed when the inlet is completed.

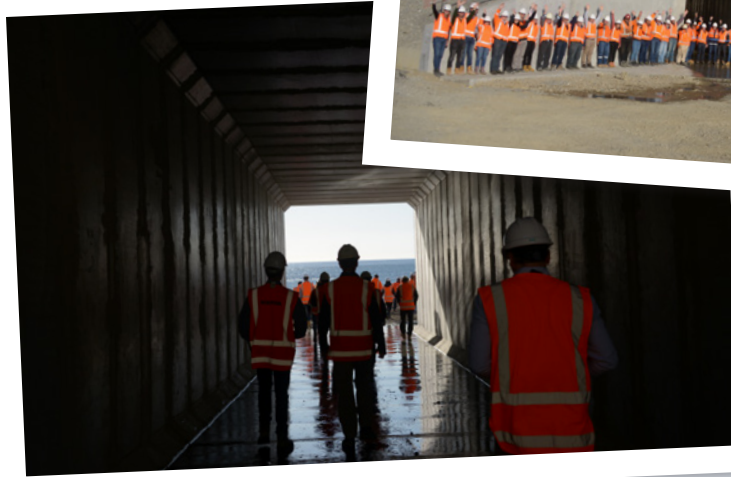
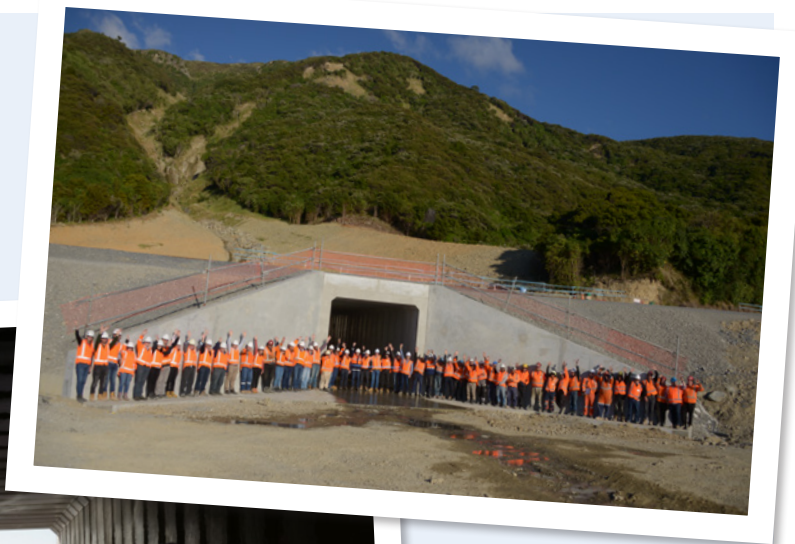
Crews at Jacob's Ladder A celebrated the

early completion of their project, just south of Ōkiwi Bay, which wrapped up a month ahead of schedule. The temporary detour around this site has now been closed, with traffic returned to two lanes over the completed culvert on State Highway 1.
