The Bulletin Kaikōura earthquake update

This Bulletin provides the latest information about the rebuild of road and rail networks damaged by the Kaikōura earthquake in November 2016. The Bulletin is produced by the North Canterbury Transport Infrastructure Recovery (NCTIR) - an alliance representing the NZ Transport Agency and KiwiRail, on behalf of Government.

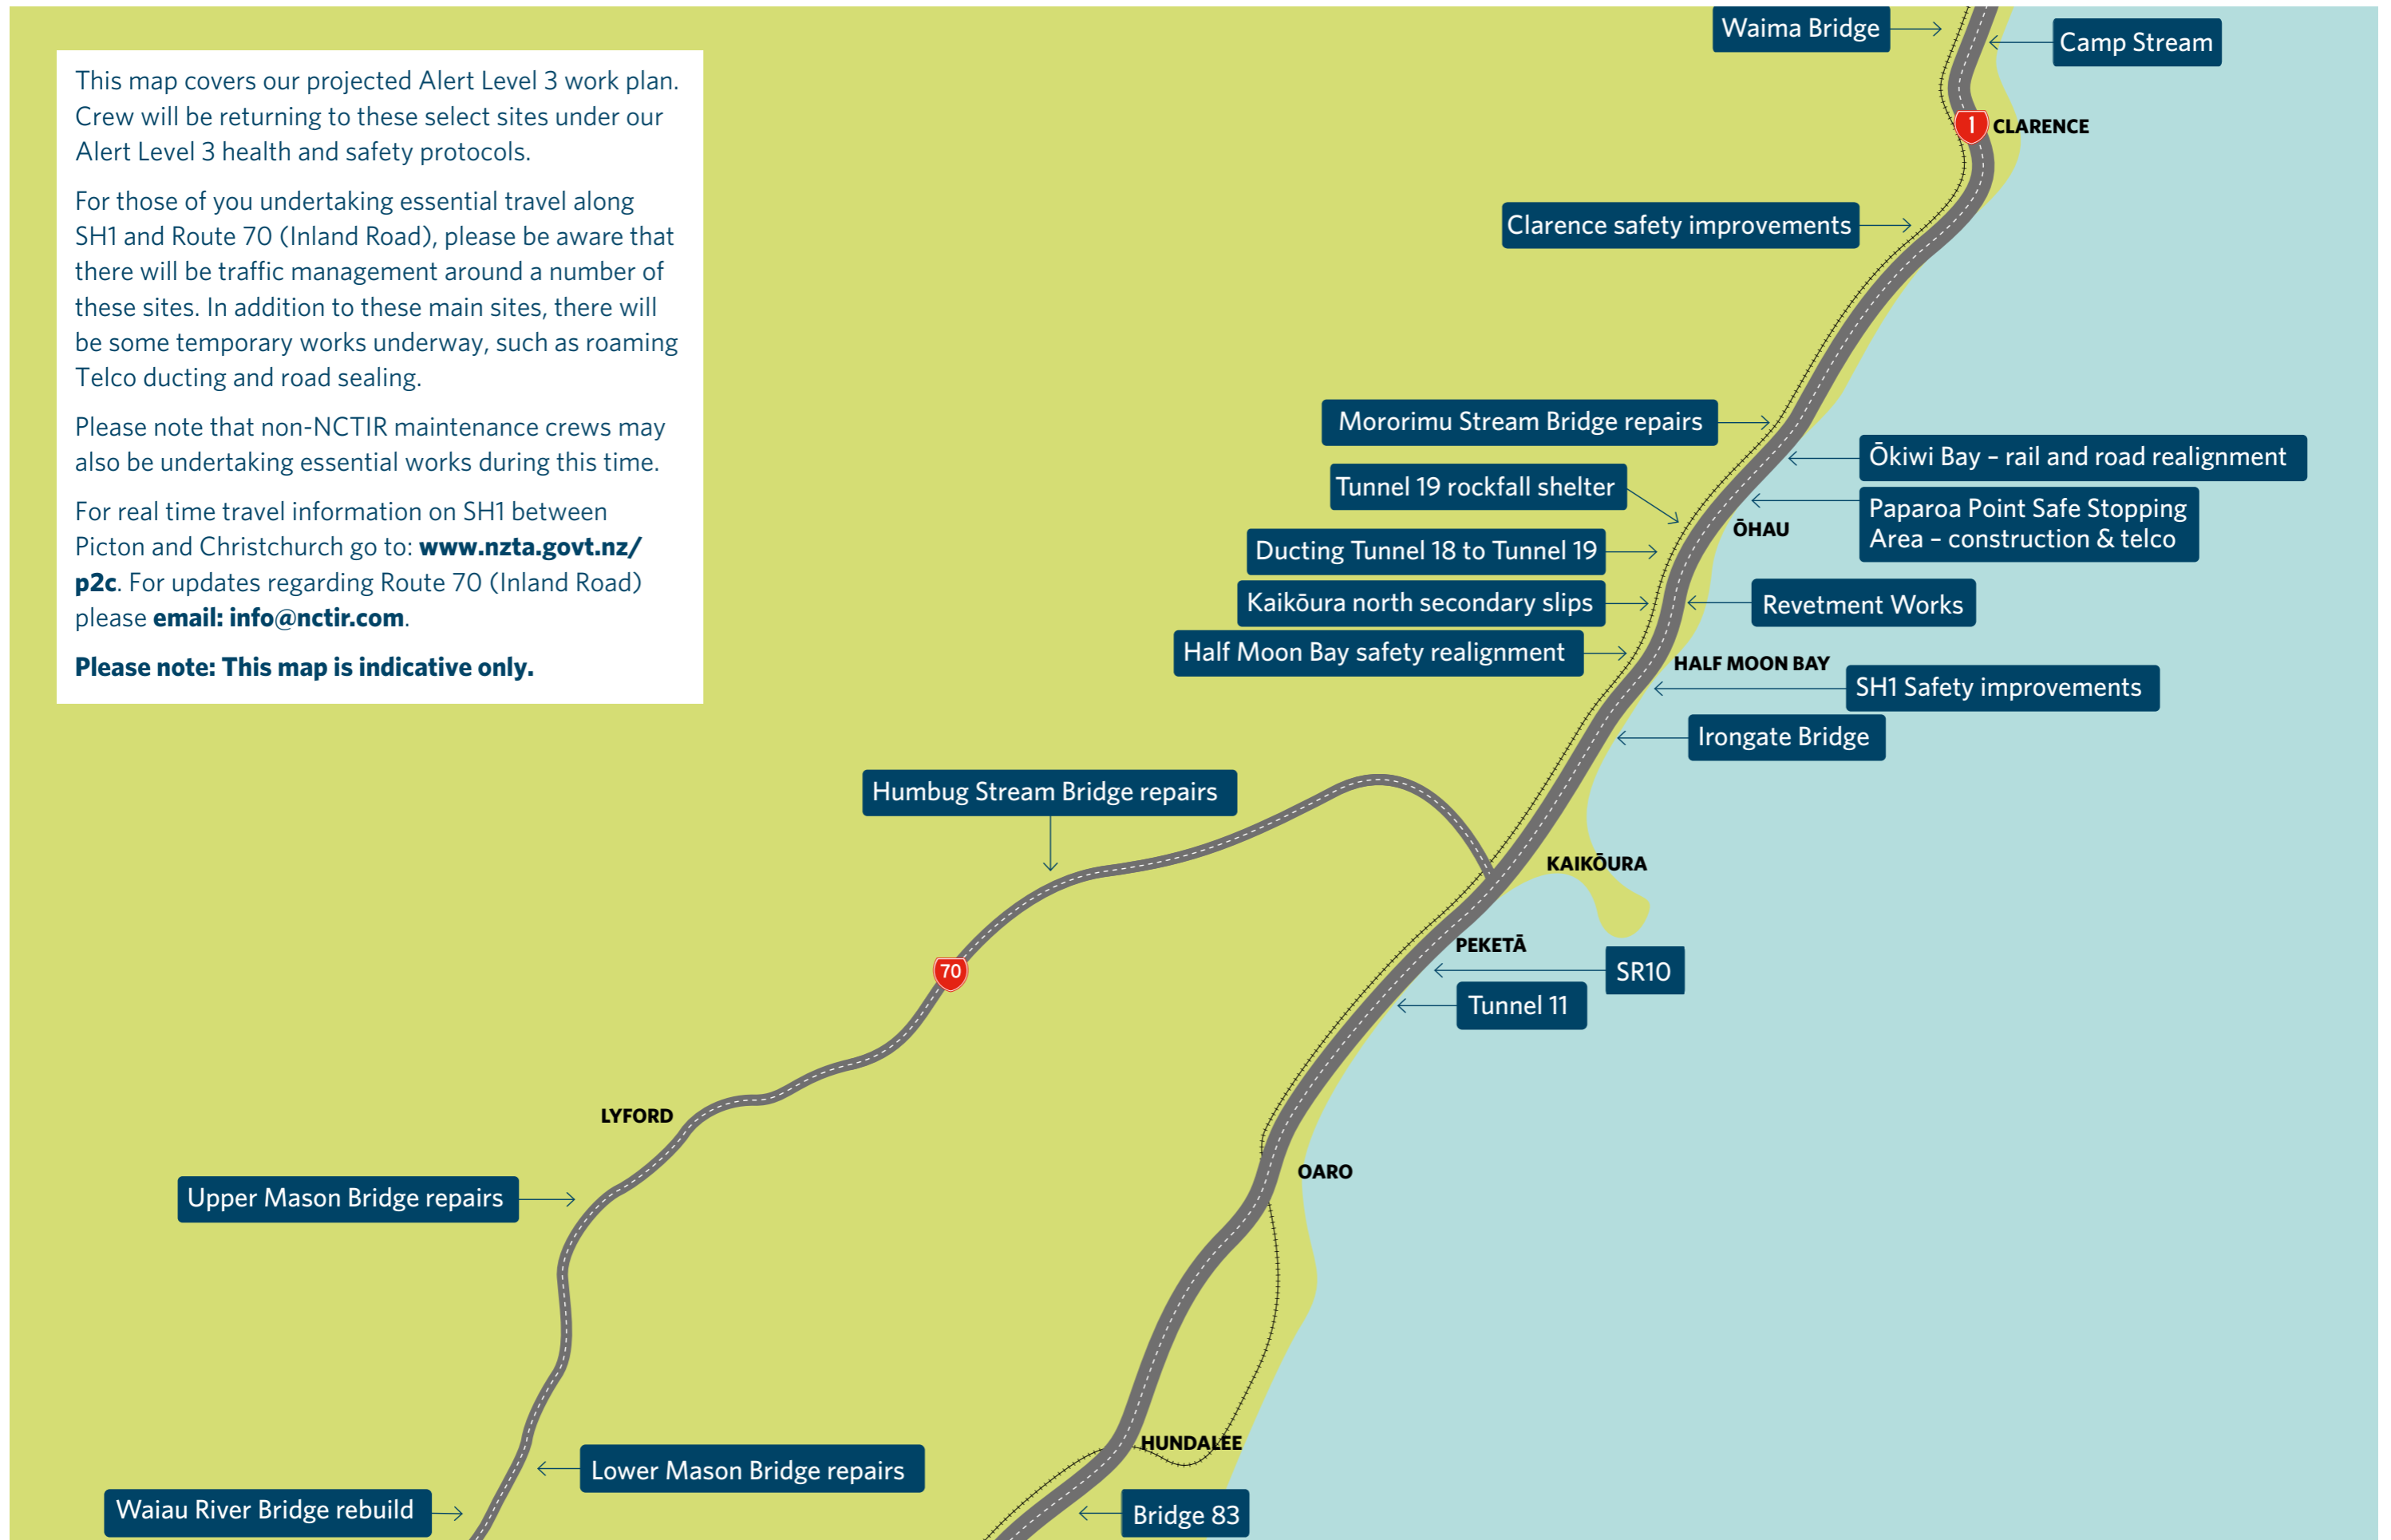
Level 3 work map

This map covers our projected Alert Level 3 work plan. Crew will be returning to these select sites under our Alert Level 3 health and safety protocols.

For those of you undertaking essential travel along SH1 and Route 70 (Inland Road), please be aware that there will be traffic management around a number of these sites. In addition to these main sites, there will be some temporary works underway, such as roaming Telco ducting and road sealing.

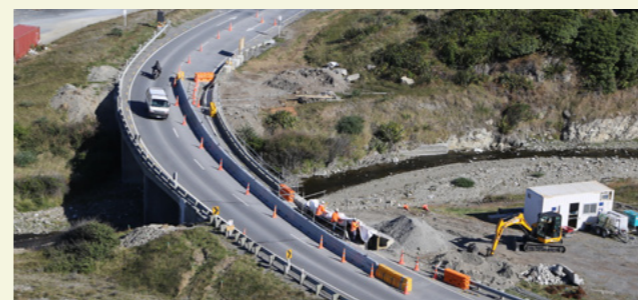
Earthquake repairs were well underway at the Mororimu Stream Bridge (north of Ōkiwi Bay) before lockdown. These repairs involve reconstructing parts of the bridge's abutments and approaches, hydro-demolition of existing abutment wingwalls, careful reconstruction of the reinforcement, concrete crack injections, and upgrading the road safety barriers.

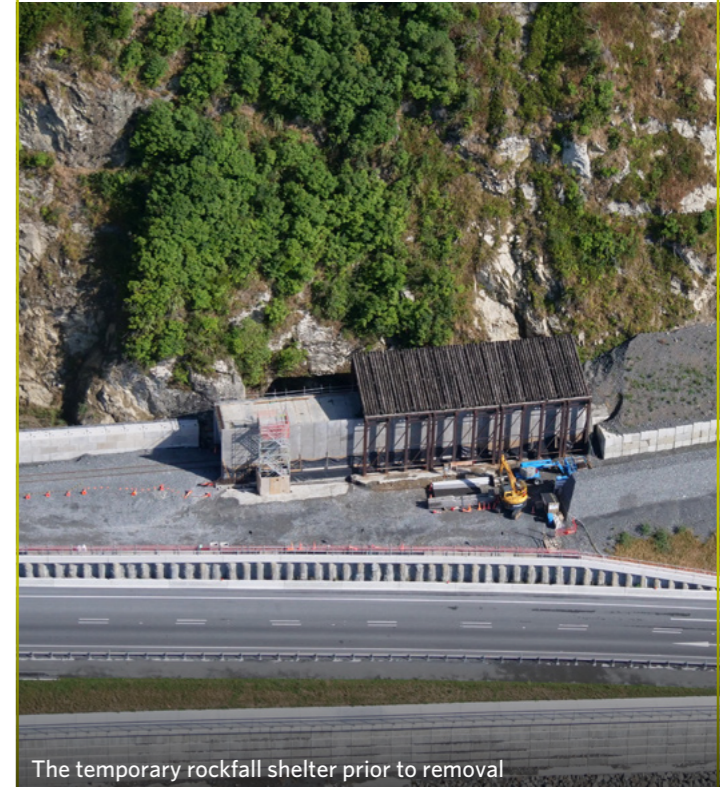
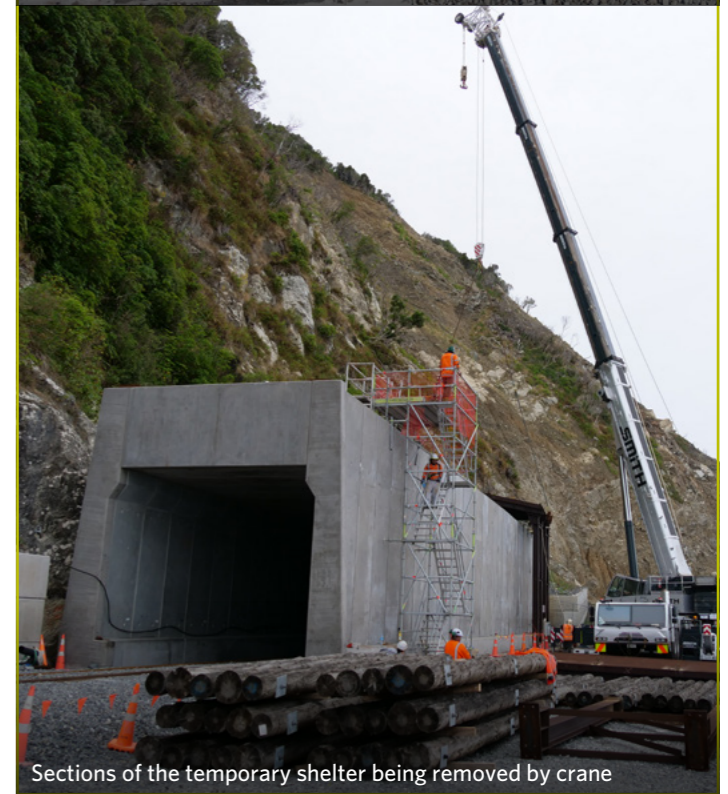
The temporary rockfall shelter that has been in place at Tunnel 19 since the 2016 earthquake was removed last month, revealing the new permanent tunnel shelter beneath. Crews are now back on this site under Alert Level 3, and can focus on installing rock anchors and backfilling.

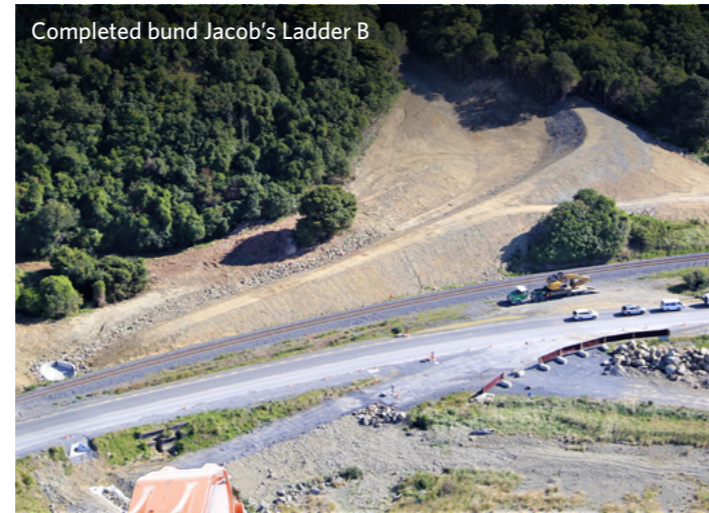
Completed bund Jacob's Ladder B

With the bund and catchment basin at Jacob's Ladder B (south of Ōkiwi Bay) completed before shutdown, crew can now turn their attention to the finishing touches: planting and hydroseeding.

A digger with a special mulcher head attachment was bought in to chip the remaining trees that were removed from the basin, with the resulting mulch to be spread over the outward side of the bund. DOC's focus was to encourage the growth of native species on the outward side of the bund, as this will be unaffected by any future debris flow.

To reduce the spread of exotic and invasive plant species all machinery entering the site was washed, and active weed control put in place. The bund was hydroseeded last week, with a mixture of fast-growing and long-lived native seeds that have been eco-sourced. Some further planting is planned during the June/July planting season.

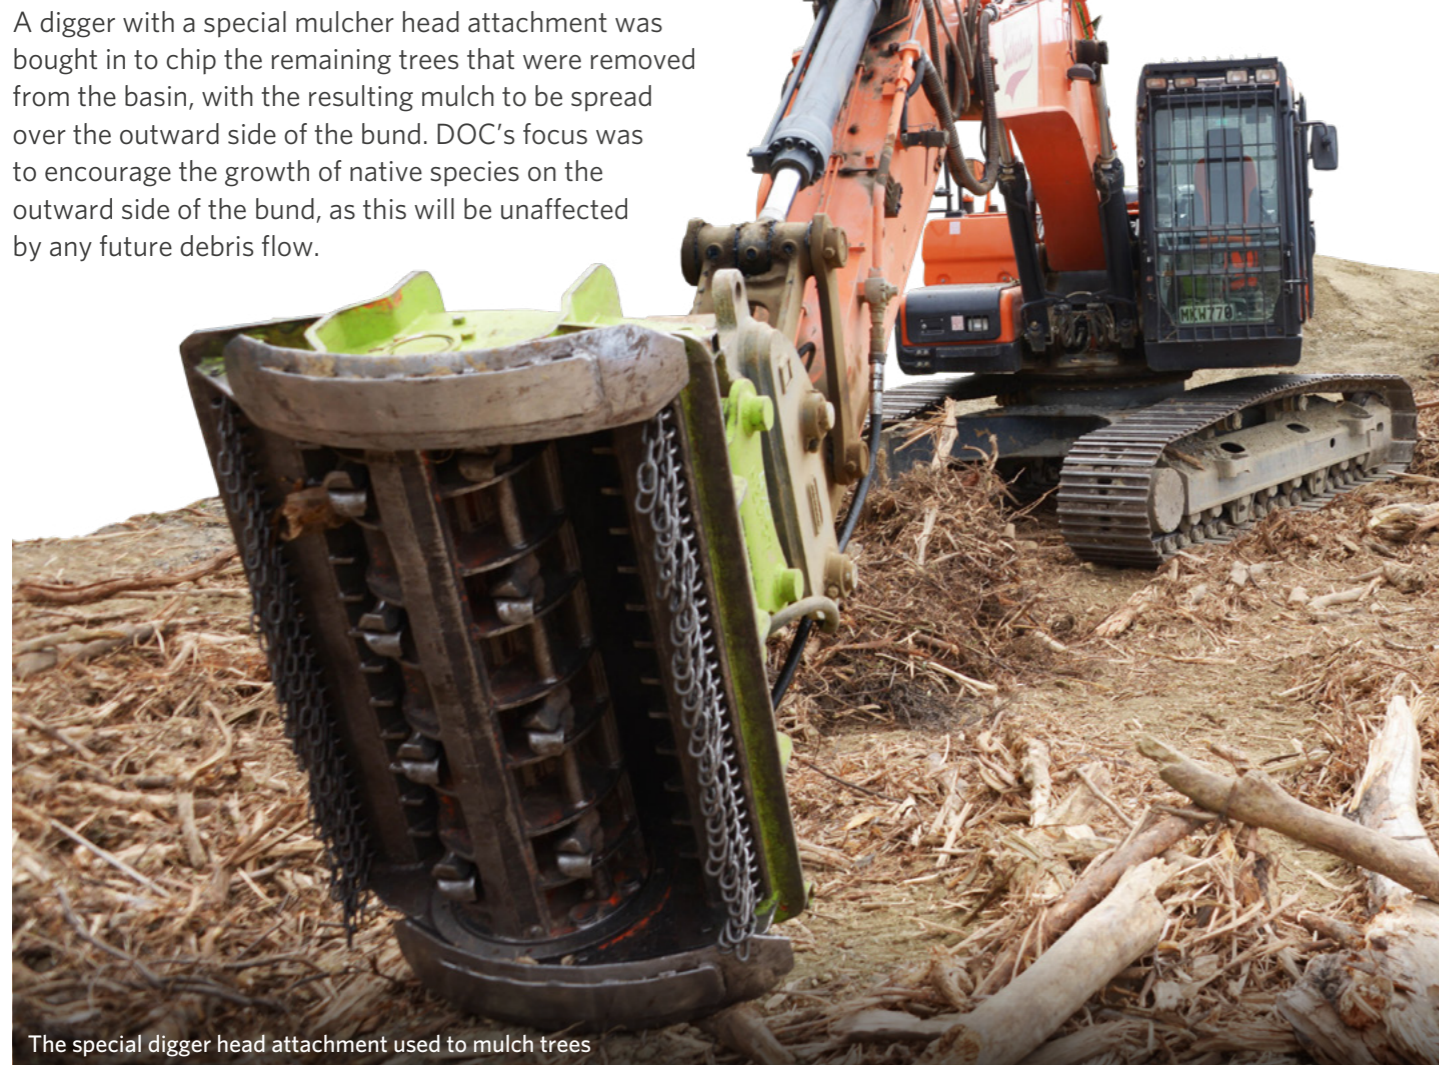
The special digger head attachment used to mulch trees

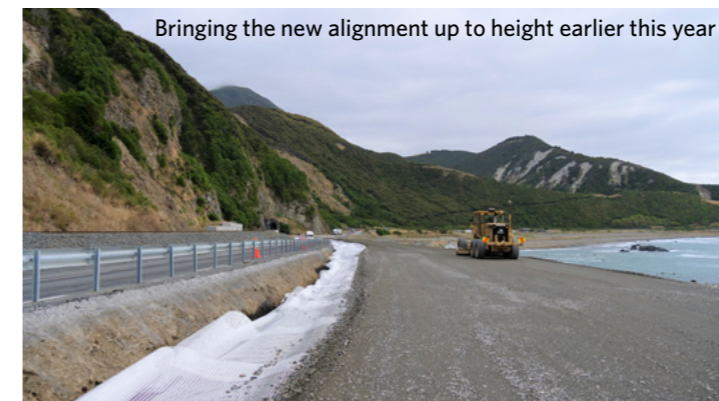
Bringing the new alignment up to height earlier this year

The new road alignment will reduce the number of curves from three to two, remove a dip in the road, increase the radius of the curves and widen the centreline.

'The majority of the alignment is being built on the existing footprint of the road - building it up to match the height of the realignment section,' says NCTIR Site Engineer Kerry Baillie.

'Layers of geogrid have been added beneath the embankment to ensure structural integrity of the rebuilt road for future resilience,' says Baillie.

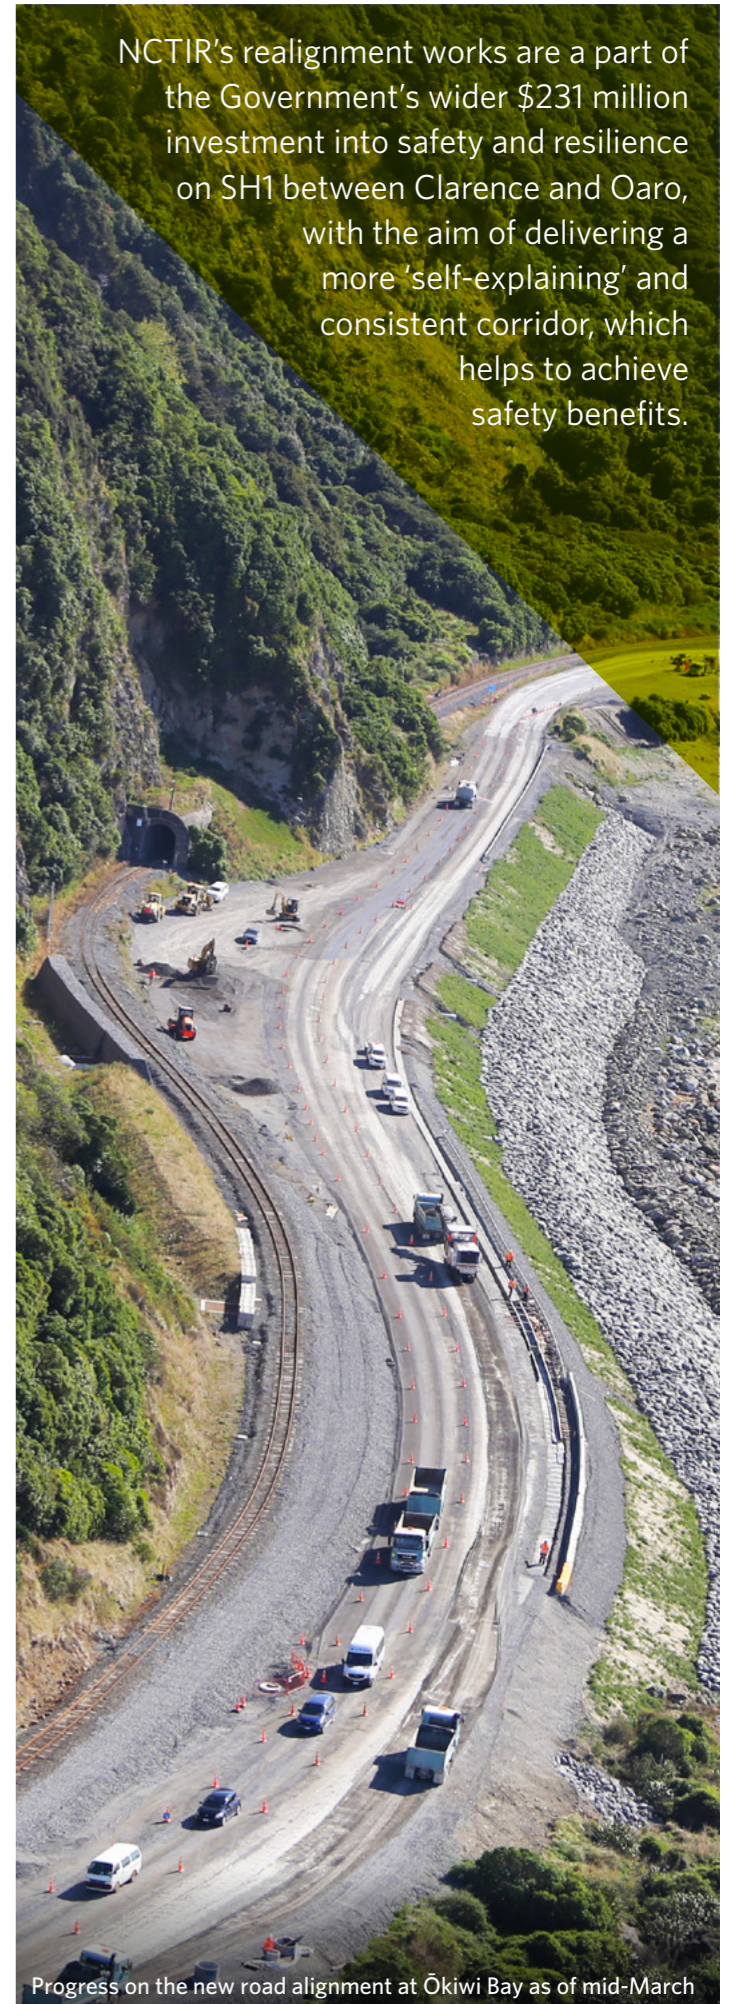
Progress on the new road alignment at Ōkiwi Bay as of mid-March

Part of the road was built on the slip material to reduce construction time and cost, and to decrease the amount of excavation and imported river gravels required, providing a more sustainable solution.

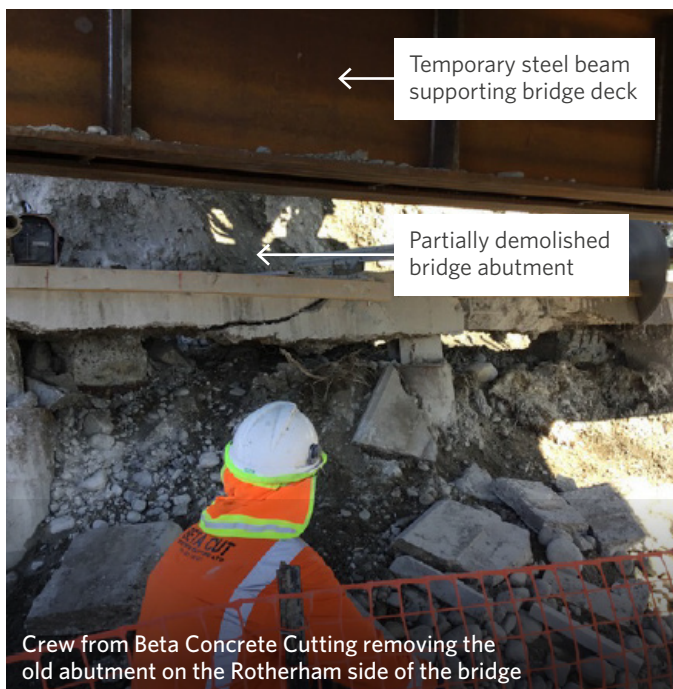
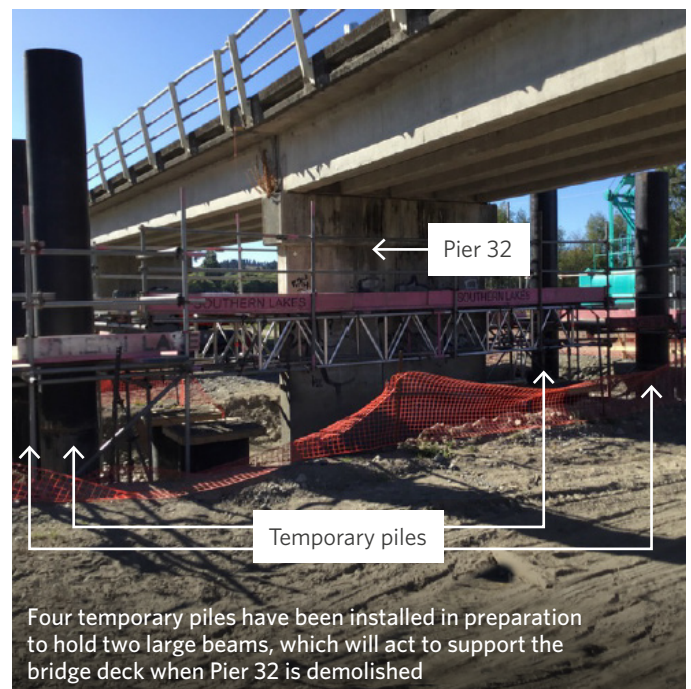
Repairs on the Waiiau Bridge, which started in November last year, are now continuing under Alert Level 3. This involves replacing pier 32 and the southern abutment, and repairing 34 expansion joints. A temporary Bailey bridge has been installed over the southern end of the bridge where the abutment and pier will be demolished to keep the road open to traffic. Below are some photos showing the progress made on this work just prior to the COVID-19 shutdown.
