APPENDIX H

Chain of Custody Forms

The MacKays to Peka Peka Expressway route¹ ('the Expressway') has been identified as one of eight sections within the Wellington Northern Corridor (SH1 from Levin to the Wellington Airport) which is an identified "Road of National Significance" (RoNS) in terms of the 2009 Government Policy Statement².

As part of the Assessment of Environmental Effects (AEE) for the Project, a series of technical reports have been produced. This report is a Stage 1 desk study which relates to the assessment of effects from land and groundwater contamination. The aim of this desk study is to ascertain whether

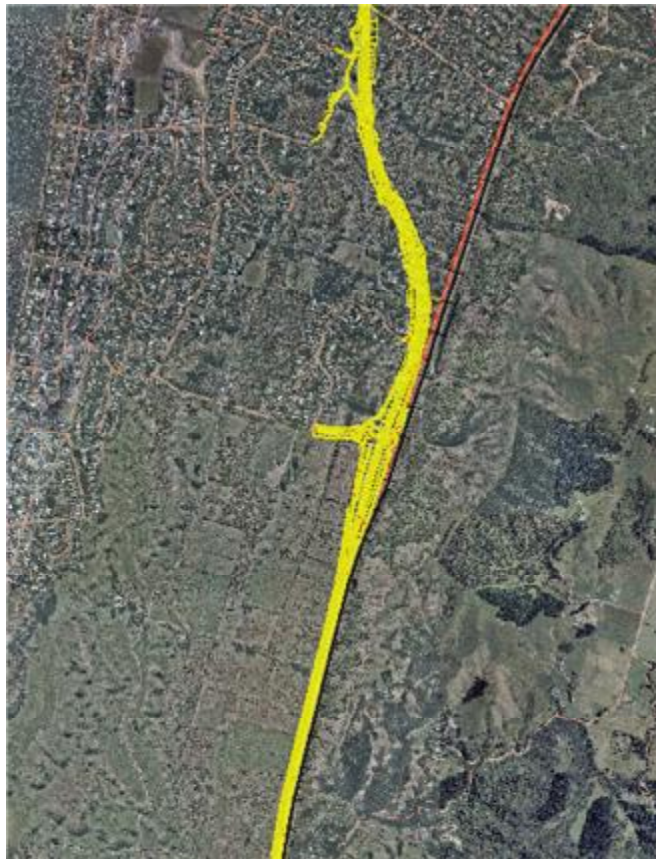
Figure 2: Sector 1

The extent of Sector 1 is shown in **Figure 2** with the yellow line indicating the route of the Expressway. Maps of the route are shown in Drawing EN-CL-009, Volume 5.

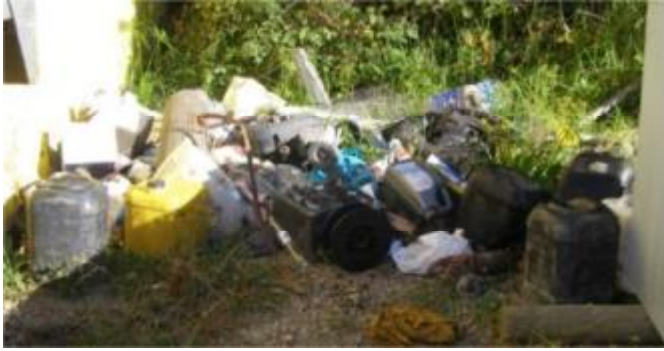
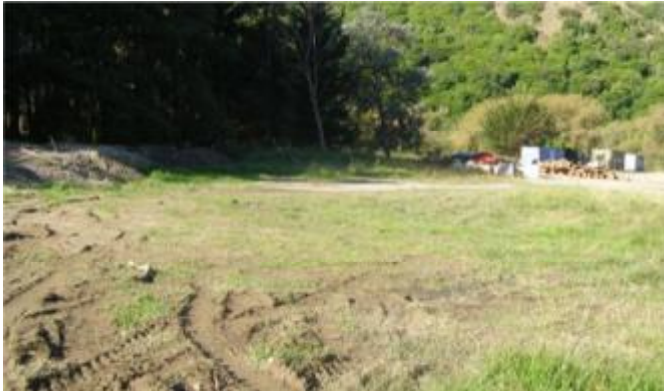
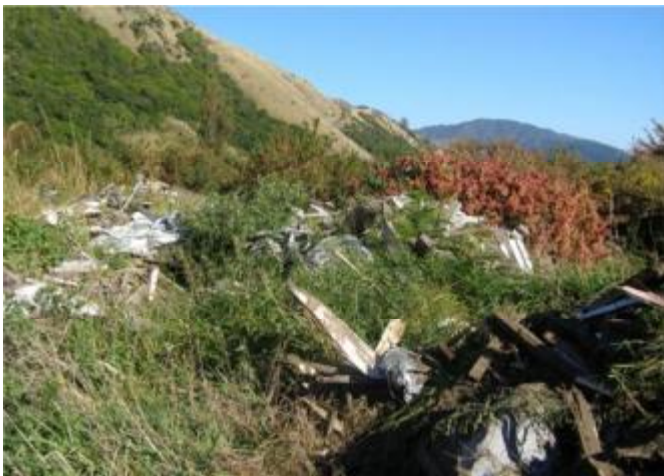
Location	Activity	Observations
16 Leinster Avenue	Commercial Garden Centre	There did not appear to be any significant bulk storage area for pesticides and herbicides within the garden centre building area. The land area behind the buildings was being used as a contractor/transport storage yard. The ground had been levelled using imported fill, with stockpiles of materials at the edge of the site. There was evidence of dumping of waste materials including timber, sheet metal, empty chemical containers and drums. Photographs are included below.
150 Raumati Road	Unoccupied bush area	The land was generally low lying bush/wetland area. There was evidence of dumping of waste materials including sheet metal, timber and an abandoned car. An area of ground may have been levelled with fill materials. Photographs are included below.

Figure 3: 16 Leinster Avenue

Figure 4: 16 Leinster Avenue

Figure 5: 16 Leinster Avenue

The properties at 16 Leinster Avenue and 150 Raumati Road are within the construction footprint of the Expressway and portions of the land will also be used for the construction of stormwater wetlands/ponds. Further investigation of these sites is recommended.

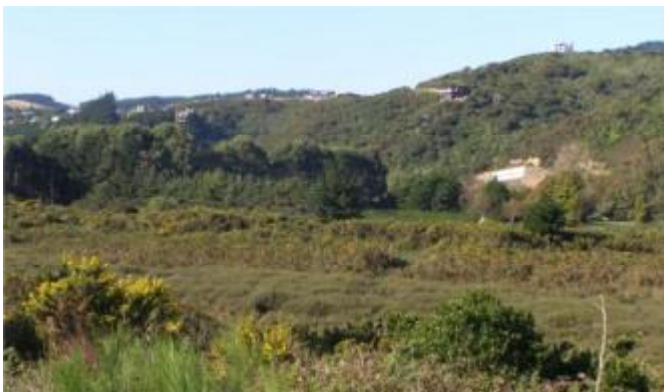
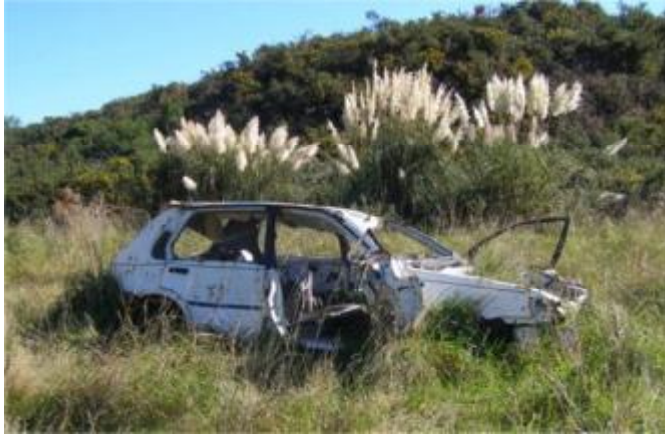
Figure 6: 150 Raumati Road

Figure 7: 150 Raumati Road

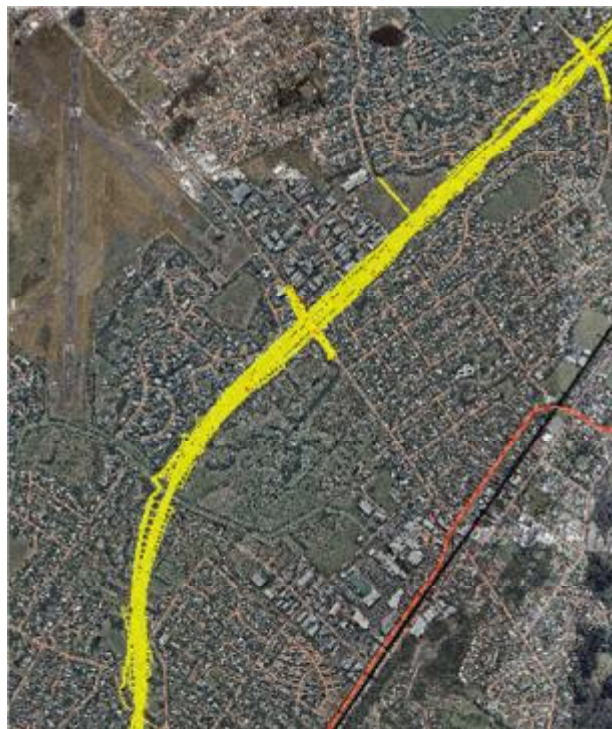
Figure 8: Sector 2

The extent of Sector 2 is shown in **Figure 8** with the yellow line indicating the route of the Expressway. Maps of the route within this sector are shown in Drawings EN-CL-010 and 011, Volume 5.

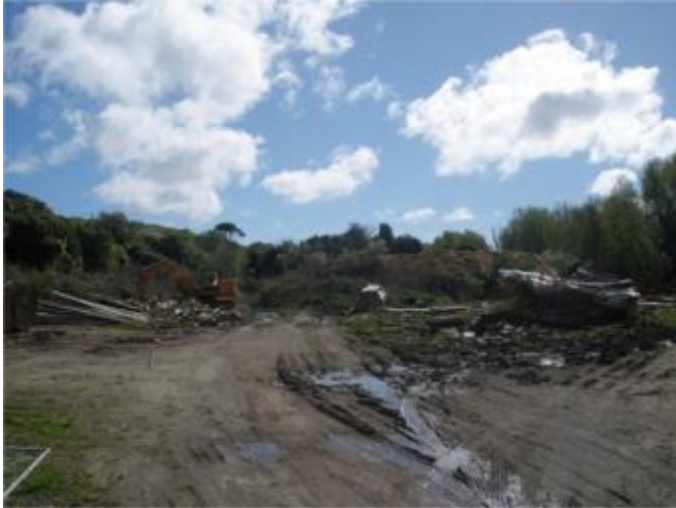
Of the properties listed above, only the land parcels at 55 Rata Road, 109 Kāpiti Road and the area of designated land behind Manchester and Sheffield Streets are affected by the Expressway construction footprint. As the remaining sites of potential interest are not directly affected, no further investigation of the sites was considered necessary.

Figure 9: 55 Rata Road

The properties at 55 Rata Road, 58 Kiwi Road and 109 Kāpiti Road are within the route of the Expressway, with the land at 109 Kāpiti Road and 58 Kiwi Road likely to be used to construct stormwater wetland/ponds. Further investigation of these sites is recommended.

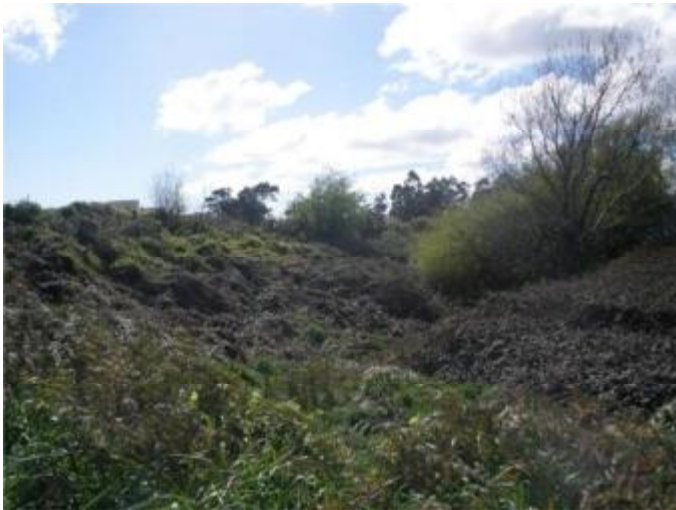
Figure 10: Area of designated land behind

Manchester and Sheffield Streets

Vacant land adjacent to industrial areas can be susceptible to illegal dumping of rubbish and unwanted materials. Whilst no waste materials were able to be observed due to the dense vegetation within the designation behind the industrial area of Sector 3, further inspection of this area is recommended.

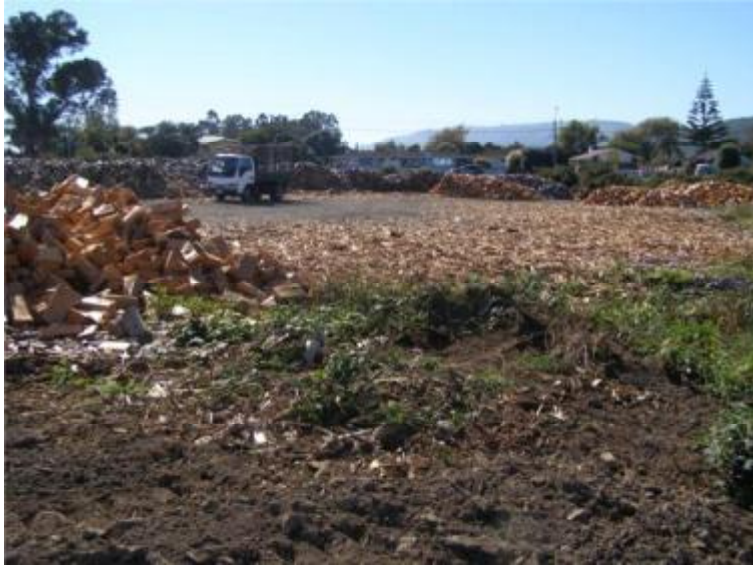
Location	Activity	Observations
109 Kāpiti Road	Firewood storage area	The site had been raised from its original level by placement of fill. The area covered by the fill was extensive and from visibly different sources. Photographs are included below.

Figure 11: 109 Kāpiti Road

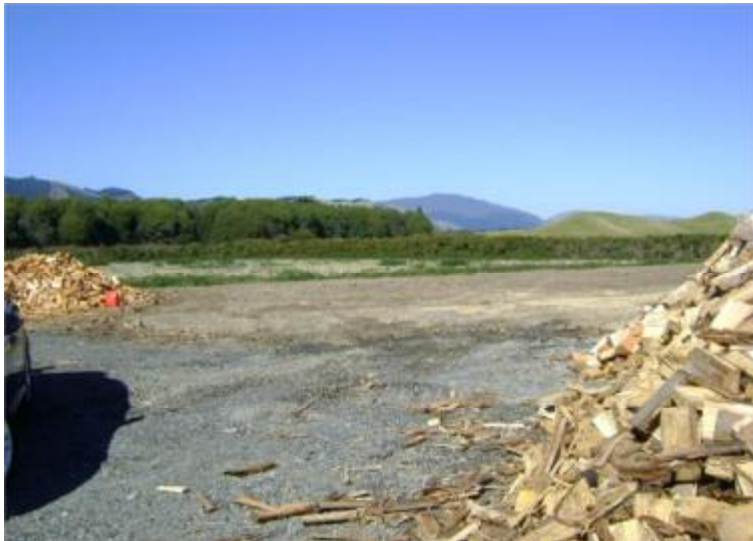
Figure 12: showing fill placement

from multiple sources, natural ground level seen in the background

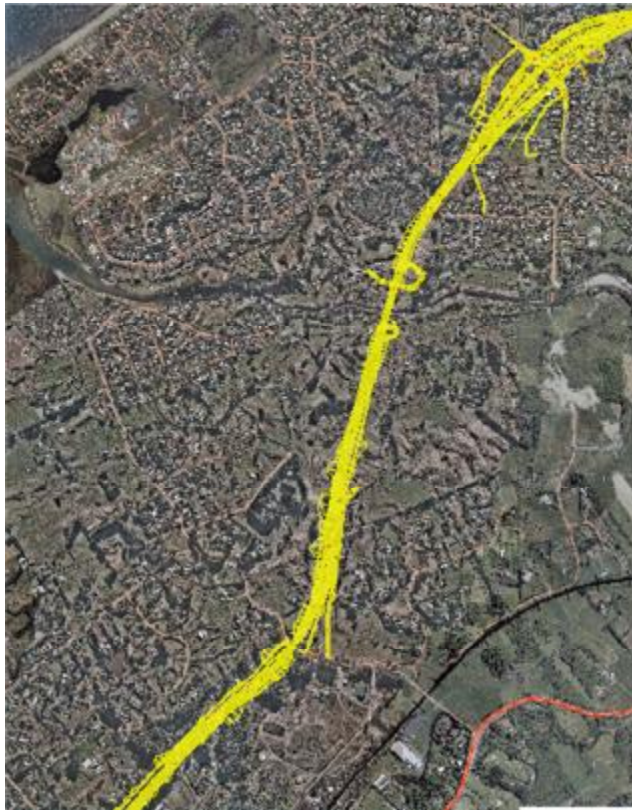
Figure 3: Sector 3

The extent of Sector 3 is shown in **Figure 13** with the yellow line indicating the route of the Expressway. Maps of the route within this sector are shown in Drawings EN-CL-012 and 013, Volume 5.

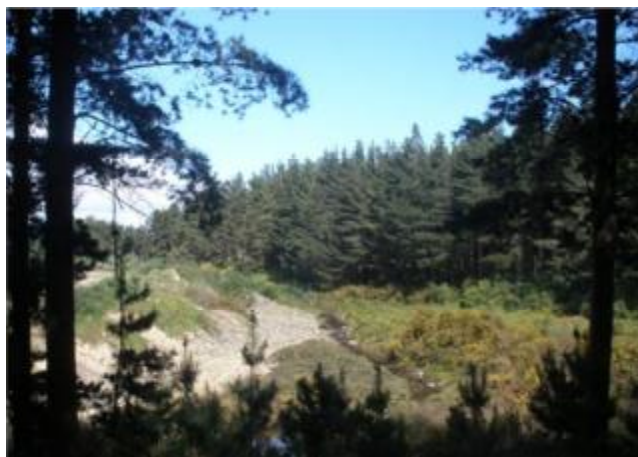
Location	Property Address	Activity	Observations
Otaihanga	160 Otaihanga Road	Landfill	Landfill currently accepts cleanfill green waste and treated sludge from the wastewater treatment plant. Leachate collection ditch observed which contained floating waste materials.
Otaihanga Road to Waikanae River	Various	Rural / Lifestyle blocks	No activities indicating the potential for land contamination.

Figure 14: Otaihanga Landfill – toe of landfill,

route to the right in the pine trees

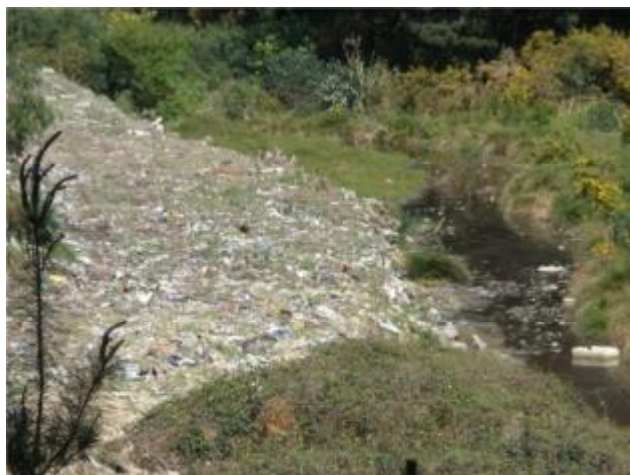
Figure 15: Otaihanga Landfill – Landfill Drain.

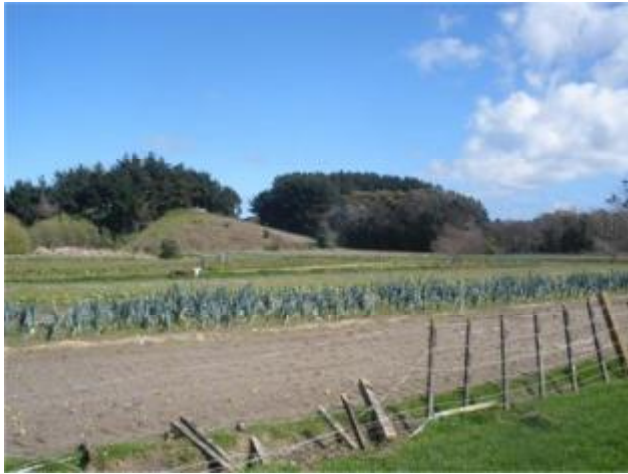
Figure 16: 124-154 Te Moana Road

The intersection at Te Moana Road would pass directly through the property at 124-154 Te Moana Road and therefore further inspection of this property is recommended.

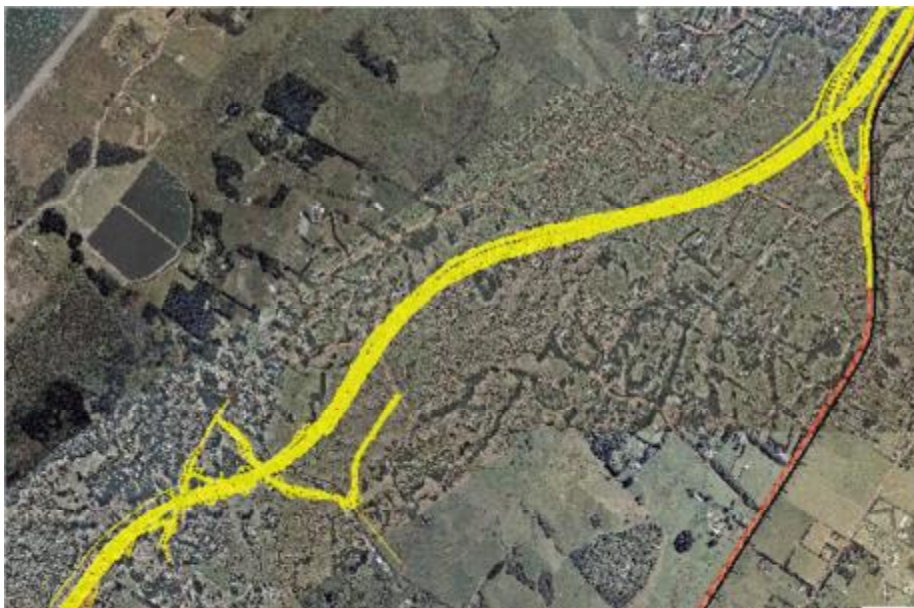
Figure 17: Sector 4

The extent of Sector 4 is shown in **Figure 17** with the yellow line indicating the route of the Expressway. Maps of the route within this sector are shown in Drawings EN-MP-003a, Volume 5.
