| Project: MACKAYS TO PEKA PEKA EXPRESSWAY | |
| Title: Contaminants Exceeding Guideline Values Sector 2: 55 Rata Road | Status: Document ID: Drawing No: GIS-3320901-99 |

Title: Contaminants Exceeding Guideline Values
Sector 2: 58 Kiwi Road

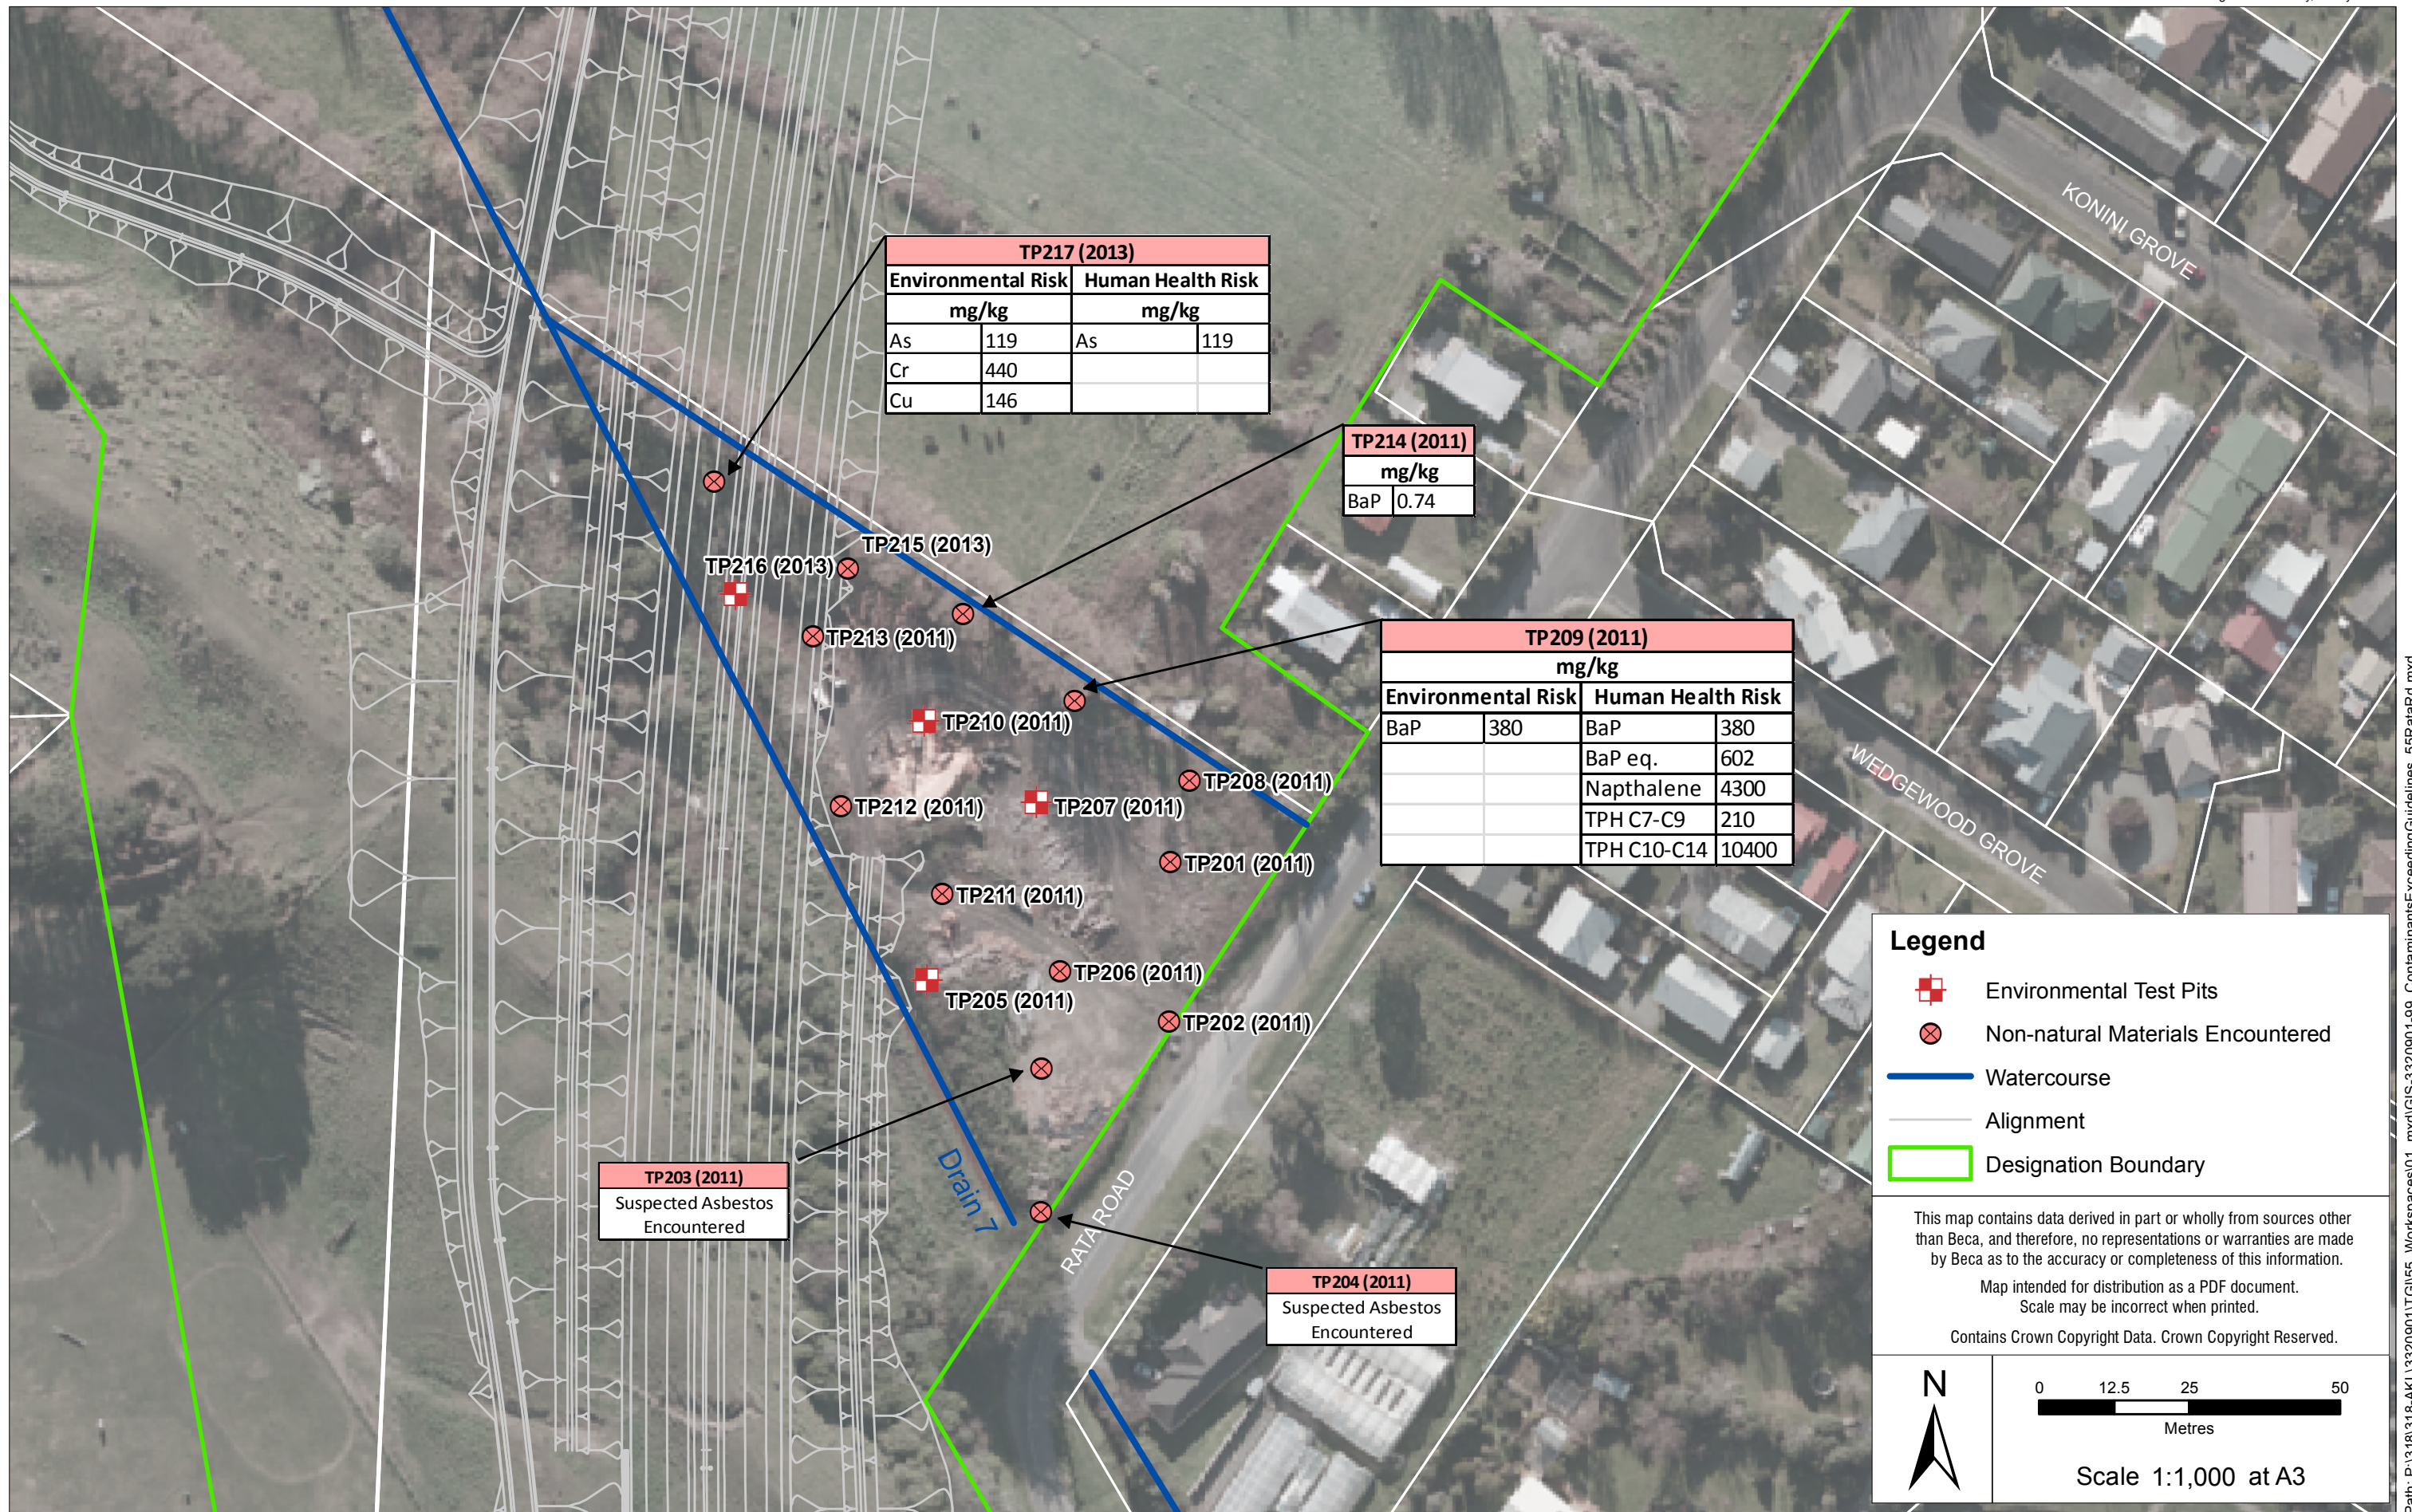
| TP217 (2013) | | | |
| Environmental Risk | | Human Health Risk | |
| mg/kg | | mg/kg | |
| As | 119 | As | 119 |
| Cr | 440 | | |
| Cu | 146 | | |

| TP214 (2011) | |
| mg/kg | |
| BaP | 0.74 |

| TP209 (2011) | | | |
| mg/kg | | | |
| BaP | 380 | BaP | 380 |
| | | BaP eq. | 602 |
| | | Napthalene | 4300 |
| | | TPH C7-C9 | 210 |
| | | TPH C10-C14 | 10400 |

TP203 (2011)
Suspected Asbestos Encountered

TP204 (2011)
Suspected Asbestos Encountered
