# APPENDIX 2: Avifauna Monitoring and Management Maps

<b>1</b>	<b>Introduction</b> .....	<b>3</b>
1.1	Consent conditions .....	4
1.2	Integration between Ecology, Landscape and Stormwater .....	6
<b>2</b>	<b>Methodology</b> .....	<b>7</b>

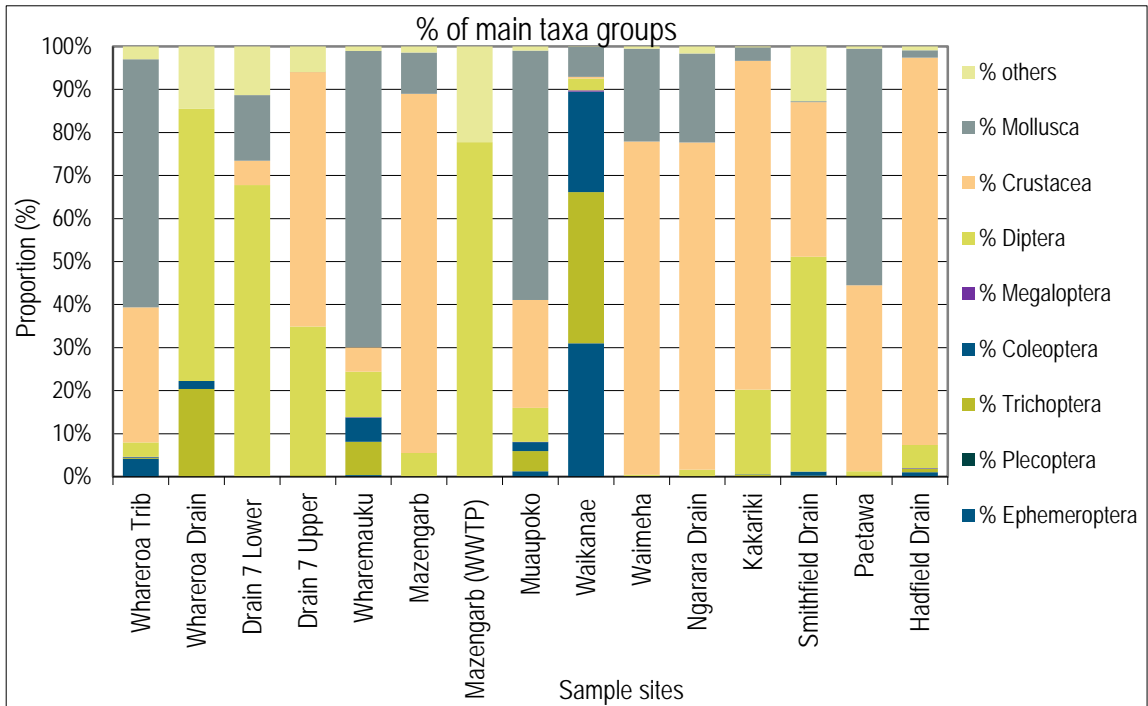
Figure 1 Macroinvertebrate community composition (% abundance) at each sampled site.

Figure 1 presents the community composition of macroinvertebrates in each waterway as a percentage of abundance within each taxonomic group. Figure 2 presents community composition as the percentage of taxa present within each taxonomic group. Both provide insights into the health of the waterways.

The most highly represented taxa in terms of abundance across all sites (with the exception of the Waikanae River) are Crustacea and Mollusca, and in particular Paricalliope (which have no soft-bottom MCI value) and a hard bottomed MCI score of 5, and Potomopyrgus with a soft bottom MCI value of 2.1. Midges (*Chironomus* sp.) dominate in some waterways. Only the Waikanae River had a notable varied assemblage with evident EPT fauna, in particular Trichoptera and Ephemeroptera, making up the greater proportion of the species within the samples. Attachment 3 provides the baseline data for sensitive taxa, species and abundance comparisons in line with the trigger conditions (discussed in section 6 below).

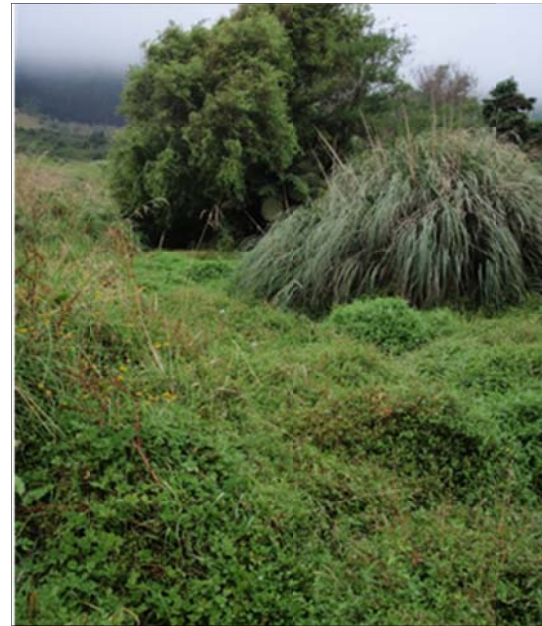
The Paetawa Drain is a channelised waterway, sourced from within a predominantly plantation pine catchment east of SH1. At the sampling site the drain waterbody runs through pasture, partially stock fenced but stock access is apparent.

Stream bank vegetation is made up of pastoral weeds (almost entirely covering the waterway over the summer months) with occasional *Carex geminata*. Much of the stream banks are under cut, heavily grazed and pugged. The substrate is deep mud (up to 50 cm) over sand. The water is made up of pools with occasional runs.

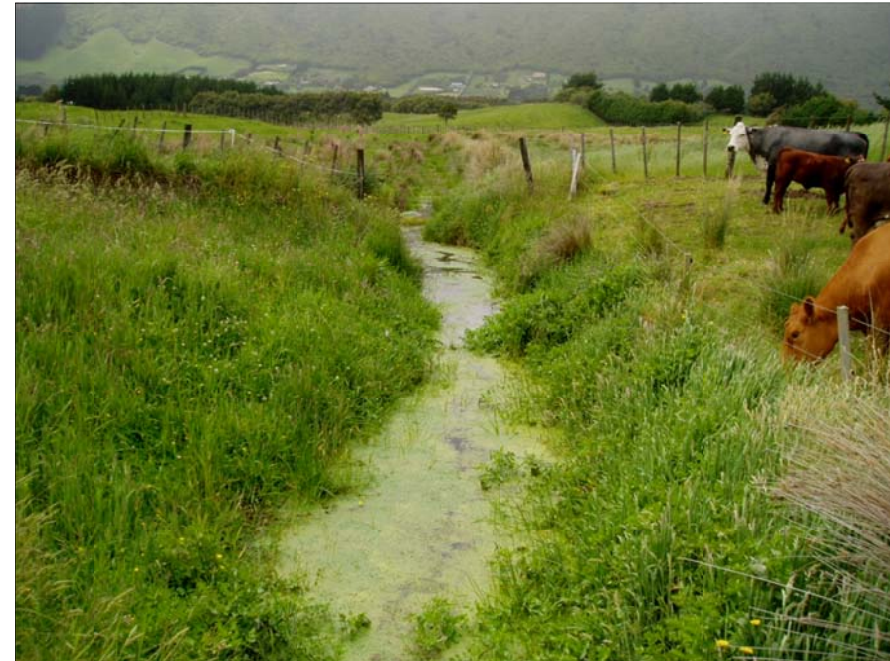
Highly modified drain cut through peatlands which would originally have been extensive wetlands. The drain is choked with aquatic weeds, and surrounded by wet pasture with Juncus.

Deep muds predominate and there is unrestricted cattle access.

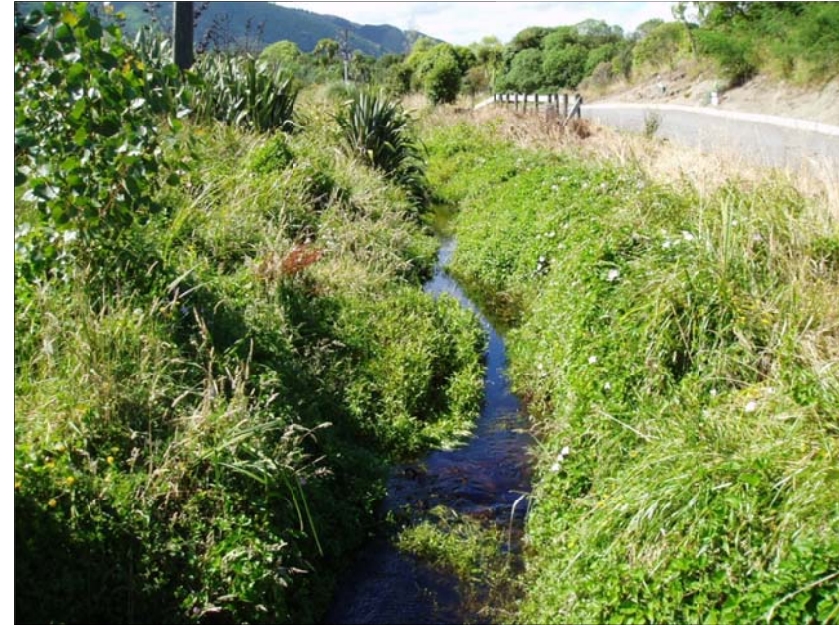
At the sampling site, the Kakariki Stream is a channelised stream with high quality upstream components, which add to its potential ecological

values. The habitat type consists of 80% run and 20% back water combined with in-stream macrophyte (monkey musk, watercress, water pepper) which provides good fish cover. The substrate type consists of fine gravels, and sands with fine sediments (not anoxic).

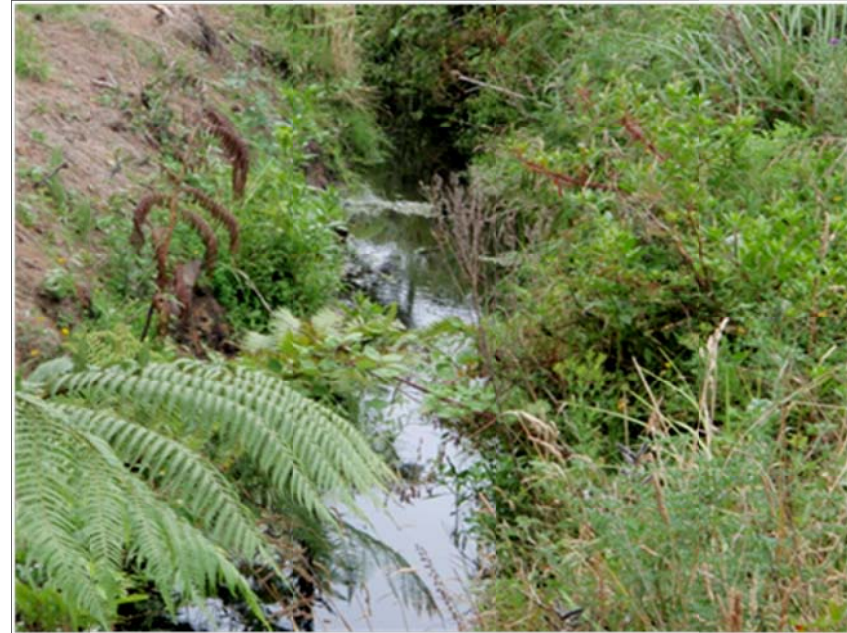
Occasional ferns and mahoe occur on stream banks, but recent clearing of the plantation pine has damaged the riparian vegetation and rendered

much of the stream bank unstable. The sampling site was separated by a low gradient culvert under a farm track, which allows for fish passage.

Downstream of the culvert the drain has deeply incised banks with still backwater and pool habitat under pine forest. The pool habitat of this portion of the waterbody, combined with the excessive pine leaf litter, traps suspended solids, rendering the water dark red/brown in colour. The stream bed sediments consequently have become highly anoxic in this zone, and while the in-stream debris would normally provide good habitat for fish, the water quality is severely degraded.

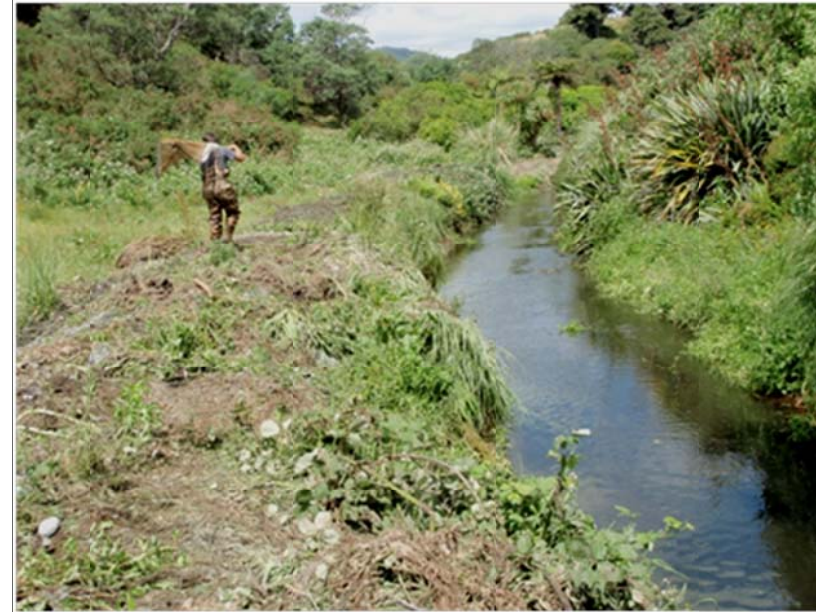
A large (5 m wide) stream in a mix of urban back yard and rural land. Parts of the urban section of this stream has a riparian vegetation buffer and is a backyard feature for many bordering properties. Downstream riparian vegetation was made up of pasture grass (grazed to the edge), *Carex geminata* and blackberry, with a few willows. No riparian fencing was present. Along the sampled reach, the habitat consists of run pool 80%/20% flow. Water quality studies show elevated nutrients, bacteriological counts.

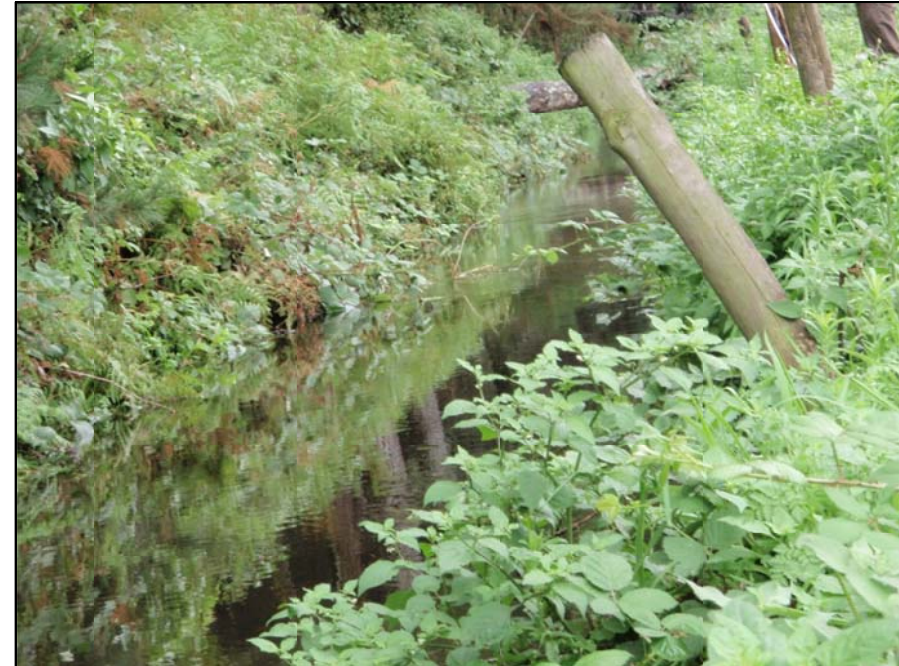
Receiving the outflows of the treatment plant the surveyed section of the drain is a regular sided, 5–8m wide, 0.5m deep, soft bottomed drain surrounded by a pine plantation (riparian). More recently the riparian pine has been thinned (chopped down) and the stream is relatively open along its riparian edges. The bed has deep muddy and algae drifts over a sandy–muddy bottom with numerous woody debris. While abundant in eel the general water and habitat condition is poor and habitat variety (substrate, water and bank) low.

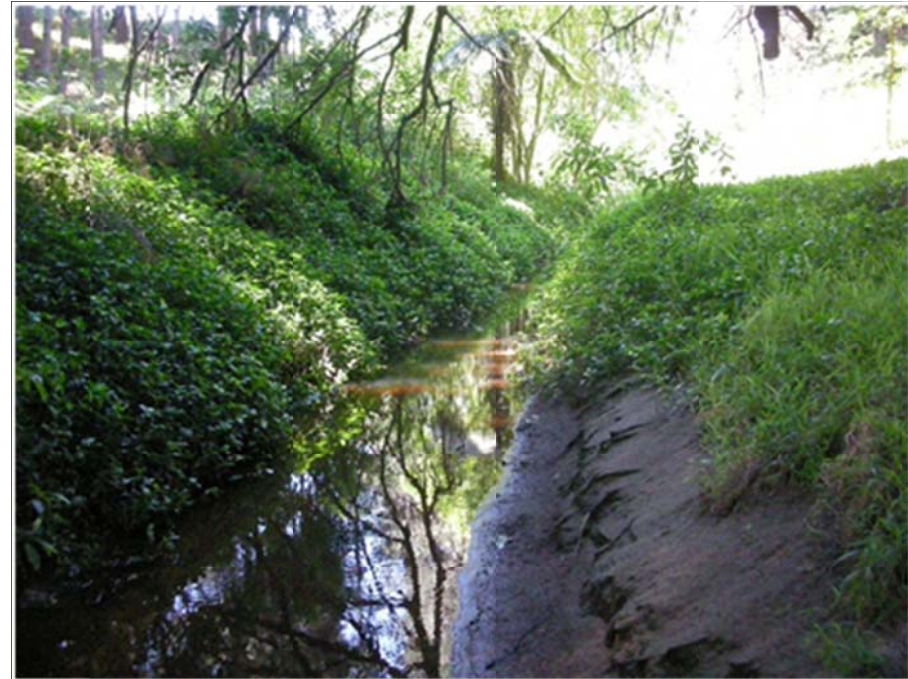
A natural stream that has been extensively modified upstream of works by upgrade works at SH1 and NIMT, stream diversion works through a series of large open artificial ponds, and a residential subdivision.

The Mazengarb Stream is a tributary of the Waikanae River. It has a number of point source discharges of contamination in its catchment including potentially the Otaihanga Landfill and Paraparaumu Waste Water Treatment Plant, with the WWTP Drain entering the Mazengarb Stream just downstream of the sampling location.

At the sampling location, the stream flows beneath an old stand of macrocarpa and pine, with a thick mat of Tradescantia fluminensis covering the stream banks to the water's edge. The substrate is predominantly muds over sand.

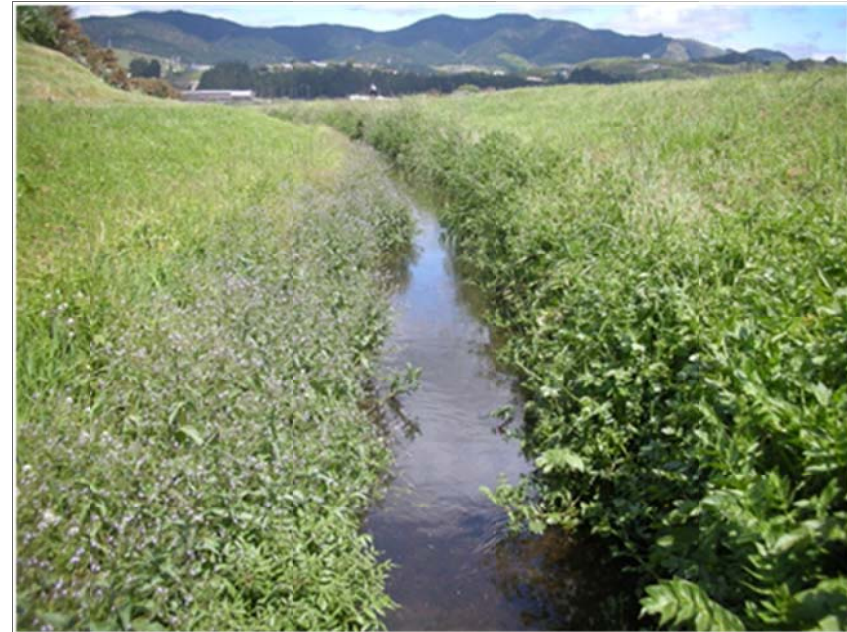
The Wharemauku Stream is a highly modified urban drain, channelised and influenced by urban (Paraparaumu Town) and industrial activities, as

well as discharge from adjoining drains from peat lands and residential areas.

The substrate comprises embedded cobbles and sand with a run/pool habitat with little instream debris. Despite being highly modified, the Wharemauku Stream does provide valuable habitat and is a known migratory pathway for many native fish species.

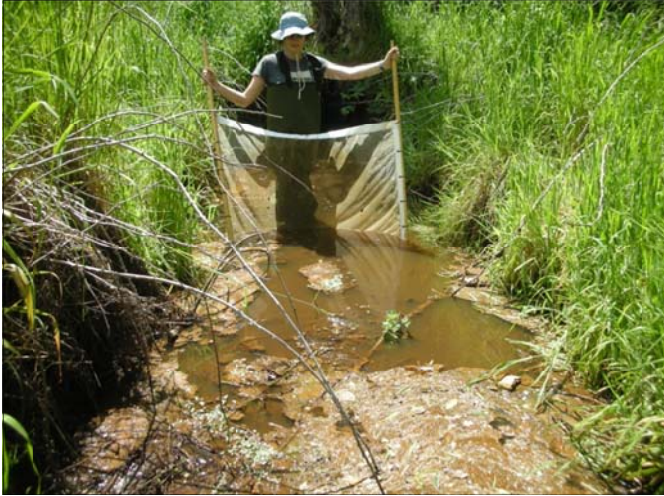
Very low value, vegetation highly modified weed field. Freshwater community highly robust and unlikely to be adversely affected.

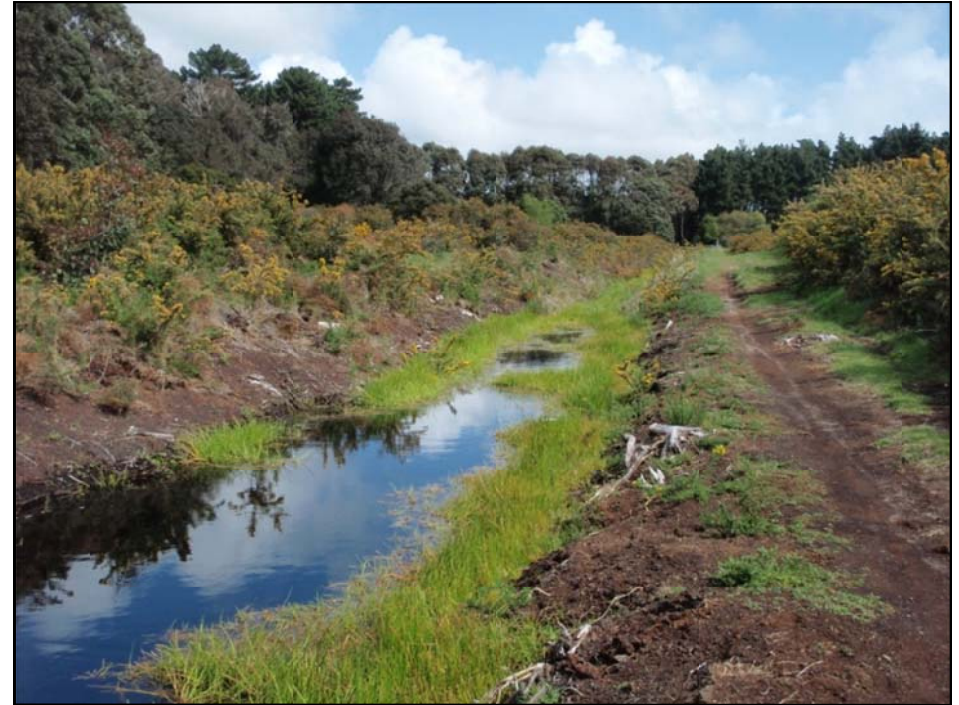
Very low value, vegetation highly modified weed field. Freshwater community highly robust and unlikely to be adversely affected.

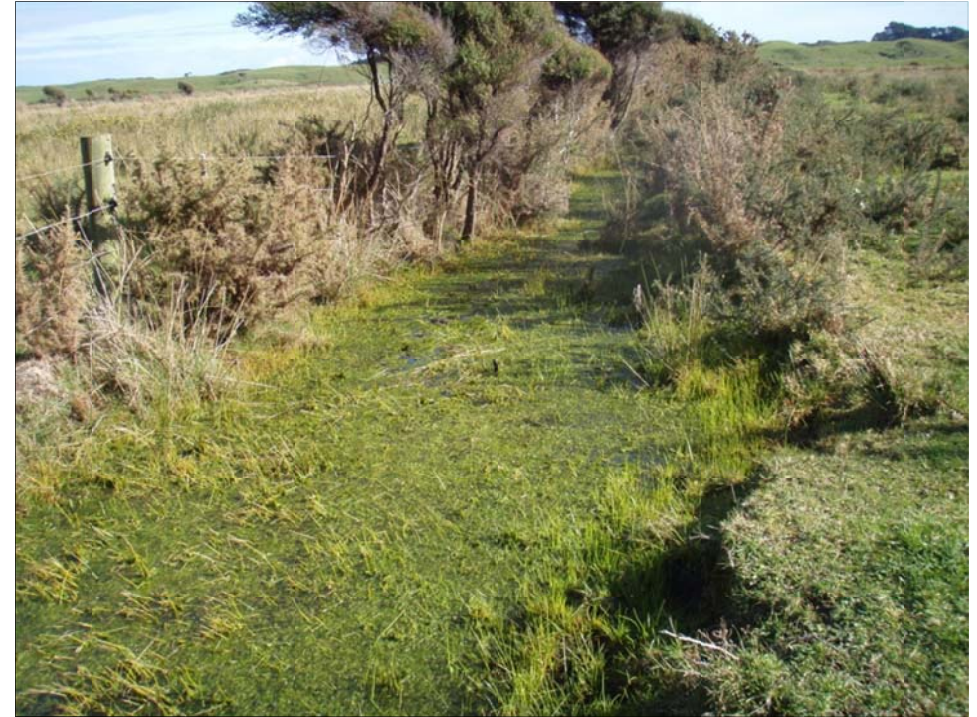
These drains form the northern headwaters of a more natural stream which discharges to the coast, although waterbody connections are almost entirely subsurface flows.

Alignment only affects the small drain to the north. Potential for sediment to move down these channels to the main stem is minimal and we consider risk of direct and indirect effects are negligible.
