Appendix 4 Mud Fish Survey Results Report

MacKay's to PekaPeka Expressway Mudfish Survey Report

January 10th 2013

BoffaMiskell LTD

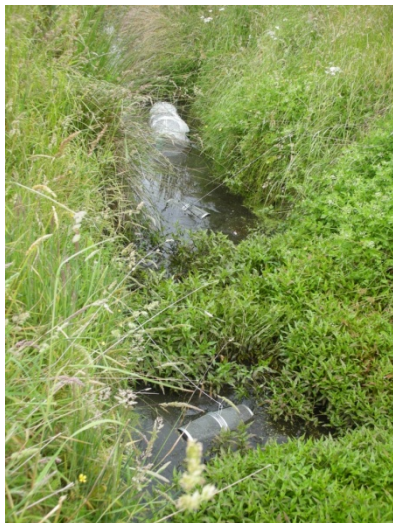
Photo 1 Smithfield Drain

Site Conditions: Dry, followed a period of little rainfall and entering dry conditions. Dry grass surrounding the stream and recent stock access in upper portion of Smithfield Drain. Very little water present in the upper site and waterbody consisted of deep muds with a small continuous watercourse of between 10 and 30cm wide and approximately 3-8 cm deep water on average above the muds. The lower Smithfield Drain site was characterised by more and deeper water, less modification and a number of deeper pools and areas of blackberry. A lack of stock access due to steep banks has resulted in more riparian habitat under blackberry and rushes.

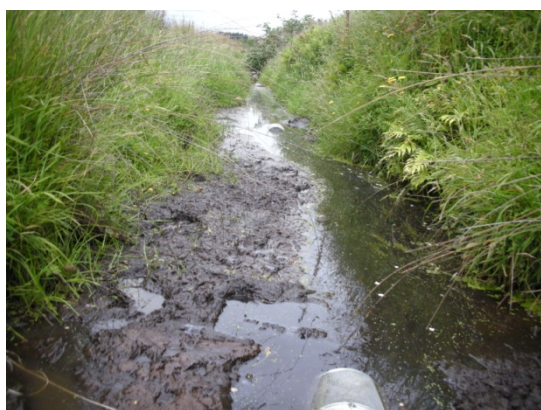
Photo 2 Paetawa Drain

Site Conditions: Dry conditions, followed a period of little rainfall. Stream banks fenced from cattle and long grass overhanging stream along entire length surveyed. Lots of stream vegetation dominated by monkey musk, water cress and rushes/reeds. Water depths ranged between 8 cm to deep pools of 40cm in parts. Stream substrates predominantly fine sands and silts, with some mud. The Paetawa Stream looked to be fenced from cattle on both sides for some months – particularly the southern side. There was an absence of deep muds that characterised the stream during the initial SEV survey.

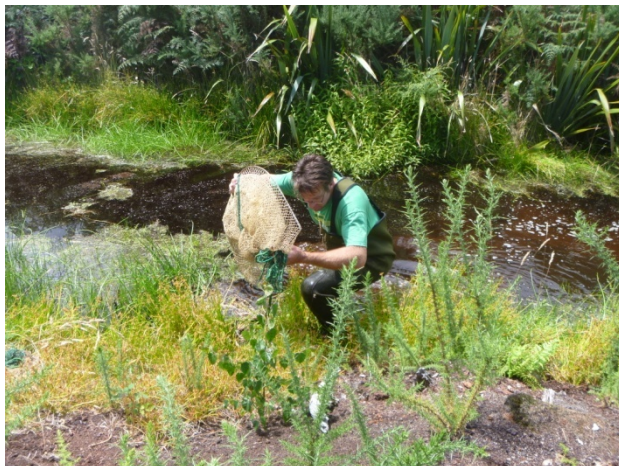
Photo 3 Drain 7

Site Conditions: Water table still relatively high and no recent stream modification (this section is subject to regular drain clearance by KCDC). Some overhanging vegetation (predominantly pine and manuka regeneration with some gorse) present and lots of in-stream vegetation (predominantly *Isolepis prolifa* and duckweed) and instream debris (predominantly old logs and branches from peats).

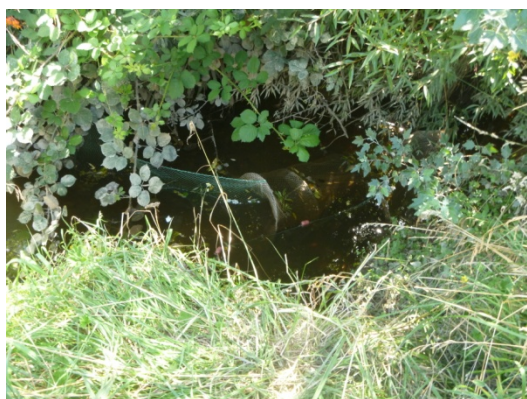
Photo 5 Muaupoko Stream (upstream)

Site Conditions: This water body has two different conditions upstream and downstream of the walking trail. Downstream of the trail the planted riparian vegetation provides full shade and organic input into the stream. The stream banks are 100% sand, high (750mm to 1500mm) which erode easily. The downstream depth ranges from 800mm to 1300mm. The substrate is 100% sand. The water clarity is poor due to the dark tannin tones and depth.

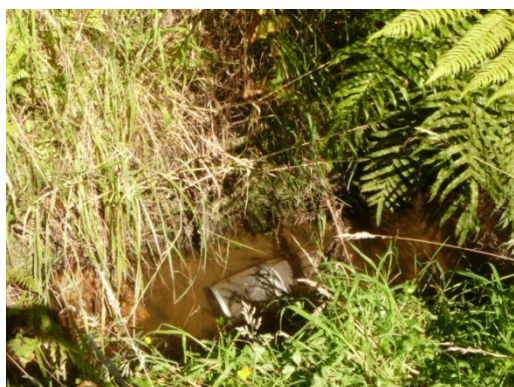
Photo 6 Hadfield Kowhai Stream

Site Conditions: The Hadfield Kowhai Stream runs below mature pine trees. The stream banks are steep and sandy, at 800 –1000mm high. The canopy consists of pine (overhead), with fern (Asplenium), Calla lily (Zantedeschia) and blackberry in small areas on the stream bank offering extra cover, assisting in erosion control. The stream bed is made of fine gravels and sands, with a depth of 20mm over the majority of the reach, with 2 to 3 pools at 300mm. At the upstream portion of the reach, at the culvert entrance fine mud has accumulated over the gravels enabling monkey musk (*Mimulus* sp) to take hold.

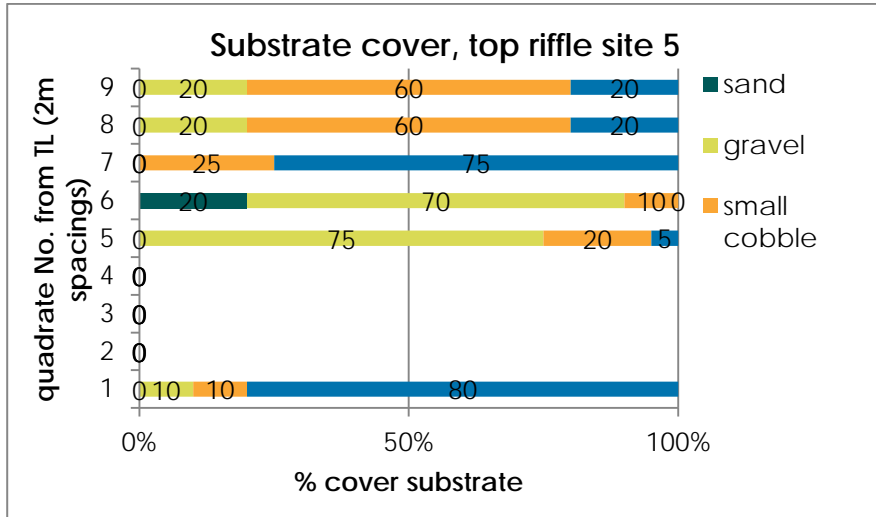
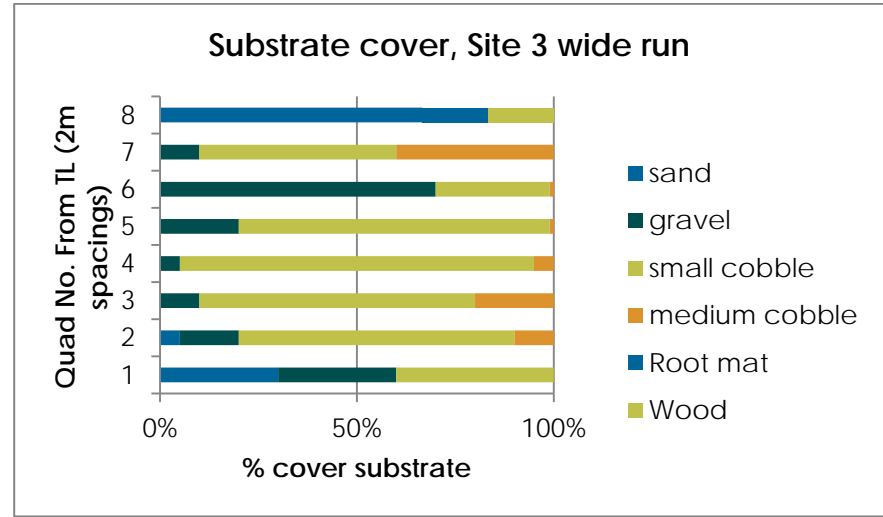
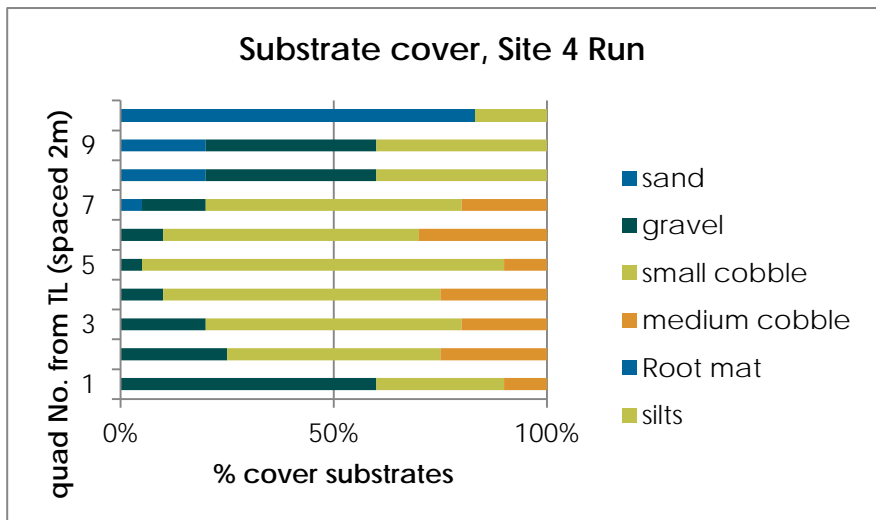
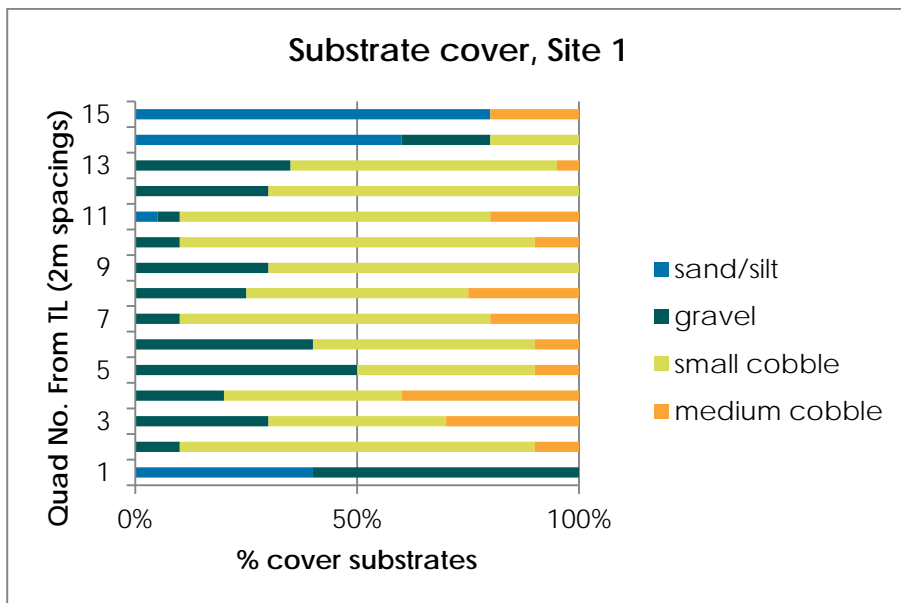
Substrate types and composition from multiple 1 m² quadrats at each site

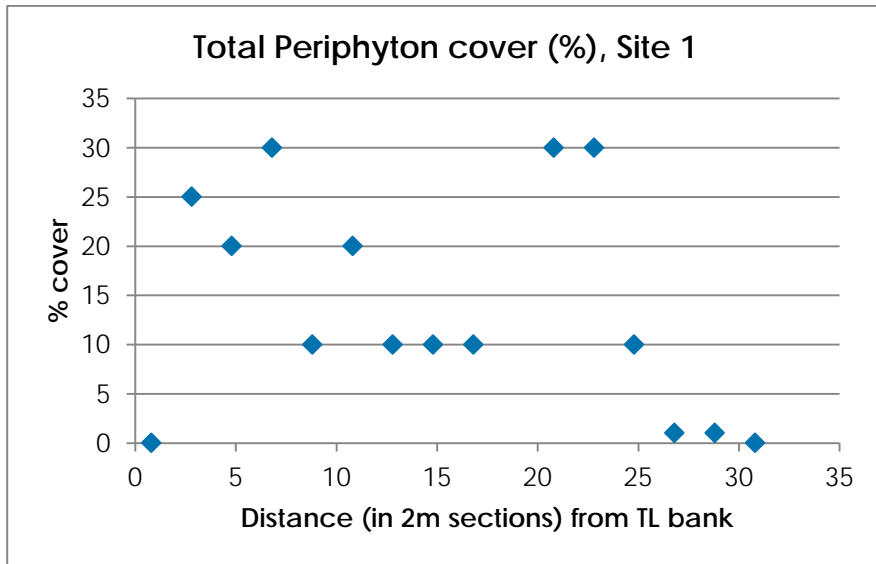
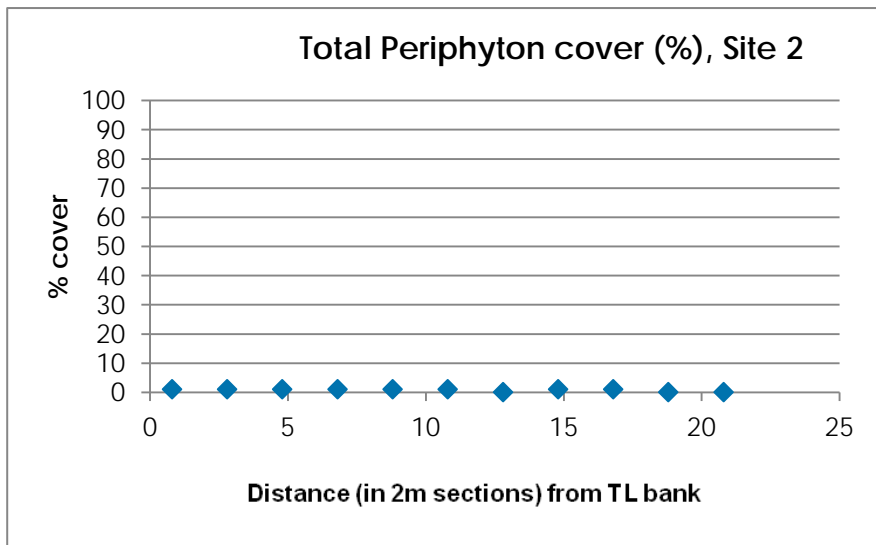
Periphyton Substrate Cover.

As described in the methods visual percentage cover of 1 m² quadrats was made of periphyton cover and included notes on the basic algae types present.

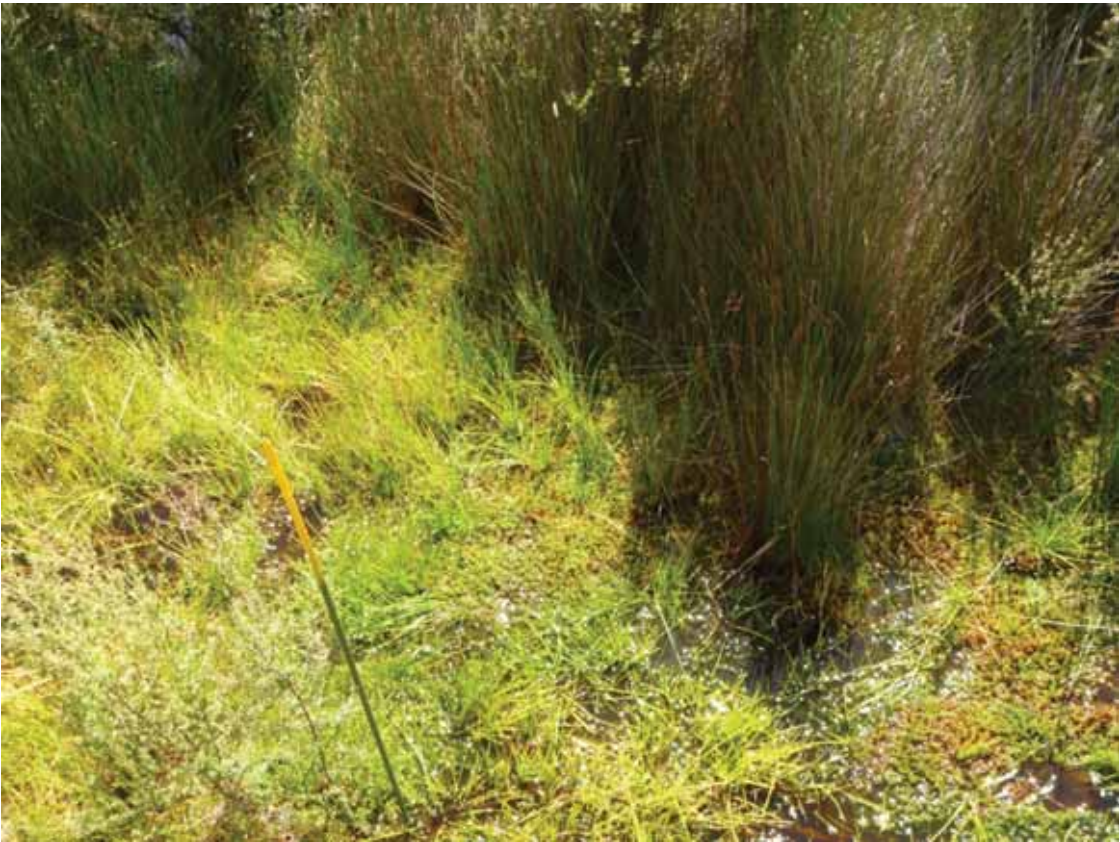
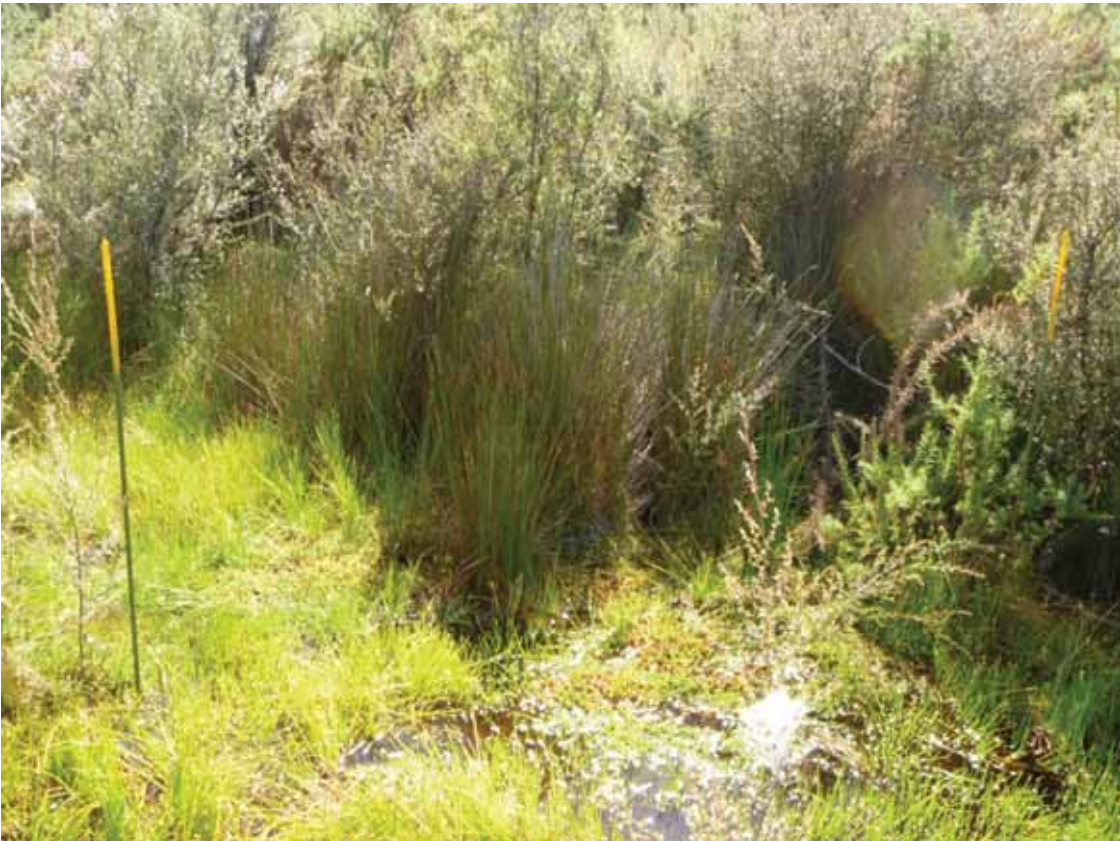
Raumati Manuka Wetland Plot 1 Photopoints:

Species	Manuka	%N	1.8	%P	0.10
---------	--------	----	-----	----	------

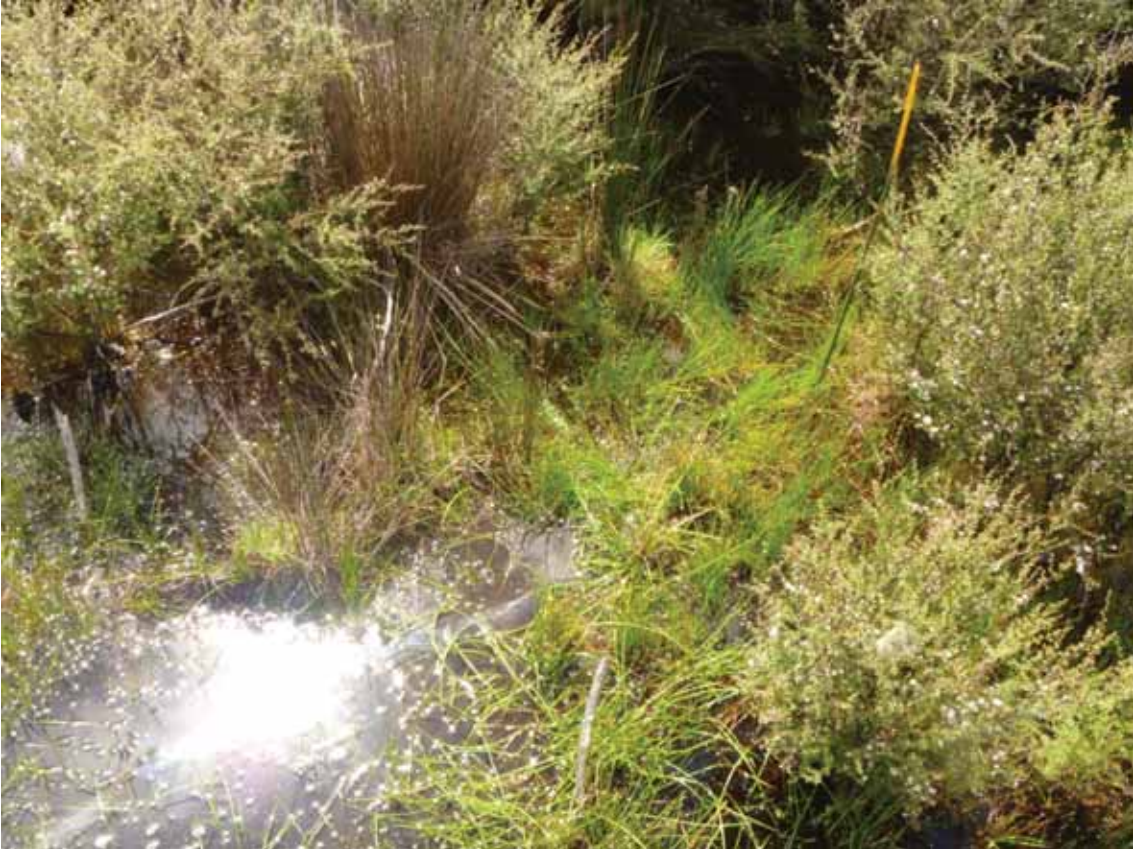
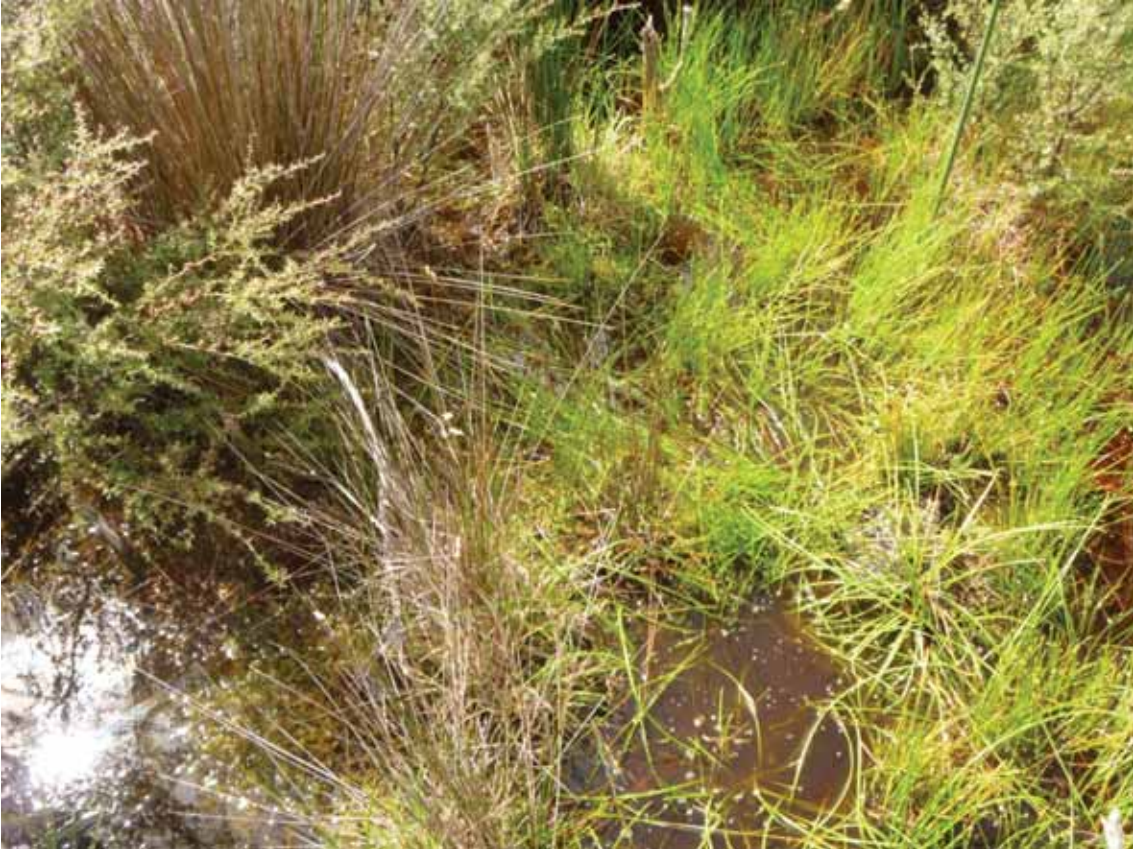
Raumati Manuka Wetland Plot 2 Photopoints:

Species	Manuka	%N	1.8	%P	0.10
---------	--------	----	-----	----	------

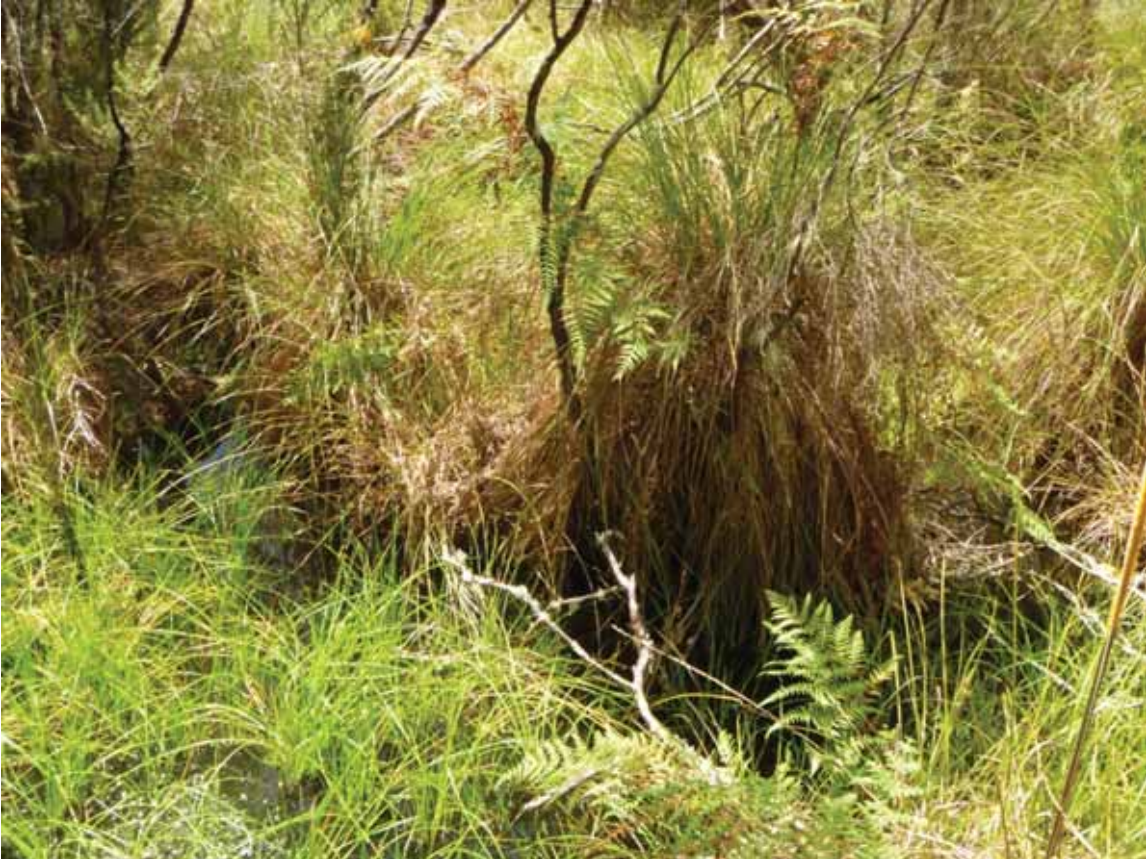
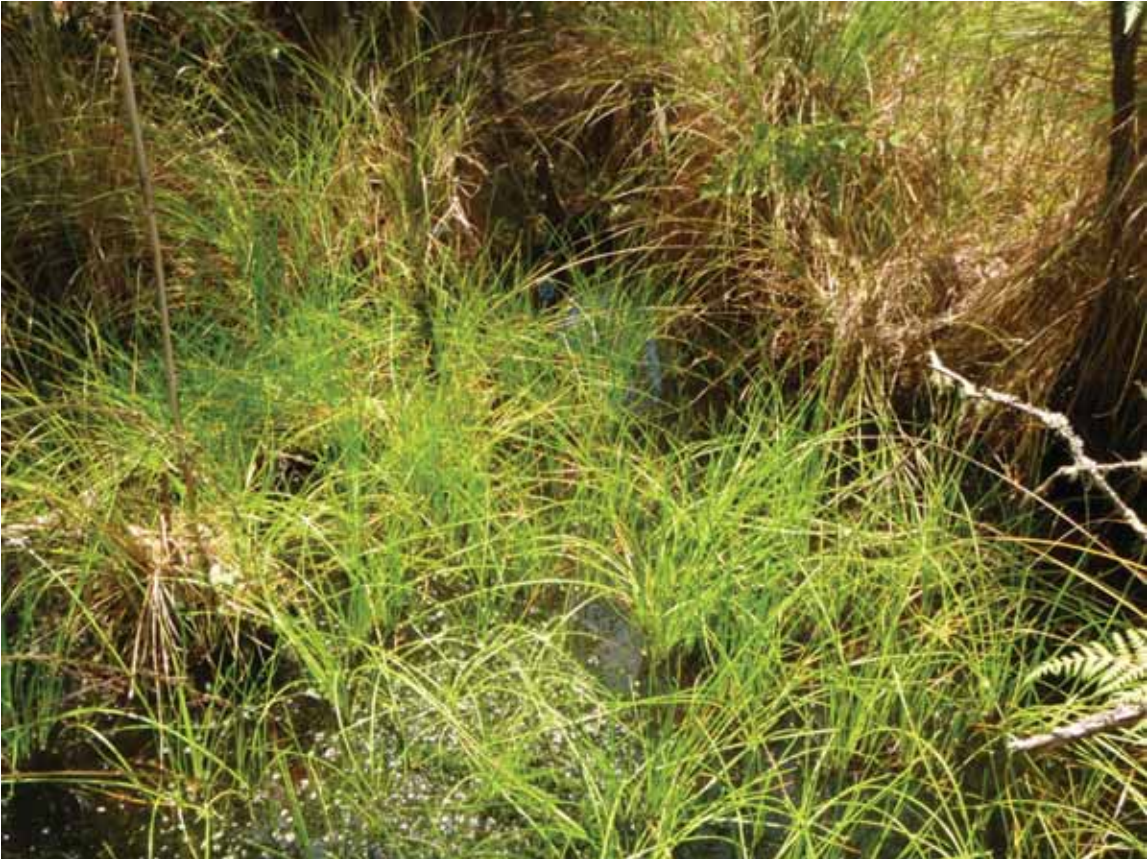
Otaihanga Northern Wetland Plot 1 Photopoints:

Species	Manuka	%N	1.6	%P	0.13
---------	--------	----	-----	----	------

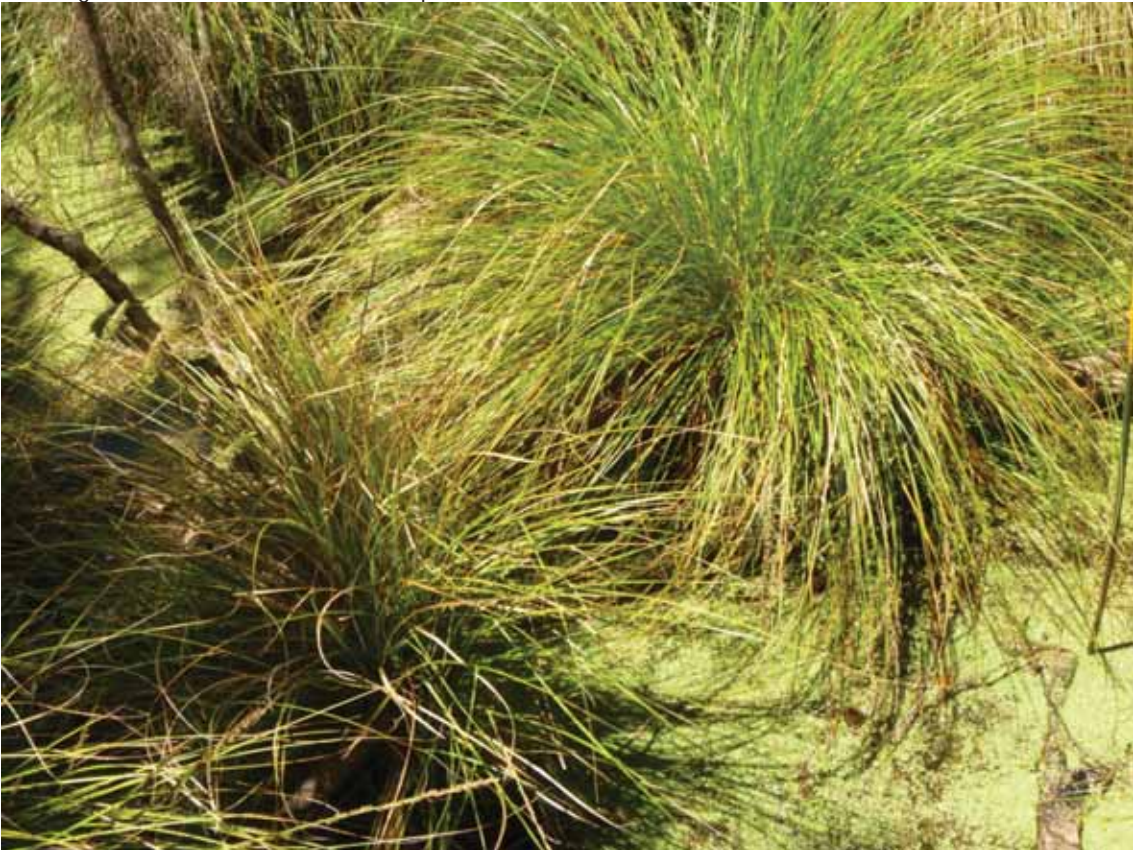
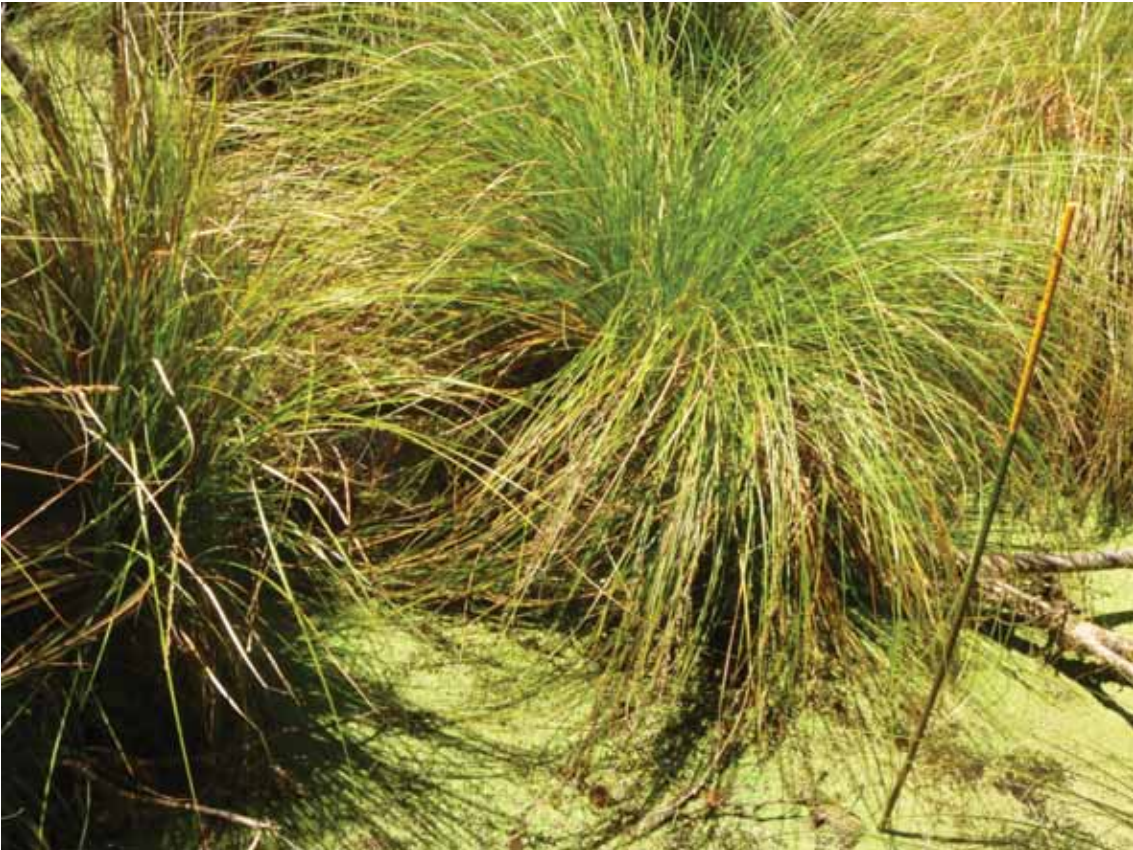
Otaihanga Northern Wetland Plot 2 Photopoints:

Species	Kanuka	%N	1.5	%P	0.09
---------	--------	----	-----	----	------

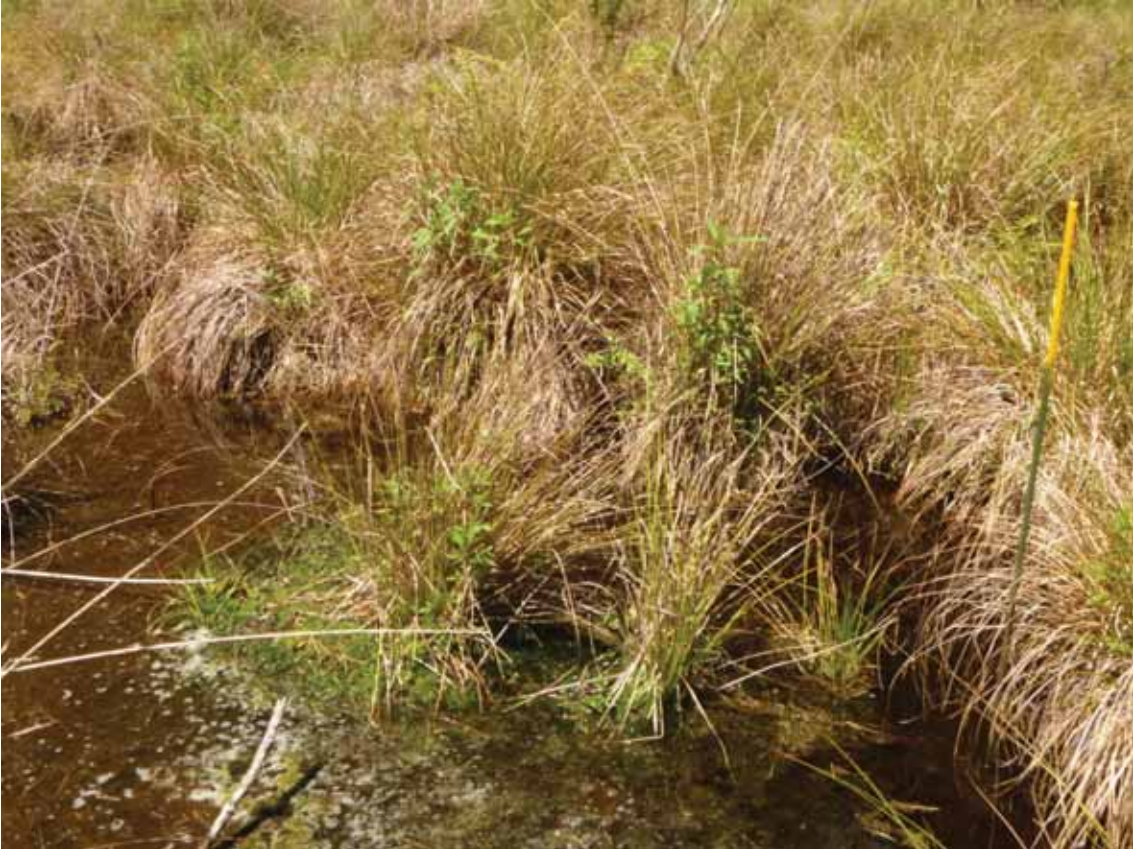
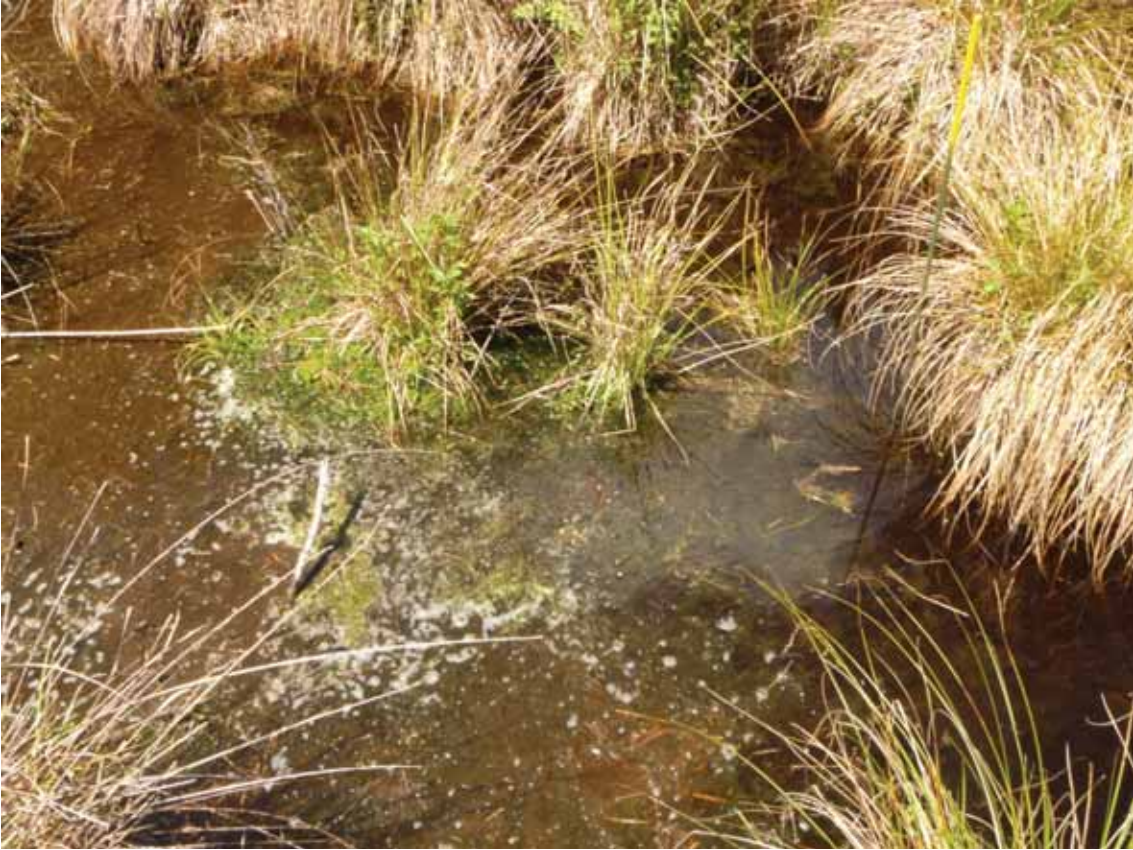
Otaihanga Southern Wetland Plot 1 Photopoints:

Species	Carex secta	%N	1.6	%P	0.23
---------	-------------	----	-----	----	------

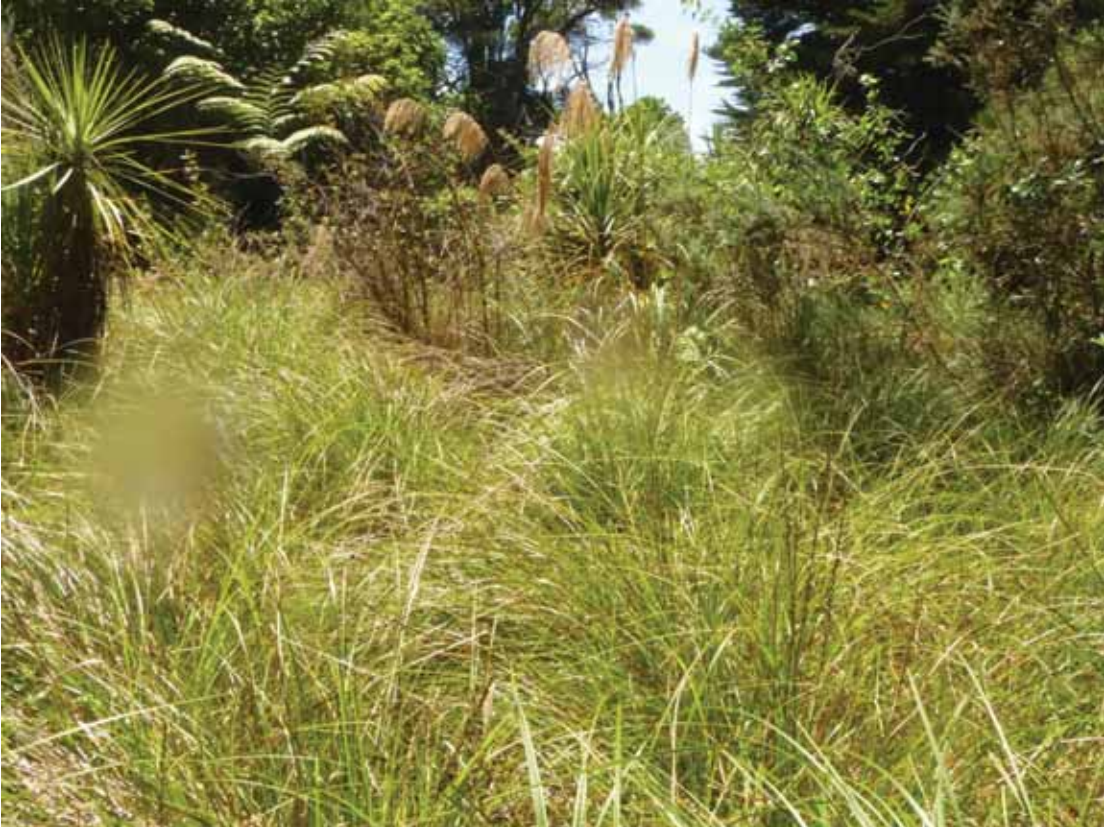
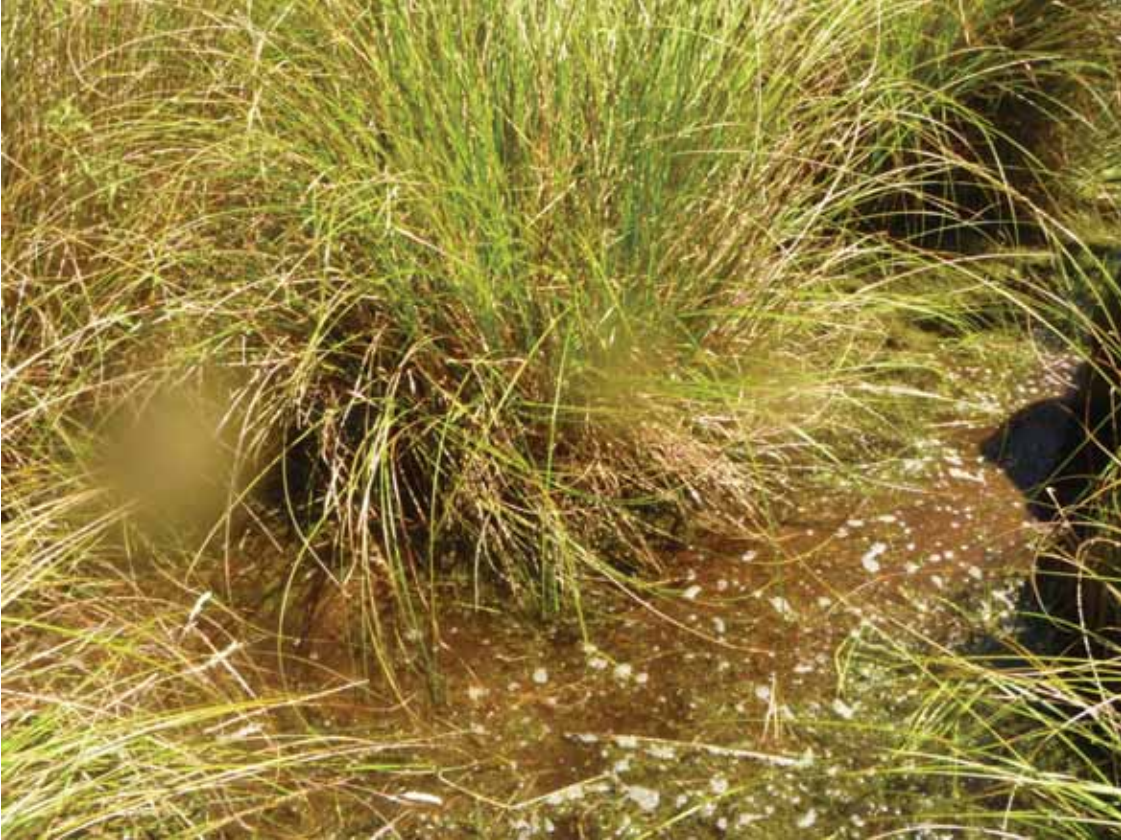
Otaihanga Southern Wetland Plot 2 Photopoints:

Species	Carex virgata	%N	1.7	%P	0.13
---------	---------------	----	-----	----	------

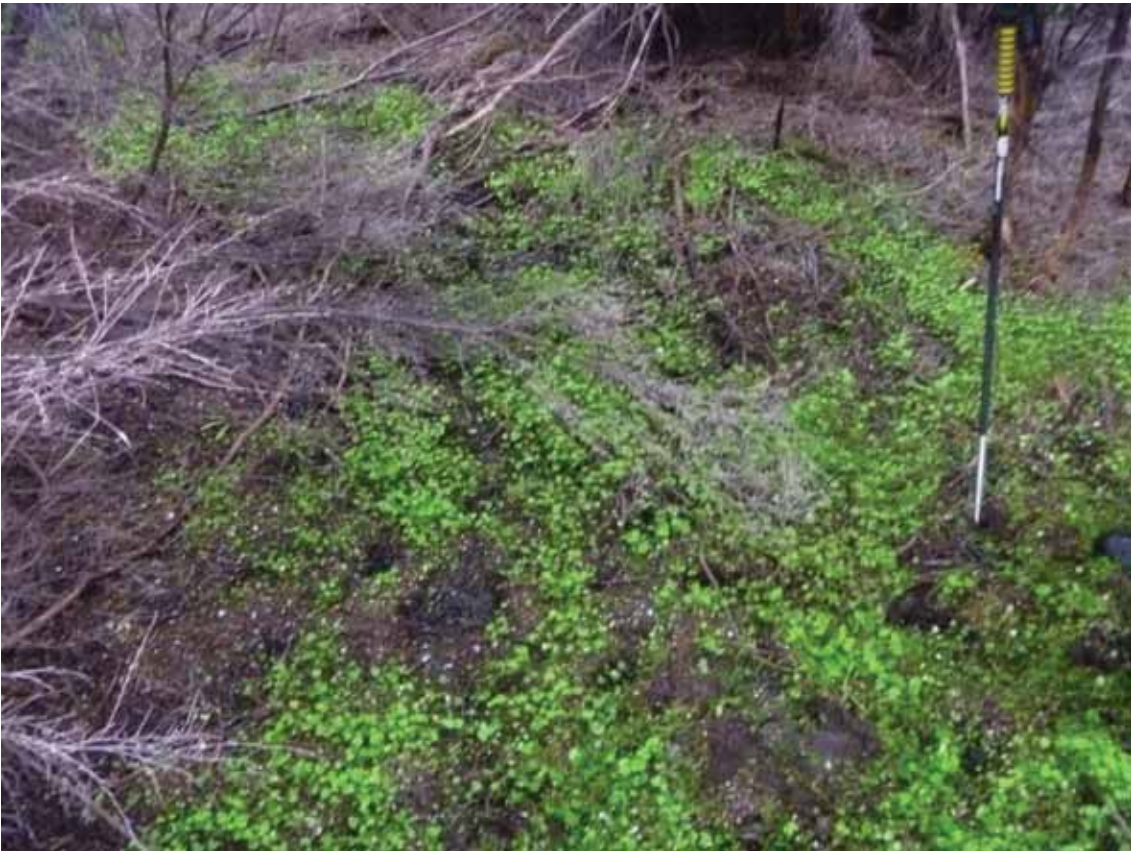
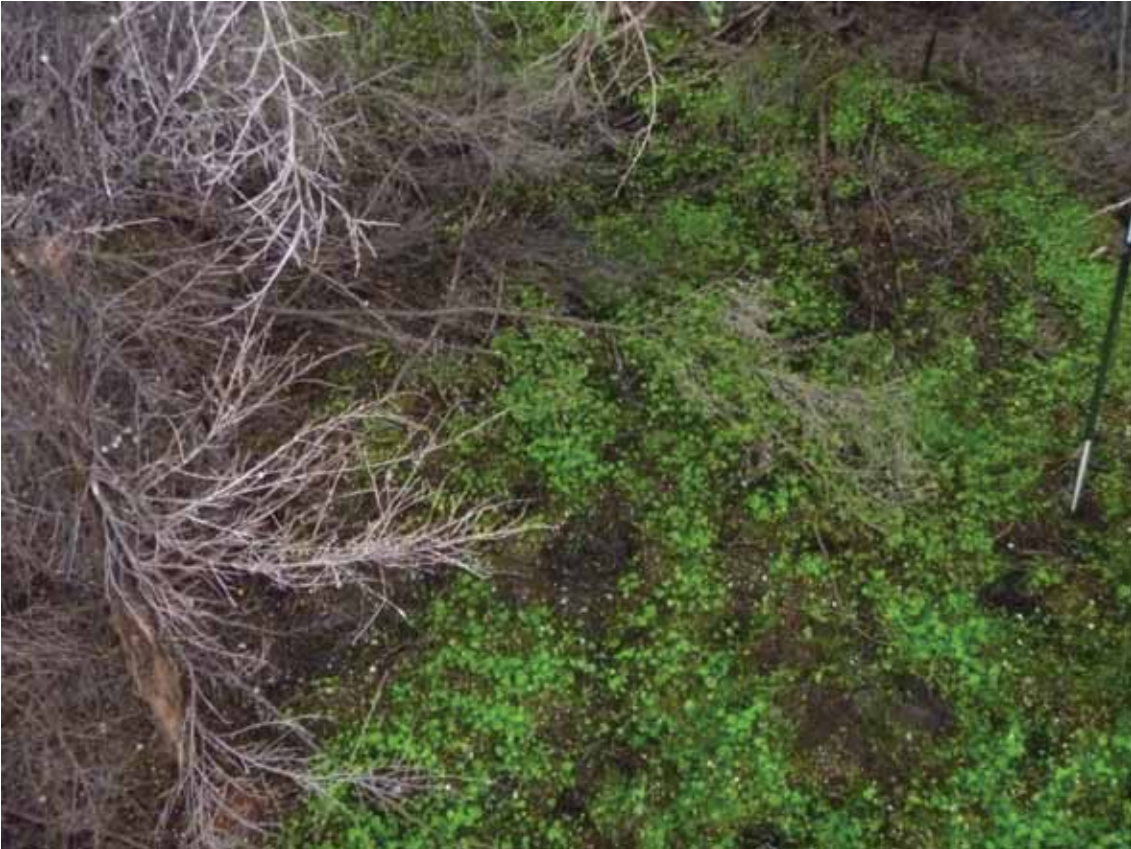
El Rancho Wetland (Wegbery) Wetland Plot 1 Photopoints:

Species	Manuka	%N	1.7	%P	0.11
---------	--------	----	-----	----	------

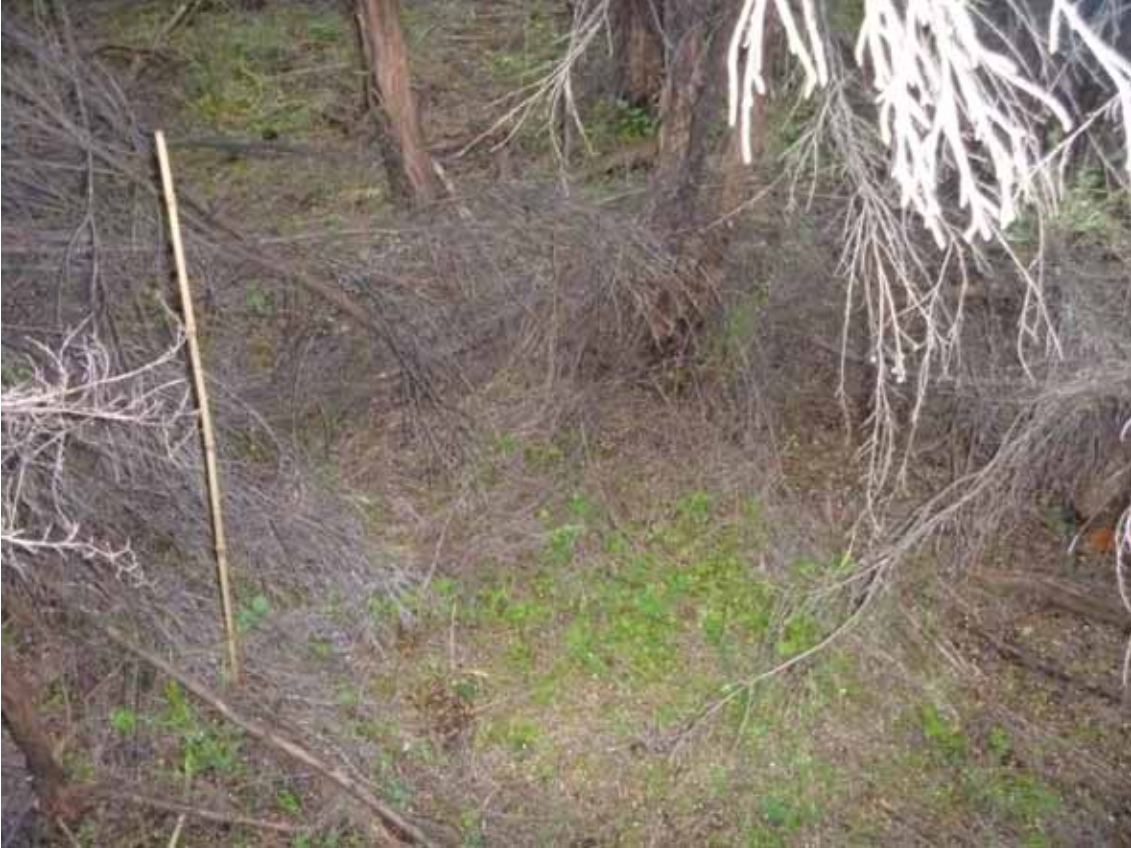
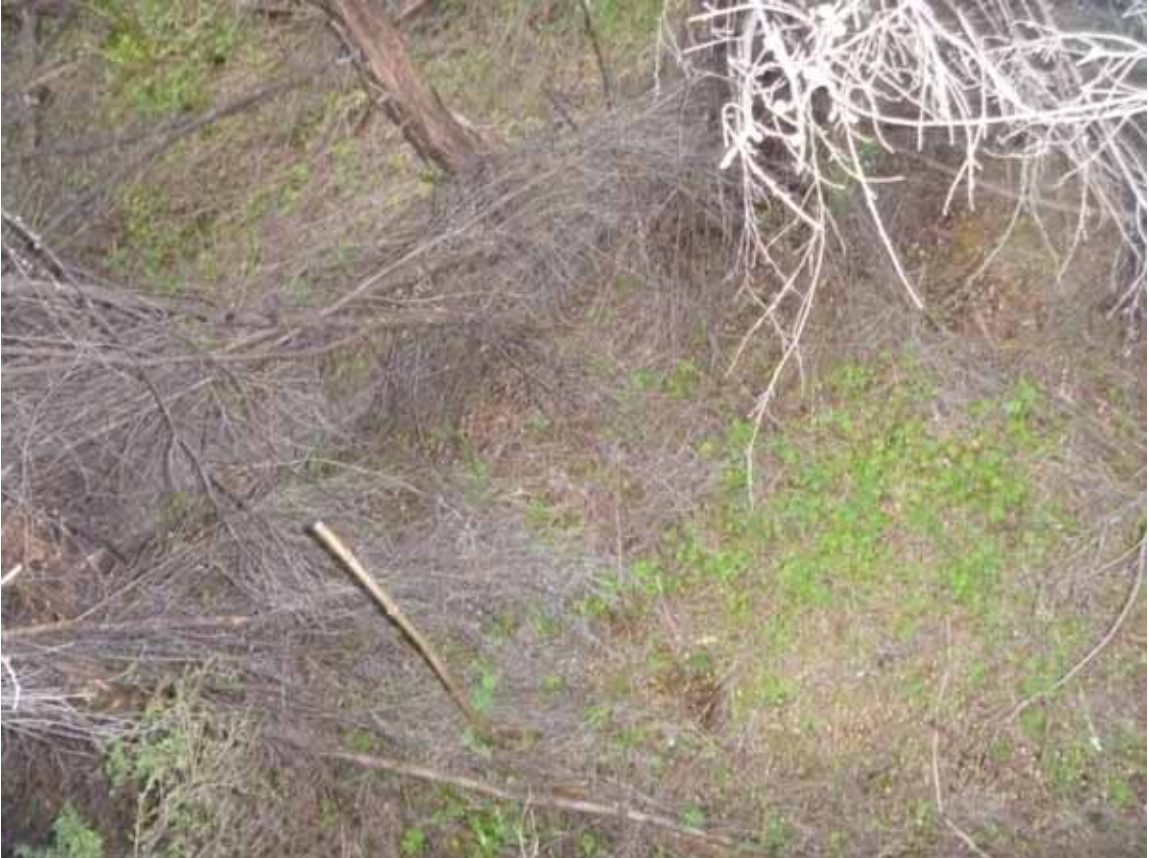
El Rancho Wetland (Weggery) Wetland Plot 2 Photopoints:

Species	Manuka	%N	1.4	%P	0.09
---------	--------	----	-----	----	------

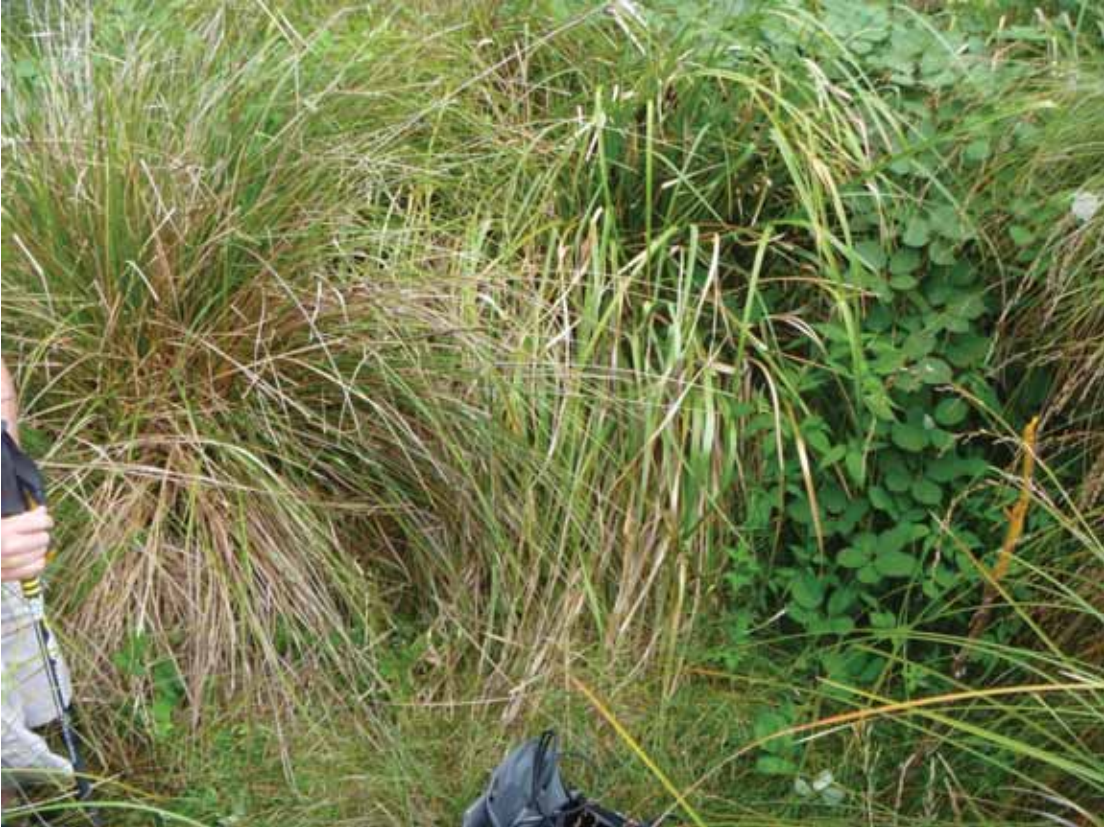
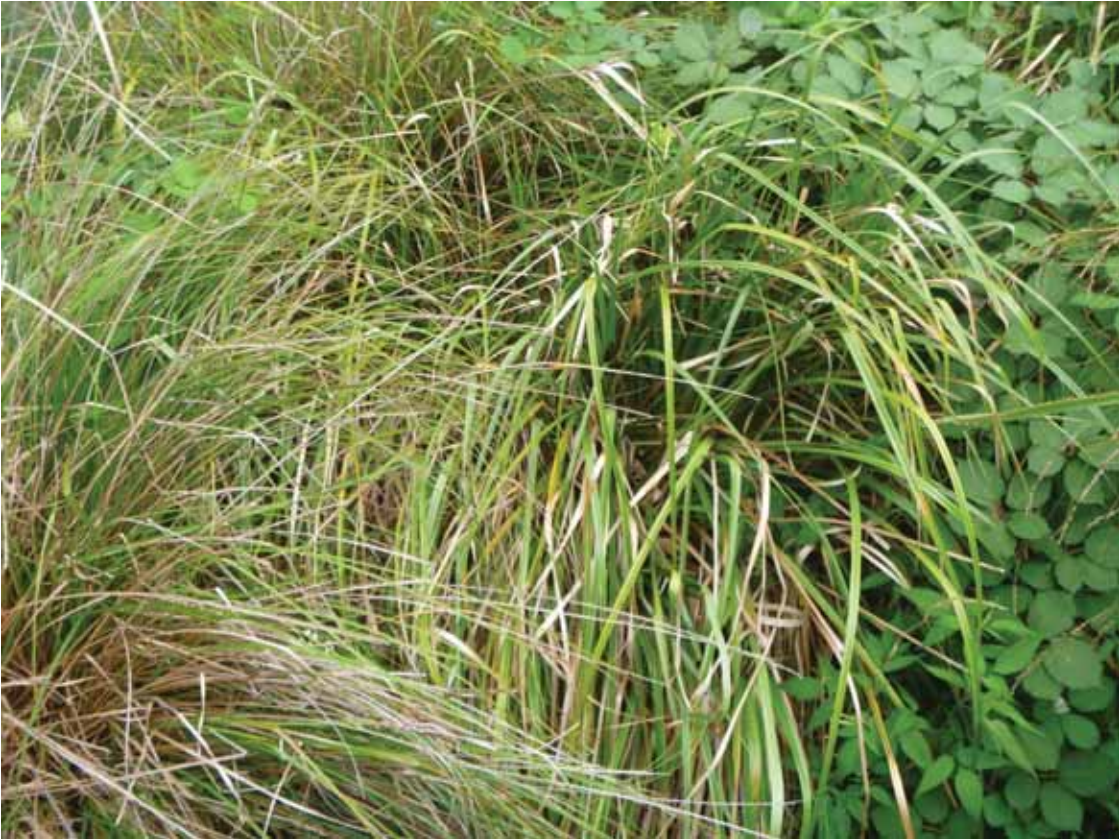
Ngarara Wetland Wetland Plot Photopoints:

Species	Carex secta	%N	1.7	%P	0.13
---------	-------------	----	-----	----	------

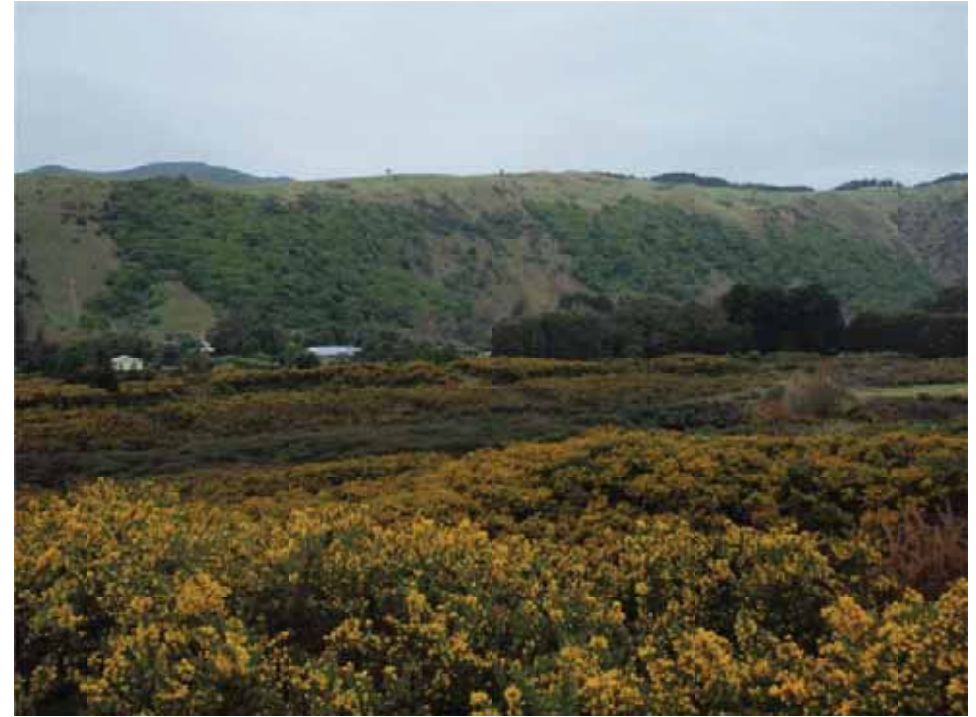
The ecological value of the wetland is assessed as Medium.

- Limited wetland vegetation clearance on northern margins as part of Expressway embankment construction (0.03 ha loss).
