Appendix 4 Mud Fish Survey Results Report

MacKay's to PekaPeka Expressway Mudfish Survey Report

January 10th 2013

BoffaMiskell LTD

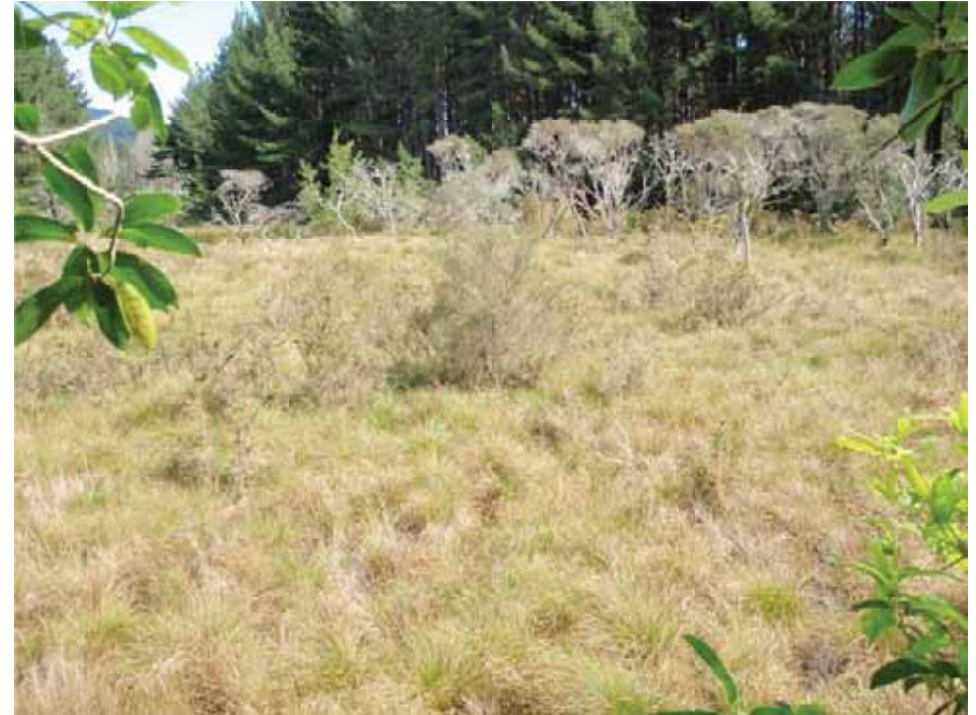
The ecological value of the wetland is assessed as Medium.

- Approximately 0.55 ha of vegetation clearance through southern half of this wetland as part of Expressway embankment and cycleway construction.

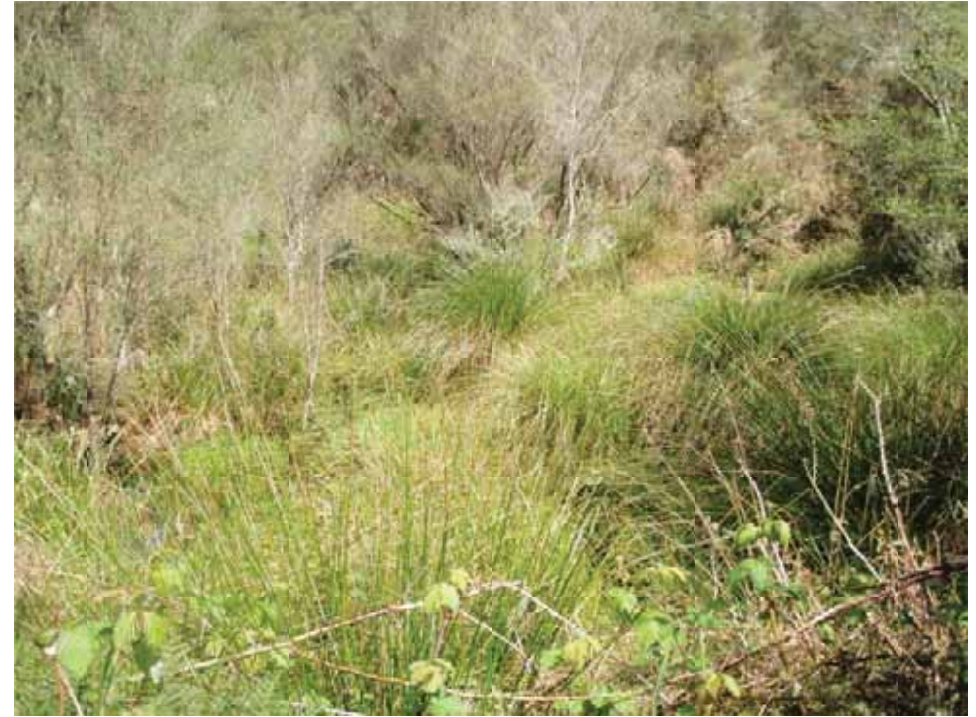
The ecological value of the wetland is assessed as Medium.

- Approximately 0.53 ha of vegetation clearance through southern half of this wetland as part of road embankment and cycleway construction.

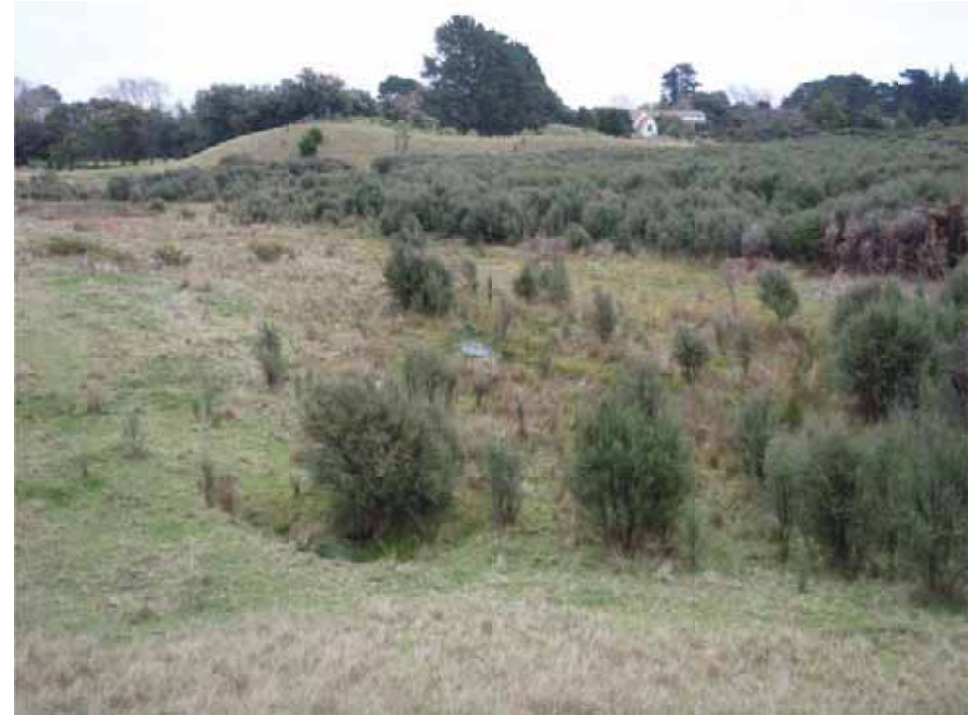
The ecological value of the wetland is assessed as Medium.

- Approximately 0.38 ha of vegetation clearance through southern half of this wetland as part of road embankment construction.

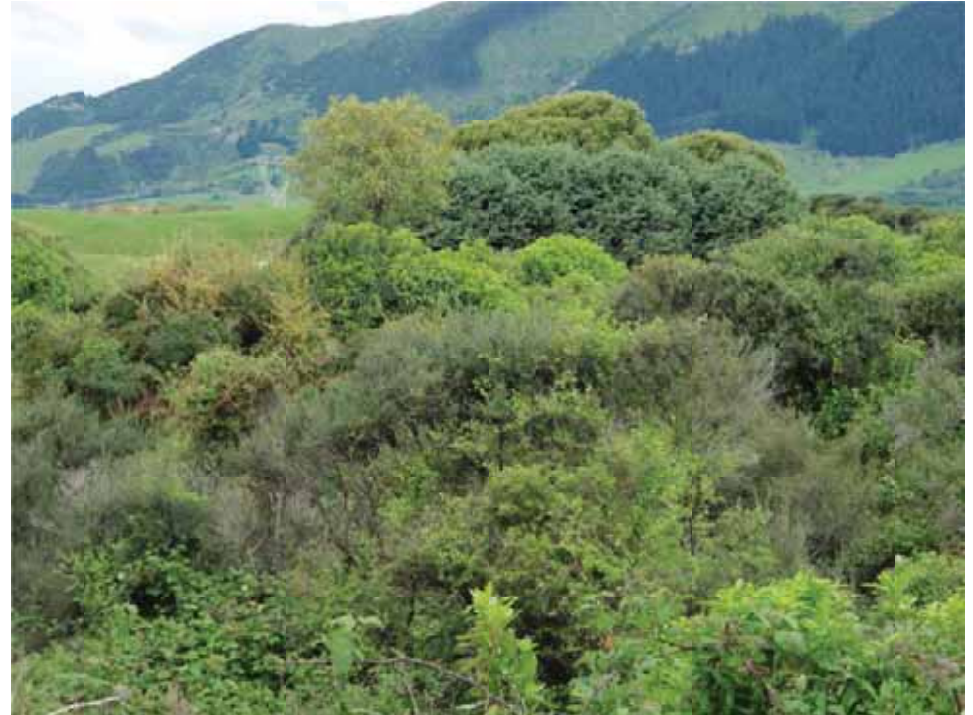
- Indirect effects only – limited vegetation clearance adjacent to northern margins of this wetland as part of road embankment construction.

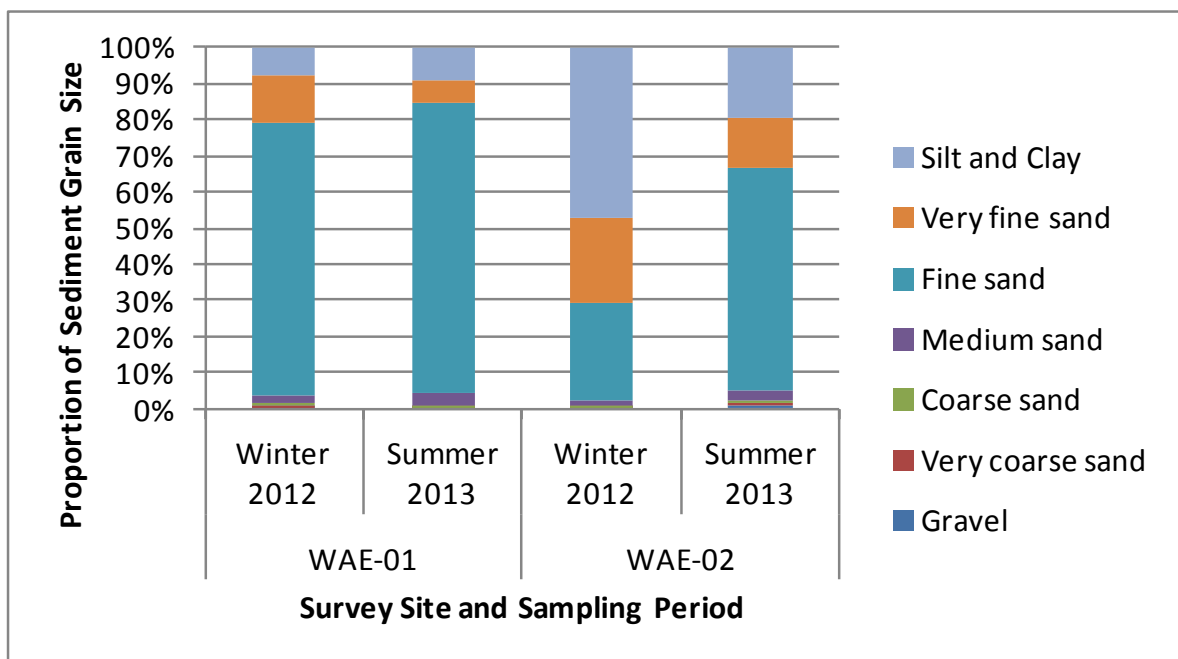
The grain size distribution at site WAE-02 was different to that of WAE-01 and different between the two survey times. In winter, the surface sediment comprised approximately 45% silt and clay, 20% very fine sand and 30% fine sand. However, the summer survey indicated a reduction in silt and clay to approximately 20% and very fine sand to 15%, whereas fine sand was detected at approximately 60% (Figure 6).

Sediment grain sizes between medium sand and gravel comprised less than 5% at both sites during both sampling periods (Figure 6).

Figure 6: Proportion of sediment grain size by site and season.
