Technical Report 19

# Ambient Vibration Assessment Report

### 11.1 MACKAYS TO PEKA PEKA - Ambient Vibration Monitoring Results

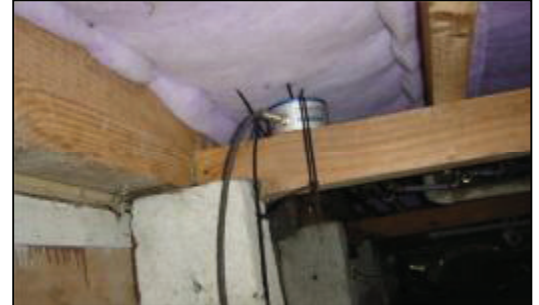
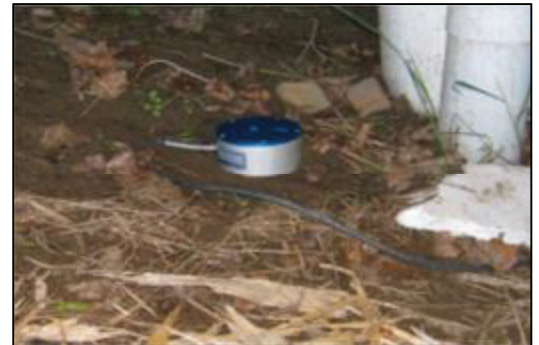
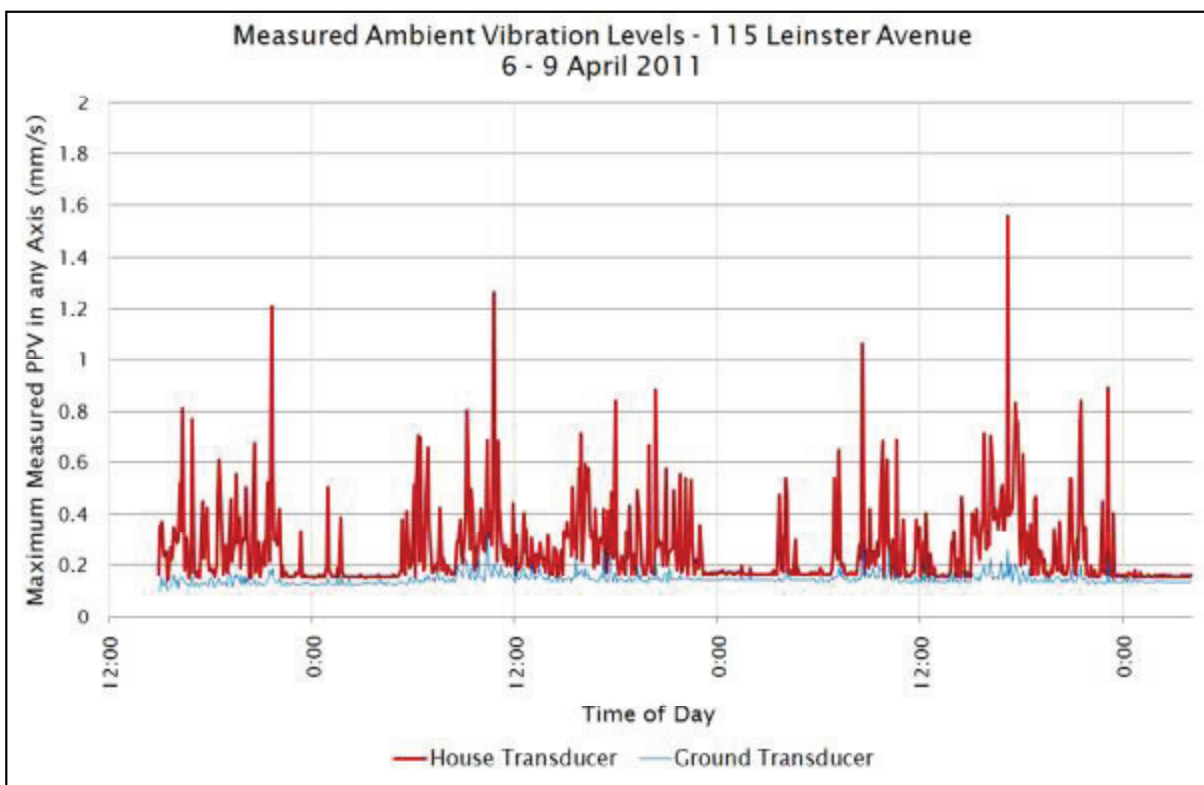
Location: 115 Leinster Avenue  
Project Sector: 1  
Date: 6 – 9 April 2011  
Distance to major road: 105 metres from existing SH1  
Equipment: Instanetel Minimate Pro6

Maximum dwelling PPV: 1.56 mm/s  
Mean uncontaminated dwelling PPV: 0.17 mm/s

Setup comment: Timber pile foundations. One geophone was tied to the outer end of a timber sub-floor bearer, the other was placed on the ground beneath the dwelling.

This dwelling has a timber sub-structure on piles; the dwelling geophone recorded pronounced vibration levels on the dwelling which are largely uncorrelated with the ground vibration data. The peaks in the dwelling data generally reduce during the night-time period (11.00 pm to 5.00am) i.e. when the occupants are asleep.

The mean uncontaminated dwelling PPV was 0.17 mm/s which is below the threshold of human perception of 0.3 mm/s PPV for a residential receiver (refer Section 3.3).

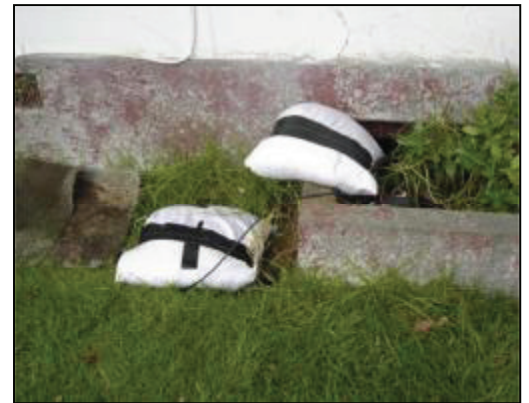
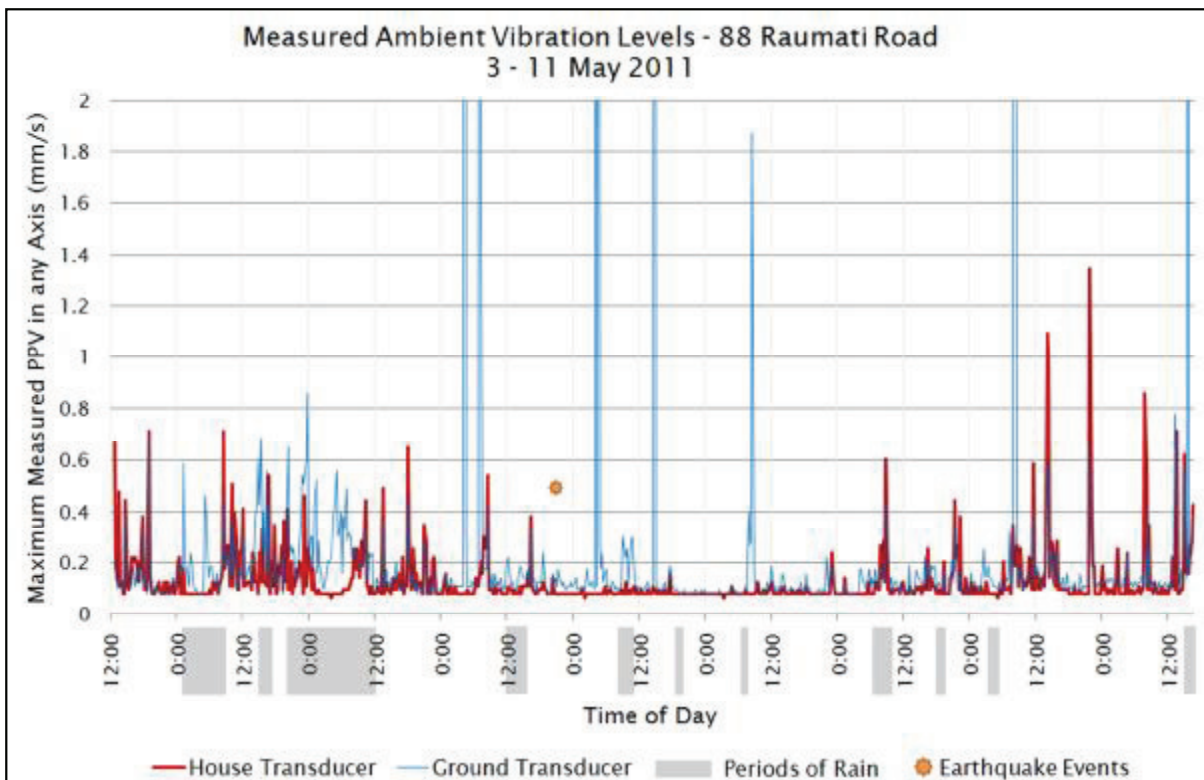
## 11.2 MACKAYS TO PEKA PEKA - Ambient Vibration Monitoring Results

Location: 88 Raumati Road  
 Project Sector: 1  
 Date: 3 – 11 May 2011  
 Distance to major road: 30 m from Raumati Road  
 Equipment: Instatel Minimate Plus

Maximum dwelling PPV: 1.35 mm/s  
 Mean uncontaminated dwelling PPV: 0.09 mm/s

Setup comment: Dwelling transducer placed on concrete parapet of sub-floor access point and sandbagged. Ground transducer placed in lawn immediately adjacent, with ground spikes, and sandbagged.

Access to an ideal dwelling transducer location was difficult at this site. The chosen location was the concrete parapet of a sub-floor access point, directly adjacent to the ground transducer. The foundation type is unknown, but presumed to be timber with plastered brick perimeter.

There were several high magnitude spikes measured by the ground transducer. These are not shown in dwelling transducer trace so, considering the close proximity of the two transducers, these were most likely due to some local disturbance of the ground transducer by a person or animal.

In general the data shows no distinct correlation either between the two transducers, or in the day-to-day levels. In the dwelling data there are consistent occupant-generated vibrations with a 2 day period mid-survey where there was little or no activity indicating the occupants were away, however during this period there are still several of the ground peaks mentioned above.

The mean uncontaminated dwelling PPV was 0.09 mm/s, which corroborates the residents' statement that they feel no traffic vibration.

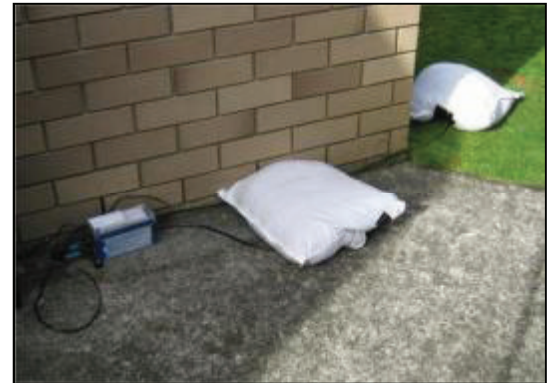
### 11.3 MACKAYS TO PEKA PEKA - Ambient Vibration Monitoring Results

Location: 55 Milne Drive  
 Project Sector: 2  
 Date: 20 - 26 May 2011  
 Distance to major road: 15 m from Milne Drive  
 Equipment: Instatel Minimate Plus

Maximum dwelling PPV: 2.06 mm/s  
 Mean uncontaminated dwelling PPV: 0.09 mm/s

Setup comment: Dwelling transducer placed on exposed aggregate patio attached to house and sandbagged.  
 Ground transducer placed in adjacent lawn with ground spikes and sandbagged.

This dwelling had a poured concrete foundation, so there is little influence from occupant activity on the dwelling transducer.

Peaks in the dwelling data generally correspond to higher peaks in the ground data, indicating the source of vibration is outside. However, these peaks are generally inconsistent and occur sporadically. This does not align with a traffic vibration profile, which would typically be smoother, so is more likely due to local disturbance of both geophones by a person or animal, and the peak is higher in the ground data because of the soft ground.

There were several periods of rain and 3 earthquake events, which have been removed from the mean uncontaminated dwelling PPV, which was 0.09 mm/s

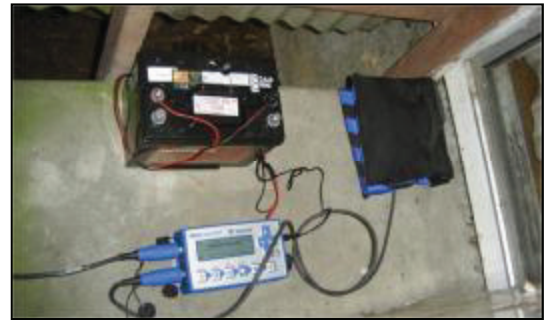
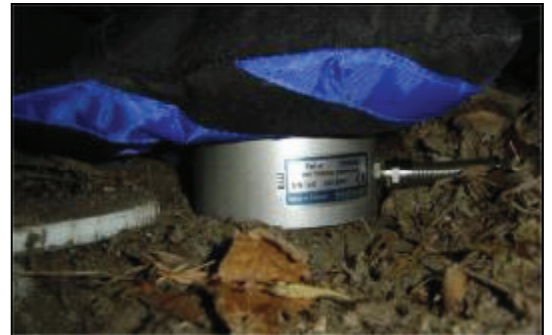
## 11.4 MACKAYS TO PEKA PEKA - Ambient Vibration Monitoring Results

Location: 1/100 Kāpiti Road  
 Project Sector: 2  
 Date: 12 – 19 April 2011  
 Distance to major road: 60 m from Kāpiti Road  
 Equipment: InstanTel Minimate Pro6

Maximum dwelling PPV: 1.25 mm/s  
 Mean uncontaminated dwelling PPV: 0.20 mm/s

Setup comment: Presumed pile foundations, but no access to the under-floor area. Dwelling transducer placed on concrete patio (attached to house) and sandbagged. Ground transducer placed in adjacent garden with ground spikes and sandbagged.

There was a very close correlation between the dwelling and ground results at this location, with practically every peak showing in both traces at similar magnitudes.

There is an apparent rise in measured levels during the daytime. This may be due to heavy traffic on Kāpiti Road, which is one of the busiest roads in the area, but the activity generally continues through the night, which is not typical for heavy traffic.

Notwithstanding this, the levels are generally below the threshold of perception with the odd period of sustained higher levels such as daytime on 18th May.

The mean uncontaminated dwelling PPV was 0.2 mm/s and the residents stated that they feel no vibration. The foundation type is unknown, but presumed to be timber with plastered block or brick perimeter.

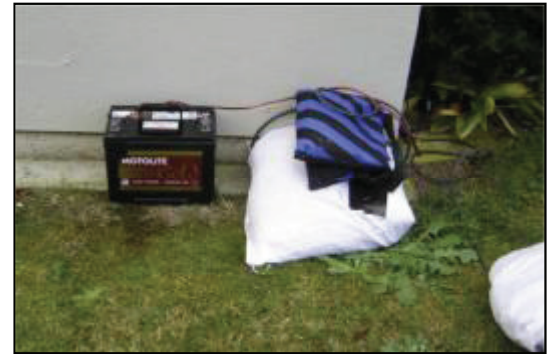
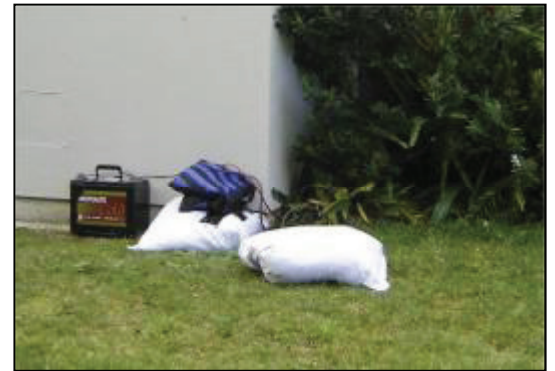
## 11.6 MACKAYS TO PEKA PEKA - Ambient Vibration Monitoring Results

Location: 155 Otaihanga Road  
Project Sector: 3  
Date: 3 -11 May 2011  
Distance to major road: 85 m from Otaihanga Rd  
Equipment: Instanetel Minimate Pro6

Maximum dwelling PPV: 0.69 mm/s

Mean uncontaminated dwelling PPV: 0.13 mm/s

Setup comment: Dwelling transducer placed on edge of poured concrete foundation and sandbagged. Ground transducer placed in adjacent lawn with ground spikes and sandbagged.

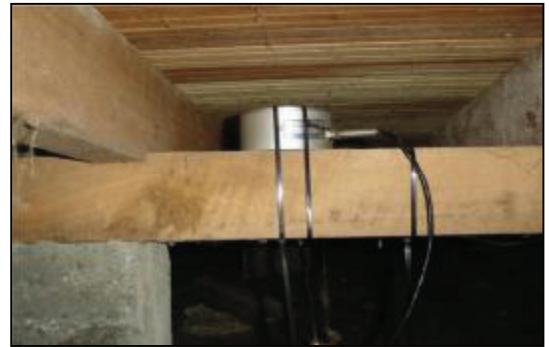
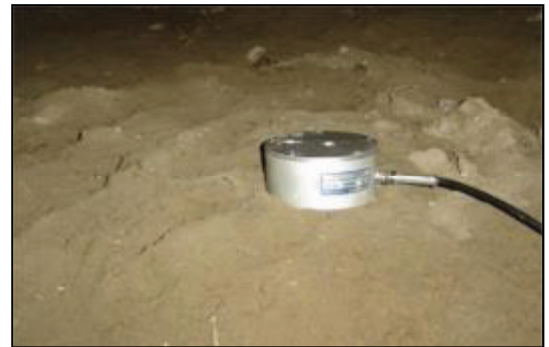
## 11.7 MACKAYS TO PEKA PEKA - Ambient Vibration Monitoring Results

Location: 28 Puriri Road  
 Project Sector: 3  
 Date: 12 - 19 May 2011  
 Distance to major road: 420 m from Te Moana Rd  
 Equipment: Instatel Minimate Plus

Maximum dwelling PPV: 3.79 mm/s  
 Mean uncontaminated dwelling PPV: 0.09 mm/s

Setup comment: Dwelling transducer fixed to floor joist with cable ties. Ground transducer placed in ground under dwelling with ground spikes and sandbagged.

It is noted that the peaks seen in the ground data are likely to be from the same source, transferred into the ground through the piles.

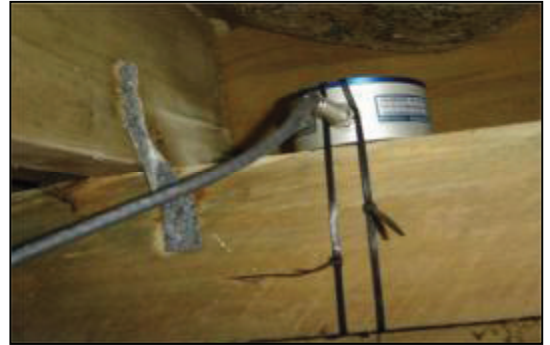
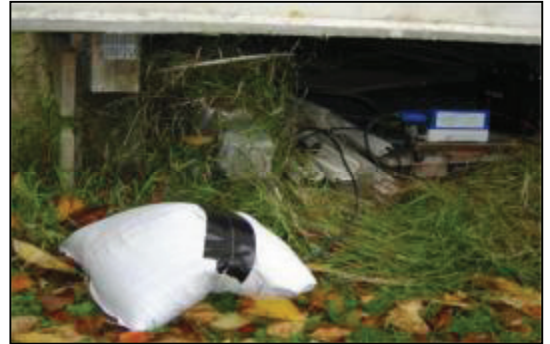
## 11.8 MACKAYS TO PEKA PEKA - Ambient Vibration Monitoring Results

Location: 164 Te Moana Road  
Project Sector: 3  
Date: 12 - 19 May 2011  
Distance to major road: 20 m from Te Moana Road  
Equipment: InstanTel Minimate Pro6

Maximum dwelling PPV: 2.05 mm/s  
Mean uncontaminated dwelling PPV: 0.19 mm/s

Setup comment: Dwelling transducer fixed to floor joist with cable ties. Ground transducer placed in ground outside with ground spikes and sandbagged.

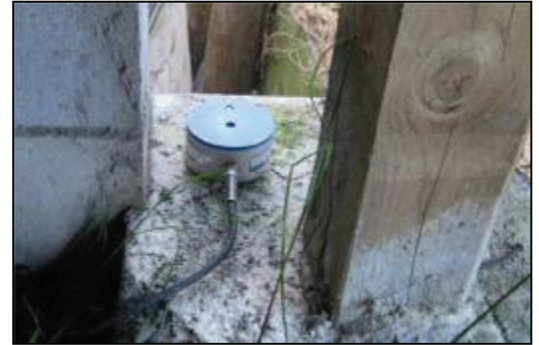
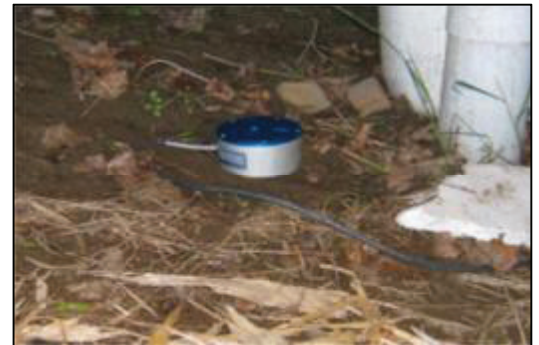
## 11.9 MACKAYS TO PEKA PEKA - Ambient Vibration Monitoring Results

Location: 20 Peka Peka Road  
 Project Sector: 4  
 Date: 20 – 26 May 2011  
 Distance to major road: 150 m from existing SH1  
 Equipment: InstanTel Minimate Pro6

Maximum dwelling PPV: 0.9 mm/s  
 Mean uncontaminated dwelling PPV: 0.16 mm/s

Setup comment: Dwelling transducer placed on concrete footing and sandbagged. Ground transducer placed in ground under dwelling with ground spikes and sandbagged. Note waste pipes close to ground transducer.

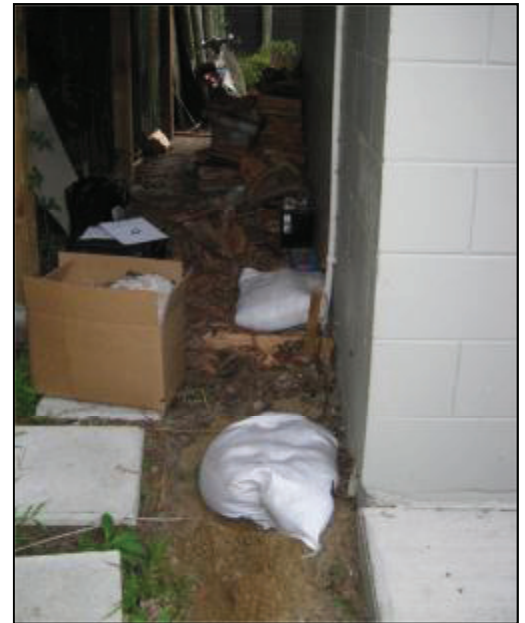
## MACKAYS TO PEKA PEKA - Ambient Vibration Monitoring Results

Location: 158A Main Road (SH1)  
Project Sector: N/A  
Date: 4 – 8 July 2011  
Distance to major road: 15 m from existing SH1  
Equipment: InstanTel Minimate Pro6

Maximum dwelling PPV: 3.38 mm/s  
Mean uncontaminated dwelling PPV: 0.35 mm/s

Setup comment: Building is used as an office. 'Dwelling' transducer placed on poured concrete patio at side of building and sandbagged. Ground transducer placed in adjacent ground with ground spikes and sandbagged. Note ground transducer closer to road.

The results at 158A Main Road show a strong correlation between the two traces, which is expected with poured concrete foundations. This site is used as an office and the occupant says the vibrations from trains and trucks are noticeable, and are such that she would not choose to live there.

This response corroborates the dwelling data which shows frequent peaks above the residential perception threshold and a mean uncontaminated dwelling PPV of 0.35 mm/s. This value is lower than the ground data mean PPV (with the contaminated data also removed for consistency) of 0.4 mm/s, indicating traffic and/or trains are the major vibration source(s).

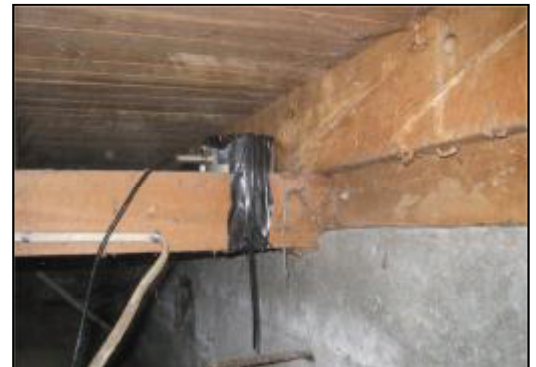
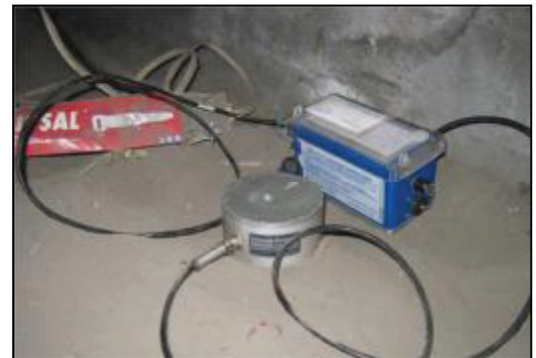
## MACKAYS TO PEKA PEKA - Ambient Vibration Monitoring Results

Location: 170 Main Road (SH1)  
 Project Sector: N/A  
 Date: 4 – 8 July 2011  
 Distance to major road: 24 m from existing SH1  
 Equipment: Instatel Minimate Plus

Maximum dwelling PPV: 3.76 mm/s  
 Mean uncontaminated dwelling PPV: 0.28 mm/s

Setup comment: Timber subframe and block perimeter.  
 Dwelling transducer fixed with cable ties and duct tape to floor joist, by intersection with perimeter plate. Ground transducer placed in ground under dwelling with ground spikes and sandbagged.

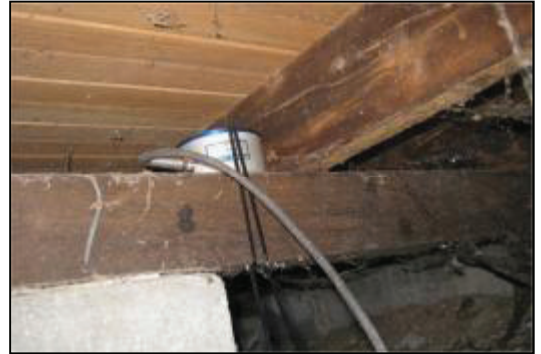
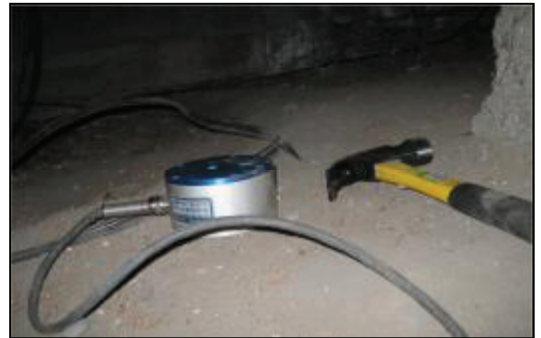
## MACKAYS TO PEKA PEKA - Ambient Vibration Monitoring Results

Location: 174 Main Road (SH1)  
Project Sector: N/A  
Date: 11 – 18 July 2011  
Distance to major road: 36 m from existing SH1  
Equipment: InstanTel Minimate Pro6

Maximum dwelling PPV: 8.76 mm/s  
Mean uncontaminated dwelling PPV: 0.33 mm/s

Setup comment: Timber subframe. Dwelling transducer fixed with cable ties to floor joist, adjacent to pile.  
Ground transducer placed in ground under dwelling with ground spikes and sandbagged.

These occupant-generated peaks dominate the trace, and have been removed from the dataset resulting in a mean uncontaminated dwelling PPV of 0.33 mm/s. This is a higher value than at 170 Main Road, despite being 12 metres further from the road, which could be symptomatic of the dwelling transducer position, or different ground conditions.

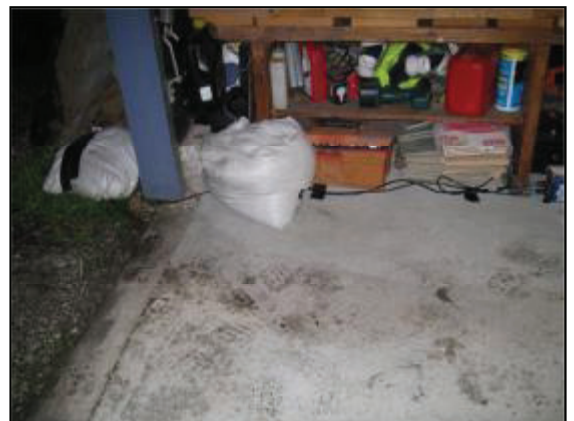
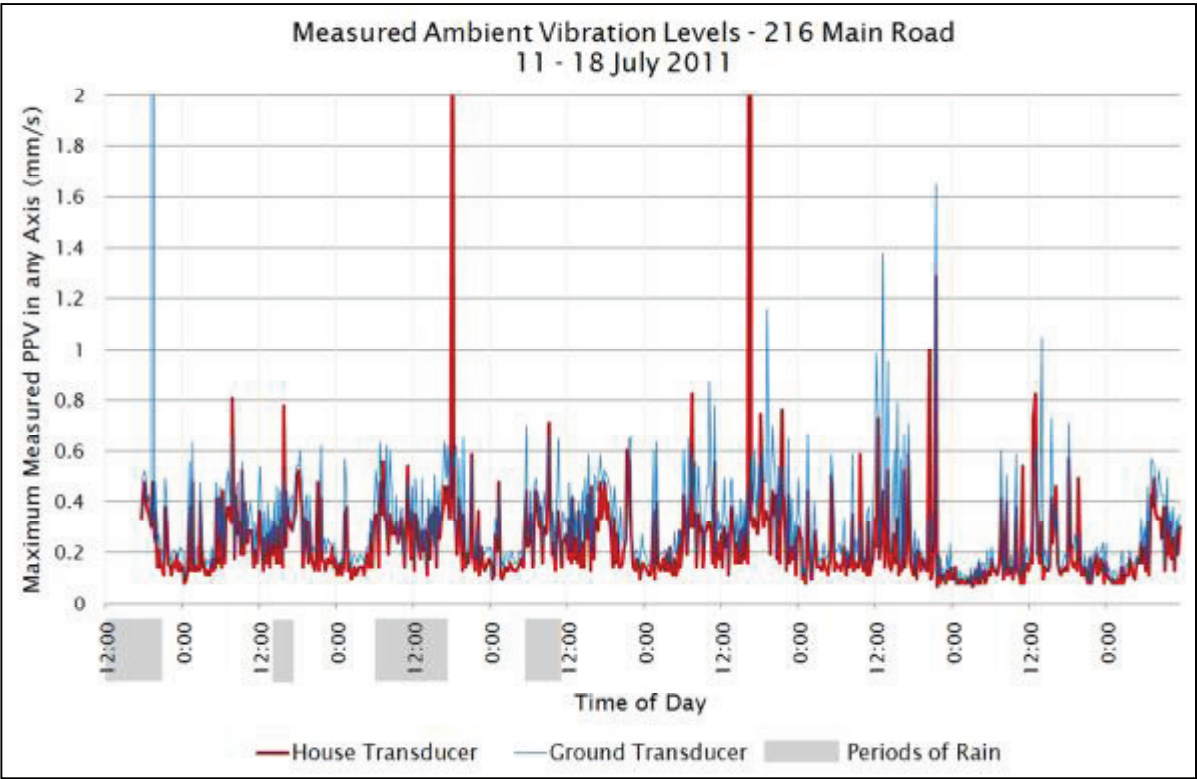
## 11.13 MACKAYS TO PEKA PEKA - Ambient Vibration Monitoring Results

Location: 216 Main Road (SH1)  
Project Sector: N/A  
Date: 11 – 18 July 2011  
Distance to major road: 30 m from existing SH1  
Equipment: InstanTel Minimate Plus

Maximum dwelling PPV: 4.60 mm/s  
Mean uncontaminated dwelling PPV: 0.20 mm/s

Setup comment: Transducers positioned at entrance to garage. Dwelling transducer placed on concrete floor

and sandbagged. Ground transducer placed on ground outside and sandbagged.
