The North Island Weather Events (NIWE) that struck the top half of New Zealand had a significant impact on the transport system, across state highways, local roads and rail. Along with the slips, damaged bridges and culverts, there was significant damage to road surfaces and pavements, particularly in the Tairāwhiti region.

The solution: Foam Bitumen Stabilisation (FBS) rehabilitation treatments. Quick to build compared to standard pavements, and with less sensitivity to moisture under ideal conditions, this treatment provided the solution required while not having the disbenefits of other options. However, special considerations were still needed to provide the best possible outcome.

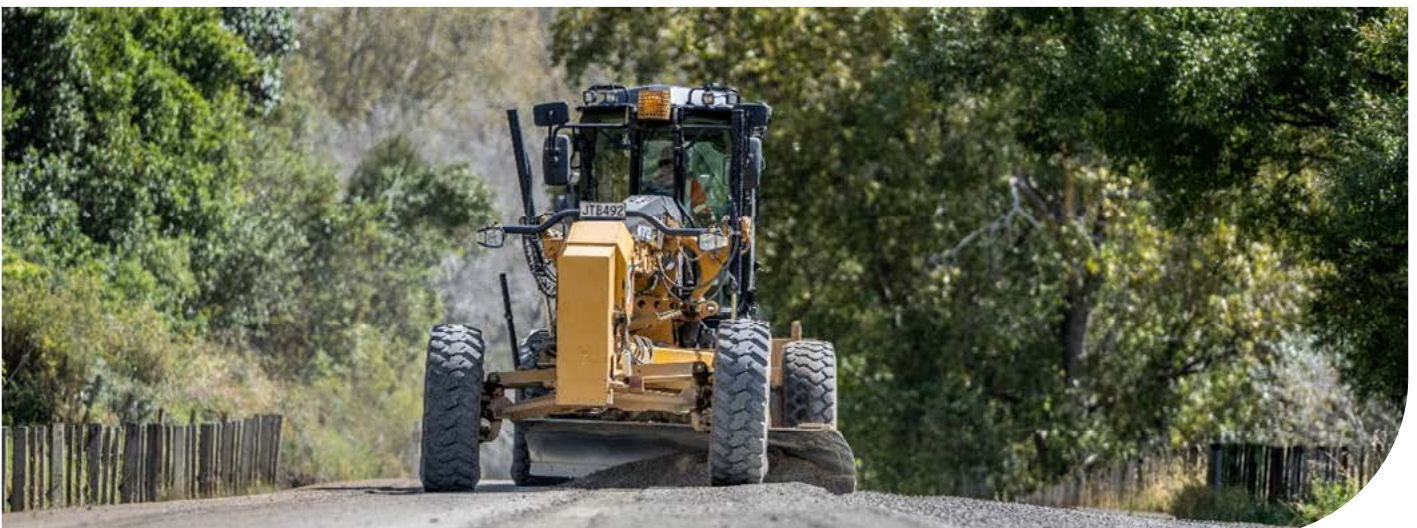
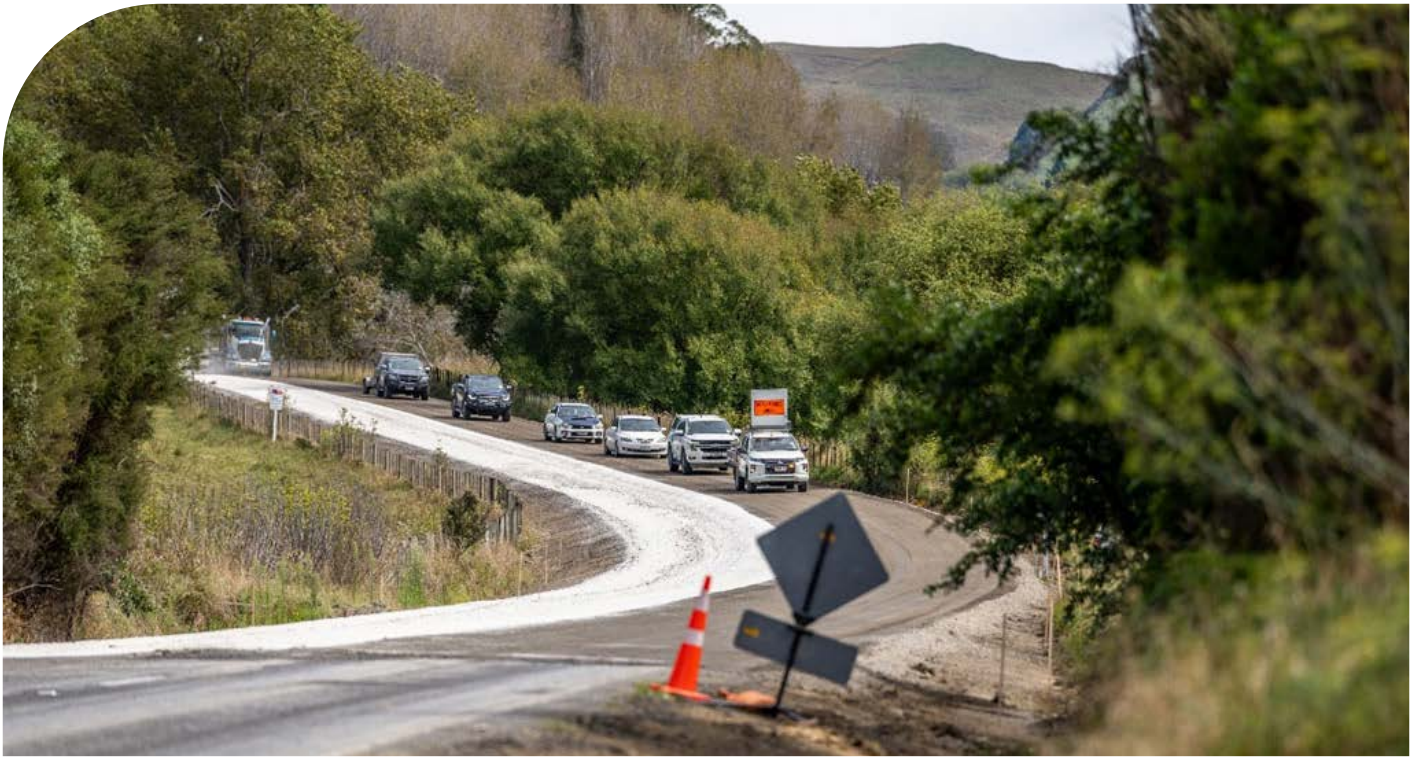
Hiway Group then arrived onto site, conducting pretreatment of the existing pavement, introducing new material if required and applying lime to control moisture levels. Following this foamed bitumen is injected into the pavement. Moisture level is important when this step takes place, and thus timing and sequencing was critical.

Finally, the pavement was prepared for surfacing, followed by line marking. Following any enabling works a typical site took 8 days to construct
