APPENDIX F

Waitarere Beach Road Curves Project Preliminary Geotechnical Assessment of Effects

Prepared for The New Zealand Transport Agency

November 2015

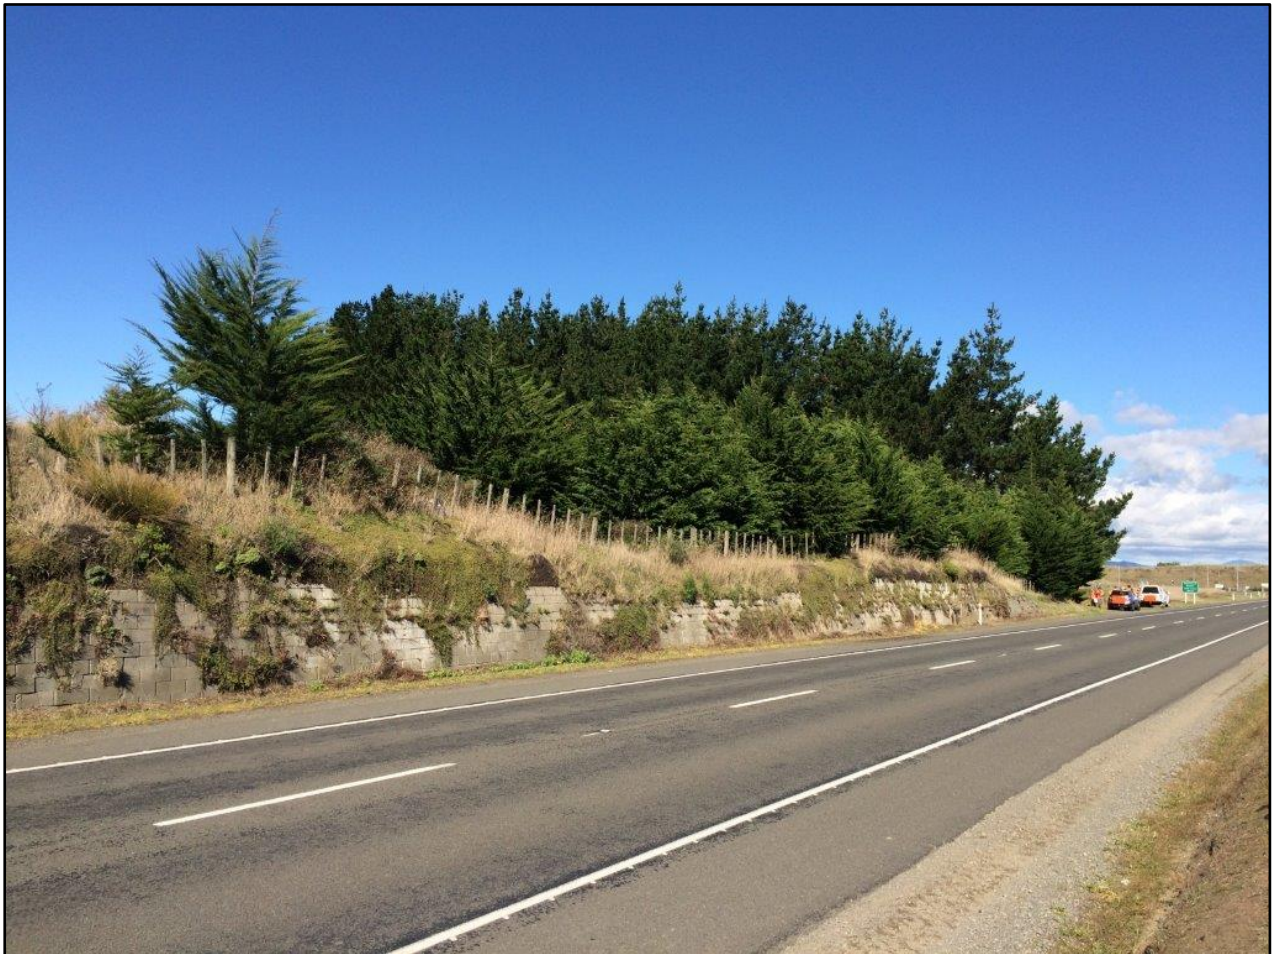
Two existing road cuttings comprised of unreinforced concrete block walls have been constructed to retain the silty dune sands and maintain the property above the highway within the Project Area (refer to Figure 3-1). These walls are up to 3m high and are approximately 50m long. They appear unreinforced and show signs of settlement, deflection and degradation. If these walls are required to maintain these boundaries, they are likely to require replacement to the level suitable for the state highway environment as outlined in version 3 NZTA Bridge Manual.

Figure 3-1: Pre-existing large concrete block retaining wall placed to stabilise sand dune slope cut adjacent to SH1.

1. Old retaining walls within the Project area found on the existing road are unlikely to meet current design performance requirements and will require replacement. Replacement retaining walls and newly identified retaining walls will require thorough investigation and design to standards described within the 3rd edition Bridge Manual (SP/M/022).

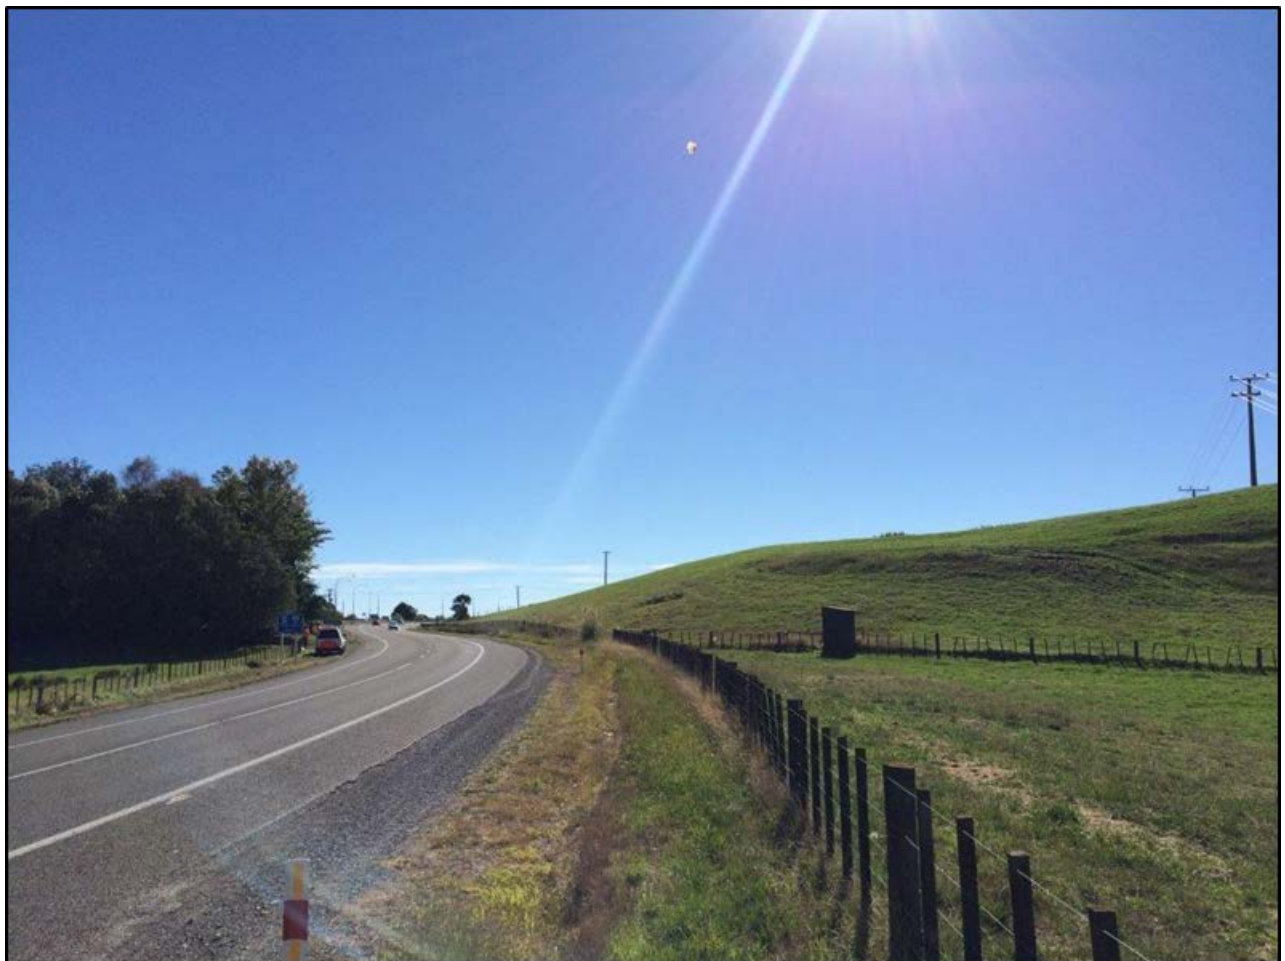
The majority of the slopes observed on site are sand dunes (**Q1ds**). These dunes are considered completely cohesion-less other than that developed as part of soil aging process. They are very loose to loose, fine and uniformly graded, providing low friction angles only. Table 1 below is a summary of the slope stability observed from the site walkover for the existing sand dunes in the Project area.

Slope angles	Stability summary
10 - 15°	Generally stable with only surficial stability issues
17 - 18°	Unstable and show signs of sliding, slope creep, soil creep, erosion and rilling
20° +	Unstable, ground deformation prevalent, erosion, sliding, rotation and slope creep

Figure 4-1: Large sand dune generally stable at approximately ~10° - 15°.

Preliminary field slope stability observations of existing cut slopes in similar sandy materials indicate that the slopes become unstable if cut too steeply; therefore, it is recommended that 10° be adopted as a maximum cut slope angle at this preliminary stage of the project. Should this cut angle not be possible, options such as retaining structures should be considered.

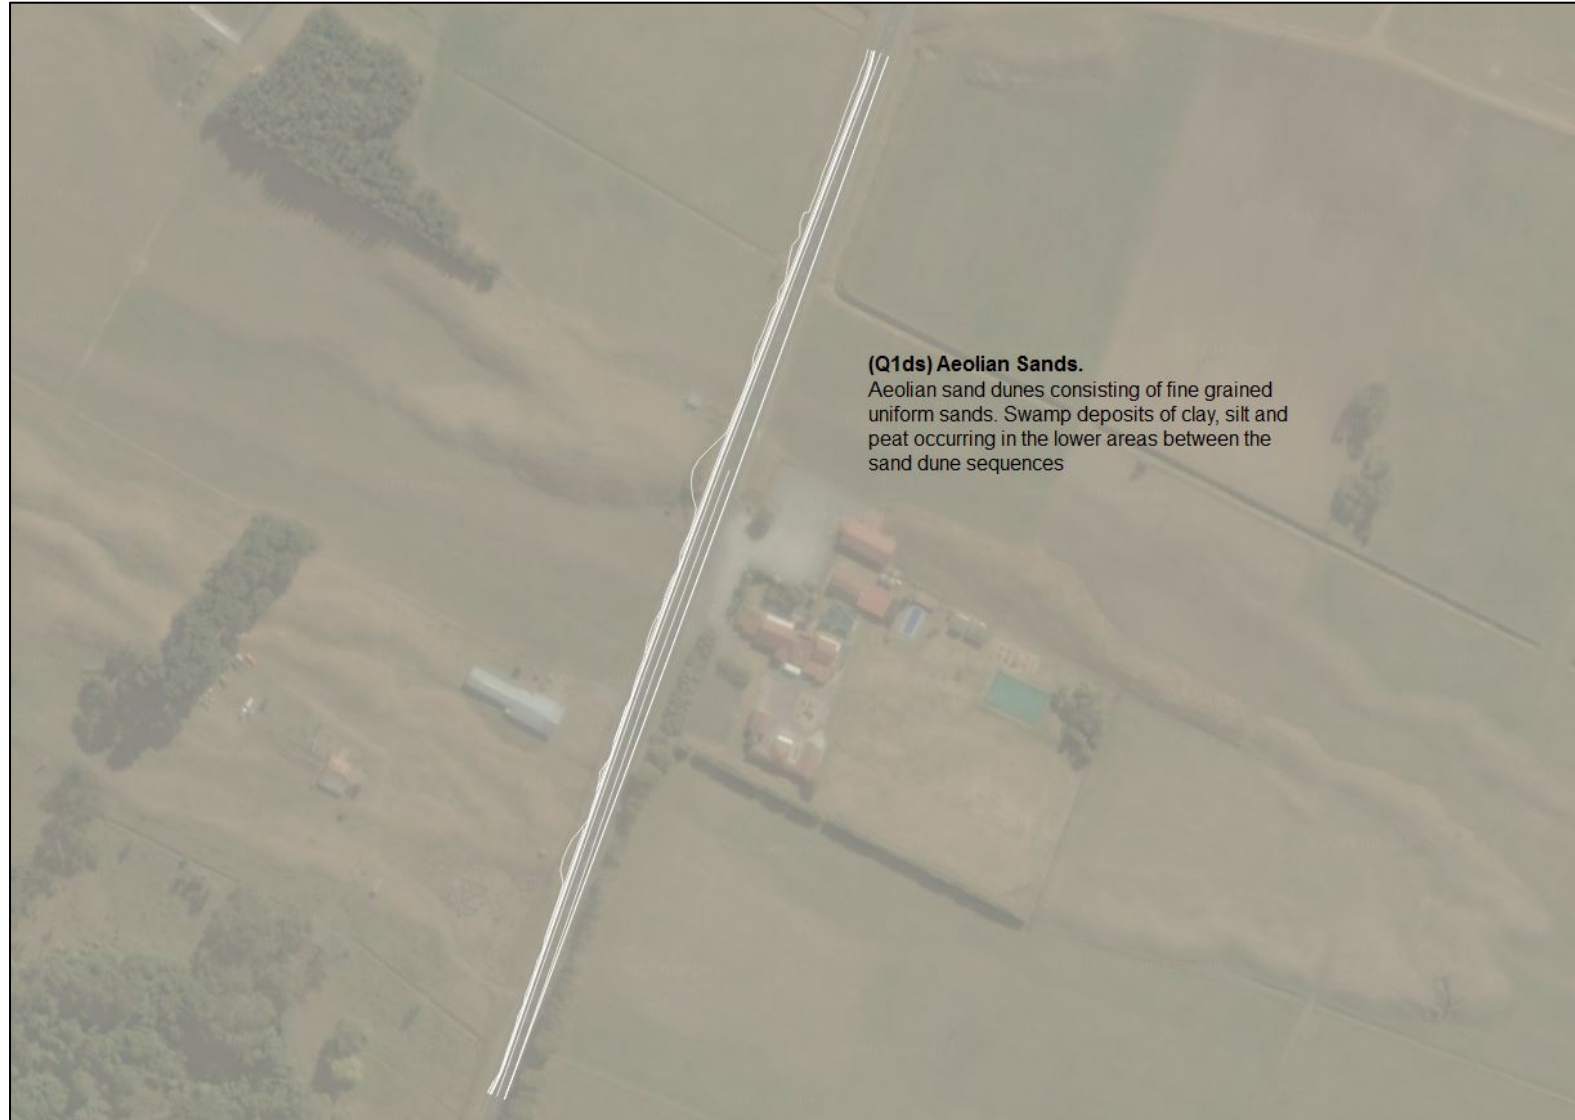
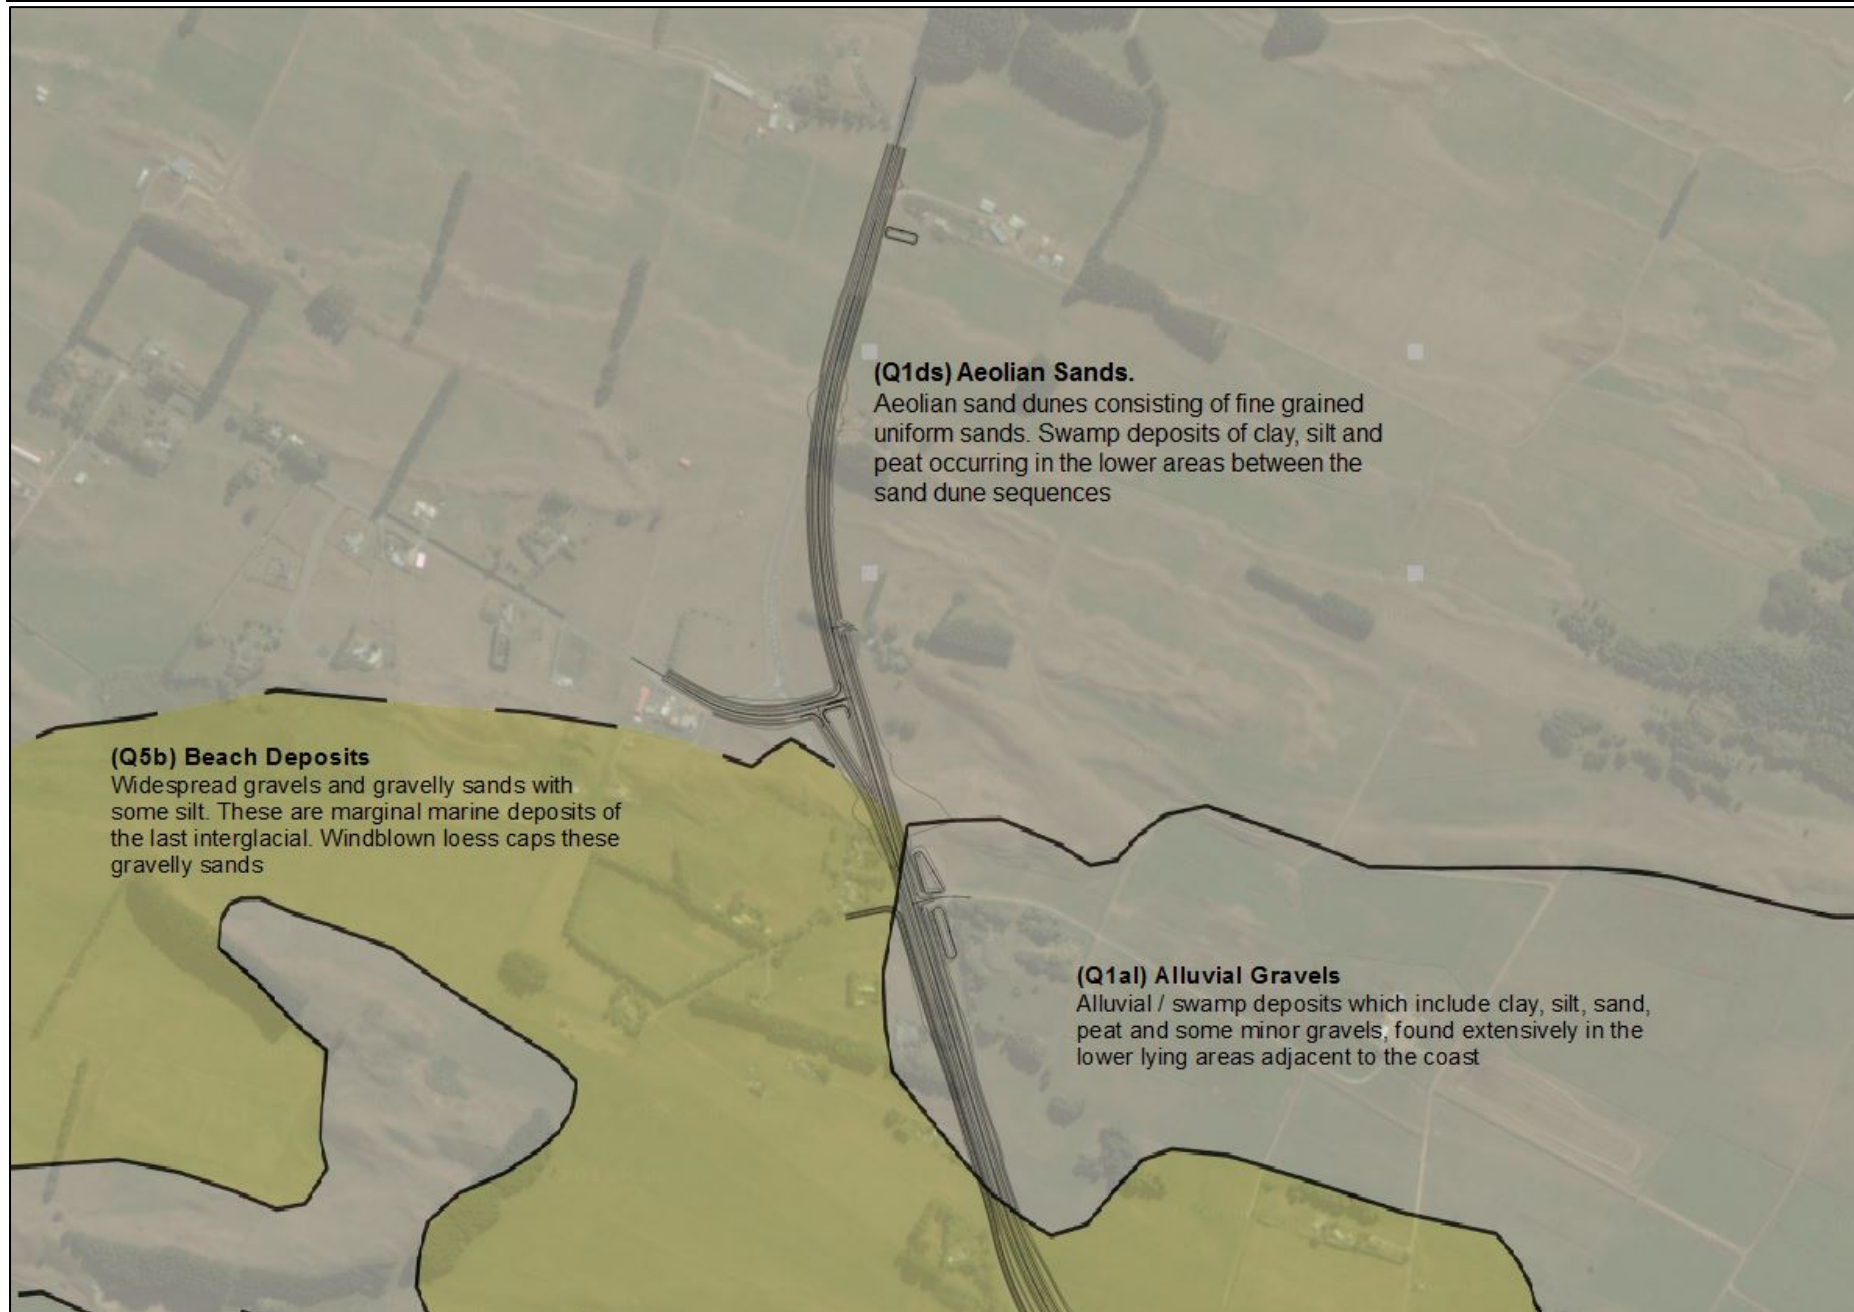
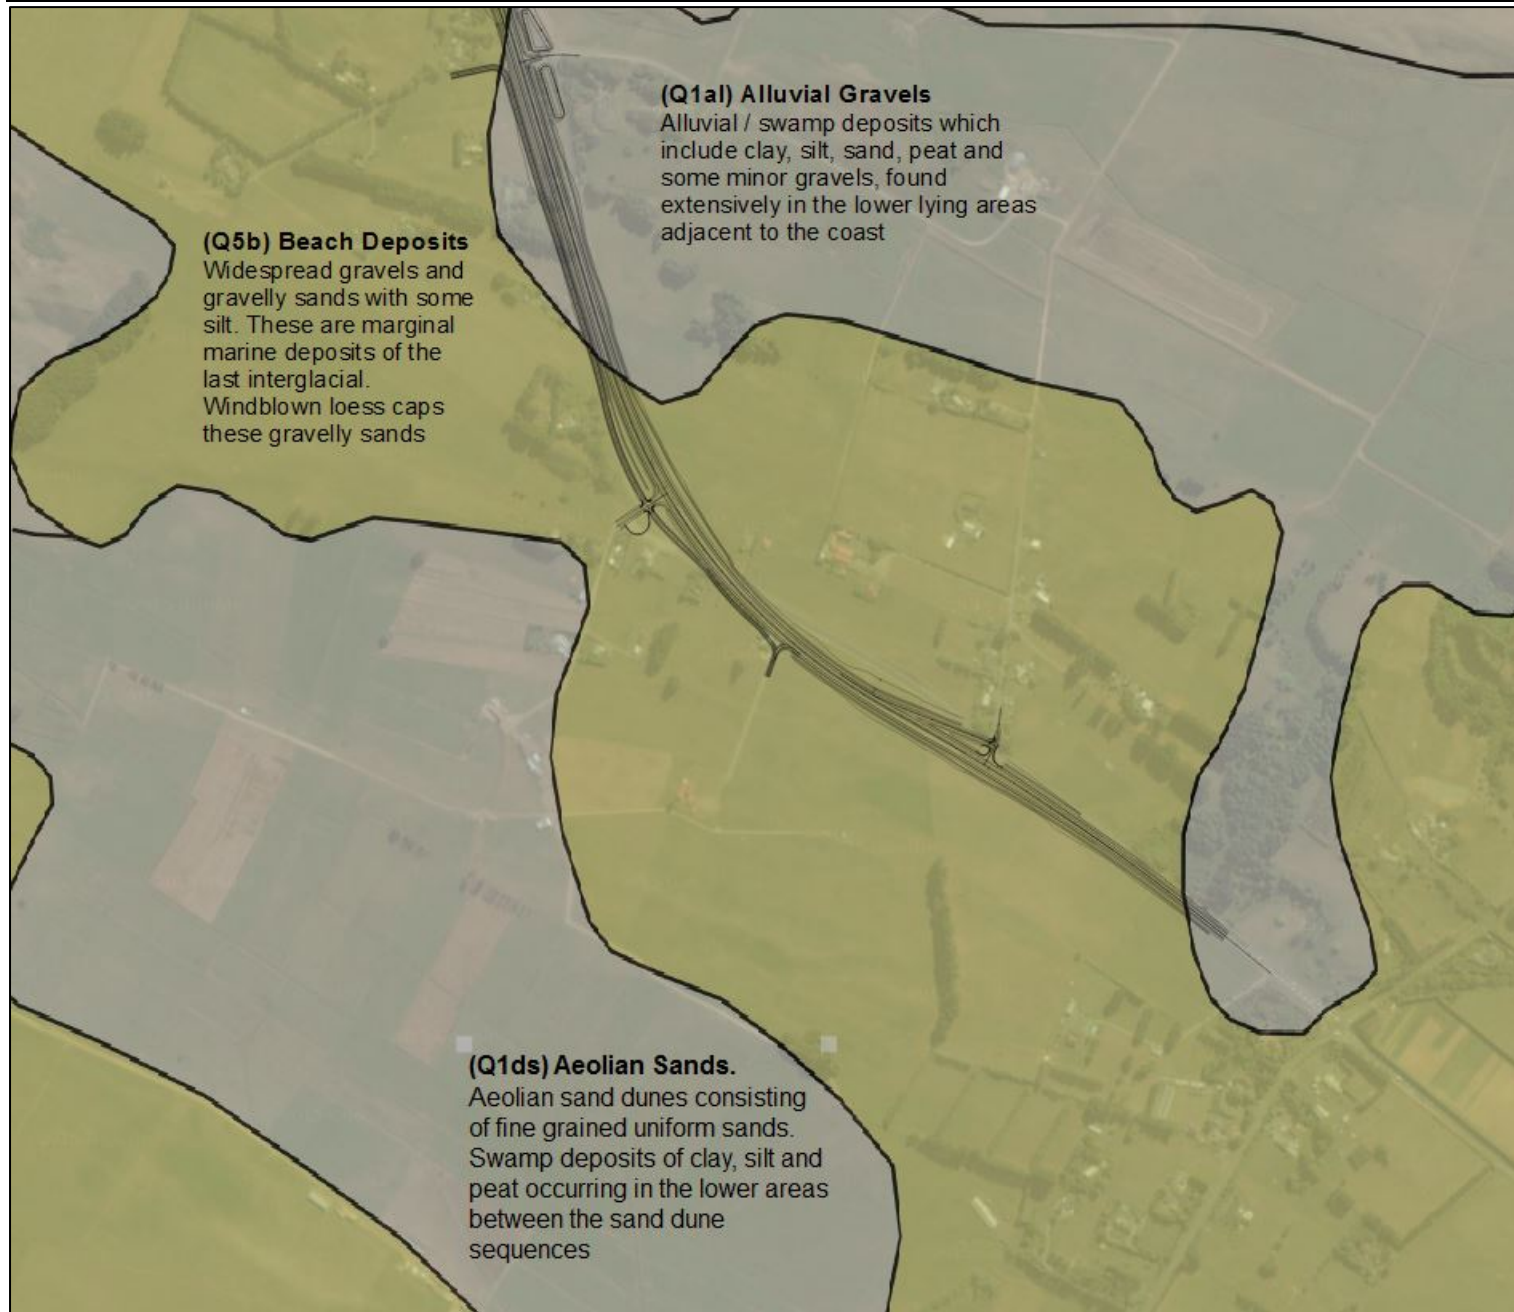
Appendix A Preliminary Geological Map (3 sheets)

Polygon shapes for the known mapped regional geological materials have been sourced from the GNS QMAP Map 10 dataset and imported as a GIS layer into Google Earth Pro as a base layer. Additional information such as the project route alignment and topographic contours have also been added to provide project context of the areas affected by these materials. Please refer to Appendix A for preliminary geological maps of the project area.

(shows surficial and covering geological sequence only as referenced from GNS QMAP 10 Wellington)
