1 Mangamuka Gorge slip repairs

Progress update May 2024

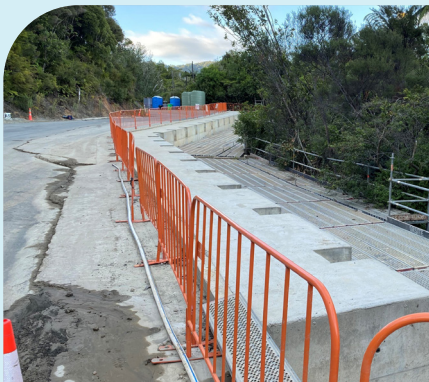
Slip A5 - Complete!

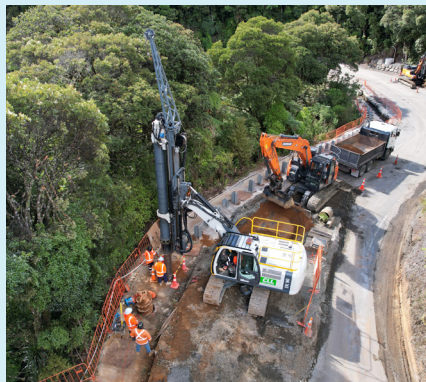
Slip A26 - UC Piling rig in action.

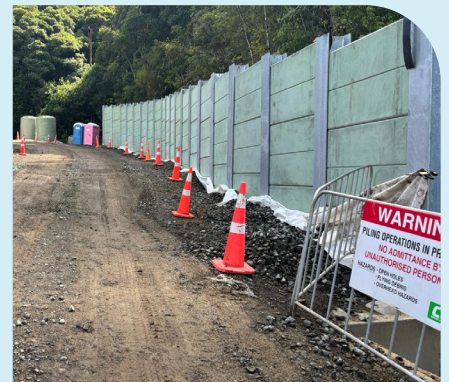
Slip A27 - Complete!

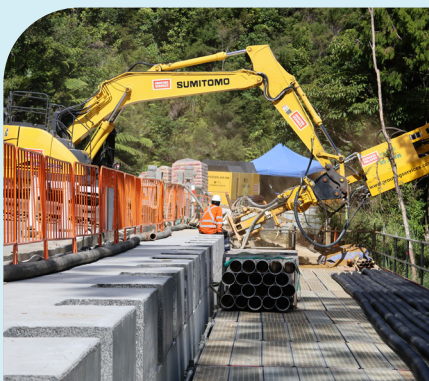
Slip A3 - Anchors being installed.

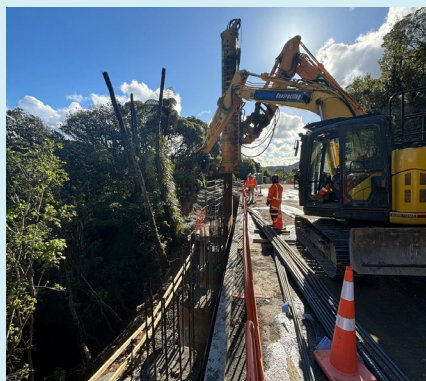
Slip A6 - Driving the lagging plates behind the permanent piles.

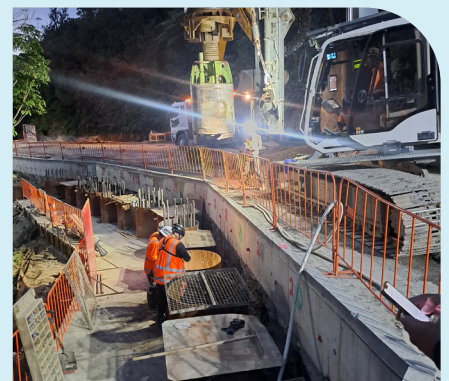
Slip A6 - Piling during night works.

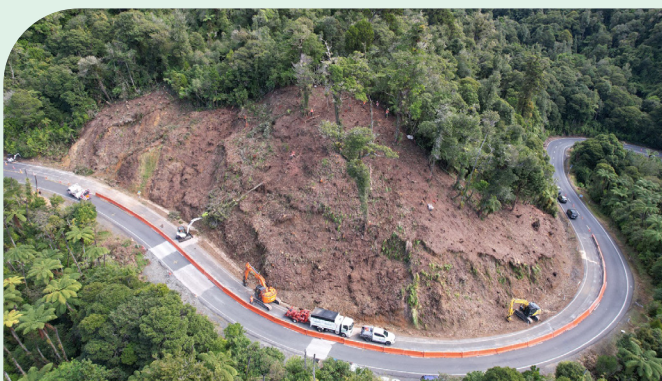
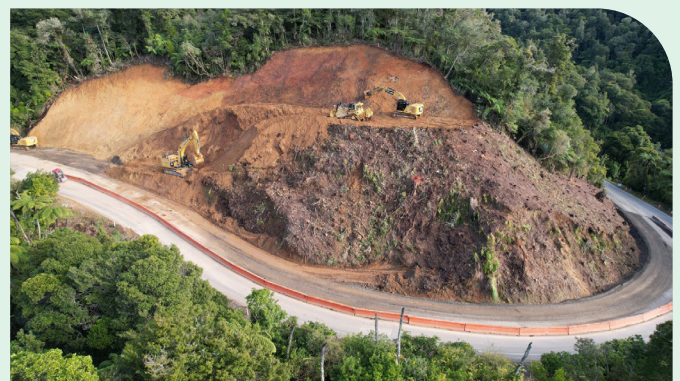
Progress with the clearing of vegetation and beginning of earthworks on A11 (left photo taken 30 April 2024, right photo taken 14 May 2024). All land and vegetation is carefully checked and wildlife relocated prior to anything being removed.

Work on one of most complex slips (A11) has commenced. This slip is estimated to be approximately 20m deep with the top of the slip being 200m up the hill. Approximately 30,000m³ of material needs to be removed, and the existing road needs to be realigned away from this slip-prone site.

The repairs to Slip A11 require excavations into the Maungataniwha Range. Approximately 30,000m³ of material will need to be removed. This is a significant amount of work, particularly given the logistical challenges of operating in a constrained environment surrounded by multiple other operational sites. Before any machinery was brought onto the site, our specialist team of ecologists, kaitiaki, kiwi dogs and handlers, and arborists carefully cleared the site of vegetation and relocated any wildlife they encountered, ensuring the site was ready for the next phase of work.
