Hollyford Road rebuild complete

After a lot of hard work by repair crews, the Hollyford Road has been fully restored following a destructive flood in February 2020.

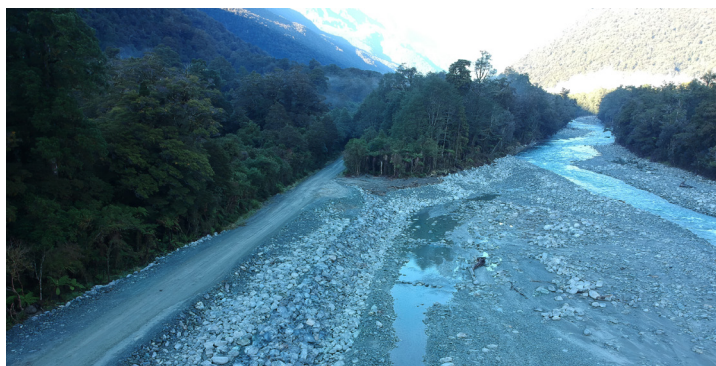
A repaired section of the Hollyford Road

Following the February 2020 flood, Waka Kotahi confirmed \$1.8m in funding to repair the road. This work was carried out by the Milford Road Alliance team and their sub-contractors. It involved fixing bridges, culverts and significant washouts. People can now drive to Humboldt Creek and the start of the Hollyford track, as they could before the flood. However, the severity of the storm changed the course of the river meaning the newly repaired road doesn't finish exactly on the river where it had previously. People should consider this if they are planning a trip down the river. It will take some years for flood damaged areas adjacent to the road to fully recover. Further maintenance is planned to keep the road open as much as possible. We appreciate the patience of those who used the road while this job was being carried out.

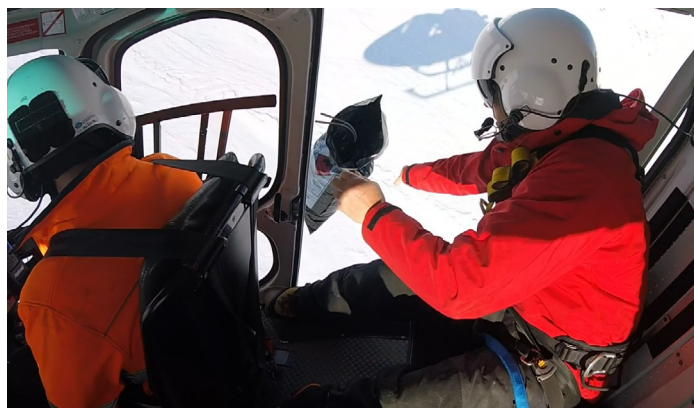
Explosives going out the door to shift an unstable area of snow above SH94

Conditions in alpine areas are constantly monitored with passive (no stopping zones along the road) or active measures (reducing snow volume with explosives) to make the road as safe as possible.

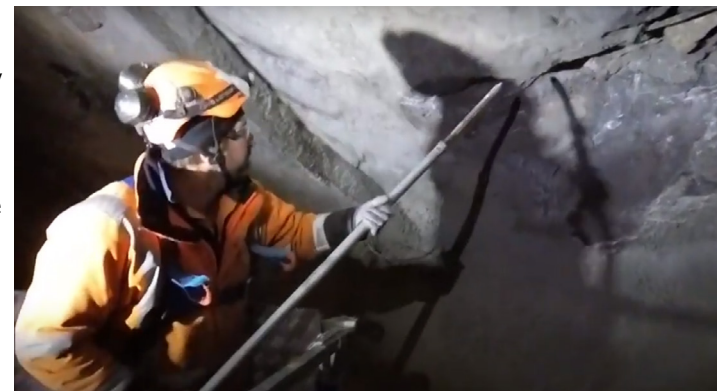
Removing loose rock from a section of wall inside the Homer Tunnel

In recent weeks, loose rock has been removed from the tunnel roof and walls. Rock must regularly be manually prised off to reduce the potential of rockfall that exists due to the natural rock the tunnel is mostly lined with. Investigations into several larger and more complex safety upgrades for the Homer Tunnel will continue through winter.

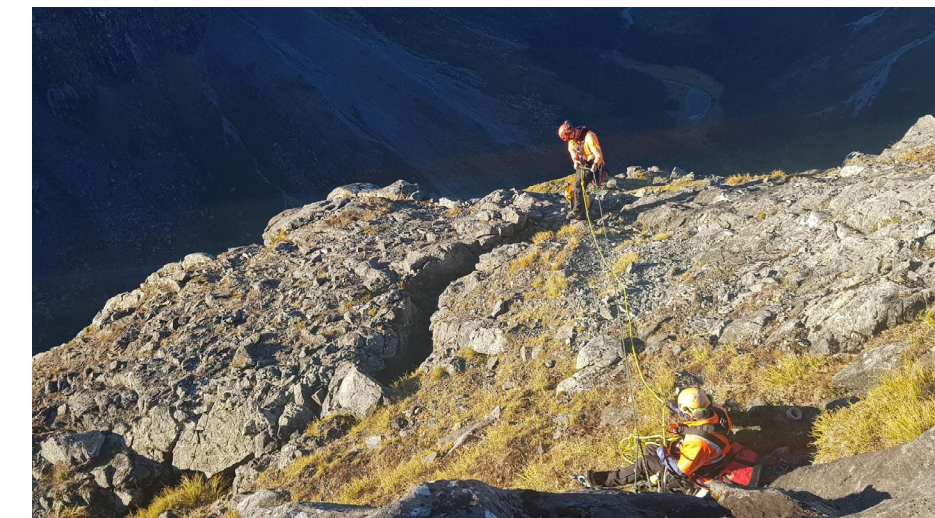
Several telemetry monitoring points are located on rock features above the tunnel entrances. The photo above shows one of our team checking one of these for rock movement at a site 800m directly above the eastern side of the tunnel. Any rock movement detected by this equipment is relayed straight to Homer Tunnel operations centre staff to analyse.

Regular rock removal was carried out over summer in mountainous areas above the Homer Tunnel entrance. We removed loose material and rocks that could hit the road hundreds of metres below and identified areas where this work may need to be carried out in future. We do our best accommodate people wanting to be in this alpine area of the Homer Saddle during February/March when we do this work - but ask that they check with us first before going into the area.
