# TREC Pānui

East Coast recovery mahi | Issue 7 - 30 September 2024

Transport  
Rebuild  
East Coast

TREC Pānui is a monthly newsletter from the Transport Rebuild East Coast (TREC) Alliance updating communities across Te Tairāwhiti (Gisborne) and Te Matau a Māui (Hawke's Bay) about the recovery work on state highways and rail networks impacted by Cyclone Gabrielle.

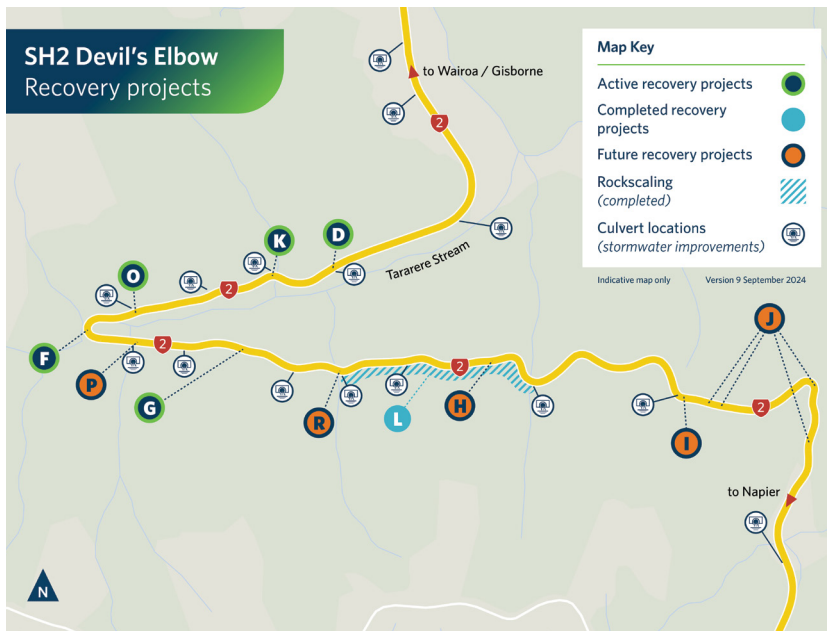
Devil's Elbow is an extremely hilly and winding section of SH2 in Hawke's Bay that was massively damaged during Cyclone Gabrielle. Blocked and damaged stormwater culverts and drains, overslips and underslips make it a complex site consisting of more than 11 recovery projects (see map below).

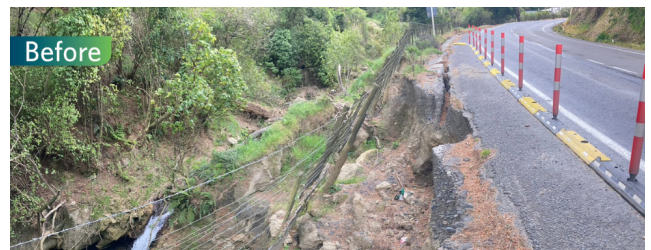
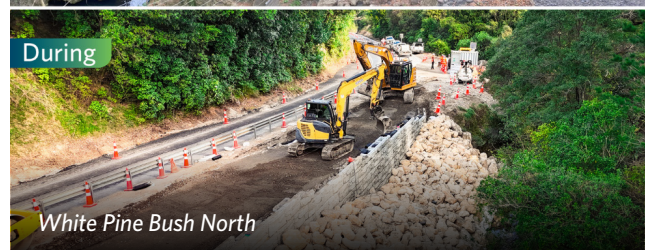
Most of the work has been happening out of sight from the road. Our team has been installing anchors to stabilise the ground beneath it. This is followed by work to rebuild the shoulder, repave the road, and install the guardrail.

Recently, we started work on White Pine Bush North, another recovery site just up the road from the underslip repair. This involves building a retaining wall to repair a dropout.

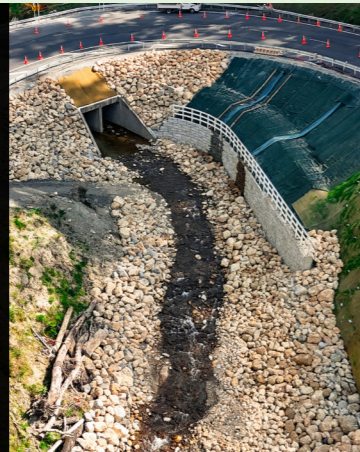
This photo shows a twin box culvert at Devil's Elbow after Cyclone Gabrielle. The intensity of the water and debris being carried by the water flow wore down (scoured) the earth and embankments surrounding the culvert at both ends. You can see the earth under the road carved away by the water and debris flows. The road was severely weakened and at risk of falling away further without repairs. The culvert itself was still functional and did not need replacing.

At the inlet of Devil's Elbow a retaining wall and rip rap (large rocks) have been put in place to protect the road and the embankments surrounding the inlet. At the outlet we have strengthened the embankments with a combination of concrete block retaining walls and reinforced aggregate covered with scour proof geo-fabrics, and rock lining. This will improve the resilience of the road across the stream.

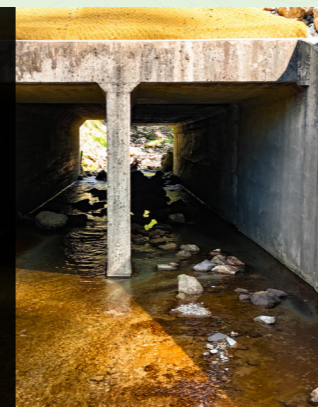
Rocks have been placed inside the culvert to allow fish to move through it creating ebbs and flows as well as resting places.

For repaired culverts, we aim to maintain or improve fish passage at the inlet and outlet of the culvert using rock rip rap and by fixing perched (overhanging) culverts, for example we were able to fix the overhanging culvert apron at Devil's Elbow culvert which was a barrier to fish.
