**SEISMIC TESTING &
BEHAVIOUR OF A
1936-DESIGNED
REINFORCED-CONCRETE
BRIDGE**

Transfund New Zealand Research Report No. 78

J. MAFFEI
Department of Civil Engineering,
University of Canterbury,
Christchurch, New Zealand

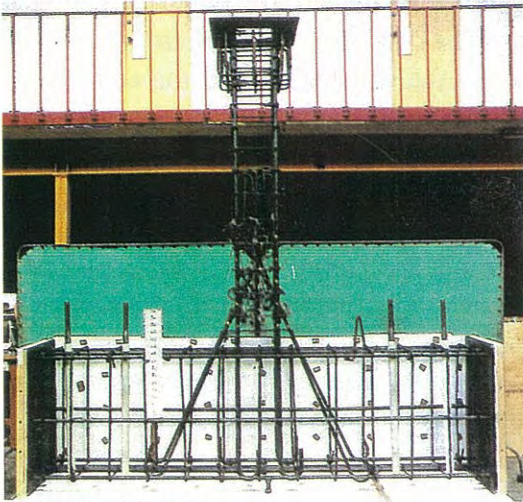
Figure 3.2 Test of the column to foundation-beam specimen:

(a) Reinforcing steel cage

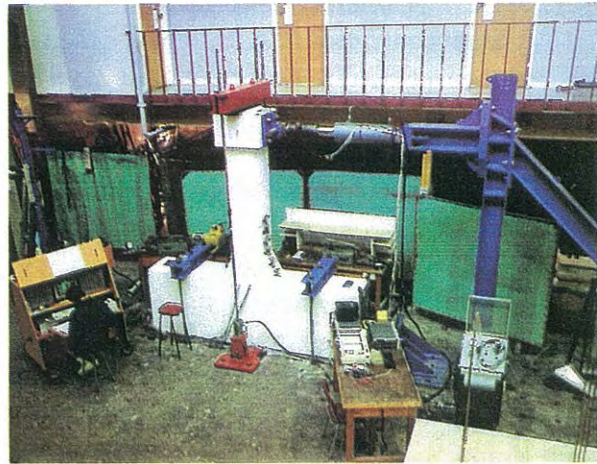
(b) Test set-up

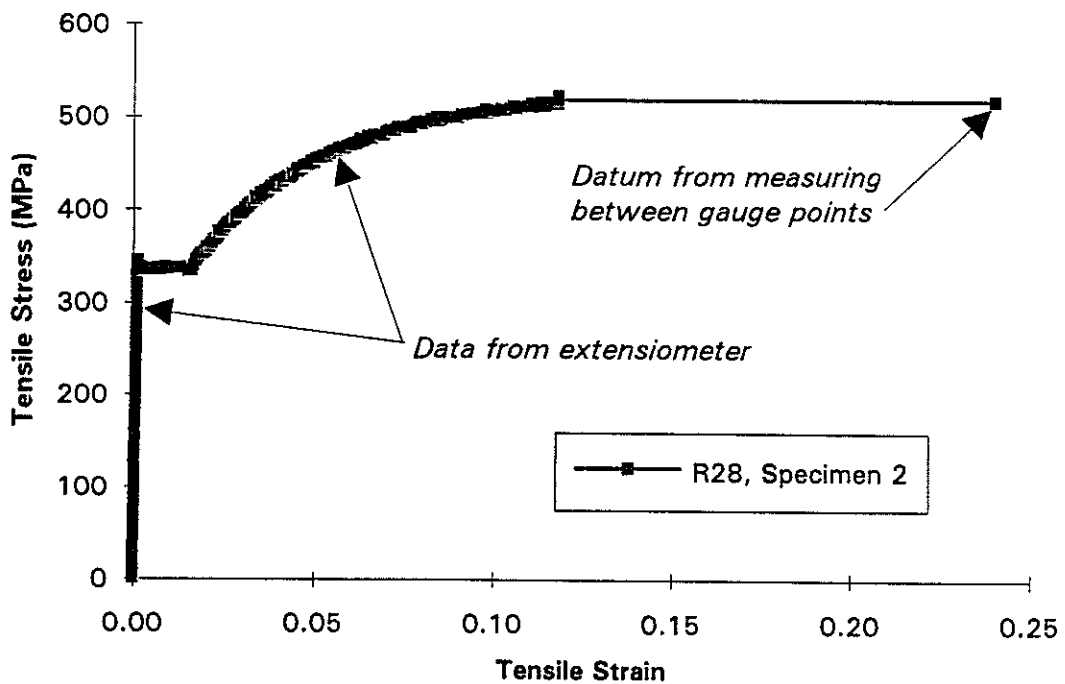
Figure 3.3 Typical stress versus strain behaviour of the reinforcing steel used in the column to foundation-beam specimen.

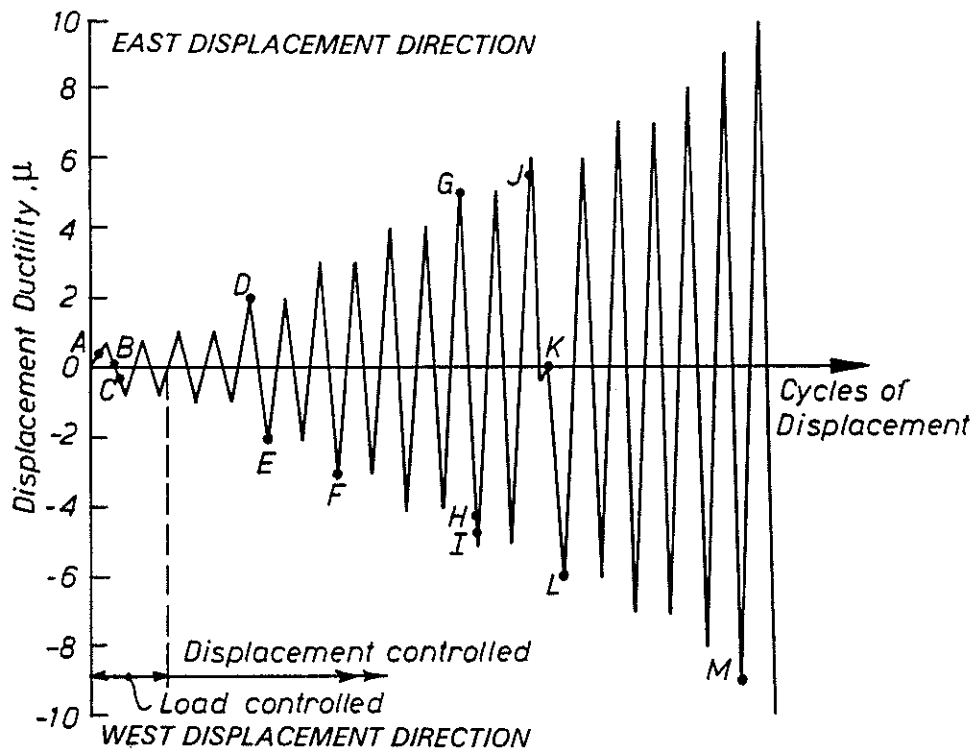
- A Flexural-tension cracks on west face first observed at V (capacity) = 35 kN.
- B Remove and recalibrate load cell.
- C Flexural-tension cracks on east face first observed at $V = -26$ kN.
- D Cracking caused by compression crushing on east face (ductility $\mu = +2.0$).
- E Minor cracking caused to compression crushing on west face.
- F More extensive cracking caused to compression crushing on west face ($\mu = -3.0$).
- G Spalling on east face ($\mu = +5.0$).
- H Fracture of top-plate weld for first east longitudinal bar.
- I Fracture of top-plate weld for second east longitudinal bar.
- J Fracture of top-plate weld for one west longitudinal bar.
- K Test remaining top-plate weld and repair top plate.
- L Spalling on west face ($\mu = -6.0$).
- M Anchorage splitting cracks occur at the base of the foundation beam.

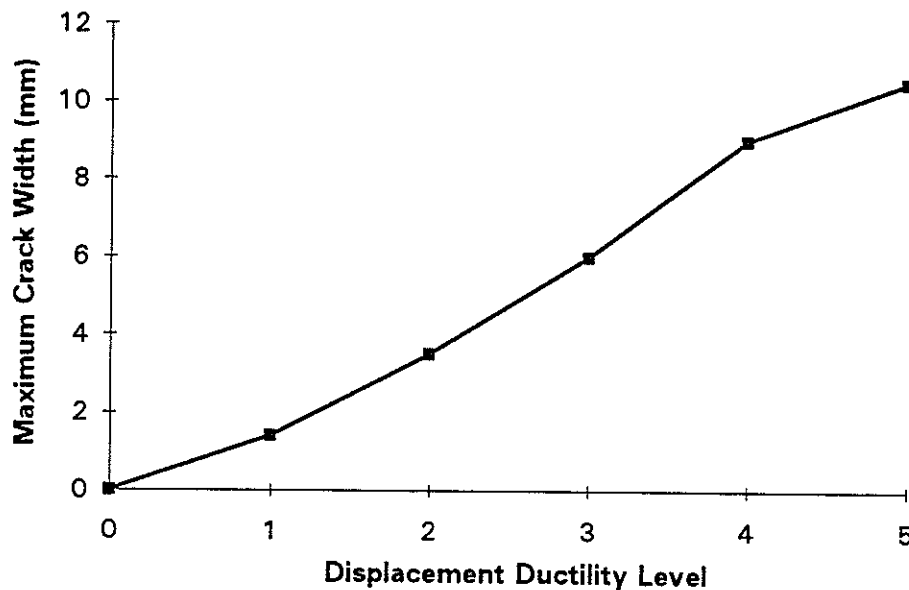
Figure 3.7 Maximum crack width (mm) measured during testing.

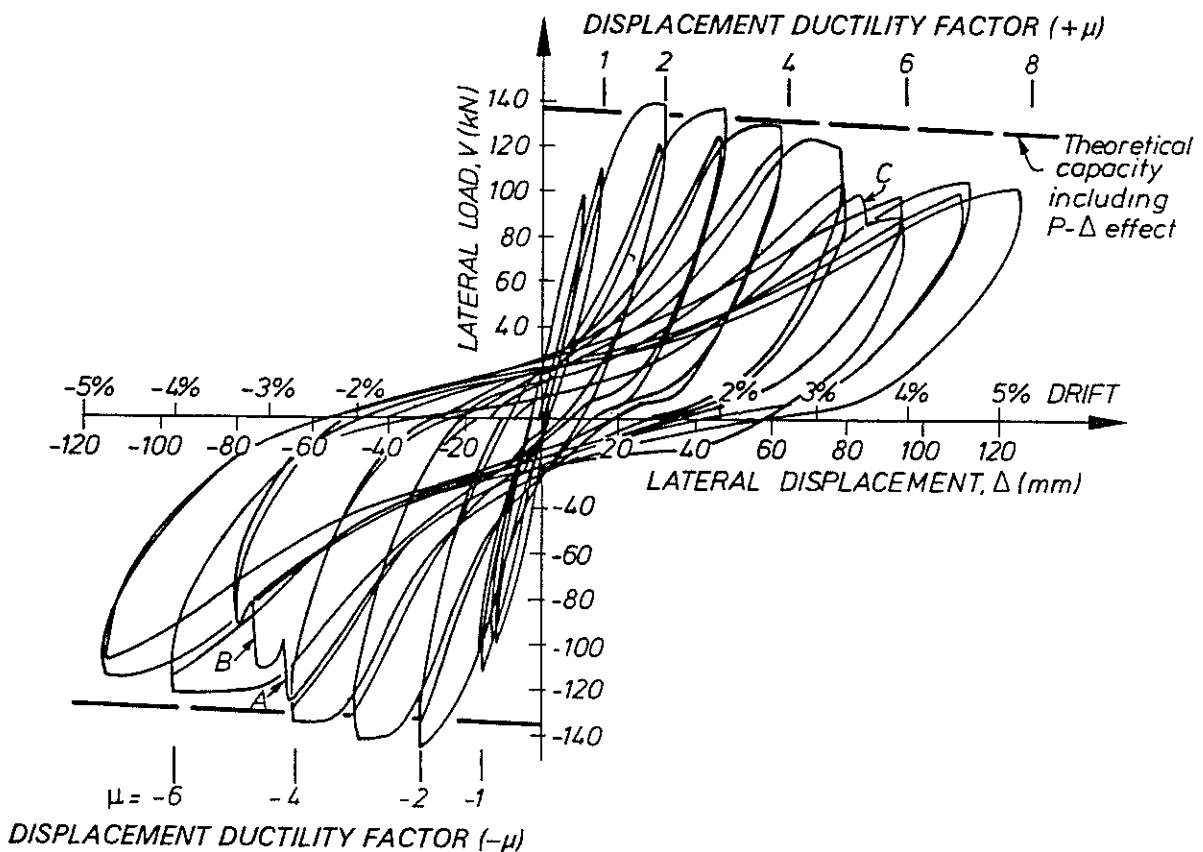
The maximum capacity measured during testing was 138 kN in the eastward direction and 144 kN in the westward direction. Both maximum capacities were reached at the first cycle to ductility $\mu=2$ in each direction.

Figure 3.8 Lateral-load versus lateral-displacement hysteresis loops, to ductility $\mu=7$, for the column to foundation-beam test.

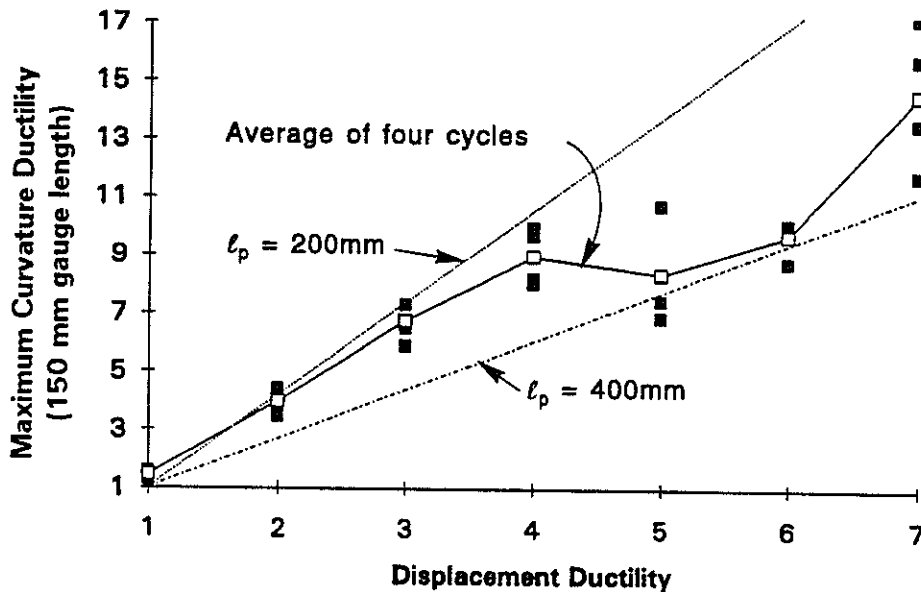
In general, curvature ductilities will increase in step with displacement ductilities. If the plastic-hinge length remains constant, curvature ductility will increase linearly with displacement ductility. However, the column can also accommodate increased displacement ductilities without increased curvature ductilities, if the plastic-hinge length increases.

Figure 4.5 Measured concrete curvature ductility, versus displacement ductility, indicating an increase in concrete plastic-hinge length, l_p .

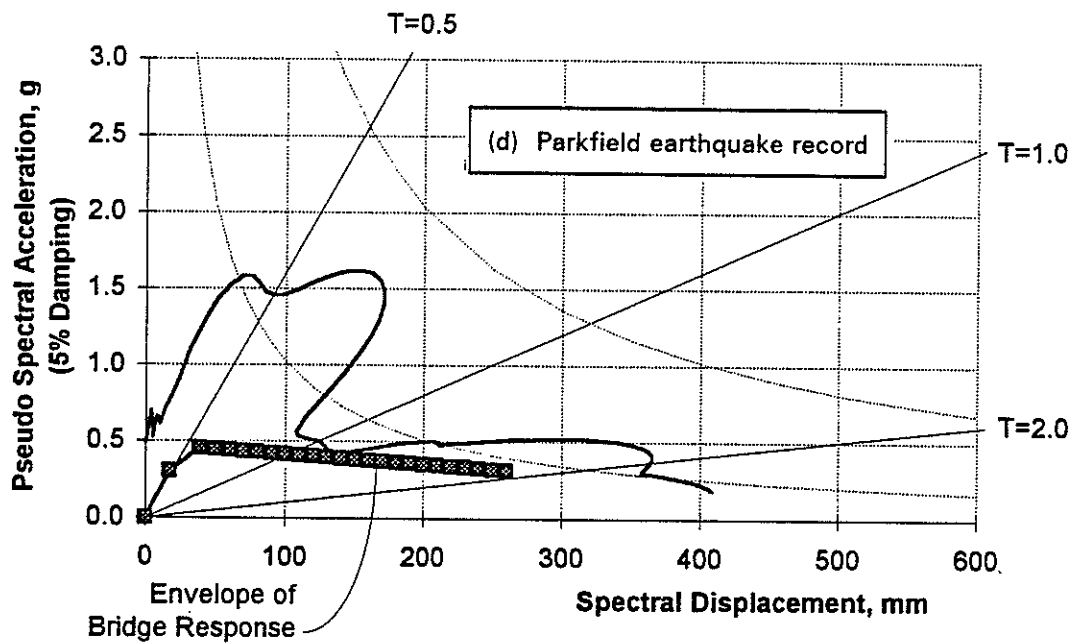
Figure 5.3 Response spectra (a) and (b) for the earthquake records used as input to the *Ruaumoko* analysis.

Figure 5.3 Response spectra (c) and (d) for the earthquake records used as input to the *Ruaumoko* analysis.

Figure 5.3 Response spectra (e) and (f) for the earthquake records used as input to the *Ruaumoko* analysis.
(continued)

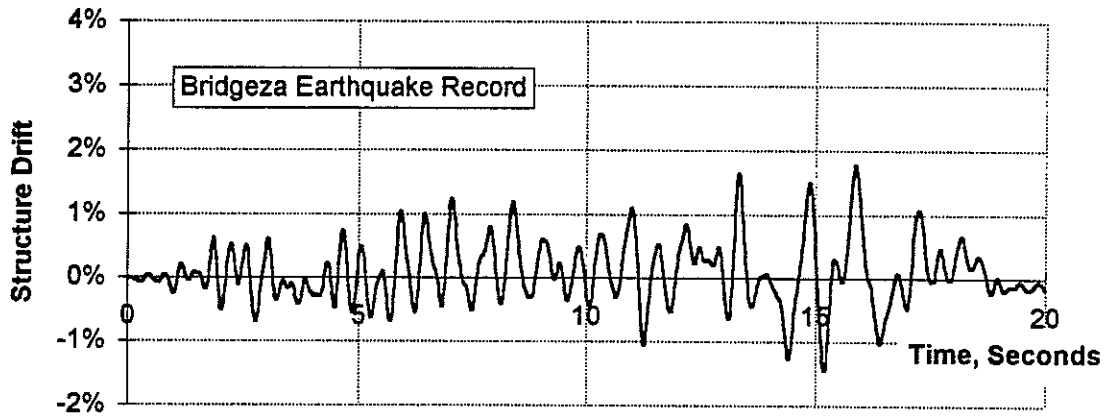
Figure 5.5 Structure drift time-history results for the Bridgeza earthquake record.

(a) Unretrofitted bridge

(b) Anchorage-retrofit bridge

(c) Ideal structure

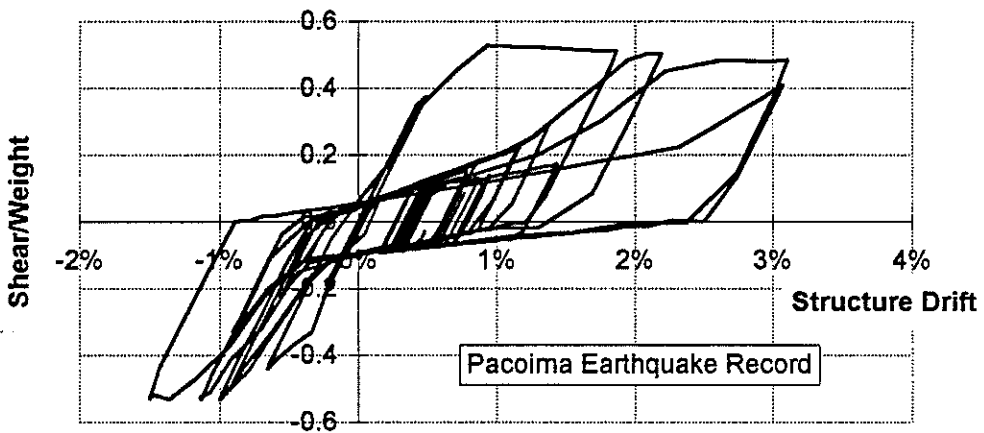
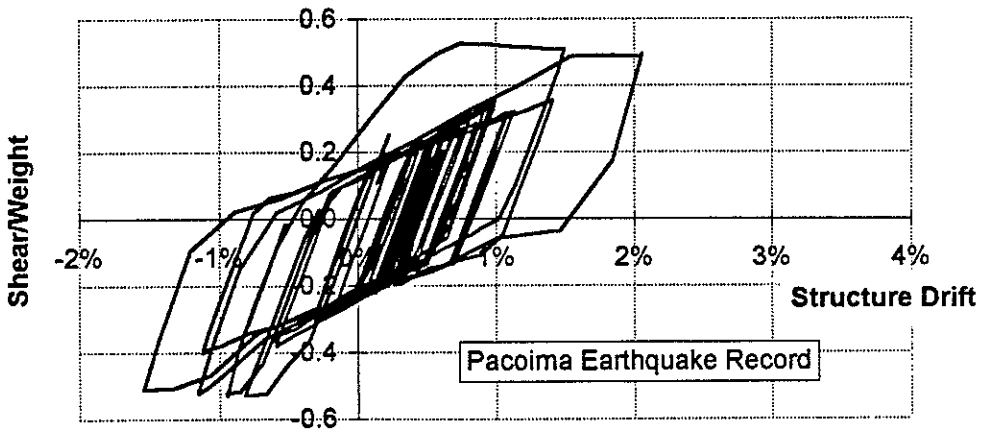
Figure 5.8 Lateral-force versus lateral-displacement hysteretic response for the Pacoima earthquake record.

(a) Unretrofitted bridge

(b) Anchorage-retrofit bridge

(c) Ideal structure
