**Health Monitoring of  
Superstructures of  
New Zealand Road Bridges:  
Rakaia Bridge, Canterbury**

**Transfund New Zealand Research Report No.167**

R.P. Andersen, W.S. Roberts, R.J. Heywood & T.J. Heldt  
Infratech Systems & Services Pty Ltd,  
Brisbane, Australia

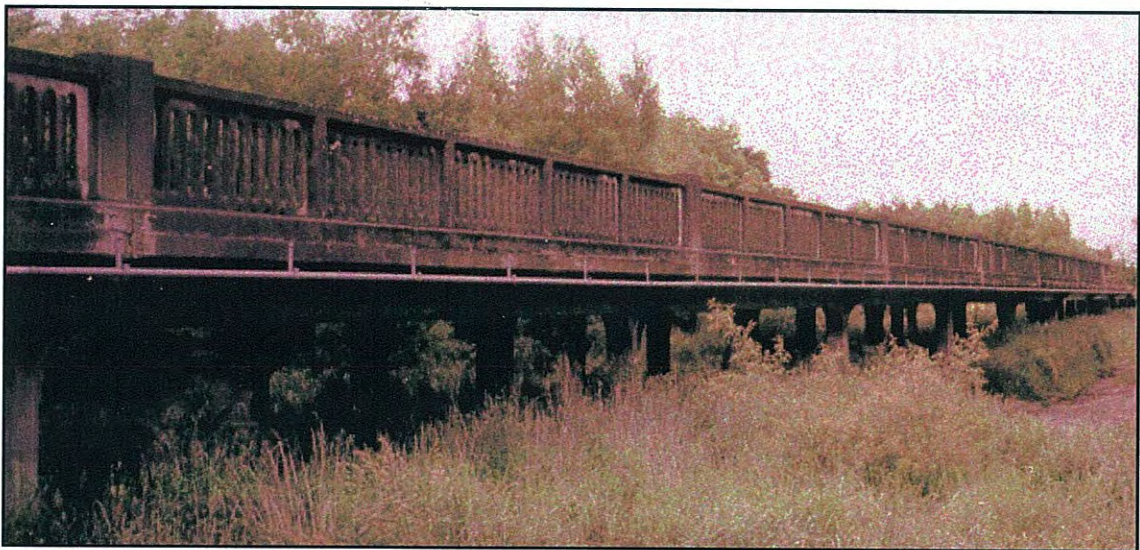
The Rakaia Bridge on SH 1S consists of 144 simply supported spans, each with four reinforced-concrete girders, supporting a reinforced-concrete deck. The concrete deck has integral kerbs and guardrails. The typical span length is approximately 12.2 m with two of the spans being 12.5 m long. Construction of the 1757 m-long bridge was completed in 1939. The bridge is illustrated in Figure 3.1, and is the longest road bridge in New Zealand.

**Figure 3.1** Rakaia Bridge, Canterbury, South Island, New Zealand.

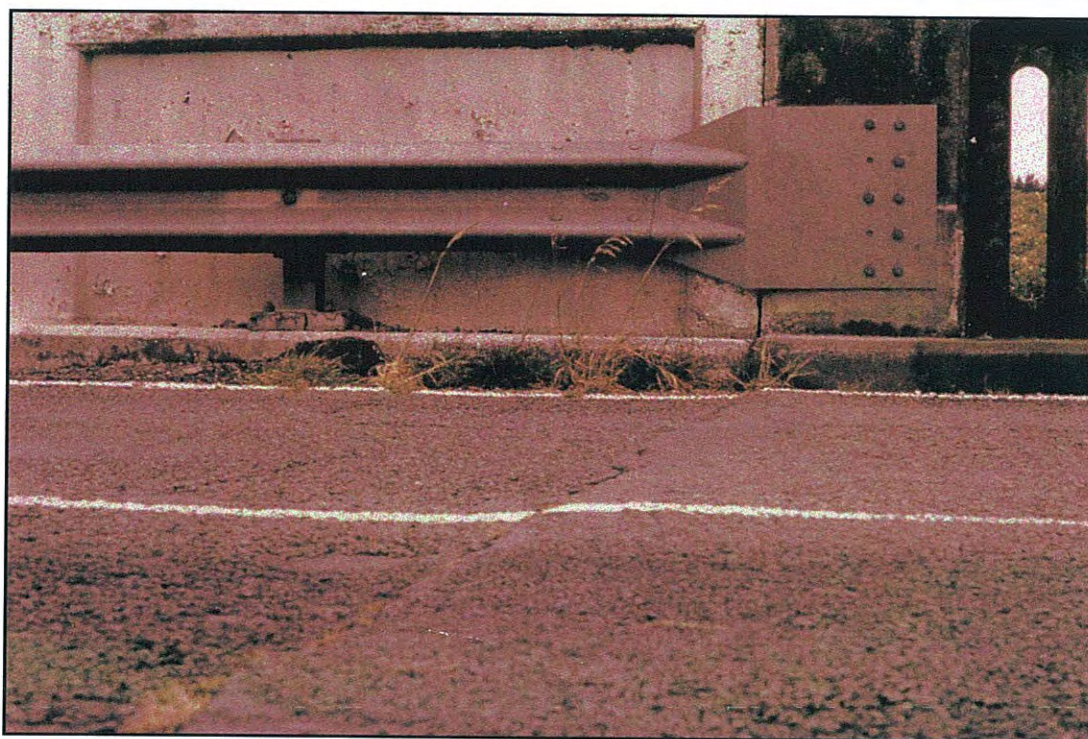
**Figure 3.2** Road profile at the northern approach to Span 1 of the bridge.

The road profile leading up to the northern approach to the bridge is deteriorating, and this approach is illustrated in Figure 3.2. The bump in the road profile is causing the vehicles to bounce onto the first span which increases the dynamic loads being applied to Span 1. For this reason this span of the bridge was monitored though the road profile for the remainder of the bridge is also of concern.

The variation in dynamic response of the main girders in the structure was largely based on the direction of travel. As mentioned in section 3, the approach to the bridge travelling south caused the vehicles to bounce onto the first (instrumented) span because of a deteriorated road profile just before the span (Figure 3.2). Vehicles travelling north do not experience the same dynamic effects and, thus, the dynamic response of the structure to heavy vehicles travelling north is not as pronounced.

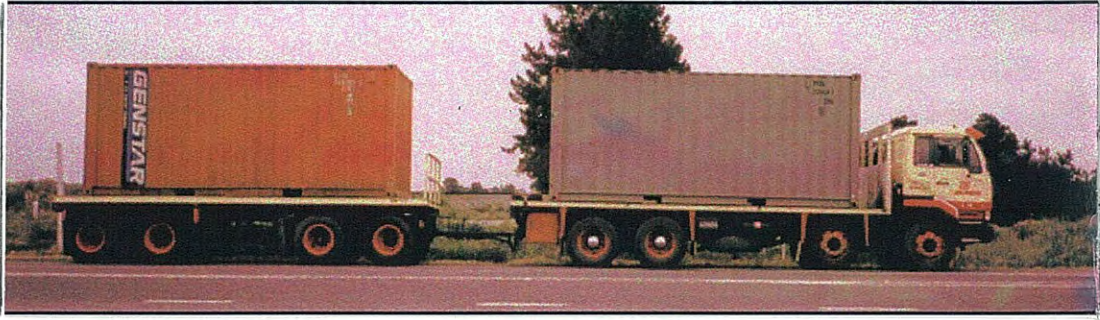
Figure 4.5 The known vehicle used for behavioural testing.

In order to provide a control for all the data gathered during the entire monitoring period, the behaviour of the bridge in response to a known load (i.e. a heavy vehicle of known mass and dimensions) was measured. This component of the Health Monitoring programme was conducted on Wednesday 25 November 1998. The vehicle (Figure 4.5) was supplied by Freightways Express, and the axle weights and configuration are illustrated in Figure 4.6.

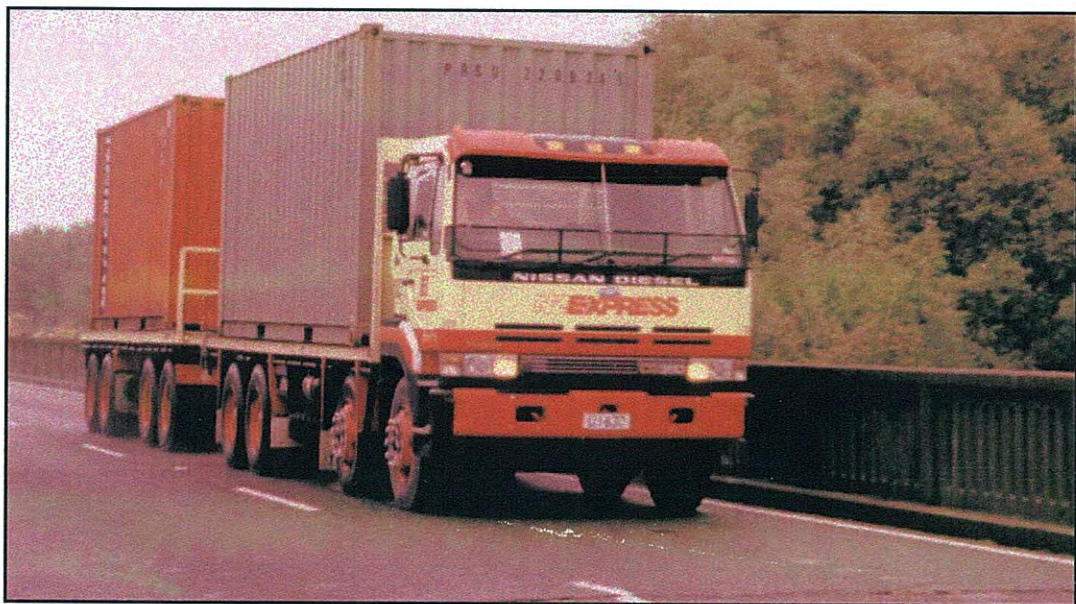
Figure 4.7 Known vehicle in the normal traffic lane during the testing.

The lateral position of the known vehicle was in the normal lane as shown in Figure 4.7. Testing was completed by slowing the traffic in each direction or in some cases stopping it for a few minutes at a time. This ensured minimal traffic interruptions and also allowed the continuous monitoring of ambient heavy vehicles between test runs with the known vehicle.

The testing with the known vehicle was conducted by recording the response of the bridge to the vehicle as it passed over the bridge at various speeds. The tests were conducted with the vehicle travelling in both directions (east, then west), at a crawl (10 km/h), 20 km/h, 40 km/h, 60 km/h, 80 km/h, and 100 km/h.

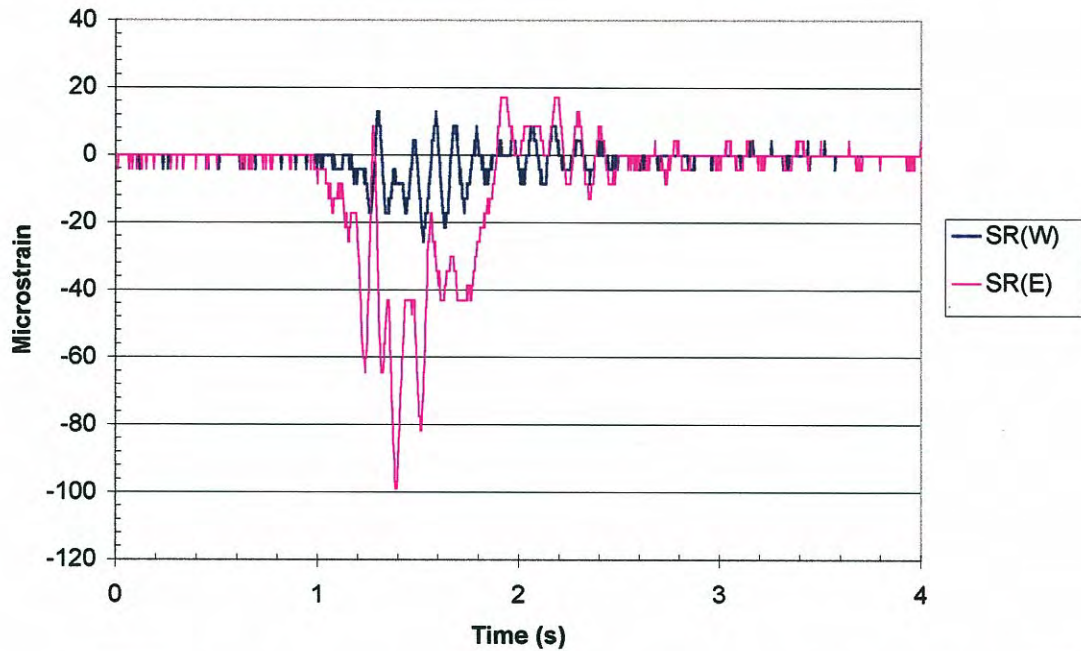
Figure 4.12 Strain response versus time for transducers installed on the guardrails, for event recorded at 6.49am, 25 November 1998.

The waveforms for the transducers installed on the guardrails are illustrated in Figure 4.12. The plot shows the response of the structure as the vehicle travelled south and shows that the guardrails experienced compression responses as expected. A scatter diagram for these transducers is presented in Figure 4.13.

These results indicate that the guardrails are contributing to the strength of the structure in terms of midspan bending. For each event, the magnitude of the strain in the guardrails is approximately half of the maximum strain in the adjacent outside girders of the structure.

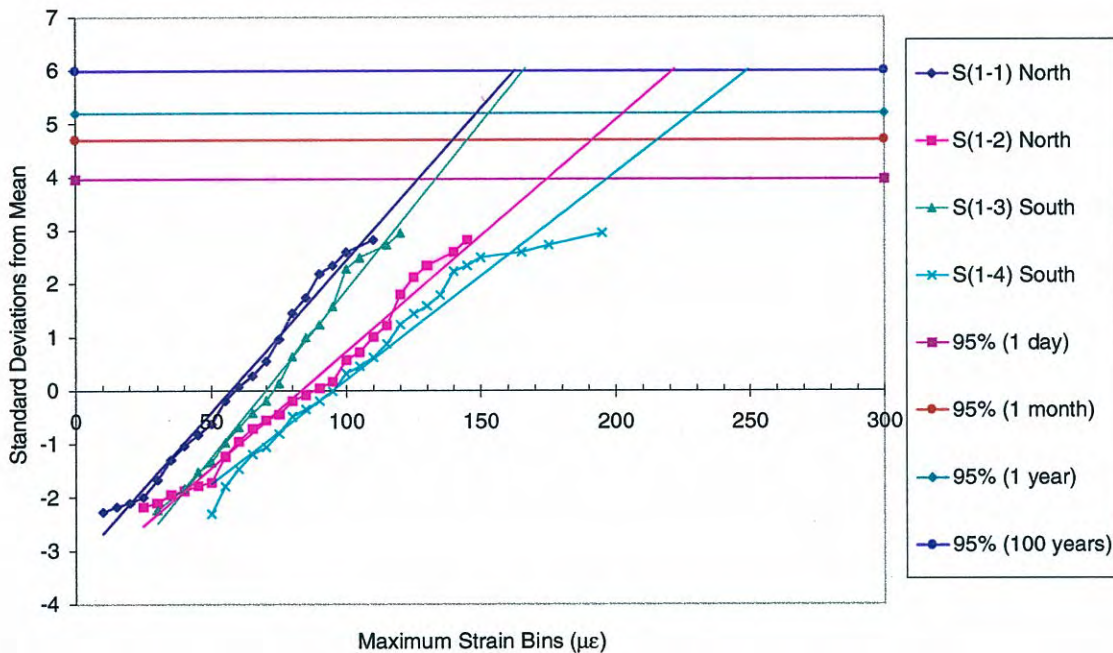
**Figure 4.17 Inverse normal plot for strain transducers installed at the midspan.**

The cumulative distribution function can then be plotted on a probability scale known as an “inverse normal scale”. The inverse normal plot for each of the transducers measuring midspan bending strain is presented in Figure 4.17. This figure presents the data separated into opposite directions: north for transducers S(1-1) and S(1-2), and south for transducers S(1-3) and S(1-4). On this graph the vertical scale represents the number of standard deviations that each point is away from the mean. The horizontal scale is the maximum strain recorded for each event. The point at which a data plot crosses the horizontal axis represents the average (mean) strain. A straight line represents a normally distributed sample of data.

Horizontal lines representing the expected position of the 95% confidence limit for the data for 1 day, 1 month, 1 year, and 100 years have been plotted. Extrapolating the recorded data allows estimates of strain for these longer return intervals. The strain extrapolated for the 95% confidence limit for 100 years represents the ultimate traffic load effect for the Fitness for Purpose Evaluation, that has been outlined in section 2.4 of this report.

The inverse normal plot shows that the strain extrapolated for the 95% confidence limit for 100 years (ultimate traffic load effect) is the greatest for the midspan transducer S(1-4). The extrapolated value is approximately 250  $\mu\epsilon$ .

Higher strains were also recorded in Girders 3 and 4 compared with Girders 1 and 2. This may indicate that the traffic is more heavily loaded travelling south or that there are differences in the structural behaviour.

A distinct change is seen in the behaviour of the response from transducer S(1-4) at around  $150 \mu\epsilon$ . This is also evident in the other transducers although it is not as dramatic. This change may represent the effect of a different population of vehicles (overloaded vehicles for example), a change in the structural behaviour (uncracked state to cracked state), or a change in behaviour associated with the guardrail. With the current data, this change in behaviour was represented by only three vehicles. A longer monitoring period is recommended to confirm the reason for this change in behaviour.

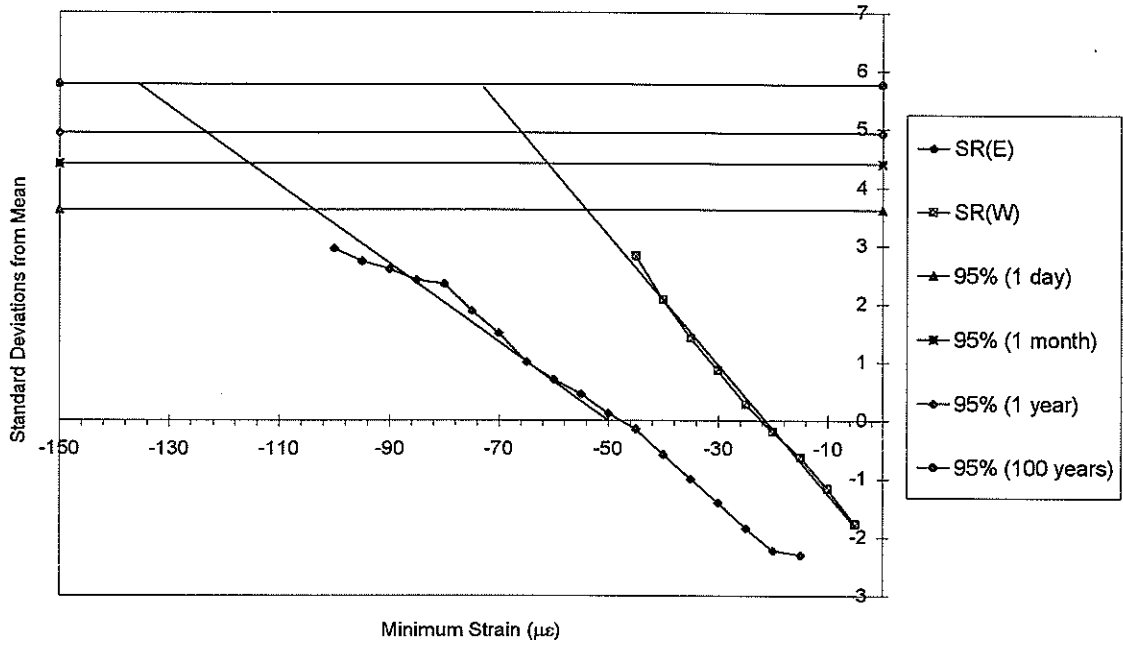
Figure 4.18 Inverse normal plot for transducers installed on the guardrails.

The inverse normal plots for the transducers installed on the guardrails are illustrated in Figure 4.18. These data show that significantly higher strains were recorded in the eastern guardrail on the side of the bridge corresponding to Girders 3 and 4.

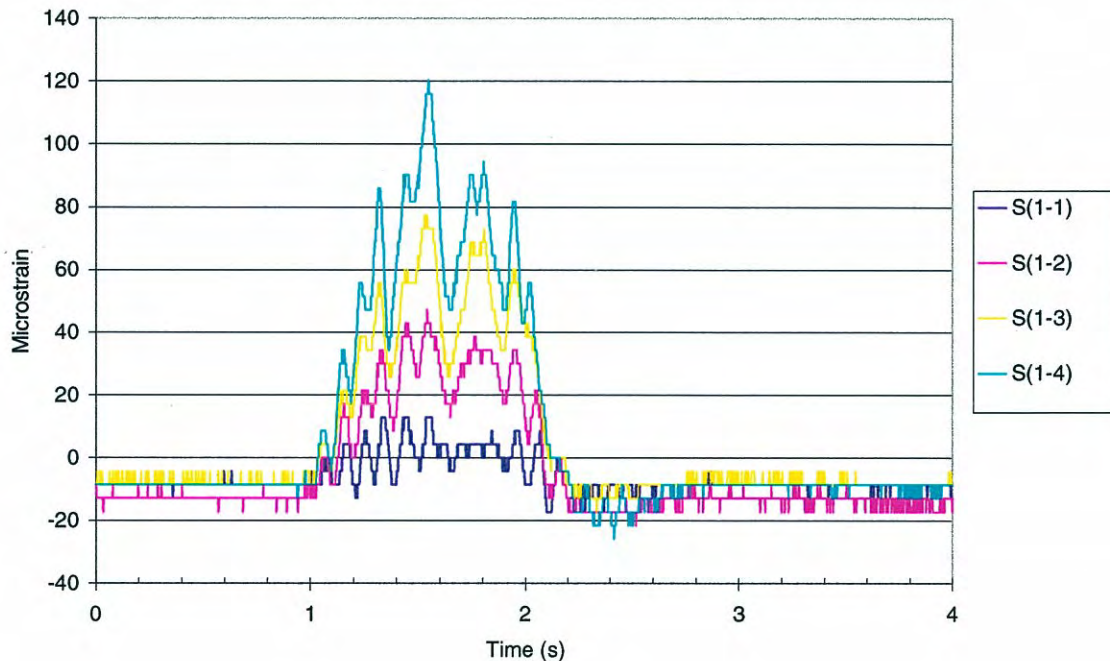
**Figure 4.21 Typical waveform for the southbound passage of the known vehicle.**

A typical waveform for the passage of the known vehicle (travelling south) is presented in Figure 4.21. The dynamic response of the structure while the vehicle was on the instrumented span is again the dominating feature.

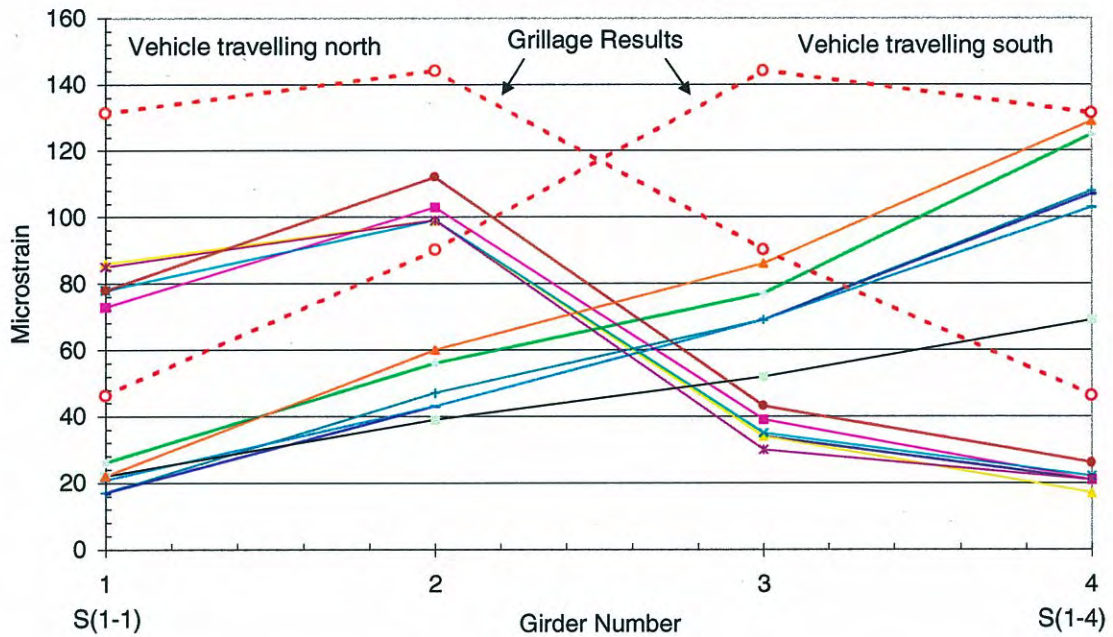
Figure 4.22 Strain distribution for known vehicle testing.

Figure 4.22 also illustrates the results from the grillage analysis that included one vehicle of the same axle and load configuration as the known vehicle. This grillage analysis included the effects of the kerb but not of the guardrail, and also does not include dynamic effects. The vehicle position for the grillage was 600 mm out from the kerb. The differences between the theoretical and recorded results could be related to the influence of the guardrail, to variations in the vehicle position on the bridge, and to relative conditions of the girders. Note that the strains recorded from the testing are significantly lower than those calculated from the grillage analysis.

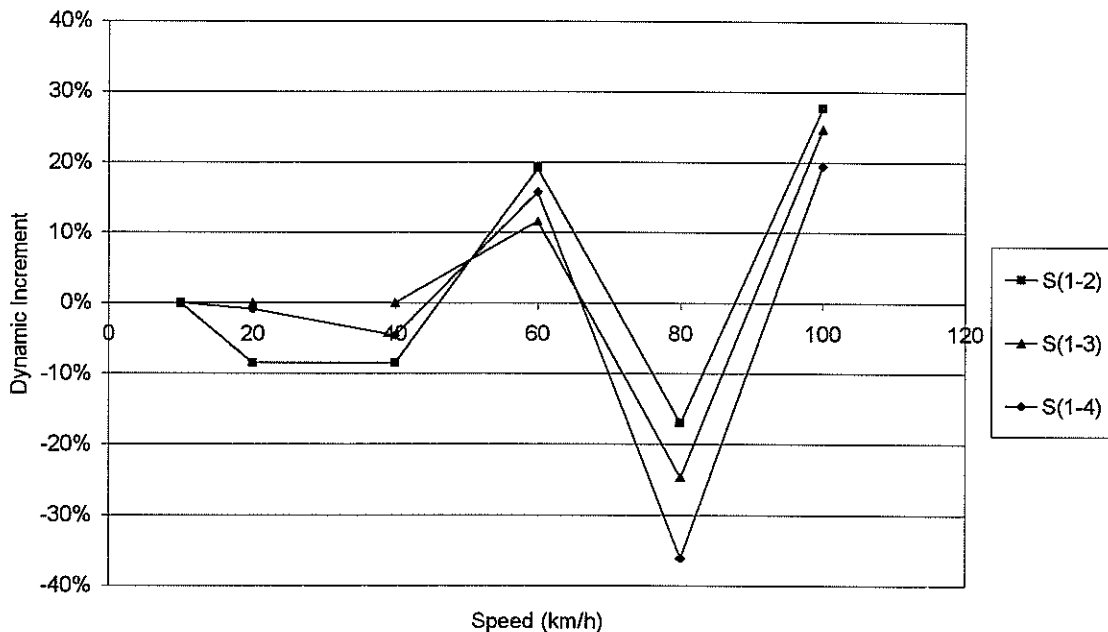
Figure 4.23 Dynamic increment plot for known vehicle travelling south.

The negative dynamic increment at 80 km/h is caused because the dynamic wheel forces are small (less than static) when the truck is over the instrumented span at this speed, compared with the forces at 60 and 100 km/h. Only the three transducers that were most affected by the passage of the southbound vehicle are presented in Figure 4.23. The maximum value of 28% was recorded at 100 km/h, and this value should be adopted for the dynamic increment (impact factor) for this structure.

The dynamic increment values for the northbound vehicle were well below the values illustrated in Figure 4.23 and are not presented here.

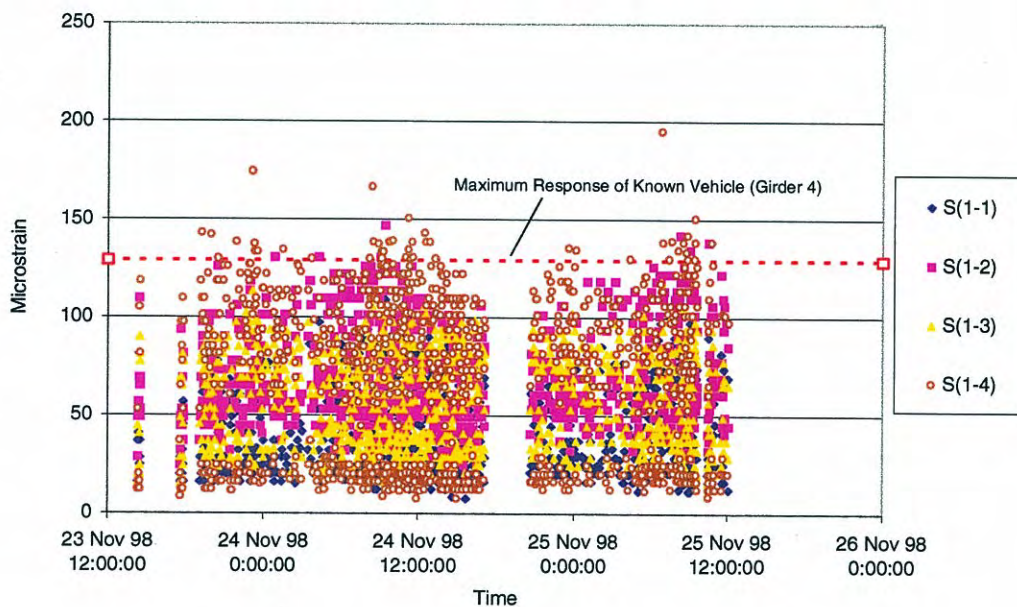
Figure 4.24 Comparison of health monitoring data to the maximum response of the known vehicle.

A summary of the data recorded for the Health Monitoring programme and the testing with the known vehicle is presented in Table 4.3. Figure 4.24 also illustrates a graphical comparison. In some cases (southbound traffic), the results for the maximum response of the structure to the ambient heavy vehicle traffic range up to 50% higher than the response to the known vehicle. For the northbound traffic, the response is around 30% higher than that caused by the known vehicle. Also the grillage analysis indicated that the response of the girders to the 0.85 HN posting load was 30% larger than the response to the known vehicle. Thus the response to northbound traffic is consistent with the 0.85 HN vehicle load, but the effects from the southbound traffic are approximately 20% higher than the 0.85 HN loading. The higher strains for the southbound traffic are probably related to a combination of some moderate overloading (around 10%) and the contribution of the road profile (higher impact effects).

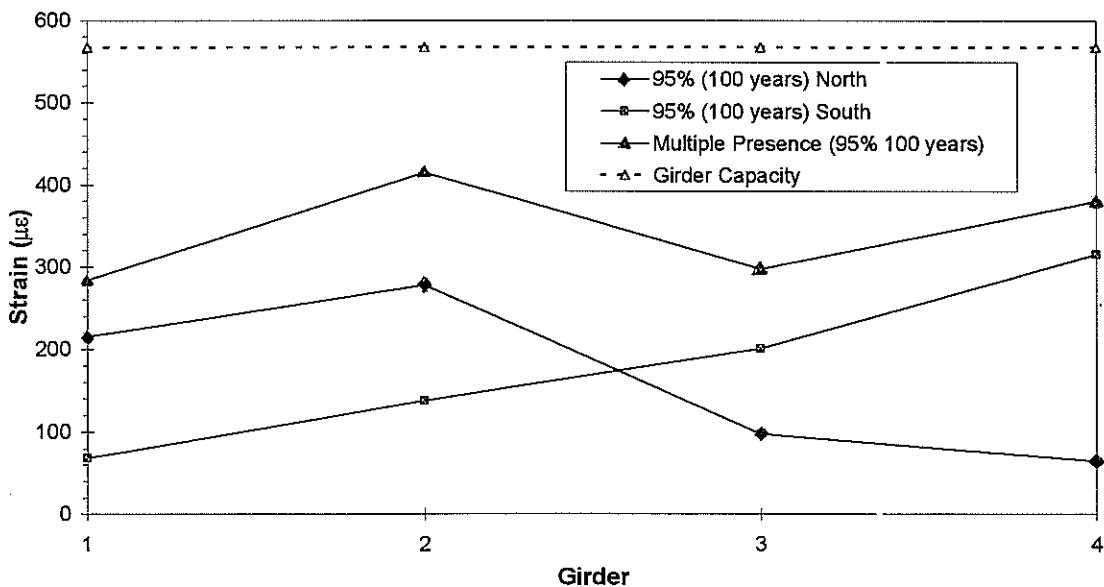
**Figure 5.1 Multiple presence using the approach that is consistent with the Bridge Manual.**

Figure 5.1 summarises an assessment of the multiple presence effects on the Rakaia Bridge based on the health monitoring data, using a method that is consistent with the Bridge Manual. The diagram shows a transverse distribution of strain for each direction and the sum of these two distributions. These distributions are based on the distribution factors from the known vehicle and the extrapolated health monitoring data. The available live load capacity for the girders is also shown. The data show that approximately 73% of the girder capacity would be utilised by a multiple presence event, and that the highest strain caused by a multiple presence event is in Girder 2.
