**Health Monitoring of  
Superstructures of  
New Zealand Road Bridges:  
Waipara Bridge, Canterbury**

**Transfund New Zealand Research Report No.168**

R.P. Andersen, W.S. Roberts, R.J. Heywood & T.J. Heldt  
Infratech Systems & Services Pty Ltd,  
Brisbane, Australia

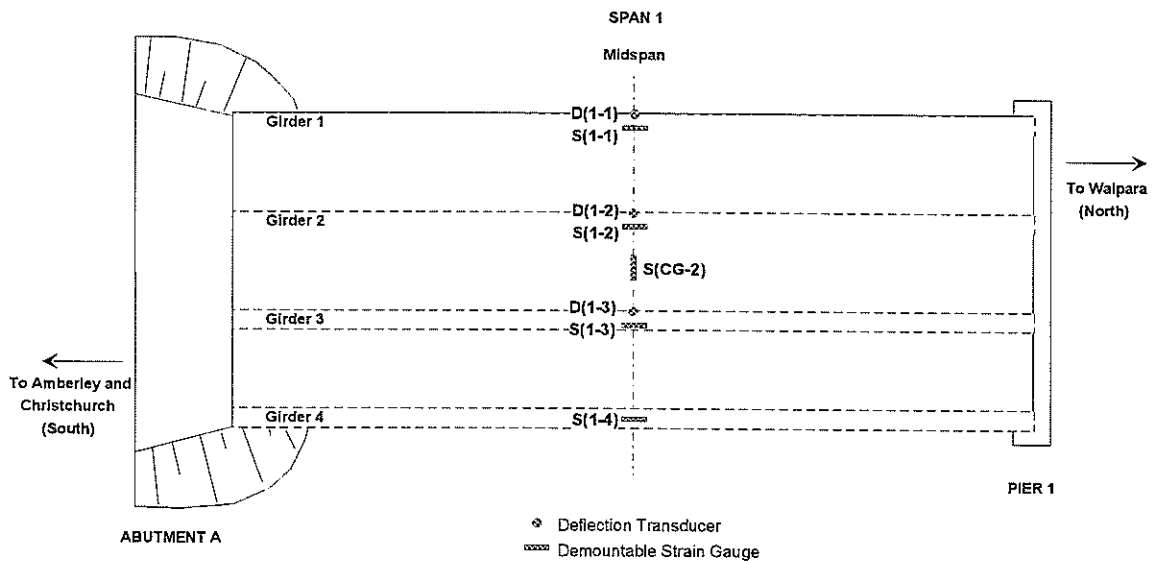
The instrumentation installed on the bridge included five Demountable Strain Gauge transducers and three Deflection transducers. The instrumentation was installed on the southernmost span of the structure, and the positions of this instrumentation are illustrated in Figure 4.1.

Figure 4.1 Instrumentation plan for Waipara Bridge.

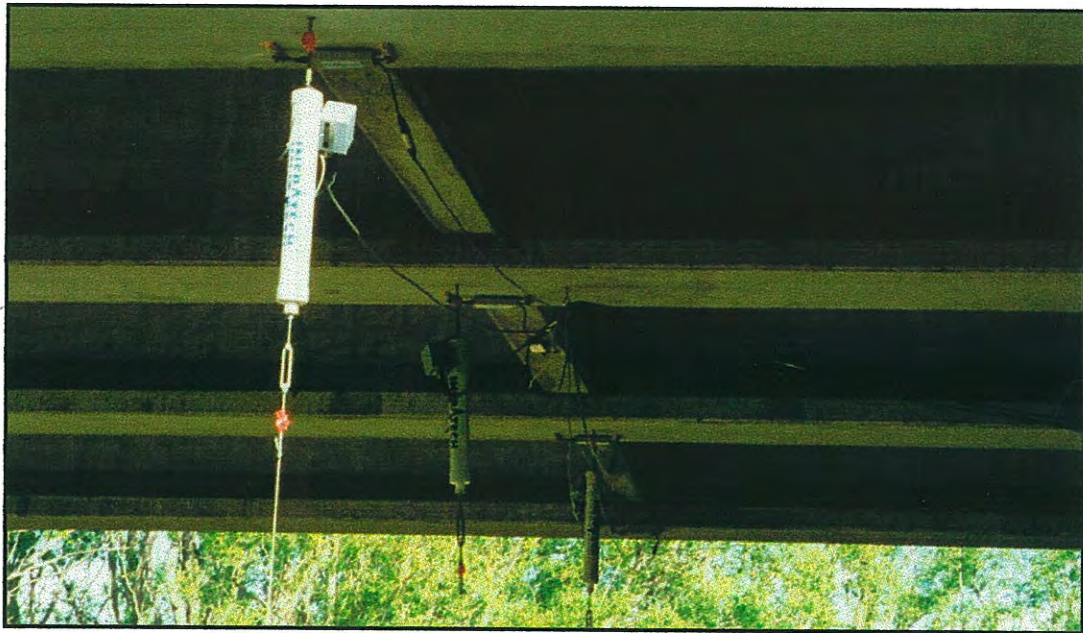
Figure 4.2 shows the installation of demountable strain gauge and deflection transducers at midspan, and Figure 4.3 illustrates the cross section of the monitored span detailing the positions of the instrumentation.

Figure 4.2 Instrumentation on the midspan of Waipara Bridge.

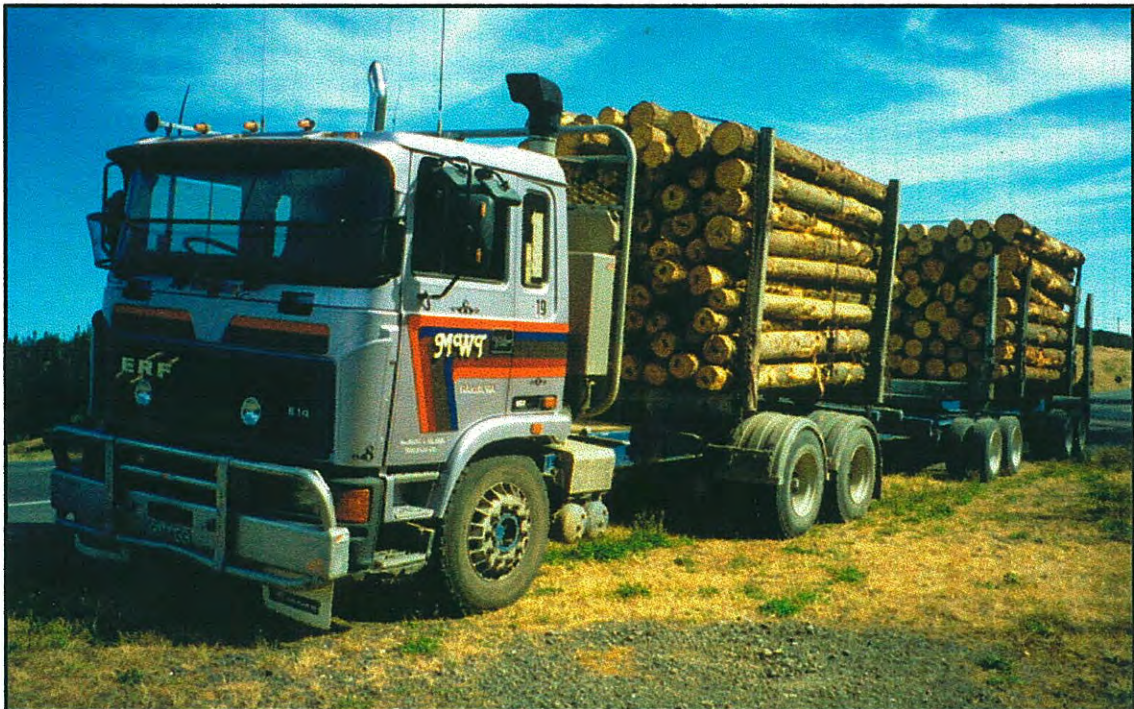
In order to provide a control for all the data gathered during the entire monitoring period, the behaviour of the bridge in response to a known load (i.e. a heavy vehicle of known mass and dimensions) was measured. This component of the Health Monitoring programme was conducted on Tuesday 24 November, 1998. The known vehicle was a seven-axled heavy vehicle of known mass and dimensions, supplied by McCarthy Transport Contractors, Raetihi, and shown in Figure 4.4. The axle weights and configuration are illustrated in Figure 4.5, and the gross mass of the vehicle was 44.2 tonnes.

Figure 4.5 Axle mass and configuration of the known vehicle.

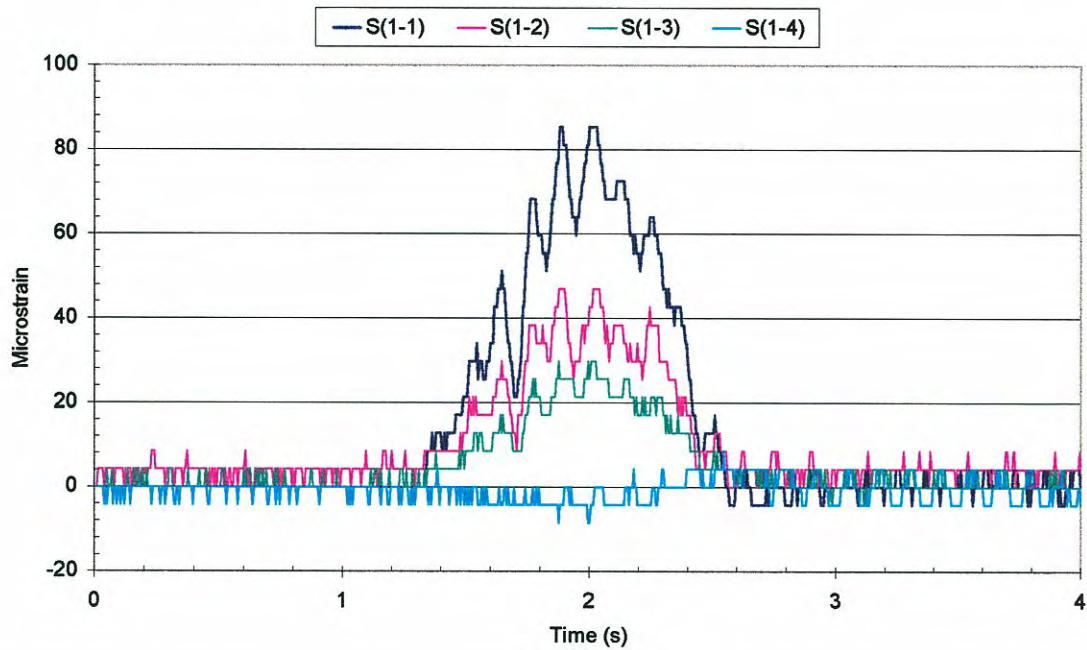
**Figure 4.16 Typical waveform for the known vehicle travelling at 100 km/h north towards Waipara.**

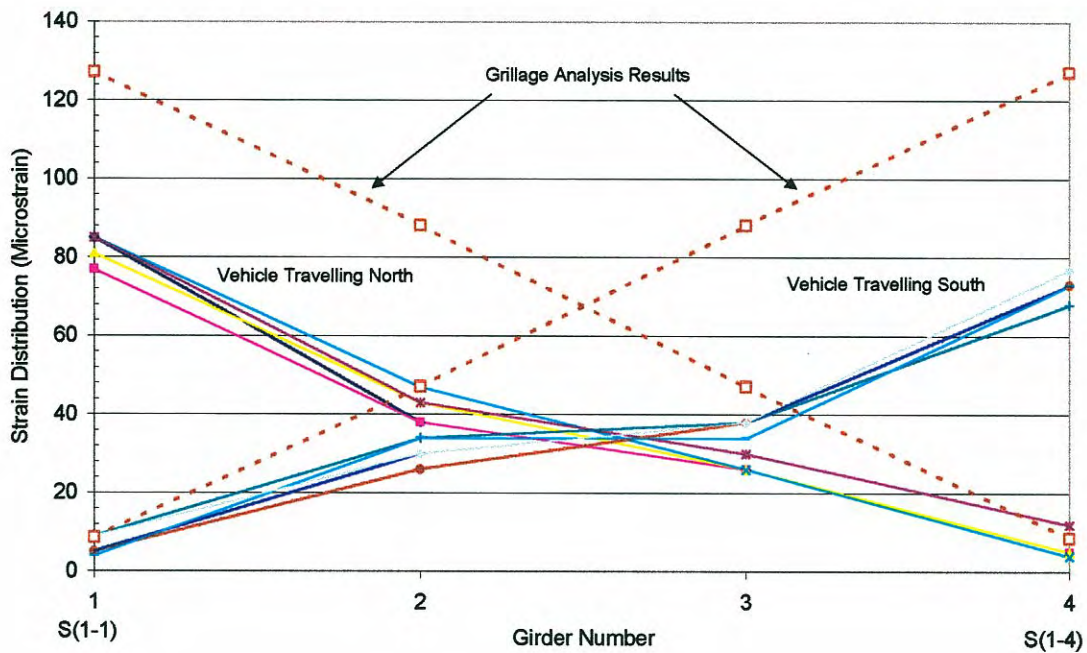
**Figure 4.17 Strain distribution for known vehicle testing at different speeds and in two directions.**

The distribution of strain into each of the girders from the known vehicle data is presented in Figure 4.17. The distribution presented is consistent with the data collected from health monitoring of the ambient heavy vehicle traffic, with higher strains recorded in the edge girders compared with those recorded in the middle girders. The distribution also shows that higher strains were recorded in Girder 1 for vehicles travelling to Waipara (north), and that, for vehicles travelling to Christchurch (south), the maximum strain was recorded in Girder 4 as expected.

Figure 4.17 also illustrates the results from the grillage analysis which included one vehicle of the same axle and load configuration as the known vehicle. This grillage analysis included the effects of the kerb but not the guardrail. The vehicle position for the grillage analysis was 600 mm out from the kerb. The differences between the theoretical and recorded results could be related to variations in the vehicle position on the bridge, and possibly the influence of bearing restraint effects.

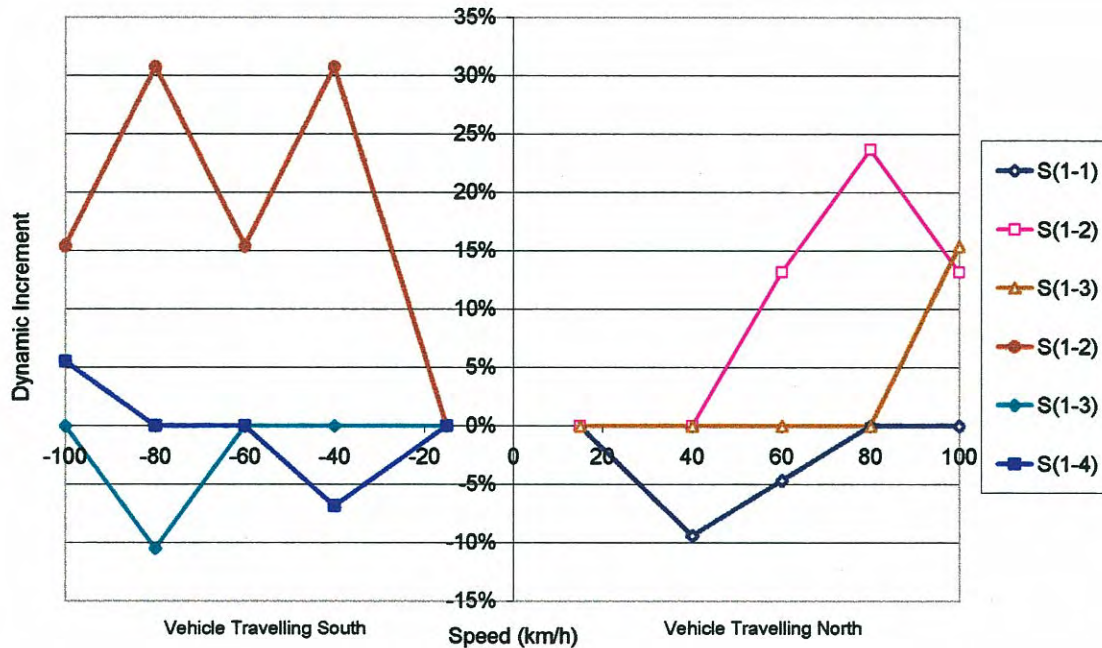
The response of the crawl test was used for the static result in the calculation of dynamic increment. The variation in dynamic increment for the known vehicle is illustrated in Figure 4.18. These results show a high dynamic response at 40 km/h and 80 km/h for the known vehicle travelling south. For the two directions of travel, only the three transducers most affected by the passage of the vehicle in that direction are presented in Figure 4.18. The maximum value of 30% was recorded at 80 km/h. This is a similar value to the value recommended by the Bridge Manual for this bridge.

Figure 4.18 Dynamic increment plot for known vehicle.

The natural frequency of the structure was found to be approximately 7.4 Hz, based on the passage of the known vehicle. The level of damping in the superstructure is approximately 1.8%. The higher dynamic response for the vehicles travelling north may be related to the effects of the road profile adjacent to the abutment of the southern approach.

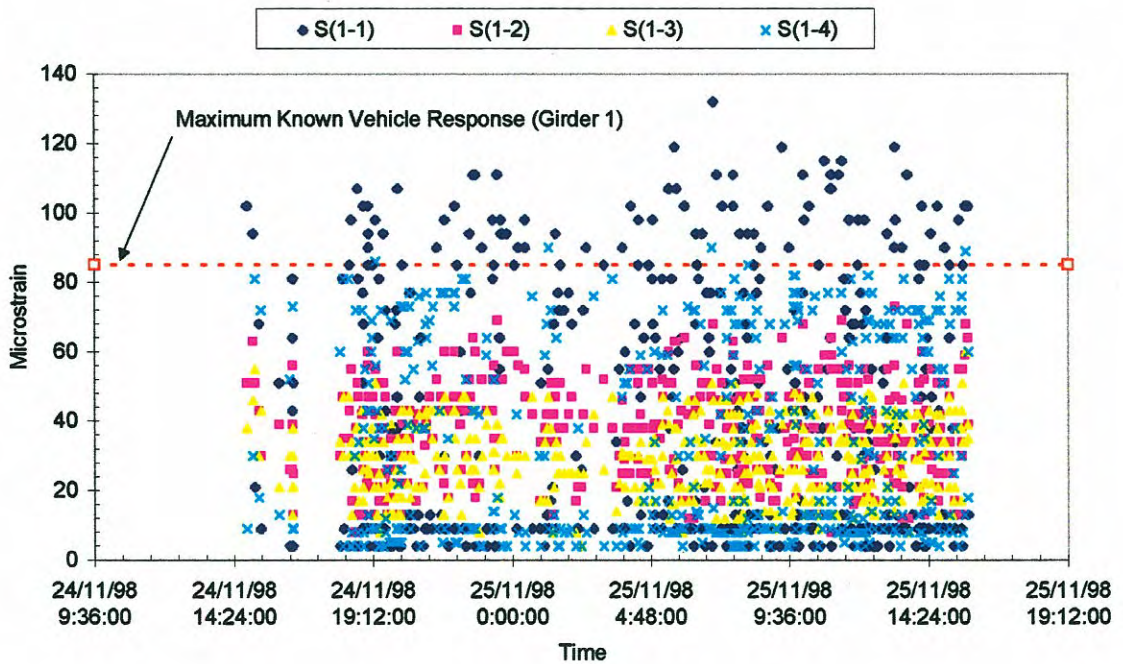
Figure 4.19 Comparison of maximum response of the bridge to the known vehicle with its response to the ambient heavy traffic.

A summary of the data recorded for the Health Monitoring programme and the testing with the known vehicle is presented in Table 4.3. The maximum recorded midspan girder strains obtained from the Health Monitoring exceed the maximum strains recorded for the known vehicle by approximately 50%. The known vehicle induced bending moments on the span that are equivalent to 90% of the bending moments from the 0.85 HN evaluation load. The implication of these two observations is that some overloading may be occurring on this route, particularly in the northbound direction. The higher strains for the known vehicle travelling north may be related to the effects of the poor road profile of the southern approach.

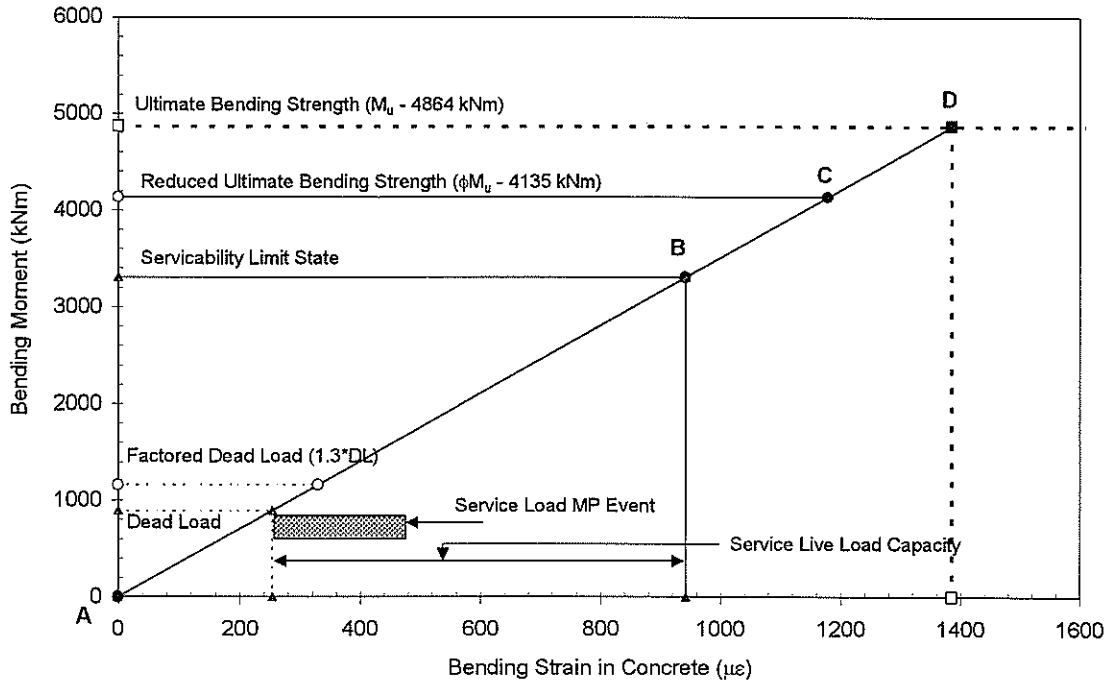
Figure 5.2 illustrates a theoretical moment versus strain curve for a typical girder of the Waipara Bridge. The graph presents the method used by Infratech to obtain a relationship between bending moment and strain in the soffit of the girder. Because the girders have not cracked in service, this relationship is presented for the girder behaving as an uncracked linear elastic section, even at ultimate capacity. This relationship is however a conservative approximation, and has not been confirmed experimentally.

Line AB on Figure 5.2 represents the linear elastic behaviour of the concrete. Point B represents the point at which the concrete cracks, and at which the behaviour of the girder would normally change. However, as the relationship is presented as a linear elastic relationship, the behaviour remains linear. The line BCD represents the linear elastic representation of the behaviour to ultimate bending strength. In this case the service load capacity relates to the load at which cracking occurs in the soffit of the beam.

Figure 5.2 also presents the reduced capacity ( $\phi M_u$ ) of a typical girder converted to an equivalent strain, based on the theoretical moment versus strain relationship. The dead load and factored dead load moment, and corresponding strains, are presented and a shaded rectangle represents the multiple presence effect under service loads.

Figure 5.2 Moment versus strain relationship, and summary of Fitness for Purpose for Girder 1.
