**Health Monitoring of
Superstructures of
New Zealand Road Bridges:
Otauru Bridge, Manawatu**

Transfund New Zealand Research Report No.169

R.P. Andersen, W.S. Roberts, R.J. Heywood & T.J. Heldt
Infratech Systems & Services Pty Ltd,
Brisbane, Australia

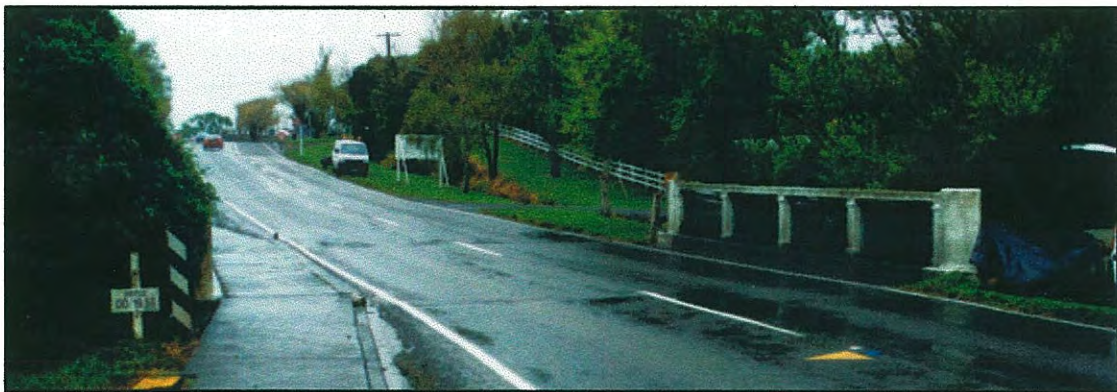
The Otauru Bridge, located on State Highway (SH)57, crosses the Otauru Stream between Levin and Palmerston North, Manawatu Region. The structure is essentially a large culvert constructed from reinforced concrete and consists of a single span including a concrete slab that is framed into the abutments. The structure is designed to act as a portal frame with a span length of 10.4 m and carries two lanes of traffic. Construction of the bridge was completed in 1941. The bridge is illustrated in Figure 3.1. It has a large transverse crack across the concrete slab at midspan and the structure moves visibly under load. This crack may be caused by restrained shrinkage or is live load-induced.

Figure 3.1 Otauru Bridge on SH57 (looking north).

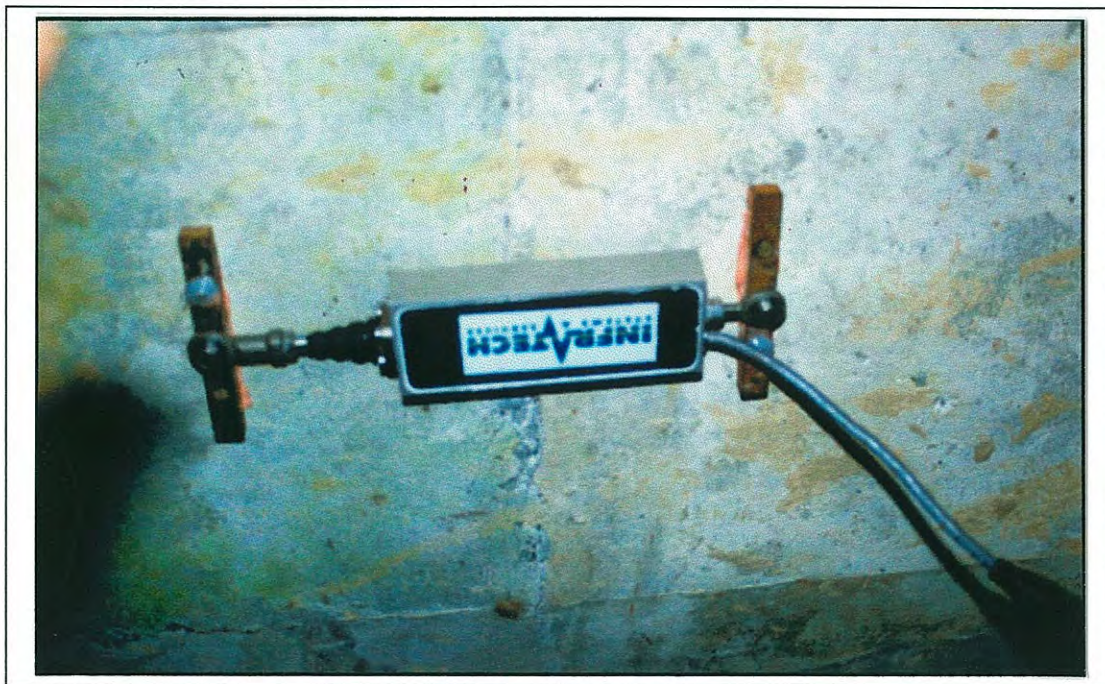
The four transducers installed across the midspan of the bridge were all positioned over a large crack in the soffit of the deck. Transducer S(1-2C) was placed adjacent to S(1-2) but away from any cracking in order to compare the difference in strain at these two points. Figure 4.3 illustrates the position of a demountable strain gauge over a typical crack in the slab.

Figure 4.3 Demountable strain gauge over a crack in the slab.

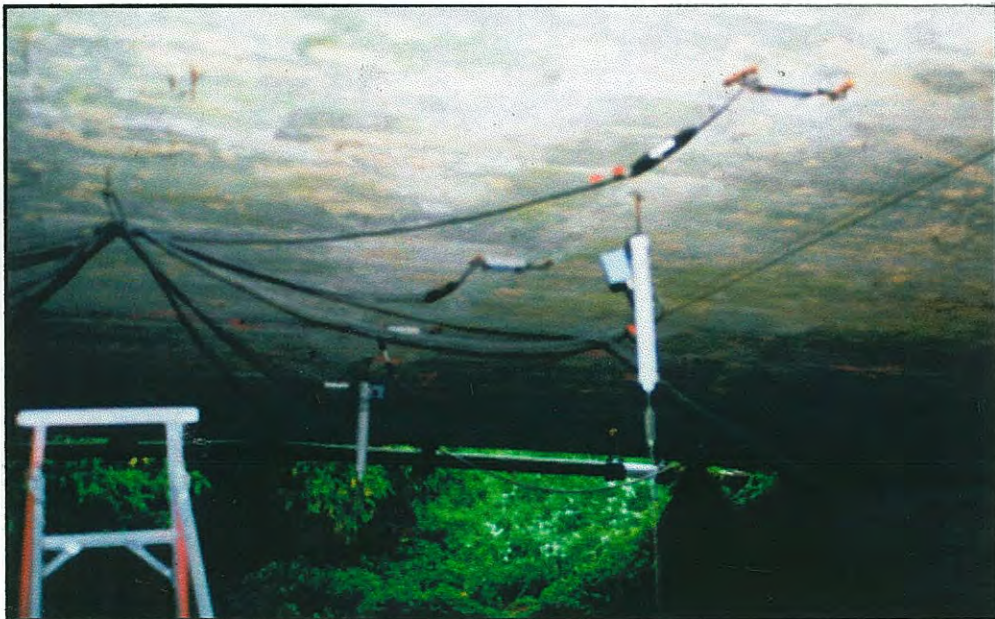
Figure 4.4 Instrumentation installed at the midspan of the slab.

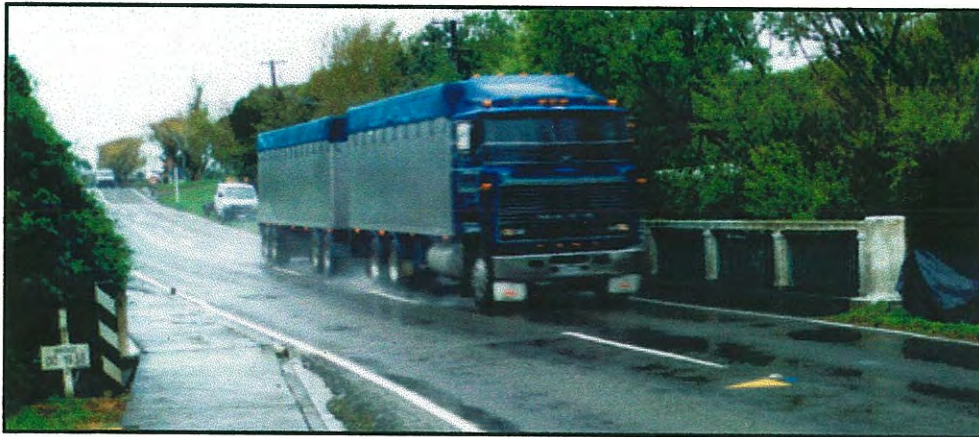
Figure 4.6 The known vehicle on the Otauru Bridge during the behavioural testing.

The testing with the known vehicle was conducted by recording the response of the bridge to the vehicle as it passed over the bridge at different speeds. The tests were conducted with the vehicle travelling in both directions (to Palmerston North and to Levin) at speeds ranging between a crawl (20 km/h) and 70 km/h, in increments of 10 km/h.

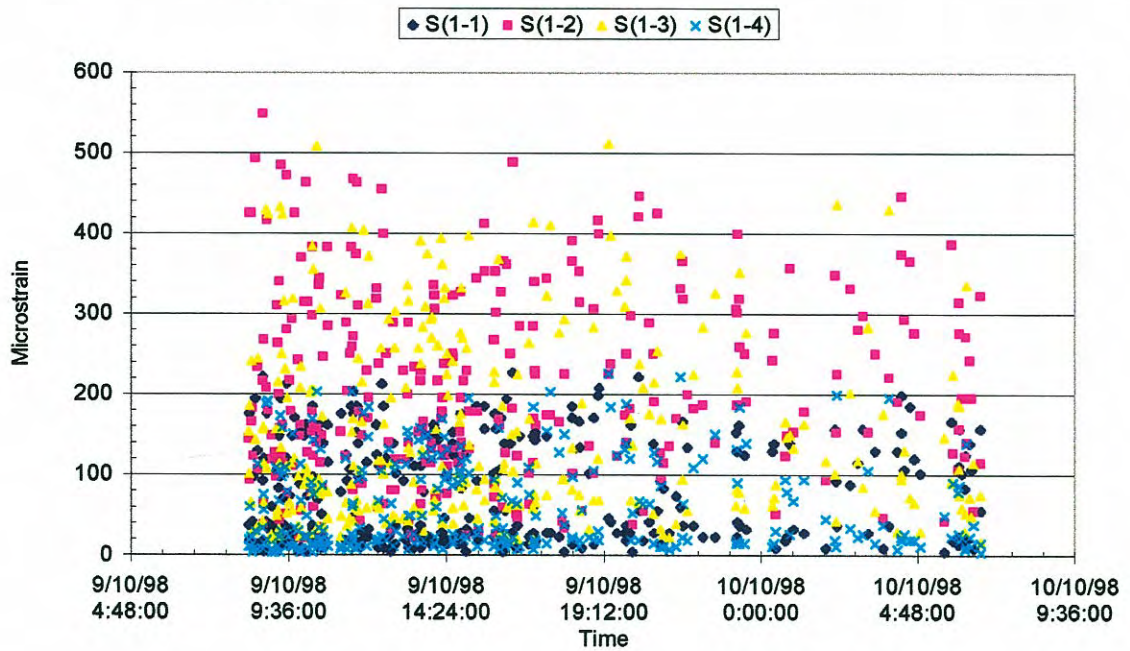
Figure 4.8 Scatter diagram for midspan strain transducers records for entire monitoring period.

A scatter diagram represents the maximum strains recorded during the passage of each heavy vehicle for the entire health monitoring period. Figure 4.8 presents the scatter diagram for the midspan transducers. These plots give an indication of the characteristics of the heavy vehicles travelling over the bridge, including distribution of mass, and the number of heavy vehicles travelling this route. The results show the difference in heavy vehicle traffic volumes between Friday (9/10/98) and Saturday (10/10/98).

The scatter diagram indicates that the greatest response in the soffit of the slab was recorded at the position of transducer S(1-2). The response of transducer S(1-3) was also quite large compared with the outside transducers S(1-1) and S(1-4). Generally the recorded strains are large in magnitude for a reinforced concrete structure.

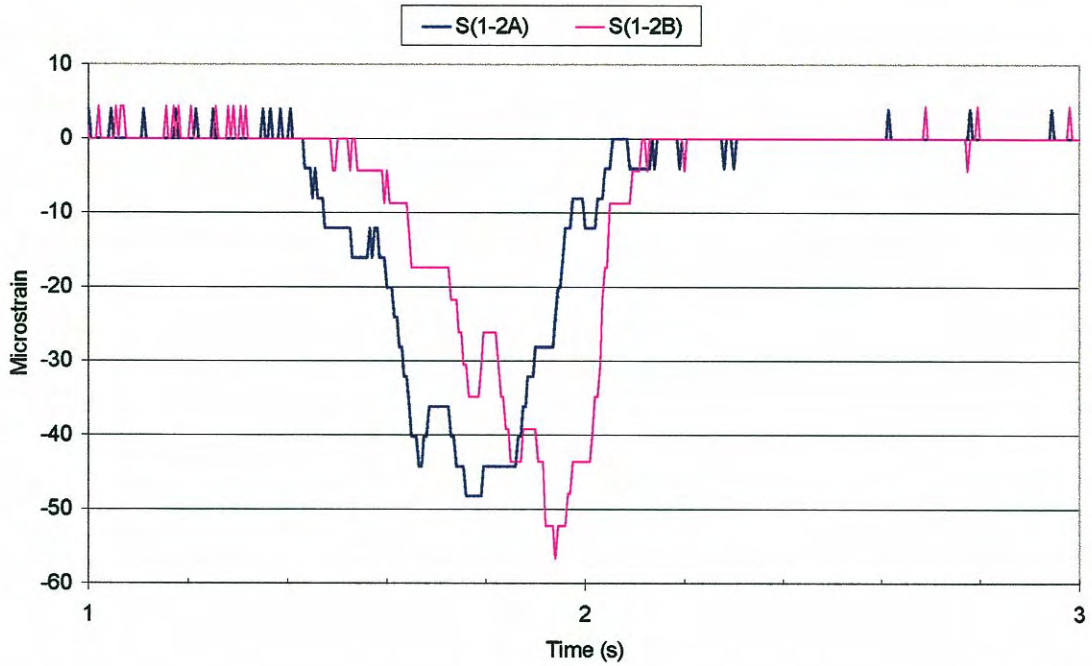
Figure 4.9 Strain response versus time for transducers installed adjacent to the abutments for event recorded at 8.47am, 9 October 1998 (vehicle travelling towards Levin).

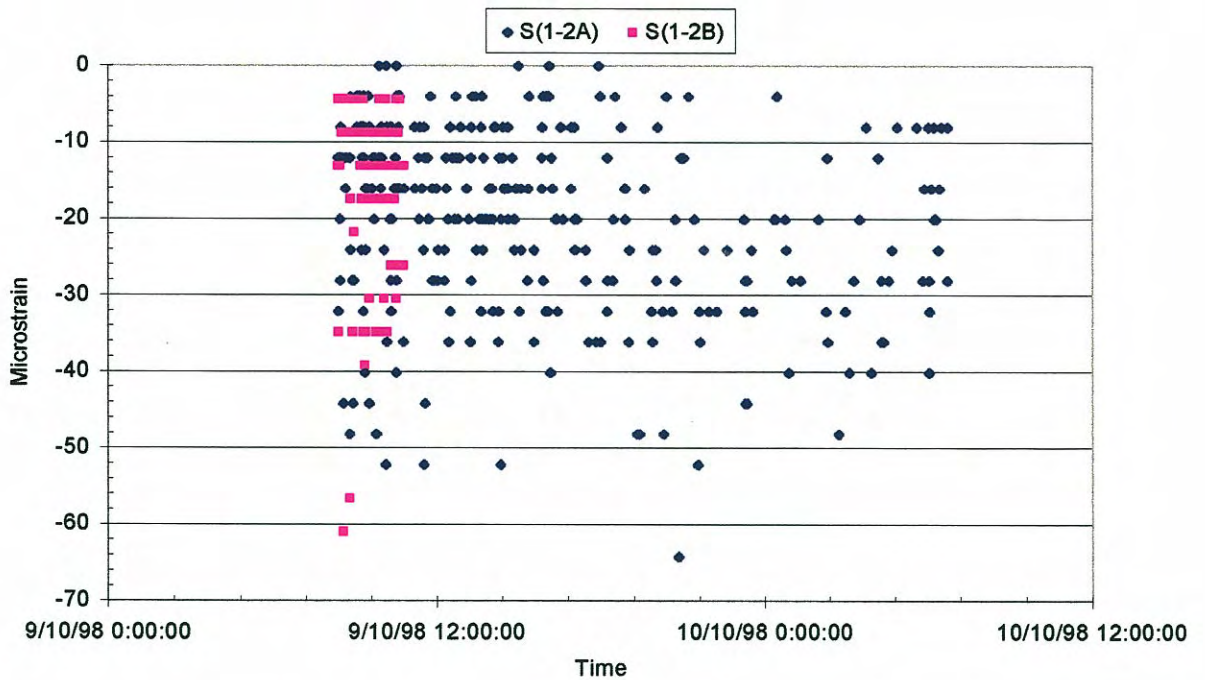
Figure 4.10 Scatter diagram for transducers installed adjacent to abutments.

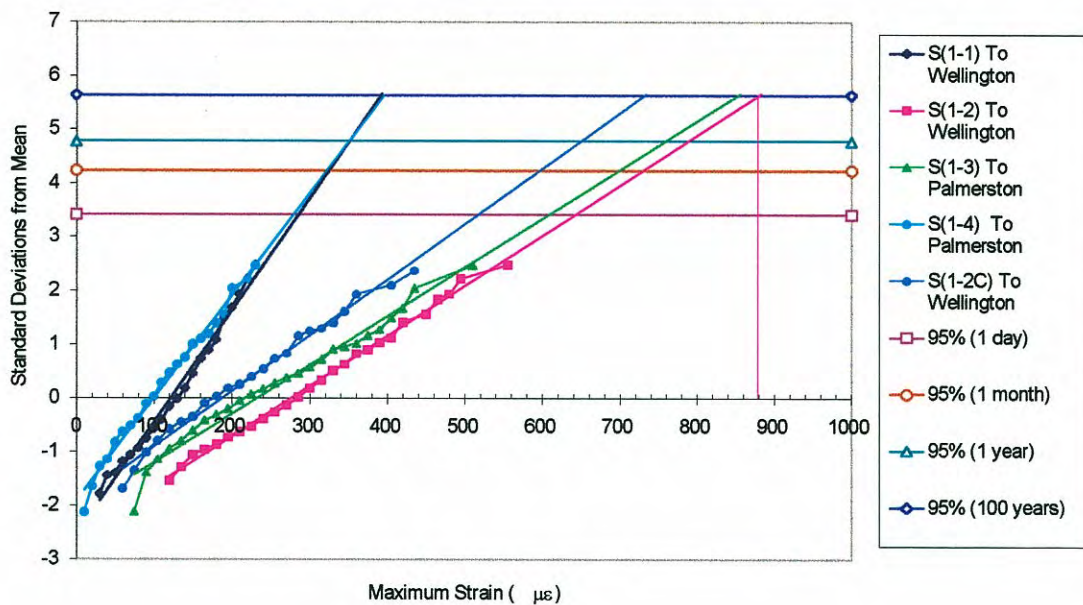
The data in Figure 4.16 show significant differences in strain between transducers S(1-2) and S(1-3) located close to the centreline of the bridge compared with transducers S(1-1) and S(1-4) located towards the edge of the structure. The kerbs and guardrails are expected to significantly influence the behaviour of this structure. The additional stiffness of the guardrails may be reducing the strain in edges of the structure.

Figure 4.16 Inverse normal plots for strain transducers installed at the midspan.

The inverse normal plot shows that the strain extrapolated for the 95% confidence limit for 100 years (ultimate traffic load effect) is the highest for the midspan transducer S(1-2). The extrapolated value is approximately $880 \mu\epsilon$.

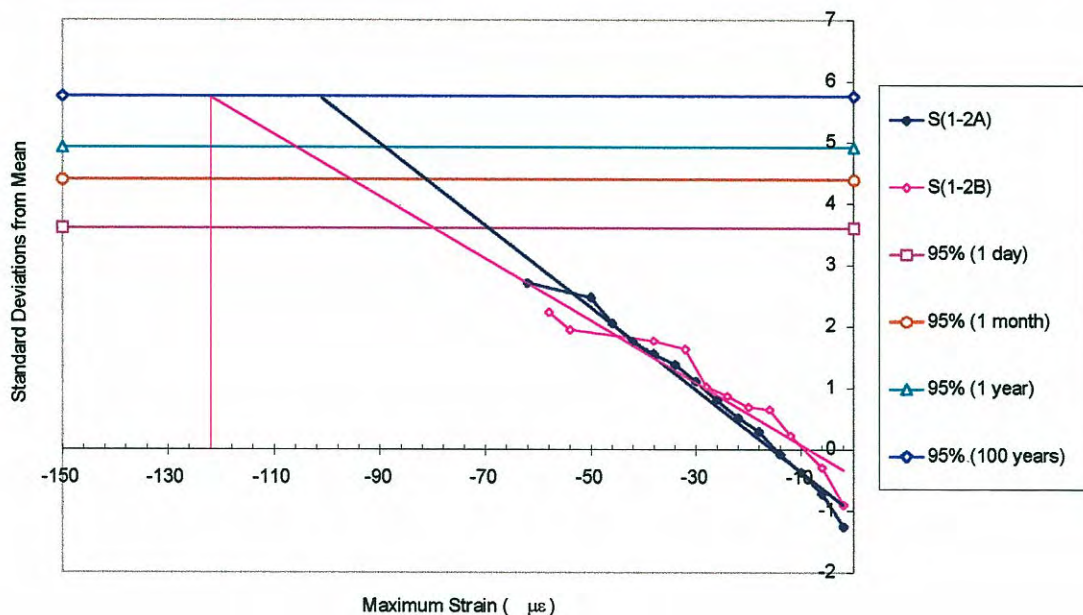
Figure 4.17 Inverse normal plots for transducers installed adjacent to the abutments.

The inverse normal plots for the transducers adjacent to the abutments are presented in Figure 4.17 for the data representing both directions of vehicle travel. The extrapolated results show very similar values with transducer S(1-2B), with the highest extrapolated event equal to approximately $-125 \mu\epsilon$.

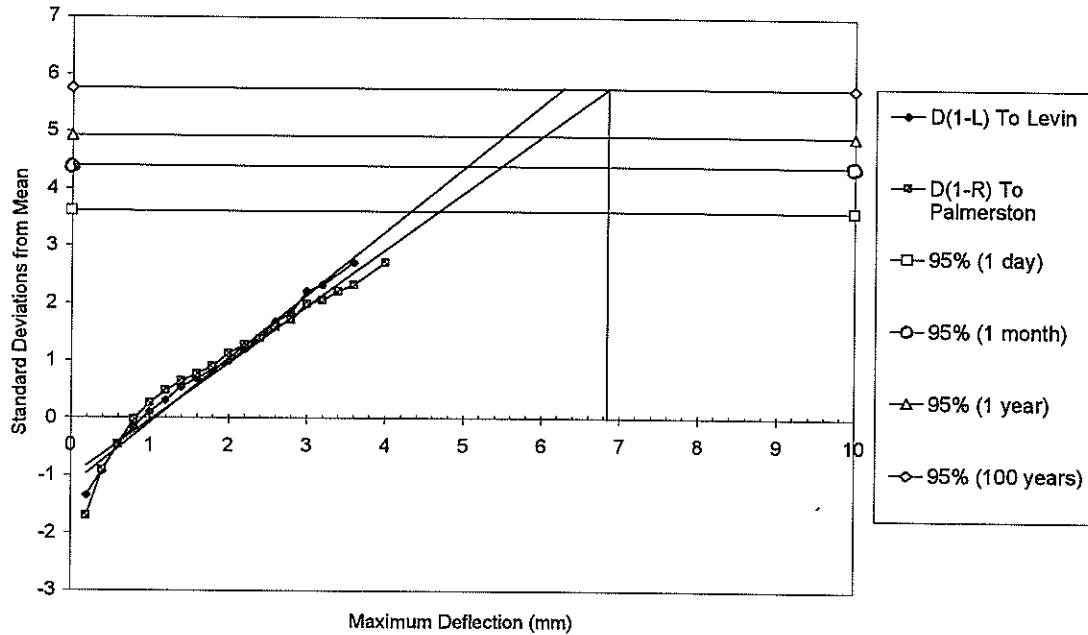
Figure 4.18 Inverse normal plots for deflection transducers.

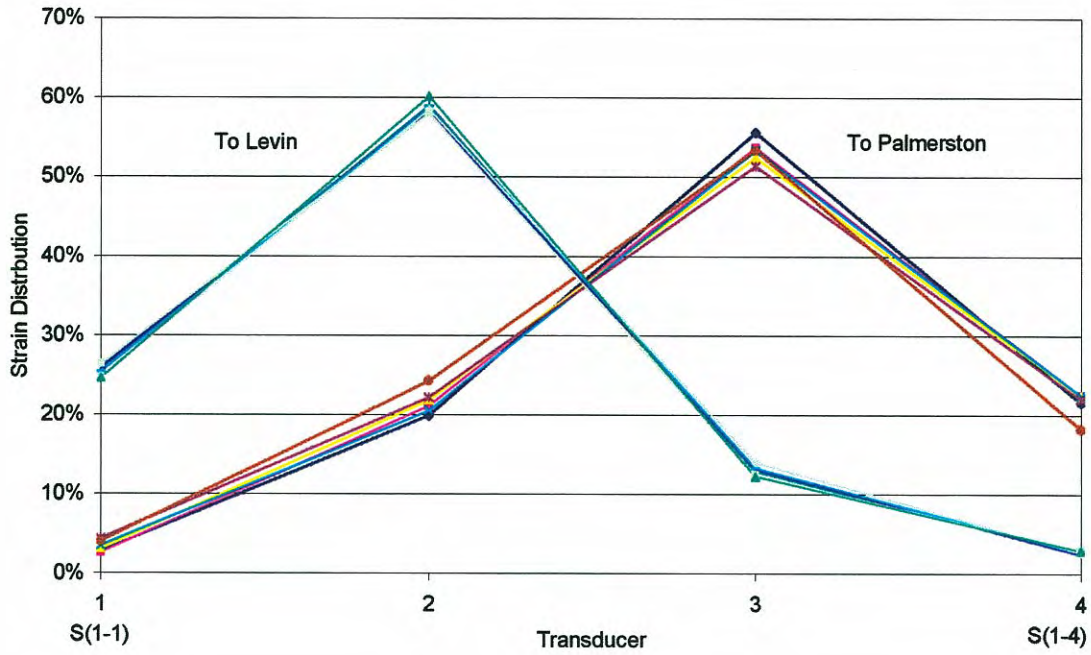
Figure 4.20 Strain distribution for test with the known vehicle.

The maximum strains that each transducer recorded during the testing with the known vehicle are presented in Table 4.2, and the distribution of load into each slab in terms of a percentage is presented in Figure 4.20. The distribution presented is relatively consistent with the data collected from Health Monitoring of the ambient heavy vehicle traffic. The results show very consistent results for the vehicle travelling in either direction.

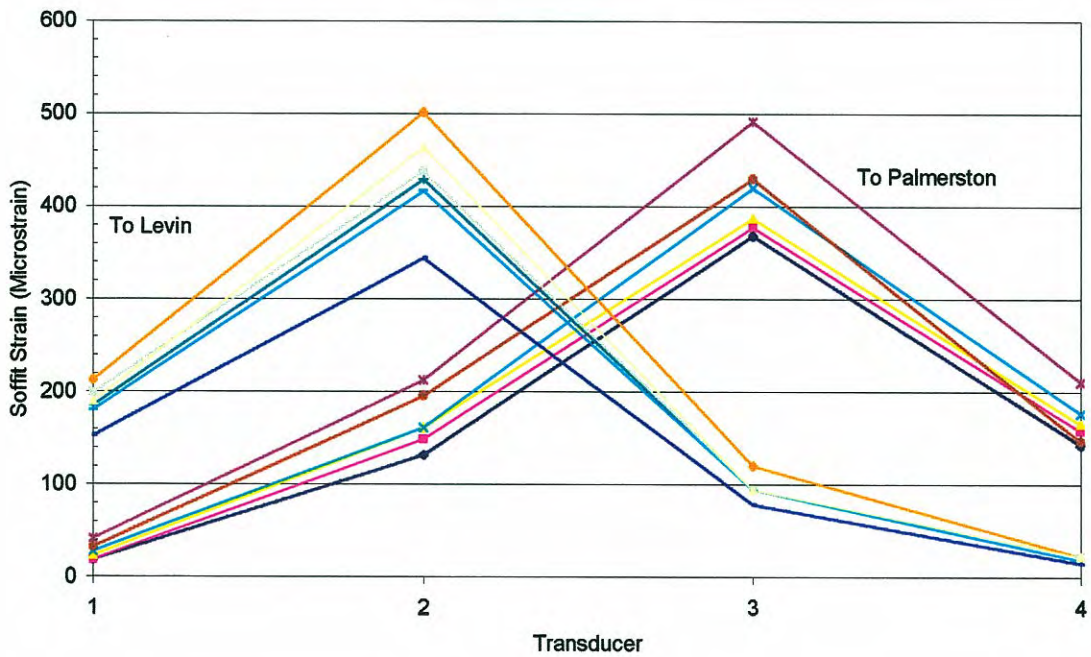
Figure 4.21 Absolute strain distribution for the known vehicle.

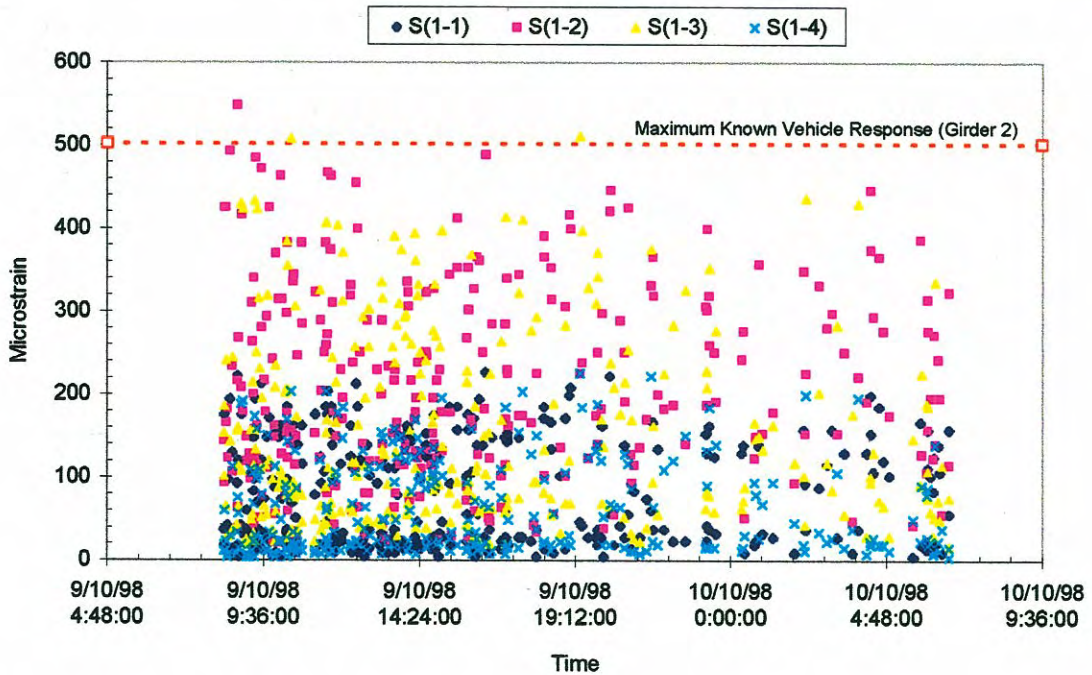
Figure 4.23 Comparison of response of maximum known vehicle with health monitoring data.

A summary of the data recorded for the Health Monitoring and the testing with the known vehicle is presented in Table 4.3. A comparison of the health monitoring data and the maximum response from the known vehicle is presented in Figure 4.23. This comparison shows that only one vehicle measured during the Health Monitoring programme caused a greater response than the known vehicle. This indicates that there is very little overloading on this route.

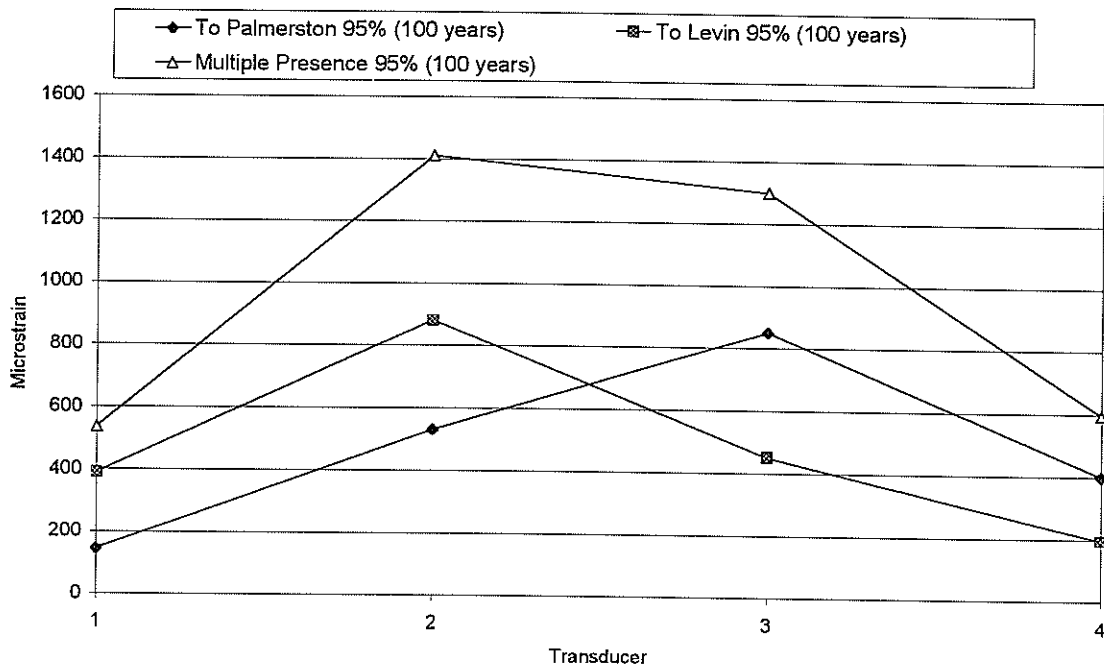
Figure 5.1 summarises an assessment of the multiple presence effects on the Otauru Bridge, based on the health monitoring data using the method that is consistent with the Bridge Manual. The diagram shows a transverse distribution of strain for each direction and the sum of these two distributions.

Figure 5.1 Multiple presence strains using the approach that is consistent with the Bridge Manual.

The maximum extrapolated health monitoring response for the midspan bending strain recorded on the soffit of the slab was 1400 $\mu\epsilon$ for a multiple presence event. This strain was extrapolated from transducer S(1-2) which was a demountable strain gauge positioned over a crack in the slab. In this case, the measurement recorded by the demountable strain gauge represents the change in crack width related to the traffic live loads. The recorded data must therefore be adjusted based on crack width theory in order to obtain the actual tensile bending strain in the reinforcement in the slab.
