**Health Monitoring of  
Superstructures of  
New Zealand Road Bridges:  
Waipawa Bridge, Hawke's Bay**

**Transfund New Zealand Research Report No.170**

R.P. Andersen, W.S. Roberts, R.J. Heywood & T.J. Heldt  
Infratech Systems & Services Pty Ltd,  
Brisbane, Australia

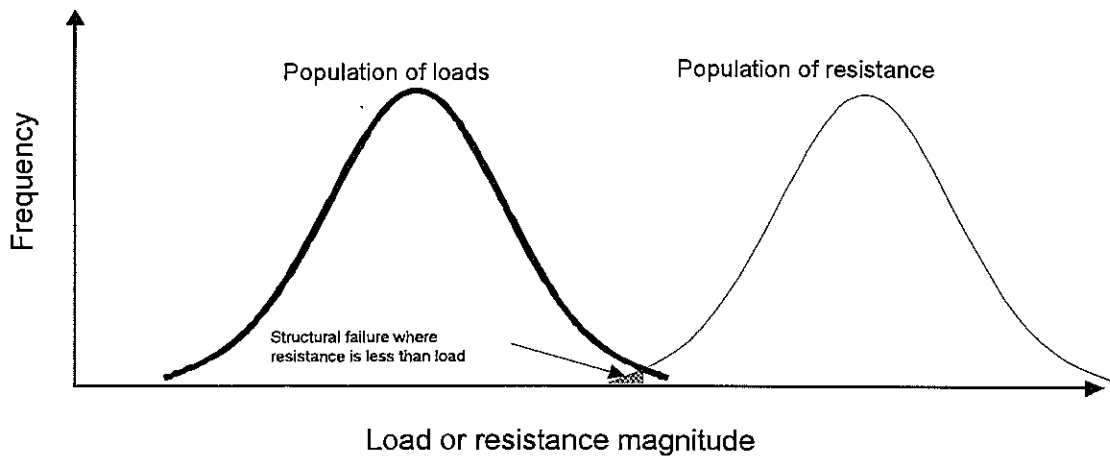
**Figure 2.1** Statistical representation of structural failure.

Both bridge design and bridge evaluation involve ensuring that the probability of the load being greater than the resistance (i.e. the bridge fails) is acceptably small. This is illustrated graphically on Figure 2.1.

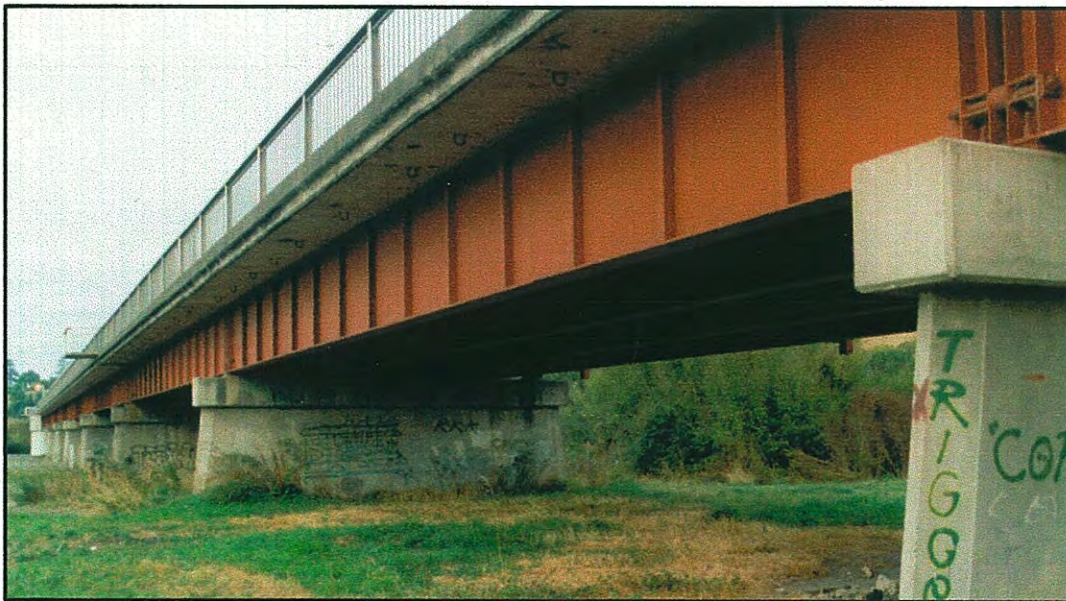
The Waipawa Bridge is located on State Highway (SH) 2, and crosses the Waipawa River near the town of Waipawa, about 70 km south of Hastings, in Hawke's Bay Region, North Island. The bridge consists of fourteen simply supported spans 21.6 m in length. Each span includes four steel plate "I" girders supporting a composite reinforced concrete deck. Channel shear connectors connect the deck slab to the steel girders. Construction of the 304 m-long bridge was completed in 1958 and is illustrated in Figure 3.1.

**Figure 3.1** Waipawa Bridge, in southern Hawke's Bay, North Island, New Zealand.

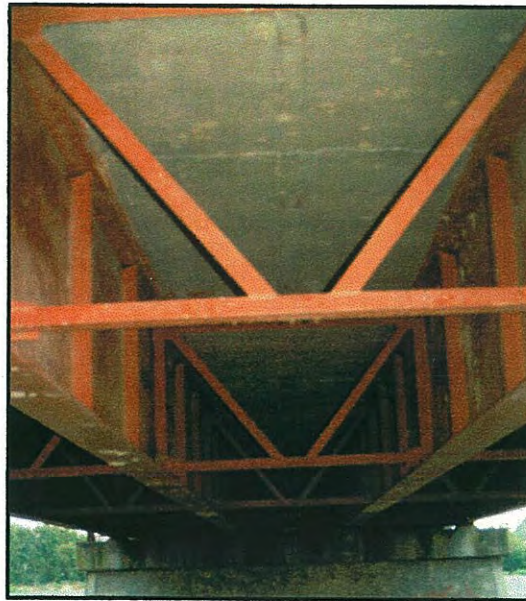
**Figure 3.2** Bracing of the main girders.

The girders of the structure are braced diagonally at the ends and at regular intervals along the length of each girder. This bracing is illustrated in Figure 3.2. The bridge is generally in good condition, and the transverse cracks that occur in the deck slab at regular intervals are believed to be caused by shrinkage effects. The drawings show that the slab is lightly reinforced longitudinally and that this reinforcement is grouped in bands between the girders to avoid the channel shear connectors.

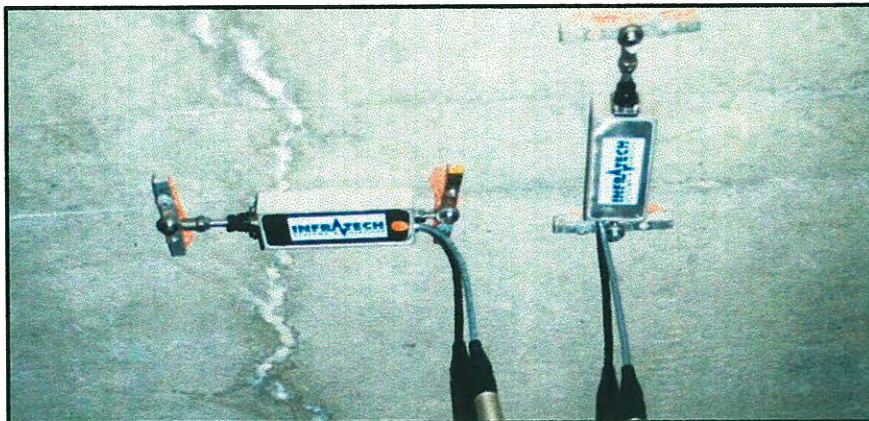
Figure 4.4 Instrumentation on the deck.

Figure 4.3 illustrates a demountable strain gauge on the midspan of a typical girder. The transducers installed on the concrete deck slab are illustrated in Figure 4.4, and they were installed to measure the transverse and longitudinal bending in the deck. The transducer measuring the longitudinal strain is located over one of the transverse shrinkage cracks. The orientation and position of the foil strain gauges is illustrated in Figure 4.7. These gauges were installed on the southern end of Girder 4 to measure the shear response of the girder.

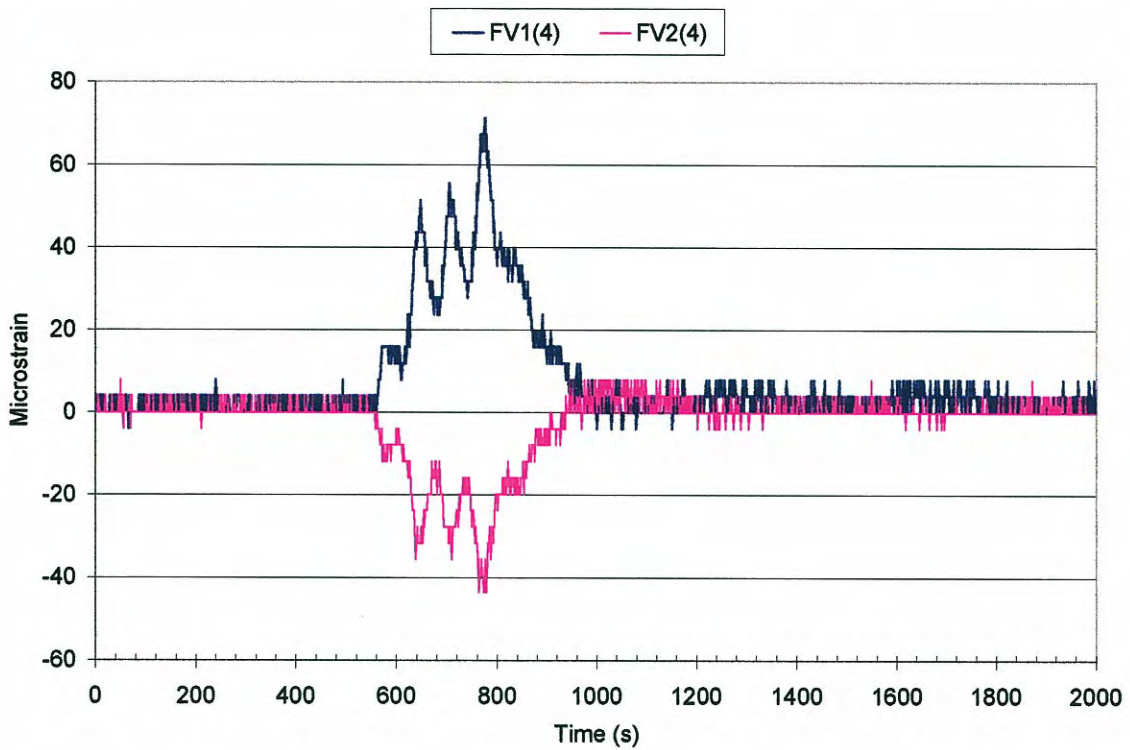
Figure 4.9 Waveforms for shear transducers recorded during the passage of a northbound vehicle.

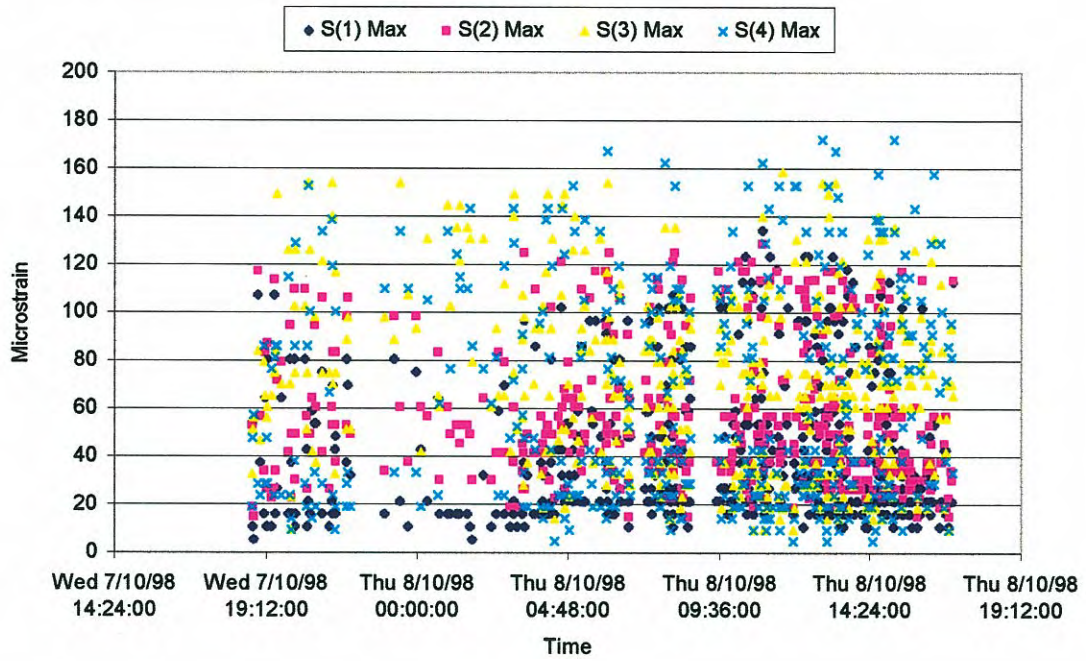
Figure 4.10 Scatter diagram for the midspan transducers.

The distributions for the midspan transducers are not linear, indicating that the data are not normally distributed. A closer inspection of the scatter diagram (particularly for transducer S(2), in Figure 4.10) shows that the data have two distinct populations. This is better illustrated on the histogram in Figure 4.12. The reasons for these two populations may be two different groups of heavy vehicle traffic, or the effects of vehicles travelling in different directions (lanes) on the bridge.

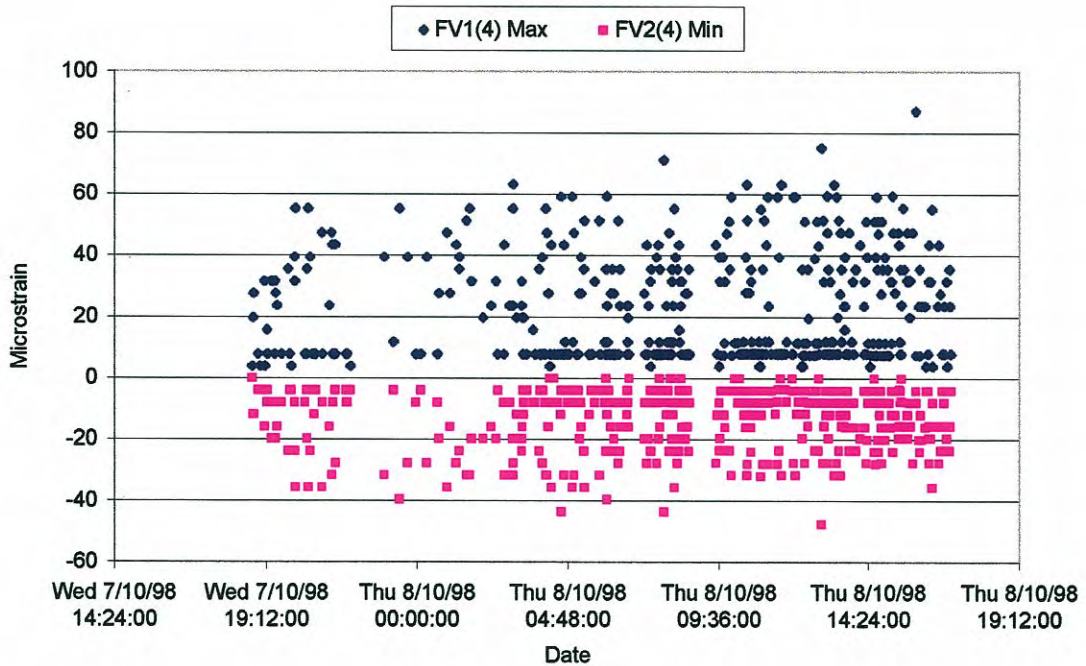
Figure 4.11 Scatter diagram for the shear transducers.

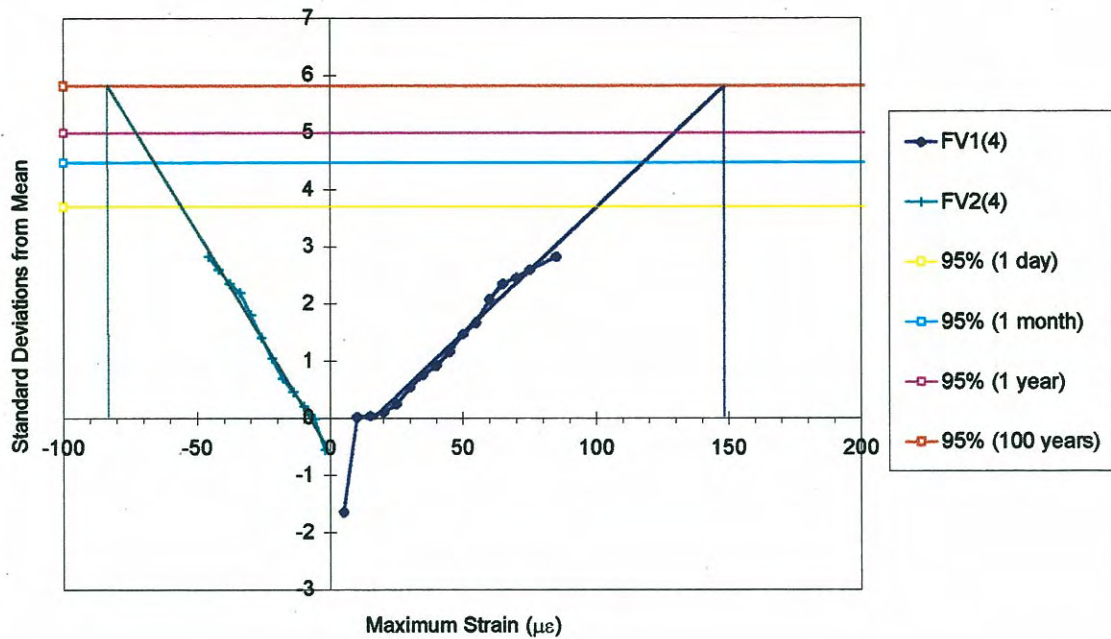
Figure 4.16 Inverse normal distribution for foil strain gauges.

The inverse normal distributions for the foil strain gauges measuring the shear effects in Girder 4 are presented in Figure 4.16.

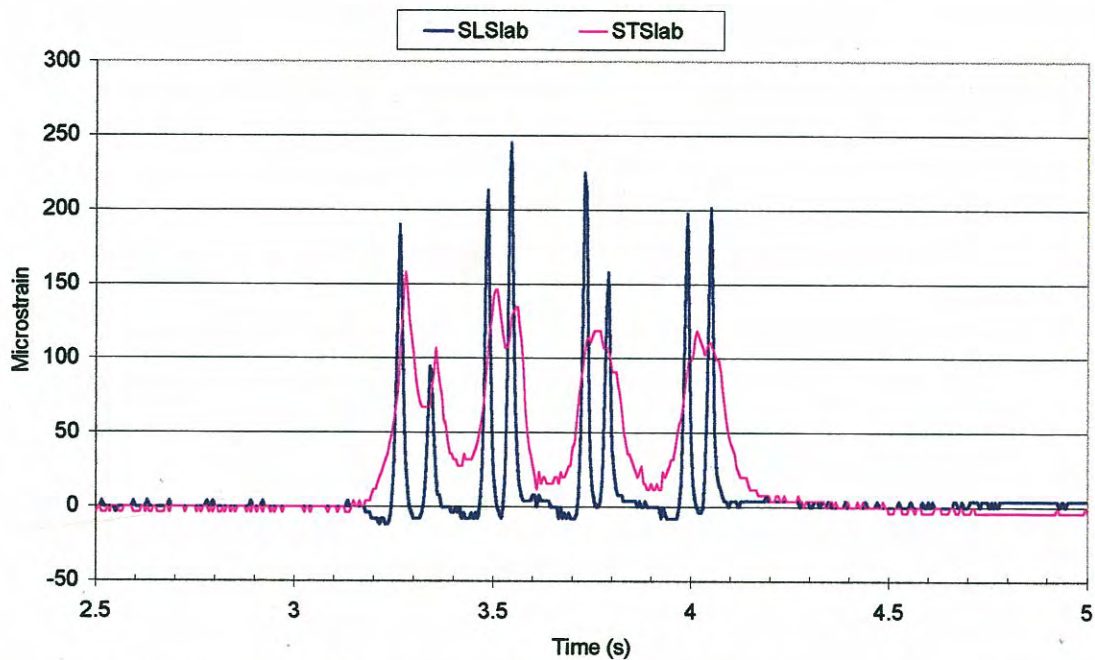
Figure 4.17 shows clearly the response of the deck to each individual axle as it passed over the instrumented span. The waveforms show differences between transverse and longitudinal bending strains in the deck.

Figure 4.17 Waveform for deck transducers for the passage of a northbound vehicle.

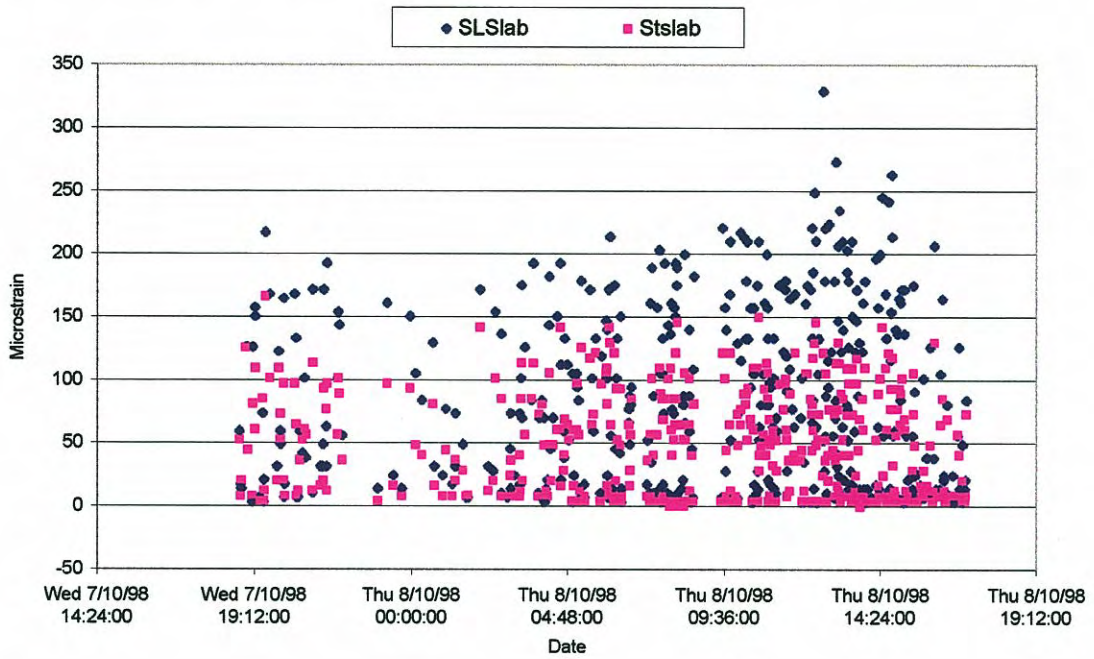
**Figure 4.18 Scatter diagram for transducers installed on the deck.**

The scatter diagram for the deck transducers is presented in Figure 4.18. The maximum event recorded for transducers SLSlab (longitudinal) and StSlab (transverse) were  $330 \mu\epsilon$  and  $165 \mu\epsilon$  respectively. The scatter diagram shows that longitudinal deck strain was consistently higher than the transverse deck bending strain. This is because the transducer that measured the longitudinal strain was located over one of the transverse cracks in the slab. Figure 4.19 presents the inverse normal distribution for the deck transducers, and the extrapolated values for the two deck transducers are summarised in Table 4.2.

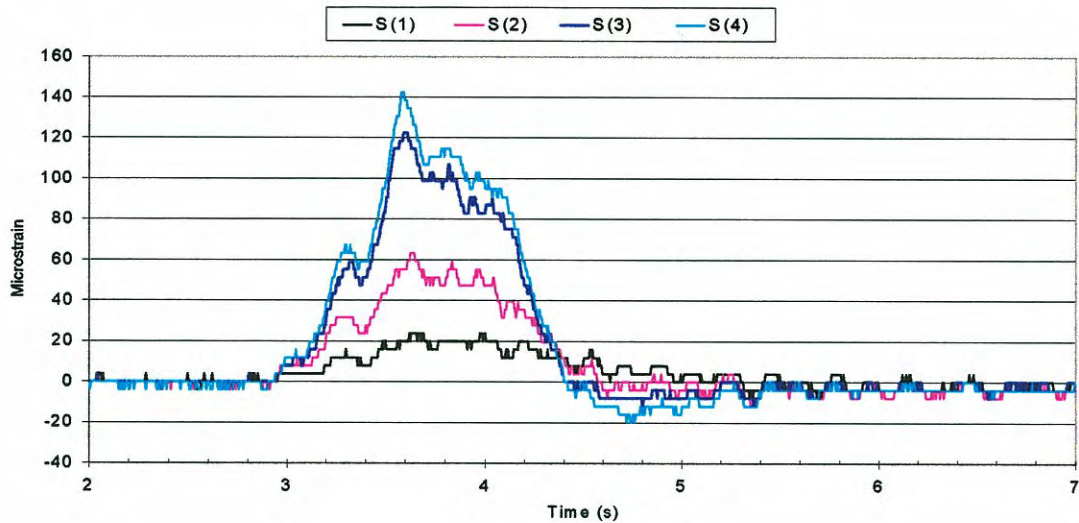
A typical waveform from the testing with the known vehicle is presented in Figure 4.20. In this figure, tensile strains are positive and compressive strains are negative.

**Figure 4.20** Waveforms for midspan transducers for northbound vehicle travelling at 80 km/h.

The dynamic response of the structure after the vehicle passed over the span is evident. The compressive (negative) strains recorded after the vehicle had passed over the span indicate some continuity between the instrumented span and its adjacent span, which is described in section 4.3. The maximum strains from the testing for each of the transducers on the main girders are presented in Table 4.3.

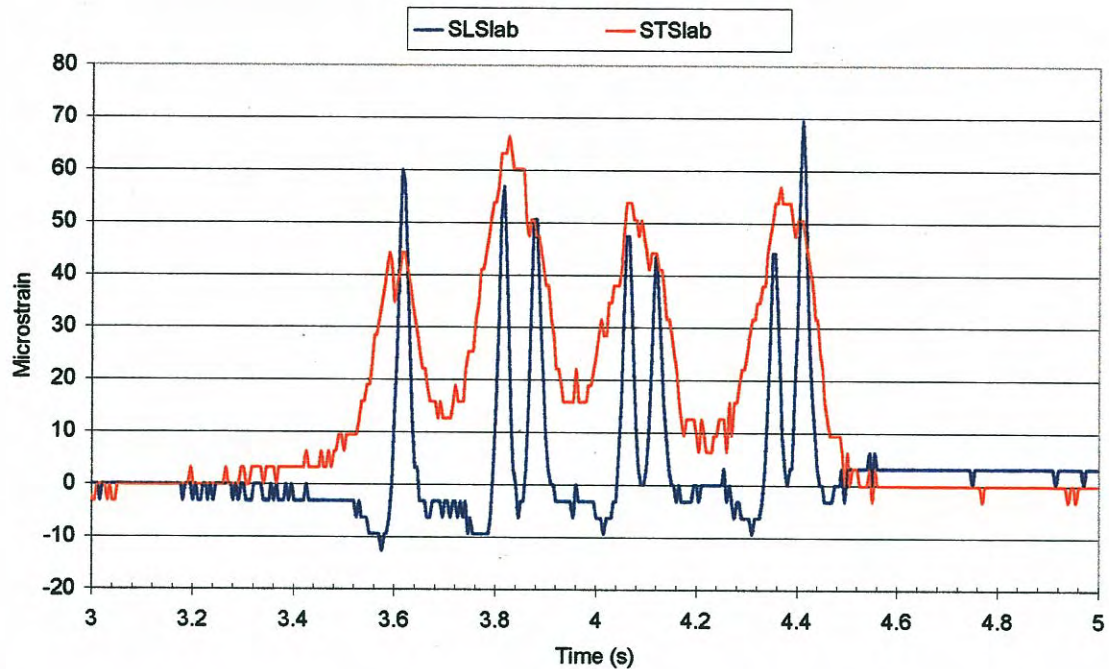
Figure 4.24 Waveform for deck transducers for vehicle travelling south at 80 km/h.

The values for the bending in the slab are also much larger for the Health Monitoring. Strains in the deck are more sensitive to wheel positions and a greater range of wheel positions would be expected from the ambient traffic.

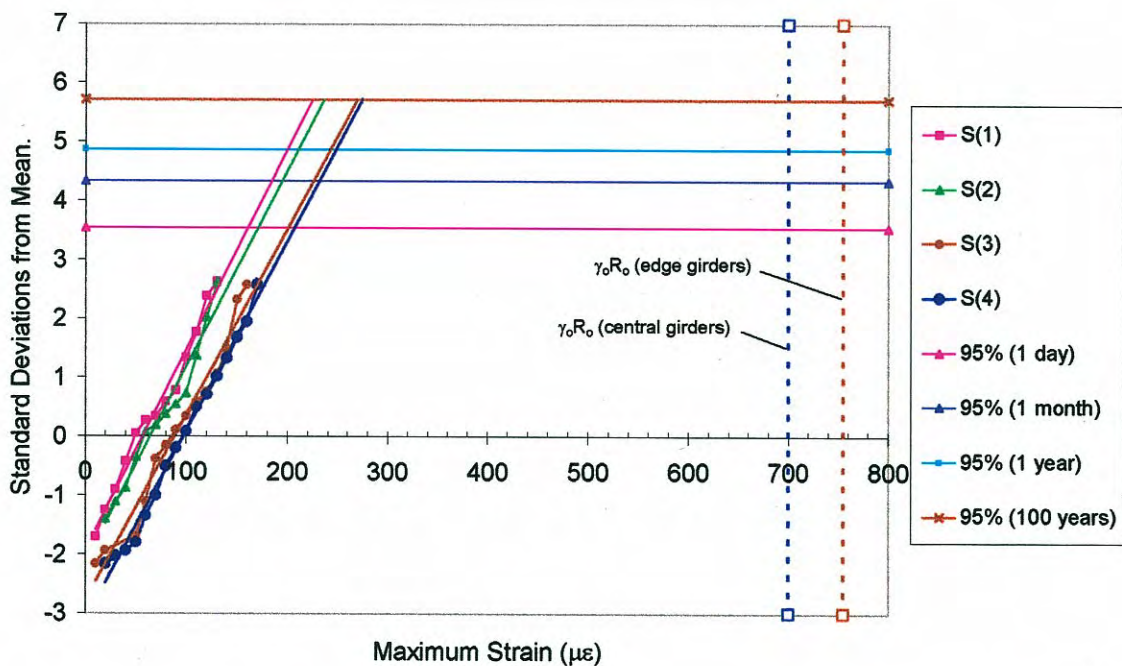
Figure 5.1 Inverse normal distributions for midspan transducers showing the ultimate live load capacity.

The analysis in section 3.2 of this report indicated that midspan girder bending was the critical mode of failure for the girders of the Waipawa Bridge. Thus the Fitness for Purpose has been determined based on this failure mode. The moment capacity ( $\phi M_{bx} - 1.3DL$ ) for the ultimate traffic live load was 3340 kNm for the critical edge girder and 2950 kNm for a middle girder. These moments correspond to strains in the soffit of the girders of 755  $\mu\epsilon$  and 700  $\mu\epsilon$  respectively. Figure 5.1 illustrates the extrapolated health monitoring data with these ultimate live load strains superimposed on the graph. This information shows that the ultimate traffic live load strain (95% in 100 years) is approximately one third of the available live load capacity.
